Nicodemus National Historic Site
Nicodemus, Kansas
Historic Structures Report
National Park Service

25 October 2002

Bahr Vermeer Haecker Architects, Ltd.
in association with
Wiss Janney Elstner Associates, Inc.

Historic Structures Report

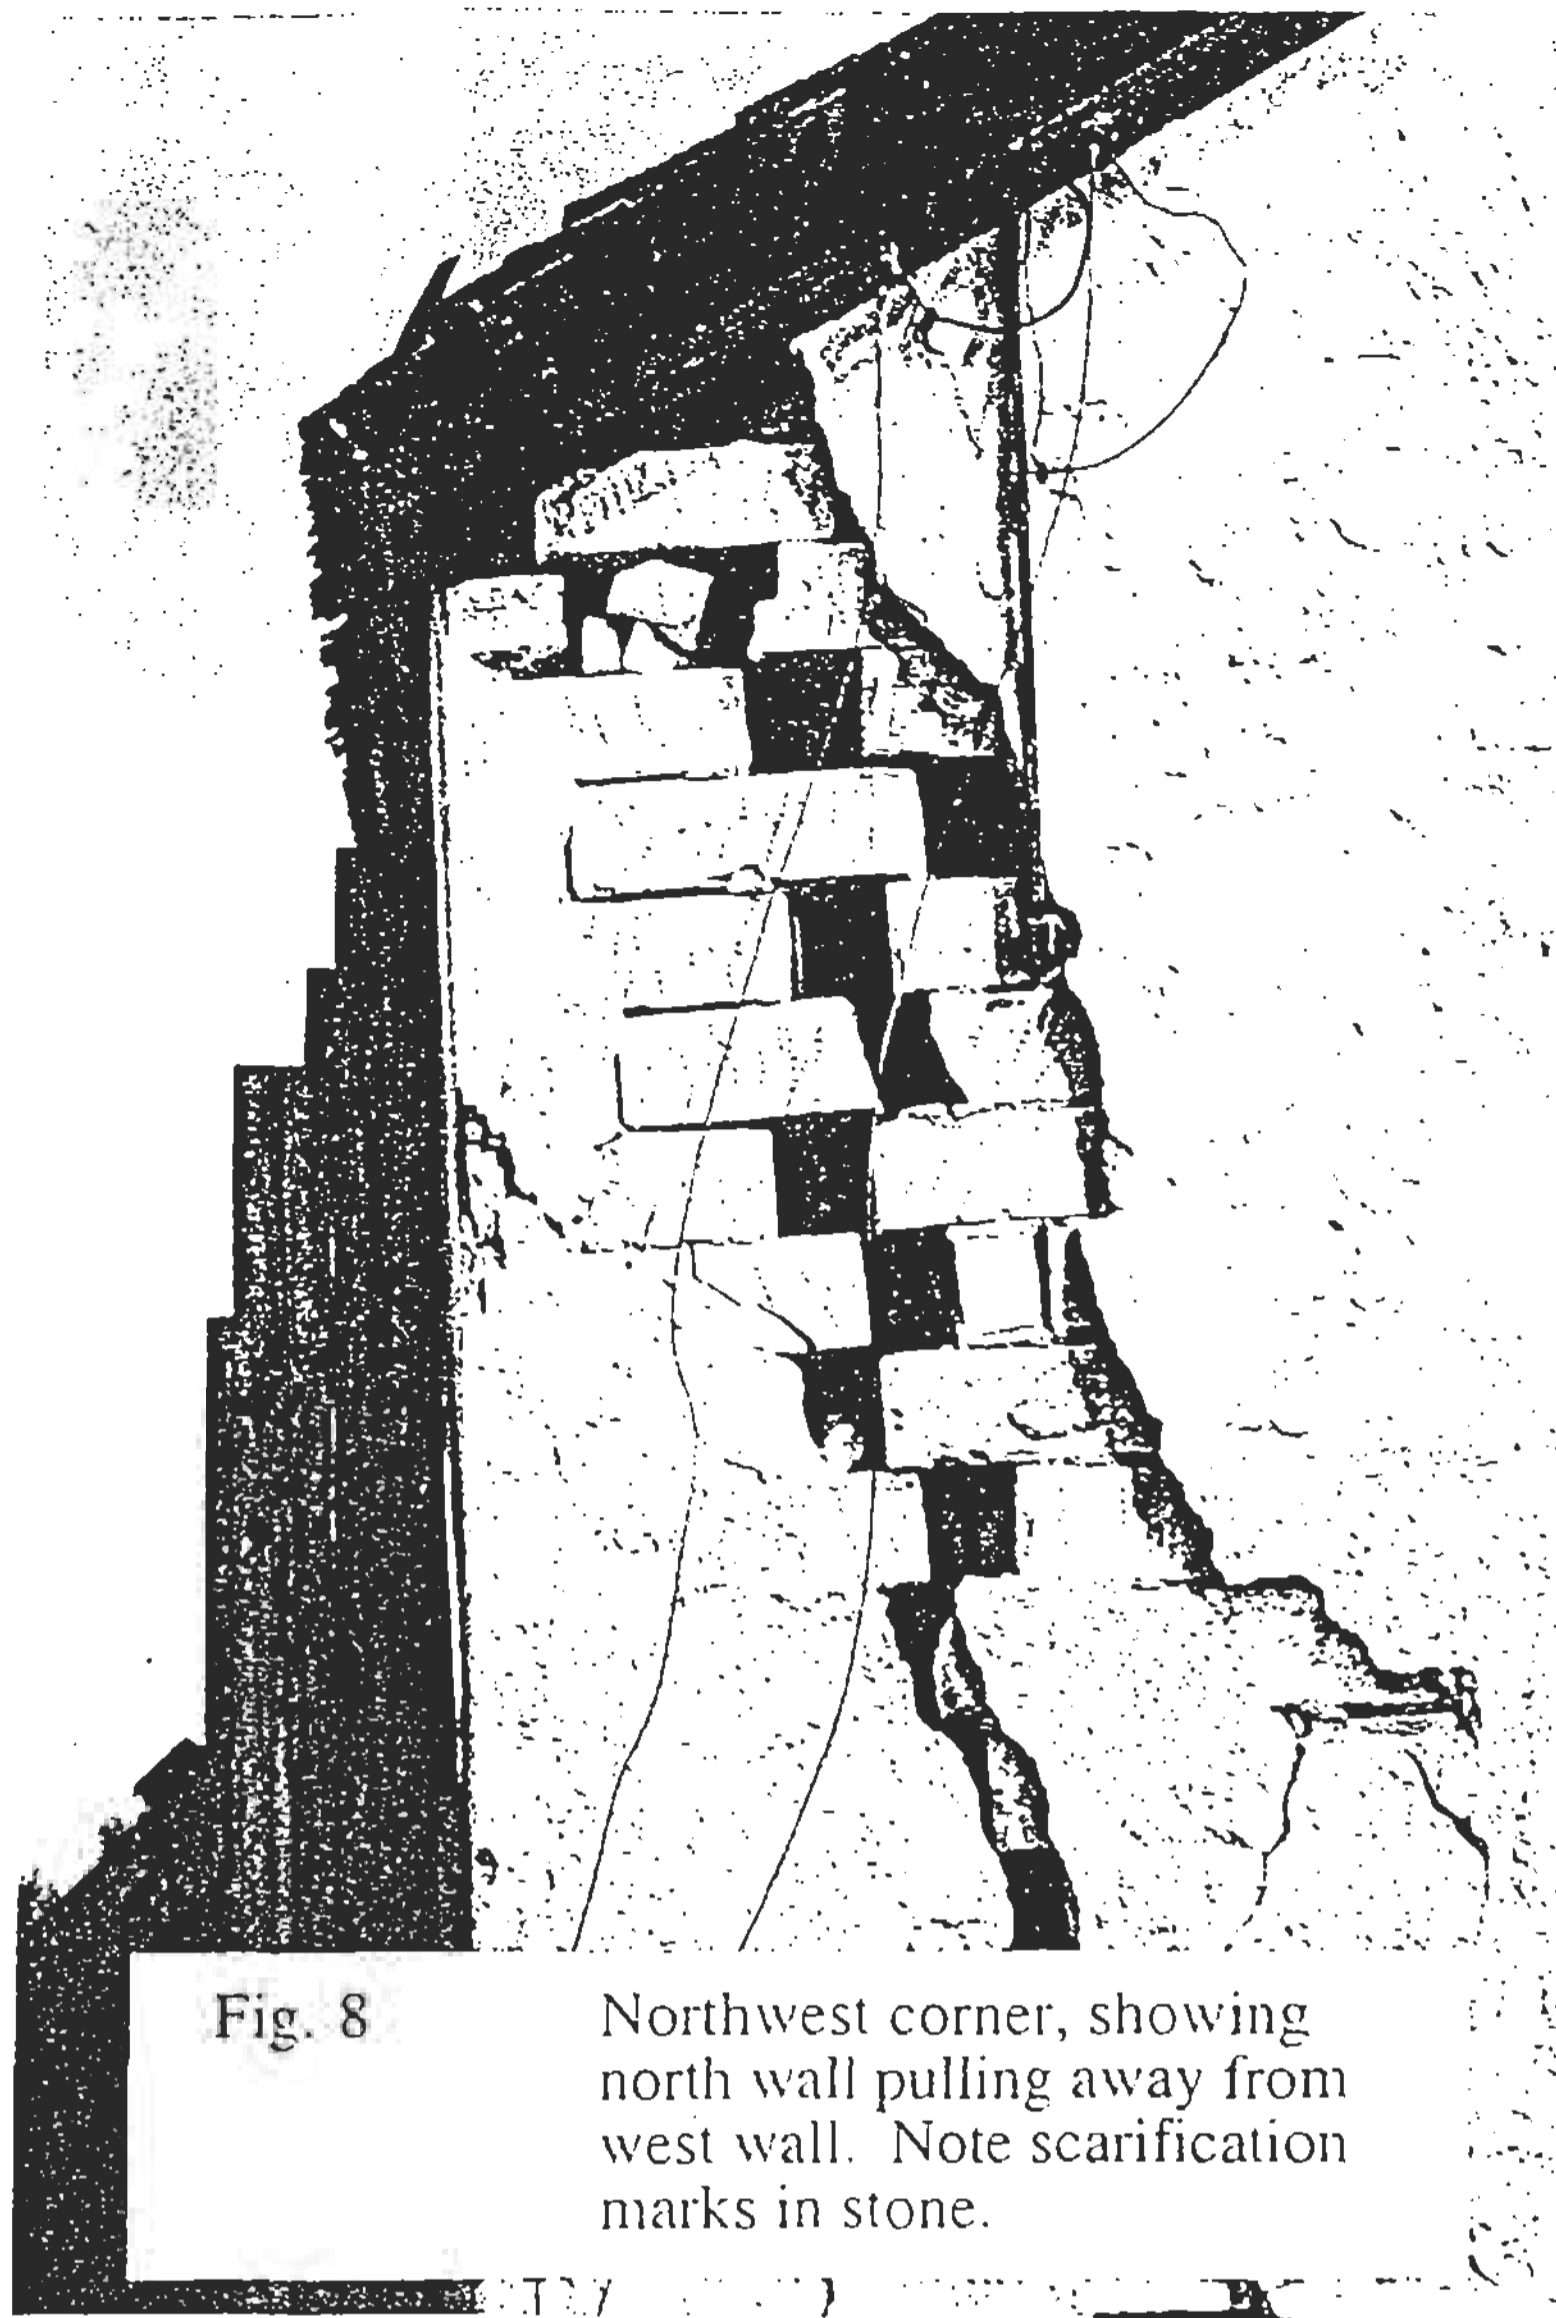
Fig. 8

At some point in the past, possibly in the 1930's, the exterior wythe of limestone blocks was scarified and a cement plaster stucco was placed over the entire exterior (Figs 1, 8). The interior finish on the stone walls is painted plaster which appears to be original. The exterior stucco is fairly intact, except for some vertical cracking, on the vestibule and on the east and west walls of the main church. The stucco on the south wall has fallen off along the entire length of the wall for a height of about twenty-four inches above the foundation (Fig. 3). Stucco has fallen off from the eastern half of the south wall for a height of four to six feet, indicating a more severe problem in this area (Fig. 2). The stone exposed to the exterior appears to be in fairly good condition, except at the base of the wall in the eastern half of the south elevation. In general, not much mortar remains, although the extent of this condition is difficult to determine without removal of the stucco.

been shored up from the interior and the exterior with wood shoring (Figs 7, 10). Much of the stone has collapsed, leaving the remainder of the wall very unstable. The north wall is about six inches from vertical at the west end (Fig. 8).

Northwest corner, showing north wall pulling away from west wall. Note scarification marks in stone.

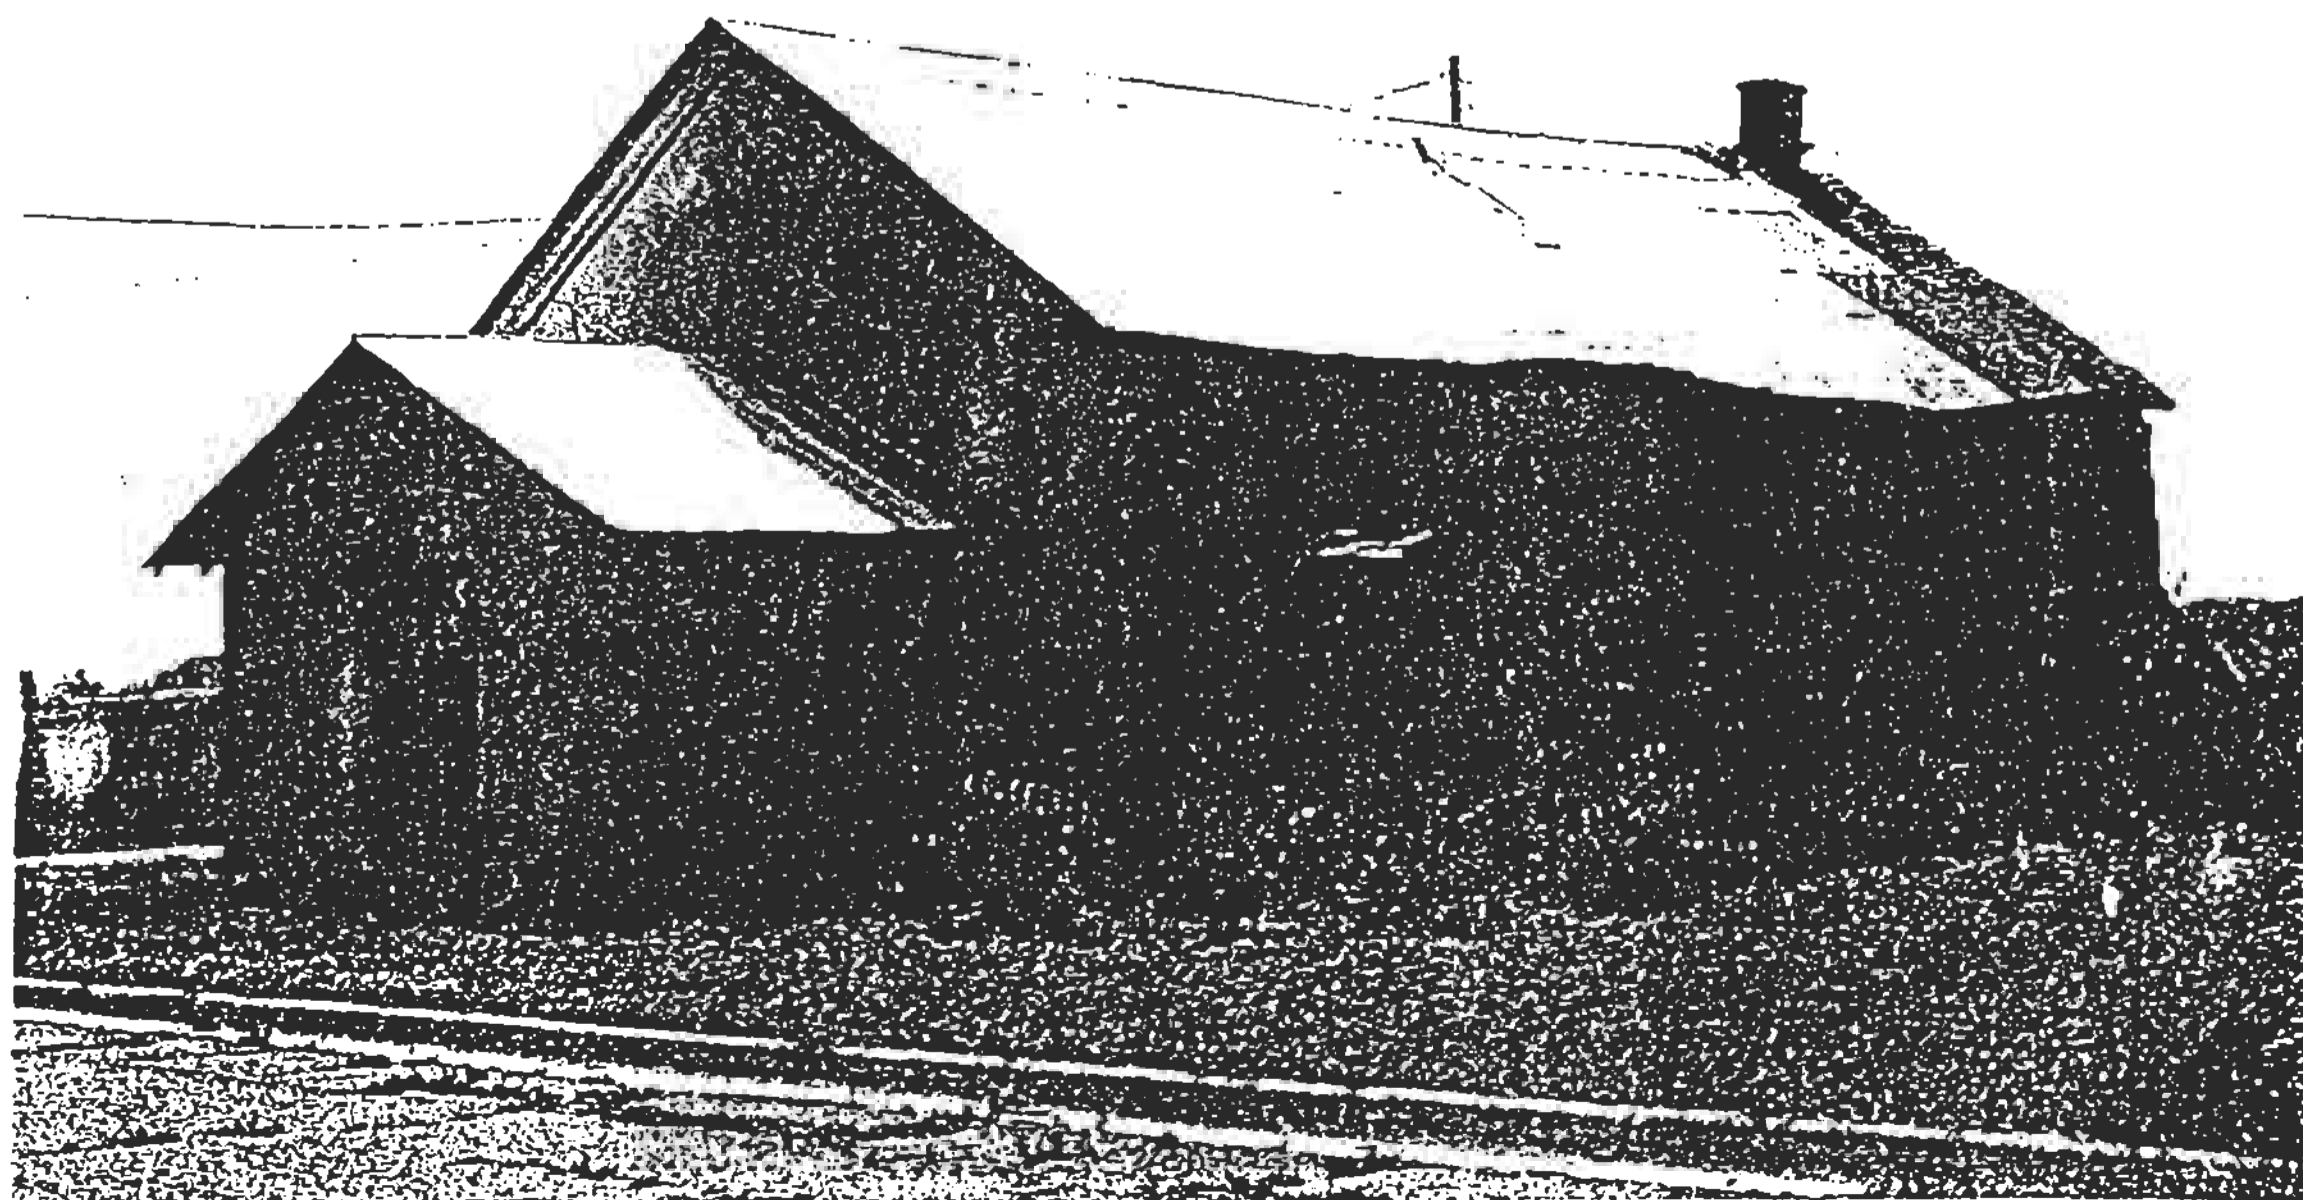
Fig. 9

The north wall of the main church is extremely dilapidated and partially collapsed (Figs 7, 9, 12). At some point in the past, a large opening (about twelve feet high and about twelve feet long) was cut into the western portion of the north wall (Fig. 12). Another opening, about eight feet high and about six feet wide, was cut into the eastern portion of the north wall (Fig. 12). The north wall has

North and east sides

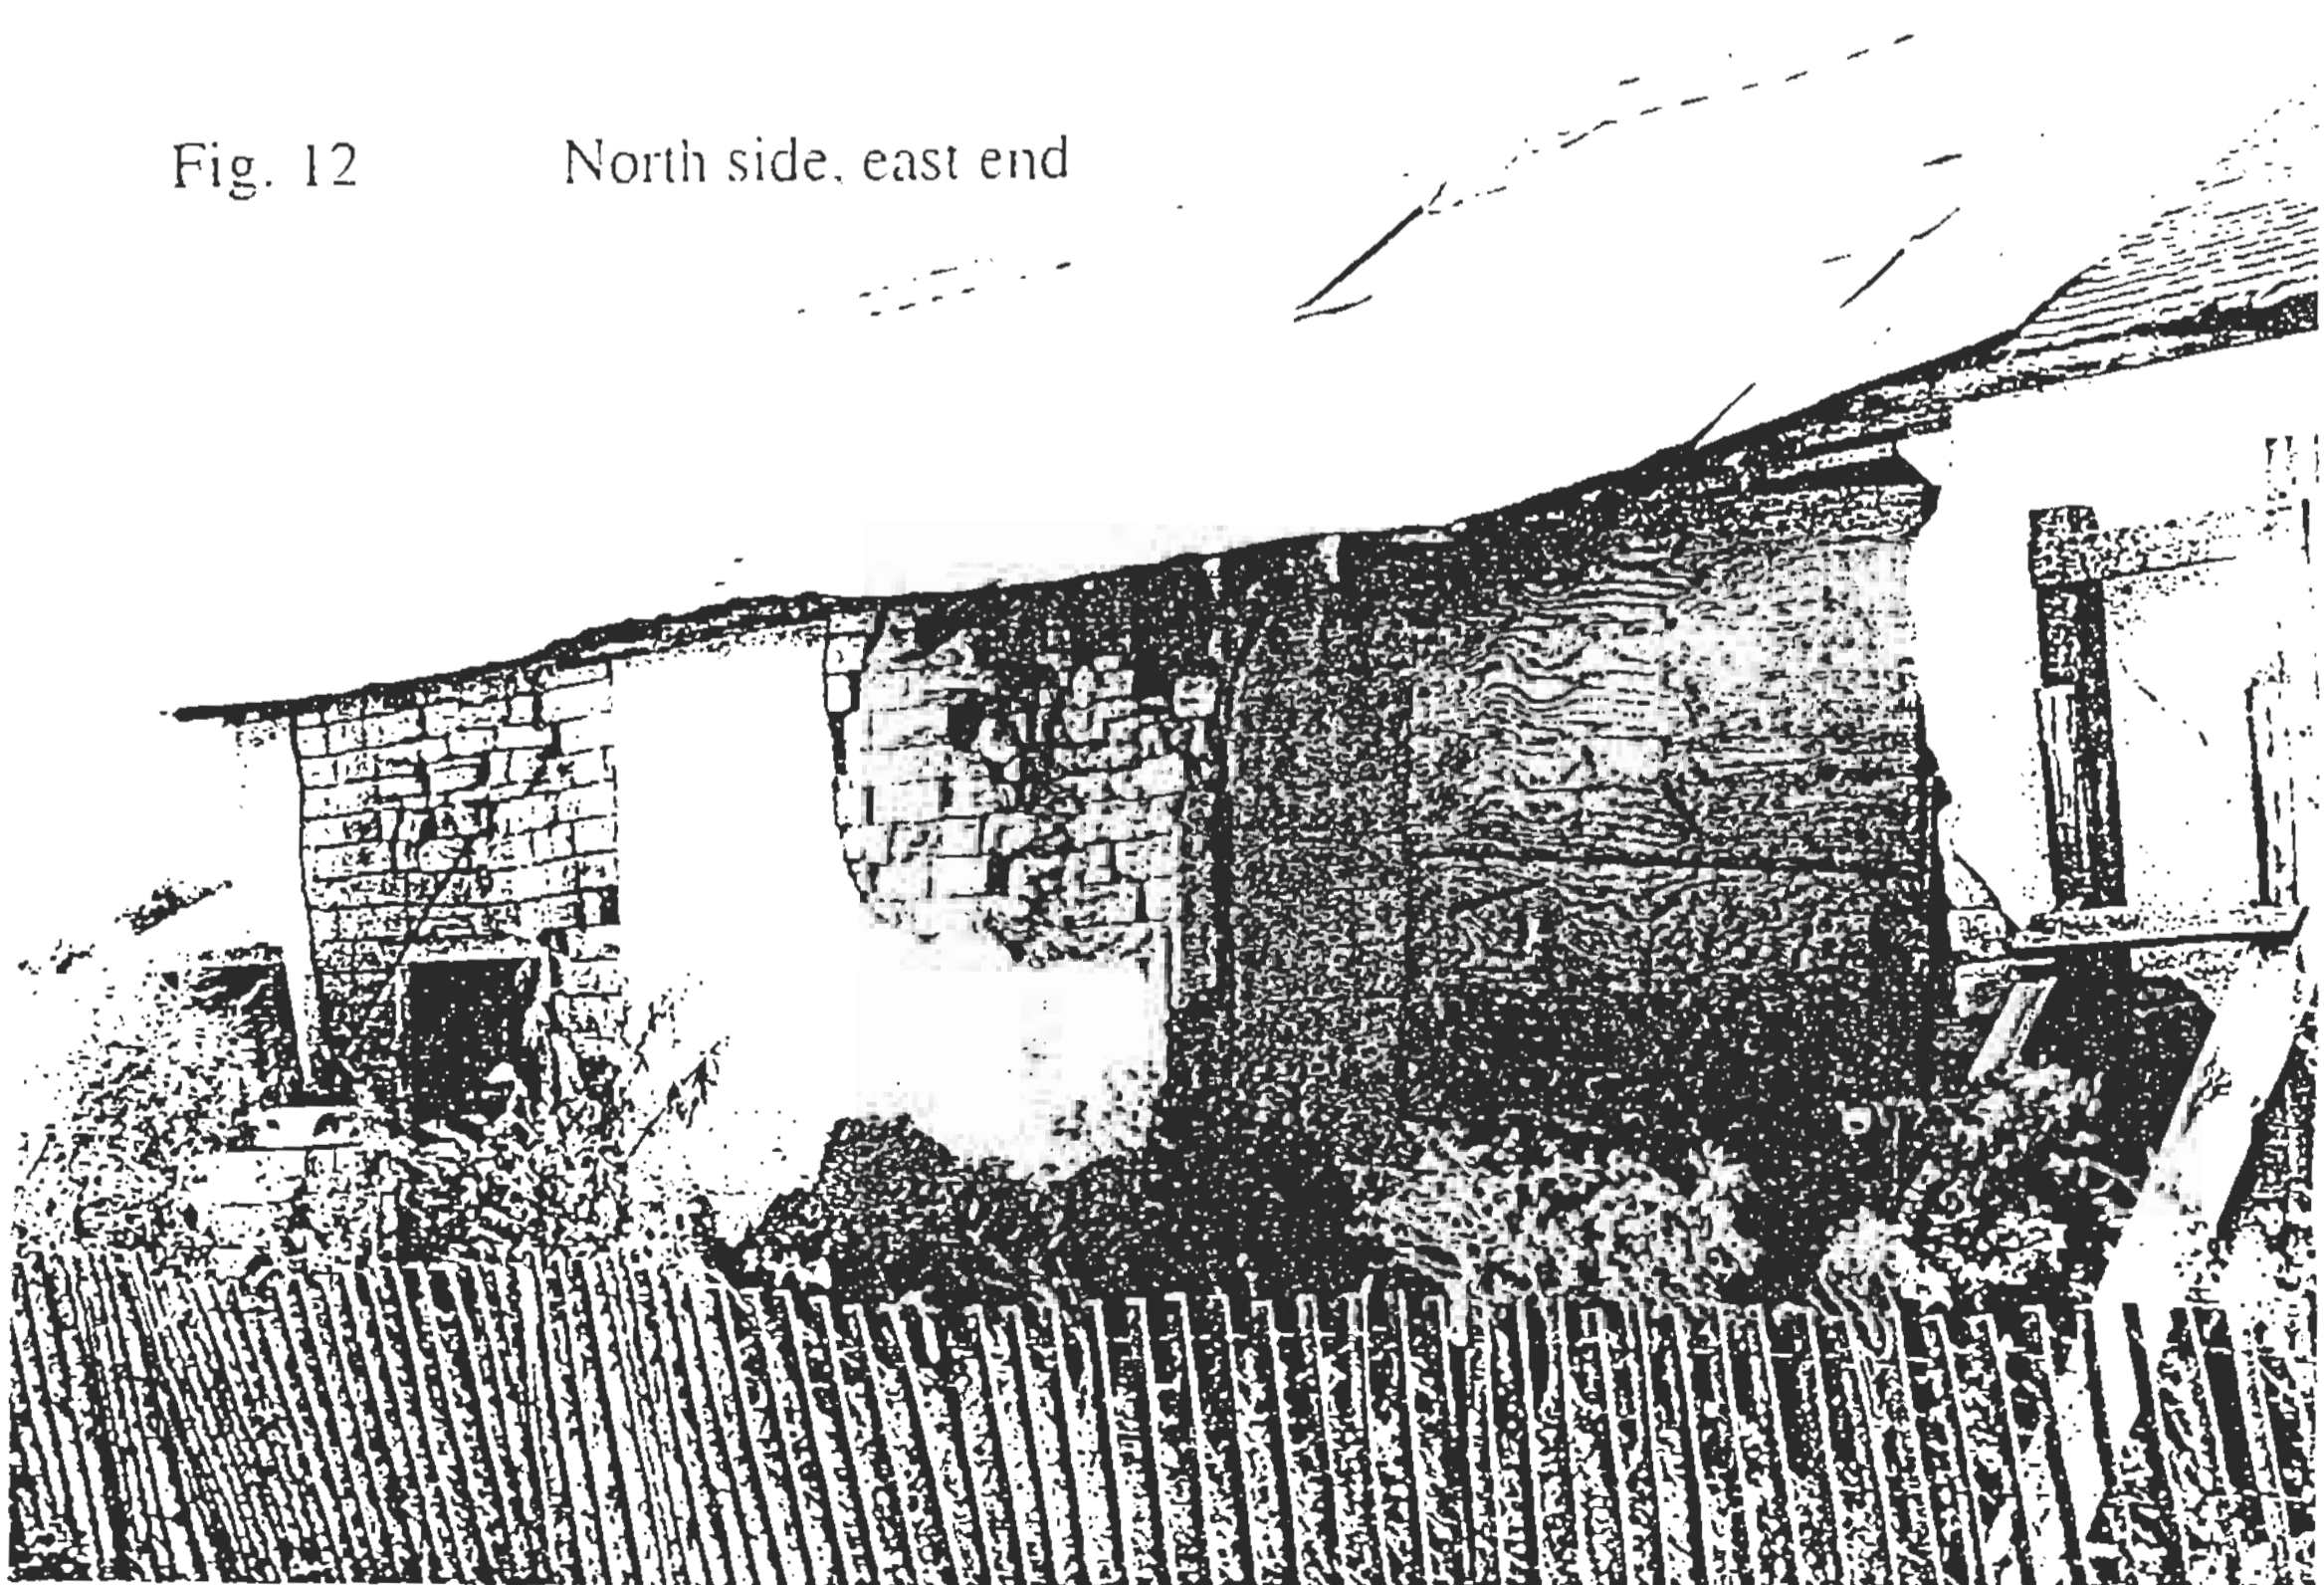
Fig. 12

North side, east end

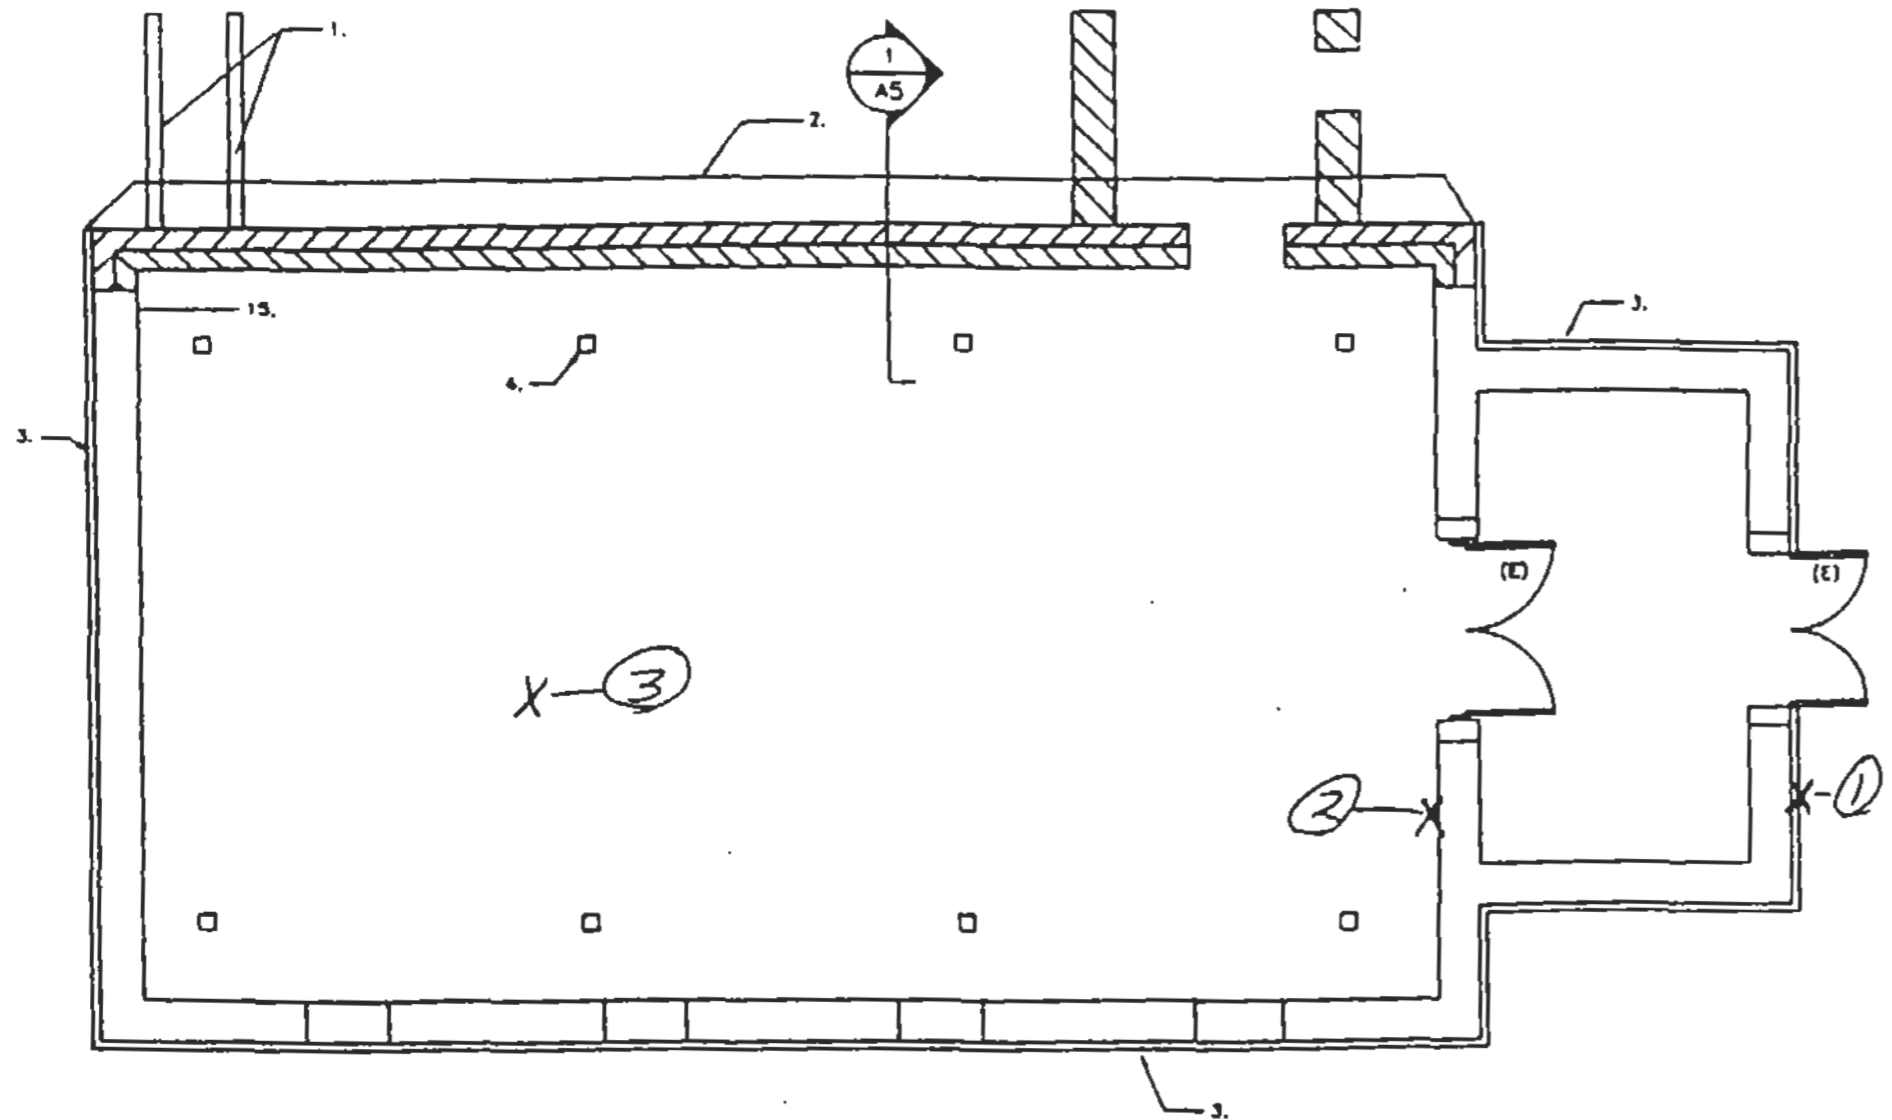
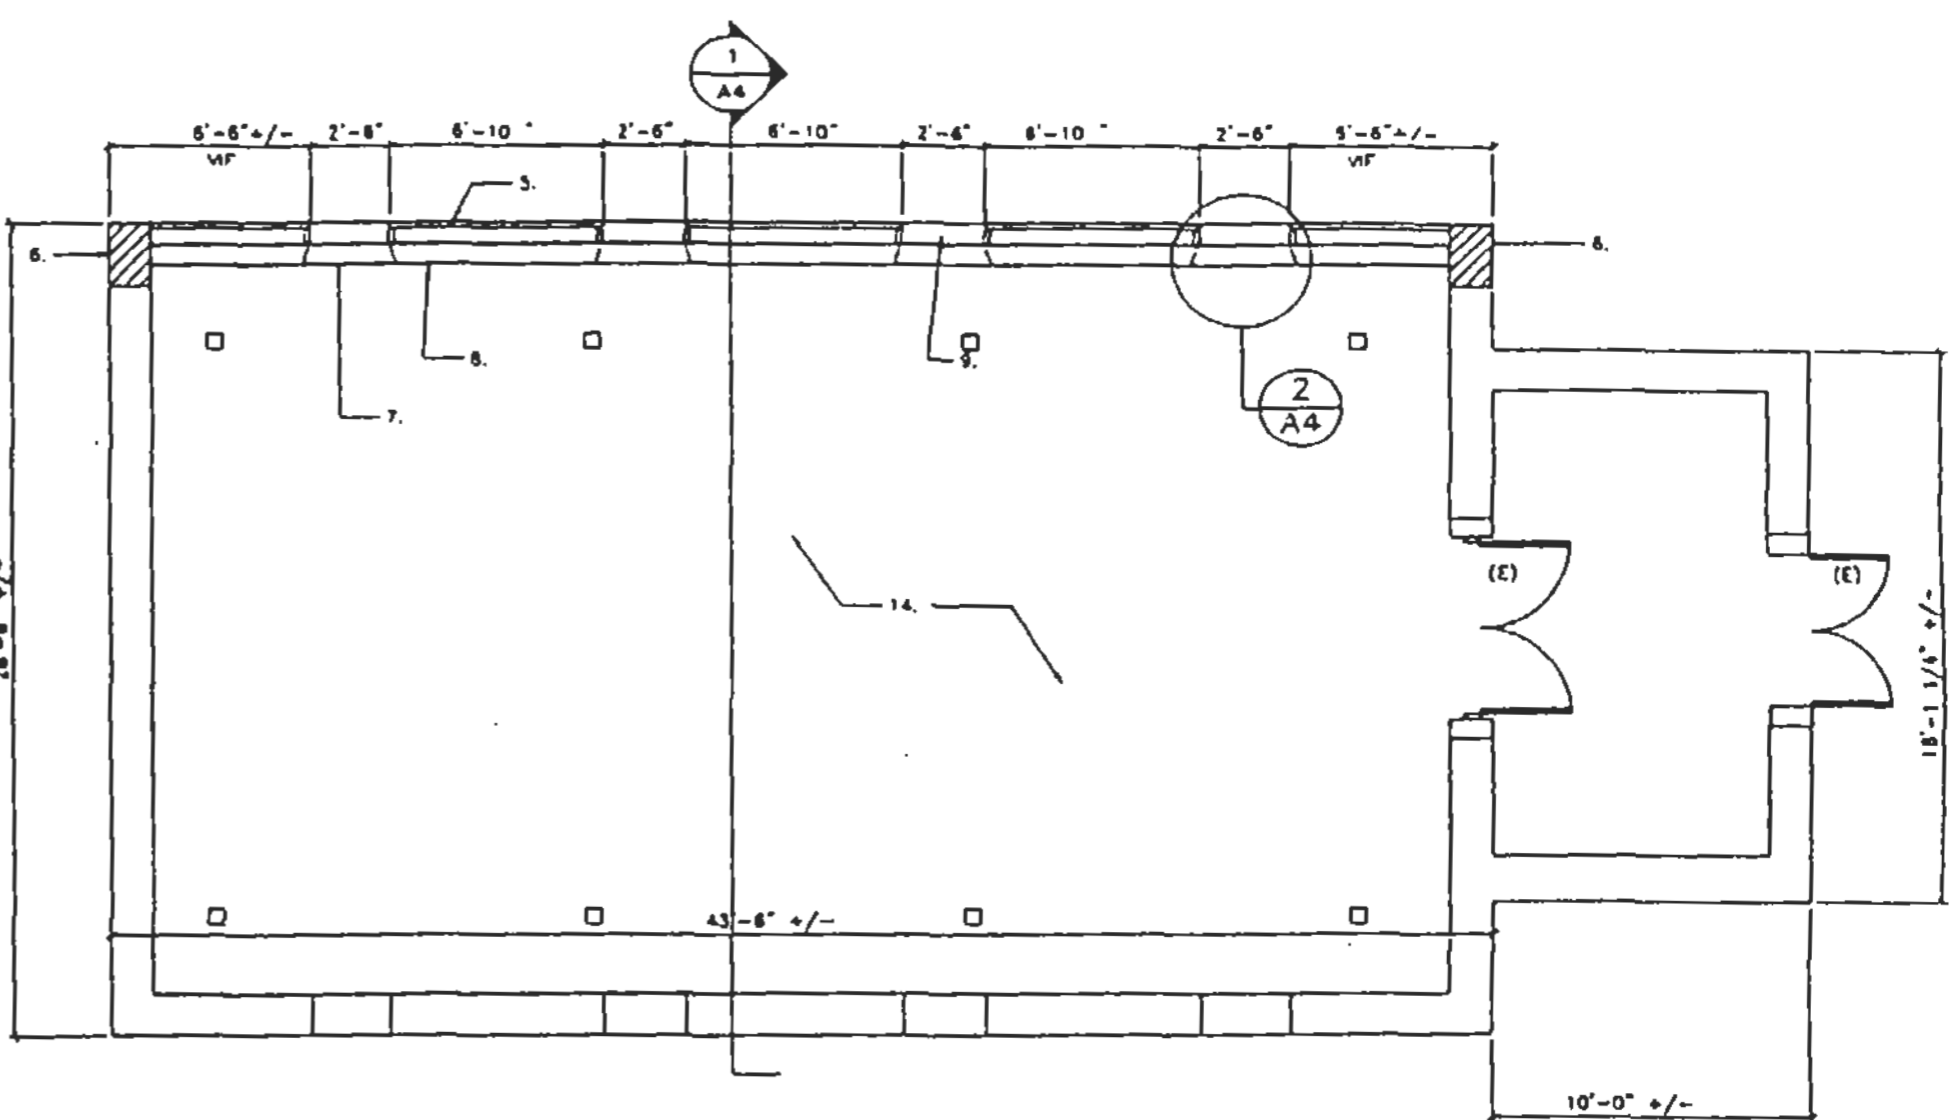
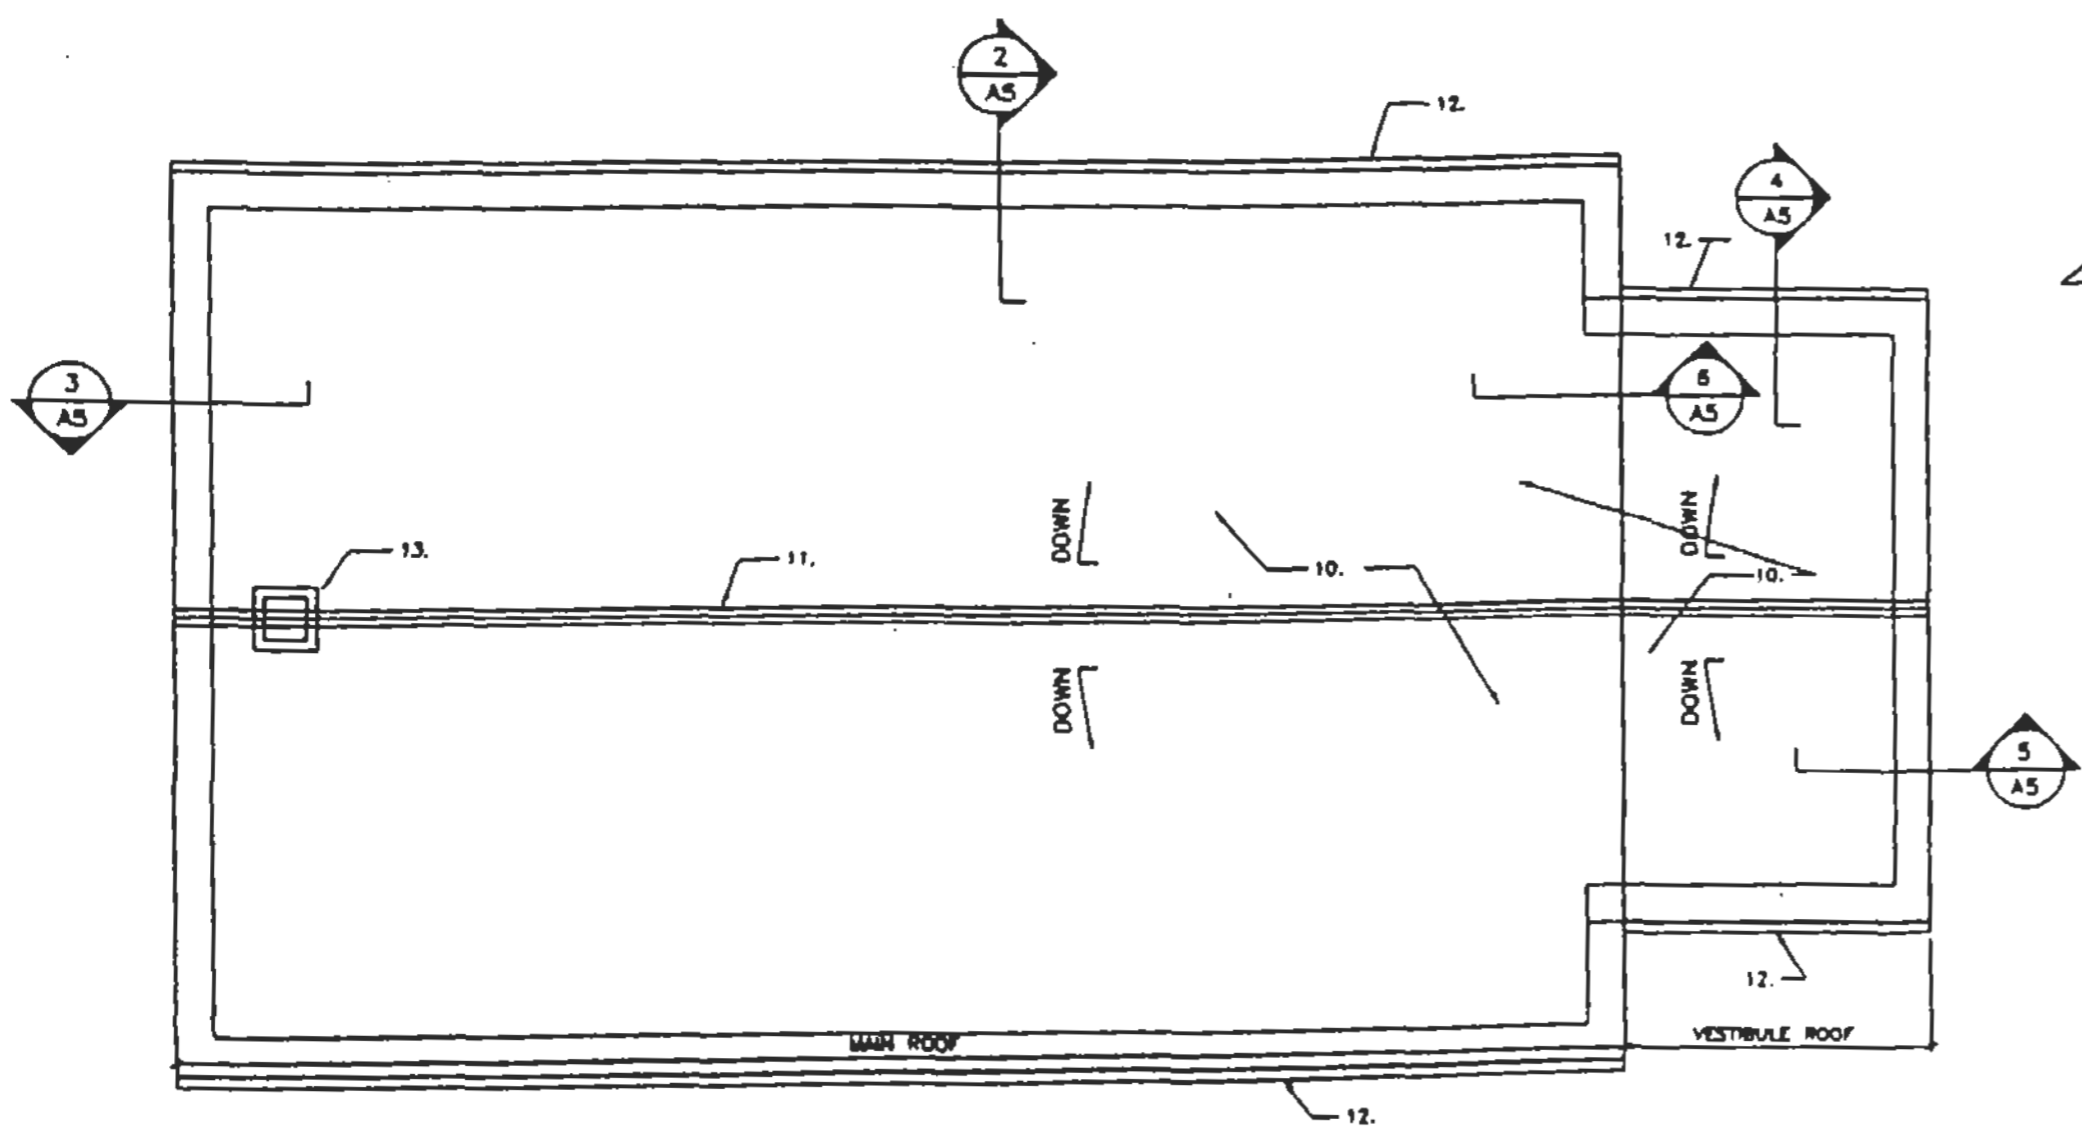
KEYED NOTES
 (##) = Negative Asbestos Sample
 (#) = Positive Asbestos Sample
 X = Sample Collected

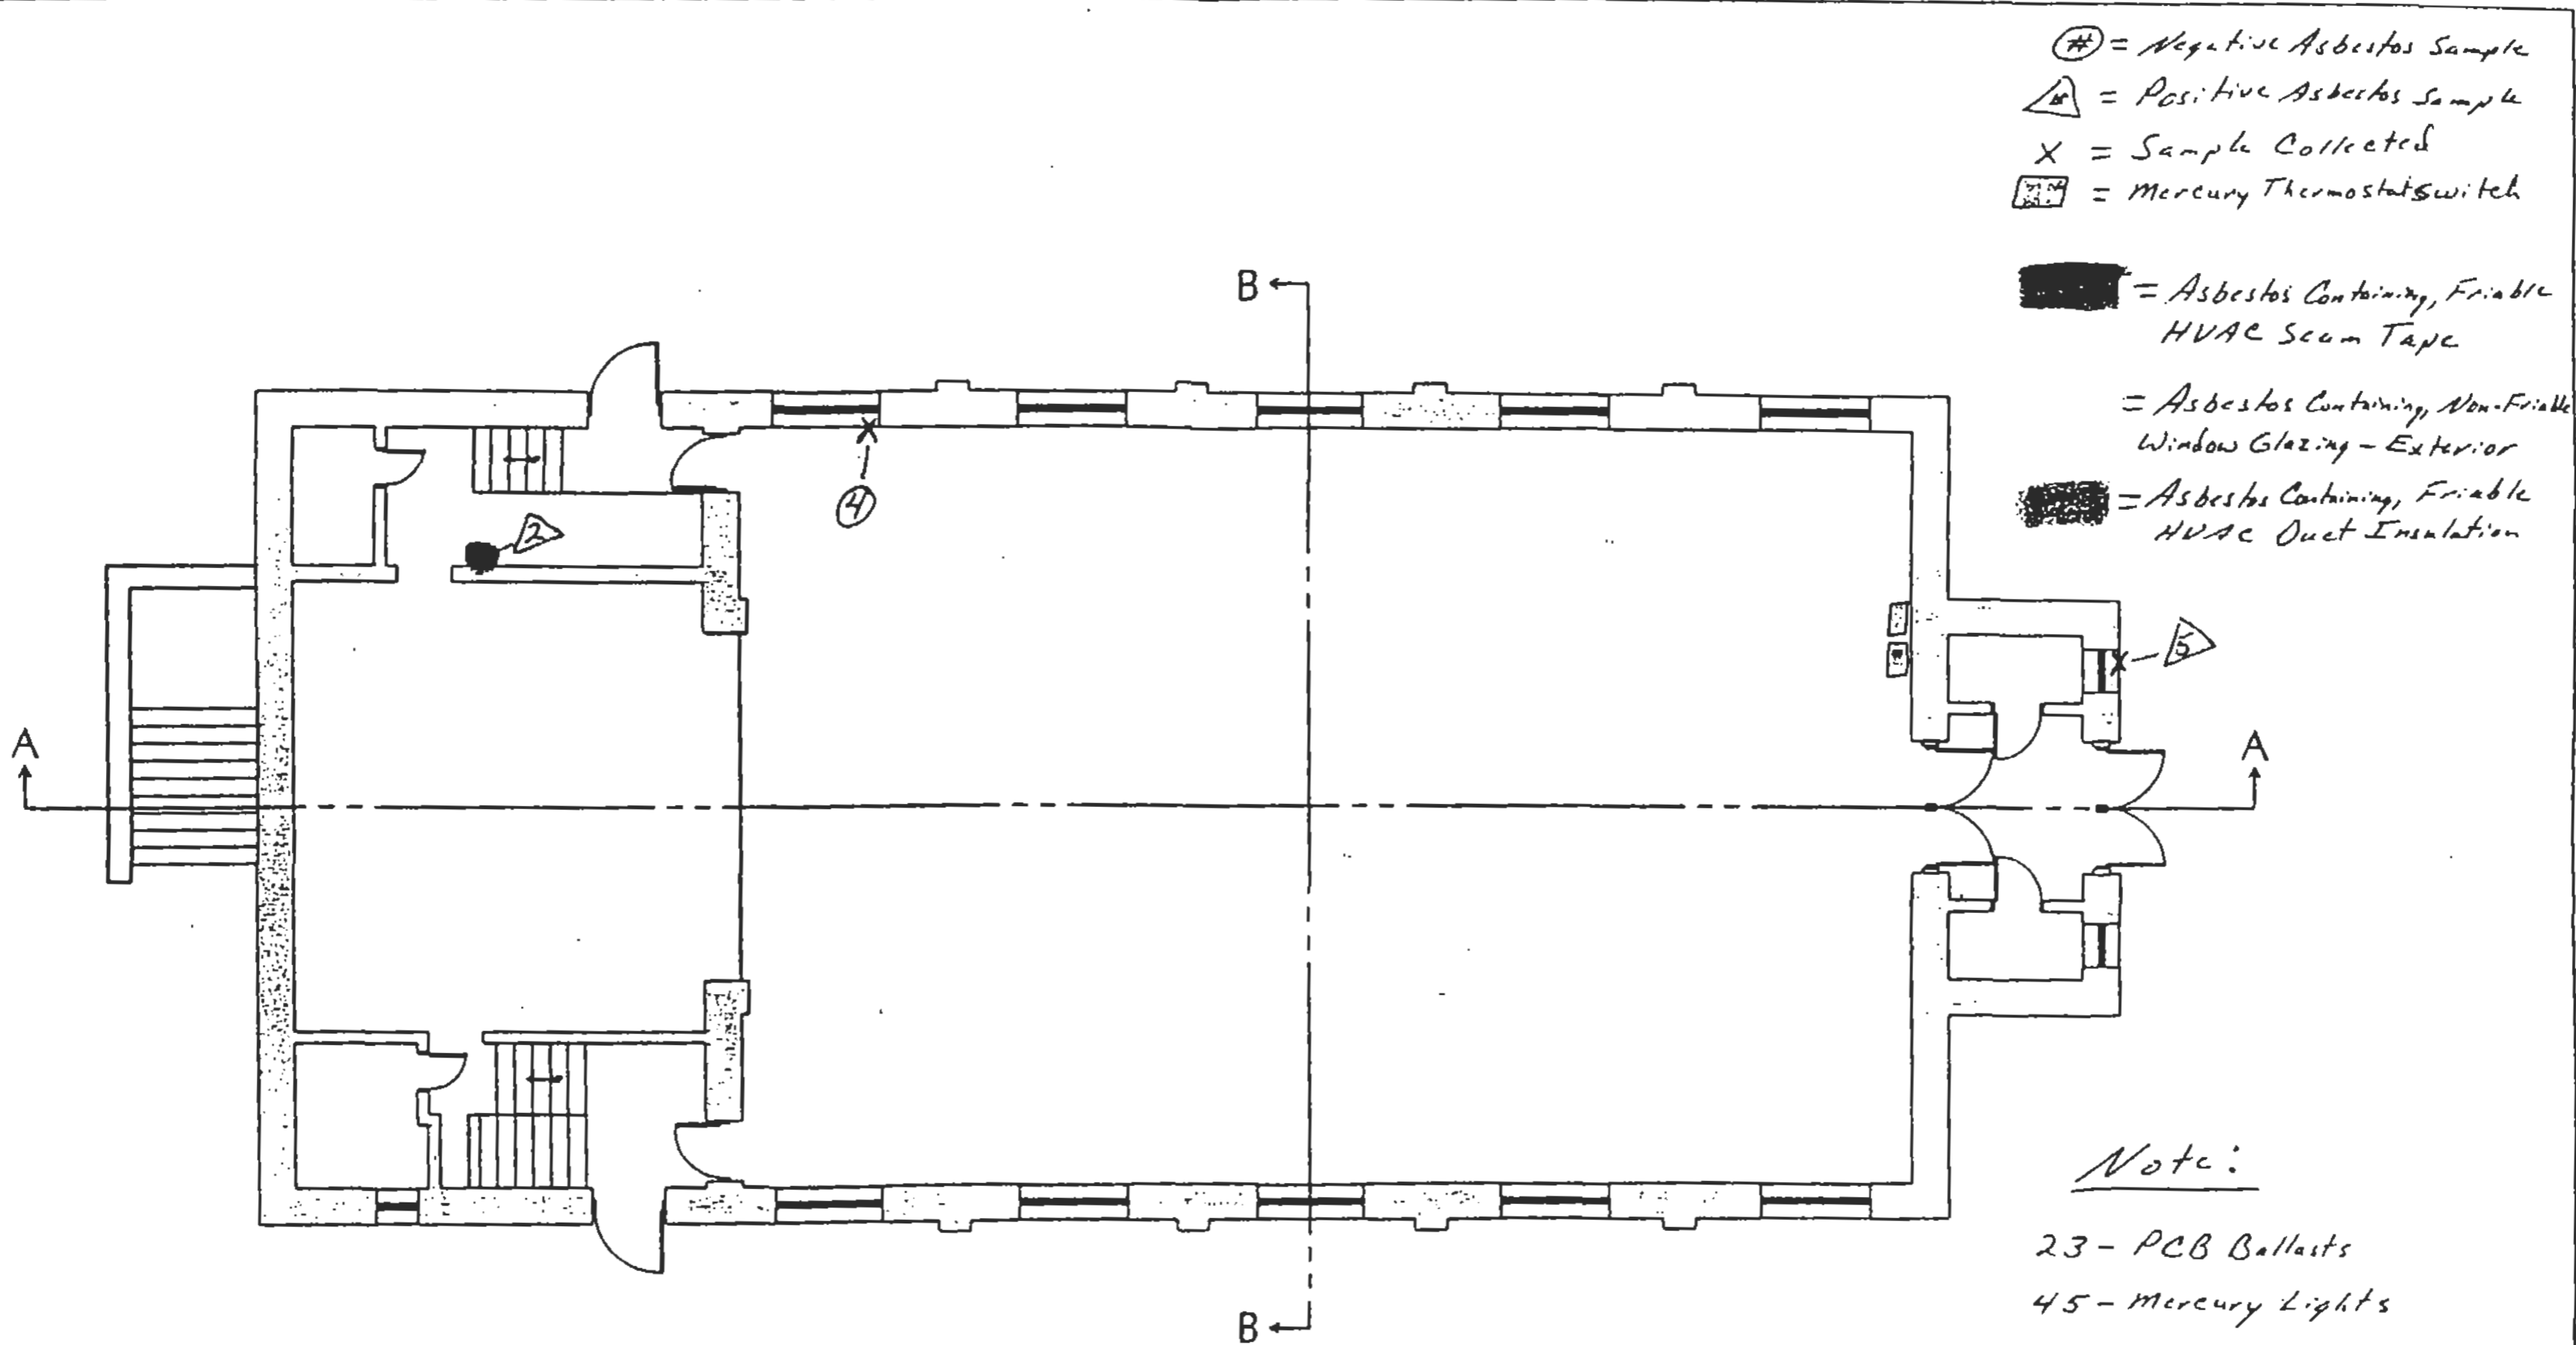
MAIN FLOOR PLAN

Note:
 23 - PCB Ballasts
 45 - Mercury Lights
