Nicodemus National Historic Site
Nicodemus, Kansas
Historic Structures Report
National Park Service

25 October 2002

Bahr Vermeer Haecker Architects, Ltd.
in association with
Wiss Janney Elstner Associates, Inc.

Historic Structures Report

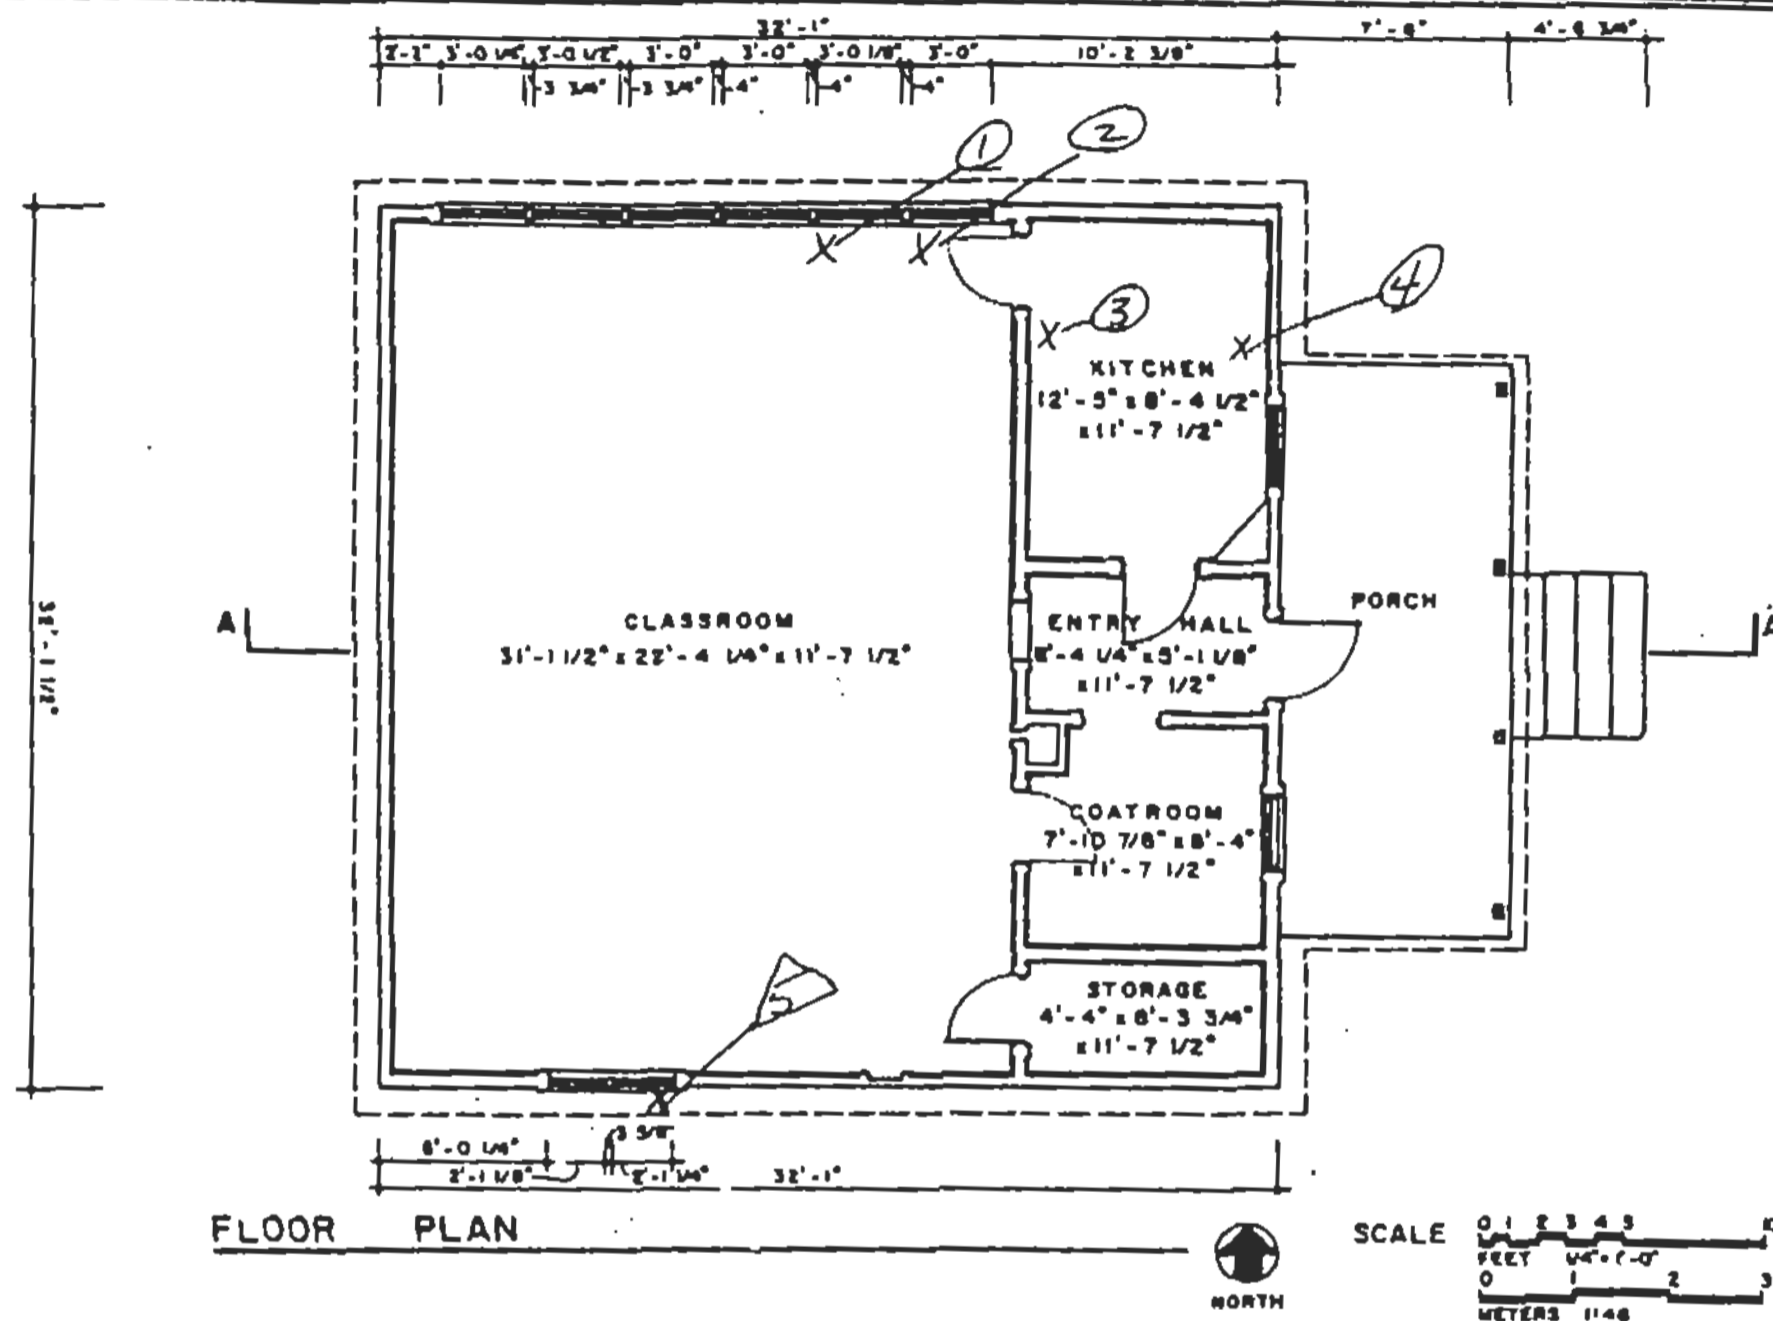
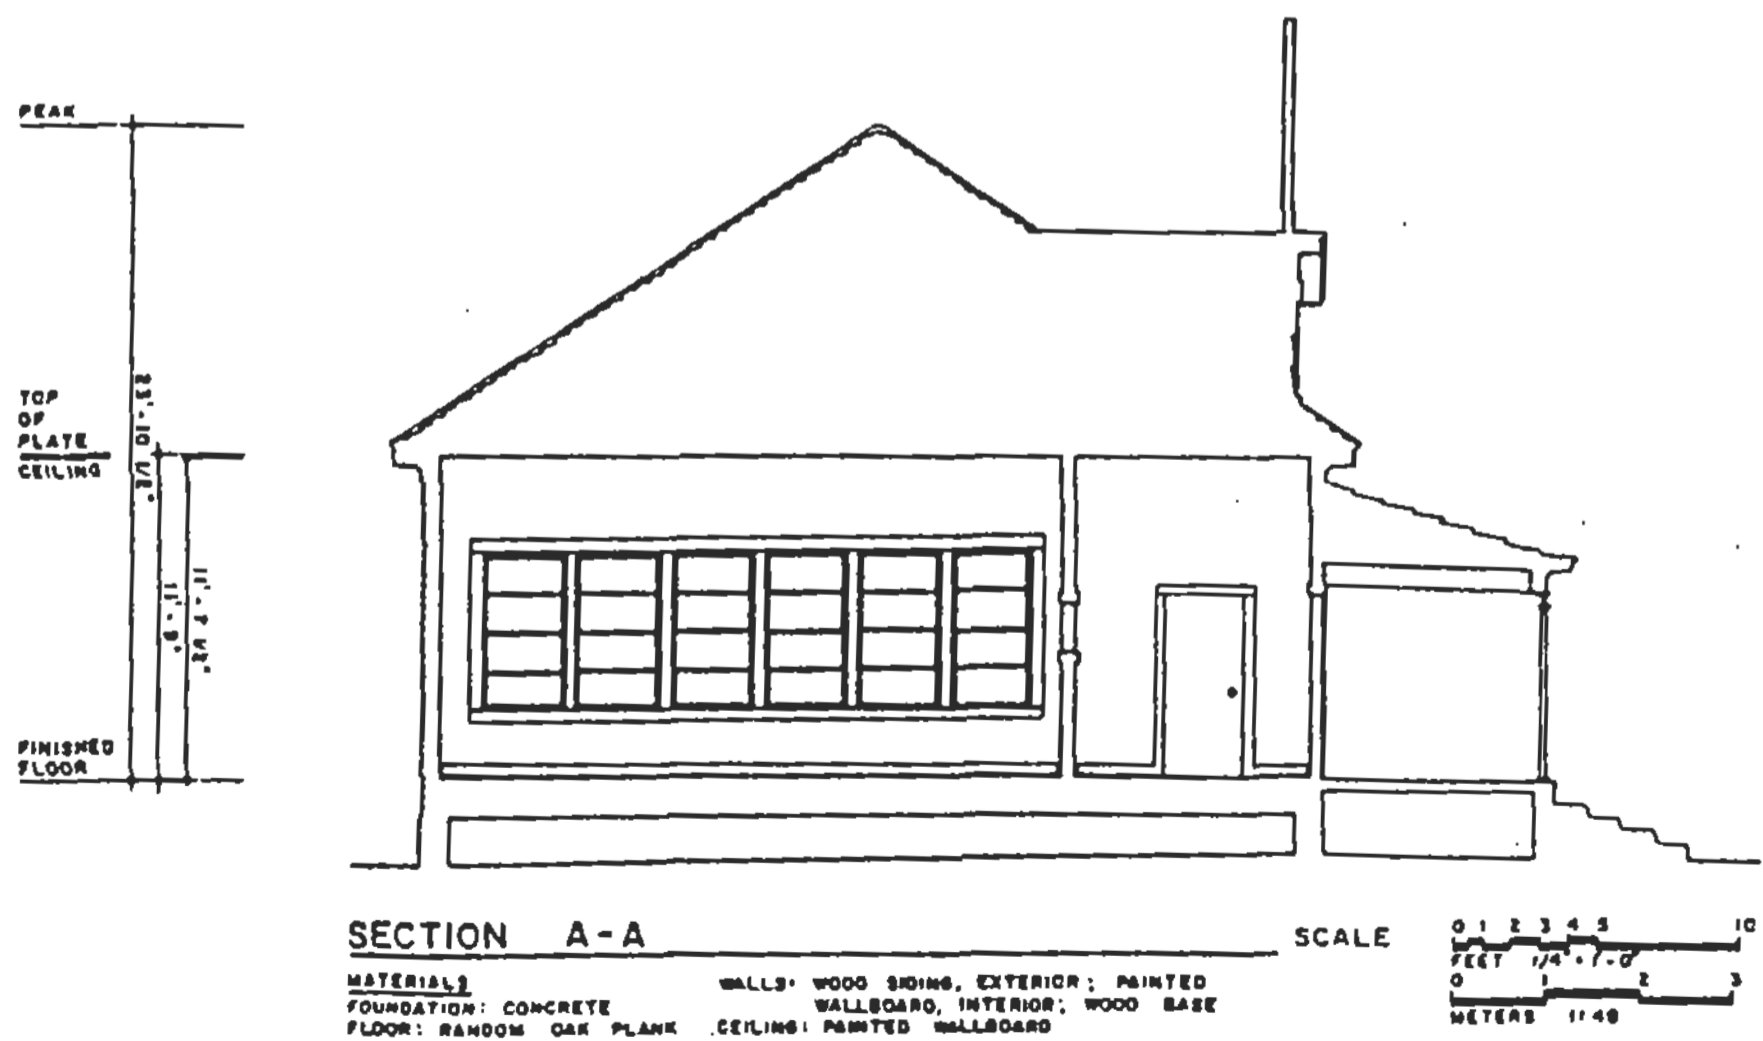
DISTRICT NO. 1 SCHOOLHOUSE
 GRAMM COUNTY
 PROJECT, 1983
 EVERETT L. FLY

8 - PCB Ballasts

11 - Mercury Lights

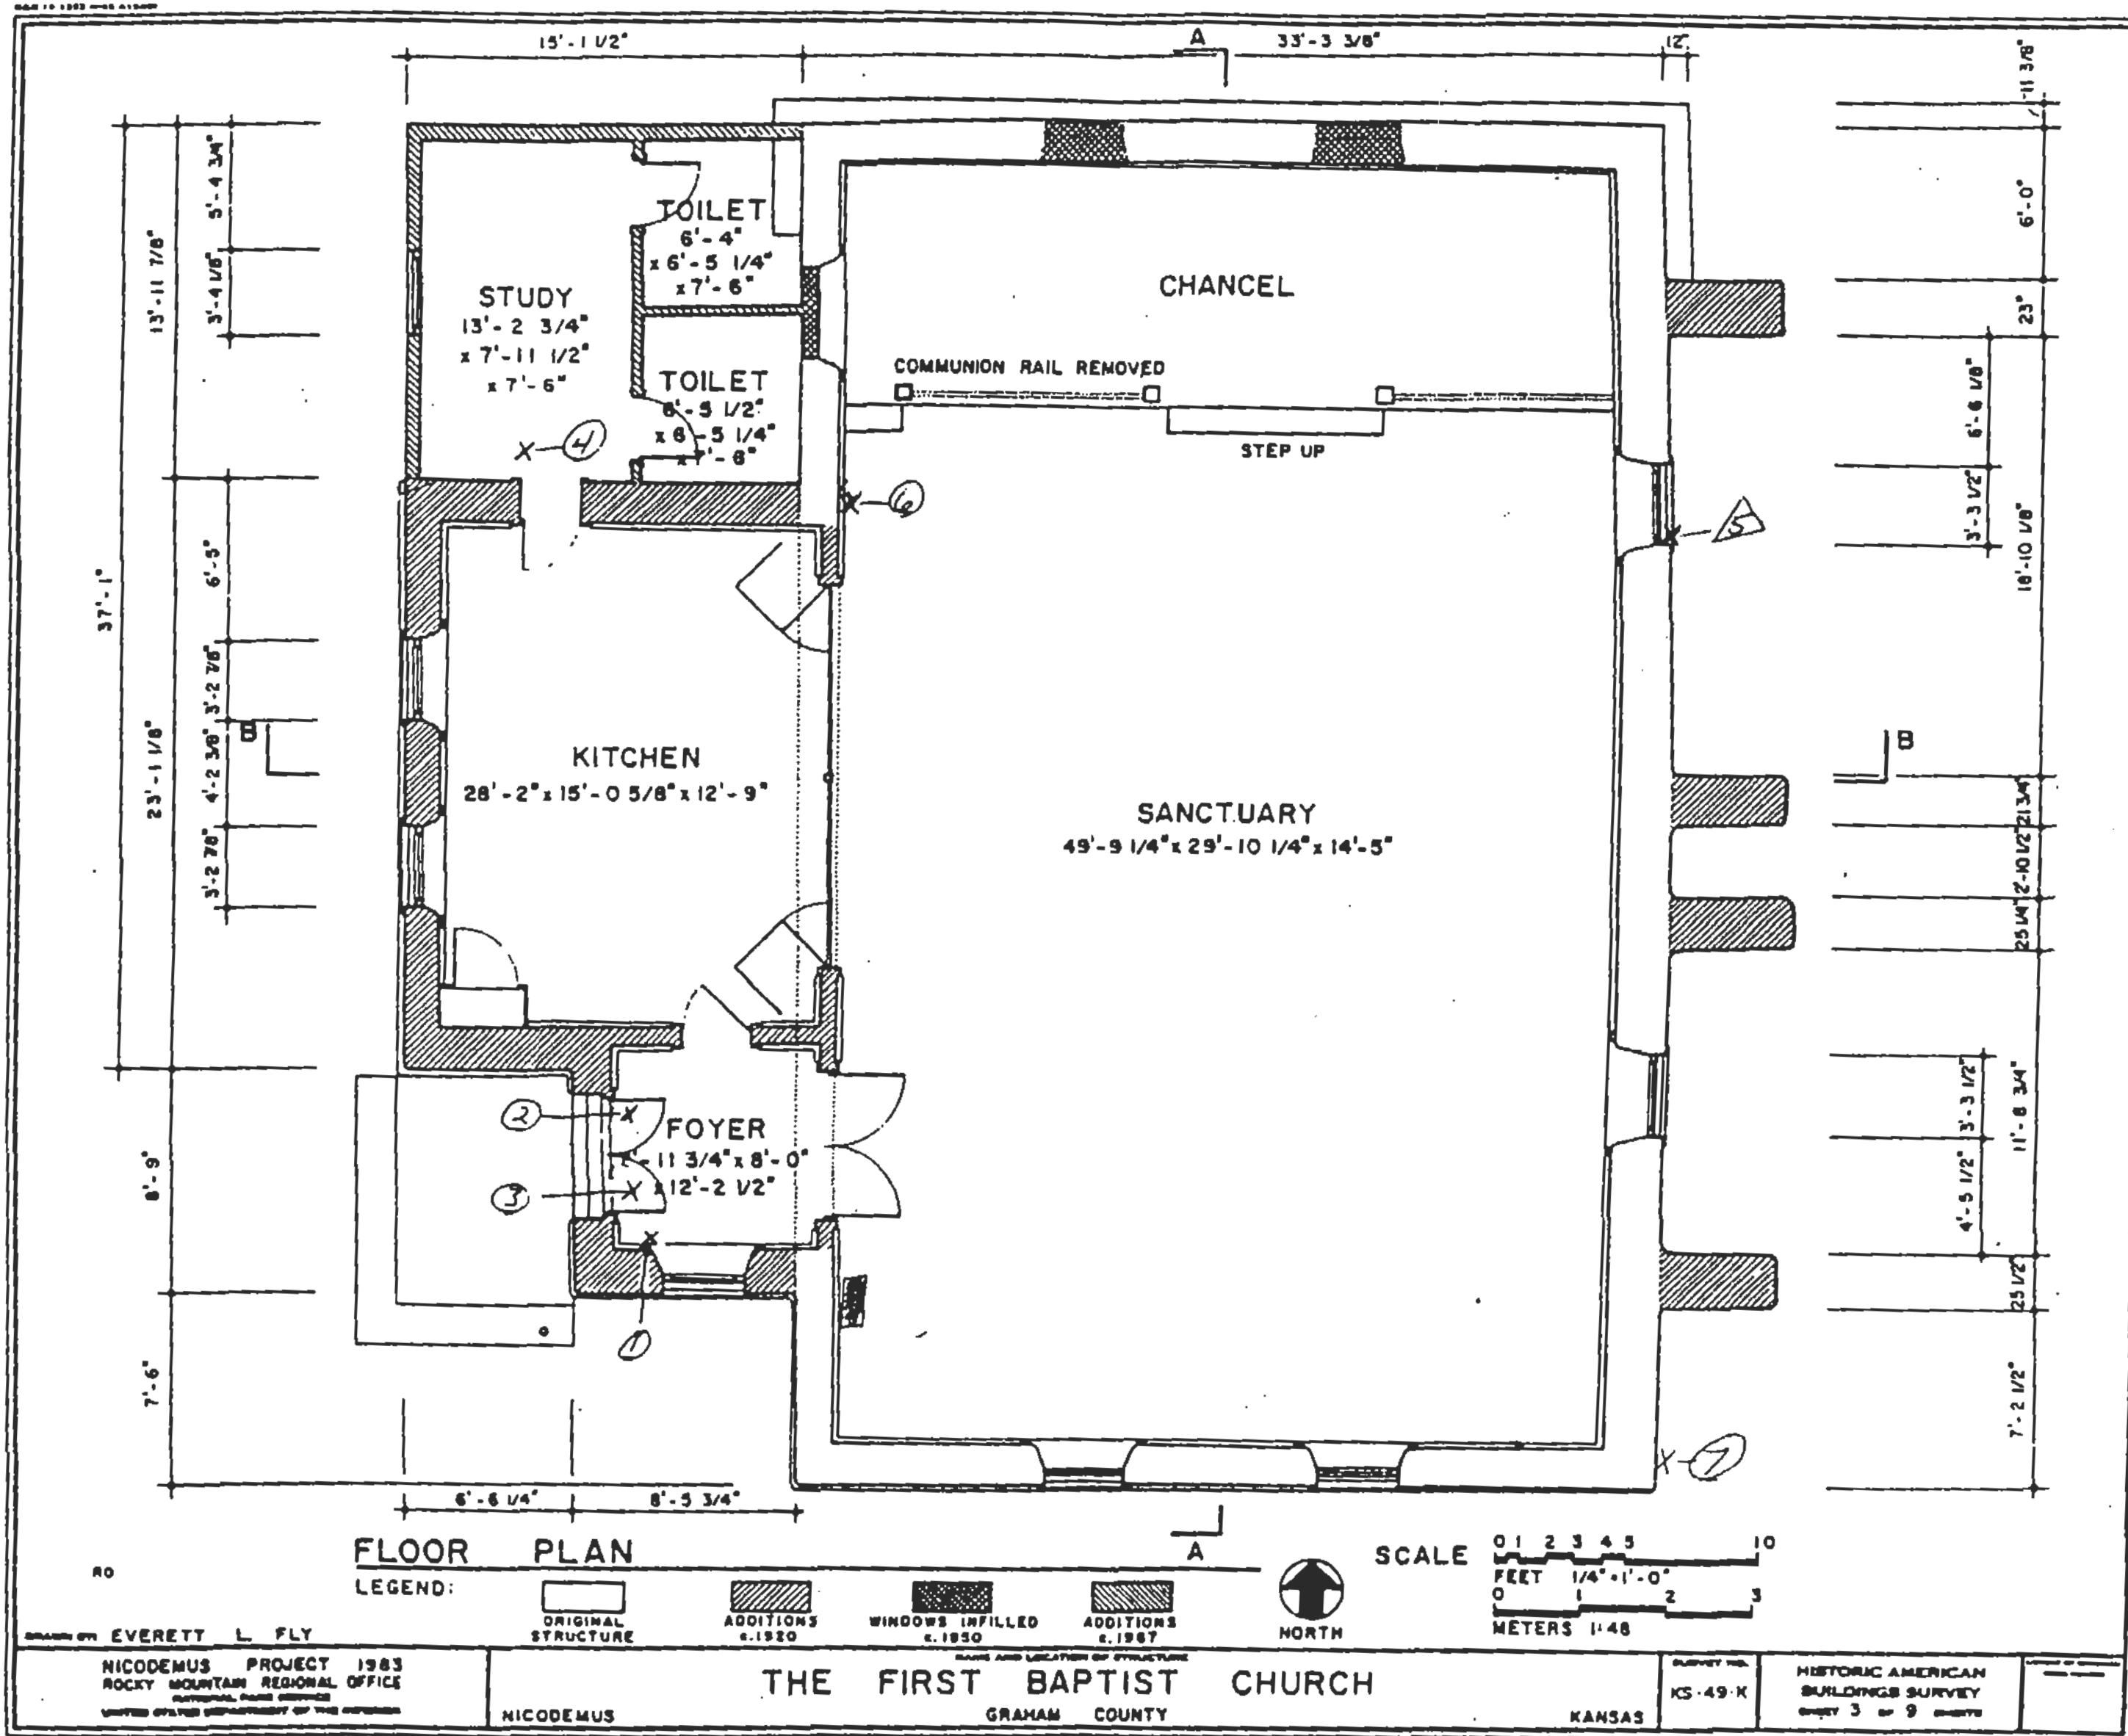
⊕ = Negative Asbestos Sample
 ⊕ = Positive Asbestos Sample
 X = Sample Location

▨ = Asbestos Containing, Non-Friable, Window Glazing - Exterior

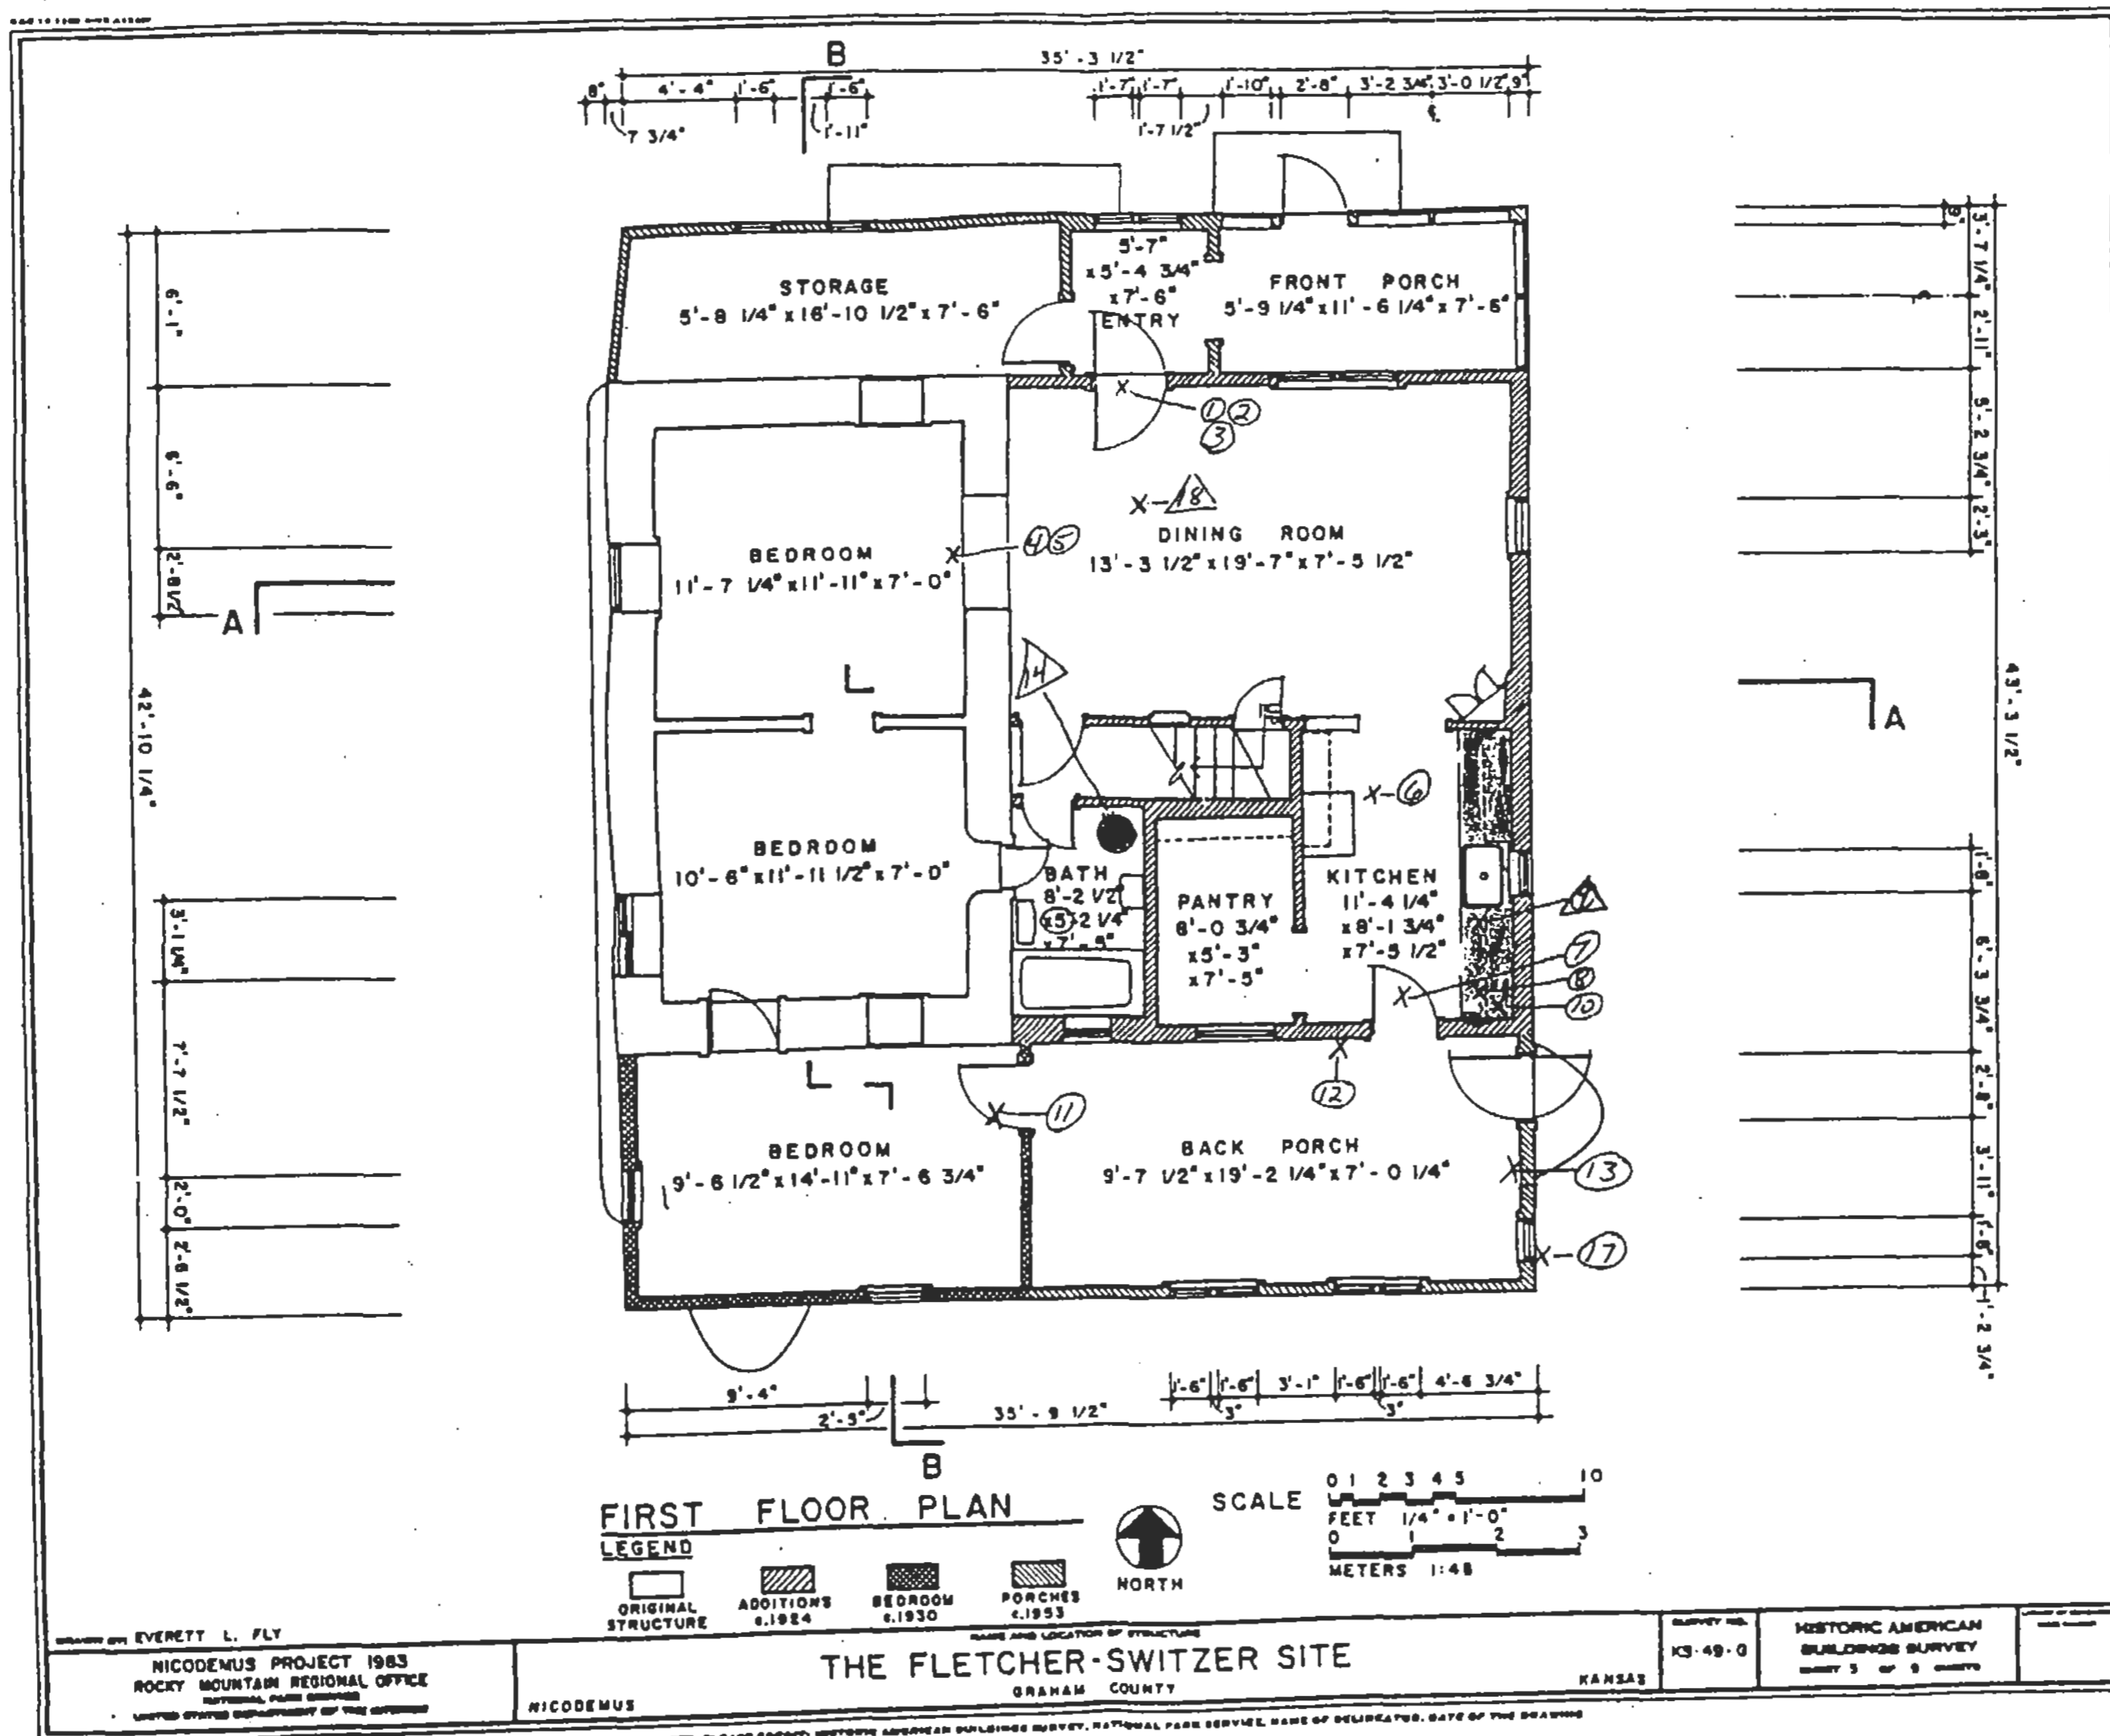
FIRST FLOOR PLAN

- ⊕ = Negative Asbestos Sample
- ⊕ = Positive Asbestos Sample
- X = Sample Collected
- = Asbestos Containing, Friable Joint Compound, Caulk, & Wall
- = Asbestos Containing, Friable Sheet Counter Top
- = Asbestos Containing, Non-Friable Transite Pipe

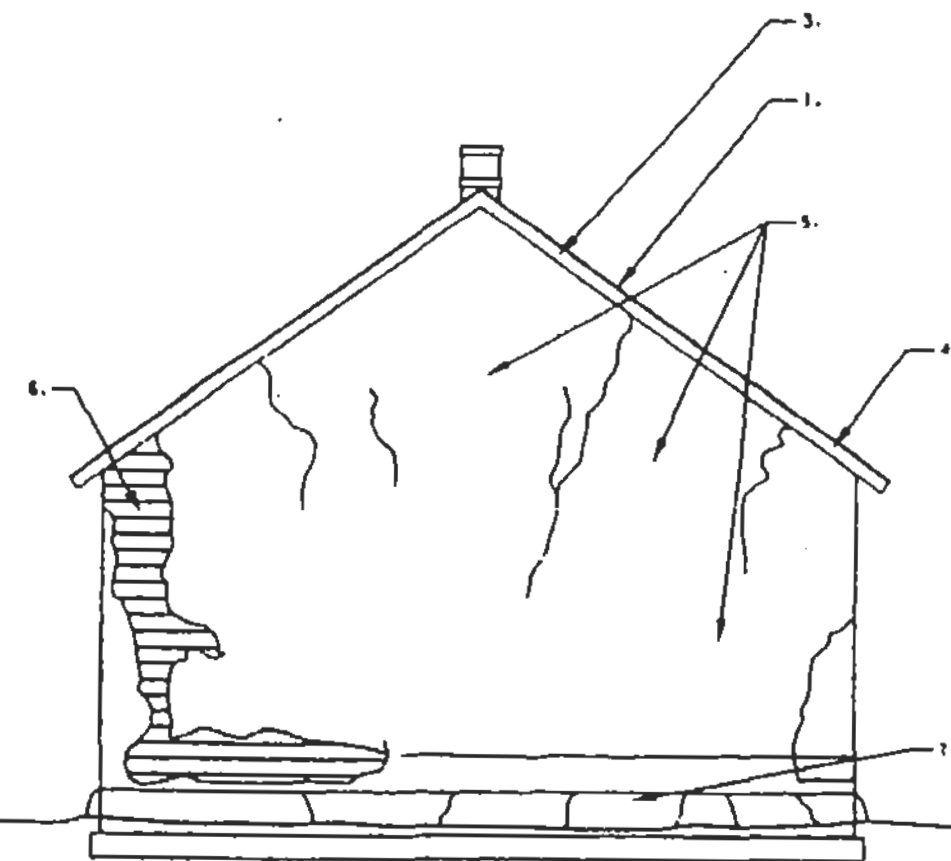
2
A3

SOUTH ELEVATION

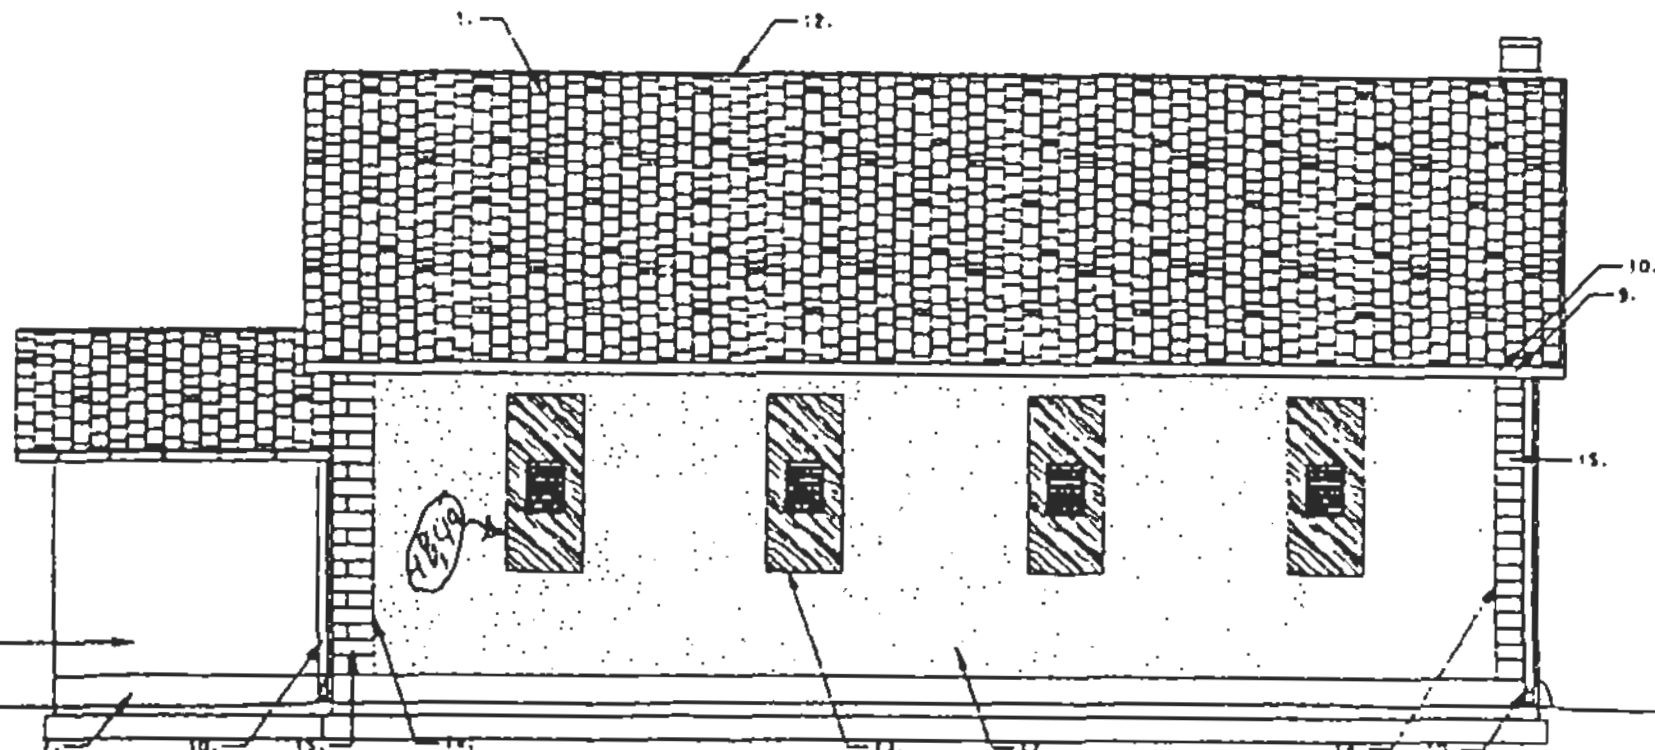
3
A3

WEST ELEVATION

4. REPLACE 1X4 WOOD TRIM. PAINT.
5. COMPLETELY REMOVE EXISTING STUCCO. STUCCO IS CRACKED IN NUMEROUS LOCATIONS AND IS NOT ORIGINAL.
6. EXPOSED LIMESTONE WALL TO REMAIN. EXISTING WALL CONSISTS OF EXTERIOR WYTHE CUT LOCAL SOFT LIMESTONE FACE BLOCKS, OF UNIFORM CREAMY YELLOW COLOR, MOSTLY UNIFORM SIZE OF 12" LONG, 6" HIGH, 8" DEEP. UN TOOLED JOINTS. LAID UP IN ASHLAR PATTERN. INTERIOR WYTHE OF STONE IS CUT LOCAL LIMESTONE BLOCKS, UNIFORM CREAMY YELLOW COLOR, LAID UP IN RANDOM ASHLAR. SIZES VARY FROM A MAXIMUM OF 20" LONG X 7" HIGH, TO A MINIMUM OF 10" LONG X 4" HIGH, WITH THE MOST COMMON SIZE BEING 12" LONG X 6" HIGH WITH UN TOOLED JOINTS. REPOINT WALL WHERE POSSIBLE USING LIME MORTAR. REPLACE EXTREMELY DEGRADED STONES WITH STONES SALVAGED FROM THE NORTH WALL. DUE TO THE EXISTING EXTERIOR STUCCO, AND INTERIOR PLASTER, THE EXTENT OF THESE REPAIRS IS UNKNOWN.

1. REMOVE EXISTING ROOF DOWN TO RAFTERS. INSTALL NEW ROOF RE: 3/4".
2. REMOVE EXISTING MASONRY CHIMNEY AND PLYWOOD COVERING.
3. REPLACE 1X12 WOOD SOFFIT AND OUTRIGGERS. PAINT SOFFIT.

7. REMOVE EXISTING ADHERED CONCRETE BASE ENTIRE PERIMETER OF BUILDING.
8. EXISTING HISTORIC WOOD PANEL DOORS TO REMAIN.
9. REPLACE 1X4 WOOD FASCIA, 1X4 WOOD TRIM AT WALL AND 1X12 WOOD SOFFIT. PAINT.
