Ocmulgee National Monument
Visitor Center
Historic Structure Report

December 2008

Joseph K. Oppermann - Architect, P.A.

2008
Historic Structure Report
Visitor Center
Ocmulgee National Monument
LCS#: 091399

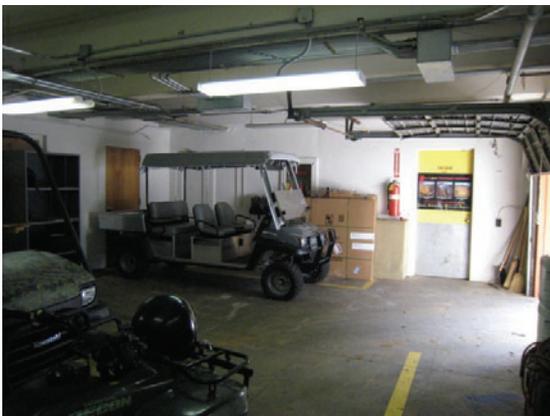
Figure C-81. Southeast oblique view of the garage.

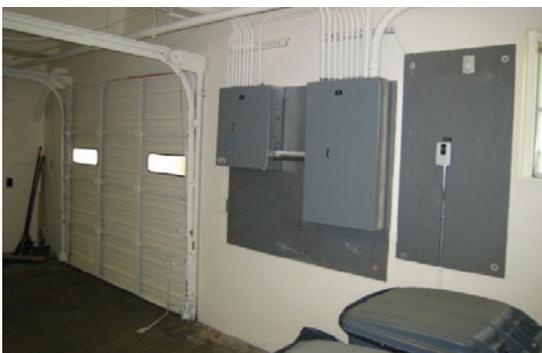
Figure C-82. West wall of garage.

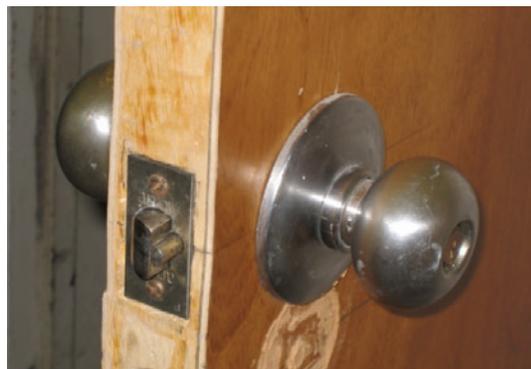
The southernmost doorway on the east wall originally opened from the "Heater Room." The original wood door was to be painted. According to the previous facilities manager, the current replacement door is a salvaged door installed in 1997. The door is varnished wood, flush panel, measuring 3'-0" x 6'-11" x 1 3/4". The door has three Type 2 hinges. There are two modern, chrome doorknobs. The door has been patched for a previous set of doorknobs, which may be the current set but at a lower height.

Figure C-83. Doorknobs at southernmost door to Room 021.

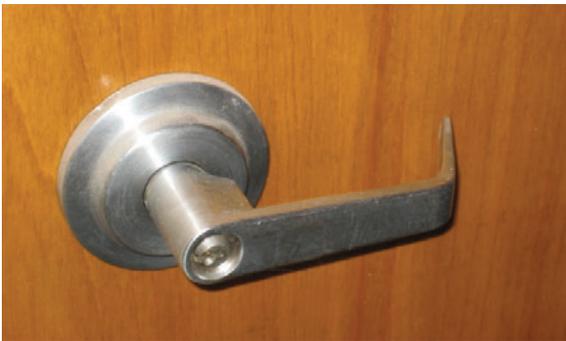
The middle doorway opened from a "Closet." The original door was to be made of wood, painted, flush panel and measuring 2'-8" x 7'-0" x 1¾." The current door was salvaged from elsewhere in the building and installed here in 1997. The door is varnished wood, flush panel of same dimensions as the 1950 specifications. This door has three Type 2 hinges and a pair of chrome door handles similar to but not identical to those on the adjoining double doorway to the north.

Figure C-84. Door handle of northernmost door to Room 021.

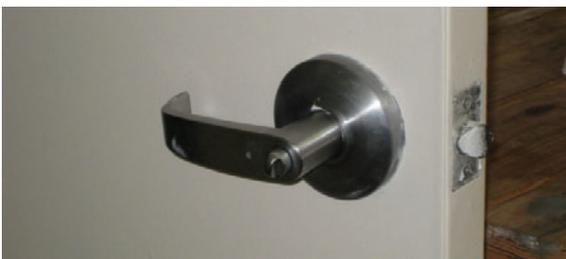
The northernmost doorway, the doorway to Room 022, was modified in 1997 to accommodate a shorter and wider pair of doors. These doors opened from the large room intended for "Photography." The plans called for painting and "reusing the oak (double) doors" from the first-floor entry on south side of the now central corridor. Those doors were noted as measuring 2'-6" x 7'-0" x 1¾." The current doors are flush panel, clad in steel. They measure 3'-0" x 6'-8" x 1¾". These doors have chrome handles and Type 2 hinges.

Figure C-85. Door handle for steel-clad, double doors to Room 022.

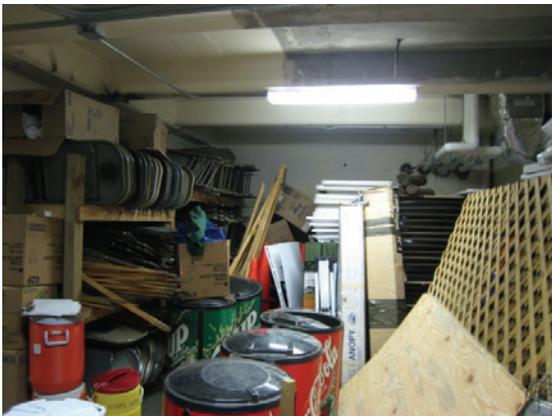
This now is one, large rectangular room measuring 14'-6" x 26'-5" with an 8'-9½" ceiling height. Initially, this space was subdivided into several, small rooms as indicated by period construction documents and confirmed by wall fragments still evident. The period plans indicate the room's uses were for supplies, a closet, a heater and a dark room. From prior to 1989 to 2003, this room was completely filled with mechanical equipment. In 2003, the clay tile dividing walls were removed. The room is now used for storage.

Figure C-86. Room 021 used for storage.

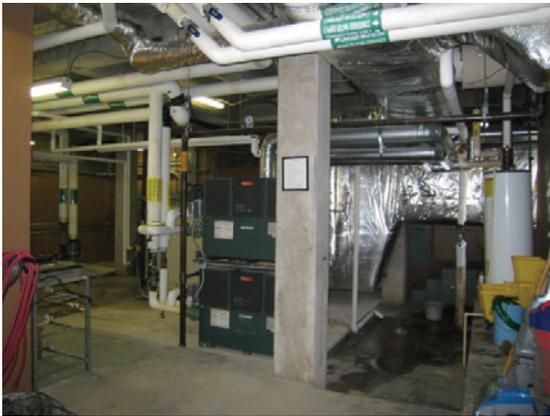
Figure C-89. Northwest oblique view of furnace or solar room.

Natural calamities have also played a part. Of special importance is the malfunction of the mechanical system and sump pump in 2001. As a result, the Solar Room (Room 023A) and an archival storage area (Room 023B) were flooded. Mechanical equipment was damaged. Many of the records were

reportedly damaged beyond recognition and were subsequently discarded. Identification of which records were lost is not known.

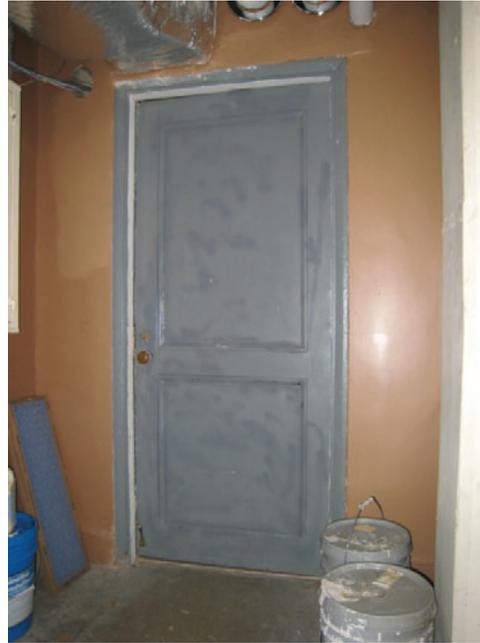
Figure C-90. Doorway of 1938-41 on south wall relocated in 1950-51 from north wall of Room 003.

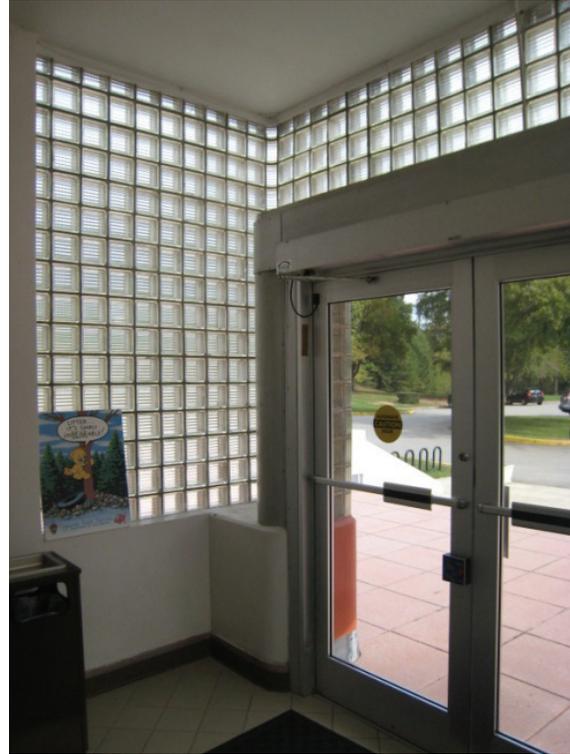
- **Doors:** There are two pairs of doors in sequence to create an airlock. Both pairs are replacements, aluminum frames with glass, installed circa 1970. The original aluminum framing for the two doorways remains intact. Electric openers were installed in the early 1990s.

Figure C-99. Replacement doors in original door frames of main entrance.

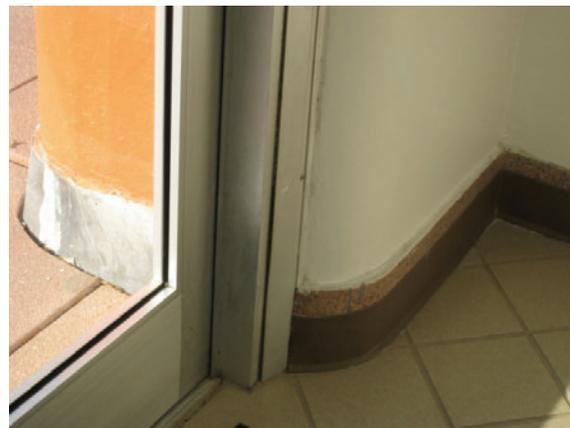
- **Baseboards:** A four-inch, molded vinyl baseboard is glued atop the six-inch terrazzo baseboard.

Figure C-100. Vinyl baseboard applied over original terrazzo baseboard.

- Installing replacement systems, such as double-glazed window units, can improve the building's energy efficiency;
- Retaining and repairing damaged original features, such as the terrazzo floors and baseboards, is expensive. Installing modern materials which are readily available and easily installed, such as ceramic tile flooring and molded vinyl baseboards, is quickly implemented and inexpensive.

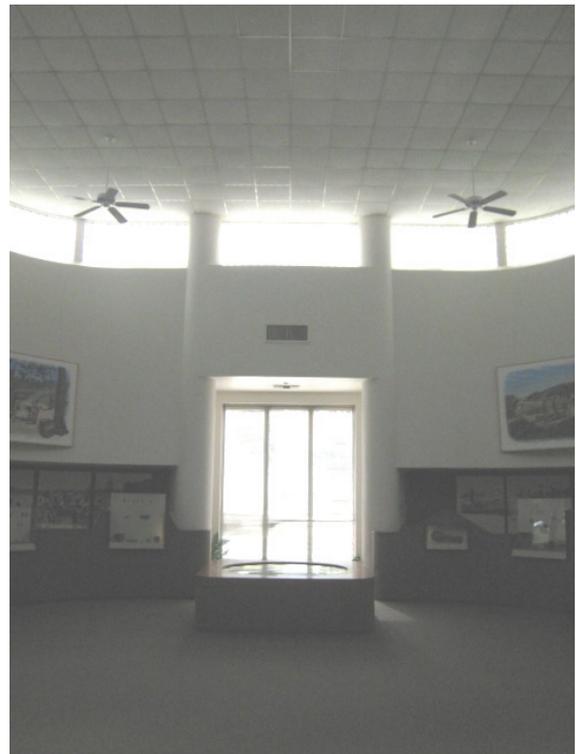
- *Windows:* A single large window is at the first floor visitor level. It measures some 9'-0" x 10'-0" and is located at the center of the south elevation to provide a commanding view of the Earth Lodge. The window unit is a replacement for the one installed in 1950-51.

Figure C-102. Window on the Earth Lodge.

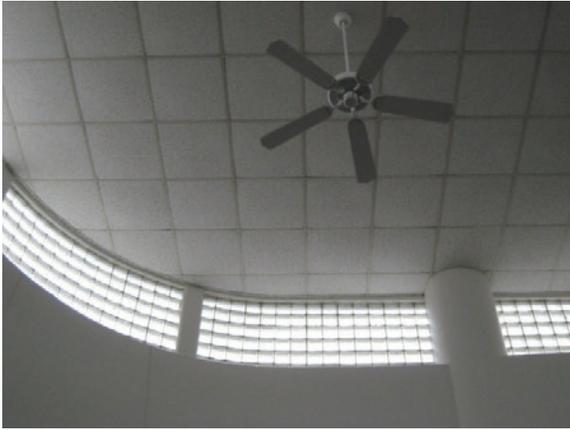
Figure C-103. A band of glass blocks.

High above, a band of glass blocks, six rows vertically measuring some 3'-0" in height, circles the rotunda just below the ceiling.

- Repair, preserve and maintain the original 1939-51 aluminum window units;
- Replace the original glass block units that are severely damaged and the replacement glass block units of inappropriate design with salvaged or reproduction units that are duplicates of the original design;

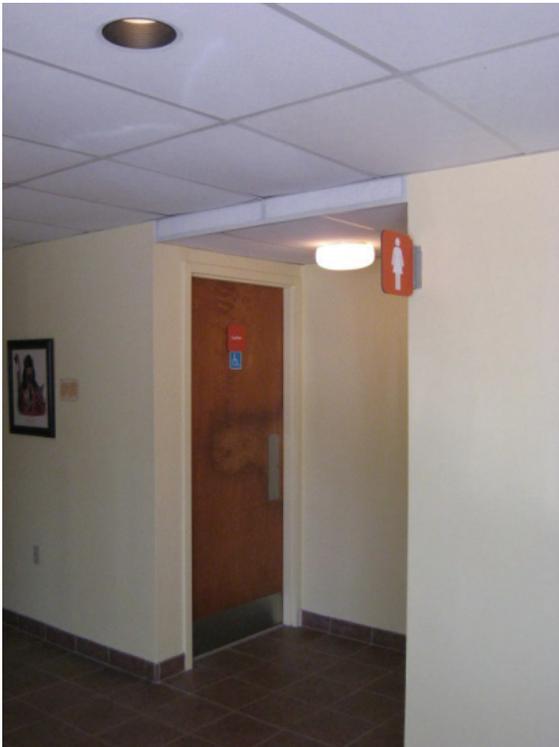
The doorway to the electrical closet (Room 108) dates to 1950-51. The steel frame is intact as is the door and its hardware. The door is painted wood, flush panel, measuring 3'-0" x 6'-11" x 1 3/4" with two Type B doorknobs and Type U escutcheons. The doorways to the two restrooms and the janitor's closet (Room 107) between them date to 1981-82. All three doors are varnished wood, flush panel. The door to the janitor's closet is 2'-6" x 6'-11" x 1 3/4" while the two doors to the restrooms are 3'-0" wide. The restroom doors each have three Type 4 hinges, a chrome push panel measuring 4" x 1'-4," a 10" chrome handle, and an 8" kick latch. The door to the janitor's closet has two, chrome, Type E doorknobs and three Type 2 hinges.

Figure C-106. Typical door, recessed canister light and ceiling fixture along central corridor.

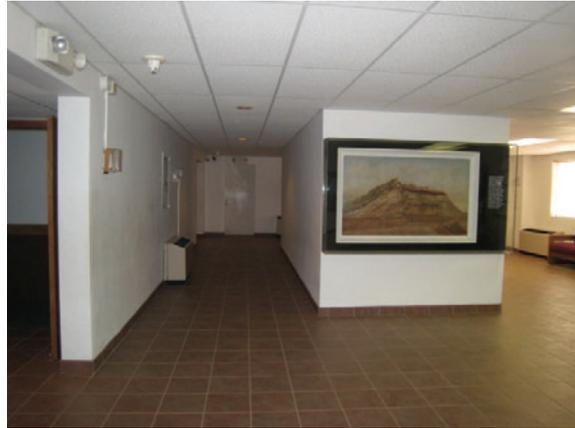
Figure C-113. Back hall looking north.

- At the Rotunda, the Gift Shop, the Central Corridor, the Back Hall, Terrace Lobby and Terrace Vestibule investigate physical evidence of original flooring and associated design characteristics. Repair and restore flooring associated features to their 1951 design;

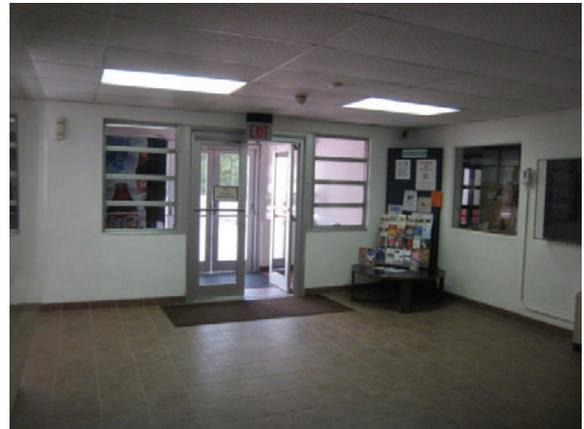
Figure C-119. Southwest oblique view of the terrace lobby.

- **Doors:** The framed aluminum and glass doorway on the east wall dates to 1950-51. The pair of aluminum and glass doors are replacements, however, dating to circa 1970.

- Replace the modern-design, c. 1970, aluminum-and-glass doors of the Public Entrance Vestibule, the Terrace Vestibule, the West (Staff) Entryway, and the current Gift Shop doorways with reproduction doors matching the 1951 design;

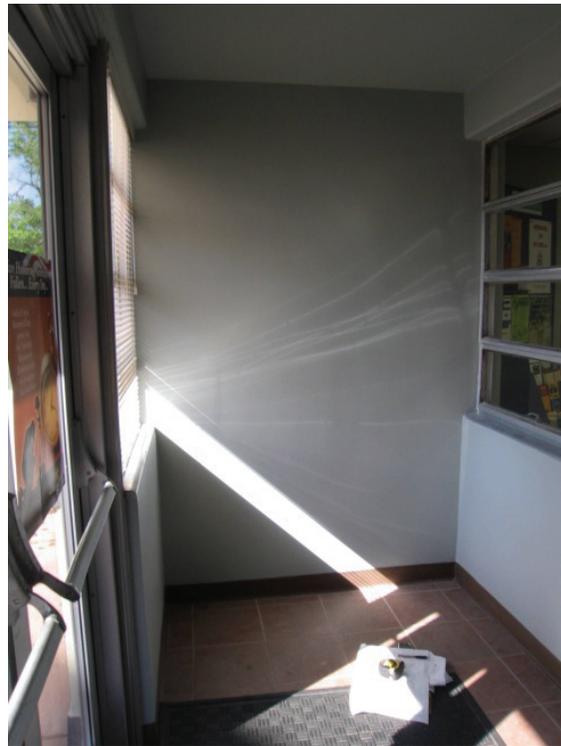
Figure C-120. Terrace vestibule looking south.

This vestibule is rectangular in plan, measuring 5'-0" x 11'-8" with a 7'-11" ceiling height. This room is largely intact and continues to serve its original use.

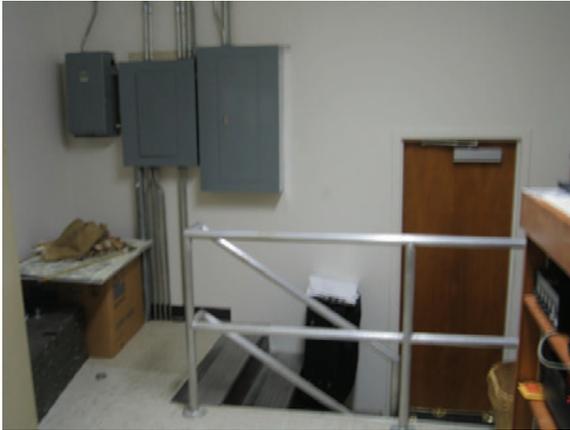
Figure C-130. Audiovisual control room looking north.

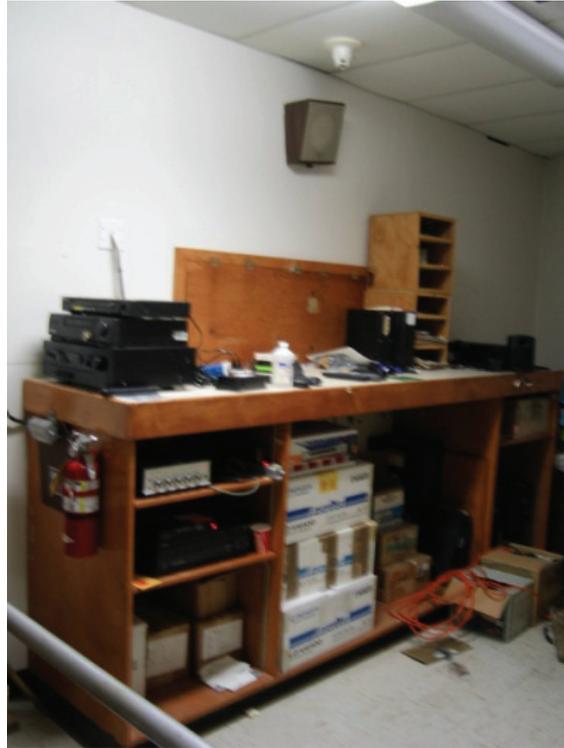
Figure C-131. The audiovisual control desk along the east wall.

- **Electrical Systems:** There are two ceiling-mounted, two-bulb fluorescent lighting fixtures. Three panel boxes are on the north wall. The AV control desk is along the east wall.

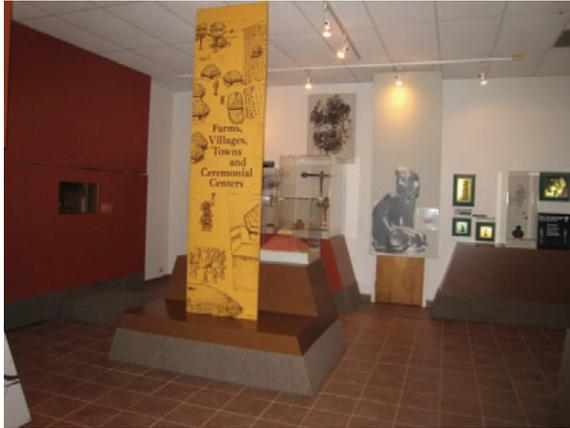
Figure C-132. Exhibit hall looking west.

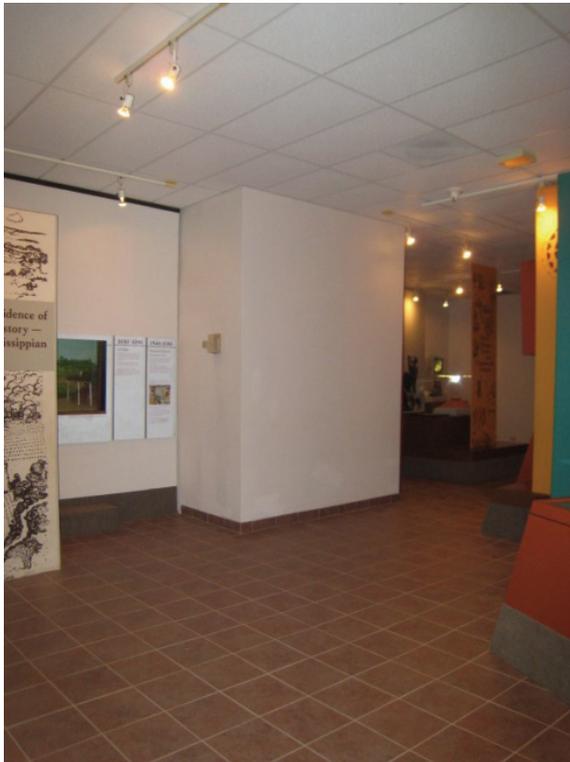
Figure C-133. Exhibit hall looking southwest.

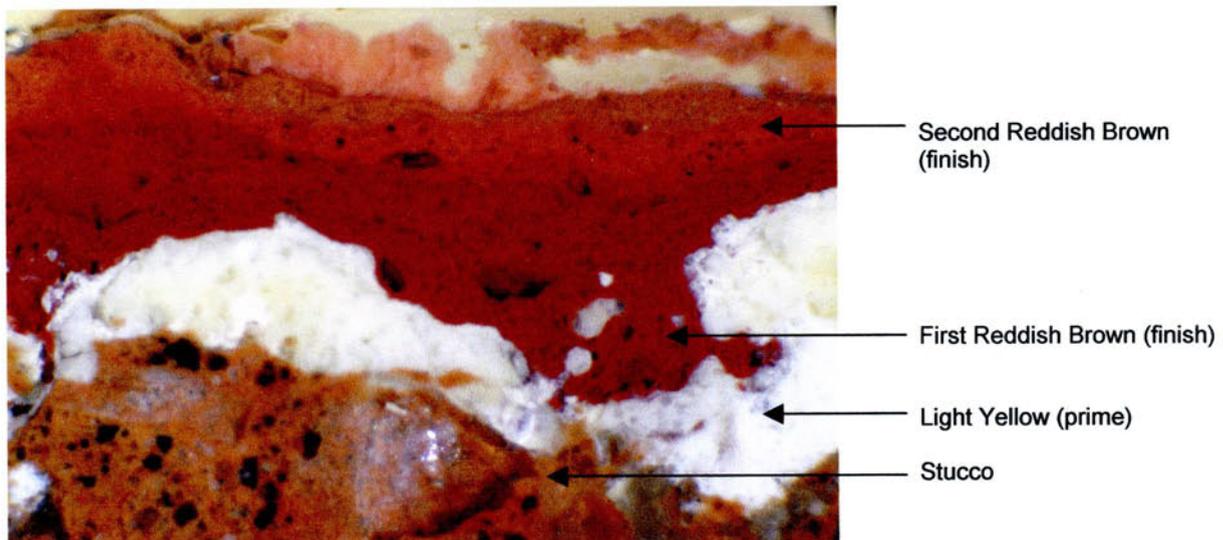
Sample # 2: Frieze (underside) at northeast elevation

Our analyses and color evaluation disclose that all of the samples exhibit very good paint layer evidence. There are only five layers of paint on the samples. The first two layers are the prime and finish coats. The two samples from the ornamental frieze area show a reddish brown stucco substrate, which has a prime of a light yellow, followed by a moderate reddish brown oil paint. There are three more reddish brown finish paint layers above the first finish paint. The five samples from general wall locations show a prime and finish of the light yellow oil paint. There are three more finish paint layers above the first finish.

A crosssection photomicrograph of the layers on the frieze is below.

The evidence on your samples indicates that the building has been painted four times; however, it is unclear whether or not the first finish coat dates from the late 1930's or the 1950's or possibly later. Since the early construction was interrupted by the war and not completed until the early 1950's, it is most likely that the first paints are from the '50's. However, you have mentioned that there has been some reference to sandblasting at the building in the late 1970's. This raises some uncertainty as to whether the first layer is from the 30's or 50's. With only four finish coats on the samples from a building that is at least 57 years old, it raises the question: can it be that the exterior was only painted every 14-to-15 years? Because of the ambiguity, it seems advisable to do more investigation of the exterior to gather additional samples that either confirm or refute this uncertainty. Additional analyses of the samples in hand would not resolve this uncertainty because the pigments and oil vehicles available in the early 1950's are the same as would have been available in the mid 1940's as well as in the 1970's.
