HISTORIC STRUCTURES REPORT

BATES WELL RANCH

ORGAN PIPE CACTUS NATIONAL MONUMENT

A Service Learning Project of the
Preservation Studies Program
College of Architecture and Landscape Architecture
The University of Arizona

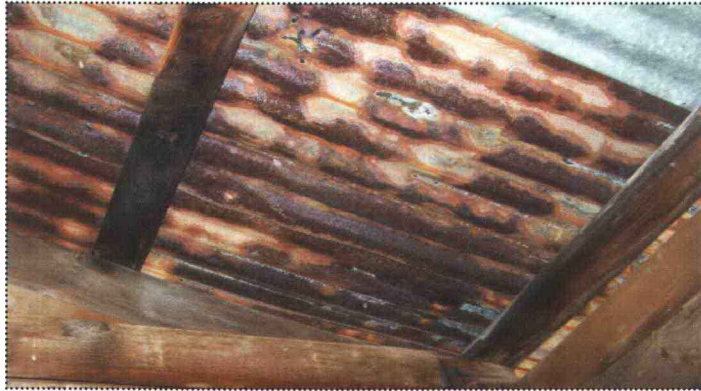
E. Rusting of the corrugated metal roof due to water damage

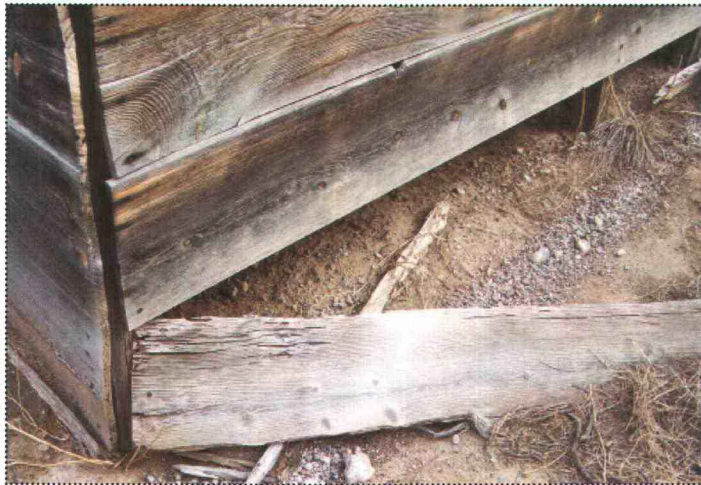
J. Falling apart of the wooden planks near the base of the structure.

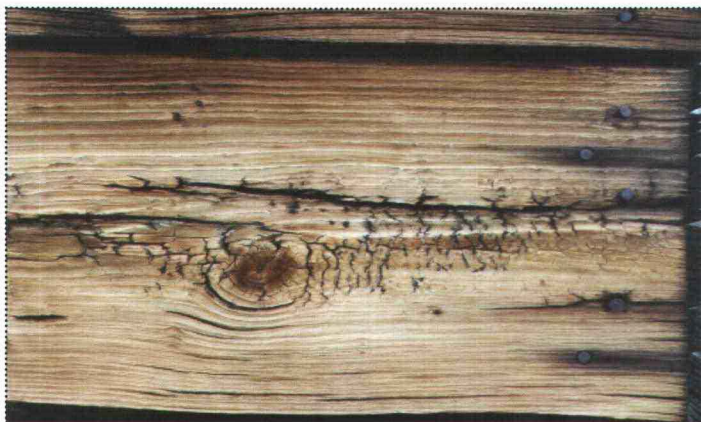
B. Rotting of wood due to microorganisms/ pests (also termite) infestation.

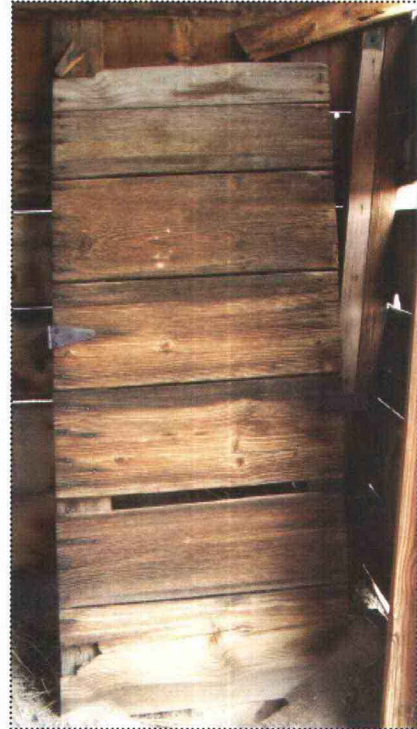
H. Dis-hinged entrance door lying inside the structure.

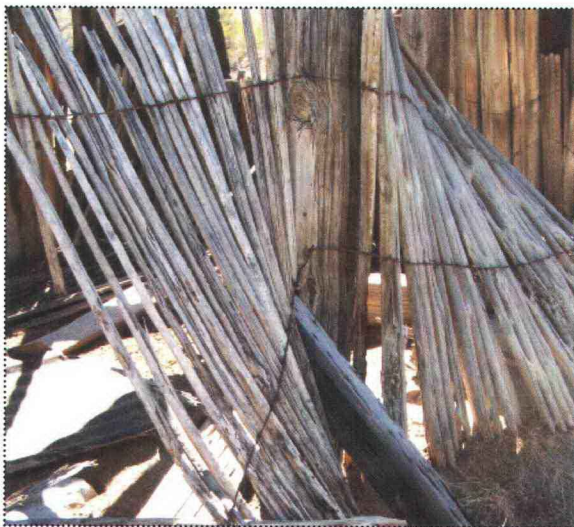
The failure of the saguaro rib cladding

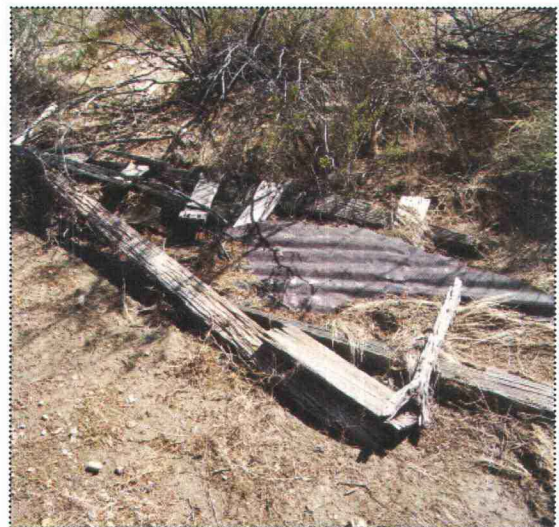
Parts of the structure lying scattered around on the site

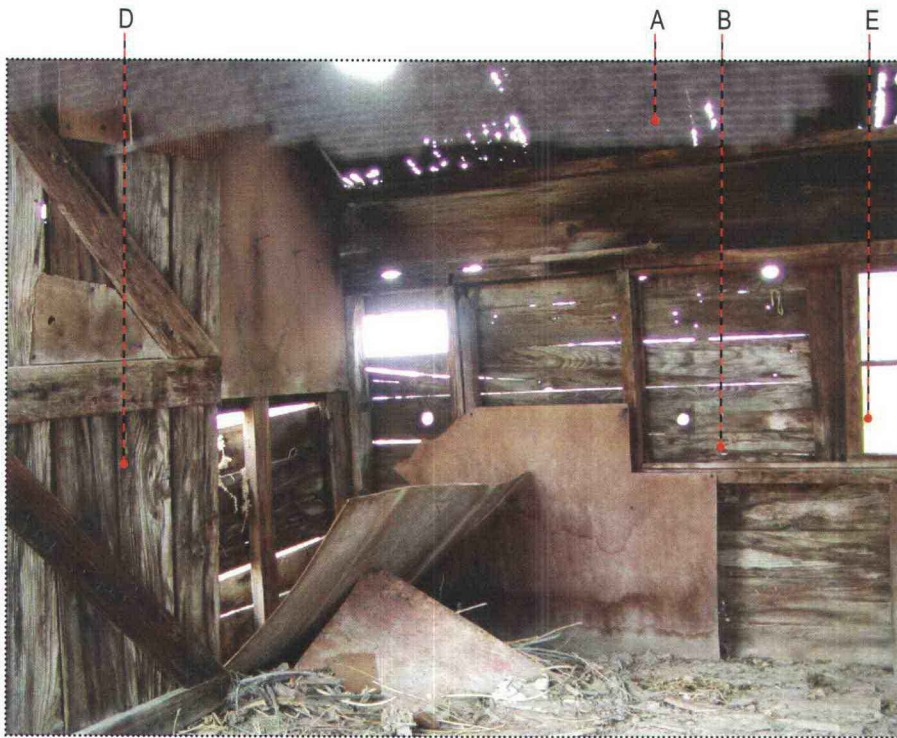
Interior elevation of the Small Residence (letters refer to notes in condition assessment table below)

Deficiencies	Recommended Treatments	Priority
A	Corrugated metal roof contains severe rust damage.	Replace roof with like material	Serious
B	Rotted/termite infested Wood	Application of biocides where severe damage.	Critical
C	Missing Components	Replace lost components with like material	Serious
D	Water Damage	Replace roof and repair or replace damaged material.	Serious
E	Broken Window Framing/glazing	Replace and repair as needed	Serious
F	Structural Failure	Repair structural damage	Critical
