historic structure report
appomattox manor

october 1982

HISTORIC STRUCTURE REPORT
PHYSICAL HISTORY AND ANALYSIS SECTION
APPOMATTOX MANOR
CITY POINT UNIT
PETERSBURG NATIONAL BATTLEFIELD
VIRGINIA

By
Richard G. Turk
and
G. Frank Williss

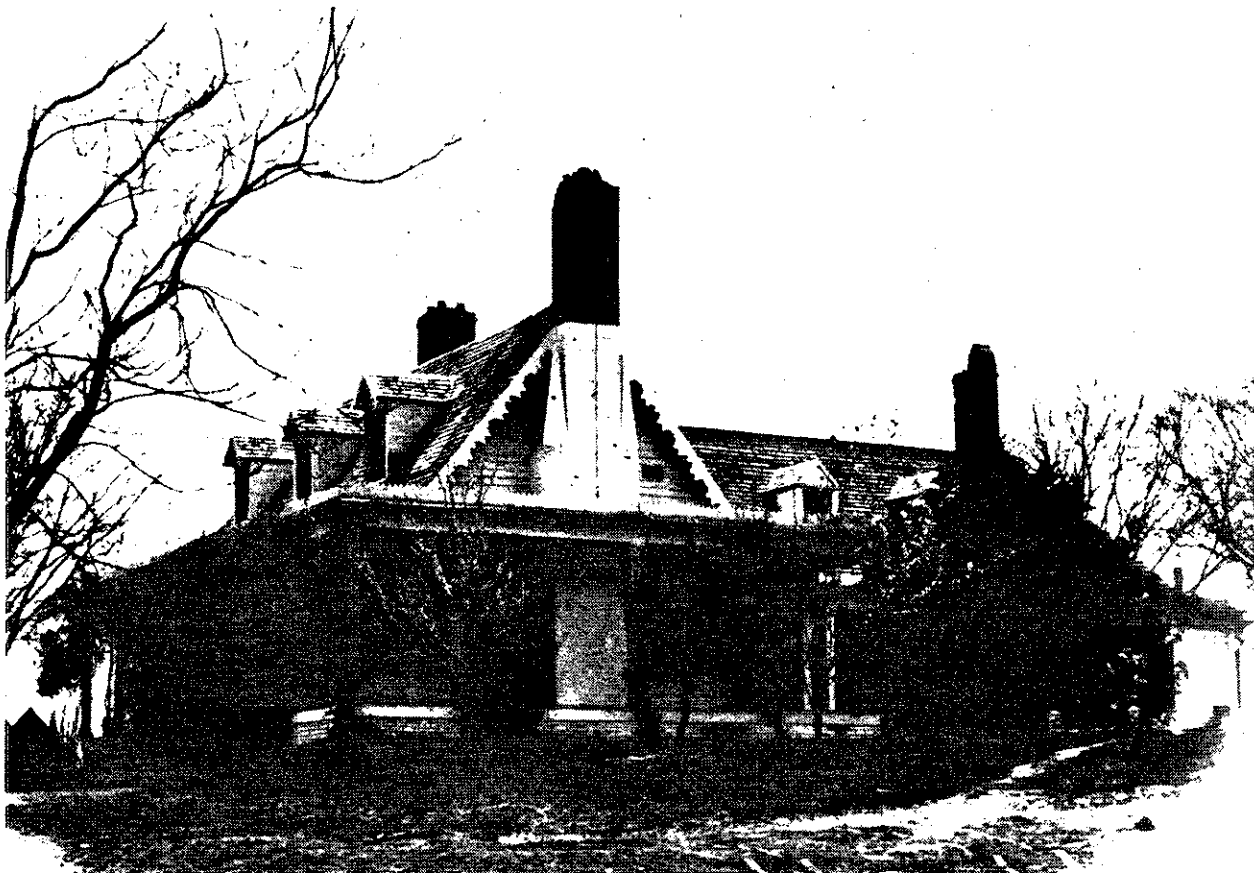
Illustration 10. Manor House from northeast, Matthew Brady photograph, c. 1865. Petersburg National Battlefield.

There is no question, moreover, that a nick in the west chimney shown in Illustrations 10 and 47 existed in 1865. But, the house was severely damaged during the Civil War.³³ The northeast chimney was clearly damaged at that time.³⁴ There is, in sum, no documentary evidence proving whether the nick in the west chimney was made at the same time, or as early as 1781.

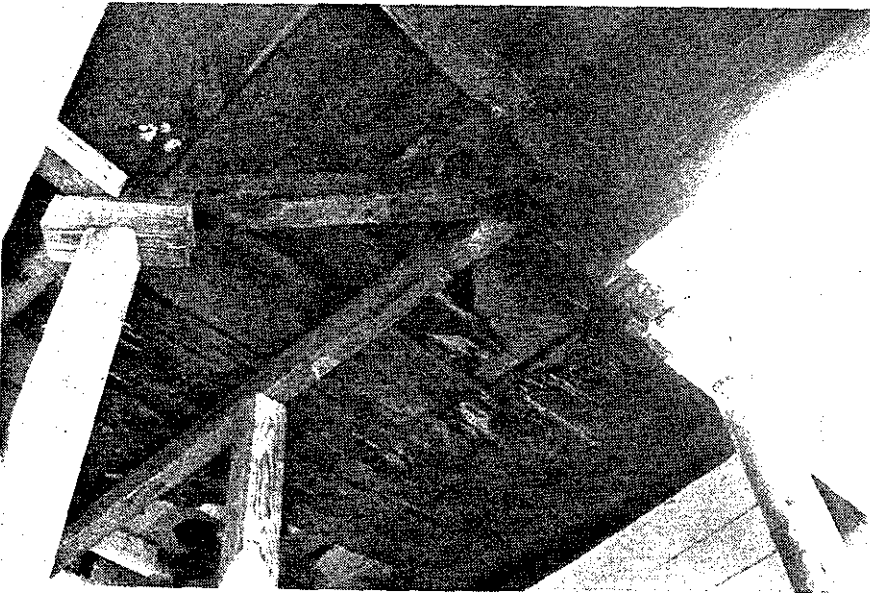
Illustration 54
Manor House
Detail, framing of east wing
Bathroom

Note: Water damage repaired
1981

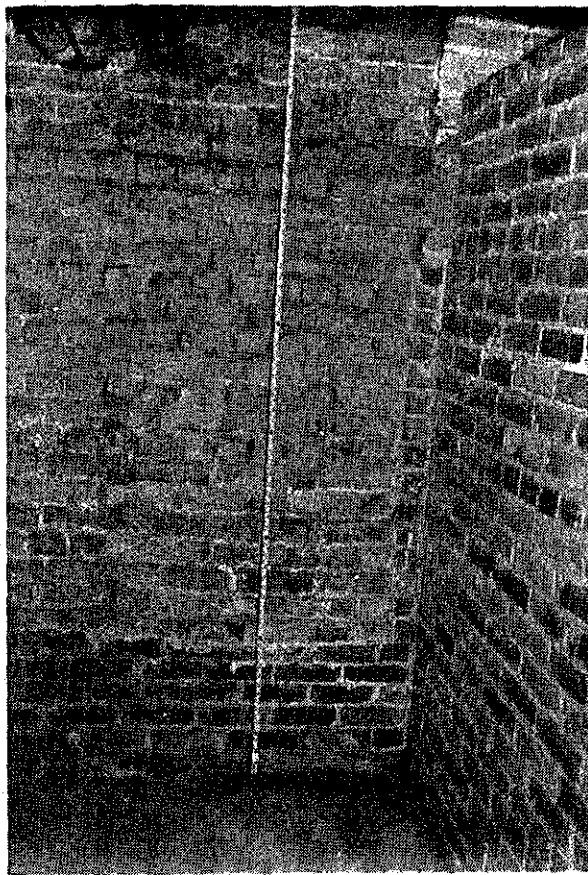
Illustration 66
Manor House, basement
Interior, Room B-12
Detail south wall

Note: Brick change at base
of wall.

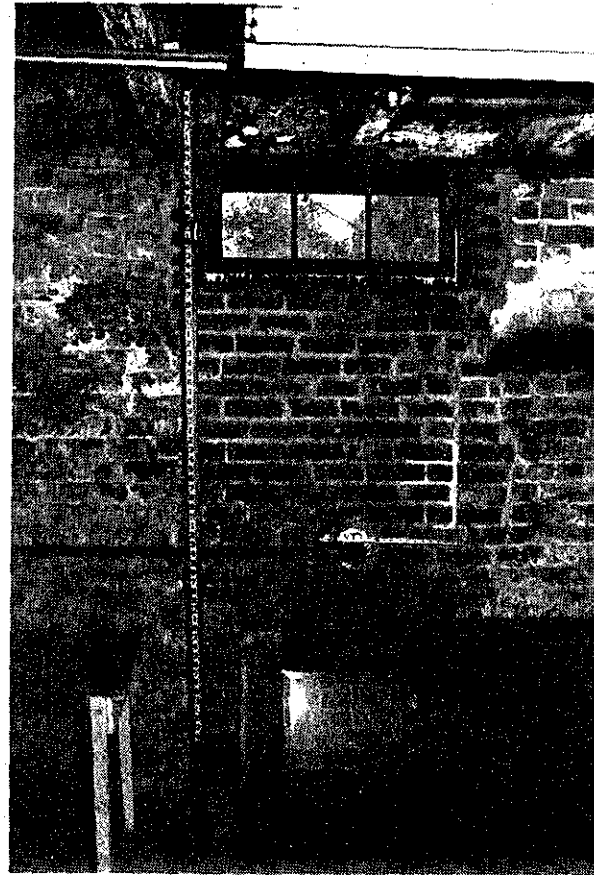
Illustration 67
Manor House, basement
Interior, Room B-05
Detail south wall

Note: Patch closed access
to 1935-54 greenhouse

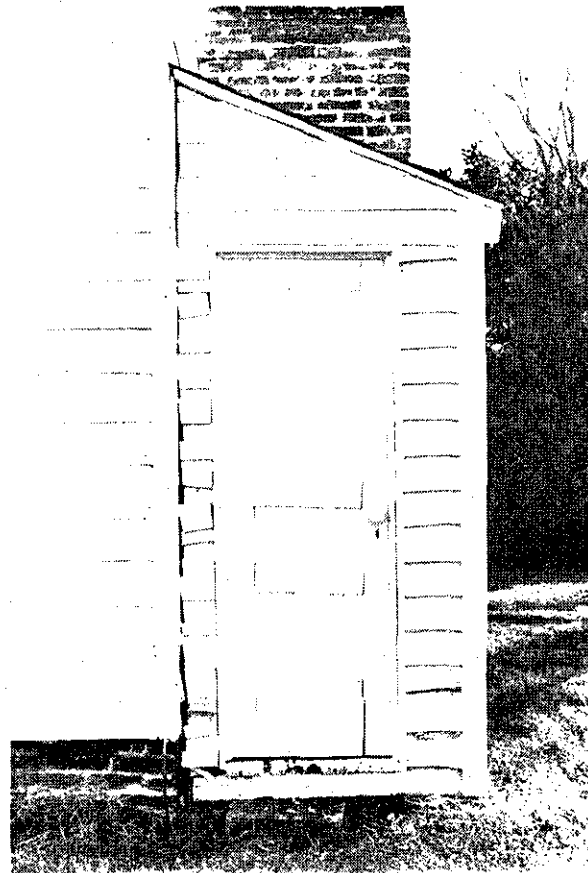
While obviously a poor quality addition, the bathroom addition appears to have been stabilized. The existing asphalt shingles were most likely wood shingles originally.

Illustration 78
Outside kitchen
West elevation, bathroom
addition

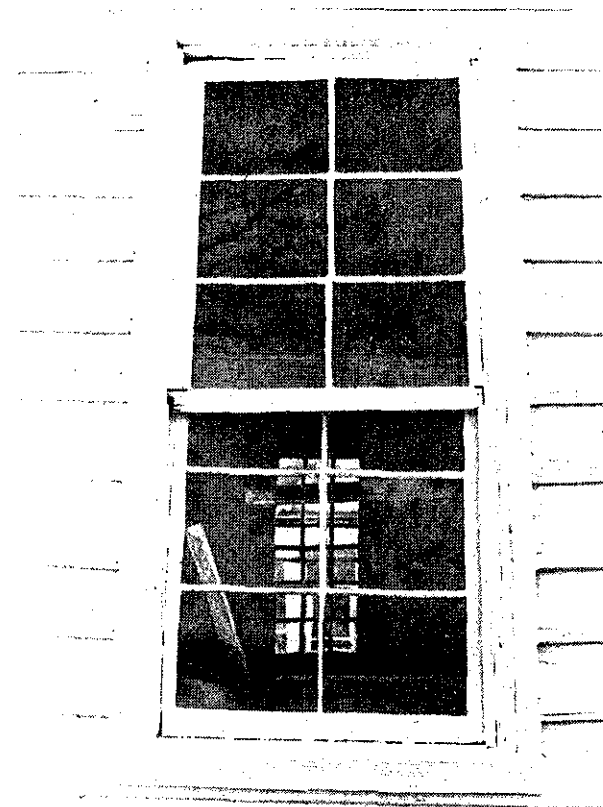
Illustration 79
Outside west elevation,
north window

The windows are basically weathertight. The north window on the west elevation is in the worst condition exhibiting deterioration at the head, meeting rail, and sill (see Illustration 79). The frames exhibit erosion of the surface, with a raised grain. All kitchen sash could be reconditioned replacing any damaged parts.

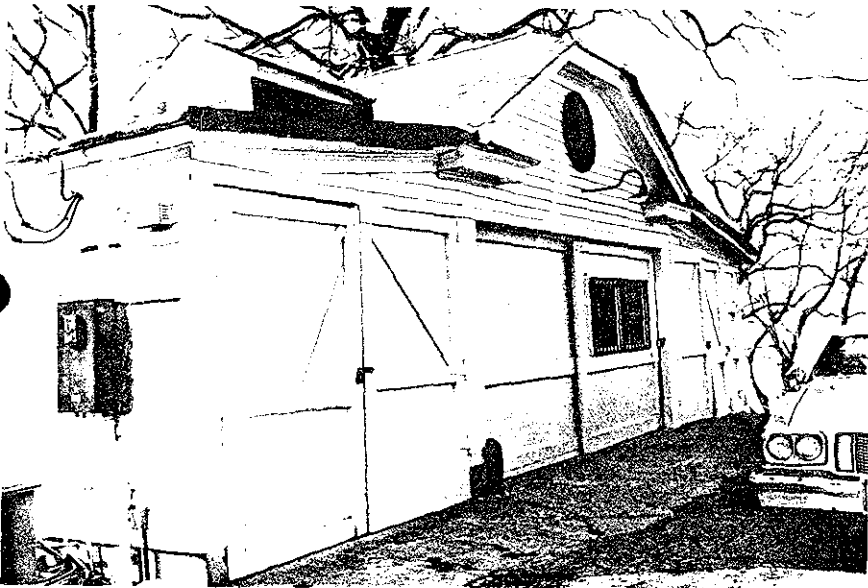
Illustration 86
Carriage House
from northeast

Approximately 25 percent of the weatherboards on the east elevation are in need of replacement, with the bulk of the work concentrated around the electrical service panel. The fascia board is also in need of replacement.

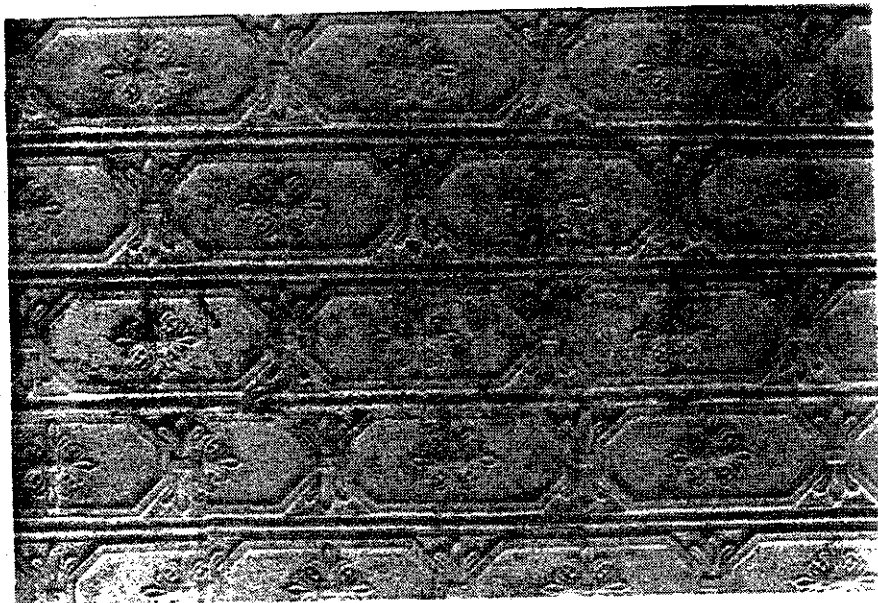
Illustration 94
Carriage House
Interior, central section
Tin ceiling (fireproofing)

The interior metal cladding is badly rusted due to continuing roof leakage. No current leaking was noted. The drywall in the addition is deteriorated due to the water and should be removed.

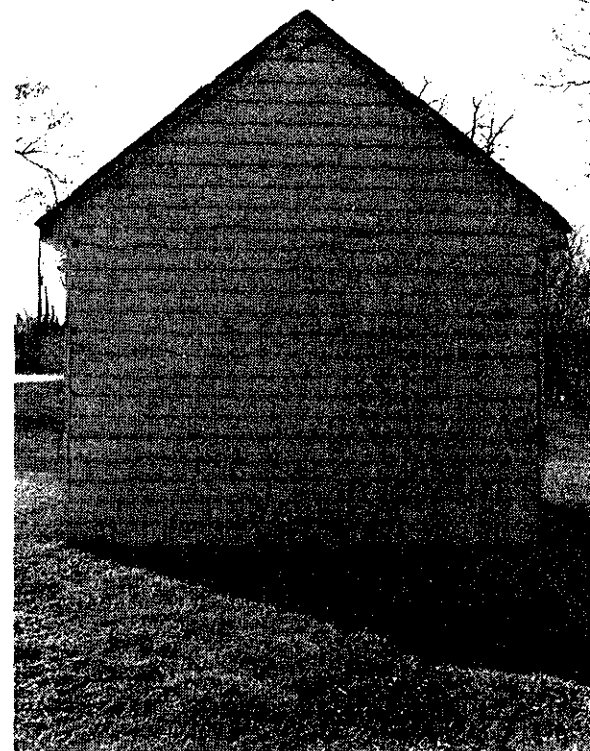
Illustration 99
Old Smokehouse
North elevation

Approximately 60 percent of the weatherboards on the building as a whole would require repair/replacement. The north elevation exhibits the worst deterioration with perhaps 80 percent of the weatherboarding requiring repair and replacement.

The corner moldings are severely deteriorated in three out of four corners with only the southeast molding in fair condition. Replacement is recommended in the three severe cases.

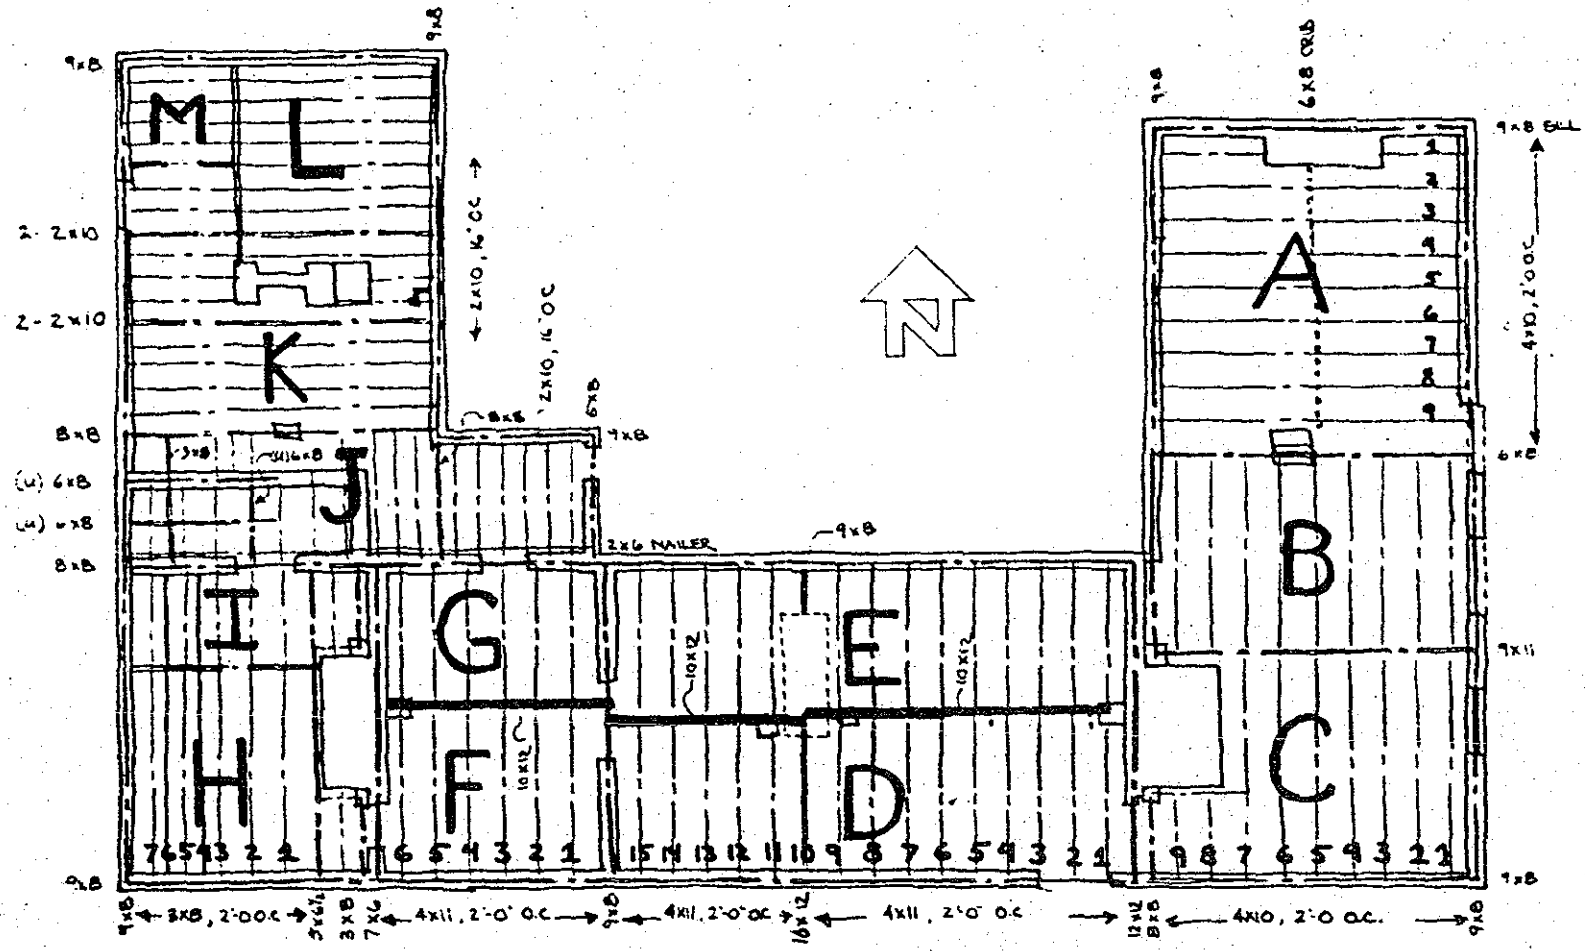
- Joist B4 - Powder post beetle damage, sound material.
- Joist B5 - Powder post beetle damage, termite damage at south end, unsound material.
- Joist B6 - Heavy powder post beetle damage at south end, poor material.
- Joist B7 - Heavy powder post beetle damage at south end, poor material.
- Joist B8 - Powder post beetle damage, sound material.
- Joist B9 - Powder post beetle damage, sound material.
- 9" x 11" Summer beam between areas "B" and "C" in sound condition.
