HISTORIC STRUCTURES REPORT

Tallgrass Prairie National Preserve

Tallgrass Prairie National Preserve
Strong City, Kansas

January 2005
Final Submission

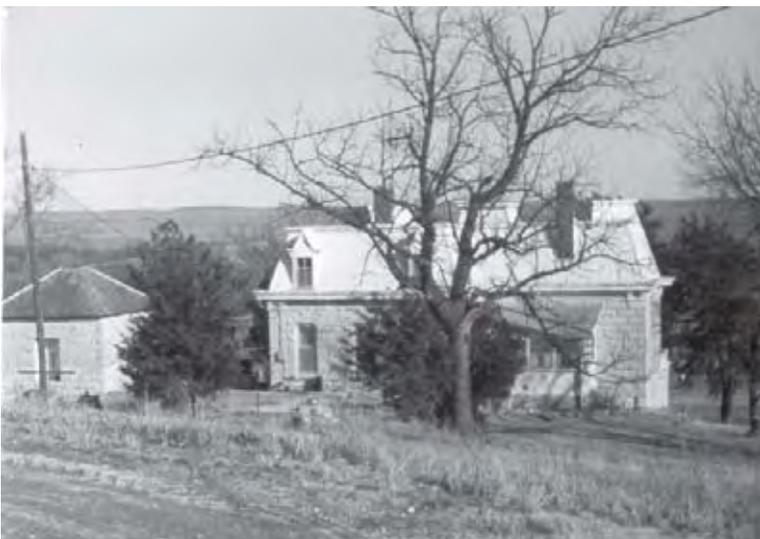
Figure A2-12: Ranch house and curing room, from the west, Burtis collection, ca. 1983.

The curing room is missing its cupola.

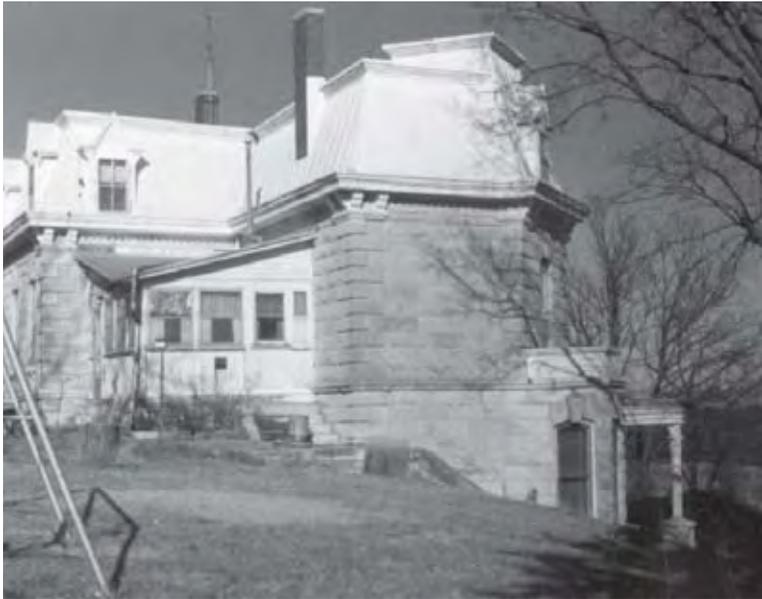
Figure A2-13: Ranch house rear porch, from the south, Burtis (Tax Credit) collection, ca. 1983.

The south door of the rear porch has been replaced by a window.

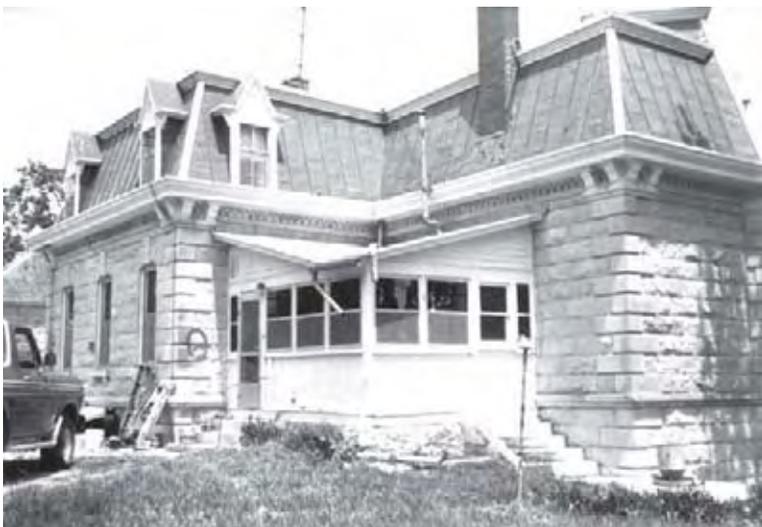
Figure A2-14: Ranch house rear porch, from the southwest, Burtis (Tax Credit) collection, 1986.

The small windows on either end of the rear porch (extreme left and extreme right in this photograph) were removed some time before 1997.

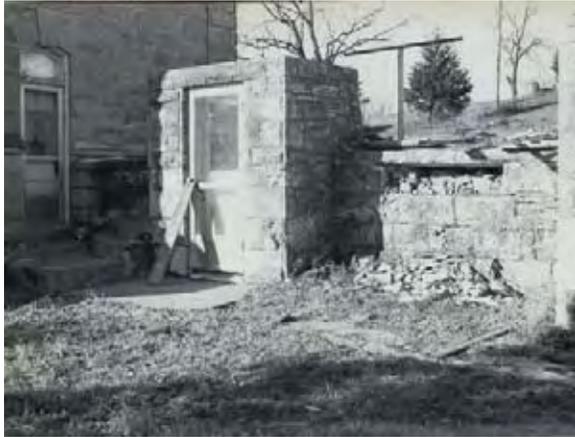
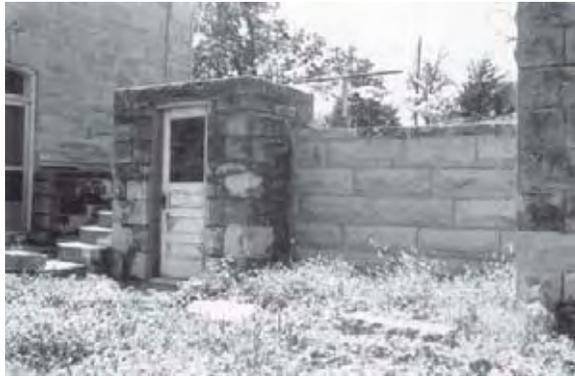
Figures A2-17 and 18: Tunnel wall, from the northeast. Fig. 17, top: Burtis collection, ca. 1983; 18: Burtis (Tax Credit) collection, ca. 1986.

The east wall of the tunnel was repaired and raised by a course. The cap stones no longer line up with the narrow course on the entrance tower. In the lower photo, stones, possibly from the repair, have been placed in the grass to form a planter.

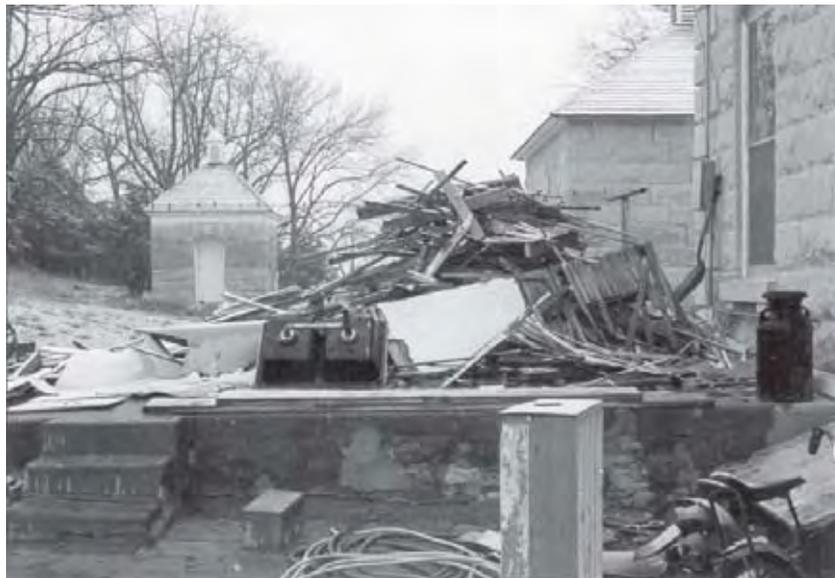
Figure A2-19: Root cellar roof, construction debris, from the south, Burtis collection, ca. 1983.

This construction debris is probably from the renovation of kitchen 205, since a kitchen sink, sheet flooring, a cabinet drawer, and substantial amounts of lath are visible.

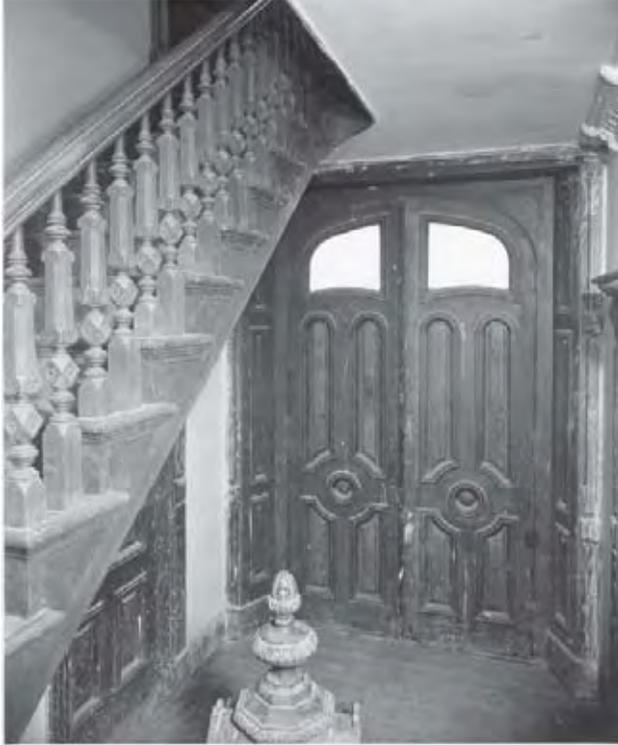
Figure A2-20: Hall 101 and view of front doors, from the west, on landing, Kinucan collection, ca. 1935.

⁷ These three photographs taken circa 1935 show water damage in the entry hall, vines growing through the bay window in the south parlor 102, and the old kitchen 105 a virtual ruin.

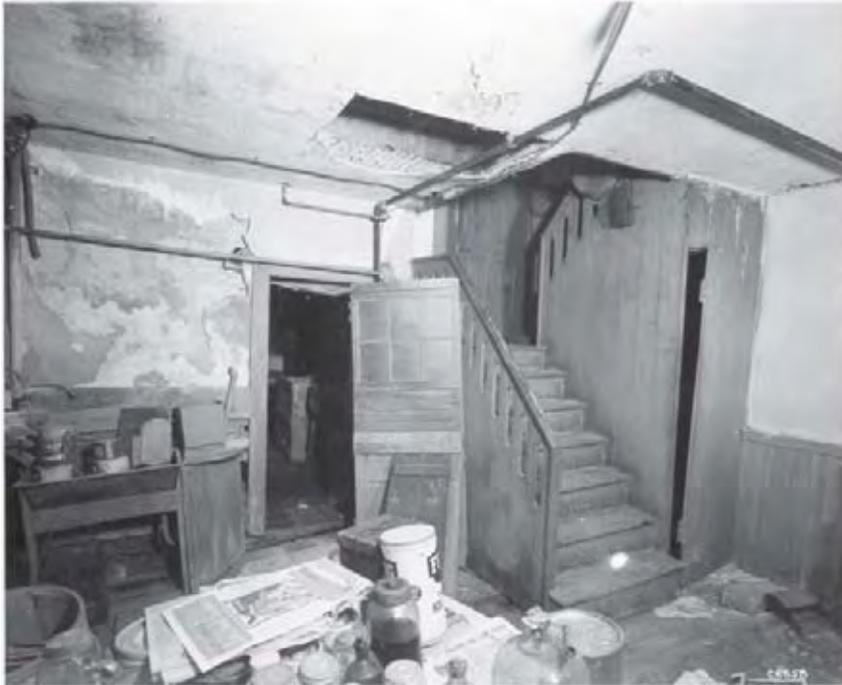
Figure A2-22: Old kitchen 105, from the southwest, Kinucan collection, ca. 1935.

The kitchen appears to be used as a utility room. The sink on the north wall is probably original. The purpose of the opening in the ceiling is unknown.

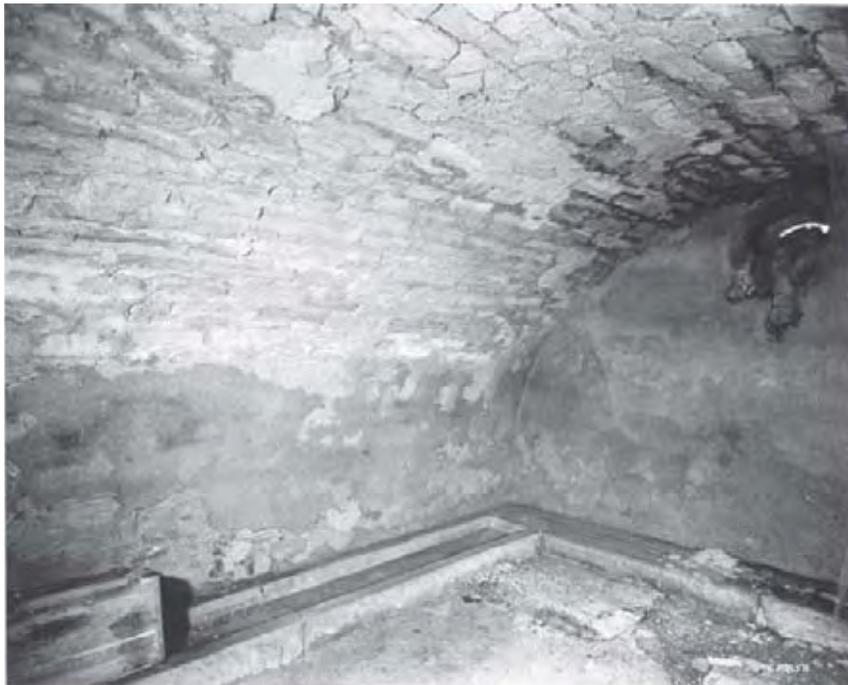
Figure A2-23: Spring house 108, from the southeast, Kinucan collection, ca. 1935.

The spring house appears to be in disrepair. The north circular vent/window is blocked.

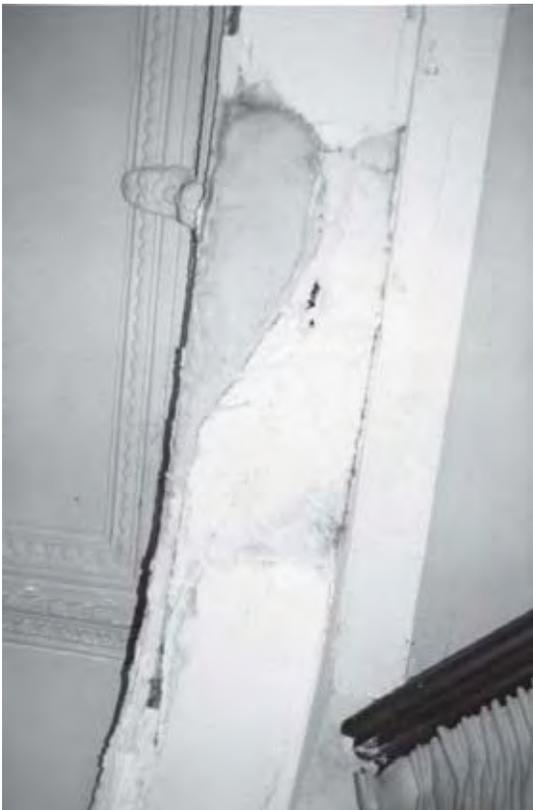
Figure A2-35: North parlor 103 arch, looking up, Burtis (Tax Credit) collection, ca. 1983.

Via access holes cut through the plaster in 2002, the structure of the arch was determined. At this location there are two wood beams supporting the floor structure and wall above. One of these beams was treated with creosote and was most likely a replacement beam.

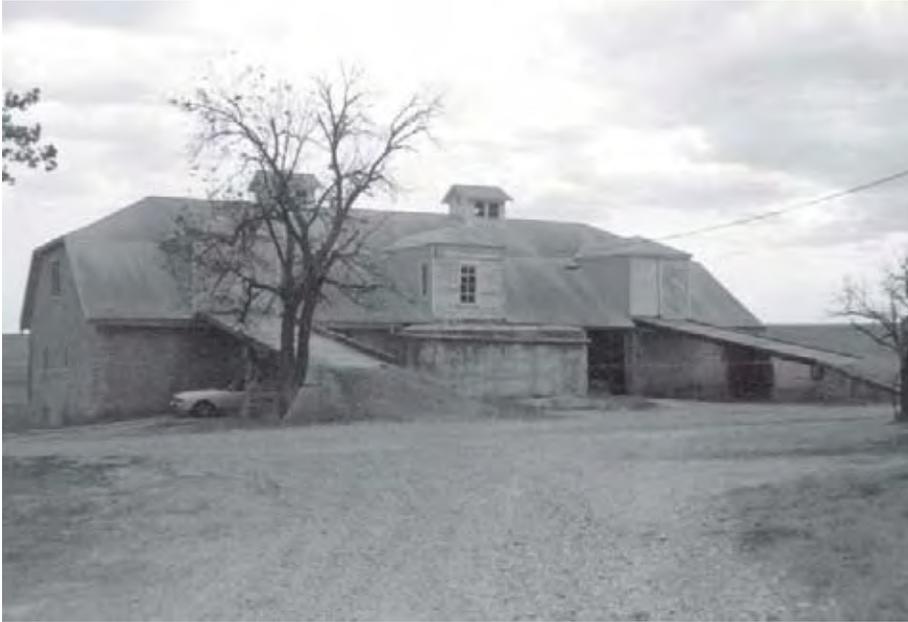
Figure A3-6: Barn, from the northeast, Burtis (Tax Credit) collection, ca. 1983.

The barn before the tax credit repairs were conducted. Note that the main north entrances are no longer arched, and the cupolas have been added.

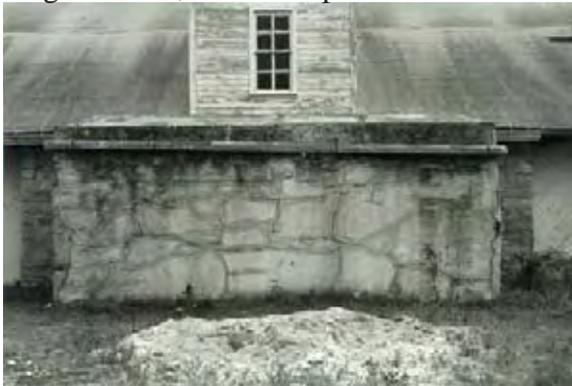
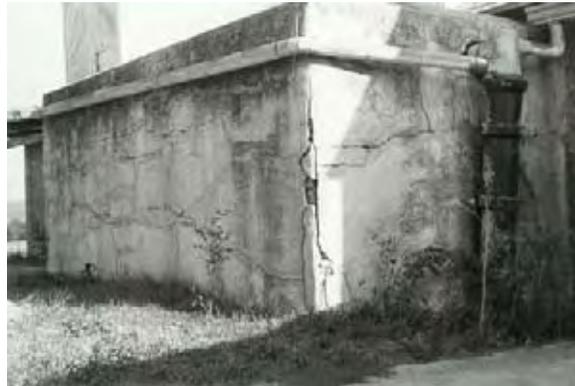
Figures A3-7 and 8: Barn cistern, from the north and the northwest, Burtis collection, ca. 1983.

The cistern parging is cracked. A pipe runs around the cistern from the east side to the collection pipe on the west. The gutter on the west feeds into the collection pipe.

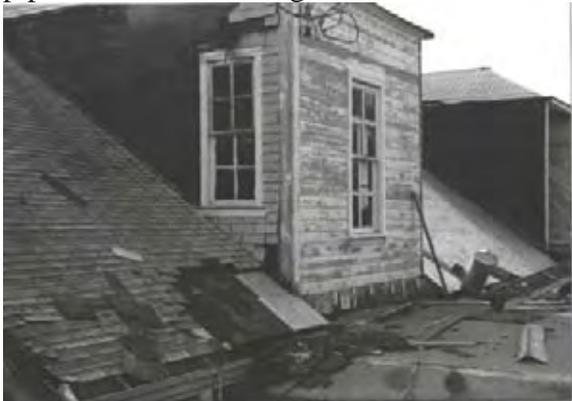
Figure A3-9: Barn middle dormer, from the east, Burtis (Tax Credit) collection, ca. 1983.

The middle dormer on the north side of the barn is shown here in its shortened form. Cut floor joists are visible where the dormer meets the cistern roof.

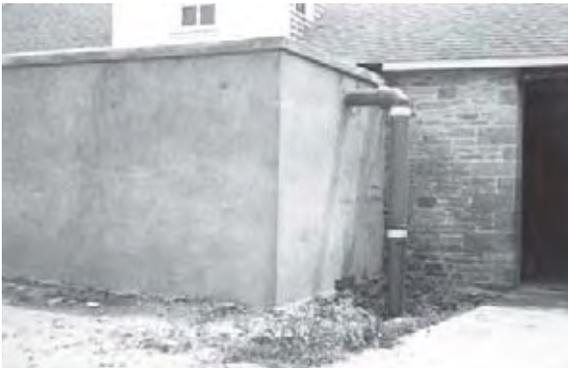
Figure A3-11: Barn cistern, from the northwest, Burtis (Tax Credit) collection, ca. 1986.

The parging has been redone, the collection pipe replaced, and the gutter has been disconnected from the pipe.

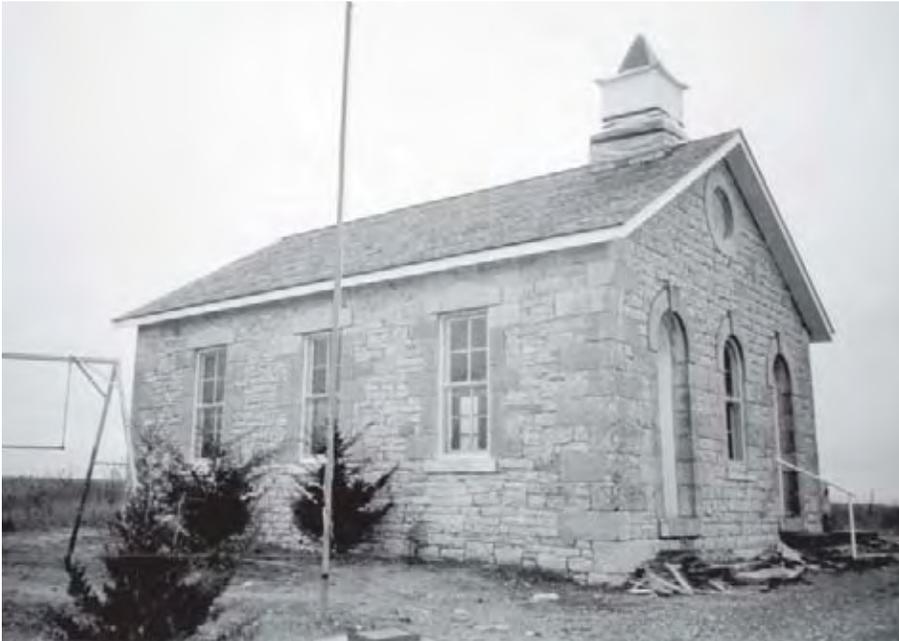
Figure A4-4: Schoolhouse, from the southeast, QEA 1997.

The south steps had not yet been replaced at the time of this photograph. The belfry replacement does not match the original.

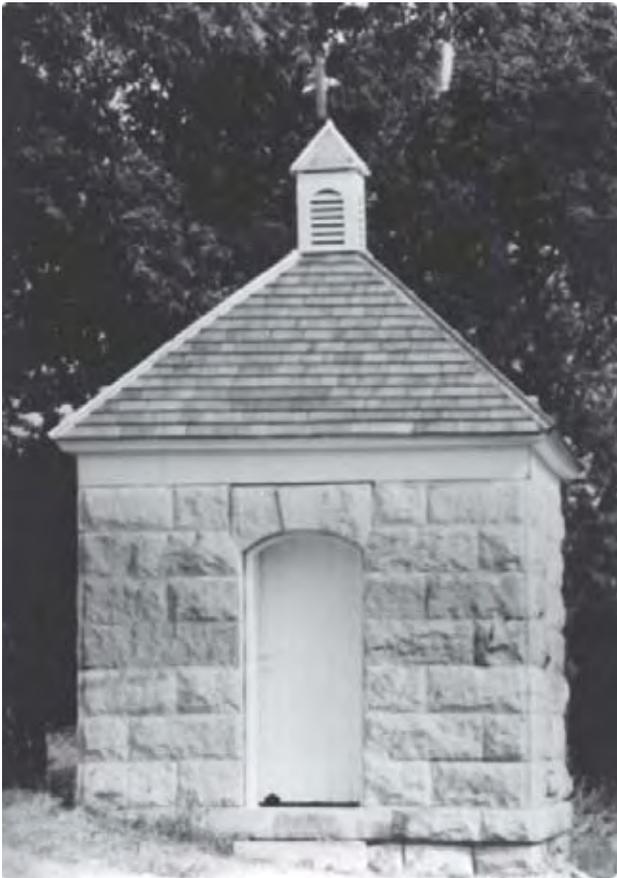
Figure A5-2: Outhouse, from the south, Burtis (Tax Credit) collection, ca. 1986.

The cupola has been repaired.

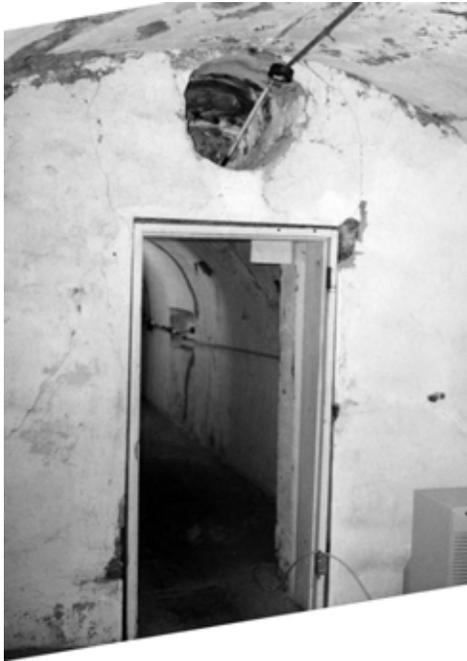
it, visible from the inside of the springhouse. The stone panel is larger than the other vent panels, while the circular vent window in this panel is the same size as the other three vents (figure B1-6). Due to the position of tunnel 107, only parts of the panel and window are visible from the tunnel. In comparison to doorway 108, stones surrounding door 105 to kitchen 105 do not have the same tool joints at the jambs (figure B1-7). This opening was likely added when the tunnel was built. This supports the assumption that the tunnel was built subsequent to the ranch house and springhouse/curing building.

Figure B1-6: Ranch house, blind vent at springhouse door 108, QEA, 01/25/02.

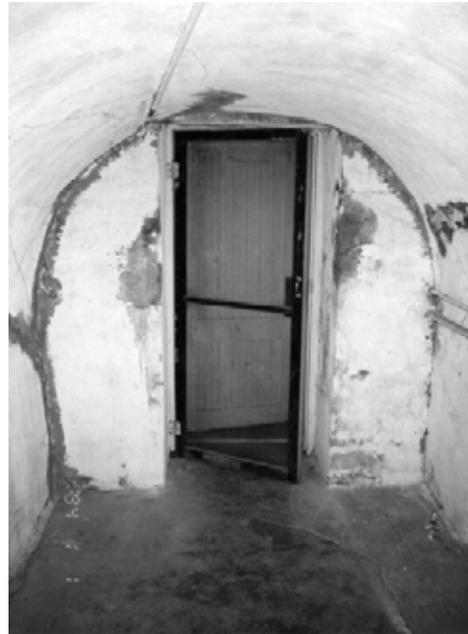
Figure B1-7: Ranch house, door 105 as seen from tunnel 107, QEA, 01/25/02.

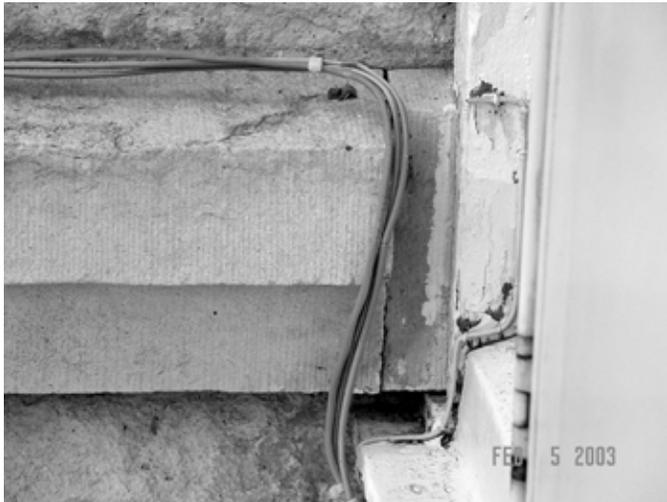
During physical investigation below the existing rear porch 207, it was observed that windows 110 and 111 have pronounced heads and sills, which project beyond the face of the wall. The jamb stones have been roughly tooled, though not to the same refinement as the corner quoins of the ranch house. The remaining stones around the windows on the south wall of the house as well as the lower part of the west wall, are random size ashlar similar to the other foundation walls. Three stones are inset into the west wall, protruding beyond the face for bearing of the porch. Another stone protrudes from the south wall; this and the window header stones support the porch structure above. Inside the rear porch 207, the water table stones transition to flat stones that form the thresholds of the doors into the ranch house, doors 202B and 204 (figures B1-8, B1-9). The doors inside the rear porch, 202B and 204, are original and do not appear to have ever been exposed to weathering.

Figure B1-8: Ranch house, watertable at rear porch 207, QEA, 02/05/03.

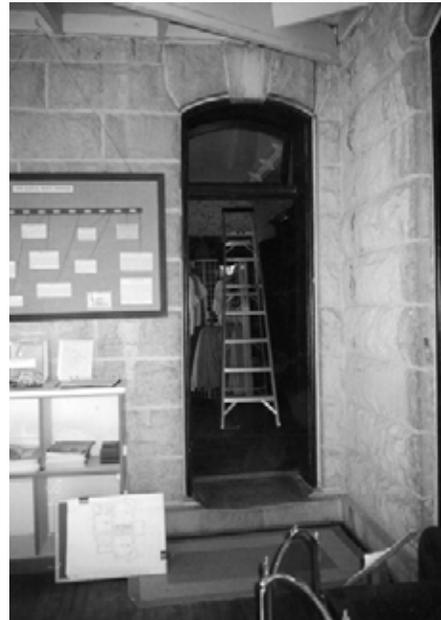
Figure B1-9: Ranch house, threshold at door 204, QEA, 07/08/98

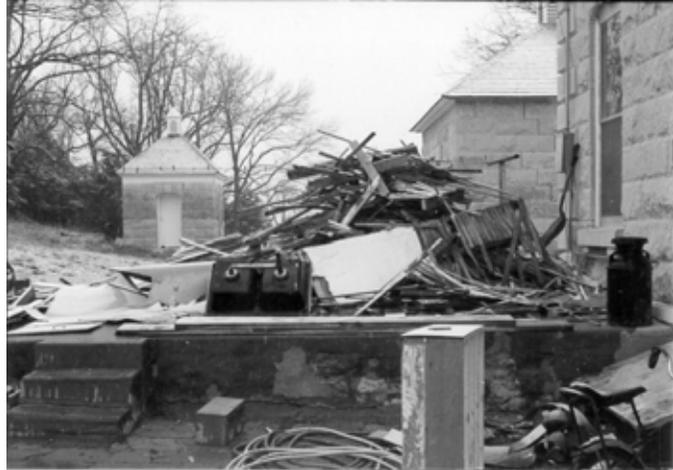
Figure B1-10: Ranch house, rehabilitation, Burtis (Tax Credit) Collection, ca. 1983.

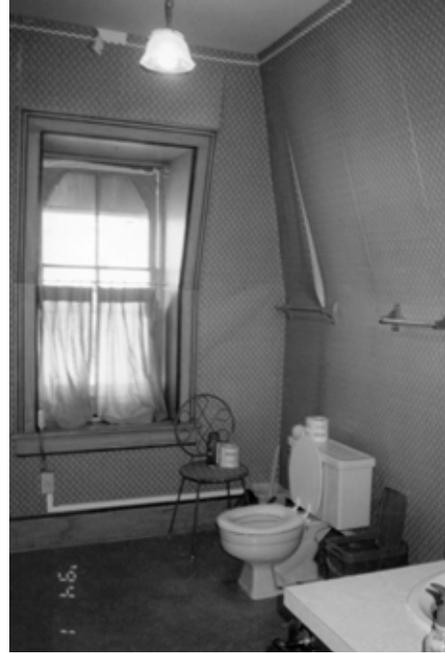
The current heating system with furnace was installed at this time. The electrical wiring was also updated. Most of the old wiring was replaced, additional outlets were provided, all surface wire was removed, and new light fixtures were installed. During the rehabilitation, old surface wiring with many breaker boxes and wiring run through old gas pipes were found.⁴⁴ Later in this episode, further electrical wiring was installed on the third floor in surface-mounted conduit. A photograph from the tax credit package circa 1983, for example, shows the west wall of bathroom 305 after renovations. Currently, this wall contains much more surface-mounted electrical conduit and fittings (figures A-52, B1-11).

Figure B1-11: Ranch house, bathroom 305, west wall, QEA, 01/25/02.

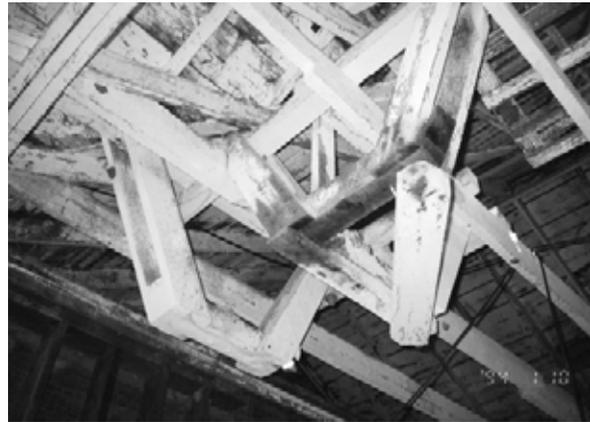
As seen in both the 1883 and 1887 lithographs (figures A1-1, A3-1), there was originally a windmill attached to the barn roof.⁴⁷ It was located on the north side, above the middle dormer, which at the time was extended to the north, where the cistern currently is located. With the help of its 30-foot wingspan, this windmill reportedly could run a pair of corn burrs, a corn sheller, a hay chopper, root cutter, or oil-cake crusher.⁴⁸ The windmill was damaged in an 1884 windstorm, and was supposedly removed prior to 1887 for fear that its vibrations would cause damage to the barn during its operation.⁴⁹ It does not appear in the 1908 postcard (see figure A1-3). Cut-off beams and bracing that may have supported the windmill or its mechanism are still visible below the middle north dormer (figure B2-1).

Figure B2-1: Barn, third floor, assumed windmill mechanism, QEA, 10/10/02.

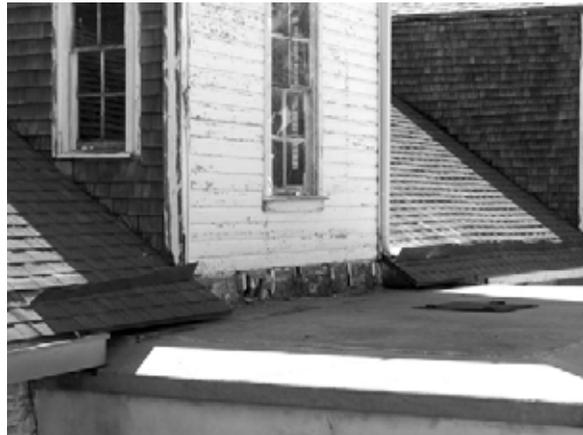
Between approximately the 1930s and 1970s, the wood structure on the north side of the barn was removed and the cistern was added in this location. The outer layers of the cistern are constructed of concrete blocks covered with portland cement mortar parging. When the wood shed on the north side was removed, the middle dormer was shortened and probably re-sided at this time with asphalt shingles. Cut-off third floor joists are still visible on the north elevation where the dormer was shortened (figures A3-9, B2-2). Since window 302 on the north façade of the middle dormer appears to be as old as window 303 on the west side, it was probably in the north wall of the original structure and reused when the shed was removed and the dormer shortened.

Figure B2-2: Barn, north elevation, cut-off beams at middle dormer, QEA, 10/10/02.

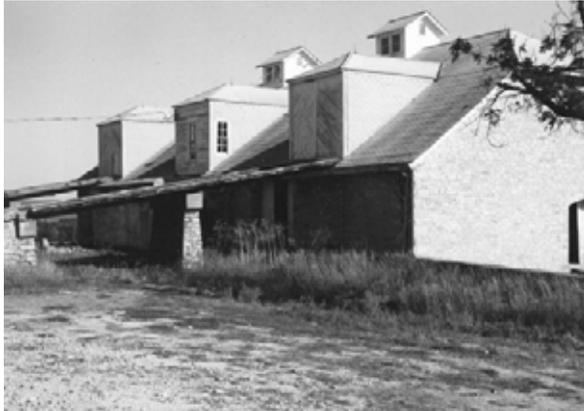
The beams of both ramps appear to have been replaced with steel I-beams by 1983. The piers and beam supports, at the earth/rubble ramps, were reinforced with concrete bond beams some time after the 1930s (see figure A3-3, previous episode) and before 1983 (figure B2-3). The eastern ramp was rebuilt with 2x12 decking sometime after the 1930s.

Figure B2-3: Barn, northwest side, circa 1980.

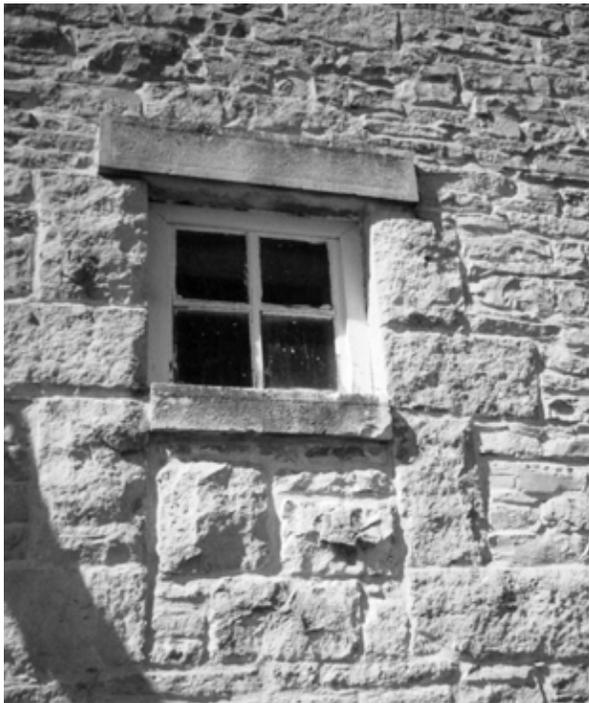
Figure B2-4: Barn, east elevation, window 110, QEA, 10/07/02.

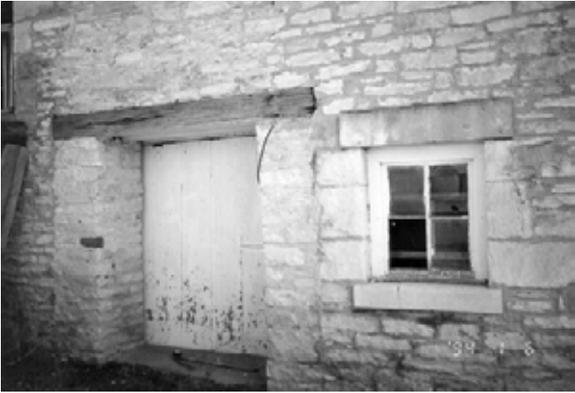
Figure B2-5: Barn, west elevation, door 101, QEA, 10/07/02.

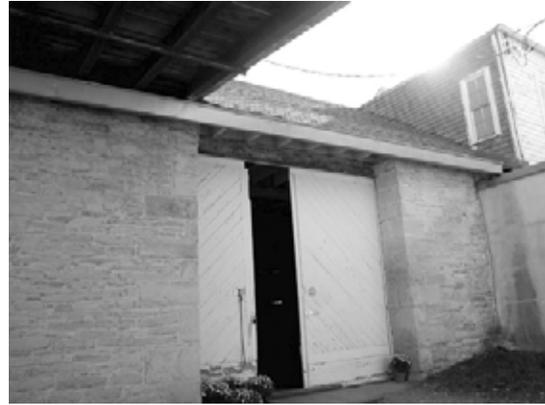
Figure B2-6: Barn, north elevation, door 201, QEA, 10/09/02.

The two openings on the north elevation, 201 and 202, have beam lintels in photos circa 1983 (figure A3-6). It is probable that the two doorways were enlarged along with the other modifications that accommodated trucks backing in. The bottom nine quoin blocks are assumed original, while those above are of a different shape, texture, and tooling (figure B2-6). Interior knee braces of second floor columns near the doorways were also removed in a configuration that seems to accommodate large trucks. South of door 201, two columns were removed and steel beams added to support the third floor, while seven new columns were added in bays to the east. This also helped support the grain bins above.

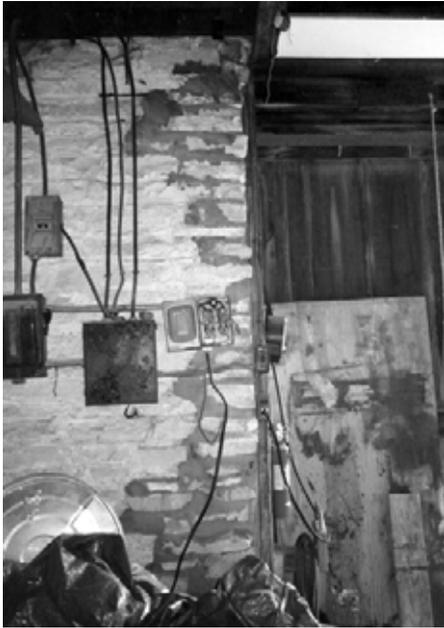
Sometime during their tenure, the Benninghovens converted the icehouse to a work shed, and sometime between 1930s-1970, Fred Howard cut a new door opening in the south wall.⁶⁶ The door opening was crudely cut and dark gray mortar patches can be seen inside the icehouse on both sides of the south door (figure B5-1). At this time, it is likely that they filled in the original door opening in the north wall. The shape of the original opening can still be seen. (figure B5-2).

Figure B5-1: Icehouse, south elevation, interior, new door, QEA, 10/08/02.

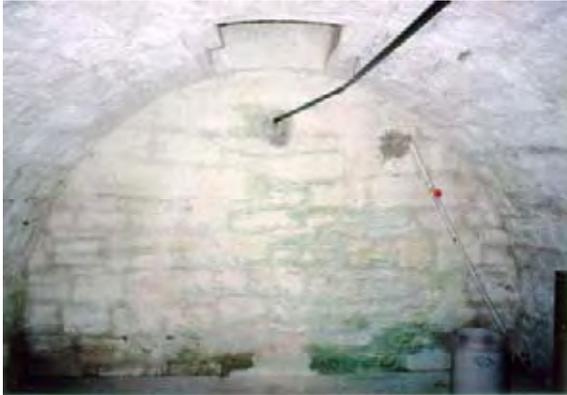
Concrete slabs were historically poured on top of the root cellar and tunnel roofs in order to prevent water leaks from both surface and subsurface water flow. The concrete cap at the root cellar is crowned to drain, but with major cracks and areas of spalling. Inside the root cellar, there is evidence of leakage (figure C2-2). The skylights within it are of cast

Figure C2-2: Leakage at root cellar wall and ceiling, QEA, 01/23/02.

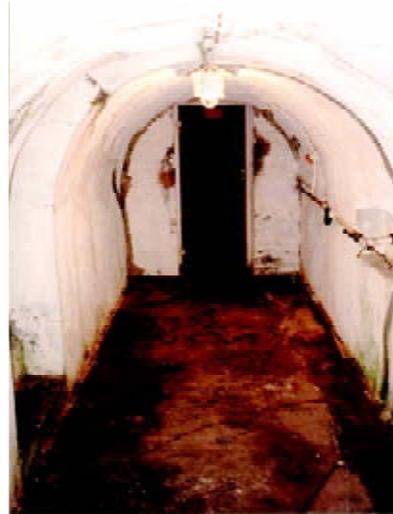
iron with round colored glass lights. Several glass elements are missing and are replaced with rubber "stoppers." Inside the tunnel, there are cracks and evidence of leakage (figure C2-3).

Figure C2-3: Leakage at tunnel walls and ceiling, QEA, 01/23/02.

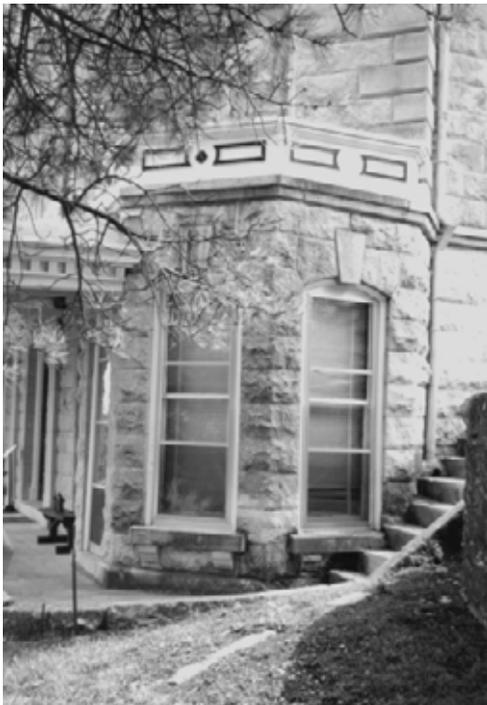
Figure C2-5: Ranch house, east elevation, north pavilion bay window, QEA, 07/07/98.

North Pavilion - Walls: The first floor portion of the north pavilion is shown in figure C2-5. The lower stone section shows staining, particularly around the base outside of the porch covering. The southeast corner of the bay window seems to have settled, and then tipped forward from the cornice to the window, and the water table is not level. The joint between the main body of the house and the bay window has widened considerably, more so at the top than the bottom. All of the stones in this area have been repointed with gray mortar (figure C2-6) but movement is still evident from the presence of new mortar cracks. Slight misalignment of the repaired mortar also indicates that the keystones above the windows have slipped. There is organic growth on the arch stones of the center window 107 because of the leaking roof overhead. At the north window 108, the stone west of the window sill is cracked.

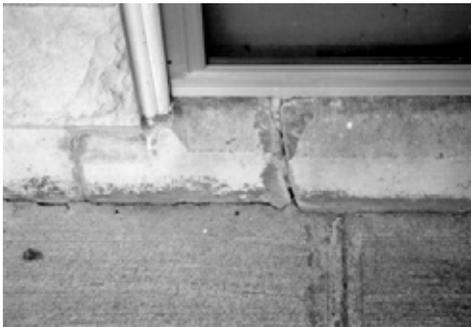
North Pavilion - Windows: The sill stone of window 106 is cracked at the quarter point to the south, and the stone has shifted outward. (figure C2-7). The sash of window 108 needs glazing repair but is otherwise in good condition.

Figure C2-7: Ranch house, east elevation, north pavilion, sill of window 106, QEA, 07/08/98.

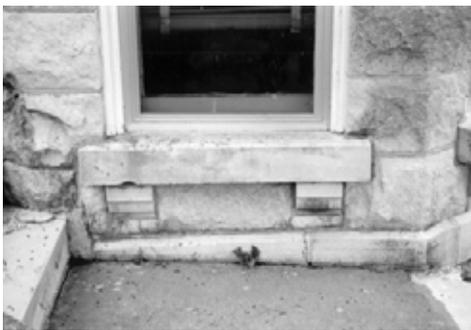
South Pavilion - Walls: At the first floor the stone is in good condition. The mortar joints have been selectively repointed, including the keystones. At the northeast panel of the bay window, the first course of stone up from the base has horizontal and vertical cracking adjacent to the jamb. Approximately 50% of the mortar joints in the center panel have been repointed with gray mortar. The lower face of the sill block of window 101 is fractured between brackets (figure C2-8). The tooled corner of the south jamb stone to the west of the window has broken off at the sill block. There is a damaged patch north of the sill block of window 102.

Figure C2-8: Ranch house, east elevation, south pavilion, base of window 101, QEA, 07/08/98.

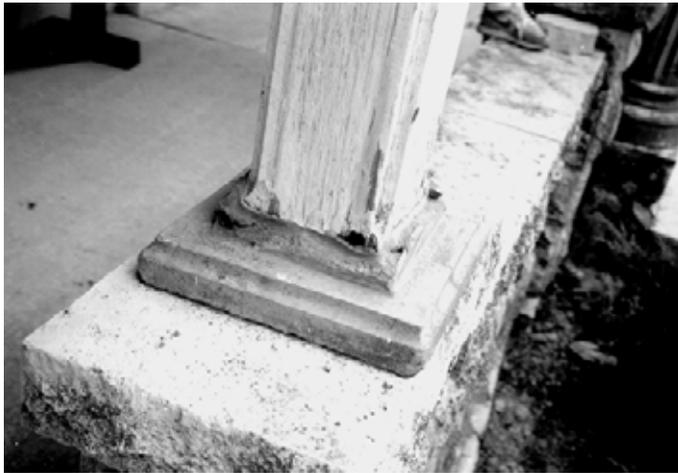
Porch and Steps: The porch, which extends the full width of the east elevation, is composed of three sections. The center section projects forward with the center pavilion, and its roof is higher than the sections to the north and south. The center section roof is supported on a pair of pilasters flanking the entry door and a pair of stone columns. The stone columns are set forward (to the east) of the line formed by three wood columns supporting each of the other two porch roof sections. Bases of the boxed wooden posts supporting porch wing roofs are set into concrete plinths. Wooden plinths probably were replaced by concrete during the mid-twentieth century after the wood decayed. Bases of the wood posts in contact with the concrete plinths are deteriorated. All six of the wooden columns have damaged stone collars into which the wood seats (figure C2-9).

Figure C2-9: Typical stone plinth, QEA, 07/08/98.

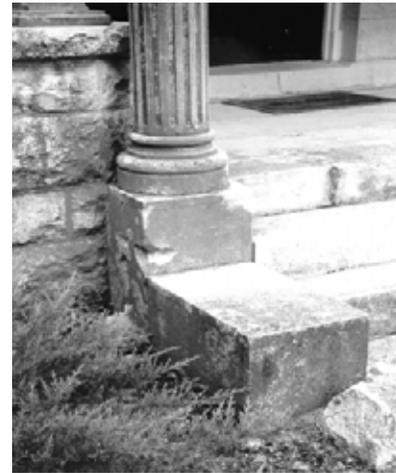
Figure C2-10: Ranch house, east elevation, center porch section. South column base at entry stair, QEA, 07/08/98.

A severely deteriorated base stone at the north stone column of the center porch was replaced in kind in 2000, along with the repointing of all the column joints. It was mortared over existing foundation stones. The south column base, however, is chipped

and the south column has a large spall in the southeast corner (figure C2-10). The stone floor has a pitted surface with cracks and spalling and the individual stones are no longer aligned with each other. The stone treads are in good condition, but the top of the lower tread has spalled and been patched.

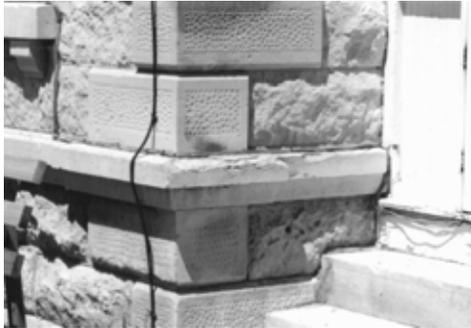
Figure C2-11: Water table condition, QEA, 07/07/98.

and the south elevation wall is completely open with a large crack. Gray mortar has been applied to this area from the water table down to the first floor. The south elevation of the west wing of the house is limestone in good condition, with selected areas in need of repointing. The water table at this area is in poor condition and its top is fractured (figure C2-11).

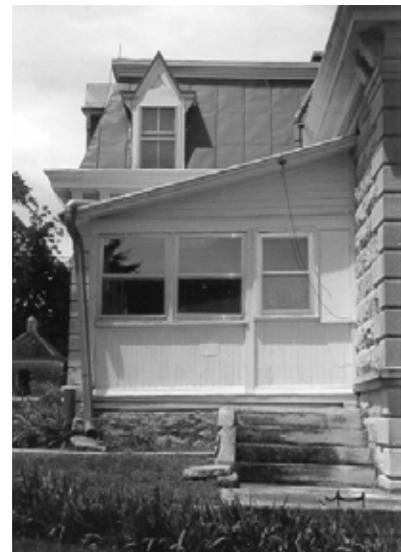
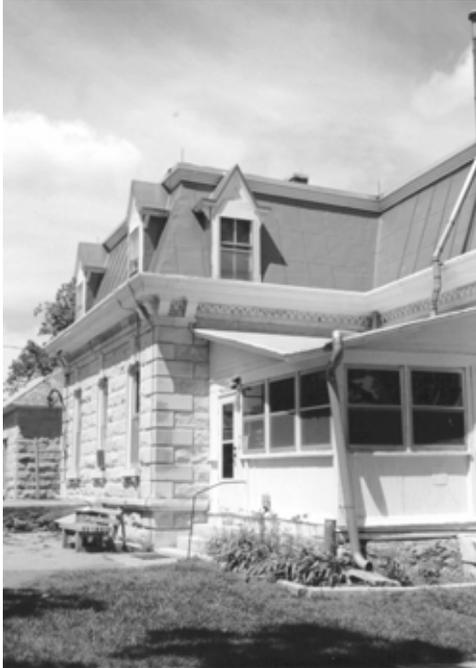
Rear Porch: There is an enclosed porch at the southwest corner of the house (figures C2-12, C2-13). The porch is constructed of wood, which is in overall good condition although weathered. The entire porch is settling at the west end. No major deterioration is apparent except at the skirt board, which is heavily weathered at the bottom and ends. The porch foundation stone is in poor condition, with numerous cracks and poor mortar joints. It appears that the stone is pushing outward at the base. The stone treads of the original office steps have heavy organic growth and the west stringer is misaligned and damaged. The entire stair is settled at the east end. The aluminum storm windows are in good condition, but are anachronistic.

Figure C2-12: South elevation of porch. The west wing is visible behind the porch. The main body of the house is to the right. QEA, 07/07/98.

Figure C2-13: Ranch house, south and west elevations of rear porch and west wing. QEA, 07/07/98.

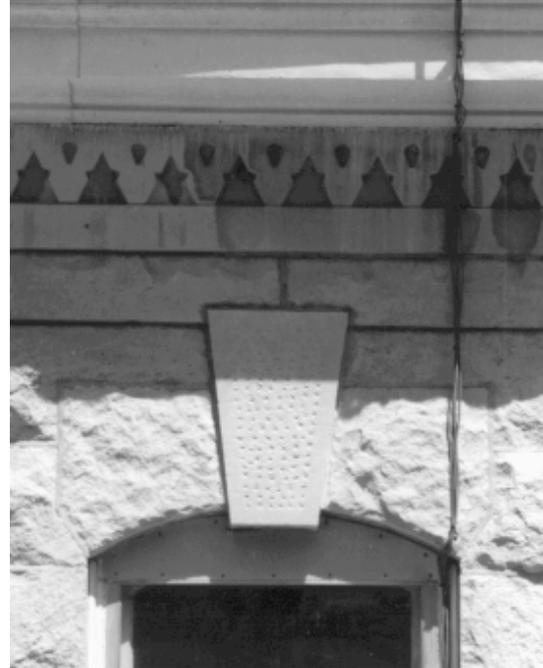
Figure C2-14: West elevation, south window keystone. QEA, 07/07/98.

Walls: The west elevation of the west wing is in overall good condition. The stone and mortar are in good condition and have been repointed. The water table is rough around the root cellar cap and the joint at that location has been repaired. It is obvious that work has been done in the mortar joints around all three lower windows. Despite this fact, all three keystones have dropped noticeably, especially the outer two (figure C2-14). When compared to the average mortar joint dimension, the joints above the keystone show a

wider joint dimension, and, although the joints had been repointed several times, they show recent cracks, which is an indication of continuous movement.

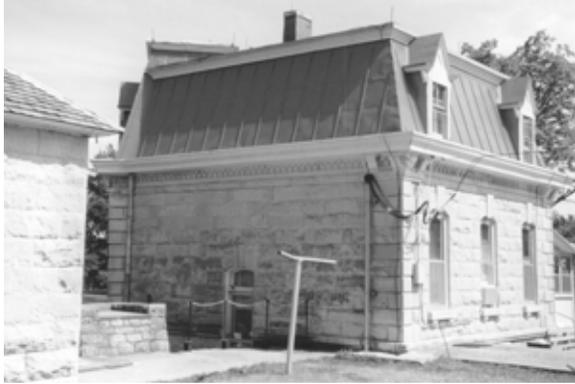
Figure C2-15: Ranch house, north elevation. The curing room is partially visible at the extreme left, QEA 07/07/98.

Walls: The north elevation is shown in figure C2-15. The stone above the water table shows evidence of dark staining from organic growth on the lower half of the wall. The mortar joints have been repointed with gray mortar and the remaining original mortar is in good condition.

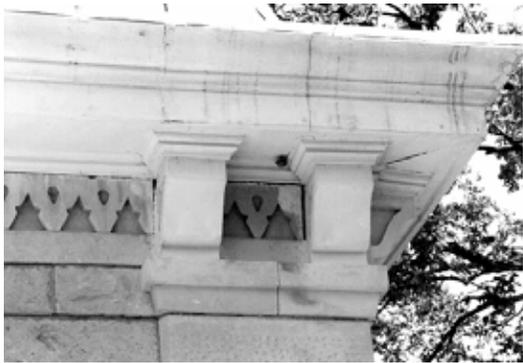
Figure C2-16: Open joint between dentils and brick, QEA, 07/07/98.

On the west elevation, the cornices are in good condition and appear to be intact although the lower cornice is stained and rusted. Nevertheless, the majority of the joints between the upper cornice, lower cornice, and stone dentils are open. The dentil stones in this area are in better condition than those previously mentioned, but of similar description and are quite stained. Vertical joints between the dentils, as well as a joint between the dentils and the first course, are open (figure C2-16). Mud wasps have created many nests within the dentil stone design around the entire house.

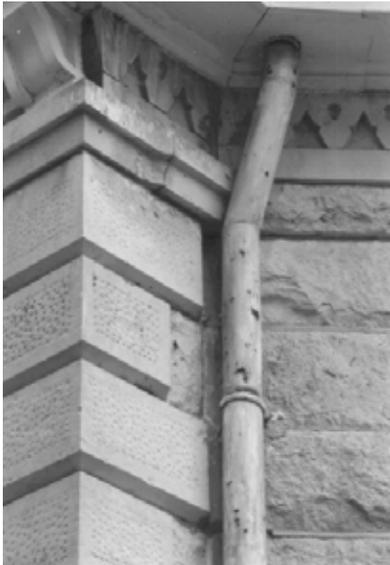
Figure C2-17: Ranch house, north elevation at pavilion, cracking at cornice, QEA, 07/07/98.

On the north elevation, the lower cornice has a split at the northwest corner miter and one at the northeast corner seam. The eastern bracket base is kicked out and a bird nest is located behind it (figure C2-17). The horizontal dentil joints are mostly open, although the vertical joints have been repointed with a gray mortar.

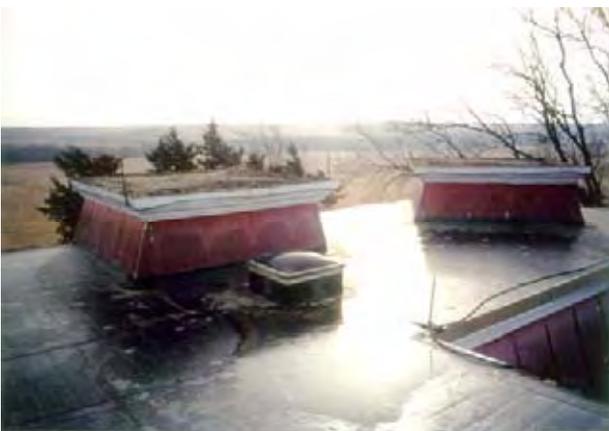
The flat, uppermost portion of the ranch house roof is a fully adhered EPDM roofing system installed in September 2001 by the NPS. The tin metal edge is painted and in good condition with some missing joint compound. There is a depression in the roof on the north side of the north chimney. This location and the area west of the skylight retain standing water and ice as observed on January 23, 2002 (figure C2-18). Evidence shows that frequent leaking has occurred through to the ceiling of hall 301 (figure C2-19). The leakage seems to have been stopped by the latest roofing membrane replacement, but it is still recommended to continue monitoring the roof for leaks.

Figure C2-18: Standing water and ice on roof, QEA, 01/23/02

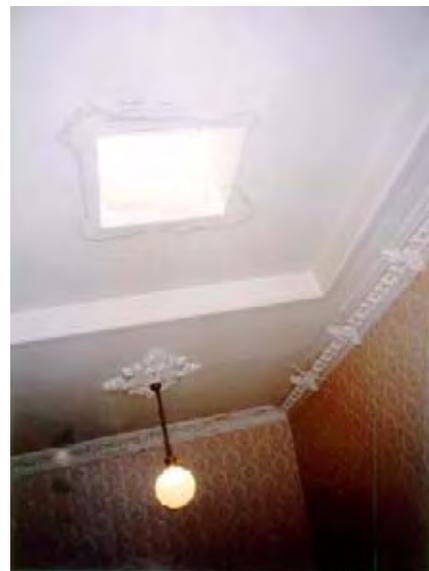
Figure C2-19: Water leakage at hall 301 ceiling, QEA, 02/25/02.

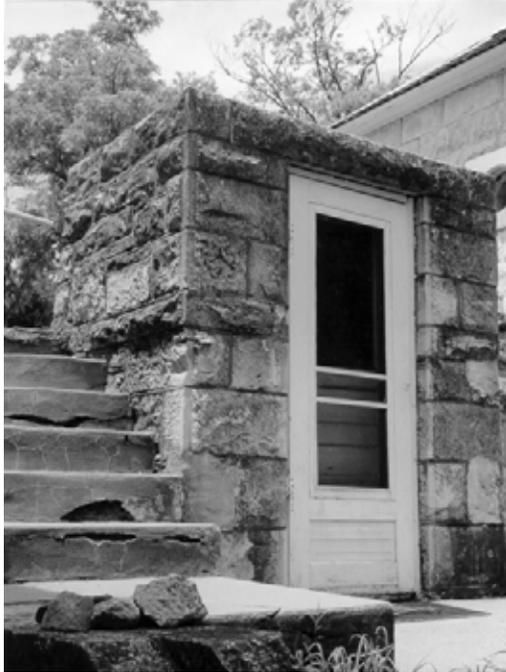
Figure C2-21: Tunnel, entrance 107, QEA, 07/07/98.

Based on the historic rendering of the ranch in the 1887 *Official State Atlas of Kansas*, it is assumed that the vertical portion of entrance 107 (figure C2-21) has been truncated. Presuming that the rendering is accurate, the entrance was depicted with a higher eave line and a pyramidal roof. The stone band surrounding the tower entrance 107, connecting with the south retaining wall, is also visible from the inside of the entrance. It is dressed and located below the parging. There is a joint in this stone band at the same point as the back of the tower footprint where the stone meets the tunnel arch stone/topping stone. The tower intersects the arch about half way from the top of the arch at the spring line. The primary cause of a major crack in the north and south walls of the opening area is moisture penetration.

The stone is in fair condition with a number of inappropriate patches utilized where it has spalled. Two of the stones have fissured from the bedding planes and one cornerstone has a broken corner. The south wall stone and joints are in poor condition with numerous patches and contain many stones that are spalling and fissured. All the stone is darkened considerably by organic growth.

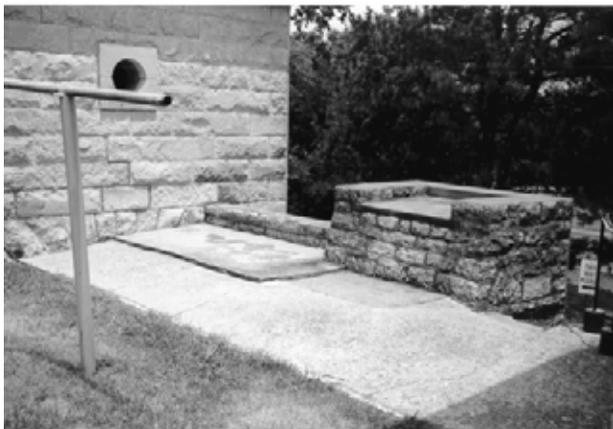
Figure C2-22: Tunnel ground plane, QEA, 07/07/98.

The steps are of formed concrete, which is spalled and cracked. The ground plane over the tunnel is also of concrete that is cracking due to the fact it has no expansion capability. The concrete slab is crowned to drain (figure C2-22) and is assumed to have originally been sod.

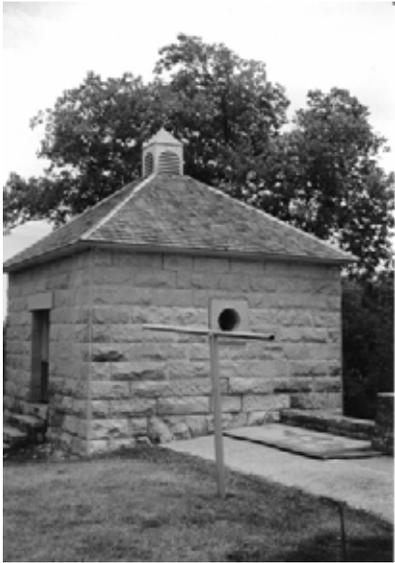
Figure C2-23: Curing room, south elevation, QEA, 07/07/98.

Walls: With the exception of the ground-level course, the stone walls are generally in good condition. The north wall is in good condition. In the center of the east wall a few mortar joints have deteriorated in the lower courses. The south wall displays mortar in five different colors. The wall is in good to fair condition with some loose mortar and spalling. At the west elevation the lower courses are spalling on either side of door 208 and mortar is deteriorating.

There are several instances of cracking that have been repointed with pink mortar. One is a diagonal crack on the south wall, starting east of the center of the round opening and moving upwards to the west. The other instance is in the east lower corner of the north wall, where there are two cracked stones within the field, in the lower two courses of the wall. The east wall also has an infilled portion at the lower center, which may have been a vent opening in the past, as well as an abandoned meter at the wall base.

Roof: The top shingles of the roof are loose and a few of them are split. The southwest corner of the ridge cap has pulled away from the anchor at the center line joint. Some loose nails are visible. The wood trim is in good condition although it is weathered and in need of repainting. Insect damage is apparent on the north, west, and south fascias.

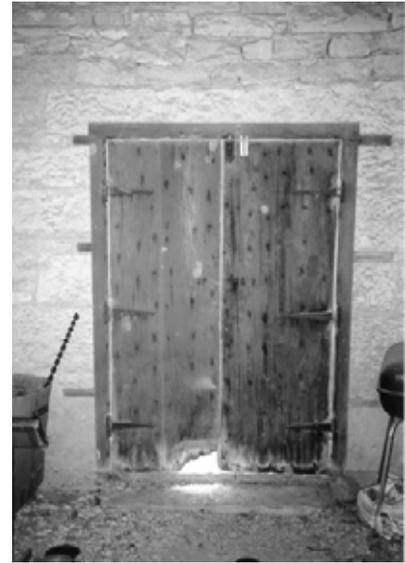
Figure C2-24: Curing room, interior, west door 208, QEA, 07/07/98.

Door: The entry door 208, on the west elevation, is inset behind the face of the stone. The bottom corner of its south leaf is rotted away (figure C2-24). The hardware is six hinges in total (three per door) and is in good condition.

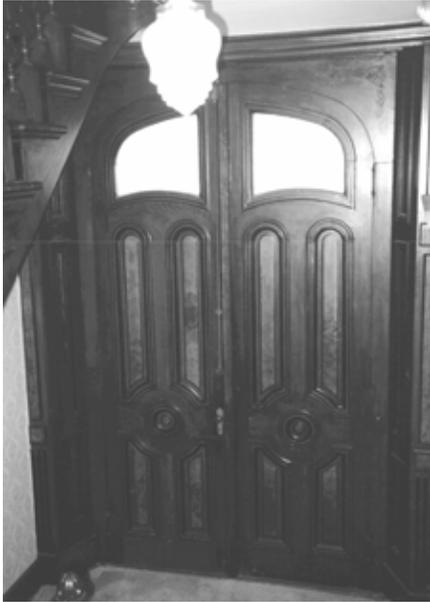
Figure C2-25: Ranch house, hall 101, east wall, and panels of front doors 101, QEA, 1998.

The hand-grained entry doors 101 in the east wall are shown in figure C2-25 while the west wall and stairs are shown in figure C2-26. All of the woodwork, including the floor boards and door frames, is in good condition. The stairs themselves show normal wear, though the top decorative element of the newel post is loose. The walls are all paper over plaster. There is some separation at the paper seams and wrinkling at the corners. The crown mouldings are in good condition. The flooring is narrow tongue and groove oak flooring in good condition over a diagonal sub-floor and the original pine flooring. When a floor vent was removed during physical investigation, the pine flooring showed evidence of termite damage.

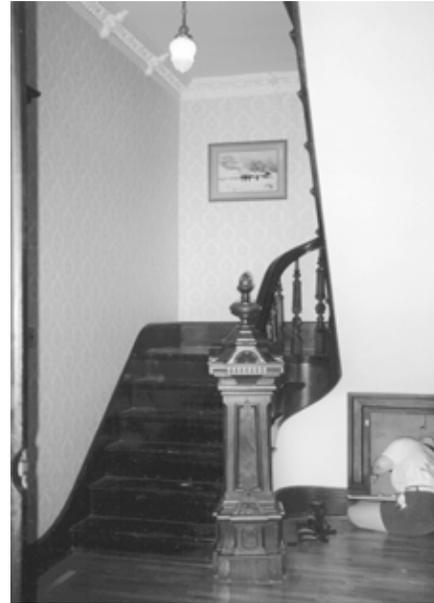
Figure C2-26: Ranch house, inside hall 101, west wall and stairs, QEA, 1998.
