HISTORIC STRUCTURES REPORT

Tallgrass Prairie National Preserve

Tallgrass Prairie National Preserve
Strong City, Kansas

January 2005
Final Submission

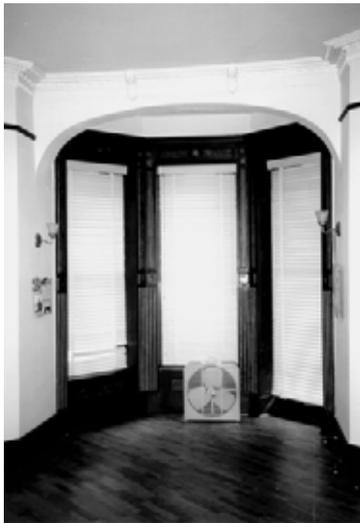
Figure C2-29: Ranch house, bay window in north parlor 103, QEA, 07/08/98. There is no crown molding at the window heads, unlike the bay window in south parlor 102 (Figure C1-31).

The plaster walls have numerous cracks but remain in good condition. This is especially the case at the base and arch of the angled wall framing the bay window (figure C2-29) which is part of the north pavilion. The bay window is missing the crown moulding that is above the window heads in the north parlor. The jamb of the south window 106 within the bay is damaged. The crown moulding throughout the room has some peeling paint. The moulding also has cracks in the north corner of the fireplace (figure C2-30) and at the right hand relief piece of the west wall (figure C2-31). On the same wall, at the south corner, the crown mould is pulling down from the ceiling. The woodwork is in good shape, but the baseboard at the fireplace is loose.

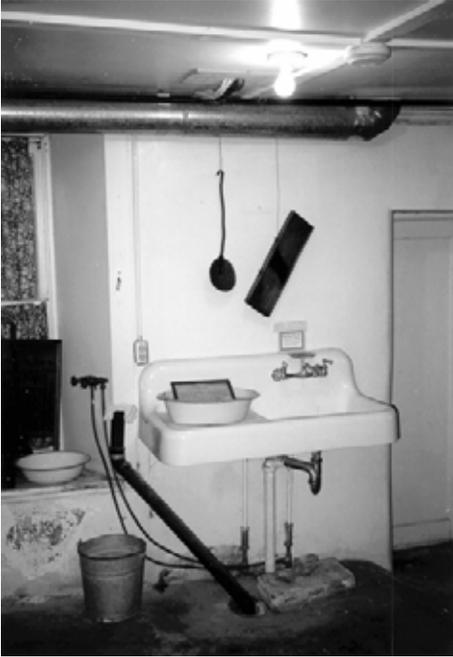
The floor is in part an exposed concrete slab, with 3 ¼-inch wood tongue-and-groove boards partially over a wood-floored pit, at the bottom of the staircase. The same 3 ¼-inch flooring is found on the landing next to door 206A, installed over the original five-inch pine boards. Both the wood flooring and the trap door to the pit are in good condition. The walls are plaster over stone, with the exception of the south wall, which is a non-original plaster partition. The lower two feet of the plaster on the north and west walls has deteriorated (figure C2-32). The window, doors, and frames are all in good

Figure C2-32: Ranch house, old kitchen 105, east wall, QEA, 07/08/98.

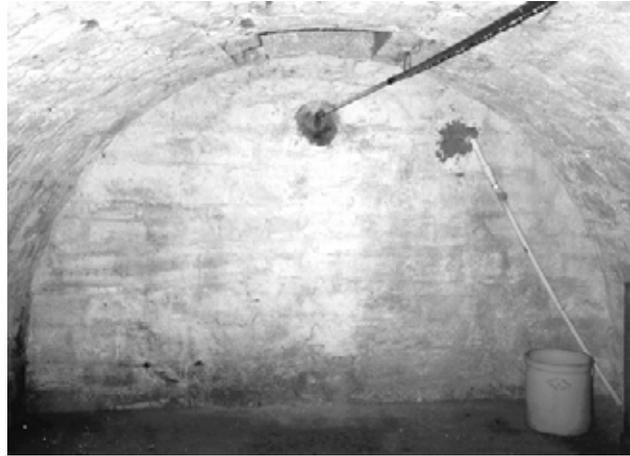
Figure C2-33: Ranch house, west wall of root cellar 106, QEA, 07/08/98.

The concrete floor slopes up to the entrance and is in good condition, with minimal cracking. The root cellar is a stone vault that has been white washed (figure C2-33). There is evidence of organic growth on the stone and a water drip along the black iron pipe that runs the length of the vault. Nearly half of the mortar is loose or has open joints. The west wall has at least four holes low in the wall, which facilitate water intrusion. In

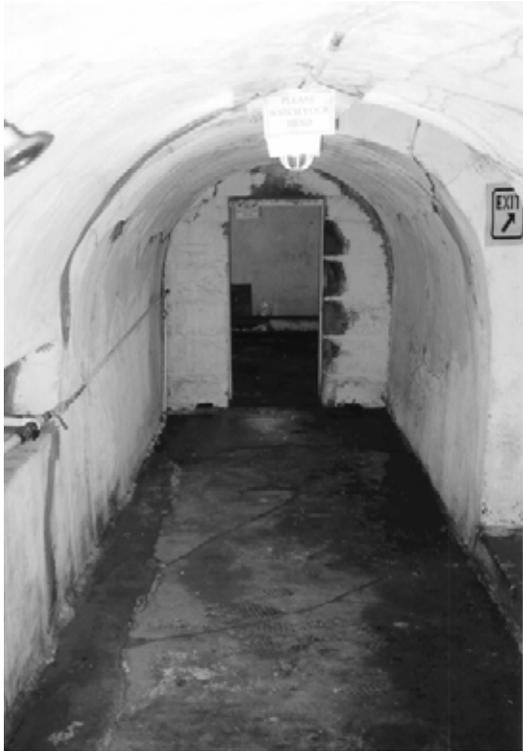
In the tunnel, the concrete floor shows signs of major cracking and shifting. There is a floor drain under the shower head on the west wall. The plaster in the tunnel is similar to that of the cowboy entrance, in that it is in poor condition with heavy cracking, spalling, and is beginning to chalk. Organic growth is also present on all the surfaces. The north wall of the tunnel is the painted, exposed stone of the springhouse (figure C2-36). The south wall is painted plaster parging over the original stone. Water infiltration is evident throughout the tunnel.

Figure C2-36: Tunnel 107 looking north to springhouse 108, QEA, 07/07/98.

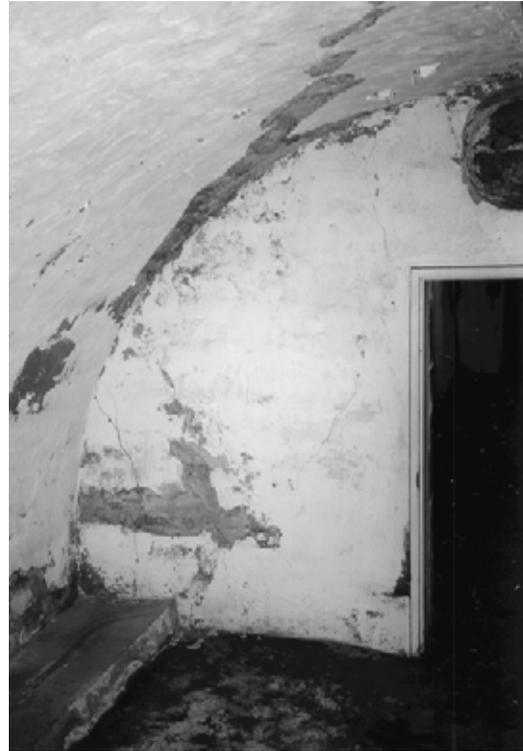
In the springhouse, the plaster condition is similar to the above instances and is failing in some areas. This is true for the walls as well as the vault (figure C2-37). The wood replacement door frame is in good condition, although the door is missing. The replacement frame is narrower than the original opening. At the north elevation, the lower circular opening has been modified and a wood screen has been installed on the inner wythe of the lower window opening.

Figure C2-37: Springhouse, east half of south wall, QEA, 07/07/98.

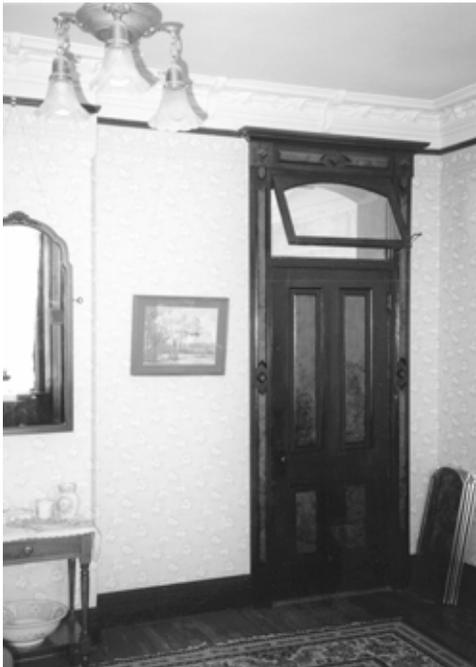
The south room walls are papered to the picture mould and plastered above it (figure C2-38). There are no visible signs of damage, except for some cracking. On the south and west walls, horizontal cracks run from the window, below the crown mould, to the edges of the walls. Another crack is located in the northeast corner of the north wall and runs up the wall into the crown mould at the miter. In addition to these, there is a diagonal crack in the crown mould at the center of the south wall and a vertical one at the head of the south window 202 on the east wall. The south wall crown mould is separating from wall and ceiling and the paint is peeling severely. The plaster ceiling has some water-related staining in the southeast corner. Just north of the chimney there is a piping stub. The floor is narrow tongue and groove oak boards in good condition over the original wide board pine floor.

Figure C2-38: South room 202, north end west wall, QEA, 1998

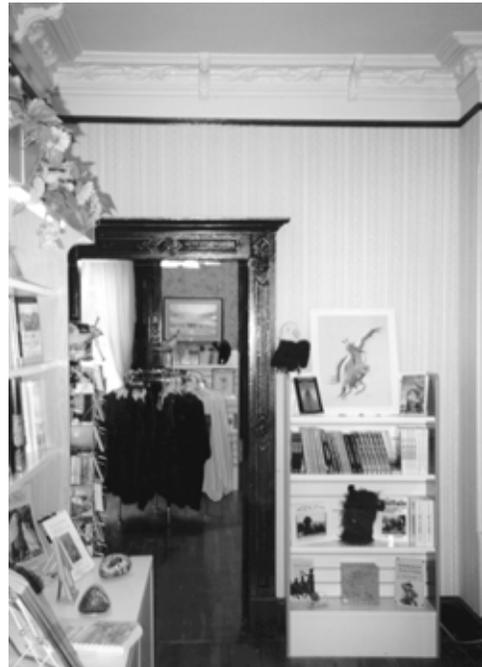
The north room 203 serves as a natural extension of the west room 204 (figure C2-39). Its walls are papered below a picture mould and plastered above it. The wallpaper is curled at the seams. There is a crack in the east corner of the south wall and another above the picture mould along the angled wall. These cracks are coming through the wallpaper and are related to the general movement of the exterior walls in the northeastern corner. The crown mould in this room is in good condition with minor cracking at the miters in the southeast and northwest corners, as well as hairline cracks all the way to the east end of the north wall. The plaster ceiling in this room has a continuous crack from the northwest corner to the southwest corner. The floor is narrow tongue-and-groove oak boards in good condition over the original wide board pine floor.

Figure C2-39: Ranch house, north of room 203, south end of west wall and view into west room 204, QEA, 1998.

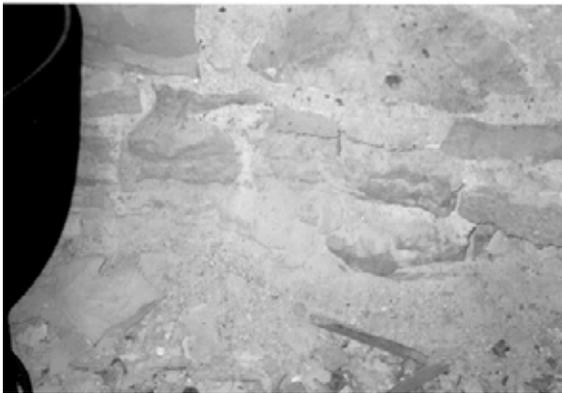
The south wall shows a major crack, just west of the round opening, from the base to the top of the wall. At the base of this crack the stone is turning to dust (figure C2-41). Another medium crack is found in the east corner stretching from the floor to the rafter. It appears that the southwest and north walls are deteriorating. The coursing and the mortar joints from the base to six feet above the floor are smaller and more carefully laid than the top two or three feet. The mortar in this top portion is in significantly worse condition and is missing entirely from many of the joints (figure C2-42).

Figure C2-41: Curing room interior. Deteriorating stone, QEA, 07/07/98.

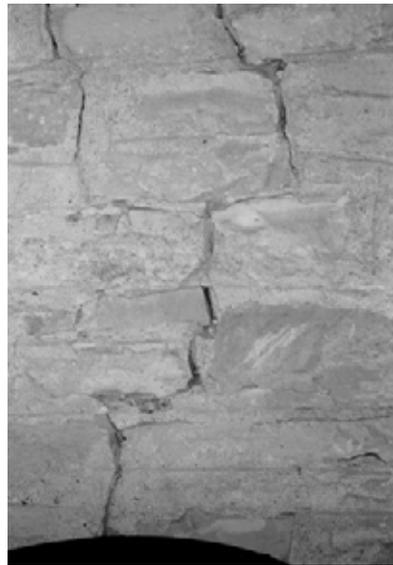
Figure C2-42: Curing room interior, crack in south wall, QEA, 07/07/98.

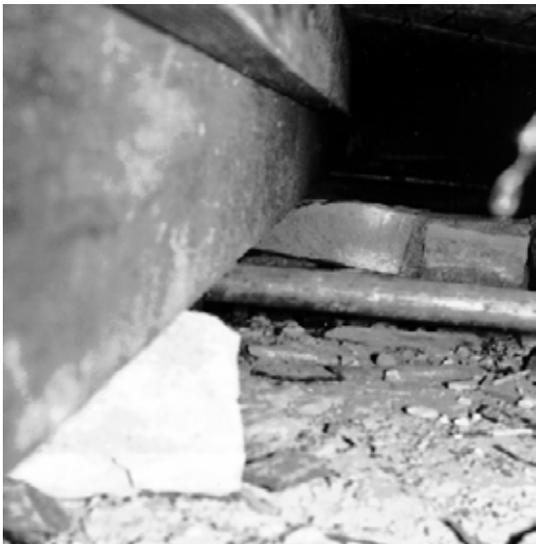
In the landing crawl space 001 below the central stair, a portion of the interior stone bearing wall has been parged. The parging is in good condition. With inspection mirrors and photographs taken 'blindly,' a stone bearing line was observed supporting the first floor joists at approximately midspan. Missing mortar was observed in the joints of this interior bearing 'wall,' however, the wall appeared to be in good condition overall.

Figure C2-45: Stone foundation at "mid-span" of eastern first floor joists at hall 101, Fitzpatrick Structural Engineering, PC; January 2002.

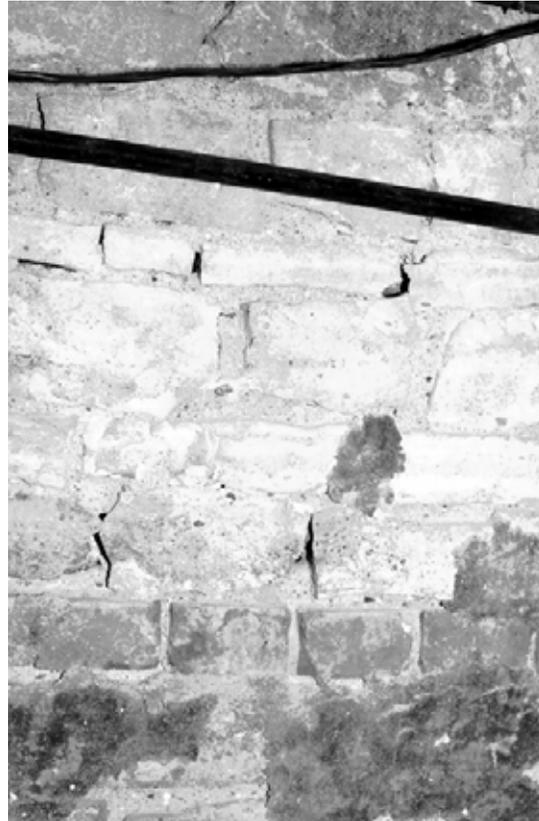
Figure C2-46: Header row of brick in center bearing wall foundation, east wall of pit 005 below old kitchen 105 floor, Fitzpatrick Structural Engineering, PC; January 2002.

In pit 005 below the floor of the old kitchen 105, the masonry foundation walls could be observed. The east wall of this mechanical room is the interior bearing wall of the Spring Hill Ranch House. It is in fair condition as the mortar is soft and powdery. There is a header row of brick in the stone foundation wall. The north and south walls of this mechanical room are not keyed into the east wall or the west wall; the north and south walls may have been added after the original construction. The northeast corner has a vertical crack of hairline width. The north, south and west walls are in good condition. There are isolated areas of missing mortar, but the walls have been repointed with a dark grey mortar. The dark grey mortar is hard, and is in good condition. There is a concrete slab-on-grade with a drain in this area. The concrete slab is in good condition with some minor shrinkage cracking related to the floor drain.

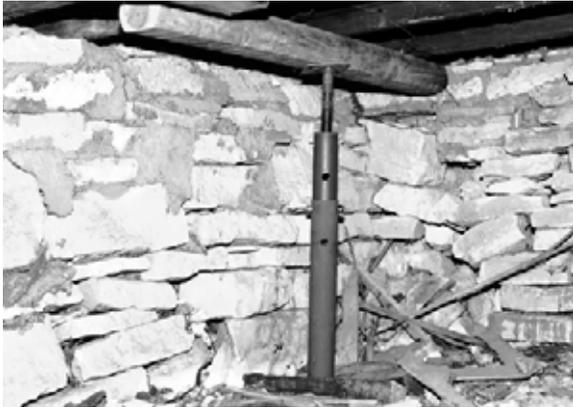
Below the rear porch 207, in the southwest corner of the house, the ashlar stone foundation walls were inspected. The ashlar stone walls have collapsed in the southwest corner. Temporary shoring has been installed to support the floor joists in this area. The north and east walls of porch crawl space 109 are the exterior walls of the Spring Hill Ranch House. Original bearing stones can be observed on the north and east walls where the original porch would have been supported. Currently, the wood porch floor structure is supported on a set of stones protruding out, or corbelled, from the east wall to support the central beam line. The central beam is supported at the other end on an old cistern foundation. This cistern is also providing support for the stud walls above. A stone is missing at the east end of the north wall. Arch cracking has developed in the stone wall above this missing stone. Several of the mortar joints in the north wall (the south wall of the Spring Hill Ranch House) are missing mortar.

Figure C2-47: Collapsed southwest corner of rear porch 207 foundation; temporary shore beam and post, Fitzpatrick Structural Engineering, PC; January 2002

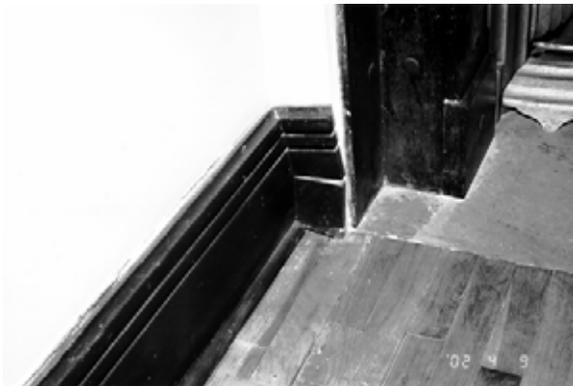
Figure C2-49: Cracked base board south of chimney in north parlor 103 at first floor level, Fitzpatrick Structural Engineering, PC; April 2002.

be minimal and localized at the ends of the members. In north parlor 103, on the south side of the fireplace, the wood floor is buckled and the baseboard at the wall is cracked. Although not verified, this area of the floor is also most likely insect damaged and repairs are required.

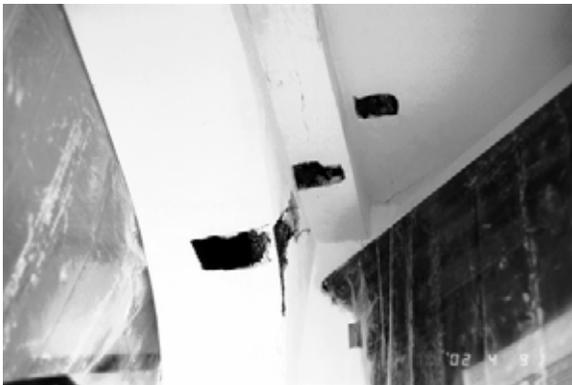
Figure C2-50: Four access holes cut to determine structure at arch at northeast bay windows 106-108 at first floor, Fitzpatrick Structural Engineering, PC; April 2002

From access holes cut in the arch at the northeastern bay windows 106-108 in north parlor 103, the span of the joists was reverified. The arch shape is non-structural, purely decorative. There are two wood beams supporting the second-floor joists and the masonry wall above, respectively. The beams span between the corners of the masonry walls created by the bay windows. The beam supporting the floor structure and wall was measured to be at minimum 4" x 8", but may be a full 8" x 8" beam. The flush framed connection between the floor joists and beam is unknown. The second beam is of a curious nature. The beam has had creosote applied to it; no other wood member within the house structure has been observed to be so treated. Wood treated with creosote or similar treatments will deter deterioration of the wood due to moisture and/or insects. The creosote beam was measured to be 7-3/4" x 14" deep. There is a one inch gap between the beams. In this gap rusted metal spikes at a regular spacing between the second floor support beam and the creosote beam can be seen. The wood fibers on the creosote beam appear to have pulled out from the surface of the beam at the spike locations (or the wood fibers were pushed out when the spike was driven?). There is also a wood stud at the north end of the arch. This stud is notched around the creosote beam and has a large (1" - 2" wide), tapered, vertical split. The split is widest at the top of the stud. There is a nominal 2x4 spiked to the exterior side of the beam to support the roof rafters for the bay window 106, 107, 108 area. The roof rafters were measured to be 2" x 6" members at 12 inch center-to-center spacings. The decorative arch is supported by 2x framing members. The 'exterior' 2x member is split in two locations, appearing as if it is three individual members. The 'interior' 2x member is in excellent condition and is a beautiful piece of dimension lumber (clear, dark grains). It should be noted in this area, metal lath was found as opposed to the wood lath used elsewhere in the house. Refer to the detail on sheet EXS-102 in the appendix.

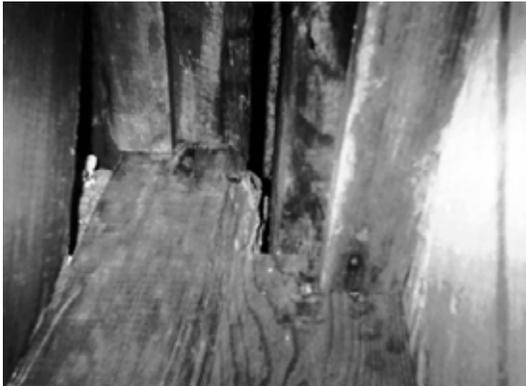
Figure C2-51: Underside of creosote beam (on right) and floor support beam (on left), Fitzpatrick Structural Engineering, PC; April 2002

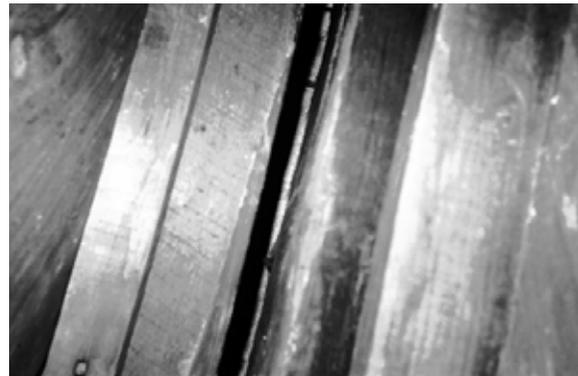
Figure C2-52: Underside of creosote beam (on right) and floor support beam (on left), note rusted steel spikes and 'pullout' of wood fibers from creosote beam in gap between beams, Fitzpatrick Structural Engineering, PC; April 2002

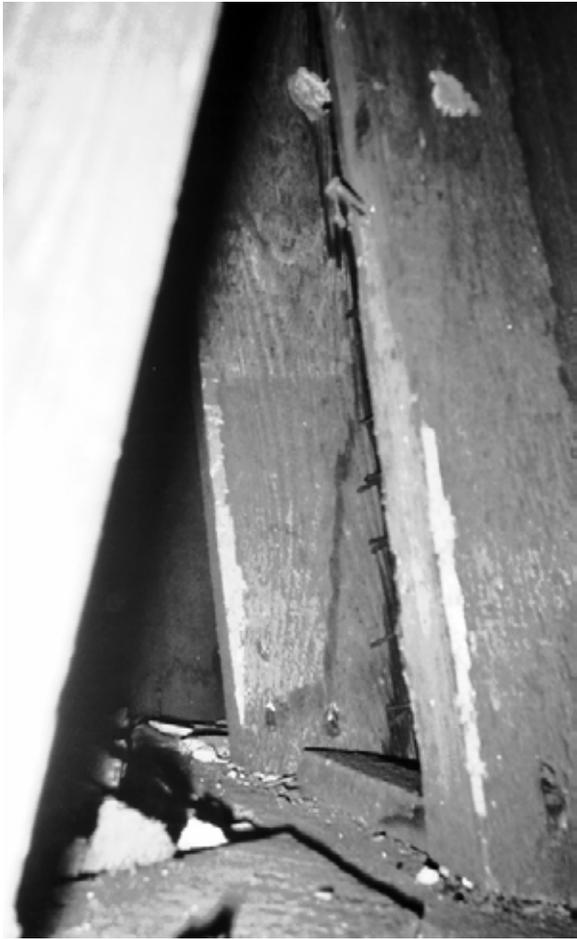
Figure C2-53: Connection of sloped stud/rafters to top of stone wall; note blocking between studs/rafters at bearing, Fitzpatrick Structural Engineering, PC; April 2002

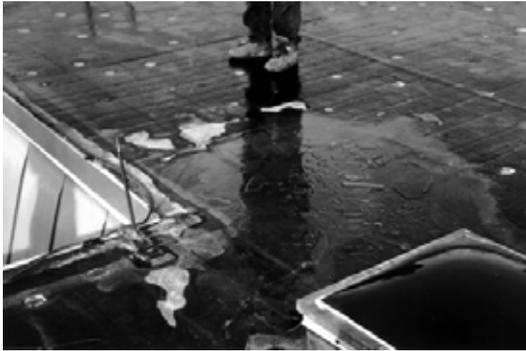
During the January 2002 inspection, relatively minimal ponding on top of the roof was observed. The EPDM roofing was recently installed (September 2001) directly over the metal roof. As evident in figure C2-56, water had severely penetrated this area of the roof previously. On April 8, 2002, there was an all-day rain, and there was no evidence of water leakage. The EPDM has sealed the 'crack.' The plaster and a 4" x 4" wood beam spanning the short hallway to the west bedroom 304 have been severely water damaged. When this area is repaired, the integrity of the structure should be verified. Other water staining has been observed at the chimneys and at the skylight. Again, when repairs are made, the integrity of the structure behind these finishes should be verified.

Figure C2-55: Ponding on roof west of skylight, Fitzpatrick Structural Engineering, PC; January 2002

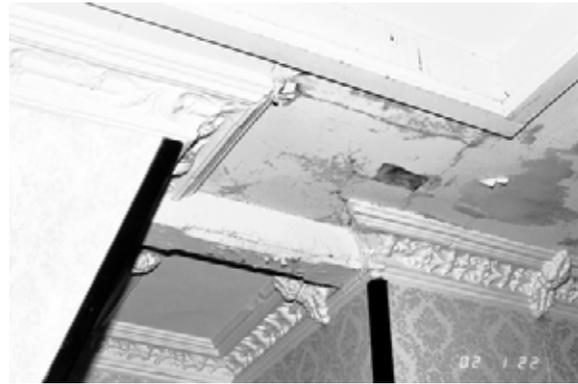
Figure C2-56: Extensive water staining at wall corner where ponding on roof was observed, Fitzpatrick Structural Engineering, PC; January 2002

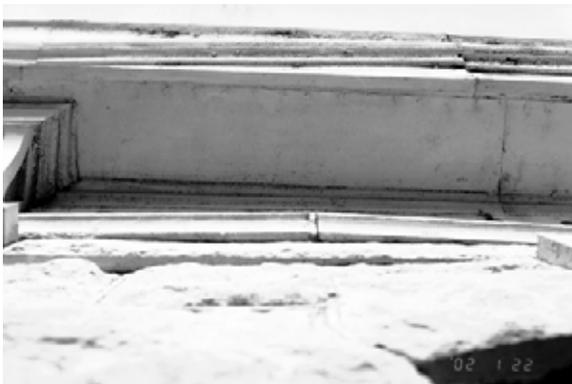
In summary, most of the cracking observed is related to water penetration and the dropping of the keystones at the door and window openings. Working together, the cracks continue to open and require repointing. Above the second floor window 201, two stones were observed to be pushing outward at the common joint between the stones. This 'bulging' movement is due to water penetrating behind the stones and freeze-thaw action of the water pushing the stones outward. Other movements of stones discussed above are also due to movements related to the freeze-thaw action.

Figure C2-58: 'Bulging' stones above second floor window 201 above southeast bay, Fitzpatrick Structural Engineering, PC; January 2002

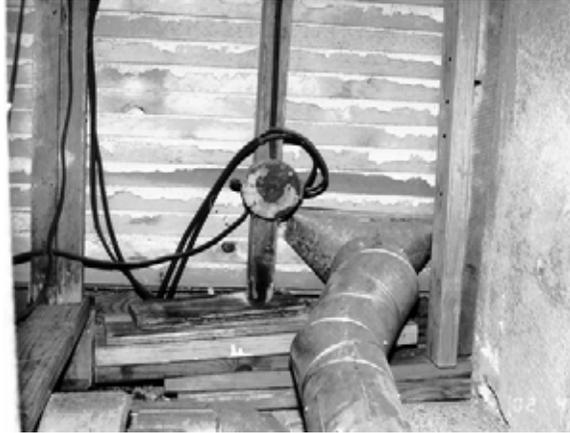
Figure C2-60: Temporary shoring of unsupported studs of north wall of parlor 102, Fitzpatrick Structural Engineering, PC; April 2002

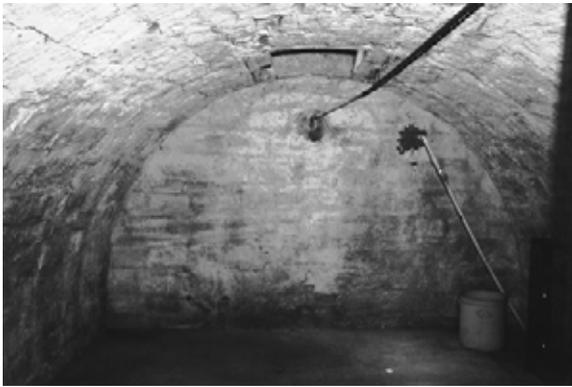
On the interior, the concrete slab-on-grade is in good condition. Water has been observed to pond below the well pump in the northeast corner. The top two courses of the east wall are of block stone, similar to those observed on the exterior of the Spring Hill Ranch House above grade. The lower portion of the east wall is of the ashlar foundation stone observed at the southeast bay windows 101-103. The east wall is in fair condition. The header for doorway 106 into the old kitchen 105 is a 2x wood member on flat and can be easily penetrated with a pocketknife. The west wall and stone arch have been built of block stones (as opposed to the ashlar stones). The vertical walls are not keyed with the arched walls. Moss was observed on all of the walls and the arch. Several attempts to

repoint the masonry joints were observed. Missing mortar was observed, especially in the south portion of the arch and at the skylights. The stones at the skylights are severely deteriorated and cracked. Other cracks, including through stone cracks, were observed in the arch structure.

Figure C2-61: Overall west elevation of Root Cellar 106, Fitzpatrick Structural Engineering, PC; July 1998

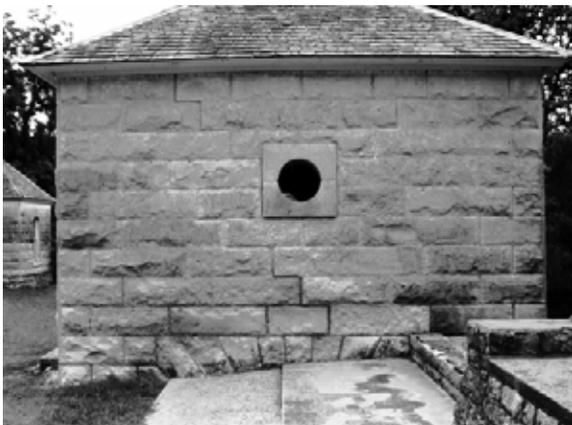
Figure C2-63: South elevation of curing room 208, note keystone arch near grade, Fitzpatrick Structural Engineering, PC; July 1998

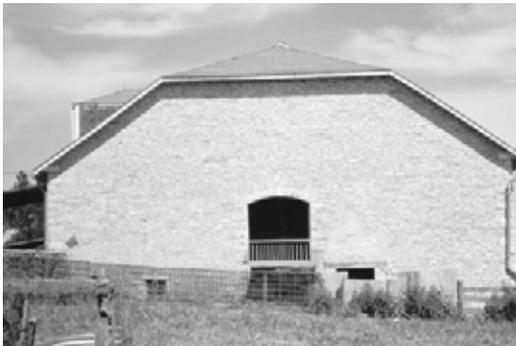
Figure C3-3: Barn, west elevation, QEA, 1998.

The west elevation is shown in figure C3-3. The limestone, mortar, and window conditions are the same as found on the south elevation. In addition, the timber lintel across the south door 101 is heavily weathered and needs protective paint. The timber piece below the second floor opening appears very precarious and requires removal (figure C3-4). Three window panes are broken in window 103. The fascia is weathered and in need of new paint. A few open joints are present between the roof and the closure board at the top of the wall.

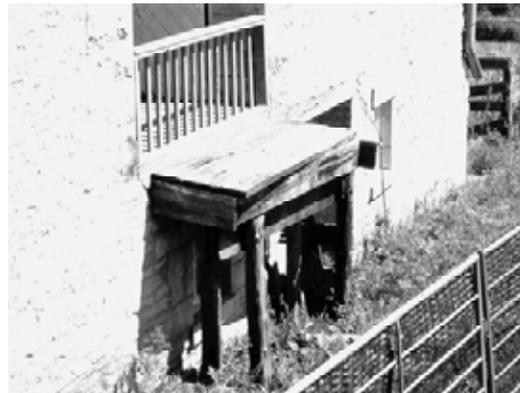
Figure C3-4: Barn, west elevation, second floor opening with unsafe timber, QEA, 07/09/98.

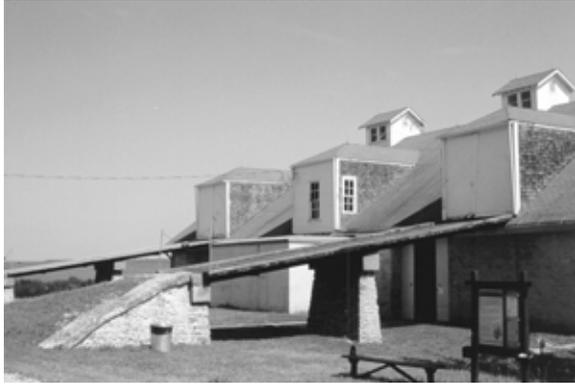
Figure C3-5: Barn, north elevation, showing ramps and cistern, looking from the west side, QEA, 07/09/98.

The north elevation features three dormers, two ramps from grade to the second floor, and a cistern (figure C3-5). Some problems with the limestone and mortar joints are present at the north elevation. While both remain in good condition, there are isolated areas of open joints toward the base of the wall. The bottom two feet is prone to erosion because of splashback from the ground, and therefore shows organic growth, especially near the cistern. The bottom nine quoin blocks of the openings 201 and 202 are original, while those above are differently shaped, textured, and tooled (figure C3-6). The above blocks date from the 1950s-1970s. The east doors 201 are sliding doors that need repainting. The beam above these doors is rusted.

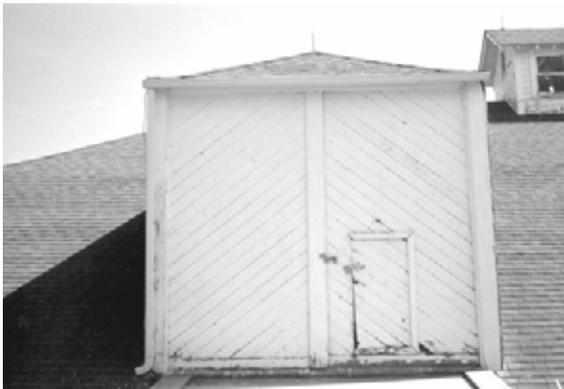
The windows and doors on the cupolas were repaired in 2003-4, as well as the fascia and soffits. An interior vertical support is pushing the top of the east wall of the east dormer outward. At the center dormer (figure C3-8), the floor joists protrude through the wall and deterioration is visible.

Figure C3-7: Barn, north elevation, east dormer, QEA, 07/09/98.

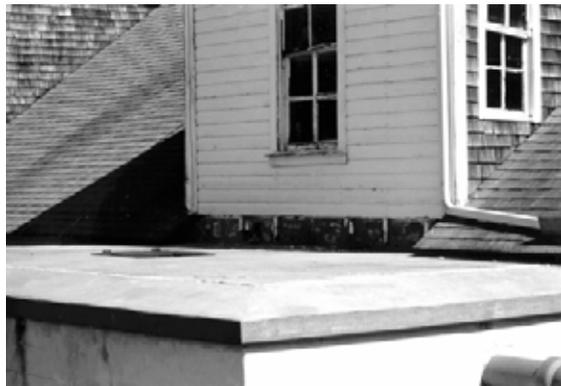
Figure C3-8: Barn, north elevation, center dormer above cistern and cistern top, QEA, 07/09/98.

The Terracon Cistern Coring report (Appendix E), indicates that the cistern has concrete walls with parged masonry concrete blocks to the north, east and west. The south wall has brick back up and concrete on the inside of the barn limestone wall. Its top is constructed of concrete with a built-in gutter. This gutter aligns with a pipe at the west end which drips off the stone cap and down to the wall. There is an access lid at the center. The wall cap consists of sloped concrete with a sealant joint where the back of the cap meets the concrete roof. Currently the dormer downspout leads into a water diverter that in turn directs the water to the roof gutter. This water diverter needs to be made out of a stronger material and placed at a steeper slope.

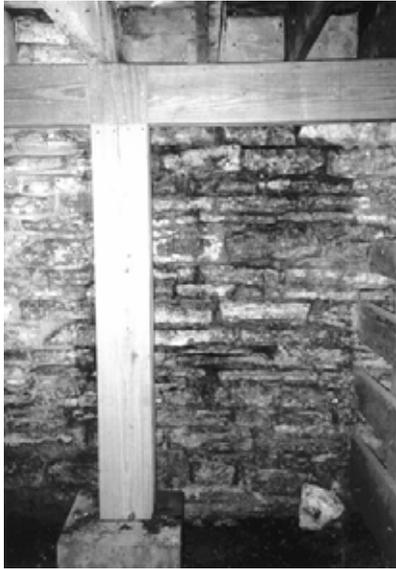
North Wall: The north wall of the stables has stone and mortar in good condition. In bay 2, there is evidence of severe stone erosion in the center of the bay, causing entire faces of stone to spall (figure C3-11). Toward the east side of bay 2, heavy saturation of water from the barn opening at doors 202 above down to the floor was observed at the wall in 1998. This appears to be a long-term problem. In addition, the joints are beginning to deteriorate at the bearing column line.

Figure C3-11: Barn, first floor, north wall, bay 2, water, QEA, 07/08/98

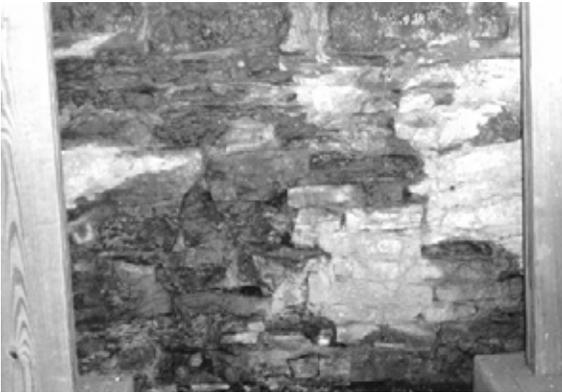
Bay 3 also had water at the intersection of the stone foundation wall and the exterior wall as well as indications of erosion. There is poured concrete between the joist spaces of the entry ramp outside. Erosion is visible in bay 4 (figure C3-12), and the stone condition is poor due to the fact that the entire section of wall is bowing inward at the center.

Figure C3-12: Barn, first floor, north wall, bay 4, stone erosion, QEA, 07/09/98.

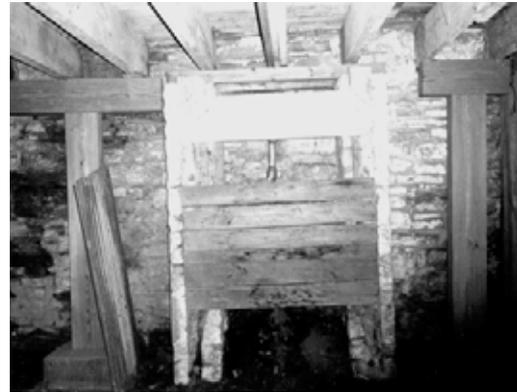
Bay 5 contains the cistern pipe and valve, which penetrate the wall approximately six feet above the floor (figure C3-13). The mortar joints inside at the north wall of the chase has open joints. In bay 6, part of the floor is concrete and relatively new wood partition walls have been added. There is an extra wythe of stone on the exterior wall and all of the joints appear to have been repointed. In 1998, there was water present that was entering the wall just above eye level and continuing down the wall to the floor (figure C3-14). A bulge at the middle of the wall is also perceptible. The east wall of this bay is in good condition with some erosion of the mortar joints along the bottom. Bays 7 and 8 are in a similar state with slight erosion of mortar and stone at the base of the wall and damp floors.

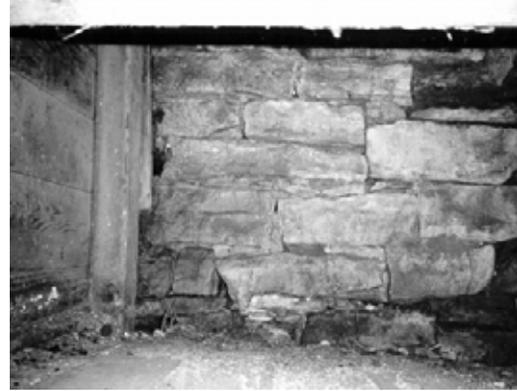
Figure C3-15: Barn, first floor, north wall, bay 9, wall behind bin, QEA, 07/09/98.

In bay 9 the stone and mortar show slight erosion at the base along the wall up to the grain bin. Behind the grain bin there are a significant number of open joints and the stone has shifted or fractured at the bedding planes in isolated instances (figure C3-15). The east wall of this bay is in a similar situation. The sash of window 111 in this wall has a deteriorated bottom rail.

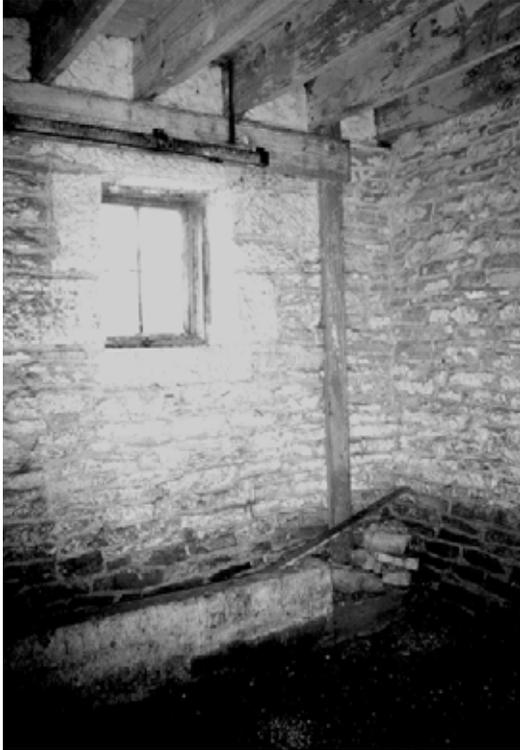
Figure C3-16: Barn, first floor, south wall, bay 34, QEA, 07/09/98.

South Wall: The components of bay 28 are all sound. Window 105 in bay 29 has one cracked light, but the other components are fine. All of the elements in bay 30 are in good condition. There is a wood guide set into the dirt for door 102. Within bay 34 there is a partial height concrete curb used to guide door 103, and another poured concrete footing for a vertical two-by member supporting the track board (figure C3-16). All of the other elements are in good condition, except for the moisture coloration of the stone and mortar at the base of the west wall.

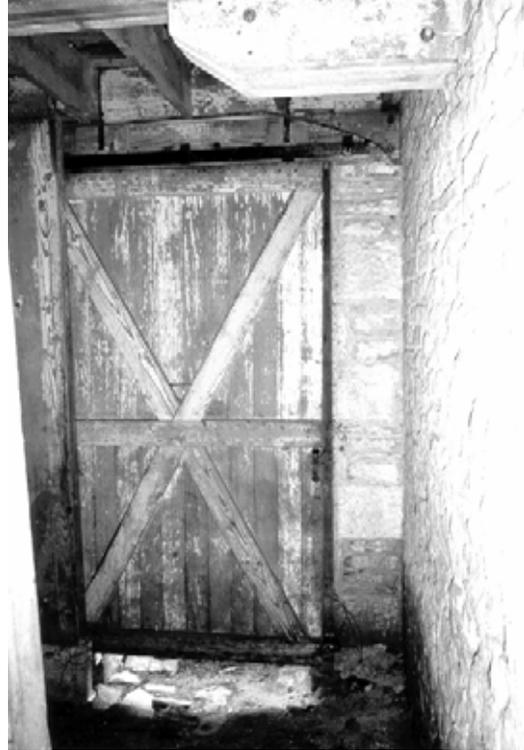
Figure C3-17: Barn, first floor, south wall, bay 34, QEA, 07/09/98.

In bay 34, the wood enclosure of sliding door 104 is built upon a short concrete curb. The west corner of the curb is unsupported (figure C3-17). The east two boards of the enclosure have been broken, which has resulted in a significant hole into the cavity. The stone within the enclosure has mostly open joints, but the rest within this bay show only minor deterioration at the base. The door here is sturdy, stable, and operable. Bay 35 has stone and mortar in good condition. Window 108 is similar except for the fact that the lower sash is missing one light and the bottom rail of that sash is coming loose at the joints (figure C3-18).

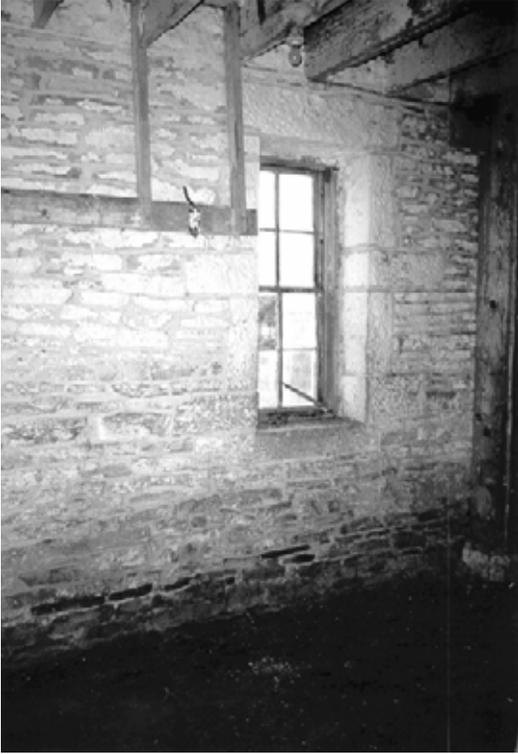
Figure C3-18: Barn, first floor, south wall, bay 35, QEA, 07/09/98.

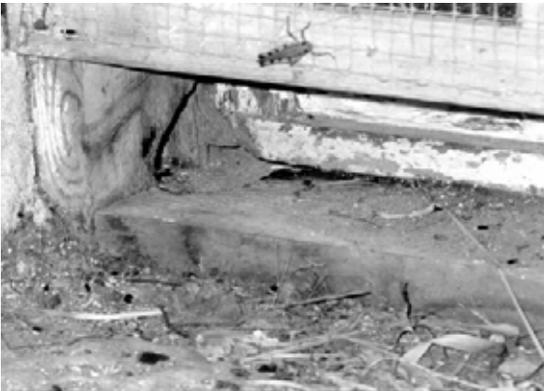
West Wall: On the first floor, along the west wall of the stables, the stone and mortar are in good condition. In bay 1, moisture is entering the wall at eye level in the corner. This corner, as well as the earthen floor, was wet during the rain at the time of survey in 1998 (figure C3-19). Window 101 in bay 1 has a crack in the sill block, just north of center (figure C3-20). At door 101 in bay 19, the threshold is stone capped in concrete. The sliding door is weathered but sound, and despite the rust on the hardware, it operates. Window 102 in bay 19 has an unusual screen in place, the lower left corner of the frame is missing a piece, and the sash is slightly eroded. There is some erosion noted along the base of the wall, particularly in bays 19 (figure C3-21) and 28. The glass in the lights of window 103 in bay 28 is broken and one is missing completely.

Figure C3-20: Barn, first floor, west wall, bay 19, window 101, QEA, 07/08/98.

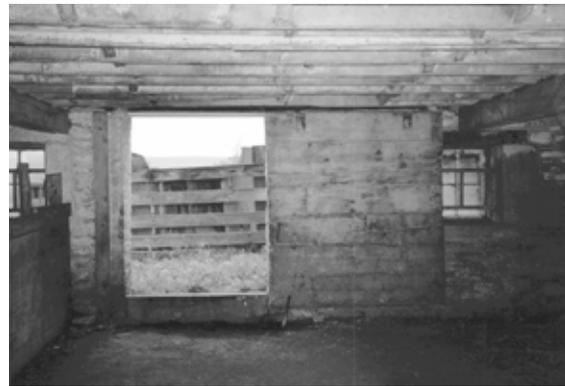
Figure C3-21: Barn, first floor, west wall, bay 19, QEA 1998.

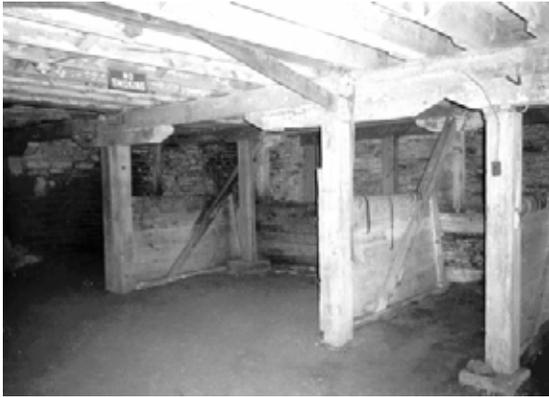
Interior Bays: The stalls within the center of the barn sit upon a floor that is predominately dirt but has concrete under the fence posts and feed bins. The pens and chutes are in fair condition, as their use and weathering is evident (figure C3-22). Some partial height vertical pen supports are loose. The typical strap hinges and cast iron hooks that comprise the hardware are rusted, but operable.

Figure C3-22: Barn, first floor, interior, northwest stable stalls, QEA, 07/09/98.

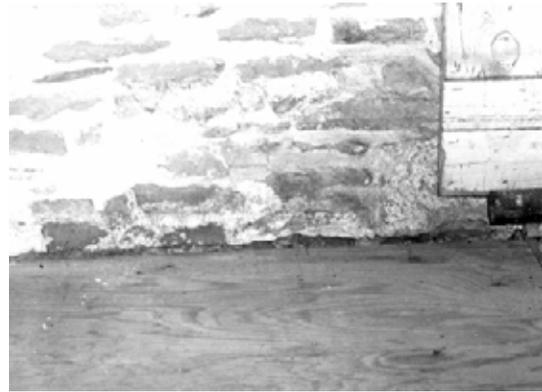
Figure C3-23: Barn, second floor, north wall, bay 2, wall deterioration, QEA, 07/09/98.

North Wall: Along the ceiling of the north wall, there are some open joints and missing stones. The wall in bay 2 shows evidence of severe deterioration that has occurred over time at the floor line (figure C3-23). The flooring in bays 1 and 2 is 4x8 plywood over what is assumed to be the original planking. Bay 3 contains the barn's west entry, door 202, and has a series of stepped wood planks on the floor leading to the opening. The door track is constructed of an iron pipe set into concrete. For pedestrian accessibility, shallow ramps have recently been built to span over the high concrete and steel thresholds of doors 201 and 202.

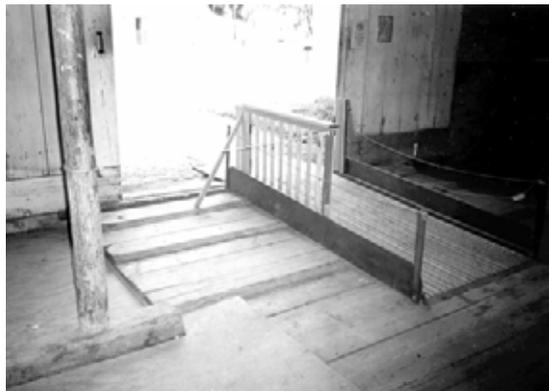
Figure C3-24: Barn, second floor, north wall, bay 3, planking at equipment level entry doors 202, QEA 07/09/98.

The original planking is exposed, with plank steps to the opening. Both planking and steps are weathered (figure C3-24). Bay 4 has cement parging along the bottom four feet of the north wall. There is a dark stain and severe bulge in the center of the wall approximately where the inside of the cistern wall meets the barn (figure C3-25). The Portland cement-based parging continues into bays 5 and 6.

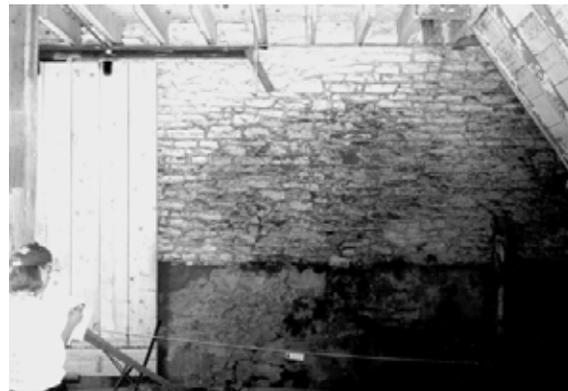
Figure C3-25: Barn, second floor, north wall, bay 4, bulge in north wall, QEA, 07/09/98.

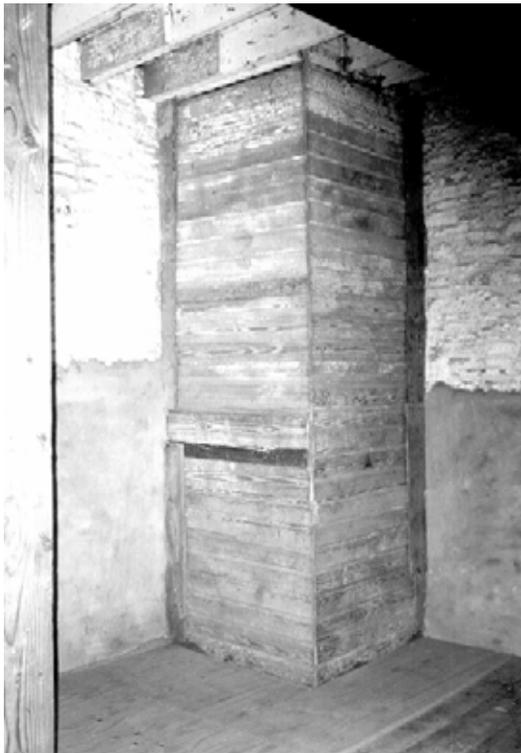
In bay 9, the wall parging that runs from the floor up to a six foot level is broken at the bottom. There are also open joints and loose stones along this line. The wood grain chute in the corner is in good form (figure C3-26). Bays 8 and 9 have 4x8 planking adjacent to the exterior wall and weathered wood planking with isolated sheet metal patches elsewhere. Along column line eight, the flooring is recessed the thickness of the planking. This area is more scarred than the former areas and is attached with cut nails here, as opposed to the wire nails found previously.

Figure C3-26: Barn, second floor, northeast, bay 9 grain chute, QEA, 07/09/98.

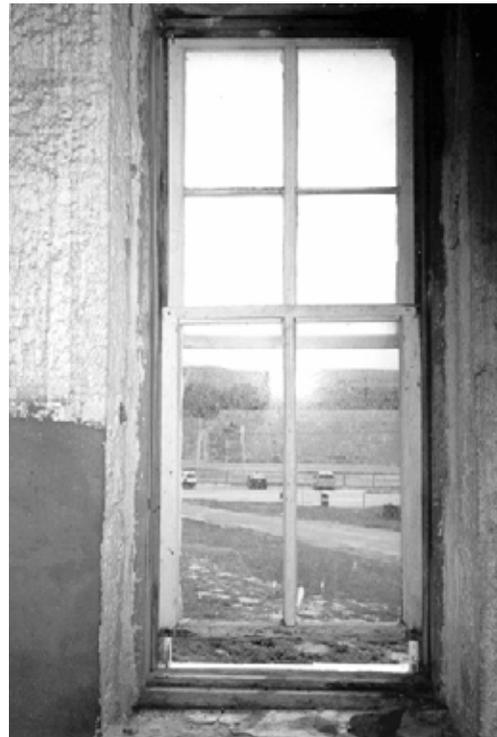
Figure C3-27: Barn, second floor, east corner wall, window 205 in bay 18, QEA 1998.

East Wall: The wall parging in bay 18 is about five feet high and has areas of delamination and cracking. Window 205 in this bay has mortar around the perimeter that is cracked and loose (figure C3-27). The parging in bay 27 improves somewhat to a point where the instances of delamination are isolated. Some of the mortar joints are open enough for air to penetrate. Bay 36 has wall parging to a point five feet from the floor, with some areas of delamination and cracking. The stone and mortar joints are deteriorating at the floor line. The floor along the east wall is the original planking with cut nails.

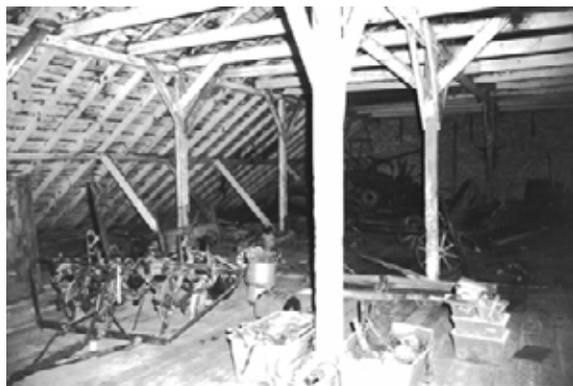
Figure C3-36: Roof framing and loft level of barn looking southwest. Note missing column in row C in background. Fitzpatrick Structural Engineering, 1998.

Figure C3-36 shows the roof framing on the southwest area of the barn from the center of the loft area. The column at C-3 may have been removed or was never constructed as discussed earlier and an apparent sag occurs in the center (row C) beam on the right side of the figure. The second column from the front, on the right side of the figure, is located at the intersection of rows C and 4 and corresponds to the center of the cupola above this area of the roof. Column C-4 has knee braces extending in both the east-west and north-south directions, compared to the typical condition of east-west bracing only. Essentially the cupola is supported by the beam along row C together with the knee braces, and the collar tie framing above this column. Figure C3-38 is a view of the cupola support system from above the collar tie area. The long beam span (due to omitted column C-3) must

support part of the cupola. This results in some sag in the beam. It should be noted that both cupolas are later additions to the structure, reportedly added around 1947.

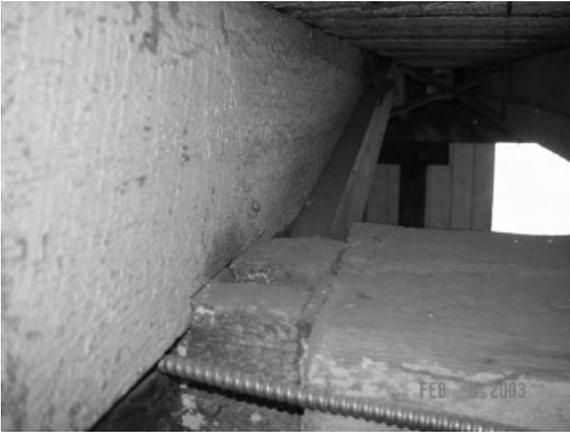
There are also reports that horse drawn wagons were driven up the ramps to the loft floor and loads of grain or hay were unloaded at that level. There is no loft-level column at the grid C-3 location in the loft. Some evidence that a column originally existed at this location was discovered, however it is not known whether or not the column was removed subsequent to construction of the barn or if it was omitted during construction. The beam in the third floor at that location has a pocket (mortise) in it that may have accommodated a column tenon See figure C3-37. The removal of this column would have permitted greater maneuverability of horse-drawn wagons on the loft floor. Grain bins have been constructed in the opposite location at the east end of the loft, and it is not apparent that the column was originally omitted at that location. Some reports indicate that the wagons would enter at one ramp, circle around the loft, and exit at the opposite ramp. Certainly, the elimination of columns at both sides would facilitate this traffic pattern. However, it is doubtful that a ranch operation would sacrifice so much valuable space to circulation, and therefore, the column removal or omission was most likely provided to ease turning of the rigs in a limited space.

Figure C3-37: Loft level beam at column C-3, note mortise at top of beam. Fitzpatrick Structural Engineering, 2003.

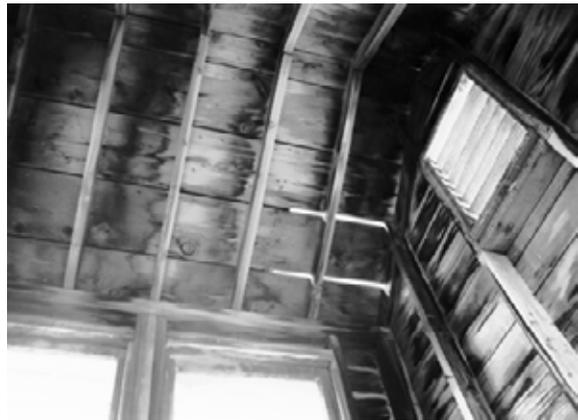
Figure C3-39: Interior of west cupola of barn Fitzpatrick Structural Engineering, 1998.

Figure C3-39 showing the west cupola interior is typical of both cupolas. Note the water staining and roof daylight shown in the figure. These conditions are ideal for insect infestation and wood rot within the cupolas.

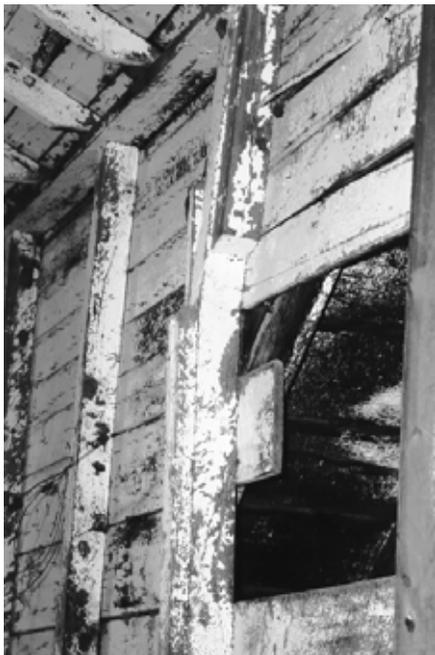
Figure C3-40: North side of east dormer of Barn, east wall framing. Fitzpatrick Structural Engineering, 1998.

The north side east dormer roof gable and hip framing are not tied together with collar ties. The lateral thrust at the wall supports appears to be pushing the dormer walls outward at the top. One timber wall stud was broken on the east wall of this dormer as shown in figure C3-40. This may be the result of the roof thrust taken together with other superimposed loading. The north side west dormer exhibits similar conditions and has only two collar ties. The roof of the center dormer on the north side has sufficient collar ties. Figure C3-42 views the center dormer from the northwest exterior side. The window frames and trim show advanced wood rot, which indicates a moisture problem within this dormer. Note the cut-off wood extensions just above the cistern roof. These may be the remains of the original windmill wood floor at the loft area.

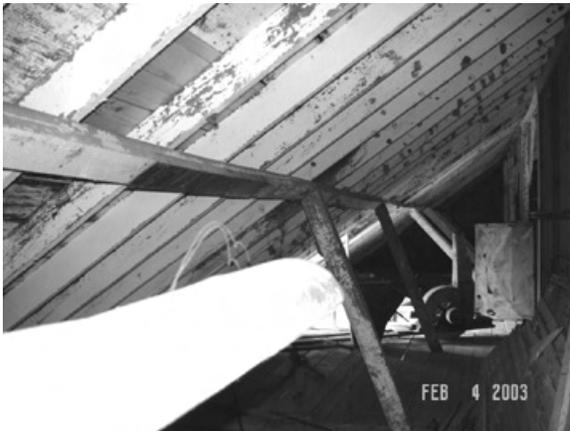
Figure C3-41; Struts and bracing for lower roof slope at south side, note deformation in doubled 2x on the flat, Fitzpatrick Structural Engineering, 2003.

The lower portion of the gambrel roof is braced with double 2xs on the flat and diagonal struts back to the third floor (loft) level as shown in figure C3-41. The doubled member on the flat is wavy and shows significant deflection. The strut angle varies, and intersects the third floor (loft) at different locations. This framing was added to support the roof rafters at the lower portion of the gambrel. These rafters likely sagged over time and required additional support. Generally, the member on the flat is not positioned to provide substantial support for the rafters without sagging which results in the waviness of those members. Additionally, the location of the support struts reduce the capacity of the third floor to carry load.

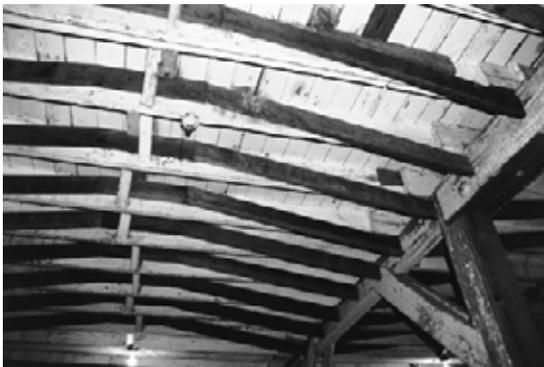
Figure C3-44: Loft level joist reinforcing in barn, Fitzpatrick Structural Engineering, 1998.

Third floor loft joists in architectural bays 11, and 20 through 23 (refer to figure C3-33) show an attempt to reinforce the joist members. A newer strut system has been added to the sides of the original wood members as shown in figures C3-44 and C3-45. Note in figure C3-45 that one joist is split and broken and no longer provides structural support. Analysis of the strut bracing system indicates that it provides only minimal support for the floor joists. The diagonal struts frame into the beams. The strut lateral forces required to provide additional support for the floor joists are very large. The beam cannot provide total resistance for the lateral forces in the strut. The strut system undoubtedly provides some support, but only in a minimal sense. This system was probably added after 1930, as the members are S4S and prior to 1968 due to the member dimensions.

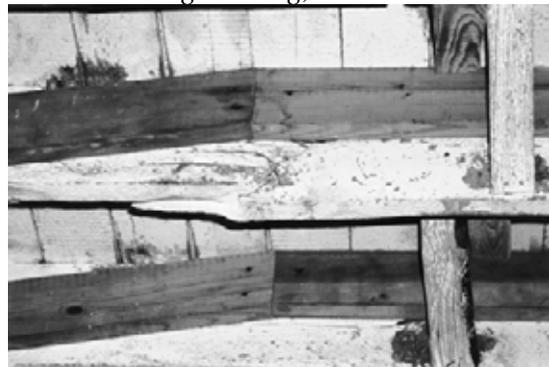
Figure C3-45: Loft level joist strut reinforcing in barn, Fitzpatrick Structural Engineering, 1998.
