HISTORIC STRUCTURES REPORT

Tallgrass Prairie National Preserve

Tallgrass Prairie National Preserve
Strong City, Kansas

January 2005
Final Submission

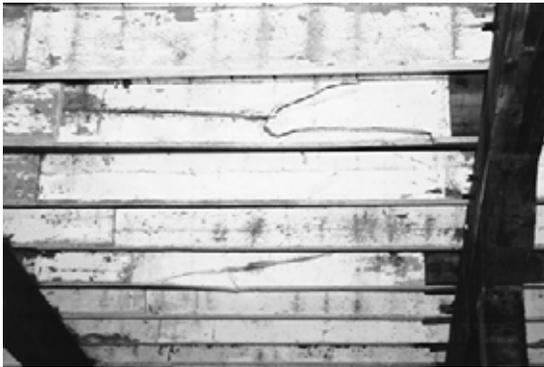
Figure C3-46: Broken, distressed joists near row B.5, between rows 9 and 0, of barn, Fitzpatrick Structural Engineering, 1998.

Figure C3-46 shows two split and broken joists in the area of rows B.5 from rows 9 to 10. Several areas of broken and replaced joists were noted. A partial tabulation of broken members follows. The tabulation is not intended to be a comprehensive list and is presented to reflect an observed recurring problem. This type of failure is usually caused by overload of the members and appears to be principally a bending distress.

Location	Number of Distressed Joists in Bay
C-D, 2-3	One joist broken and reinforced with new sister. Two additional joists have been replaced with newer joists.
D-E, 1-2	Two joists replaced.
D-E, 3-4	4 joists broken and reinforced with new sisters.
C-D, 4-5	2 joists broken and reinforced with sisters.
B.5, 9-10	2 broken joists, unreinforced.

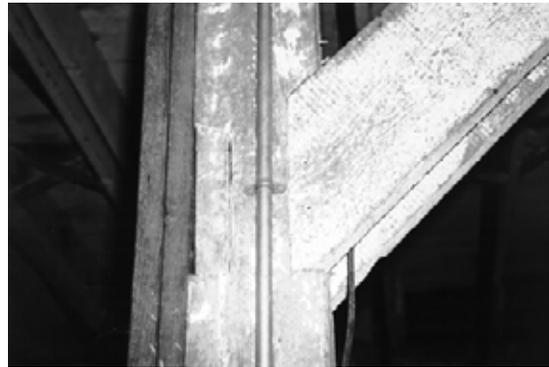
Figure C3-47: Column C-3 of barn viewed from the south. Detail of original knee bracing. Note brace on left side was cut off, Fitzpatrick Structural Engineering, 1998.

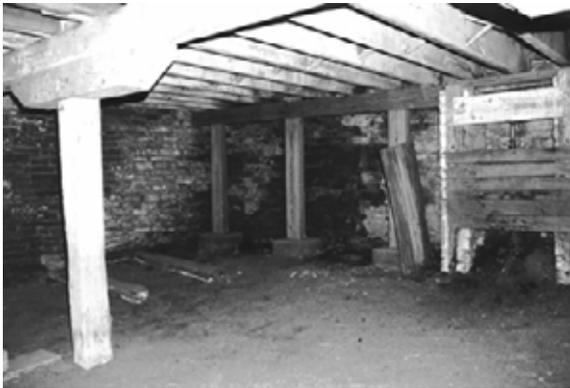
Figure C3-48: North wall of stable level west of tack room in barn (between rows 4 and 6). Note wall staining and newer shoring in background. Column B-5 in foreground is original, Fitzpatrick Structural Engineering, 1998.

Considerable reinforcement of the main machinery level floor has occurred over the years. A row of relatively recent treated wood shoring posts and beams have been added just south of the first floor wall. This shoring does not align with the columns added above the main machinery level floor. Part of this shoring system can be seen in the background of figure C3-48. The floor joists have wet rotted completely through at their north bearing (row A). The shoring row along row A.1 just south of the north barn wall is an effort to restore support for the end of these joists. It should be noted however, that the north barn wall relies on the second floor system to provide lateral support for the wall against the inward pressure of the soil at the opposite side. This support is essentially nonexistent since the ends of the joists at this wall have rotted completely through. While the shoring system provides vertical support for the deteriorated joists, it does not provide needed lateral support for the wall.

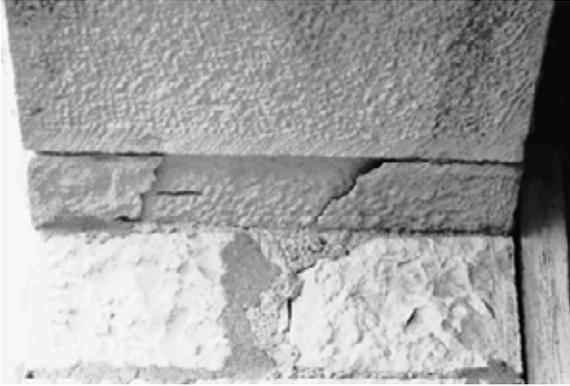
Cementitious parging has been applied to the interior face of the wall at the second floor level, south of door 203. The wall parging extends 3'-6"± above the floor, and stone

masonry is exposed above it. The north side of the door is not parged. Random mortar joint thermal cracking was noted north of the door. Crack widths of less than 1/64" were recorded. Stone spalls were observed at the door arch springline location at this level. Figure C3-51 shows this cracking.

Figure C3-51: Head of west wall door 203 at second floor level of barn. Note stone spall at arch springline, Fitzpatrick Structural Engineering, 1998.

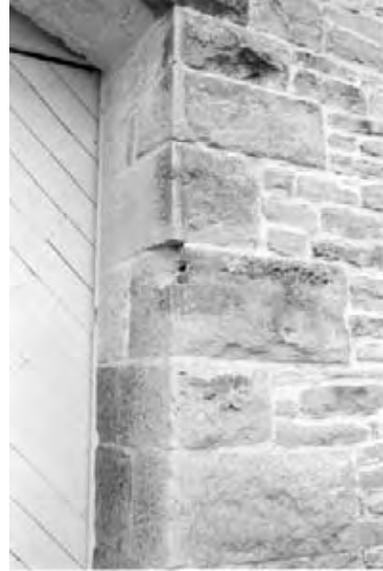
Figure C3-54: East wall, south first floor level door 105 of barn. Note stone spall at gate lintel, Fitzpatrick Structural Engineering, 1998.

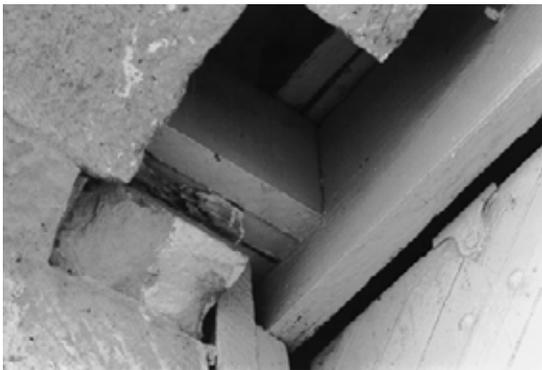
Figure C3-55: East wall of barn, south first floor level door 105 arch springline, Fitzpatrick Structural Engineering, 1998.

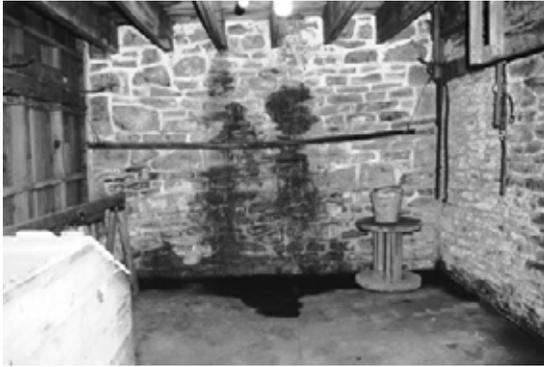
The middle section of the stable level interior wall from rows 4 to 7 shows varying signs of deterioration. The tack room part of the wall between rows 6 and 7 appears to be a newer wall built in front of the original wall in the manner of a veneer. It should be noted that the newer wall occurs in the vicinity of the east cistern wall, and that the above grade sections of the wall at that location show serious water damage. Figure C3-56 shows severe water staining on the surface of the tack room wall at the same location as the exterior water problem. The figure also shows a large damp area on the floor below this wall. The newer wall was probably built in front of the original wall to cosmetically cover serious water damage to the original wall. This damage is related to both the cistern, as discussed later, and to the poor surface drainage condition around the exterior of the cistern at this location. Figure C3-57 shows the area of wall west of the tack room between rows 4 and 6. Dark colored areas of severe water staining occur at the left of the figure (rows 4 to 5). The west cistern wall intersects this wall above grade at this location. The wall bows inward at the west end, and there is a severe loss of mortar and some loss of stone in this bay. The wall above at the main machinery level floor shows severe distress and bulging. Soil surcharge from the cistern and water laden soil at the opposite face of this wall contributes to the observed distress. Poor surface drainage around the cistern also contributes to the damage at this level. This section of wall probably reflects what happened at the tack room, although the damage to the original wall at the tack room was more severe.

Figure C3-56: Tack room of barn, north wall between rows 6 & 7, Fitzpatrick Structural Engineering, 1998.

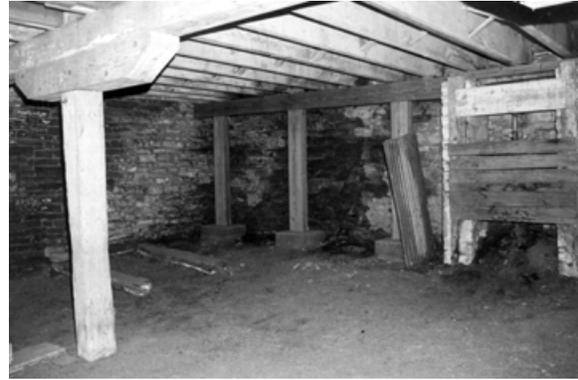
Figure C3-57: North wall of barn west of tack room, Fitzpatrick Structural Engineering, 1998.

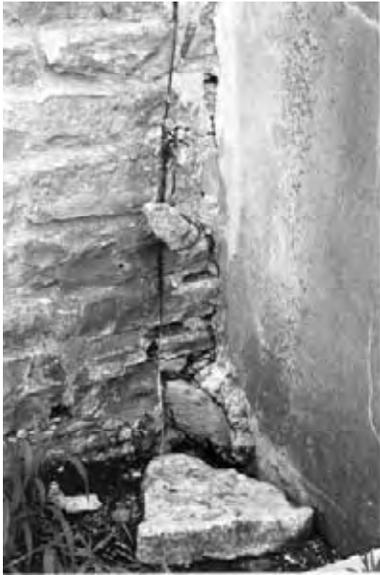
Row 4 to 7: This section of wall seems to be in the poorest condition of the main machinery level walls. It occurs opposite the cistern. Hollow soundings were recorded in many locations. Water staining was observed throughout. Water staining relates to poor cistern roof drainage. The area west of row 5, corresponding to the west cistern wall at the opposite side, shows moist parging. A large bulge occurs at the same location as shown in figure C3-59. The bulged area has been pointed with portland-based mortar, but loose stones were noted. The damaged area relates to the poor cistern drainage, but also is due to some problem with the interior of the cistern, when it was in operation. A vertical anchor board located east of row 5 was pried away from its top anchor bolt, revealing deteriorated original mortar within the wall. The anchor, however, remained securely embedded in the wall. This condition is shown in figure C3-60. It was noted that the parging stops each side of the board location.

Figure C3-59: North wall of barn, interior west of row 5, just opposite the west wall of the cistern. Note large bulge and deterioration, Fitzpatrick Structural Engineering, 1998.

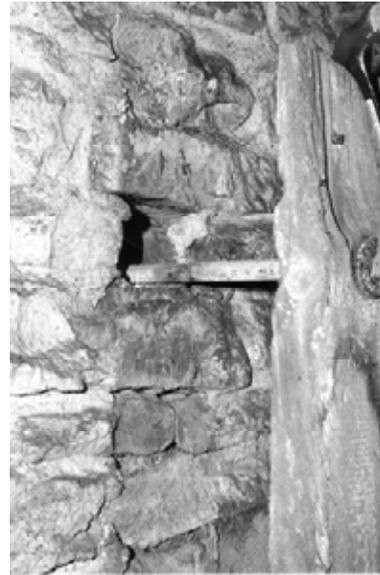
Figure C3-60: North wall of barn between rows 5 and 6. Note wall condition behind anchor board, Fitzpatrick Structural Engineering, 1998.

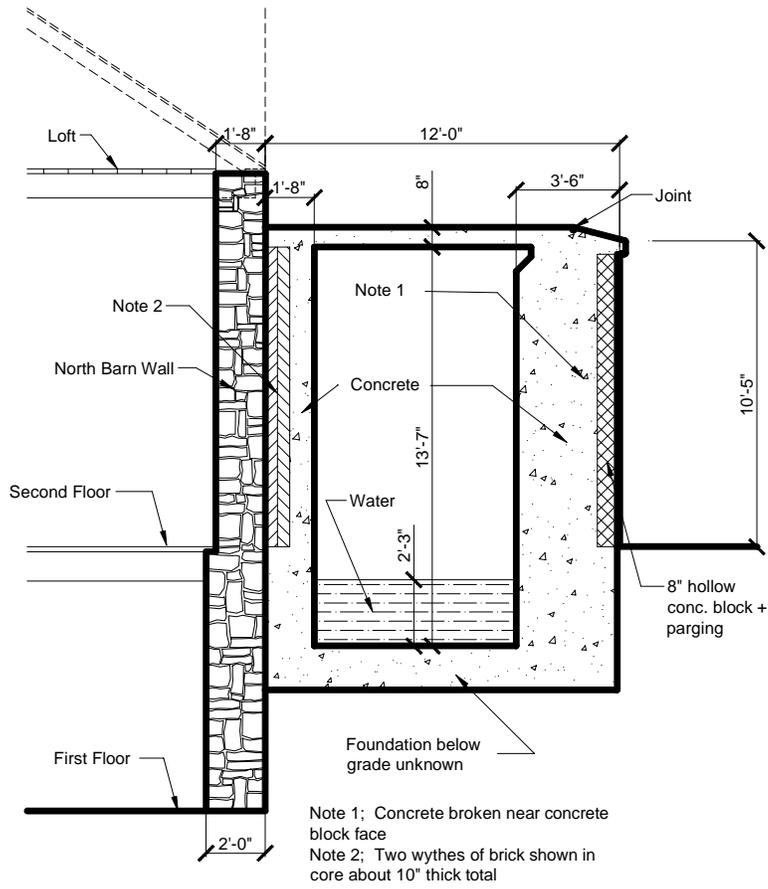
The cistern is centered on the north barn wall between column rows 4 and 7. It extends 12 feet north of the barn, and measures about 22' -5" out to out in the east west direction. Figure C3-61 is a cross section through the structure. Rough interior dimensions were obtained along the north wall of the cistern to determine the depth and condition of the subgrade foundations. Terracon took two cores through the cistern walls in June 2003. (Refer to *Appendix E: Terracon Cistern Coring Report*.) The first core (B-1) was taken through the north wall of the cistern 4 foot above the ground surface and 6' -6" from the northwest corner of the cistern. The second core (B-2) was taken from the inside of the cistern through the south wall of the cistern. Core B-2 was located 42" above the barn second floor and 6' -5" from the southwest corner (the area of the bulge in the north barn wall). Terracon's 2003 report is included in Appendix G of this report. Figure C3-63 shows a plan developed by Fitzpatrick Structural Engineering in 1999 with core locations and material indications based on Terracon's 2003 report. Figure C3-64 is a reproduction of the core information found by Terracon for cores B-1, and B-2.

Figure C3-61: Cistern at barn cross section, Fitzpatrick Structural Engineering, 1999. Updated 2003.

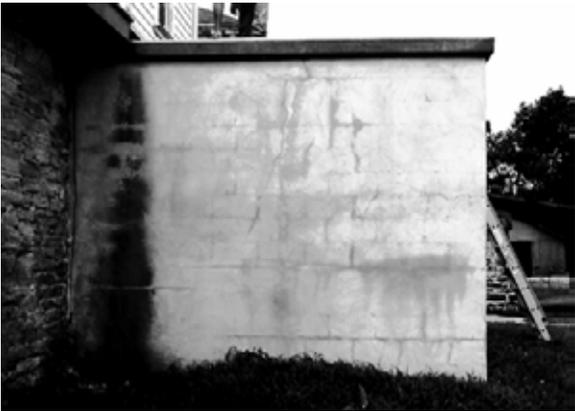
The parged concrete wall wythe may have been added over original masonry walls in an effort to protect and/or cover deterioration of the original masonry walls. In any case, the parging is telegraphing the concrete block jointing as shown in figure C3-62. Large through block vertical cracking also appears to be mirrored on the exterior of the cistern walls. These vertical cracks roughly correspond with cracking at the sloped coping portion of the concrete top slab. The jointing at the top slab may be compromised around the perimeter, which is allowing water to penetrate the walls. In any case, the conditions of the walls are a structural concern. Keeping the cistern free of water will not cause further structural damage and should relieve the existing pressure on the north wall of the barn.

Figure C3-62: East wall of cistern at barn, Fitzpatrick Structural Engineering, 1999.

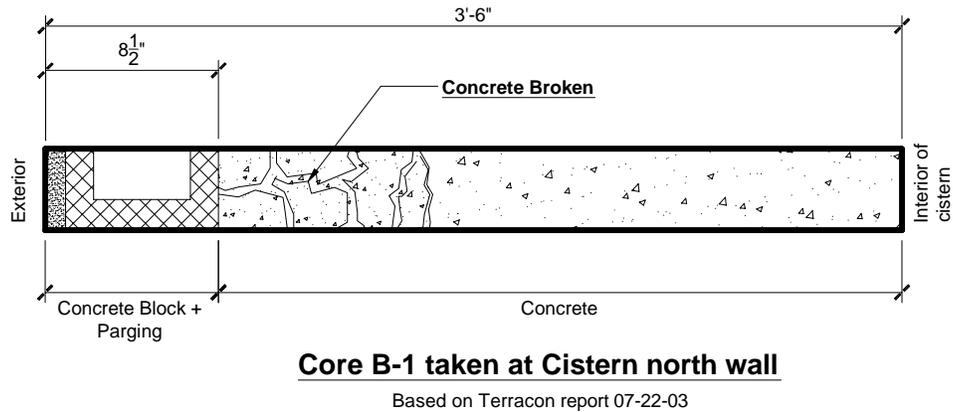
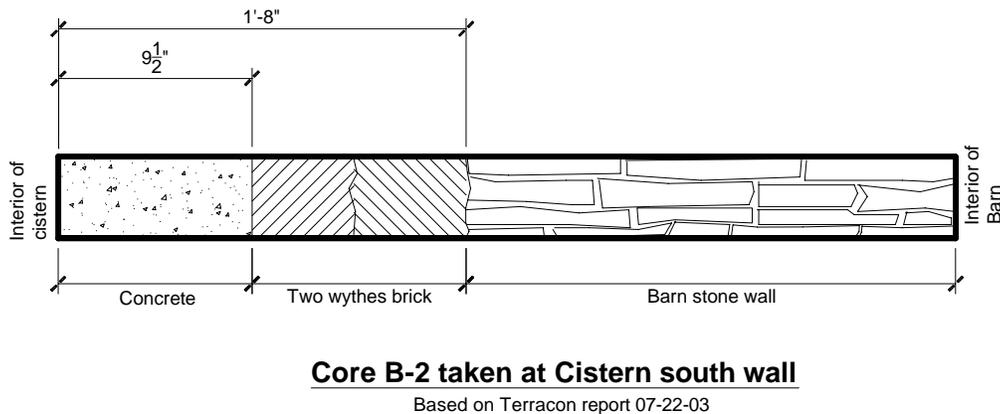
Core B-1 indicates that the north wall of the cistern is constructed of 8 ½” of masonry concrete block with cementitious exterior parging at the exterior wythe of the wall. The interior wythe is about 33 ½” of concrete at the core location. Terracon reported that a significant portion of the concrete just inside the block masonry is broken. Since the parging on the east and west walls shows telegraphing crack patterns consistent with the north wall and representative of masonry block back up, it is likely that the construction of the east and west walls is similar to the north wall (e.g. block masonry at the exterior and concrete at the interior of the walls).

Core B-2 through the south wall of the cistern (north wall of the barn) was cored from the inside of the cistern. The wythe to the interior of the cistern is made up of about 9 ½” of concrete. The next two wythes are reported to be constructed of brick for a total thickness of about 10 ½”. The remainder of the wall is the typical limestone barn wall. Terracon also reported that the interior concrete south wall of the cistern showed a ‘concave’ bowing. The bowing of the wall is consistent with the observed bowing of the barn wall, which was verbally confirmed by Terracon. Further, no gaps were reported between the various wythes making up the wall. The cistern is a later addition to the barn. The cistern probably dates after 1915 given the use of concrete and masonry block. The bowing of both the cistern wall concrete and the corresponding barn wall stone was most likely caused by water pressure due to the filling of the cistern in the past. Additionally, this condition may be aggravated by the lack of lateral restraint of the second floor at this location due to the rotted joist ends at the floor bearing. If any soil exists below the cistern (as shown in C3-61) it will exert a lateral force on the barn wall causing the wall to bow inward between the loft and first floor, providing that the base of the barn wall is restrained. The weight of the cistern and any water contained within will further increase the lateral soil pressure due to surcharge of the soil.

Figure C3-64: Cross section of cistern cores reproduced from Terracon report of 22 July 2003, Fitzpatrick Structural Engineering, 2003.

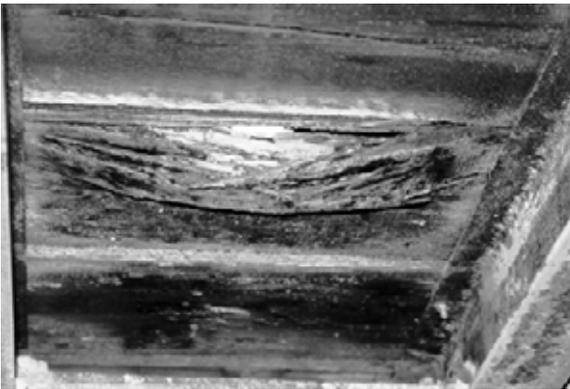
- Decking is in poor condition; Wood has rotted and failed in some cases as shown in figure C3-63. At least 8 to 9 of the 37 planks should be replaced.
- Steel beams are in reasonable condition with some rusting. They should be cleaned and painted.
- Moderate cracking of pointing mortar in abutment indicating continuing movements. Suspect that Portland based mortar was used for pointing.

Figure C3-63: Wood rot at west ramp decking of barn, Fitzpatrick Structural Engineering, 1998.

A hand analysis was performed for the ramp beams and planking. The superimposed live load capacity for the ramps is limited to 118 psf. A deflection limit of $\text{Span}/240$ for the steel beams is the limiting factor. This limit assumes that the damaged decking on the west ramp is replaced in kind.

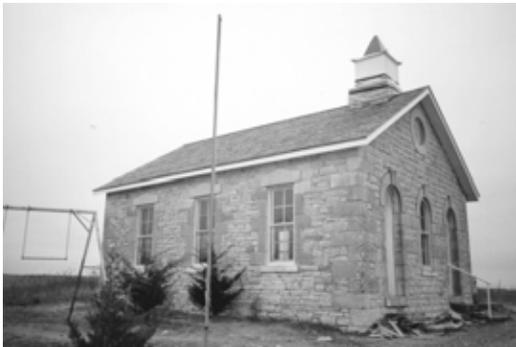
Figure C4-1: Schoolhouse, southeast elevation, QEA 1998.

Walls: The schoolhouse, shown in figure C4-1, is a simple one-story structure with a gable roof. It was constructed in 1882. The masonry bearing walls, including the foundation, are of native coursed rubble limestone. The corners and fenestrations have square cut, dressed quoins of a darker limestone. The exterior stone surfaces were repointed in 2000. There is slight spalling at a few locations. At the corners of the building, by the soffit, the stone is deteriorated. Slight organic growth is obvious around the entire exterior of the building.

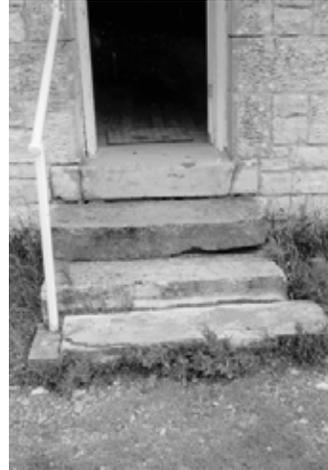
remains cracked. The original stone sills have been replaced with concrete, which is cracking. Both north and south door steps are leaning toward the building as well as cracking and heaving at the base (figure C4-3).

Figure C4-3: Schoolhouse, north entrance steps, east wall, QEA, 07/07/98.

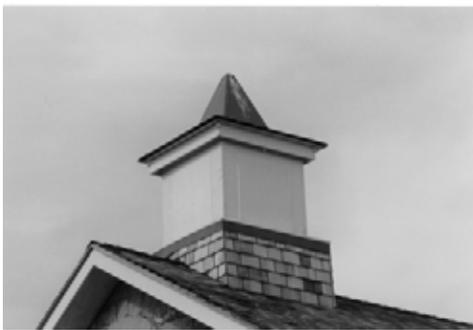
Roof: The soffit panels are in good to fair condition and in need of new paint, with some of the panels starting to shift out of plane at the joints. The north soffit, in particular, is very warped along its entire length with an opening to the east side. The fascia and breakboard are both in good form, although they are slightly weathered. There are exposed nailers on the east and west sides of the building. The roofing was replaced in 1998 by volunteer labor (figure C4-4).

Figure C4-4: Schoolhouse, northeast view of cupola, QEA, 07/07/98.

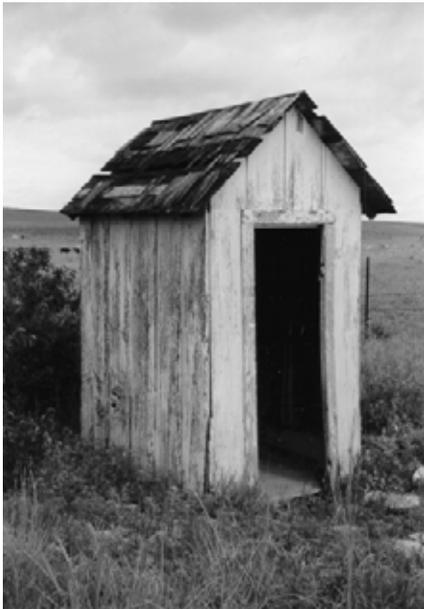
The privy, a small board-and-batten wood structure with a gable roof, is in extremely poor condition (figure C4-5). All of the wood is heavily weathered and is deteriorating significantly around the base, and the entire structure is leaning. The roof sheathing and framing are both dilapidated. At the shingles both red and white paint is visible. The floor and commode base are seemingly sound but are formed in possibly anachronistic concrete.

Figure C4-5: Privy, southeast elevation, QEA, 07/07/98

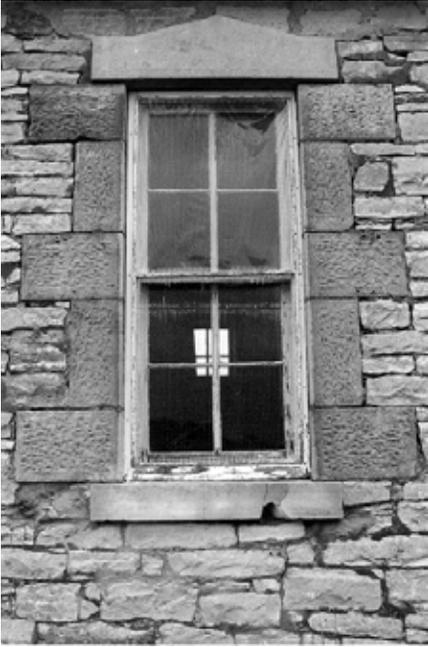
Figure C4-6: Composition of schoolhouse wall. Note window sill stone is broken and pieces of the stone are missing. To the right of the sill stone the wall has been repointed and patched, Fitzpatrick Structural Engineering, 1998.

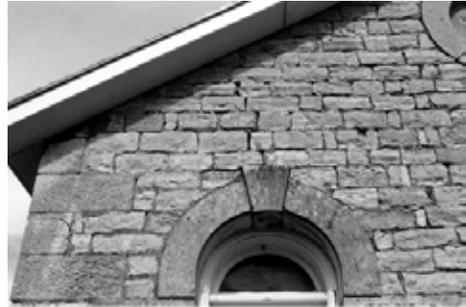
Doors: Missing mortar around the keystones for the doorway arches in the east elevation has been repaired. As recorded in the 1998 survey, there was a step crack from each of the doorway arches up to the roof line. The door sills have been replaced with concrete. Cracking was observed on the south door sill. The stone steps at the doorways are weathered, deteriorating, and have moved from their original positions (figure C4-9).

Figure C4-7: Vertical step crack between roof line and south doorway on east elevation of Schoolhouse, Fitzpatrick Structural Engineering, 1998.

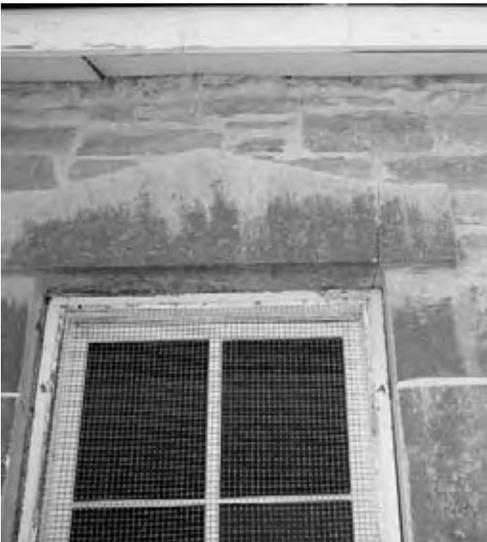
Windows: The window stone sills and lintels are in fair to poor condition. The top of the west window lintel on the north elevation is deteriorating. There is a 5/64" wide vertical crack at the west bearing of the center window lintel, north elevation as shown in figure C4-8. On the south elevation, the dressed stones the window lintels bear on have fine to ~1/32" wide cracking below the lintel bearings. The sill stones are in fair condition overall. The sill stones on the south elevation are cracked and split in several locations as is the east window sill on the north elevation. The underside of the north corner of the window sill on the east elevation is broken off.

Figure C4-8: Cracked lintel stone at right side of the middle window on the north wall, Fitzpatrick Structural Engineering, 2003.

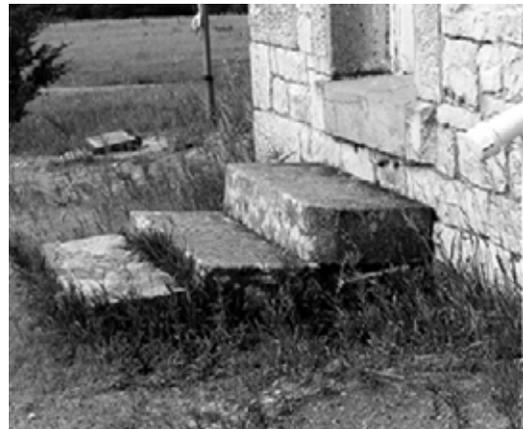
Figure C4-9: Movement of stone steps at south doorway on east elevation of schoolhouse, Fitzpatrick Structural Engineering, 1998.

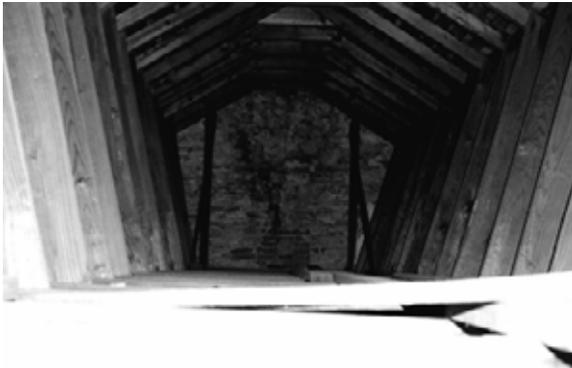
Attic: The plaster finish continues into the attic space on the east wall, but not on the west. In the west wall, just above the ceiling structure, a brick patch was observed in the ashlar stone wall as shown in figure C4-10.

Figure C4-10: Schoolhouse roof framing looking west. Note brick patch in ashlar stone wall just above ceiling framing, Fitzpatrick Structural Engineering, 1998.

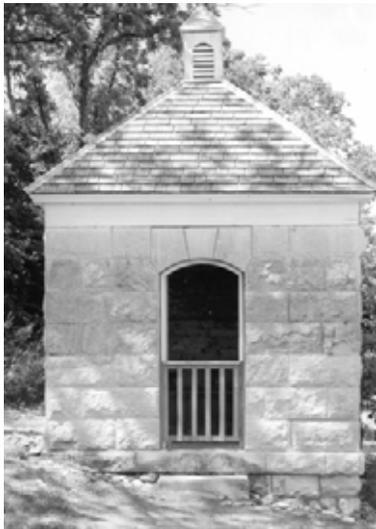
Figure C5-1: Outhouse, south elevation, QEA, 07/06/98.

The exterior walls of the structure (figure C5-1) are of rusticated coursed ashlar native limestone. The walls are in good condition overall, with the exception of some apparent damage at the base, where there is some discoloring due to organic bacteria. There is evidence of past delamination of the stone, which has been corrected and stabilized. On the south side white and silver colored paint has stained the stone. The majority of the mortar joints have been repointed using various mortar colors and tools; however, some of these new joints in the foundation are popping.

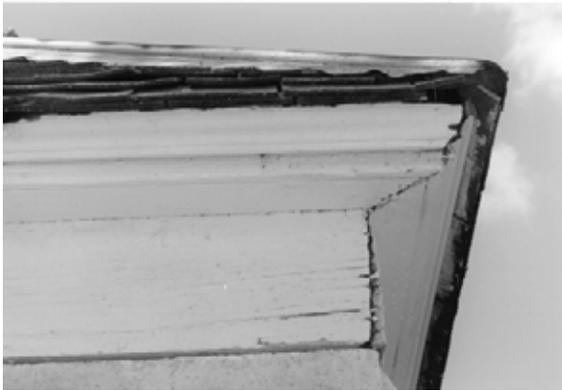
The cornice moulding is in fair condition and is beginning to pull away from the fascia board, which is weathered and splitting at its mitered corners. Both elements show instances of stabilized water damage on all elevations and significant insect damage on the north and east (figure C5-2).

Figure C5-2: Outhouse, southeast corner, QEA, 07/06/98.

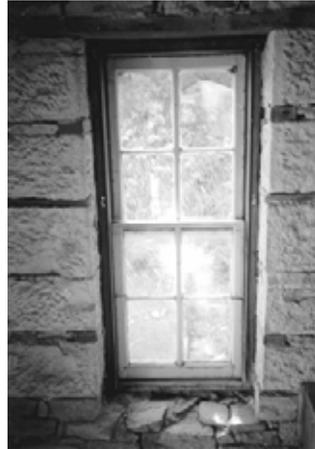
All of the four-over-four double-hung windows are in need of repairing and reglazing. The trim will require filling and repainting and a few questionable muntins and sash pieces require attention. Some wood rot is apparent at the sills due to the fact that water stands on the level surface (figure C5-3). The door frame is slightly weathered at the bottom. The door is weathered at the bottom, which has resulted in the installation of a metal patch in the lower left corner. The standard box-lock hardware and wrought iron hook lock are operable. There is significant spalling below the west window.

Figure C5-3: Outhouse, west window, interior sill, QEA, 07/06/98.

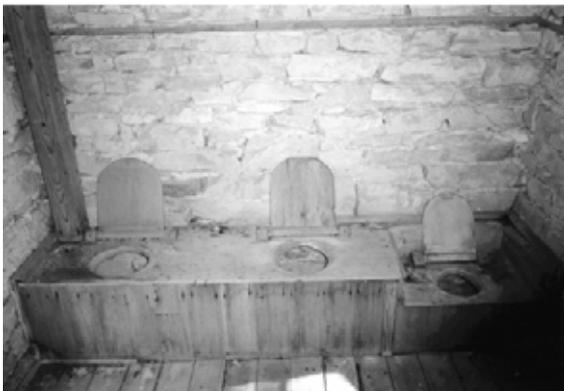
The walls are rough cut ashlar stone, which is dressed at the windows. The joints are in very good condition and are randomly mortared. The worn wooden bench has openings for two adults and one child and is missing quarter round moulding at the base (figure C5-4). A wooden pipe vents to a point just below the roof structure and then out through the cupola. The floor is composed of unfinished tongue-and-groove floorboards in fair condition. One of the joints is rotting and opening.

Figure C5-4: Outhouse interior; bench, QEA, 07/06/98.

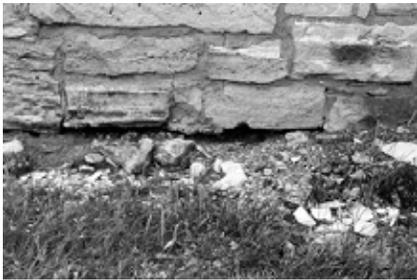
The stones below the water table are in fair condition. The joints have been repointed, but most have re-cracked and are missing mortar. On the north and south elevations, heavy organic growth is present. On the east elevation, the stones at grade level are undercut, splitting, and exfoliating as seen in figure C5-5.

Figure C5-5: Undercut stones; through stone cracks and repointed joints at base of east elevation of Outhouse, Fitzpatrick Structural Engineering, 1998.

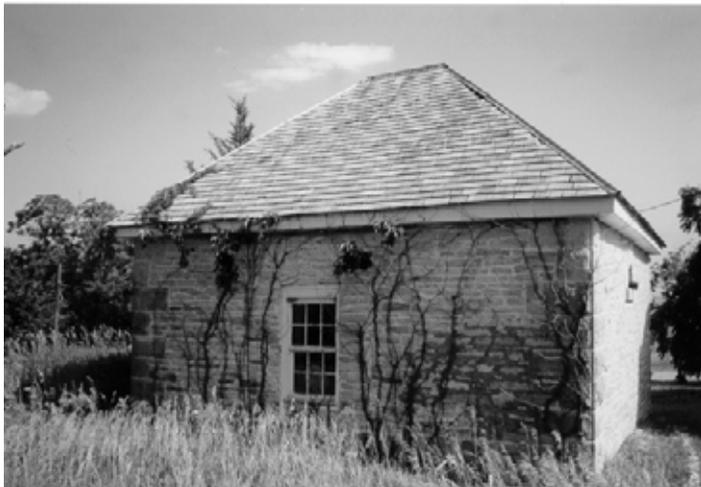
Figure C6-1: Icehouse, south elevation, QEA, 07/06/98.

Like the curing room/springhouse, the icehouse is a freestanding limestone structure with a pyramidal roof. The shingles are wood and the original cupola at the top of the truncated pyramid is missing. The exterior walls (figure C6-1) are in good condition and have all been repointed with a high-Portland cement content mortar. The north elevation mortar is white or gray in color. Some of these joints have begun to erode at the base. There is occasional spalling on the west wall and a rust stain at the sill by the arched window. The southwest corner of the building is stained. The wood elements are weathered to the extent that the soffit is warped and cracking and also split in the southwest corner. The fascia has been patched at the south end of the east side.

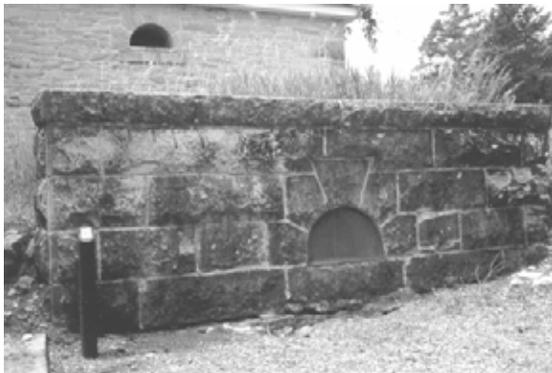
The stone cistern is shown in figure C6-2. Despite a few instances of spalling, the stone is in good condition. The north edge of the east wall is eroding and organic growth is evident in the back splash region and throughout the east face. The mortar is also in good shape and has been repointed. Some joint erosion and cracking is apparent at the base of the wall and also in the joint left of the keystone. The other faces of the structure are buried within the hill and covered in grass. The visible portion of the connector to the icehouse appears sound.

Figure C6-2: Cistern, east elevation, QEA, 07/10/98.

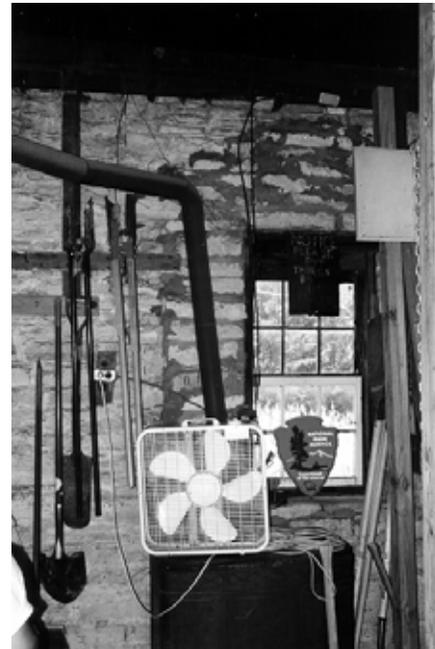
Figure C6-3: Icehouse interior, east window opening on north wall, QEA, 07/07/98.

The interior of the icehouse is shown in figure C6-3. The non-original concrete slab floor slopes up to the entry and is cracked and pitted, but is sound overall. The random course ashlar walls show severe cracking at the northwest corner of the west wall as well as minor cracking around the arches on the north wall. It should be noted that the center window of the north wall was formerly an arched opening wider than the present one, with the east jamb unchanged. The wall at the east side of the doors is infilled and severely deteriorated.

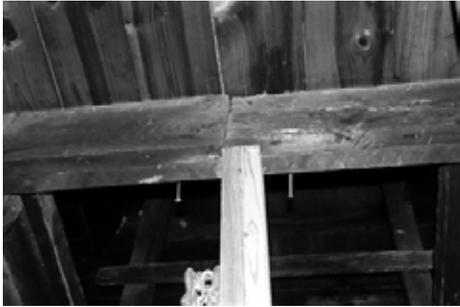
The ceiling structure of the icehouse has been altered several times. The 2" x 2" tenons observed in the curing room and outhouse were observed in the north wall of the icehouse as well. Other (probably original) ceiling joists are pocketed into the east and west walls; all but two of the original joists are headered with a newer 2x member. The newer 2x member supports the existing ceiling joists spanning east-west. The newer 2x bears on the north and south walls and the two original joists that are not headered. These two original joists frame the opening in the ceiling. The joists are not continuous from east to west, but are spliced together with the opening framing, which is spiked to the wood posts hung from the roof structure. The base of the post in the northeast corner is rotted; the post in the southwest corner is split. The southern original joist is supported at the splice location with the newer southern shore post discussed above. (See figures C6-4 and C6-5 for details.) The overall stability of the ceiling and roof structures is questionable.

Figure C6-4: Original joists spliced together center opening in ceiling structure in icehouse. Note newer shore post is not centered with joint in joists, Fitzpatrick Structural Engineering, 1998.

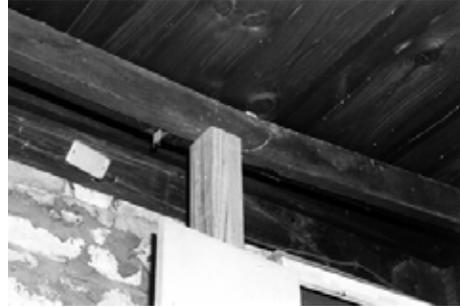
To support the ceiling and roof structures, doubled 2x4 nominal studs have been placed in two locations: one near the north window at a split ceiling joist, and one at the south side of the opening in the ceiling. The top of the north shore post was measured to lean to the north 1" in the 50-5/8" level length, and to the east 3/4" in the 50-5/8" level length. The top of the south shore post was measured to lean to the east 3/4" in the 50-5/8" level length. A grade stamp indicating kiln-dried (15 percent moisture content) southern pine, No. 2 grade was observed on one of the shore posts, confirming that the shore posts are relatively new additions.

Figure C6-5: Newer split ceiling joist supported with doubled 2x4 nominal north shore post in icehouse, Fitzpatrick Structural Engineering, 1998.

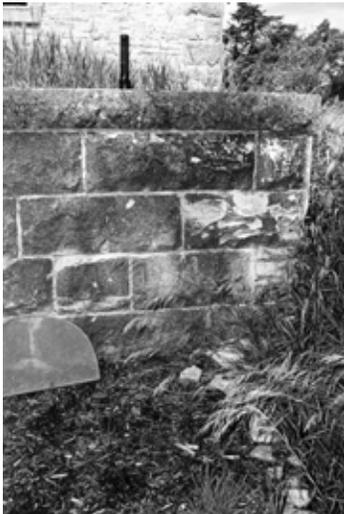
Figure C6-6: Stone deterioration at north end of east wall of cistern, Fitzpatrick Structural Engineering, 1998.

The east wall has a semi-circular opening centered on the wall. The joints have been repointed, but hairline to 3/64" wide step cracks were observed. Mortar was noted to be missing on the south side of the keystone for the opening. Organic growth was observed along the base of the wall. The stones north of the opening are exfoliating and spalling. (Refer to figure C6-6)

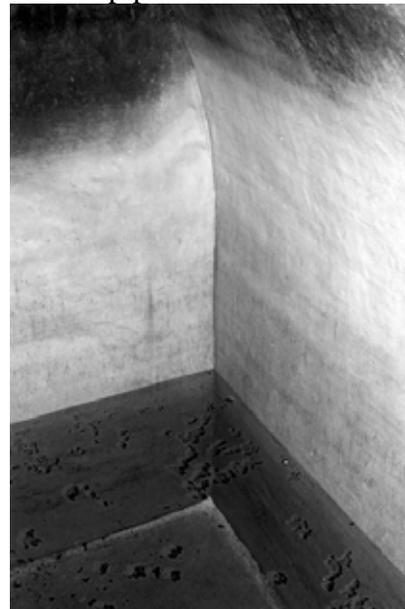
Figure C6-8: Northwest interior corner of cistern. Note heavy organic growth on arched portions of walls, Fitzpatrick Structural Engineering, 1998.

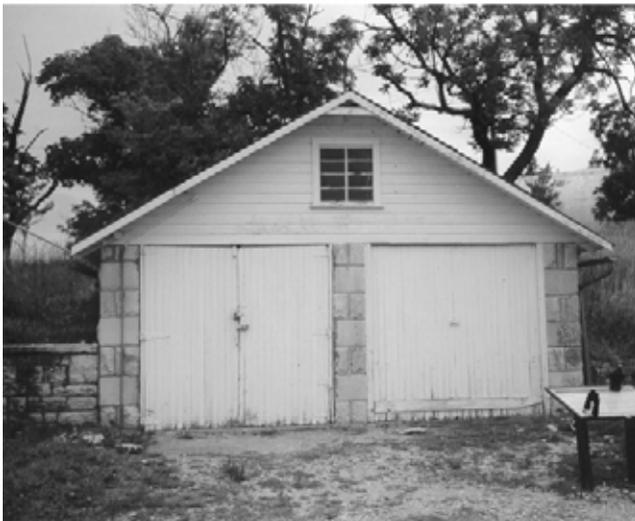
Figure C7-1: Carriage house, south elevation, QEA, 07/08/98.

The carriage house is shown in figure C7-1. Other than the organic growth around the base, the stone walls are in good condition. The condition of the mortar joints varies from wall to wall. While the joints are in very poor condition on the south wall, those that are visible on the north wall are in relatively good condition with only a few open joints. Those joints on the east and west walls have been sporadically repointed with a hard gray mortar and the original joints are rough with periodic openings. There is some missing mortar near grade on the east wall. Protruding above the window on the south elevation are the ends of two abandoned pieces of conduit. East of the window are two holes where conduit was removed.

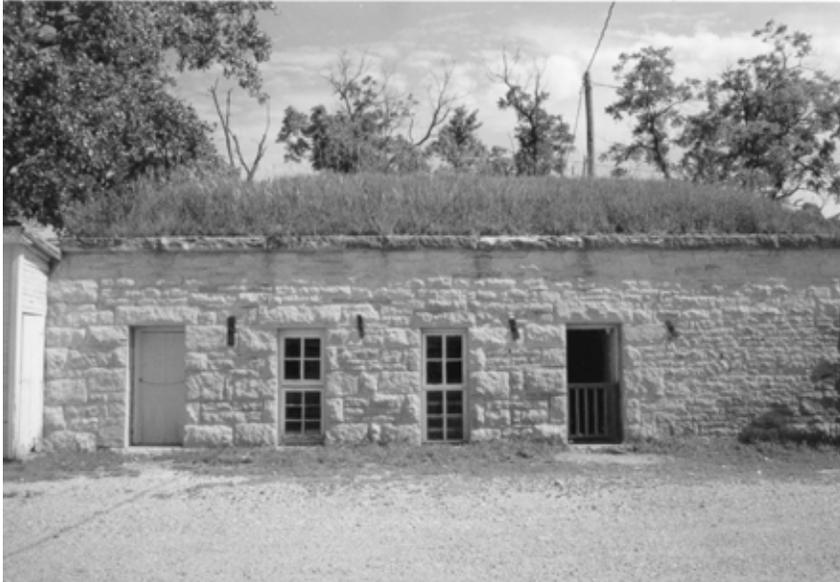
Figure C8-1: Poultry house, south elevation, QEA, 07/10/98.

The exterior walls are in good condition. The joints have been re pointed but show evidence of deterioration and some openings. The joints are eroding where the original mortar still exists. The south elevation is shown in figure C8-1. Stone is spalling at several locations on the south elevation. Along the base of the wall, there is discoloration due to the organic growth from splash backs.

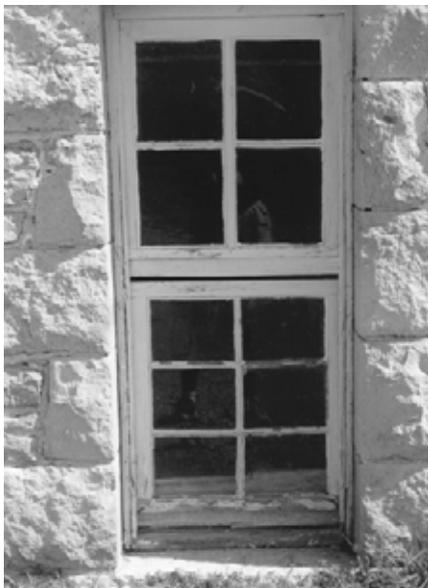
The east window frame on the south elevation is in poor condition, due to significant weathering. The sill is in very poor condition, as it is heavily deteriorated. The sash is also in poor condition because of weathering, and needs reconditioning and refitting. The west window frame is heavily weathered and in poor condition. The sill is weathered and cracking. Both the upper and lower sash of this window appear salvaged, and wood

pieces are blocking the gap in between them (figure C8-2). The muntin bar of the lower sash is separating due to the two lower glass panes missing.

Figure C8-2: Poultry house, west window in south elevation, QEA 1998.

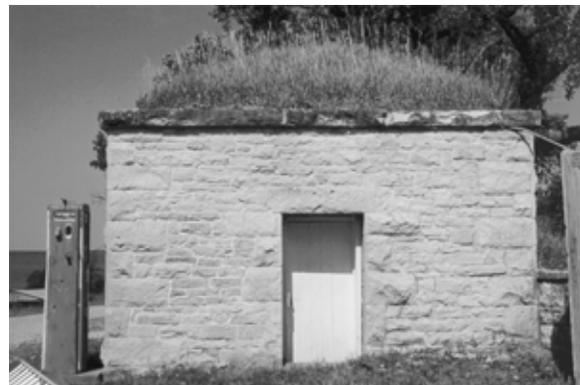
The east elevation is shown in figure C8-3 and is in good condition. It has been repointed and both the old and new mortar joints are in good shape. The door into the anteroom on the east elevation is in fair shape, with erosion at the edge and bottom. The frame shows heavy weathering and deterioration at the bottom, where it is also kicking inward. The sill is deteriorated.

Figure C8-3: Poultry house, east elevation, QEA, 7/10/98.

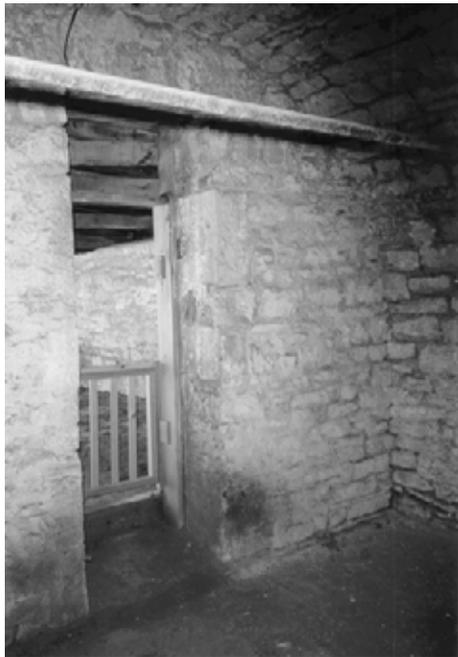
Figure C8-4: Poultry house, showing tie rods in coop area, QEA, 07/10/98

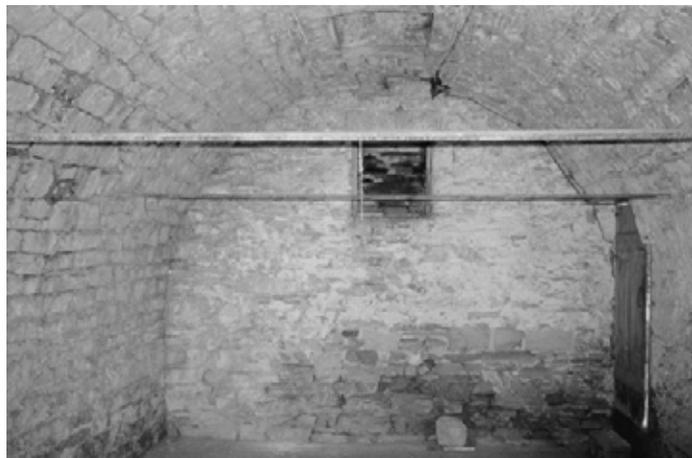
Figure C8-5: Poultry house, interior, east elevation, QEA, 07/10/98.

The opening at the west end that leads into the scratch house has dressed stones at the top of the wood frame and ashlar stone up to a large stone header. It is possible that, at some point, the door had a ventilation transom because the stone lintels are pieces of the original stone fabric (figure C8-5).
