**Timucuan Ecological and Historic Preserve**

**Napoleon Bonaparte Broward House**

**Historic Structure Report**

March 2010

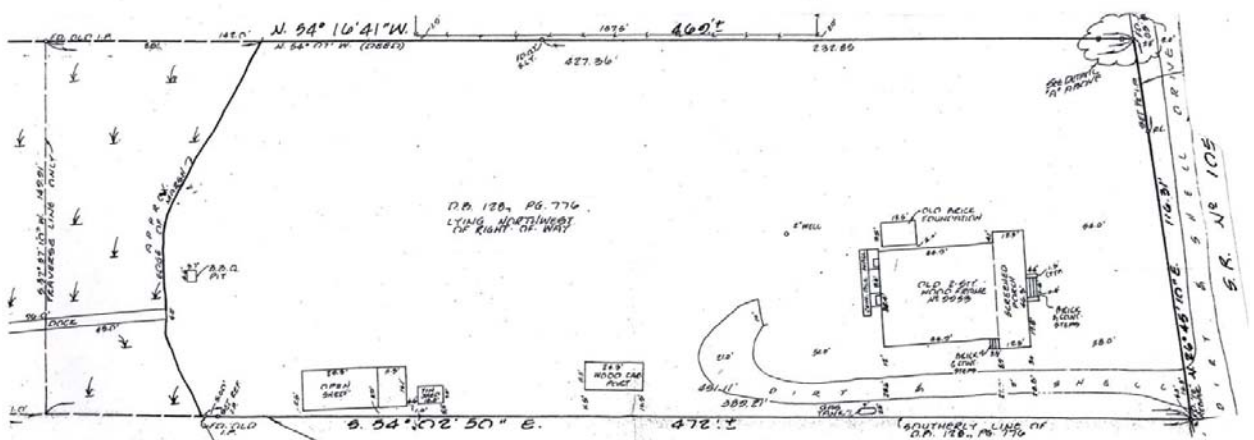
Figure 19, 1989 survey plat. (Robert Angas Engineers)

Just north of the northwest corner of the kitchen ell, the survey shows an “old brick foundation” measuring 9’ 5” by 13’ 5”. This is the foundation for the cistern.

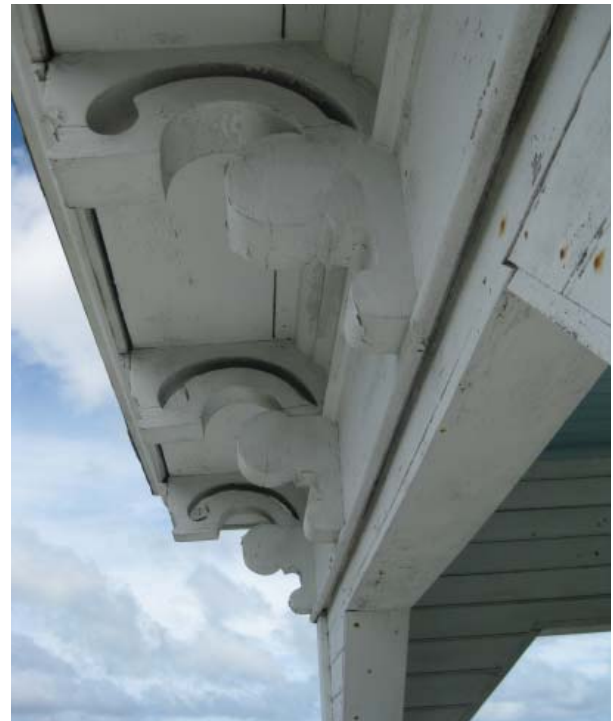
Figure 23, Cornice brackets of cupola

Several areas of the cupola required repair. The roofing shingles covering the side walls of the base of the cupola were removed and the weatherboards re-exposed and repaired. A new balustrade was installed to match that of the front porches, fixed to new corner posts with square caps. The cupola roof was re-shingled with composition shingles matching those installed on the main block, porch, and shed roofs. The lower portions of three eave brackets of the cupola were replaced (Figure 23). The wood floor, painted canvas, and roof sheeting were removed from the floor, replaced with a waterproof lining and tongue-and-groove wood floor, and painted.

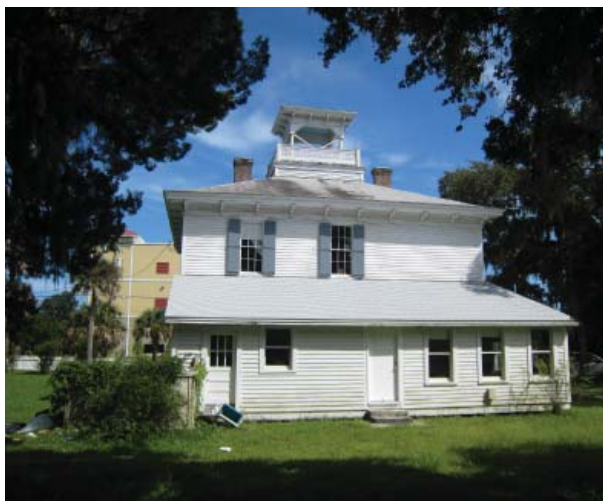
Although the window openings of the main block remained unchanged, significant fenestration and surface changes were made to the rear shed. Window openings were retained in the same locations but enlarged for new, taller, double-hung one-over-one sash to replace the earlier six-light sash. The flush horizontal exterior boards were covered with weatherboards similar to those of the main house and a skirt was added. Exposed rafter ends were covered (Figure 24)

**Figure 24.** Back of house showing replacement windows and weatherboard siding added 1996-2003. (Oppermann, 2009)

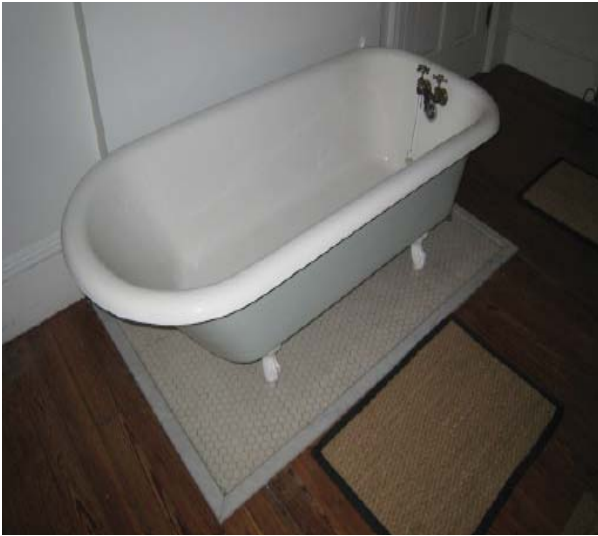
The bathtub with its cement or stuccoed surrounding wall was also removed. It too had rotted the floorboards beneath the tub. A salvaged and refinished clawfoot tub was installed in the same location, set on a replacement section of floor laid with hexagonal ceramic tiles.<sup>26</sup>

**Figure 25,** Salvaged bathtub on tile floor at the east wall of Room 105. (Oppermann, 2009)

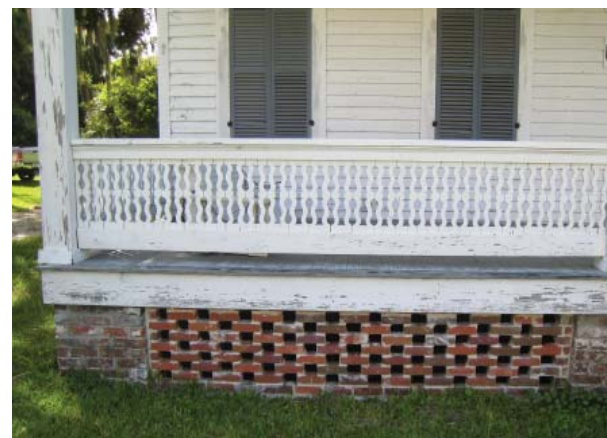
original Kitchen Ell are the original 1877 brick piers. Those of the Main Block perimeter typically measure 8" by 1'-10" with spacing between piers alternating between about 5'-6" and about 4'-6" except at the north side where both piers and spacing are longer, apparently associated with the connection of the Main Block with the original Kitchen Ell. The four piers of the double-gallery porch (which consists of a single row of piers at the east side) are set immediately below the four sets of porch columns and are larger, measuring 1'-0" by 1'-10" at the two center positions and equally deep and longer in an L-shape at the corners. The original piers also remain below the north and south walls of the center hall. Here the piers measure 8" by 2'-3". The original bases of the two chimney stacks are also intact, each measuring 2'-3" by 4'-8". All are made of the same tan-brown bricks though there apparently has been some minor replacement of individual bricks. The infill brick lattice work was added between the porch piers in 1996-2003, mimicking the work done in the 1920s when the larger porch was constructed.

Figure 10, Original brick porch piers on the east elevation with twentieth-century brick lattice infill.

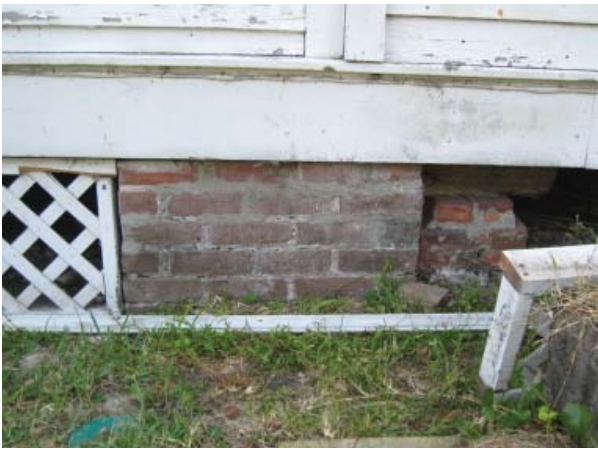
**Figure 11.** The westernmost pier of the north elevation of the Main Block is also the easternmost pier of the original Kitchen Ell.

The westernmost pier of the north elevation of the Main Block is also the easternmost pier of the north elevation of the original Kitchen Ell. The two other piers of the north elevation of the Ell are not as large as the adjoining north elevation piers of the Main Block, measuring 8" by 1' - 6" as opposed to 8" by about 2'-2", and the spacing between piers is shorter, measuring about 6'-2" as opposed to about 7'-0", but the all these piers of the north elevation appear to be made of the same type of brick. In addition to the northernmost

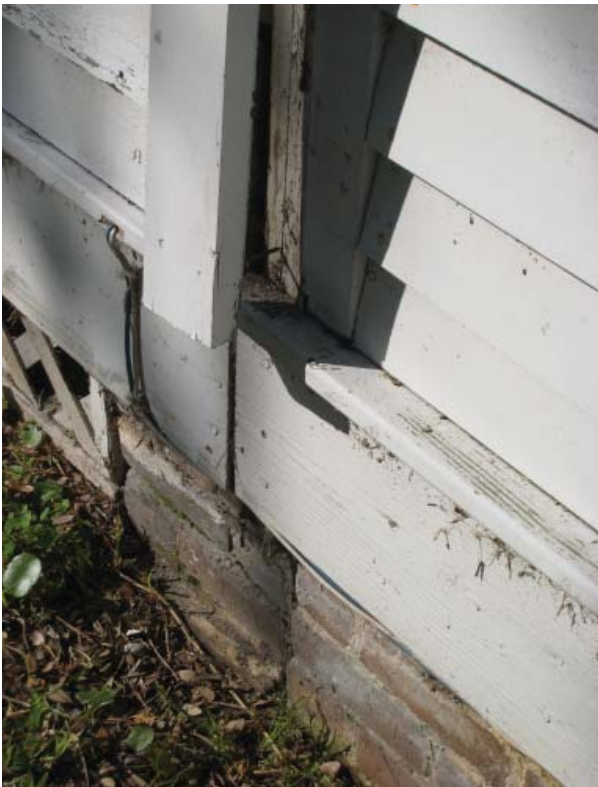
**Figure 12.** The westernmost pier of the south elevation of the Main Block abutting the easternmost pier of the Rear Shed.

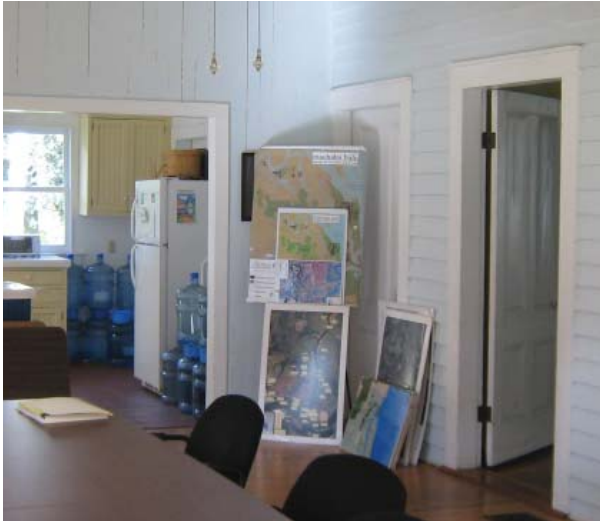
vertically; on the north side is gypsum board. Presumably this was a board wall that later had gypsum board added along with spacers to give depth and provide a nailing surface.

**Figure 13.** Weatherboards form the east walls of Room 108-Conference Room of the Rear Shed. Exposed vertical boards form the south side of the dividing wall between Room 107-Kitchen and Room 108-Conference Room of the Rear Shed.

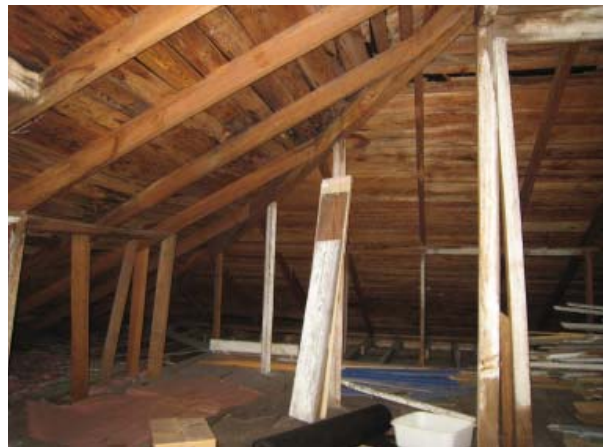
The original roof framing of the Main Block remains in place. The rafters measure 2" by 5" and are set 32" on center to form the hipped-deck roof. The rafters are sash-sawn on the long side and circular sawn on the short side. Ridge beams measure 2" by 7". Two support posts beneath each ridge beam measure 1 $\frac{1}{2}$ " by 4 $\frac{1}{2}$ ". Four posts measuring 4" by 4" form the corners of an 8'-0" by 8'-0" square at the center of the roof, each with a 3" by 4" diagonal brace. These posts support 4" by 6" horizontal beams, which support the roof rafters, ridge beams, and the floor joists of the widow's walk. The floor joists of the widow's walk run north-south.

**Figure 14.** Northwest oblique of Attic framing.

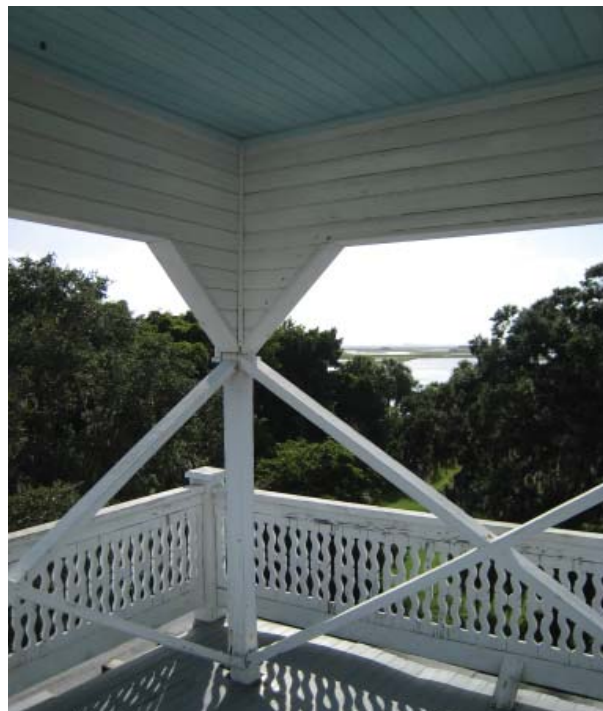
**Figure 15.** Southwest oblique of cupola.

The cupola roof is supported by four posts measuring 3¾" square, replacements installed 1996-2003. The posts rest directly above the four center posts in the Attic. The cupola posts are further supported by 1¾" by 3¾" X-bracing, also replaced at the same time as the posts. Ceiling boards block the view of the pyramidal roof rafters.

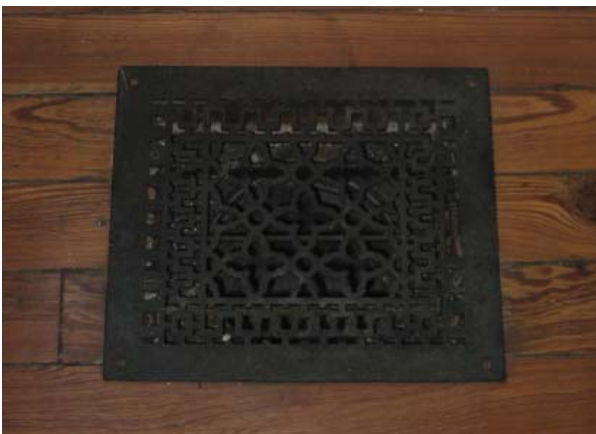
**Figure 16**, Reproduction turn-of-the-century style floor registers installed 1996-2003.

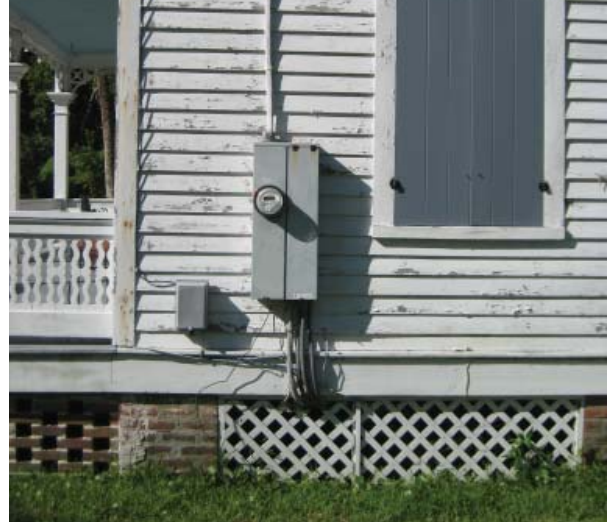
Single phase, 120/240 electrical service is provided by the Jacksonville Electrical Authority. Overhead power lines run along Heckscher Road and connect to a pole in the yard northeast of the house. A power line drops to the distribution panel and meter located on the east end of the north elevation of the house. A subpanel is located on the east interior wall of Room 107-Kitchen.

**Figure 17**, Distribution panel and meter on the east end of the north elevation.

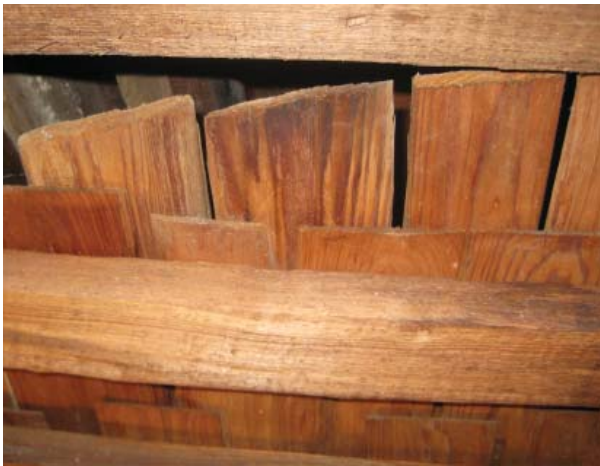
A deck-hipped roof is above the Main Block inclusive of the inset front porches. There is a pyramidal roof on the cupola. The Rear Shed has a shed roof. The roofs of the Main Block, the cupola, and the Rear Shed are covered with composition shingles installed by Zillgitt 1996-2003. An early roofing material of the main block was wood shingle, identified by testing as being Bald Cypress (*Taxodium distichum*) (Dr. Joseph R. Loferski, Department of Wood Science and Forest Products, Virginia Tech). A number of these shingles remain beneath the deck of the widow's walk.

Figure 18, Early wood shingles beneath the deck of the widow's walk.

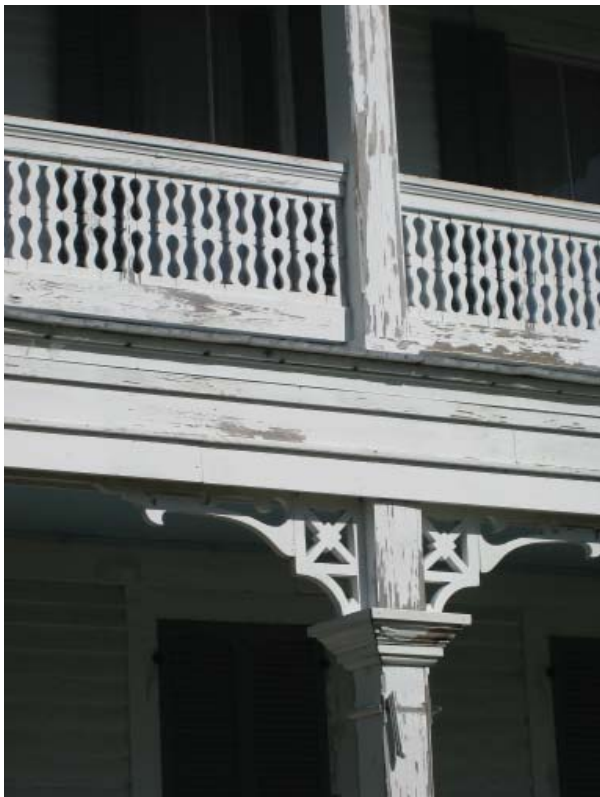
Sawn, filigreed balustrades enclose both porches, except for the central bay of the first-floor front. Much of the first-floor balustrade is assembled with reused earlier pieces from the second-floor porch, supplemented with reproduction replacements. The second-floor balustrade is a reproduction.

**Figure 20**, Sawn trim and balustrades of the east-elevation porches.

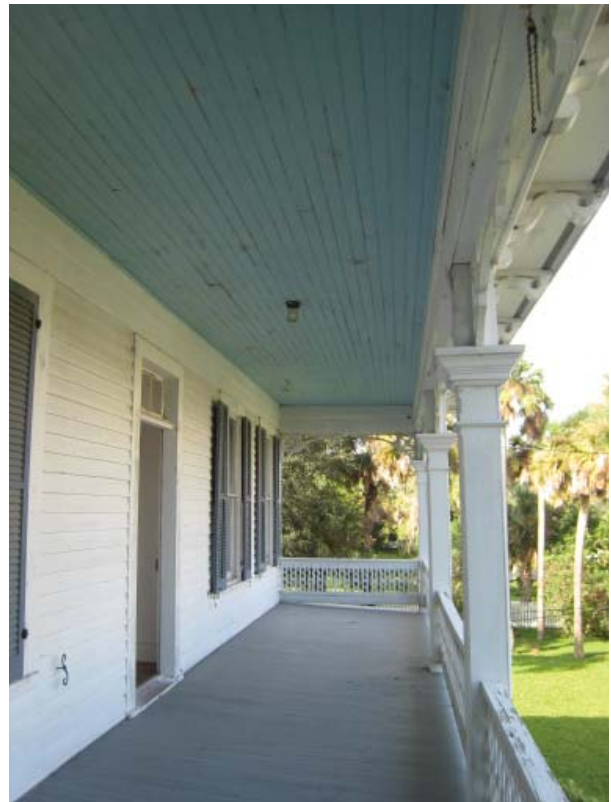
Beaded boards on the second-floor porch ceiling are original. Those on the first floor are not beaded and are modern replacements installed by Zillgitt. Boards of the second-floor porch ceiling run north-south, and those on the first floor run east-west.

**Figure 21**, Original beaded board ceiling and modern flooring of the second-floor porch.

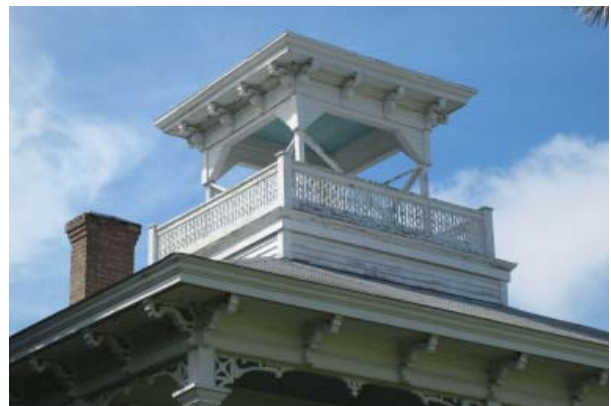
Centered above the house is a widow's walk and cupola. The cupola is centered above the widow's walk and is supported by four posts with corner bracing. Posts and corner bracing are modern replacements. The cupola is decorated with sawn brackets beneath the hipped roof overhang. These brackets are of a similar design to those of the Main Block, but are smaller in scale. According to Zillgitt, the lower portion of three brackets are replacements installed 1996-2003.

**Figure 22**, Widow's walk and cupola.

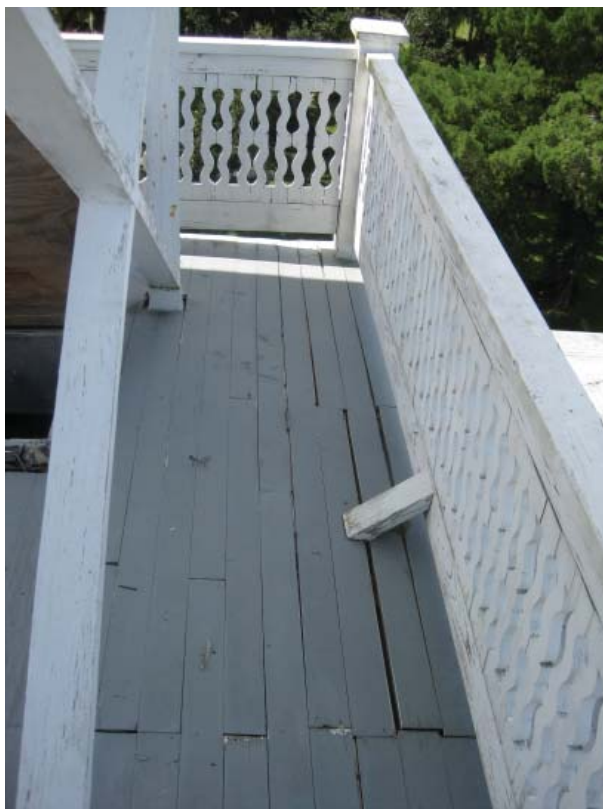
The original deck flooring of the widow's walk was likely a wood base covered by a painted canvas. By 1996, roll asphalt roofing had been installed. Between 1996 and 2003, a layer of canvas and another of asphalt sheeting were removed and replaced by Zillgitt with a membrane roofing system. A sloping tongue-and-groove wood flooring was installed on top.

**Figure 23**, Modern flooring, X-bracing, and balustrade of the widow's walk and cupola.

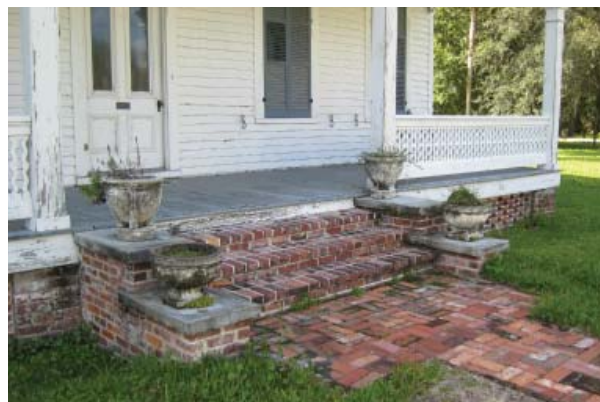
During the 1996-2003 work when the original porch design was reconstructed, the steps were replaced with a similar set of three brick steps. Centered on the east elevation, the three brick steps each measure 7'-11" in length and 1'-1" in depth. The stairs have broad stepped cheek walls with flat concrete caps measuring 8" in width. The front risers of the cheek walls are 2'-2" in length and the back risers closest to the porch are 2'-8" in length.

**Figure 24**, Brick steps of east elevation.

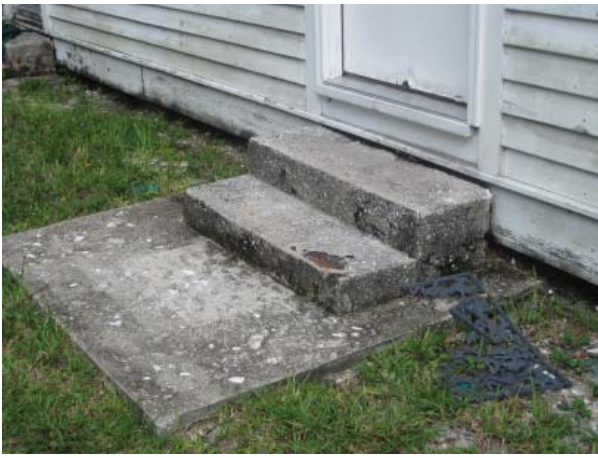
A poured-in-place concrete pad with a set of two brick steps covered with a concrete stucco is set at the center of the west elevation of the Rear Shed leads to Room 108-Conference Room. Each step measures 3'-5½" in length and 1'-1" in depth. A similar concrete pad and set of two brick steps with cement stucco leads from the exterior to Room 107-Kitchen. These steps measure 3'-3" in length and 1'-1" in depth. The date of installation is not known, but they are present in family photos of the 1960s.

**Figure 25**, West elevation poured-in-place concrete pad and cement stucco over brick steps at center doorway.

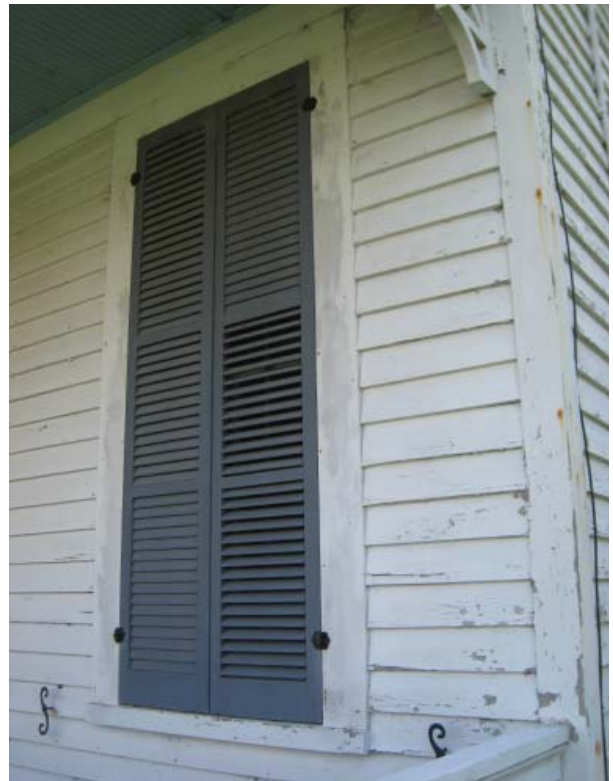
**Figure 26**, First-floor east elevation reproduction louvered shutters based on salvaged shutter.

None of the shutters currently on the house is original, though some are based on original designs. The shutters on the first-floor front (east) elevation are modern reproduction louvered shutters in a three-part design, measuring 7'-3" by 2'-10" with a thickness of 1¼", installed 1996-2003. They are based on a salvaged shutter stored at the time in the Attic and still there at the time of this report. Although a similar design, they are a mismatch in overall thickness and the design of individual elements. The replacement hinges are quite different in scale and design compared to the originals.

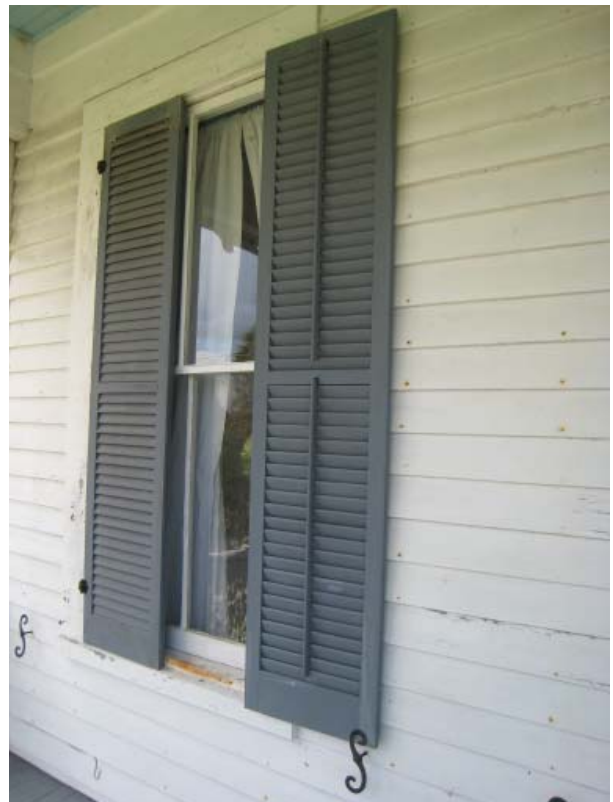
**Figure 27**, Second-floor east elevation reproduction louvered shutters based on salvaged shutter.

Shutters on the windows of the second-floor front (east) elevation are also modern reproductions installed 1996-2003, with a design based on remnants of another early shutter found under the house. These are two-part louvered shutter, again with the same design discrepancies of the first-floor reproduction shutters and hardware. (This second-floor shutter was not located during the preparation of this report, but would certainly have matched the first-floor shutter in design characteristics.)

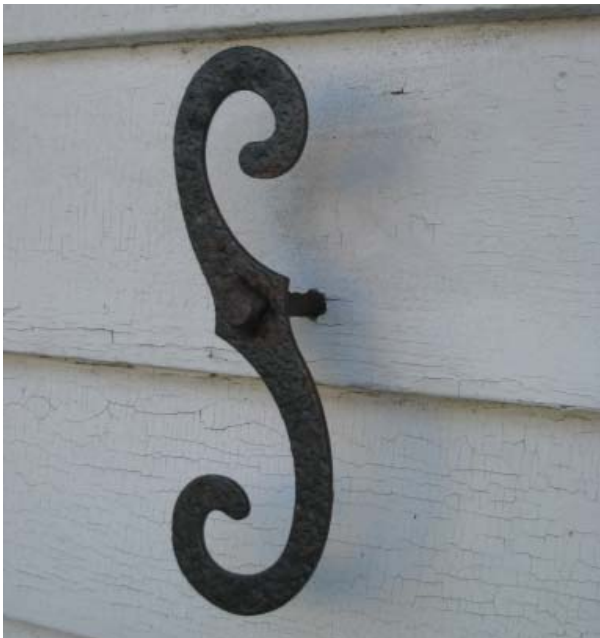
These windows are fitted with modern shutter dogs, though no evidence of earlier shutter dogs is apparent and the type of hinge on the stored salvaged shutter indicates no shutter dog was needed; it is a self-locking hinge.

**Figure 28**, Typical modern shutter dog added to east-elevation shutters in 1996-2003.

**Shutter Dogs:** Reproduction stamped-metal shutter dogs were added to east elevation window shutter in 1996-2003 (Figure 28).

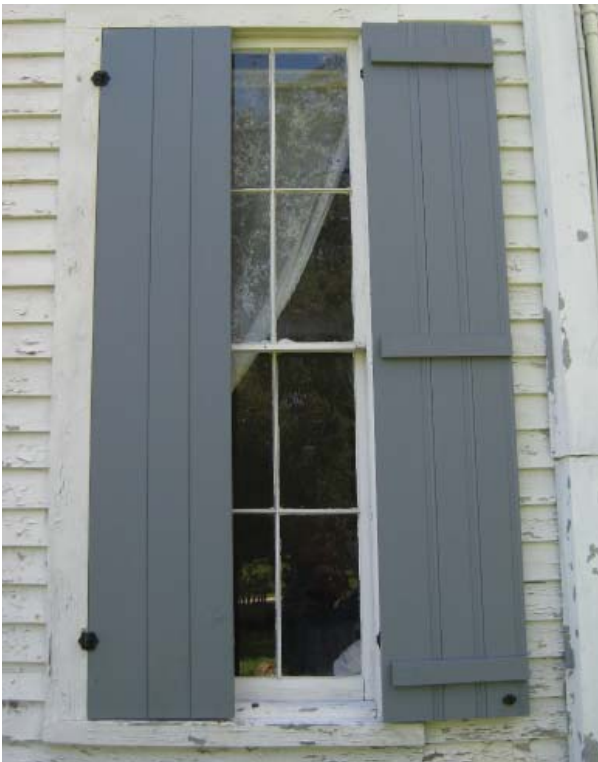
Shutters on the north, west, and south sides of the Main Block are board-and-batten shutters, as were present in 1996. Between 1996 and 2003 Zillgitt added reproduction cast iron hinges matching the ones he added to the east-elevation windows. Then, in 2008, the National Park Service replaced the shutters of the north and west elevations using ¾" by 5½" stock plank boards with reproduction iron hinges and sill latches.

The photograph from 1910-1918, which was not known to Zillgitt, indicates the Main Block had louvered shutters at that time on the south as well as the east elevation. Presumably, there would have been louvered shutters on the north and west elevation windows as well. Broward family photographs of mid-century show the first occurrence of board-and-batten shutters.

**Figure 31**, Typical board-and-batten shutters as occurring on the north, west, and south elevations of the Main Block.

**Window Shutters:** Board-and-batten shutters were added as a new design feature on the north, west, and south elevations windows at mid-century. Some of these shutters, on the west and north elevations, were replaced in 2008 (Figure 31).

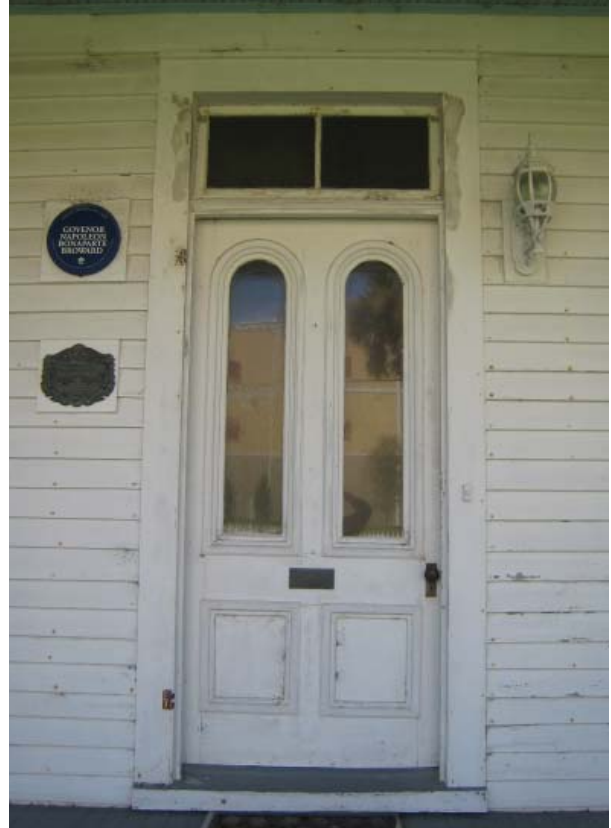
Centered on the east elevation at first floor is the front door, the doorway for the public to use when entering the house. The four-panel door is the most architecturally sophisticated of any door in the house, befitting the sole public entrance. The panel trim is bold and bulbous. The top two panels are glass with arched tops. Above is an early, if not original, two-light transom. The door measures 3'-6" by 7'-5" by 1½", the largest in the house. At one time the doorway was fitted with a screen door measuring approximately 3'-5" by 7'-6" by 1½", as

evident from the remnants of an added doorstep. The exterior door casing matches that of the other door and window surrounds of the Main Block, being flush board measuring 5¾" by ¾". The door sill is 3" in height and 4'-5" in length, with a 4 ¾" deep threshold with tapered corners.

**Figure 32**, The front entrance doorway, east elevation.

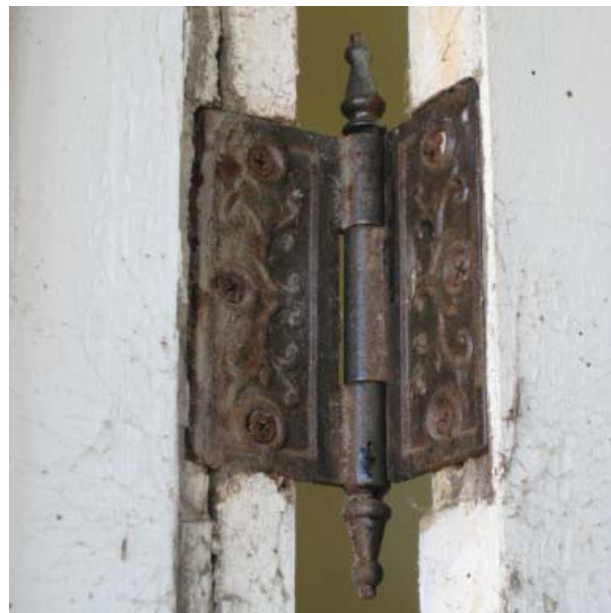
**Figure 33**, Salvaged front door hinge, exterior view.

The hinges on the door are 4", three-knuckle, salvaged replacements. The door is also fitted with salvaged decorative brass escutcheon, mortise lock and knob. All were installed by Zillgitt between 1996 and 2003. A patch for a previous mortise lock is visible above the lock rail. Two hinges that once held the screen door remain, and are five-knuckle butt hinges measuring 3" in height.

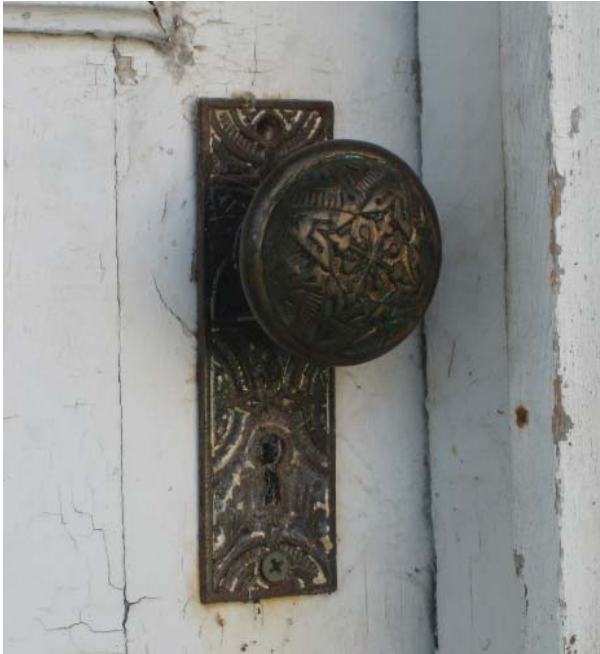
**Figure 34,** Salvaged front door plate and door knob.

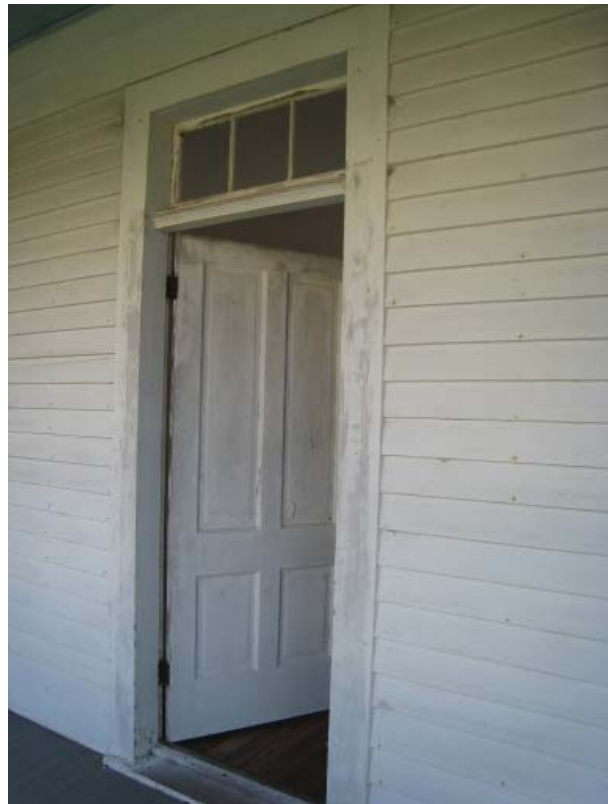
The door to the second-floor porch is centered on the east elevation. The door has four panels and measures 3'-0" by 7'-0" by 1¼". A three-light early, if not original, transom with original transom bar is set above. Exterior casing on the door is flush board, identical to that of the east first-floor door, measuring 5¾" by ¾". One of the hinges is the same as the salvaged hinges of the front door, measuring 4" in height, presumably salvaged also. The other hinge is a 3½", three-knuckle, cast-iron reproduction hinge with acorn motif typical of those found on other doors within the house. The outer face of the door is fitted with a metal doorknob. The door sill is 1½" above the porch deck, 3'-11" wide, with a 4½" deep original threshold.

**Figure 35,** East elevation second-floor doorway.

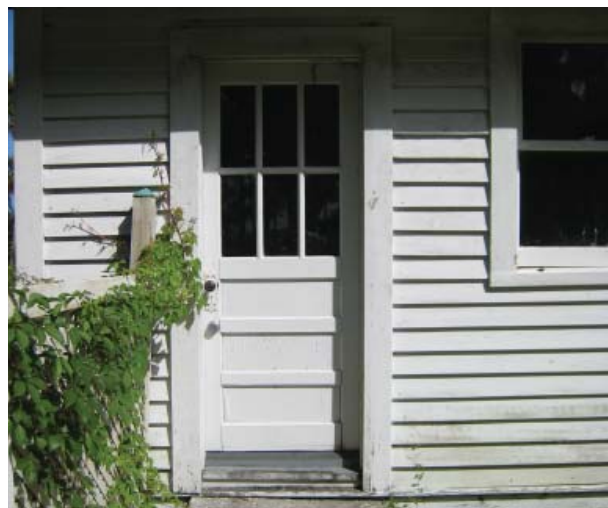
On the north end of the west elevation is an early twentieth-century door measuring 2'-8" by 6'-4" by 1⅜" and composed of three horizontal panels with a six-light sash. The door is fitted with embossed, pressed escutcheons and an embossed doorknob on both sides, fitted over a patch for a previous locking mechanism. Two five-knuckle, 4" ball-and-pin hinges, also dating to the early twentieth century, support the door. A modern, brushed-chrome dead bolt is also present.

**Figure 36,** At the northernmost doorway of west elevation of Rear Shed, an early twentieth-century sash door.

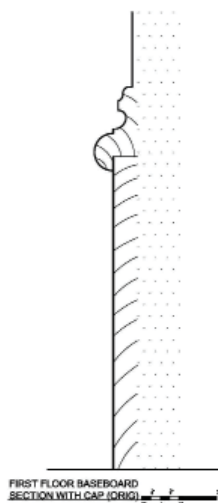
**Room Baseboards:** Baseboards throughout the rooms of the Main Block are of the same design. Room baseboards on the first floor have an 8" tall exposure with a 2¼" cap. Those on the second floor are 7" tall with an identical 2¼" cap. No shoe molding is present in either composition.

Figure 37, Typical original first-floor room baseboard with cap.

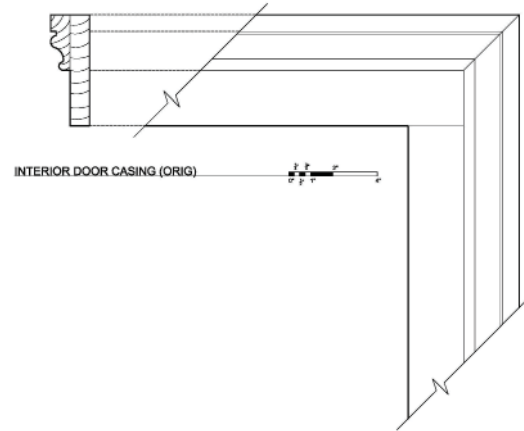
**Window and Door Casings:** Throughout the Main Block, window and door casings are of the same design, measuring 5" across with a 2¼" back band. Casing was installed with simple butt joints, while the back band was installed with mitered butt joints.

Figure 38, Typical original interior door casing.

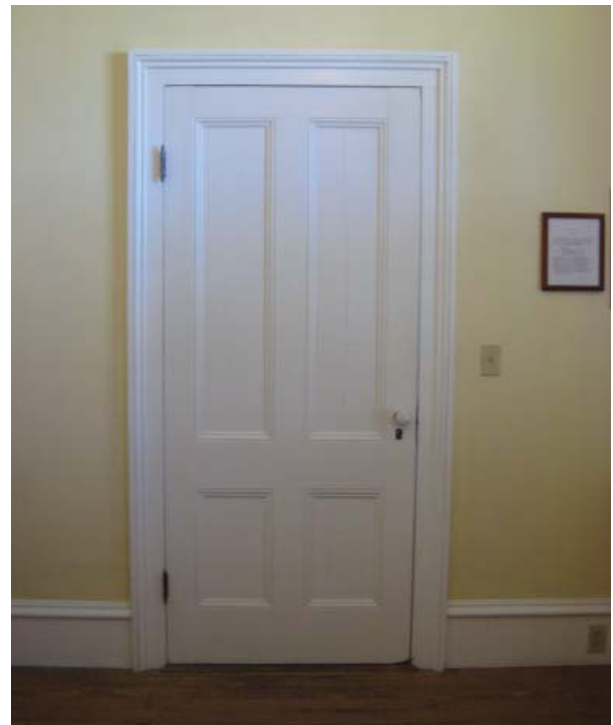
Figure 39, Common four-panel interior door.

**Doors:** Most doors on the interior of the Main Block are the original four-panel doors. Doors on the first floor measure on average 3'-0" by 7'-0", while those on the second floor are smaller in size, measuring on average 2'-10" by 6'-10".

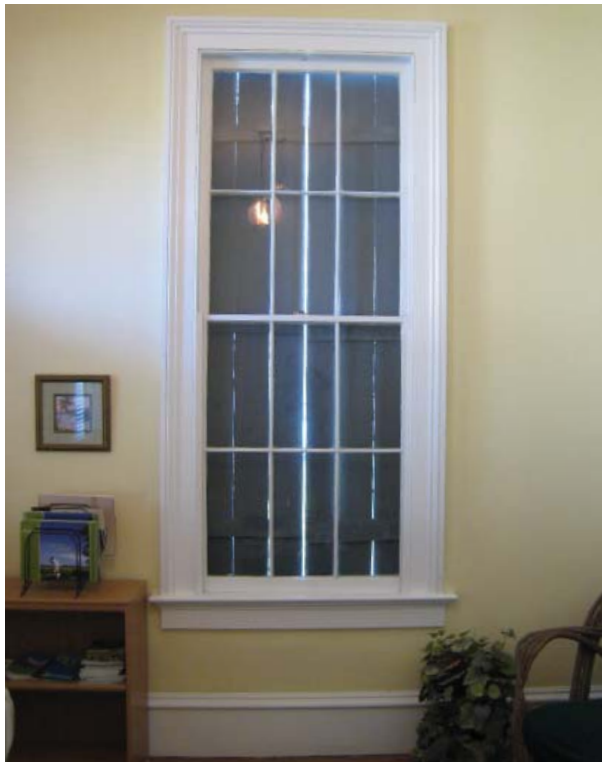
**Figure 40**, Typical six-over-six double-hung sash window of north, south and west elevation of Main Block.

**Windows:** Windows on the first floor are consistent in size, measuring 7'-1" in height and 2'-10" in width. Windows on the second floor are also consistent in size, slightly shorter than those of the first floor, measuring 6'-5" in height and 2'-10" in width. (Muntins of the six-over-six windows in the Main Block, but not the sash frame, were replaced in 1996-2003 by Zillgitt.) The two-over-two sash windows of the east elevation are probably original and have a matching design.

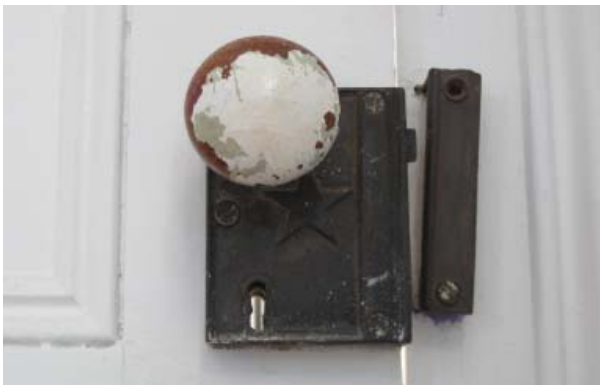
**Hardware:** A rim lock with a star design is present on a number of doorways in the house, measuring 3 $\frac{3}{8}$ " by 4". These locks are probably original.

**Figure 41**, Rim lock with embossed star design is probably original.

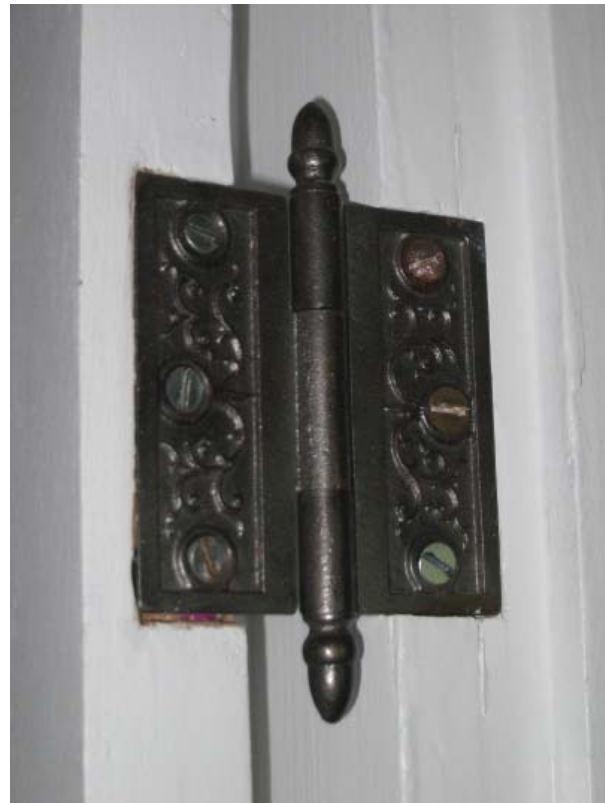
**Hardware:** Reproduction cast-iron hinges with acorn-shaped pin ends are present on many doors throughout the house. These hinges are three-knuckle and measure 3" in height. These hinges were installed in 1996-2003.

**Figure 42**, Reproduction hinge with acorn pin is a common late design element found on doors throughout the house.

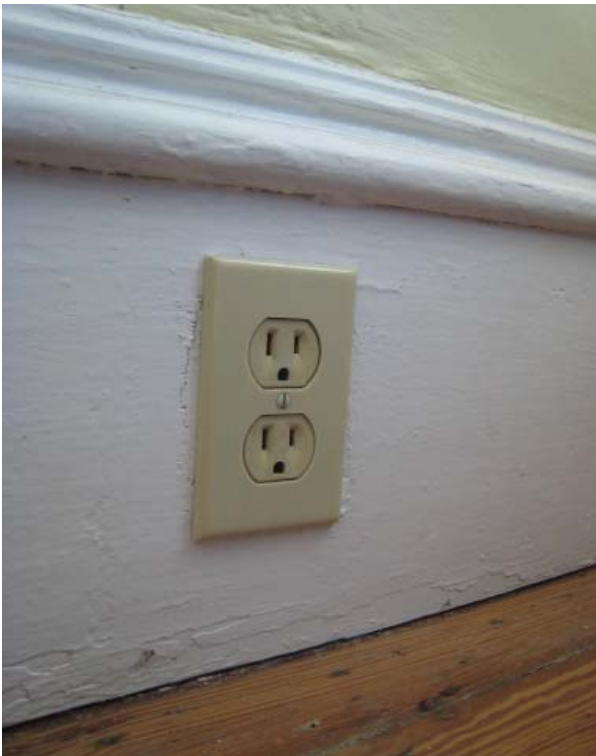
**Figure 43**, Modern molded-plastic outlet covers installed in 1996-2003 throughout the house.

**Electrical System:** Modern molded-plastic outlet and switch covers were installed throughout the house in 1996-2003 (Figure 43).

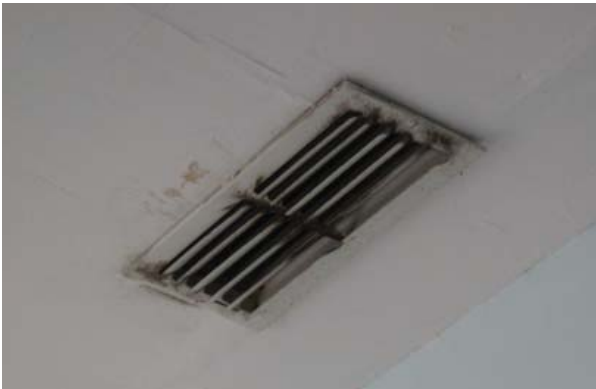
**Figure 44**, Modern metal return registers installed in 1996-2003 at second-floor rooms.

**HVAC System:** Modern metal supply and return registers were installed in 1996-2003 at second-floor rooms (Figure 44).

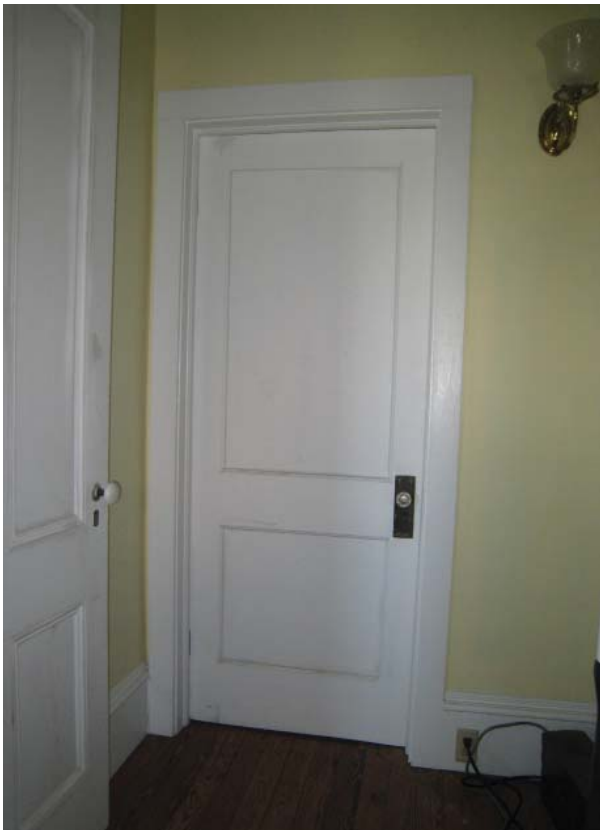
A second doorway leads to Room 104-Northwest Office. This is not an original doorway. Situated on the west wall to the south of the fireplace, this door is a two-panel door of the 1920s and measures 2'-8" by 6'-8". The door casing is flat-cut plank board measuring 3½" by 7/8". An Art Deco style doorknob and plate is found on both sides of the door. The hinges are 3" reproductions in the acorn-pin style found throughout the house. There is no threshold.

**Figure 53.** Room 103-Northeast Office door to Room 104-Northwest Office.

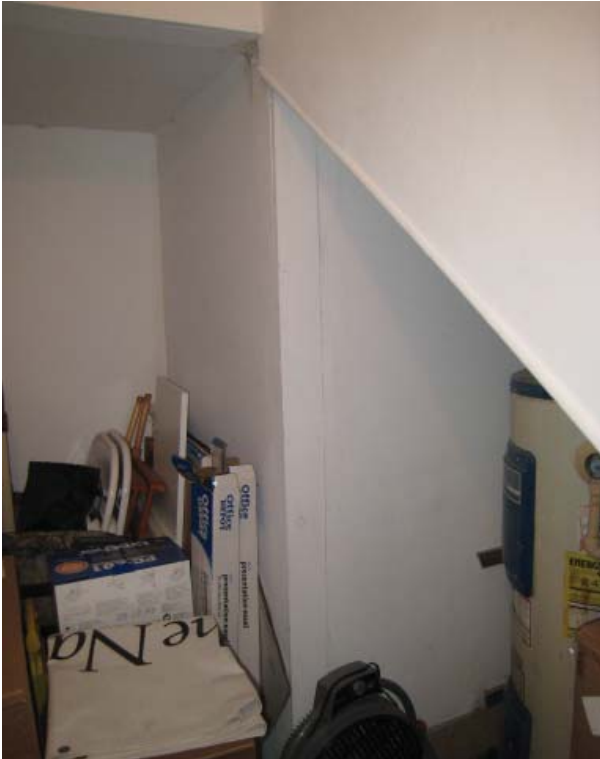
the closet space, measuring 8" in height and  $\frac{7}{8}$ " in depth. A section of flooring in the south end of the closet, where a shower had been located, was replaced by Zillgitt in 1996-2003 using floorboards cut from large salvaged timbers found in the back yard. Portions of the closet wall are of gypsum wall board added by Zillgitt.

Figure 66, Southwest oblique of Room 105-Bathroom closet.

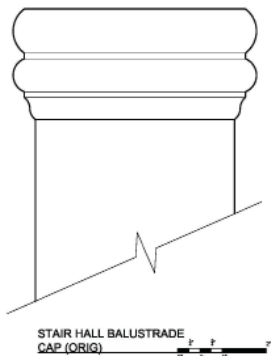
A low section of wall measuring 2'-7" in height separates the two runs of stairs. It is topped with a wood cap, illustrated in Figure 68. The original baseboard extends the full length of this wall. Removal of the cap revealed construction with cut nails, strongly suggesting its current form may be an original feature.

Figure 68, Cap of dividing wall between sections of stair runs, Rooms 106 and 206.

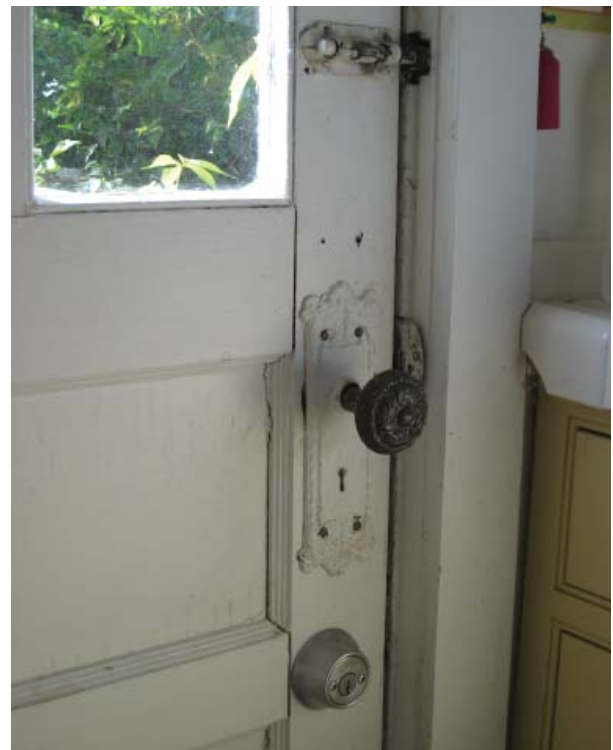
The doorway to the exterior from this room is set on the west wall. This doorway is described in the exterior features section above. Interior casing on the doorway is flush board. The door is fitted with an embossed, pressed escutcheon and embossed doorknob on the Room 107-Kitchen side. The door is fitted with a barrel lock and dead bolt.

**Figure 72**, Room 107-Kitchen door to exterior with embossed, pressed escutcheon, embossed doorknob, barrel lock, and modern dead bolt.

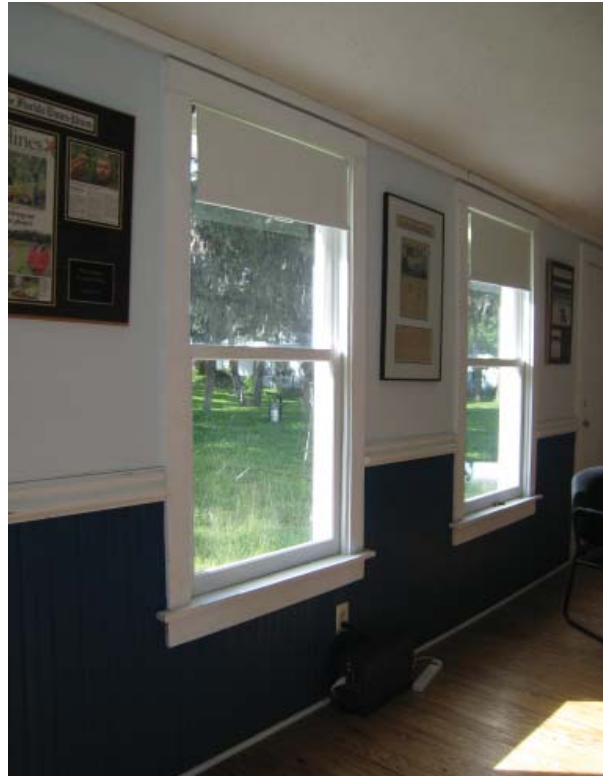
The south and west walls are fitted with modern v-groove board wainscoting measuring 3¼" in width and 40" in height. The wainscoting

is capped with a modern chair rail. Above the wainscoting the walls are covered with modern gypsum wall board. The east wall of the room is covered with original weatherboard, indicating that this was the original west exterior wall of the Main Block. The north wall is 3½" vertical boards with tongue-and-groove joinery.

Figure 74, Room 108-Conference Room west wall.

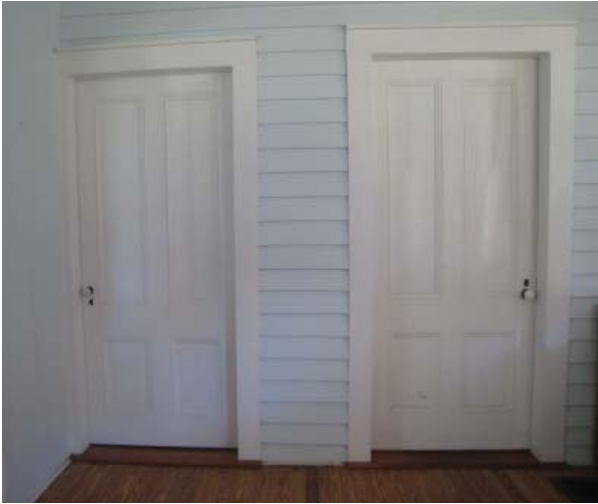
**Figure 75**, Doorways on the east wall of Room 108-Conference Room lead to Room 104-Northwest Office (left) and Room 102-Center Hall (right). Both doorways have flush board casing with a drip edge.

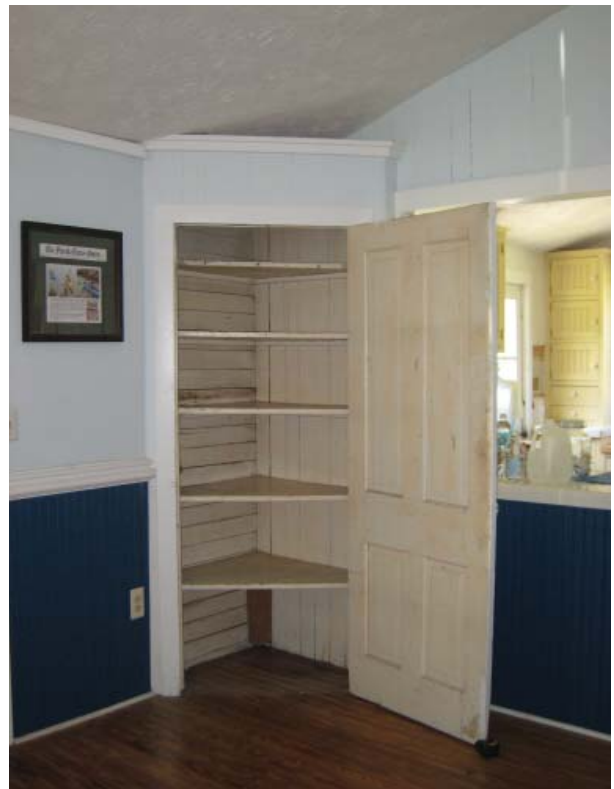
**Figure 76**, Room 108-Conference Room closet at northwest corner.

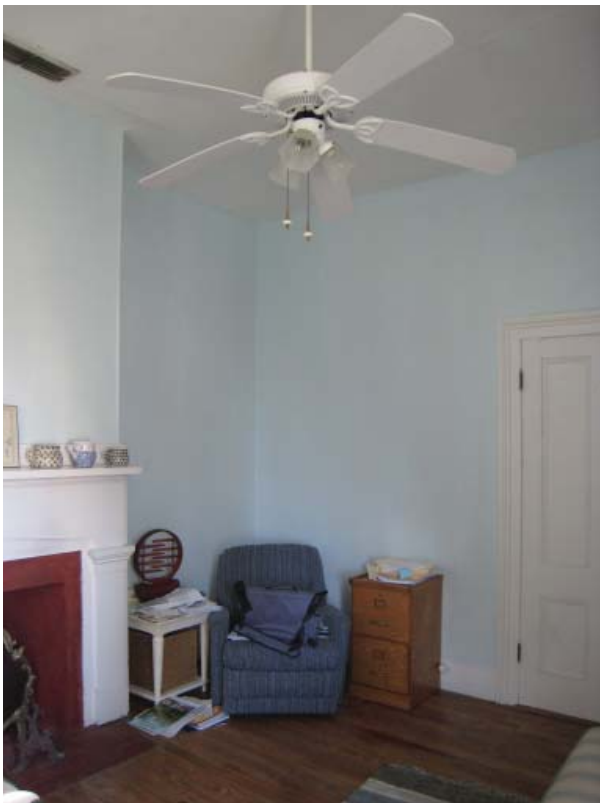
Figure 77, Northwest oblique of Room 201-Southeast Office.

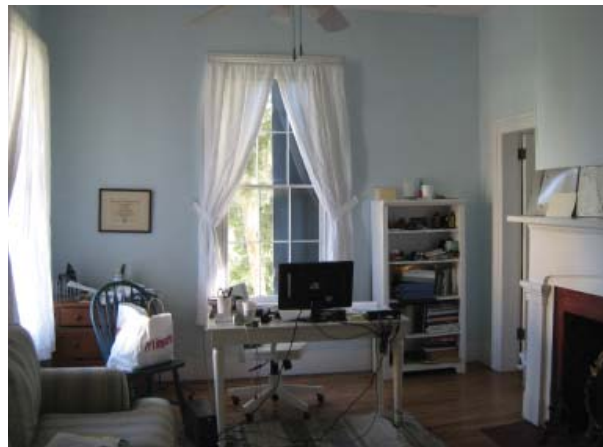
Figure 78, Room 201-Southeast Office looking south.
