**Timucuan Ecological and Historic Preserve**

**Napoleon Bonaparte Broward House**

**Historic Structure Report**

March 2010

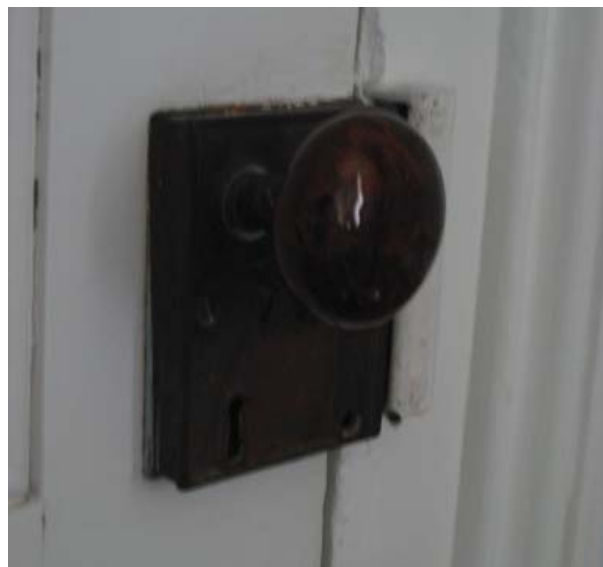
Figure 79, Room 201-Southeast Office door to Room 202-Center Hall, hardware.

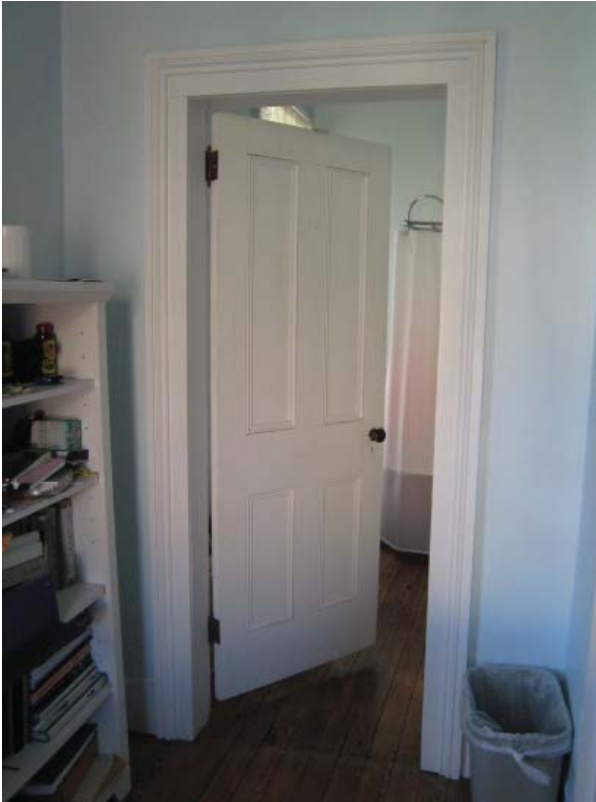
**Figure 80,** Room 201-Southeast Office door to Room 205B-South Bathroom.

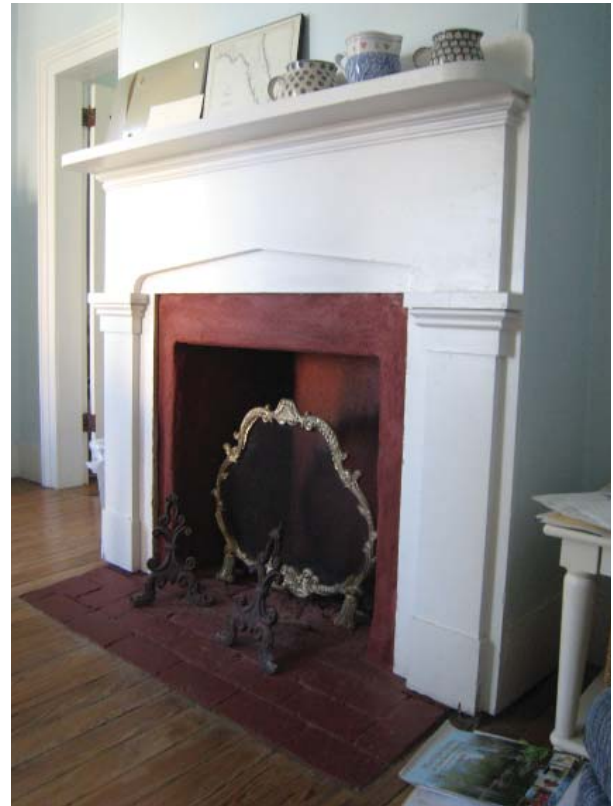
**Figure 81,** Room 201-Southeast Office fireplace and mantel.

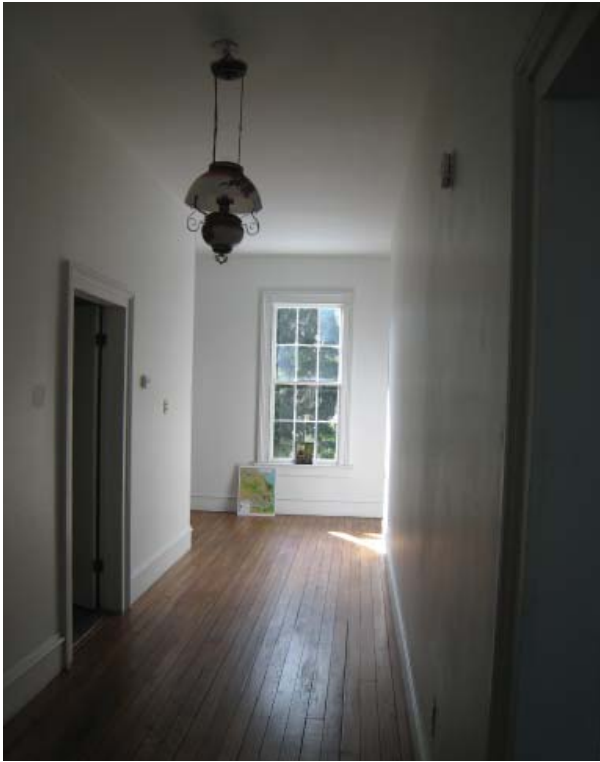
Figure 82, Room 202-Center Hall looking west.

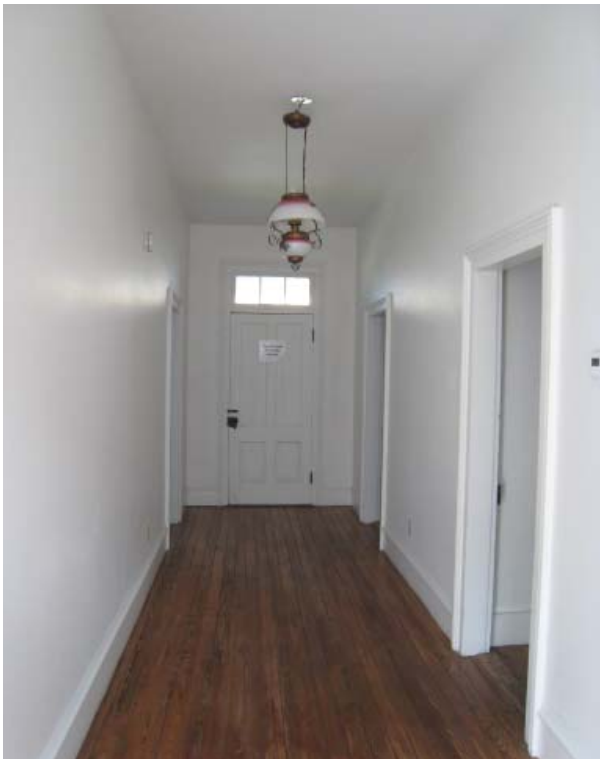
Figure 83, Room 202-Center Hall looking east.

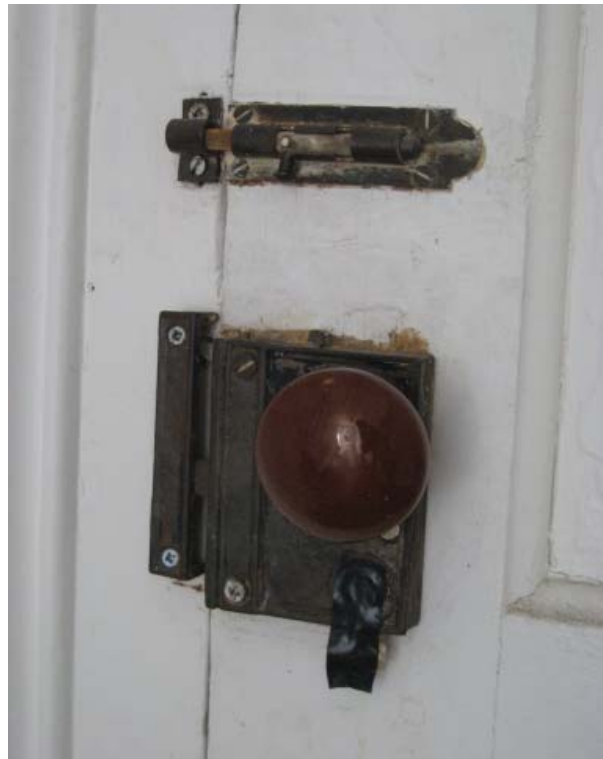
Figure 84, Room 202-Center Hall door to east porch, hardware.

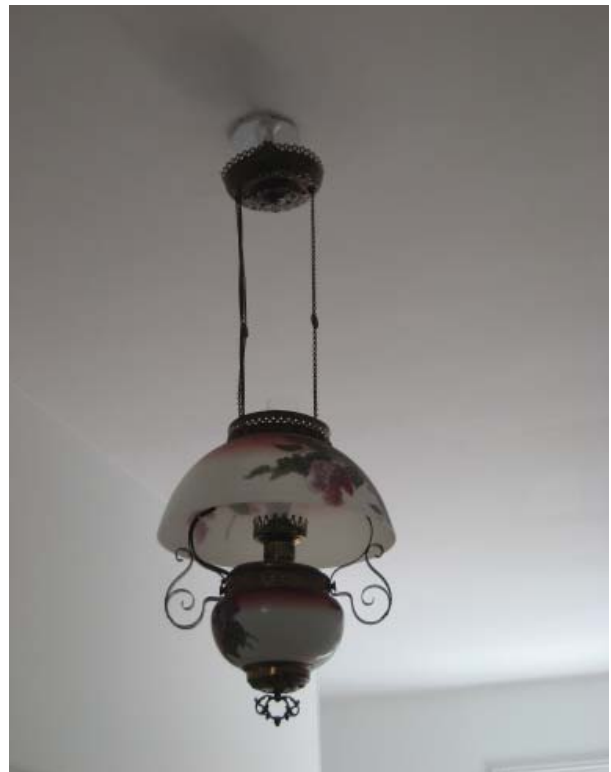
Figure 85, Room 202-Center Hall reproduction light fixture.

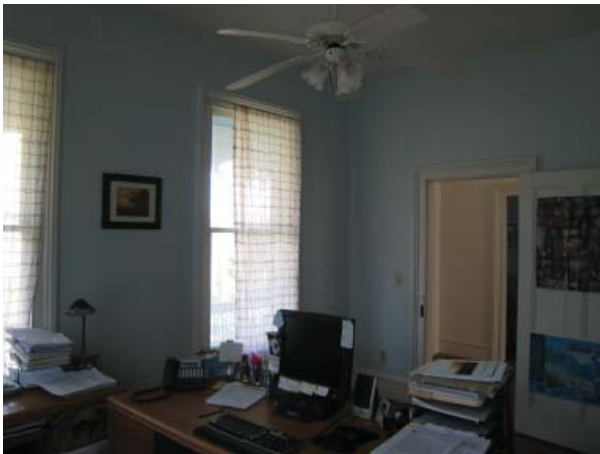
Figure 86, Southeast oblique of Room 203-Northeast Office.

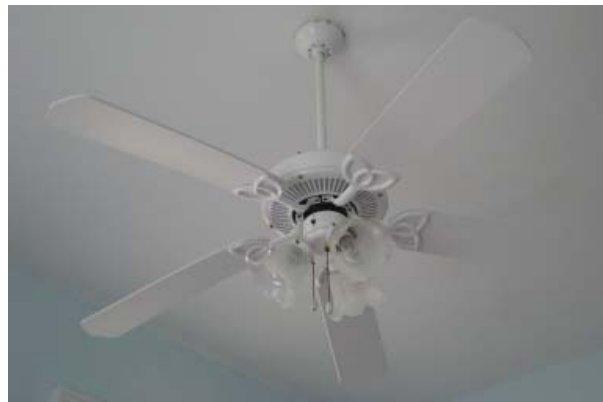
Figure 87, Room 203-Northeast Office modern three-globe ceiling fan/light fixture.

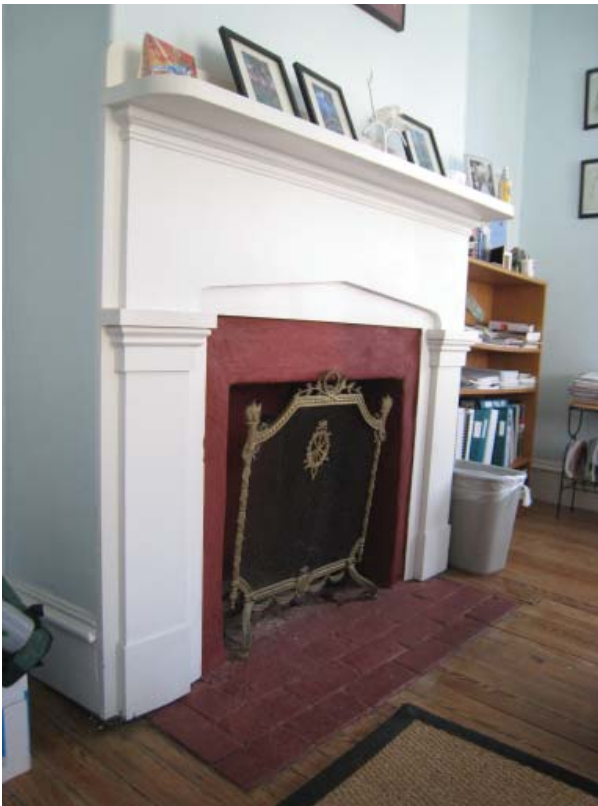
Figure 88, Room 203-Northeast Office fireplace and mantel.

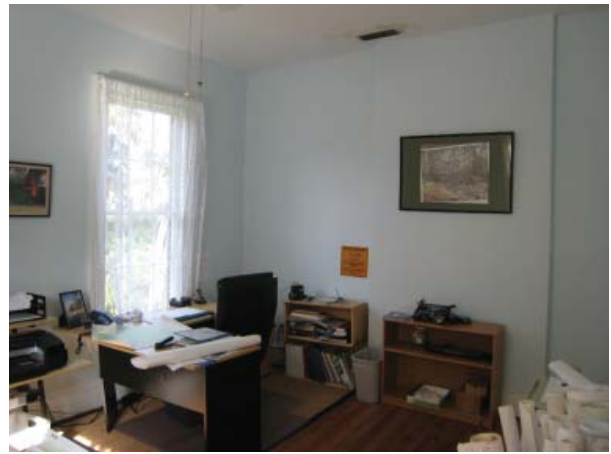
The walls appear to retain original plaster, presumably on wood lath. Hairline diagonal cracking is visible along the east wall, adjoining the chimney.

Figure 89, Northeast oblique of Room 204-Northwest Office.

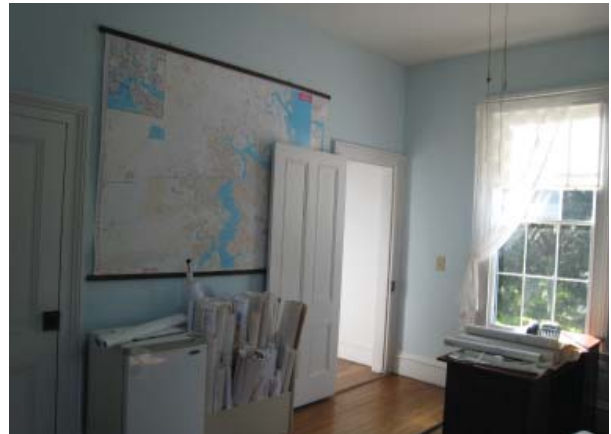
Figure 90, Southwest oblique of Room 204-Northwest Office.

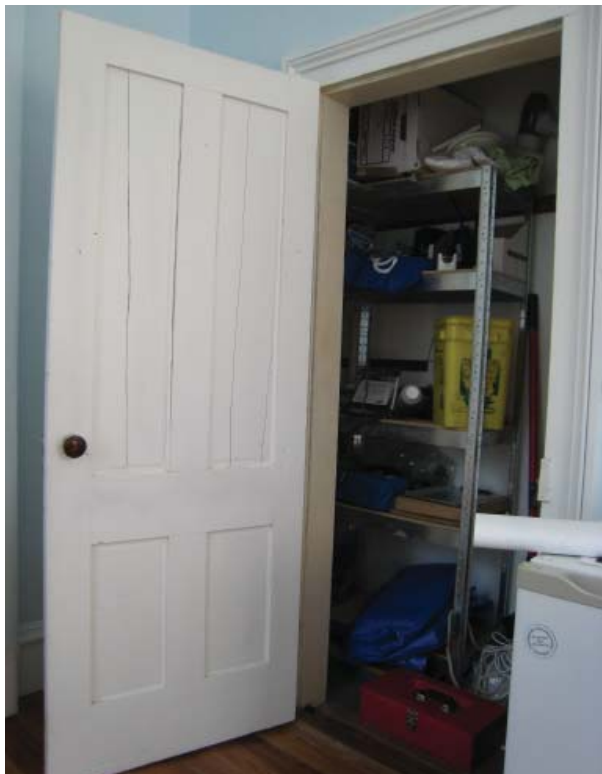
Figure 91, Closet of Room 204-Northwest Office at south wall.

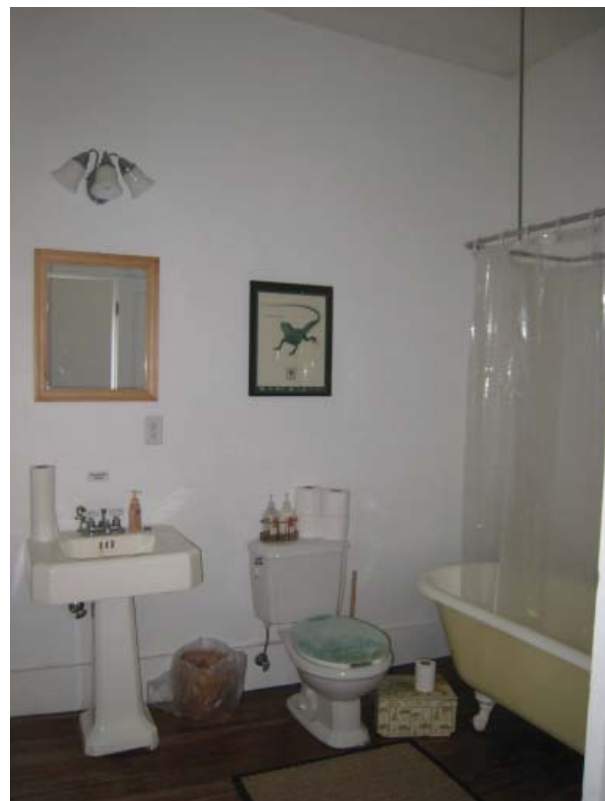
Figure 92, Room 205A-North Bathroom looking south.

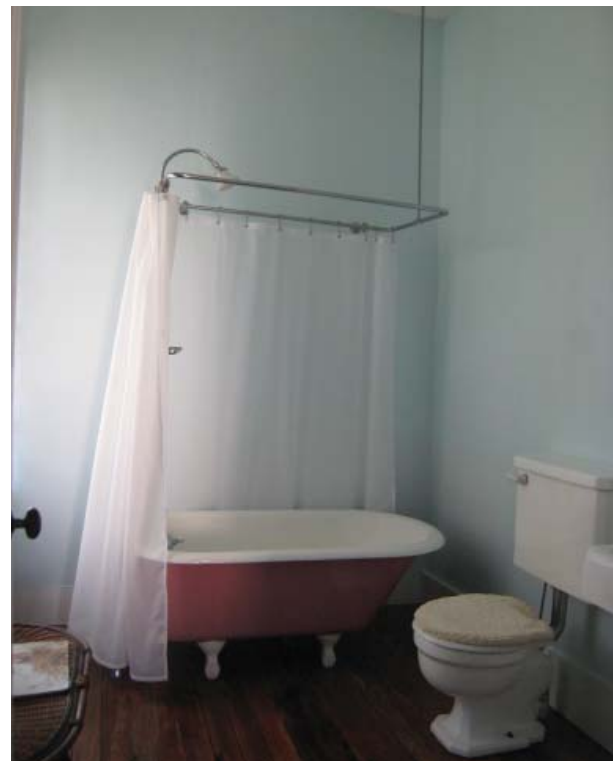
Figure 93, Room 205B-South Bathroom looking west.

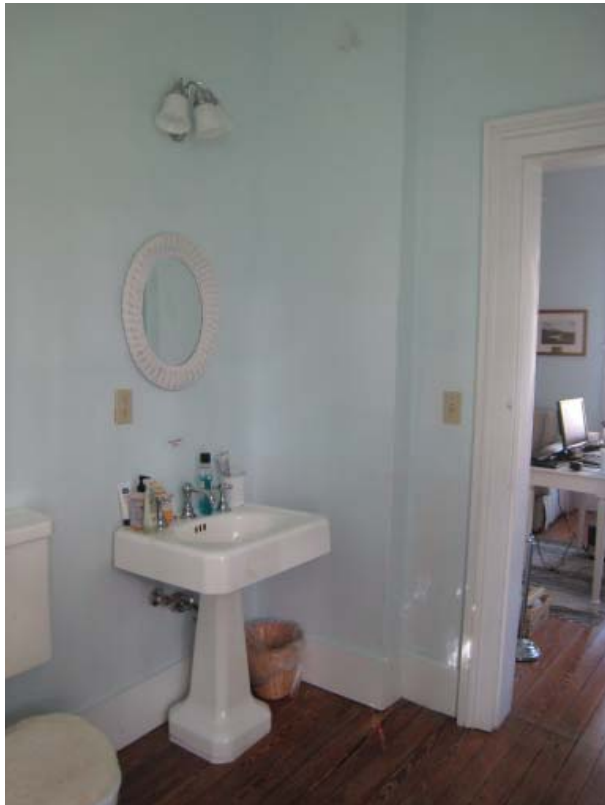
**Figure 94,** Northeast oblique of Room 205B-South Bathroom.

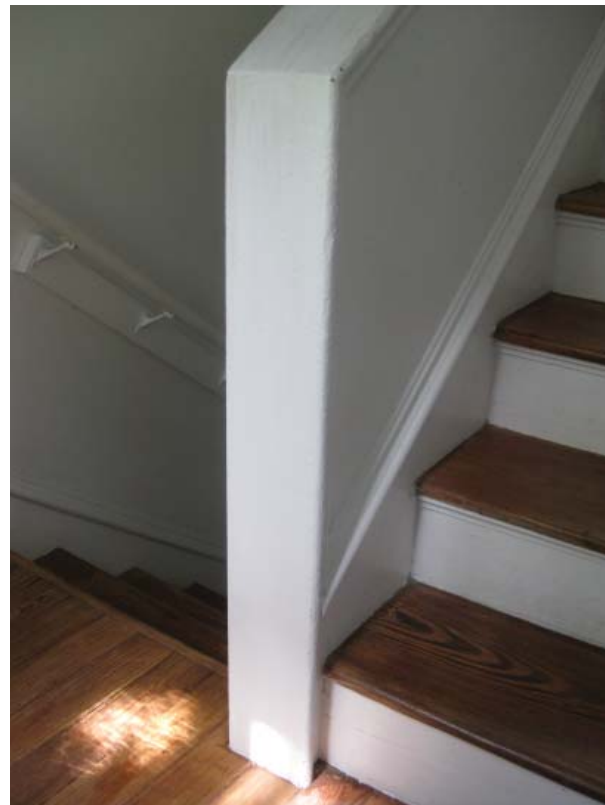
**Figure 95,** Stair wall and stairs of the stairway leading from first to second floor, looking northwest from the landing.

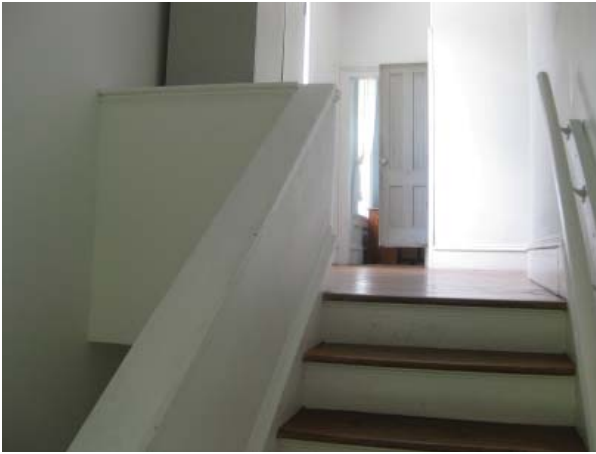
Figure 96, Room 206-Upper Stair Hall looking north.

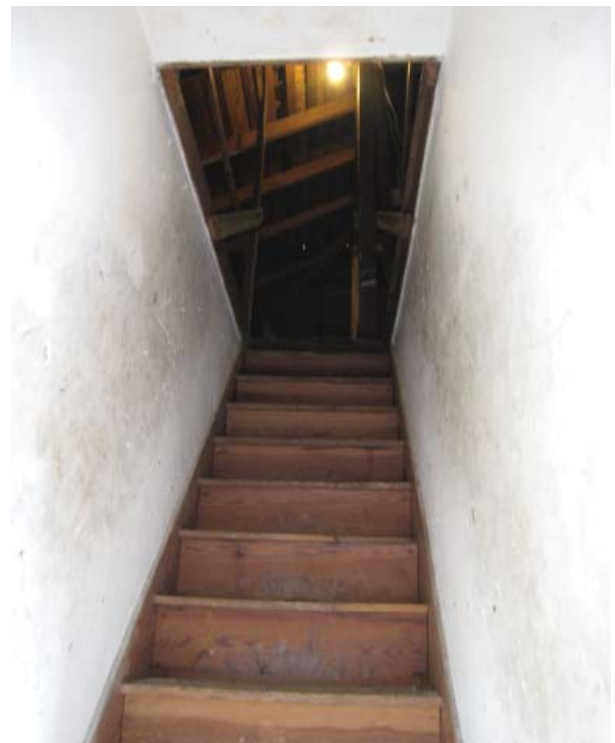
Figure 97, Room 207-Attic Stair Hall facing east.

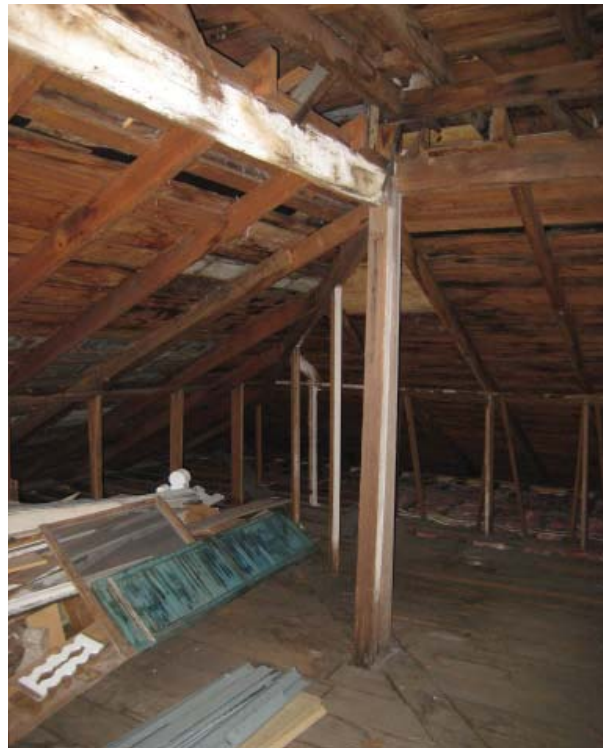
Figure 98, Northwest oblique of the Attic.

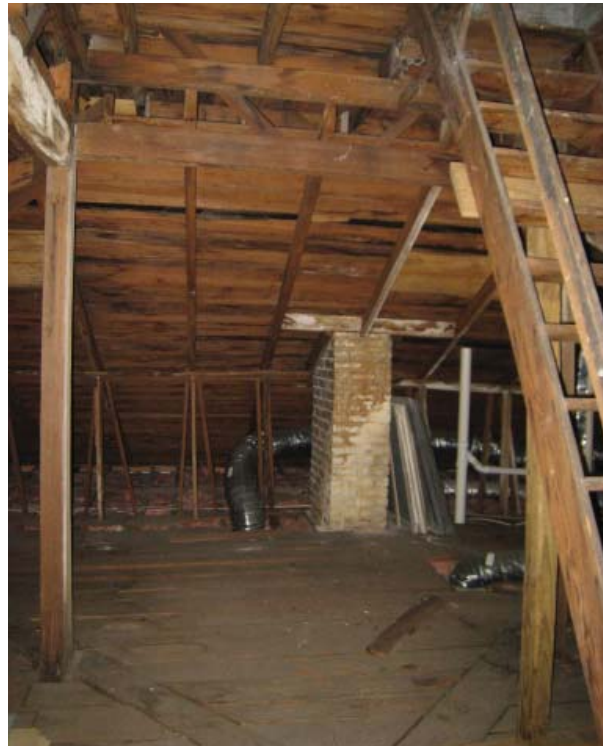
Figure 99, Attic looking south.

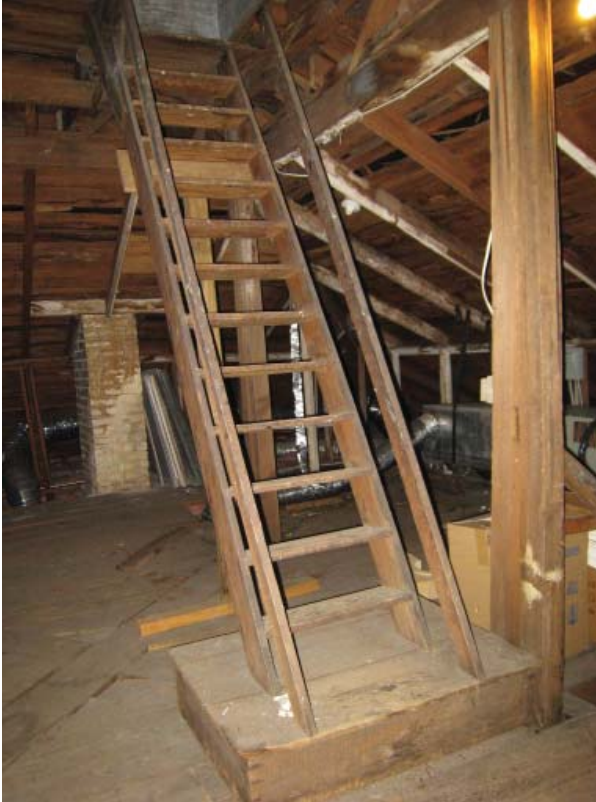
Figure 100, Attic ladder to the widow's walk and cupola.

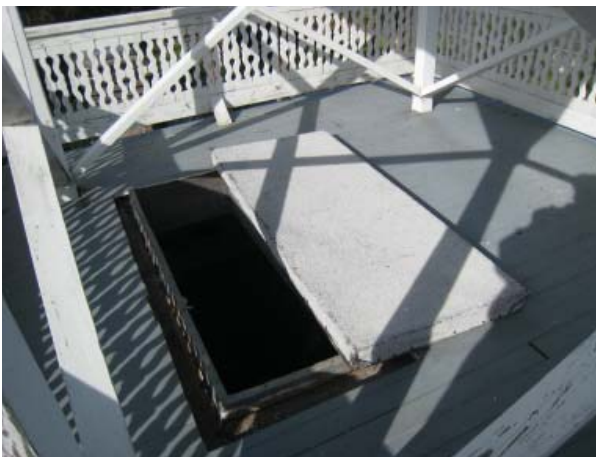
Figure 101, Hatch providing access to the widow's walk and cupola.

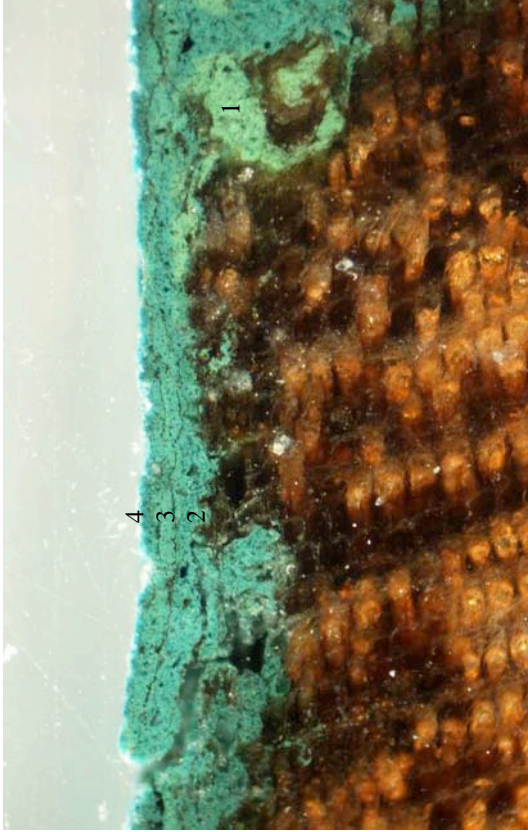
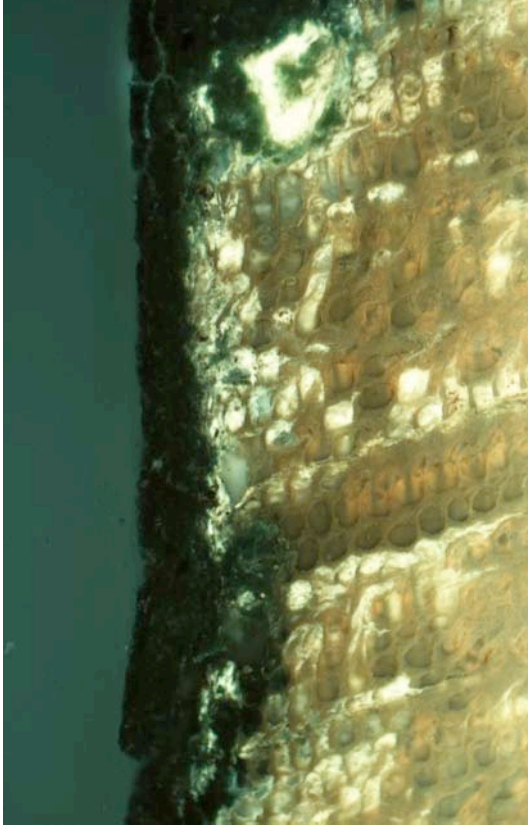
<b>SAMPLE NO:</b>	NBBH.03
<b>LOCATION:</b>	Salvaged shutter, front version

LAYER*	COLOR	NOTES
Substrate	Wood	Surface worn – stripped or weathered
1	Yellow-green	Only traces – seeped into wood substrate
2	Blue-Green	Uneven; does not fluoresce
3	Blue-green	Does not fluoresce
4	Blue-green	Does not fluoresce
5		
6		
7		
8		
9

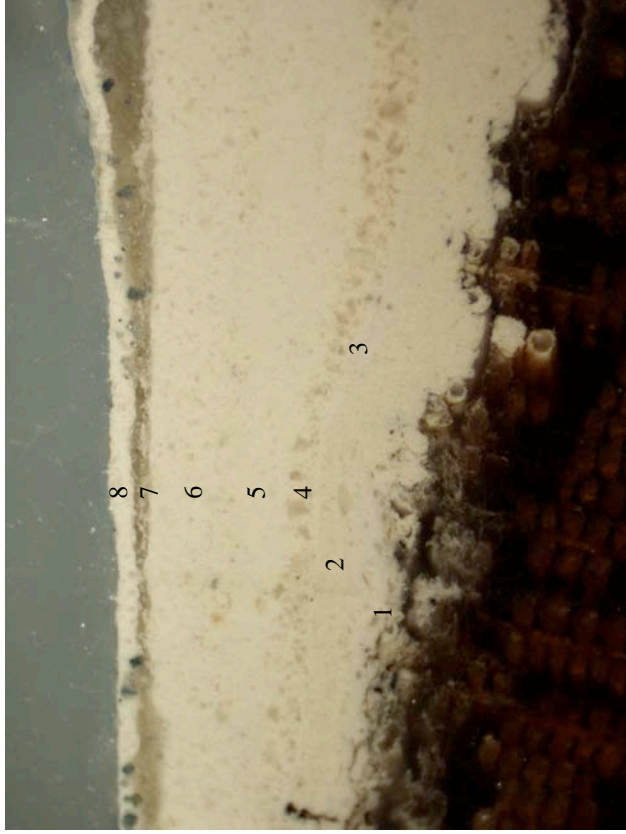
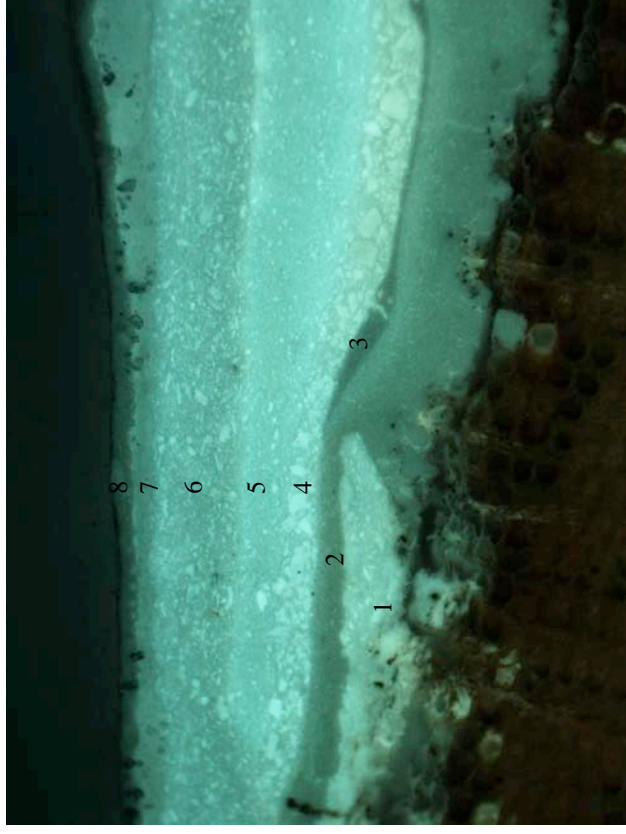
<b>SAMPLE NO:</b>	NBBH.04
<b>LOCATION:</b>	Salvaged fascia at bead

The salvaged fascia and existing porch weatherboards (Samples NBBH.04 and NBBH.43, respectively) exhibited similar stratigraphies. Both samples have 8 layers, all off-whites. Sample NBBH.43 was taken from a corner, so the early layers only exist on part of the sample. Both appear to have an early translucent white layer that is heavily soiled. No colored layers were found in either sample, and likely were always painted a shade of off-white or light cream.

LAYER*	COLOR	NOTES
Substrate	Wood	Looks worn – stripped or weathered
1	White	Partial (visible only in UV); looks seeped into wood
2	White	Looks like it may have separated from wood
3	White	Partial, thin and uneven
4	White	Fluoresces bright white with lots of translucent particles
5	White	Fluoresces bright blue green
6	White	Fluoresces blue green
7	Translucent White	Possible protective coating
8	White	thin
9		
10		
11

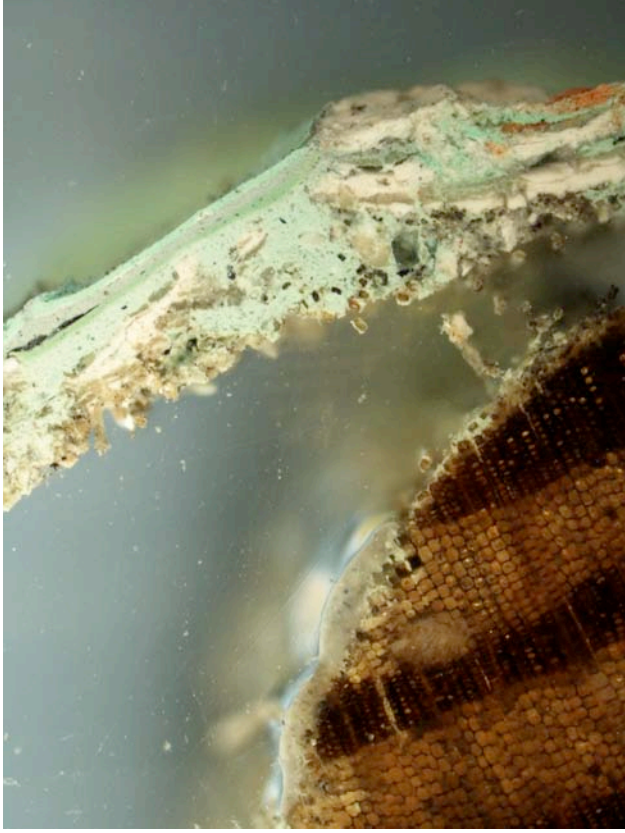
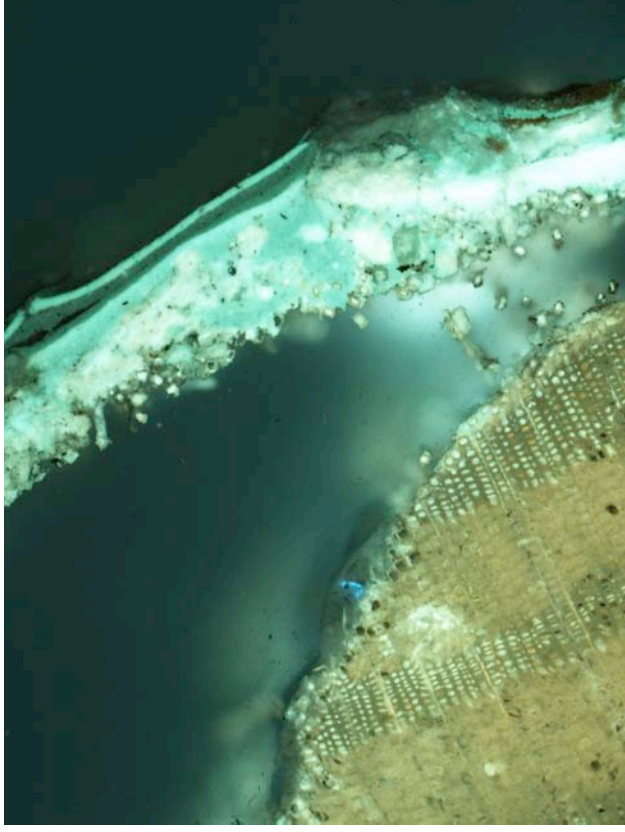
<b>SAMPLE NO:</b>	NBBH.05(1) (1 of 2 pieces of provided sample set)
<b>LOCATION:</b>	Salvaged beaded board

The salvaged beaded board (sample NBBH.05) also has some later green layers, but the green is lighter than the green found on the shutter and fluoresced differently. It has a total of 9 layers. The early layers are off-whites and light gray. The green is found at the fourth or fifth layer. From cross-section examination, it appears that the green leaked through cracks in the early layers and in some places appears to be on the surface of the wood. Examination of the bulk samples revealed that the green is found on most of the surfaces of the wood. However, the damage to the off-white layers indicates that the green had been painted over earlier, exposed paints, and thus does not represent the original color. The earliest finishes are, in fact, off-whites.

LAYER*	COLOR	NOTES
Substrate	Wood	Paint has split from substrate
1	White	Partial
2	Gray	Partial
3	Translucent white	Partial (possible protective coating)
	Dirt/separation	
4	White	
5	Pale green	Leaked down through white layers – difficult to see early layering
6	Green	
	Partial separation	
7	Blue-gray	
8	White	Traces only
	Partial separation	
9	Pale green

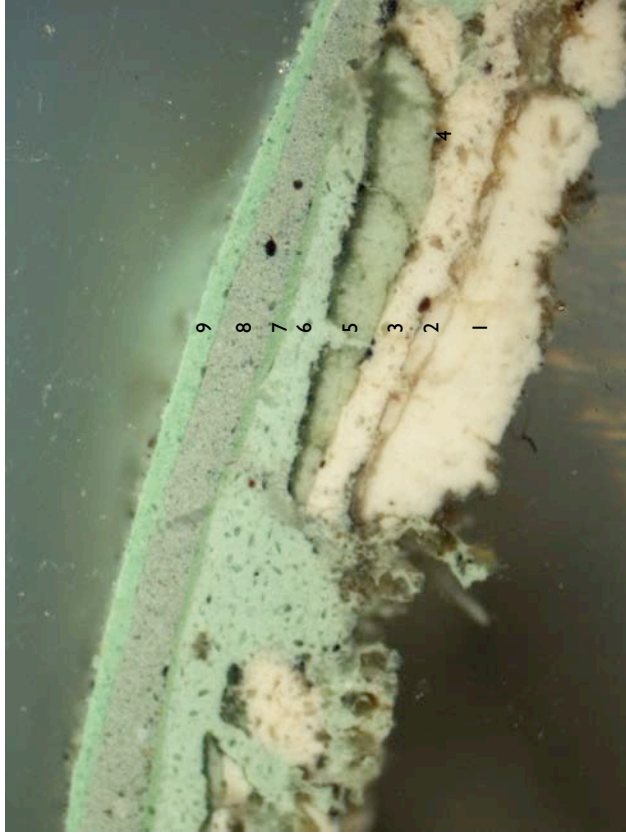
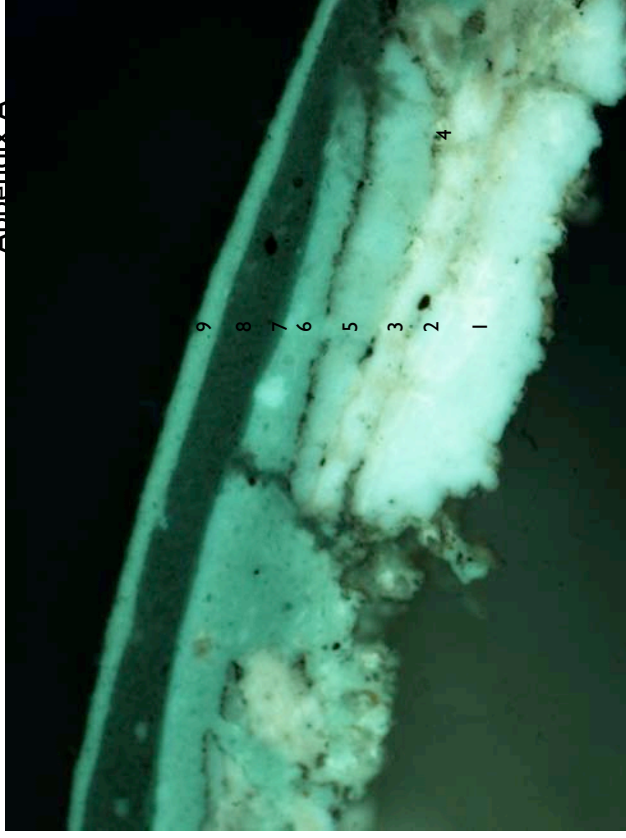
<b>SAMPLE NO:</b>	NBBH.05(2) (1 of 2 pieces of provided sample set)
<b>LOCATION:</b>	Salvaged beaded board

LAYER*	COLOR	NOTES
Substrate	none	
1	White	Partial; cracked – green from layer 5/6 has leaked through
2	White	Partial, thin, worn
3	White	Partial – rough, with lots of cracks and crevices
4	Translucent tan	Possible protective coating; may have leaked into earlier layers
5	Light green	Partial, cracked
6	Pale green	Leaked down into earlier layers
7	Green	thin
8	Blue-gray	
9	Bright green

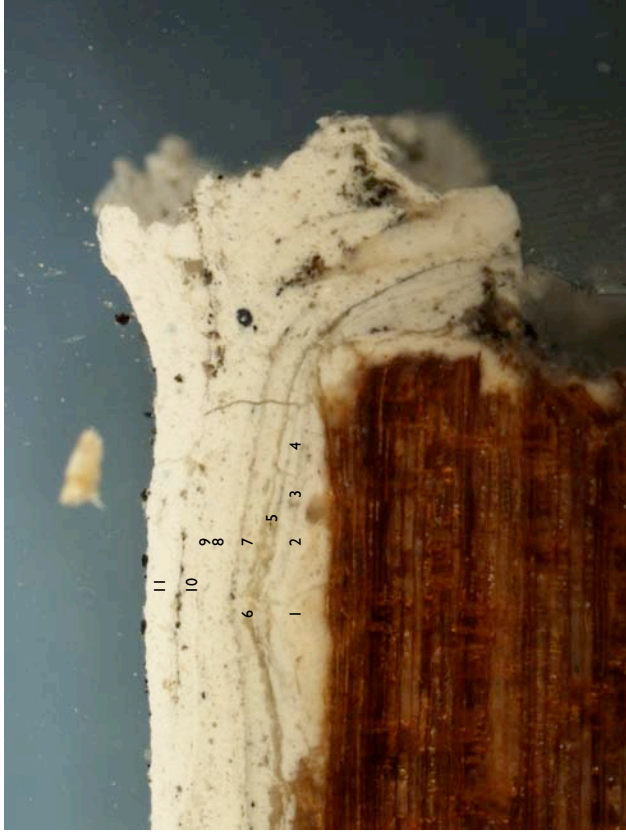
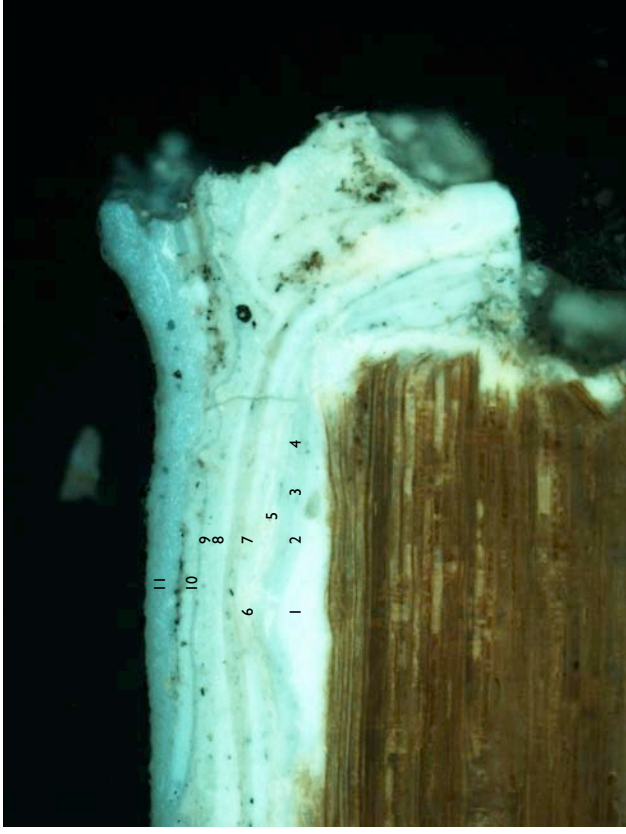
<b>SAMPLE NO:</b>	NBBH.10(1) (1 of 2 pieces set from same sample)
<b>LOCATION:</b>	East elevation, D101, front door transom bar

The front door transom bar (sample NBBH.10) also had many layers of whites and creams. Examination of the bulk sample revealed the resinous tan layer on the surface of the wood, then a layer of white. In cross-section, the previously mentioned resinous light brown coating is visible at later layers and appears to have leaked through to earlier layers and the surface of the wood.

LAYER	COLOR	NOTES
8	Dirt	
9	White	
10	White	
11	Separation	Leak from layer 11
12	White	
13	Dirt	
14	White	
15	White	Leaked down to b/t 15 & 16
16

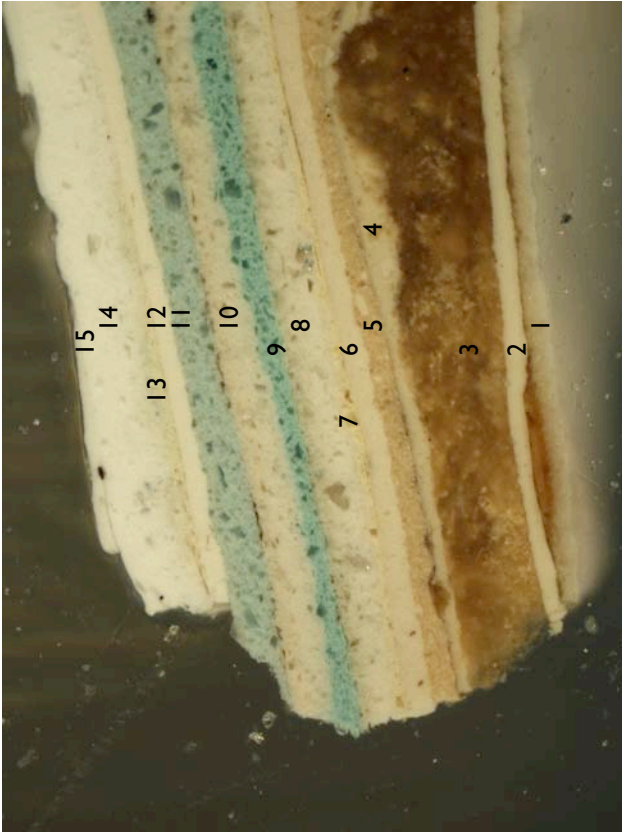
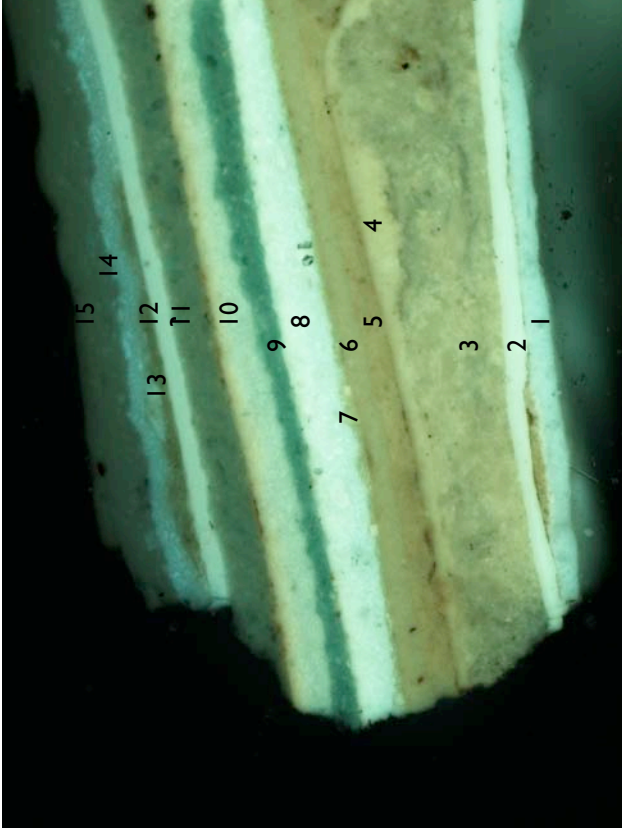
<b>SAMPLE NO:</b>	NBBH.21b
<b>LOCATION:</b>	Room 101, W101 stool, south end

LAYER	COLOR	NOTES
9	Dirt/Discoloration	
10	Blue-green	
11	Cream/white	
12	Dirt/Discoloration	
13	Light blue-green	Partial
14	Cream	Thin
15	Yellow	
16	White	
17	White	
18		
19

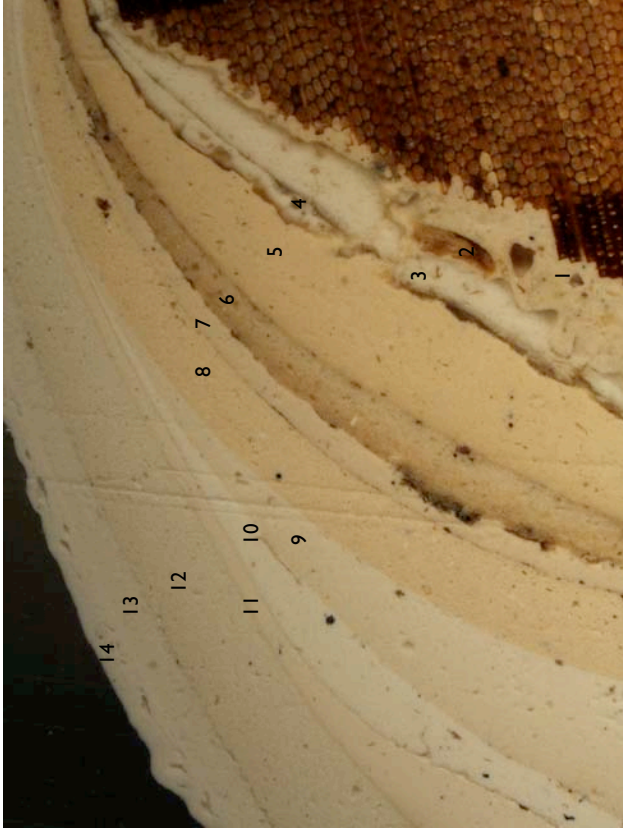
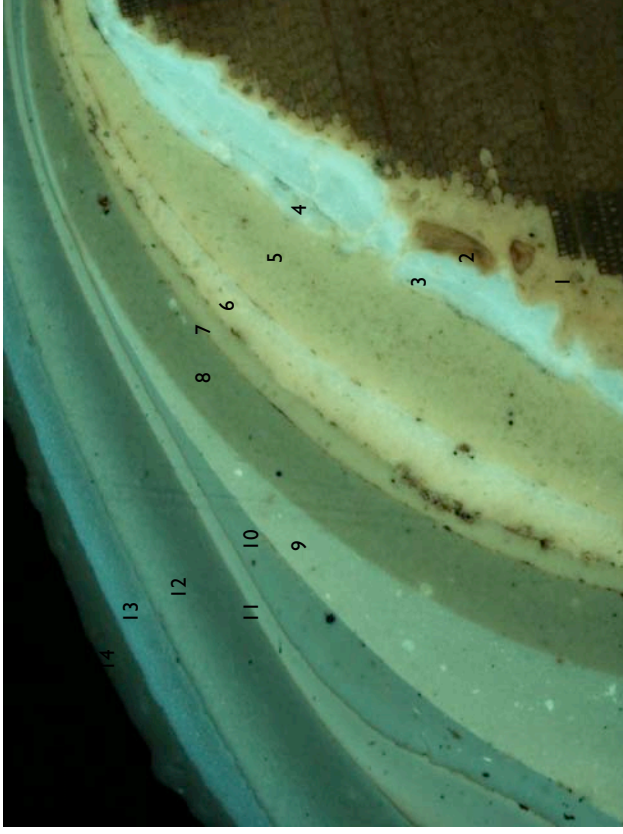
<b>SAMPLE NO:</b>	NBBH.28
<b>LOCATION:</b>	Room 102, front door, interior face of transom

The sample from the front door transom (interior, sample NBBH.28) has many paint layers. All of the layers are off-whites, creams and light tans. The surface of the wood substrate looks distressed (some paint had seeped into the surface), and may have been stripped. The first layer is a light cream, is uneven, and appears to be a finish layer from the dirt on its surface. This layer also has a thin coating of the resinous light brown sealer, which may have leaked from above. The next two layers, both off-whites, appear worn and likely were exposed as finish layers. The next layer, layer 4, is a light tan. This tan is fairly thick and intact. The subsequent layers are all light tans and creams.

LAYER	COLOR	NOTES
	Dirt	
8	Peachy cream	
9	Cream	
	Dirt	
10	Light Cream	
	Dirt	
11	Cream	
	Dirt	
12	Light tan	
	Dirt	
13	White	
14	White

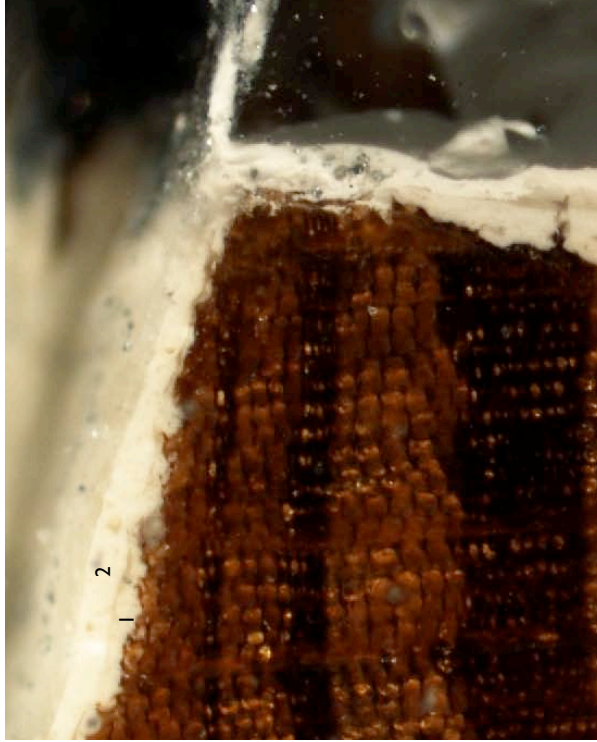
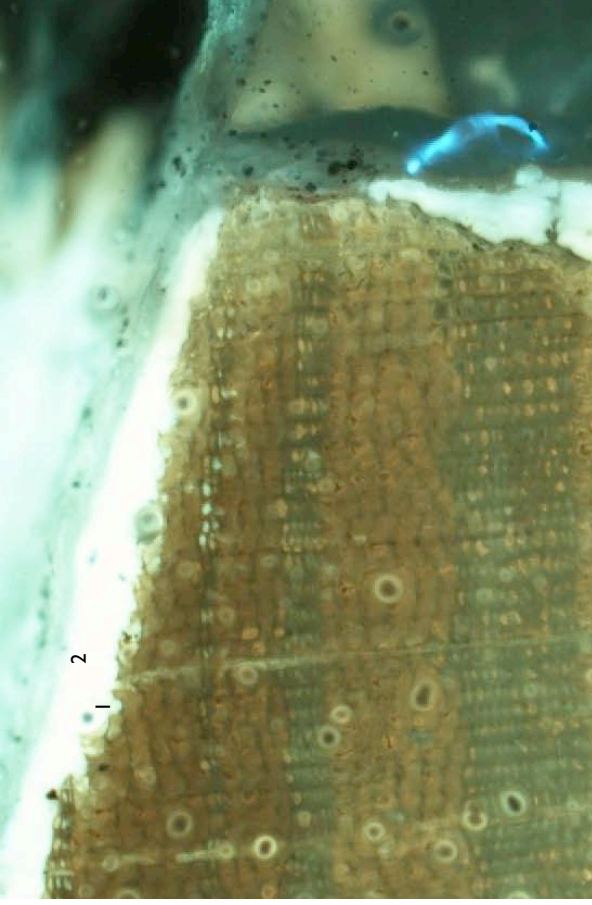
<b>SAMPLE NO:</b>	NBBH.34a
<b>LOCATION:</b>	Room 101, WI09, apron trim at W end

LAYER*	COLOR	NOTES
Substrate	Wood	Looks distressed – possibly stripped; sample separated so set separately
1	Cream	Very thin
	Dirt	
2	Cream	
3		
4		
5		
6		
7		
8		
9		
10

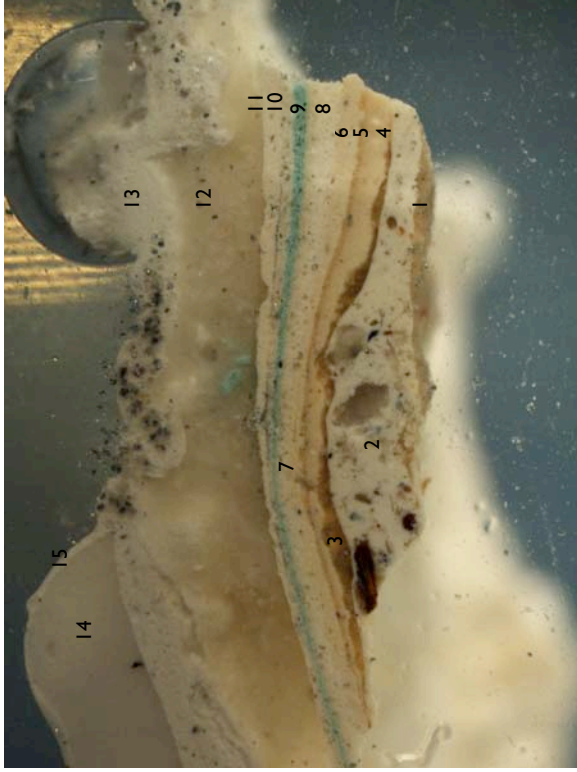
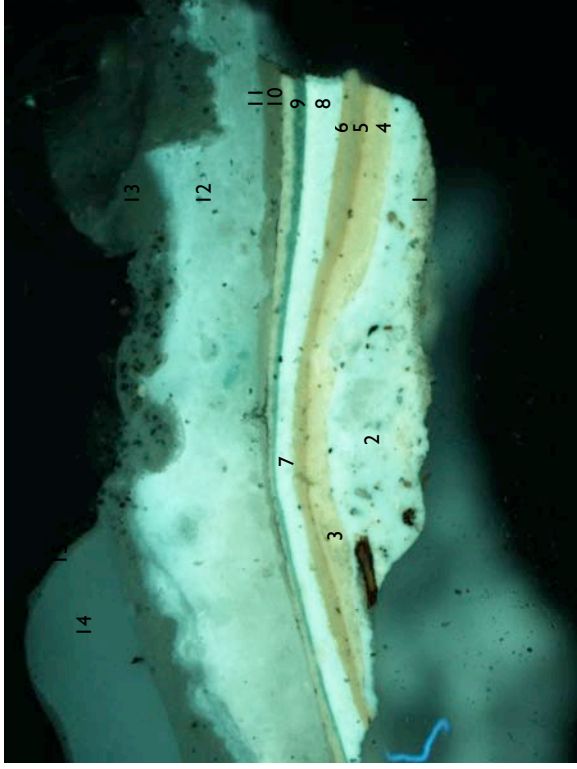
<b>SAMPLE NO:</b>	NBBH.34b
<b>LOCATION:</b>	Room 101, WI09, apron trim at W end

LAYER*	COLOR	NOTES	LAYER*	COLOR	NOTES
Substrate	No substrate		11	Cream	Thin, uneven
1	Cream		12	Dirt/discoloration	
2	Cream		13	Translucent white	Thick, uneven
3	Translucent tan	Possible protective coat	14	White	Thick, partial
4	Cream		15	Translucent white	thin
5	Light tan	Thin		White	
6	Cream				
7	Yellow	Very thin, partial			
8	Cream				
9	Blue-green				
10	White/cream	Thin, uneven			
	Dirt

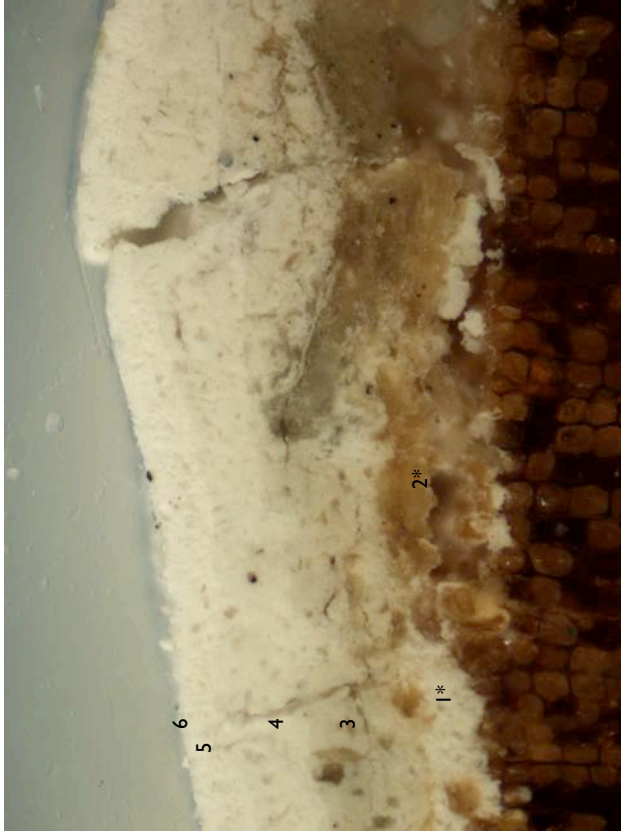
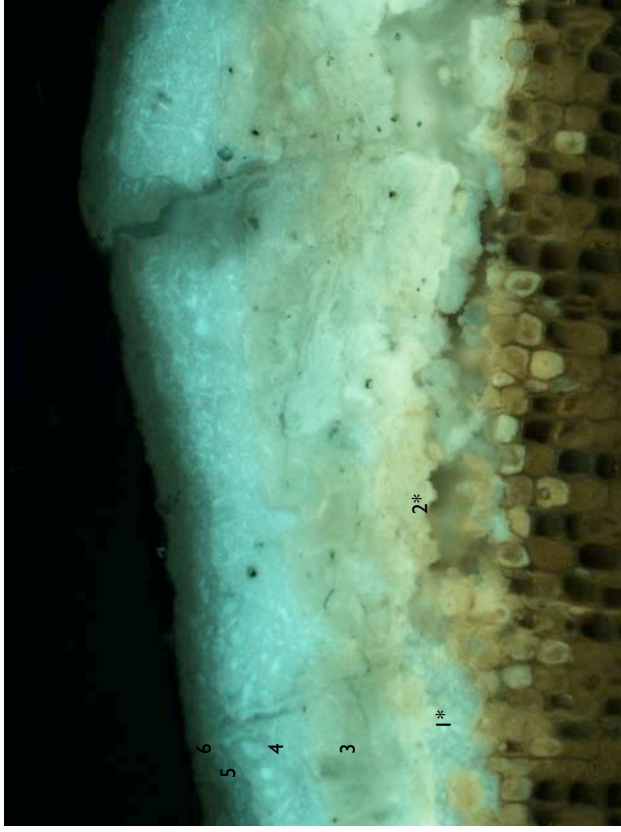
<b>SAMPLE NO:</b>	NBBH.42
<b>LOCATION:</b>	East elevation, W203, bottom sash, interior muntin

The sample removed from the interior muntin of W203 (NBBH.42) contained all creams/whites. The early layers in this sample, however, are distressed, making it difficult to tell which layer is first. The wood substrate appears worn, and may have been stripped. The resinous light brown layer found in other samples was also seen on the surface of the wood and between layers, suggesting its use as a preparatory sealer layer in later re-painting campaigns.

LAYER*	COLOR	NOTES
Substrate	Wood	Worn – likely stripped
1	Off-White*	Partial - difficult to tell if layer 1 or 2
2	Translucent tan*	Uneven, partial – looks like it seeped into wood substrate – difficult to tell if layer 1 or 2
3	Off-White	
4	Off-White	
5	White	
6	White	
7		
8		
9		
10		
11

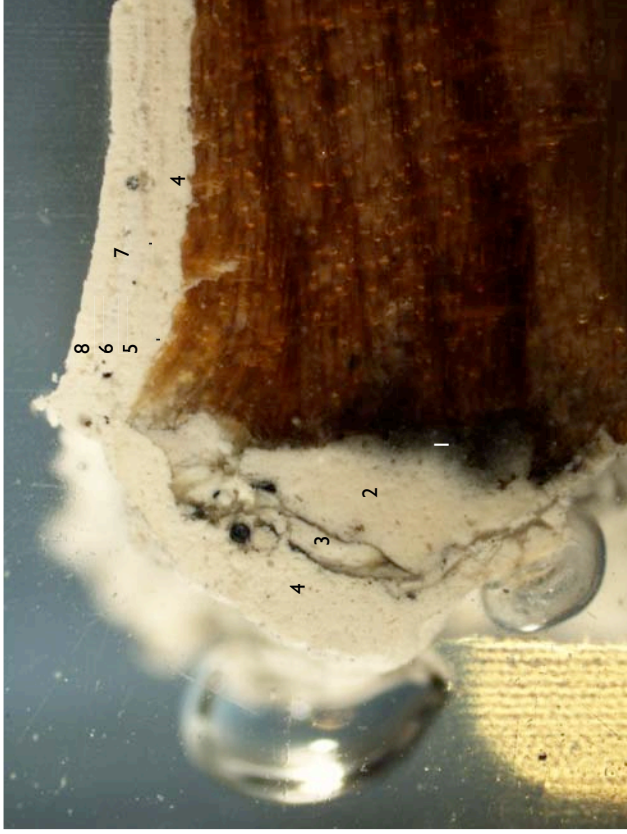
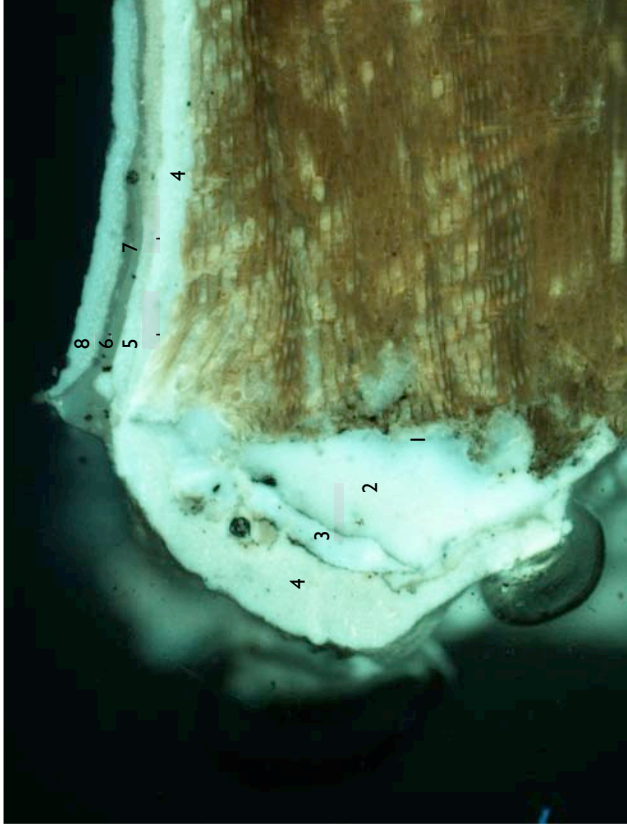
<b>SAMPLE NO:</b>	NBBH.43
<b>LOCATION:</b>	East elevation, porch weatherboards

LAYER*	COLOR	NOTES
Substrate	Wood	Weathered/
1	Translucent white/brown	Discolored – fluoresces yellowish; only on one side of sample
2	Cream/White	Only on one side of sample; thick but uneven
	Dirt	
3	Cream/White	Only on one side of sample
	Dirt	
4	Cream/White	
5	Cream/White	
6	Light cream	
7	Cream/White	Very thin; partial
8	Cream/White	
9
