**Timucuan Ecological and Historic Preserve**

**Napoleon Bonaparte Broward House**

**Historic Structure Report**

March 2010

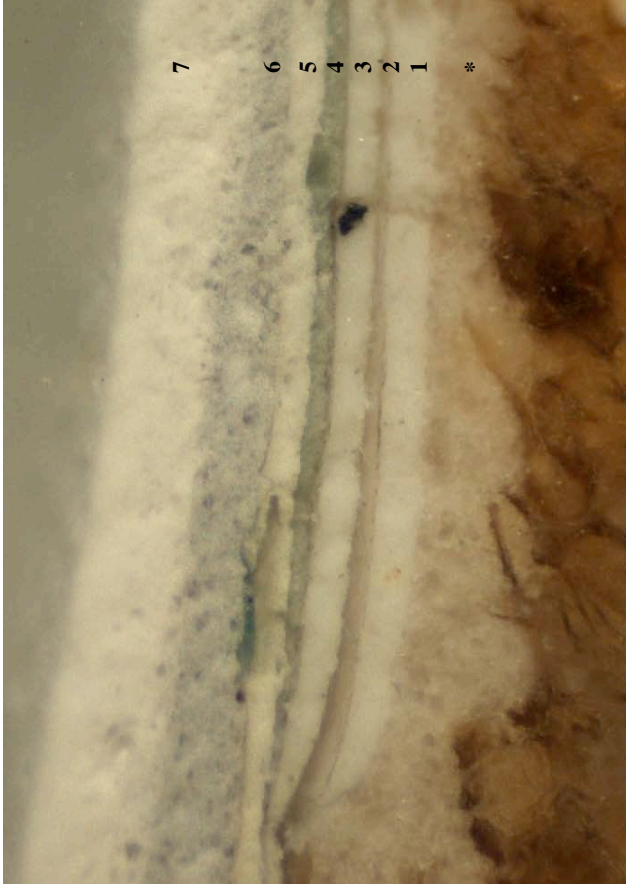
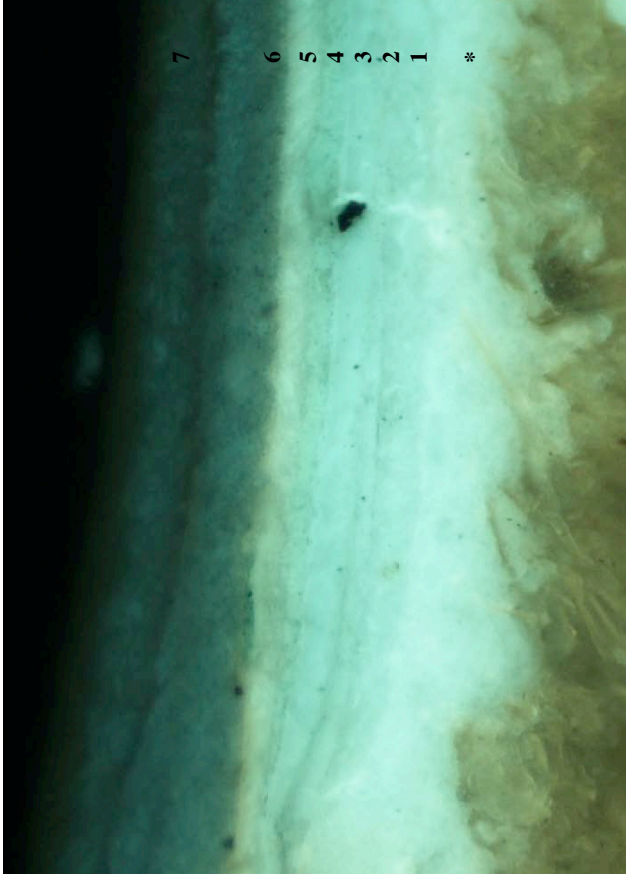
<b>SAMPLE NO:</b>	NBBH.45
<b>LOCATION:</b>	Room 203, W203, bottom sash interior muntin

LAYER*	COLOR	NOTES
Substrate	Wood	
1	White	
	Dirt	
2	Translucent tan	Possible protective coating; seeped in below layer 1
	Dirt	
3	White	
	Dirt	
4	Green	
5	White	
6	Blueish-gray	
7	White

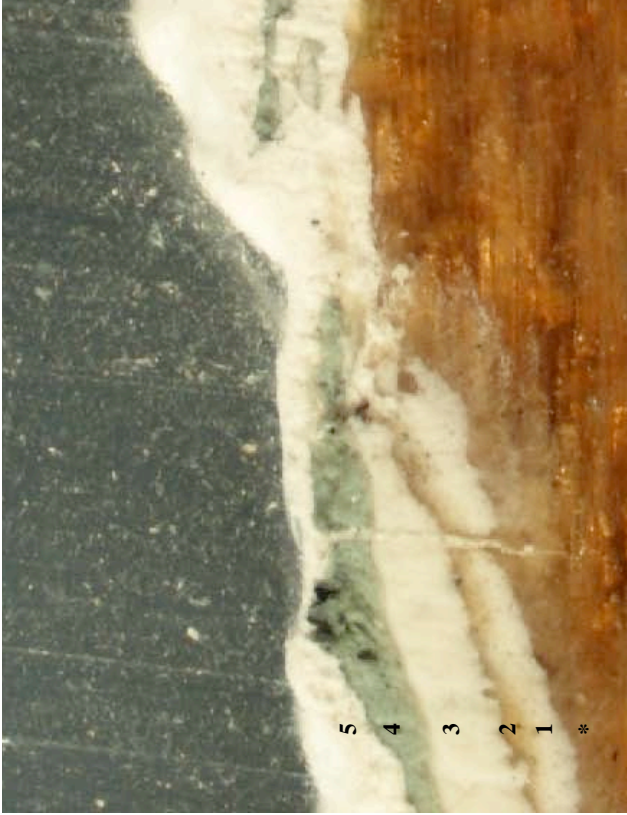
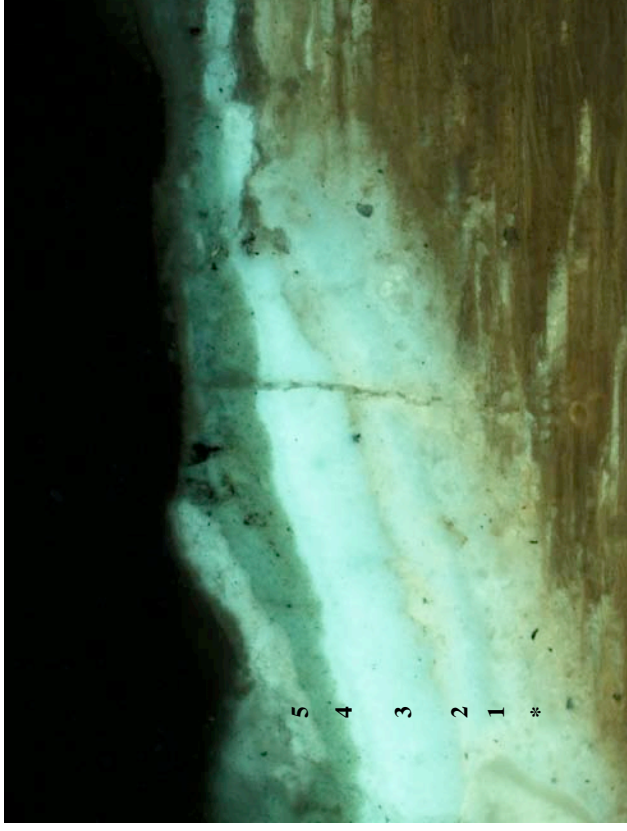
<b>SAMPLE NO:</b>	NBBH.46
<b>LOCATION:</b>	Room 203, W205, east stile, interior

LAYER*	COLOR	NOTES
Substrate	Wood	
1	White	
2	Translucent tan	Possibly protective coating; seeped into earlier layer and through fracture
3	White	
	Dirt	
4	Pale green	
5	White	
6		
7		
8		
9		
10

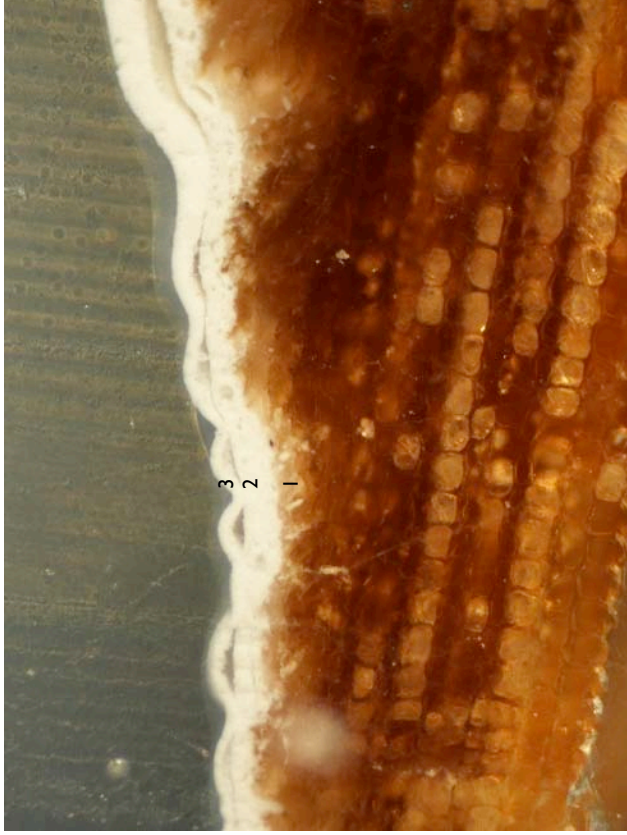
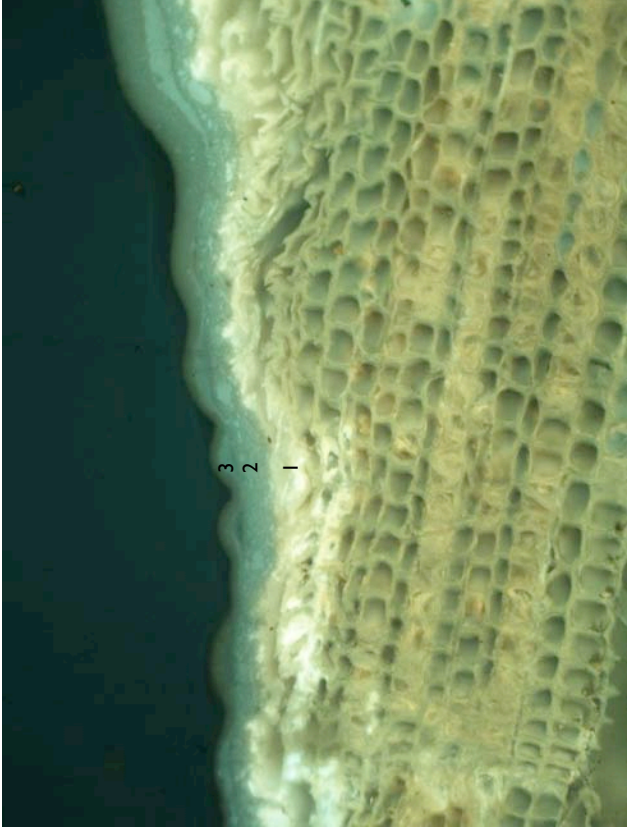
<b>SAMPLE NO:</b>	NBBH.47
<b>LOCATION:</b>	Room 202, W208, bottom sash interior, N stile at meeting rail

Given the lack of evidence in sample NBBH.47, it is impossible to tell if the window sash in W209 are original. Samples NBBH.47 and 50, however, have similar stratigraphies, sharing several early off-whites and a common light yellow at layer 4. However, sample NBBH.48 does not have the thin tan layer seen in 50. In addition, the distressed substrate in both samples suggests that the earlier paint layers may be missing.

It should also be noted that Sample NBBH.47 contains remnants of a very thin, resinous layer that has seeped into the surface of the wood. This resinous layer, which is clear and light brown in color, was seen in many samples removed from both the interior and exterior. It is not always found directly on the wood's surface, sometimes appearing later in the layering sequence. This layer appears to be a clear coating that was applied as a sealer over weathered or otherwise distressed surfaces before re-painting.

LAYER*	COLOR	NOTES
Substrate	Wood	Surface distressed – likely stripped
1	Translucent tan/cream	Thin, seeped into wood
2	White	Looks modern
3	Separation	
4	White	Looks modern
5		
6		
7		
8		
9		
10

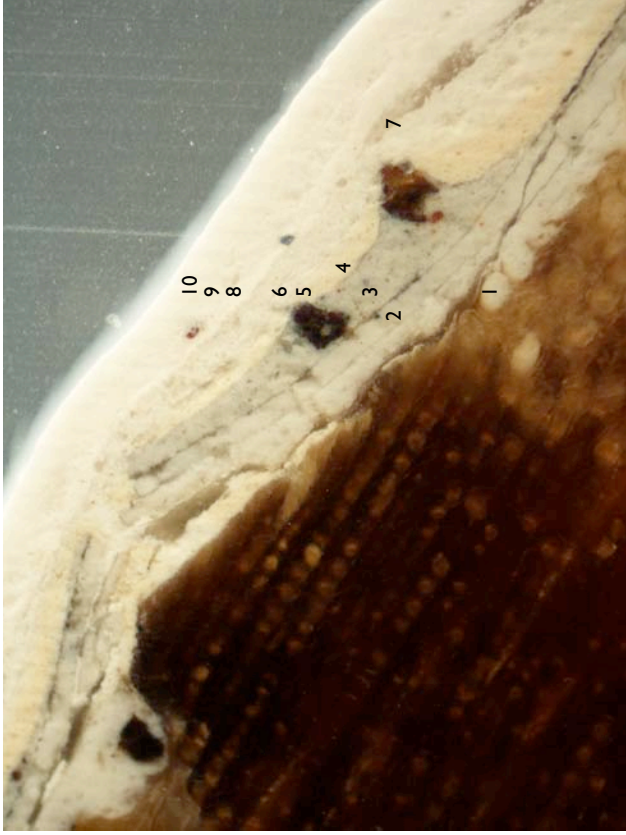
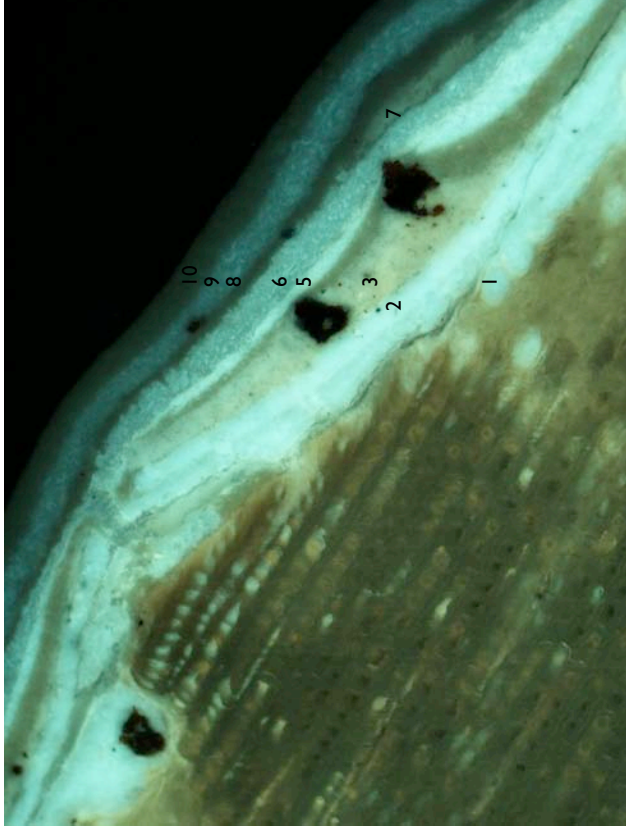
<b>SAMPLE NO:</b>	NBBH,48
<b>LOCATION:</b>	Room 202, W208, backband, E top corner

In general, the paint layering sequences for sample NBBH.48 and 50 appear to be the same. The samples have approximately the same number of layers, but the substrates in both samples appeared distressed, and may be missing earlier layers.

LAYER*	COLOR	NOTES
Substrate	Wood	Looks distressed – possibly stripped
1	Off-white	Partial; uneven; distressed (cracked); fluoresces bright white
2	Dirt	
2	Off-white	Uneven, distressed (cracked); fluoresces bright white
3	Dirt-separation	
3	Grayish-white	uneven
4	Dirt/separation	
4	Light yellow	Doesn't fluoresce
5	White	
6	White	
7	Translucent white	partial
8	White	Doesn't fluoresce
9	White	Fluoresces blue-green
10	White	Doesn't fluoresce

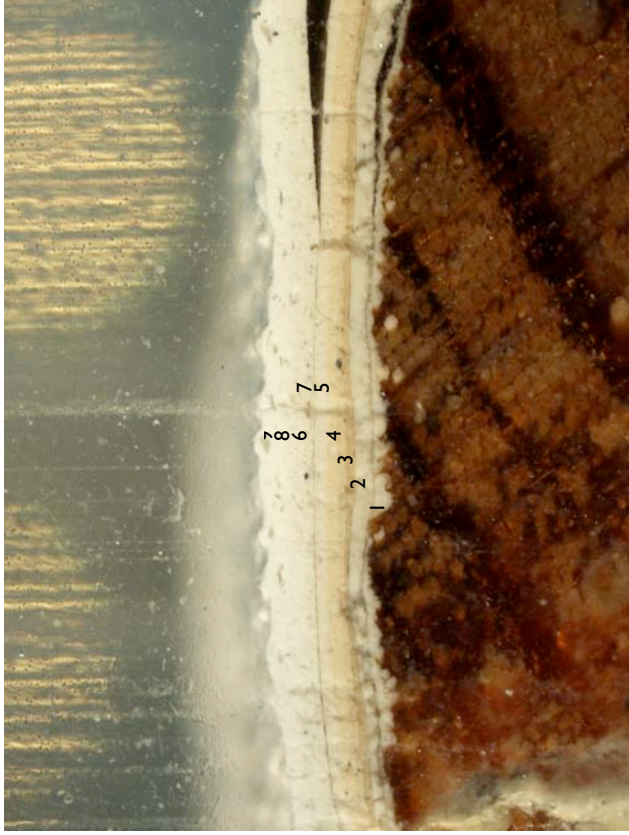
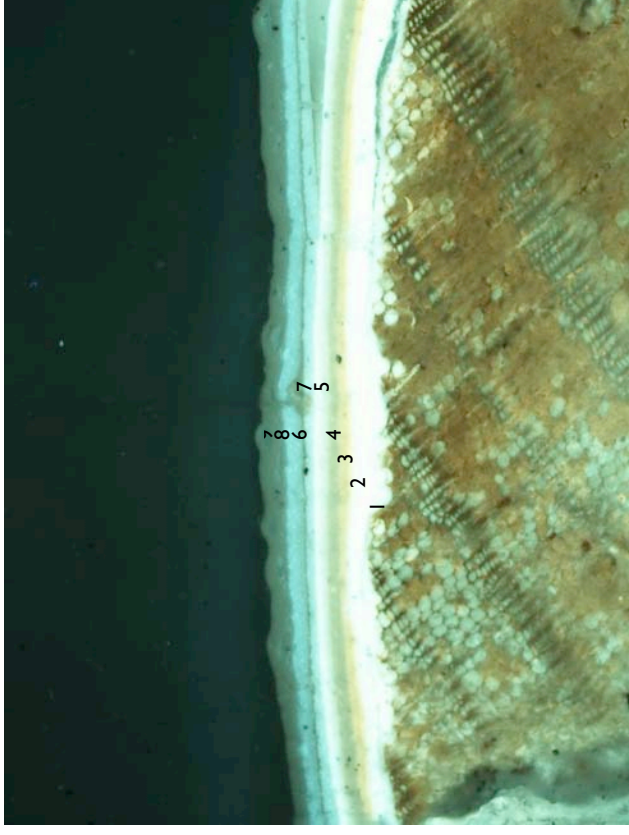
<b>SAMPLE NO:</b>	NBBH.50
<b>LOCATION:</b>	VV209, interior casing backband, E top corner

The sample from the interior window casing of W209 (NBBH.50) also shows some distress at the substrate. It has approximately nine layers. The first layer is off-white, and is very thin. There is dirt and separation between the paints after this layer, indicating that this first layer may have been a finish layer. The next layer is also off-white with a dirt layer, probably another campaign. The next layer is tan and thin. The tan is similar to the tan found at layer 5 in samples NBBH.34 and NBBH.21 (also interior window casing, but on the first floor). However, the tan layer here is the third layer. After the thin tan layer is a light yellow/tan, followed by several more off-whites.
