**WASHINGTON MONUMENT AND ASSOCIATED STRUCTURES
HISTORIC STRUCTURE REPORT**

VOLUME II – MONUMENT LODGE

FINAL REPORT

PREPARED BY
John Milner Associates, Inc.
ARCHITECTS • ARCHEOLOGISTS • PLANNERS • LANDSCAPE ARCHITECTS
535 NORTH CHURCH STREET
WEST CHESTER, PENNSYLVANIA 19380
(610) 436-9000

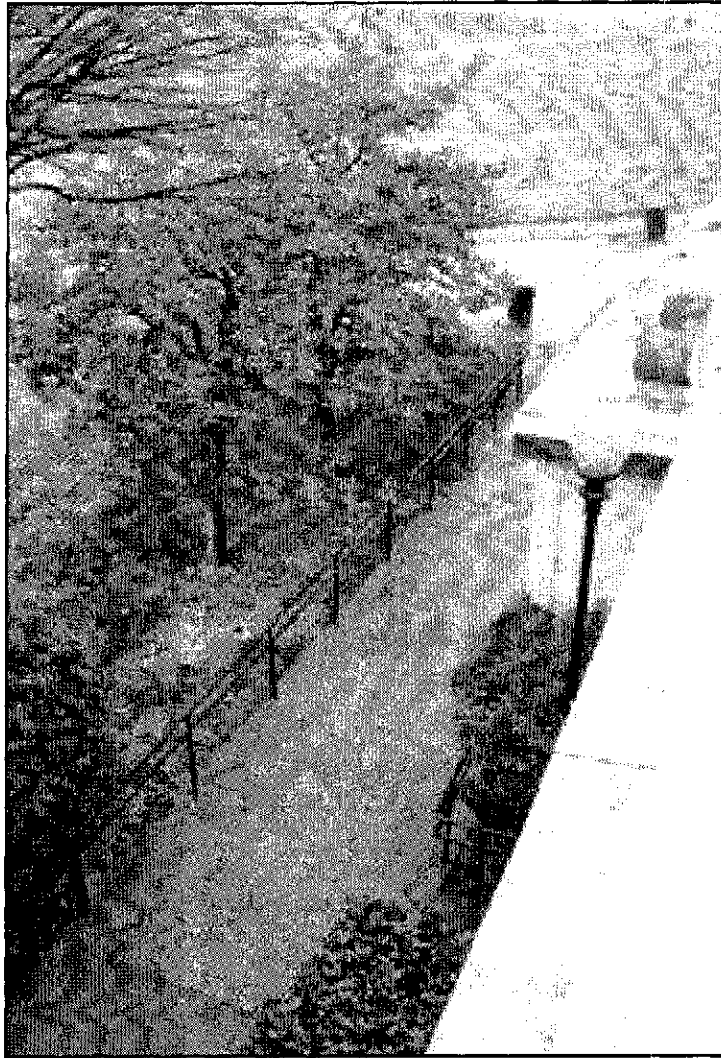
Figure 4.5: Monument Lodge, site, southwest corner.

Monument Lodge is edged with sidewalks serving the public and service entrances. The sidewalks exhibit several periods of construction and later repairs. A slab-on-grade, exposed-aggregate concrete sidewalk with 2-foot modules dating from 1931 marks the east side. Just beyond this concrete sidewalk, towards 15th Street, the path is paved with asphalt. The entrance to the souvenir shop, located on the east, has been made handicap accessible with a wood deck access ramp that bridges the 1889 granite steps and modulated concrete sidewalk (see figure 4.1). At the northeast corner of Monument Lodge, the modulated, exposed aggregate sidewalk meets smooth concrete paving with control joints (see figure 4.2). The smooth concrete sidewalk ends at the northeast corner of the Concession Addition. From this point, a remnant of the 1931 exposed aggregate concrete sidewalk with 2-foot modules continues to the northwest corner of the Concession Addition (see figure 4.3). The west side of the Concession Addition, under the porch roof, is paved with slab-on-grade concrete with 3-foot by 2-foot modules (see figure 4.4). At the southwest corner of the Concession Addition, the 1931 exposed aggregate concrete sidewalk with 2-foot modules starts again and runs to the middle of the Concession Addition on the south side. From here to the women's rest room entrance, the paving is exposed aggregate concrete with control joints (see figure 4.5). From the women's rest room entrance, the sidewalk

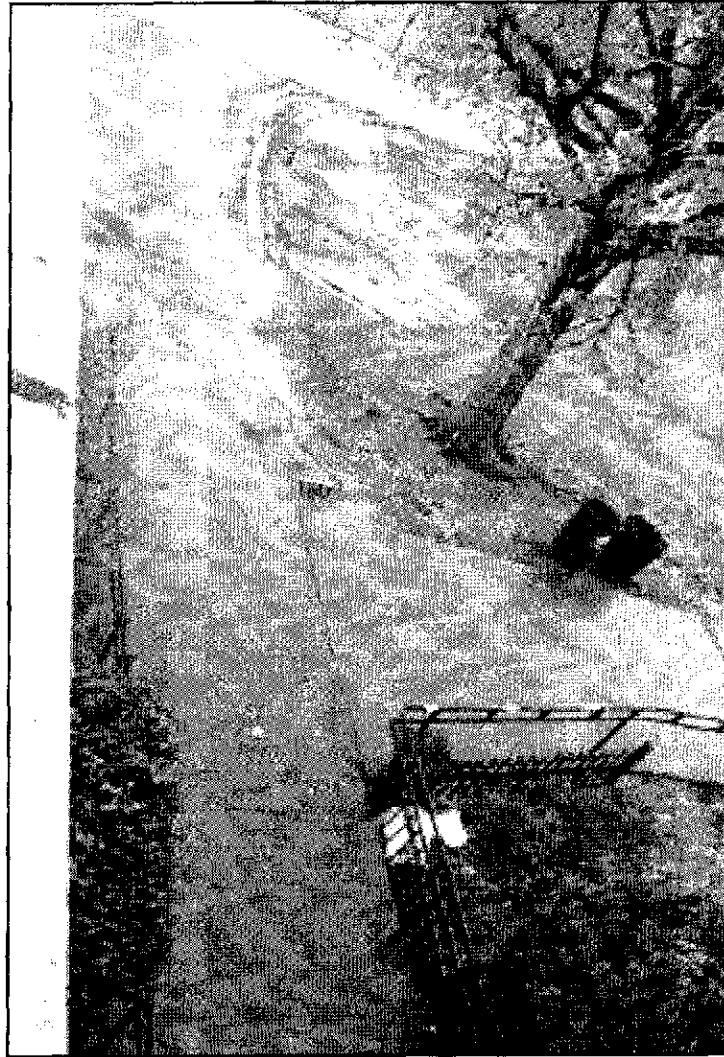
Figure 4.6: Monument Lodge. site, southeast corner.

is smooth concrete with control joints, which continues to the modulated, exposed aggregate concrete sidewalk at the southeast corner of Monument Lodge (see figure 4.6).

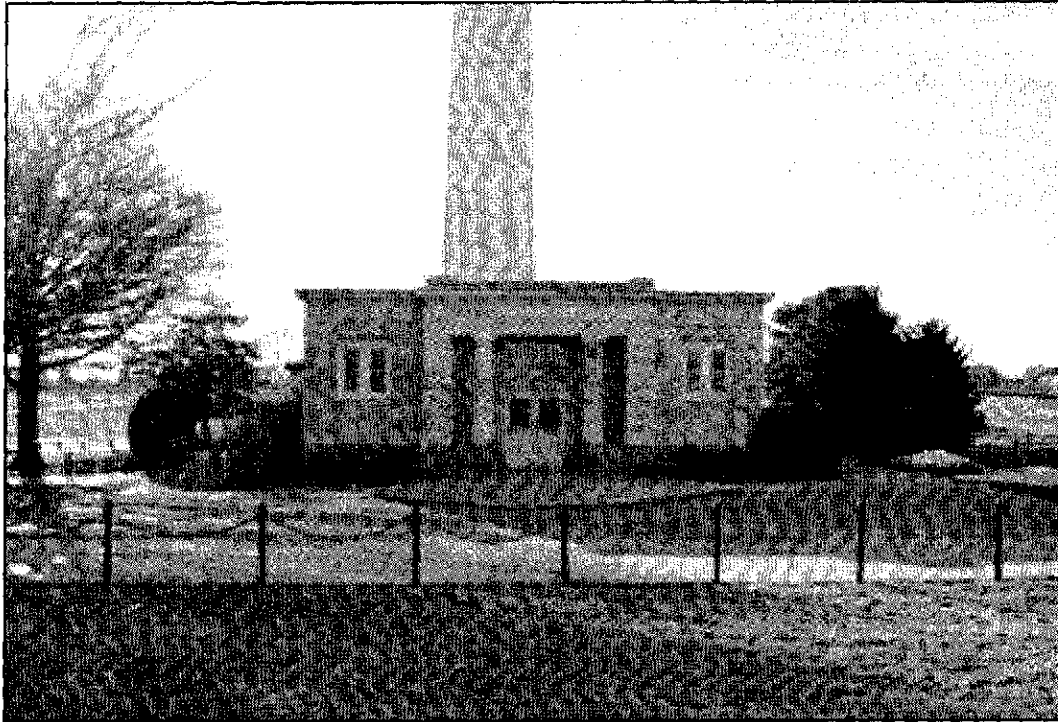
Figure 4.7: Monument Lodge, east façade.

The main east façade has three bays consisting of a slightly projecting central porch flanked by window bays (see figure 4.7). Two partially fluted Doric columns support the central porch, which is the main entrance to the souvenir shop. The east porch is further emphasized by a low parapet wall above the east entrance with rectangular blocks at either end. Two granite steps, now covered by the wood handicap access ramp, lead up to the porch. Yellow brick pointed with red-colored mortar is exposed on the inner walls of the porch; a yellow brick segmental vault forms the porch ceiling. At the underside of the brick vault, a bare bulb light in a metal cage fixture lights the portico. Diamond-shaped, 1½-foot-square marble tiles pave the porch threshold (see figure 4.8). The east entrance to the souvenir shop has two sets of double doors with an 18-light transom above. The transom is covered with a metal grille in a circular design. The exterior set of double doors consists of modern metal doors with large glass panels. The inner double doors date to 1889 and are faux-grained varnished wood with 12 raised panels, each fitted with

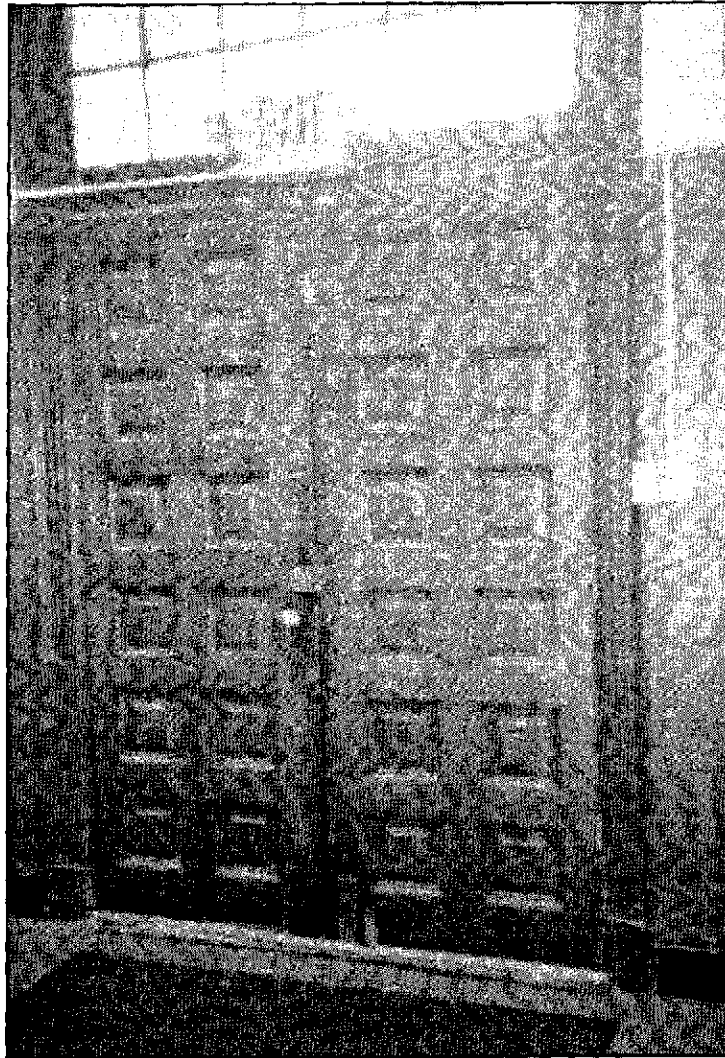
Figure 4.9: Monument Lodge, interior, souvenir shop, east entrance doors closed.

1889 bronze hinges, doorknobs, and kick plates, and a modern bolt lock (see figure 4.9). The windows in the flanking bays are set over large rectangular, raised-panel stone slabs set in the wall. Each window bay consists of two, 1-over-1, double-hung wood windows set in wood trim and bordered by fluted wood pilasters and, finished white with a projecting stone sill. The panes are clear glass above and obscured glass below (see figure 4.10). The wood window sash dates to the 1971 renovation while the window trim and decorative pilasters date to 1889.

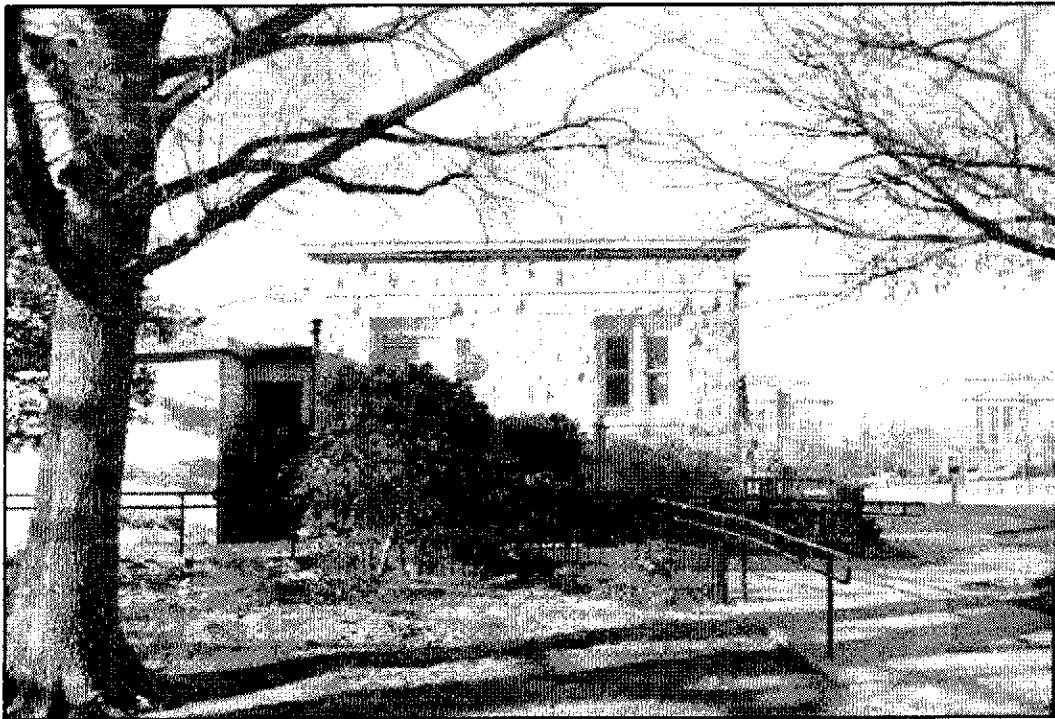
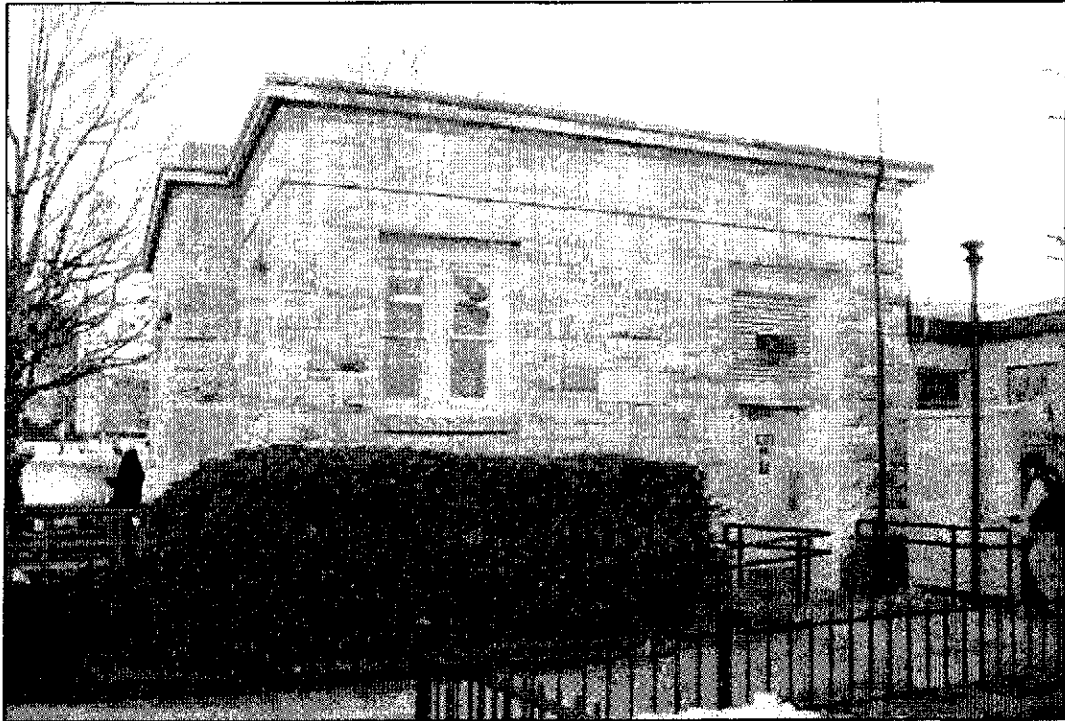
The two-bay north and south facades are nearly mirror-images of each other containing similar detailing (see figures 4.11 and 4.12). However the grade on the north façade is slightly lower than on the south. Each has a bay of twin windows to the east, identical to those found on the east façade, and a rest room entrance to the west. The rest room entrances, mens' on the north and womens' on the south, have a raised panel, metal door with brushed aluminum entrance hardware and kick plate, with a fixed, louvered wood panel above, all finished white (see figure 4.13). The louvered panel over the door is bordered by shortened, fluted wood pilasters, similar in detail to those located at the window surrounds. A rectangular light fixture is fixed to the center of each louver panel. The entrances were opened in 1931, but the current doors date to 1995–2003. The wood trim, including the wood pilasters, was constructed of salvage material from the 1889 windows and was installed in 1931. The wood louvers were installed during 1995–2003. The north façade has an iron coal door dating to 1889 that is set at the foundation level just to the east of the entrance to the mens' rest room (see figure 4.14).

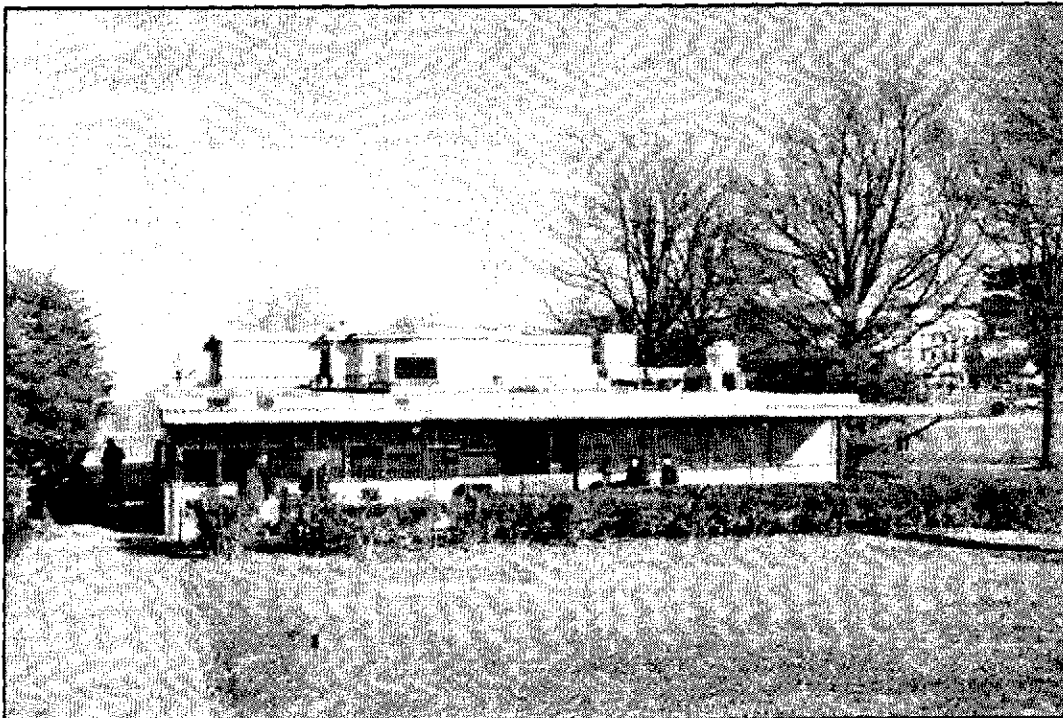
Figure 4.15: Monument Lodge, west façade overall.

The west façade of Monument Lodge is almost entirely obscured by the 1963 Concession Addition (see figure 4.15). The addition was built directly against the west façade with its projecting bay, leaving the upper portion of the original lodge structure exposed. The upper portion of the original window openings, partially exposed, has been blocked up or stuccoed over. Flashing for the Concession Addition roof has been cut into existing joints in the lodge masonry (see figure 4.16). Circular scuppers are located on either side of the projecting bay; the scuppers drain the Monument Lodge roof through short pipes. The south scupper drains directly onto the roof of the Concession Addition (see figure 4.17). A PVC hose, supported by a bucket, is attached to the pipe at the north scupper (see figure 4.18). The hose directs water towards the center of the Concession Addition roof.

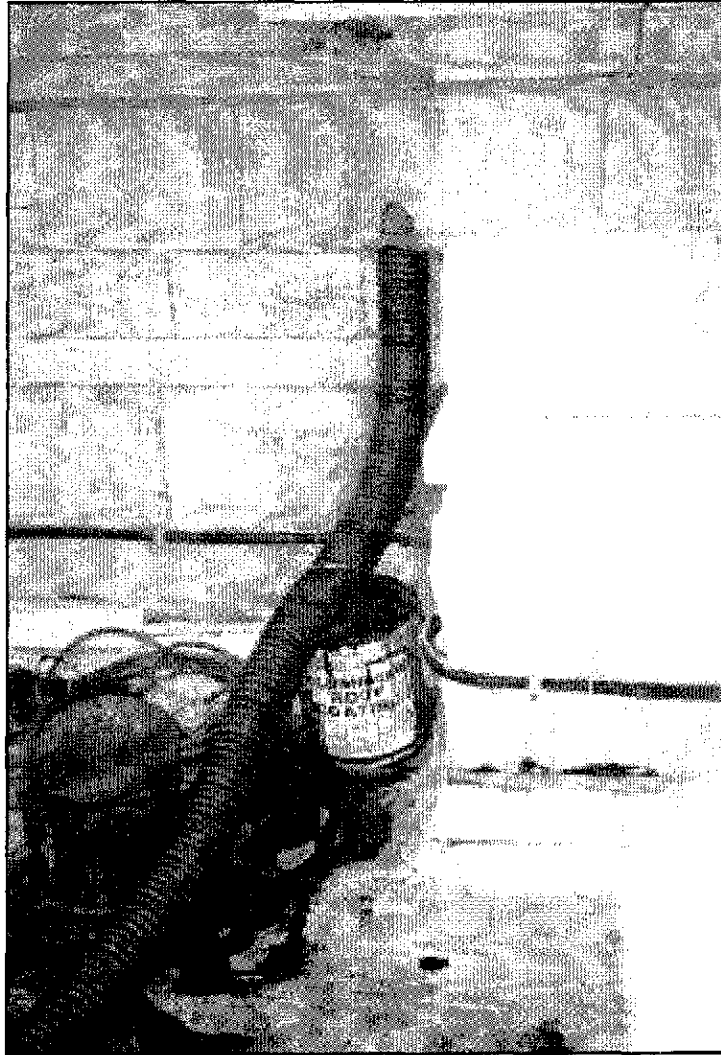
Figure 4.18: Monument Lodge, concession addition roof, PVC tubing at northwest downspout from lodge roof.

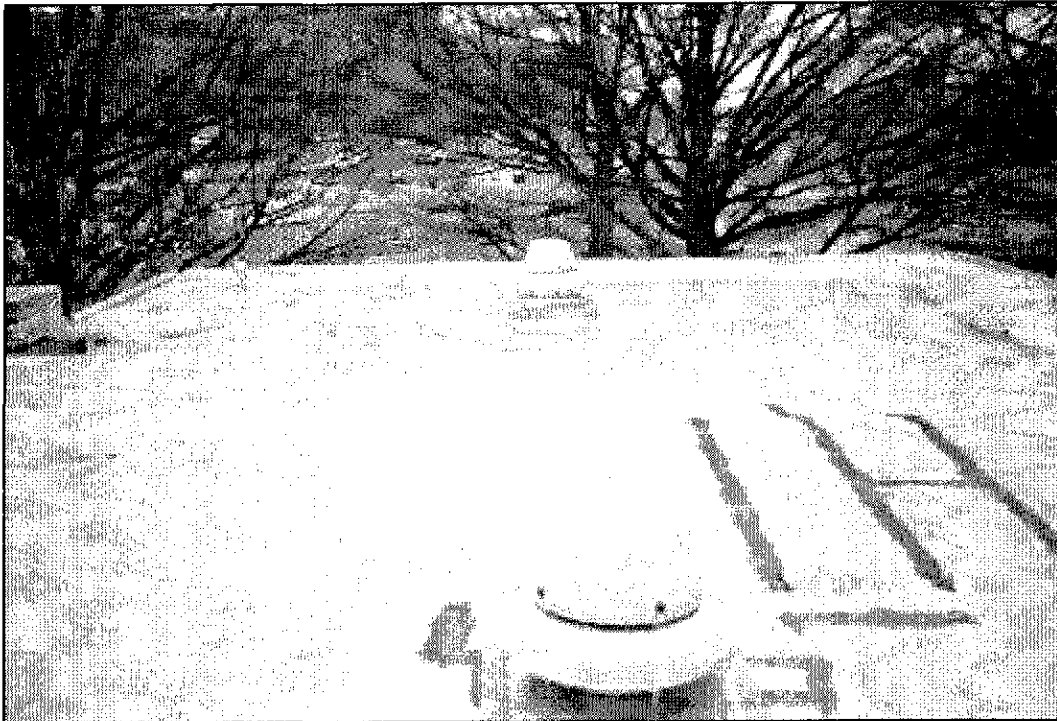
Figure 4.22: Monument Lodge, roof, looking south.

The roof of Monument Lodge is flat and covered with bituminous built-up roofing painted with a silver coating. The roof was replaced in 1976. It is not known what elements remain from the earlier roof structure; the 1889 roof had been completely replaced in 1907–1908. The roof has a very shallow peak running east-west through the center of the building, with a low pitch directing water to the north and south; the entire roof then slopes gently towards the two scuppers located to the north and south of the west bay (see figure 4.19). On the east, the roofing continues up the back of the low parapet over the central east porch. Along the remaining edges of the roof, a thin 1-inch roof curb stands approximately 6-inches from the edge of the cornice (see figure 4.20). On either side of the projecting west bay are chimney openings. The 1889 chimneys are brick-lined, faced with marble above the roofline and capped with concrete. Through-flashing is located on the interior of the chimney at the level of the roofline. A terra-cotta pipe vents out through the northwest chimney (see figure 4.21). Two roof ventilators are located in the center of the north and south halves of the roof (see figure 4.22). Four vent pipes

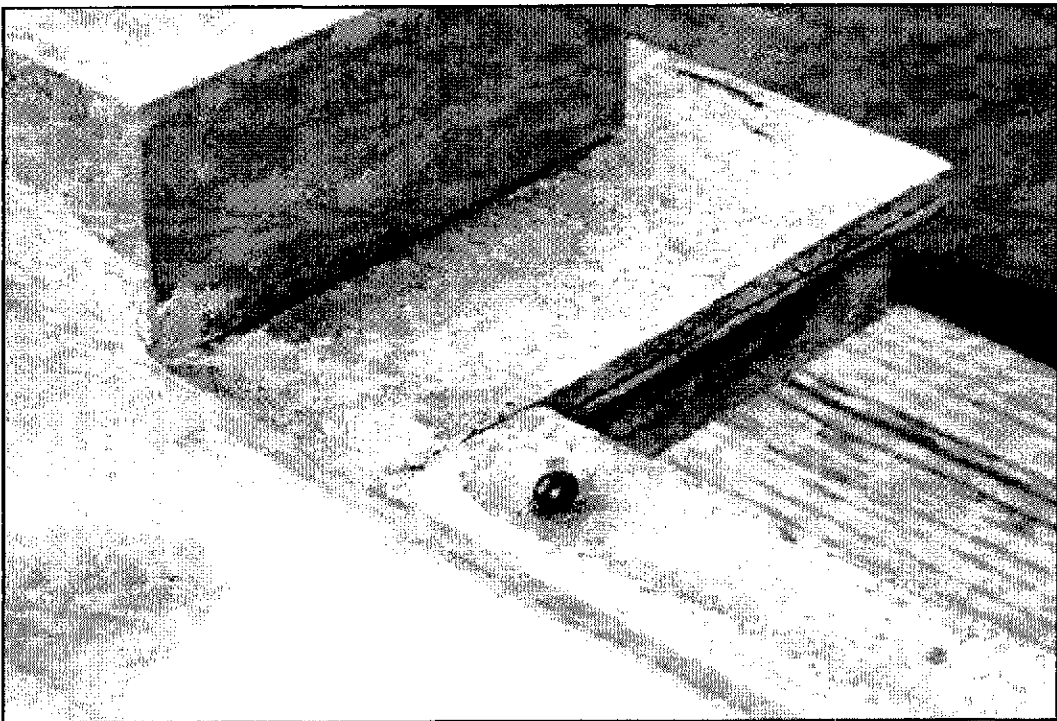
emerge through the east portion of the roof; the sides of the vent pipes are covered with built-up roofing. Four metal eyehooks, related to the 1904 flagpole structure, are embedded in the cornice masonry to the north and south of the central east porch and to the north and south of the projecting west bay (see figure 4.23).

Figure 4.23: Monument Lodge, roof, detail iron eyehook, east side.

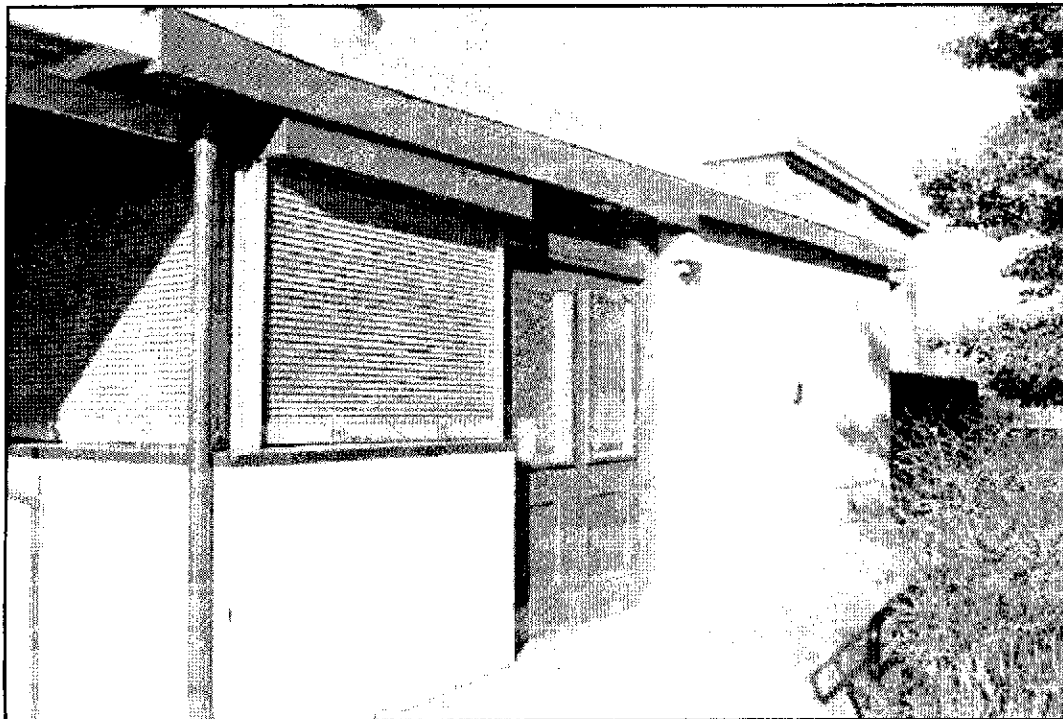
Figure 4.25: Monument Lodge, concession addition, south façade.

The north facade is exposed CMU painted yellow. There is a 1-over-1 aluminum window with fixed Plexiglas panes on the east, a central entrance to the trash room with double metal doors, and an entrance to the public concession area with glazed metal double doors on the west. On the south façade, the exposed CMU is painted yellow. There are double metal doors glazed with safety glass leading to the concession storage area on the west and a 1-over-1 aluminum window with fixed Plexiglas panes on the east. The metal window sash, doors, and door trim are finished brown. There is also a large rectangular vent grate near the foundation marking the location of the concession mechanical room (see figure 4.25).

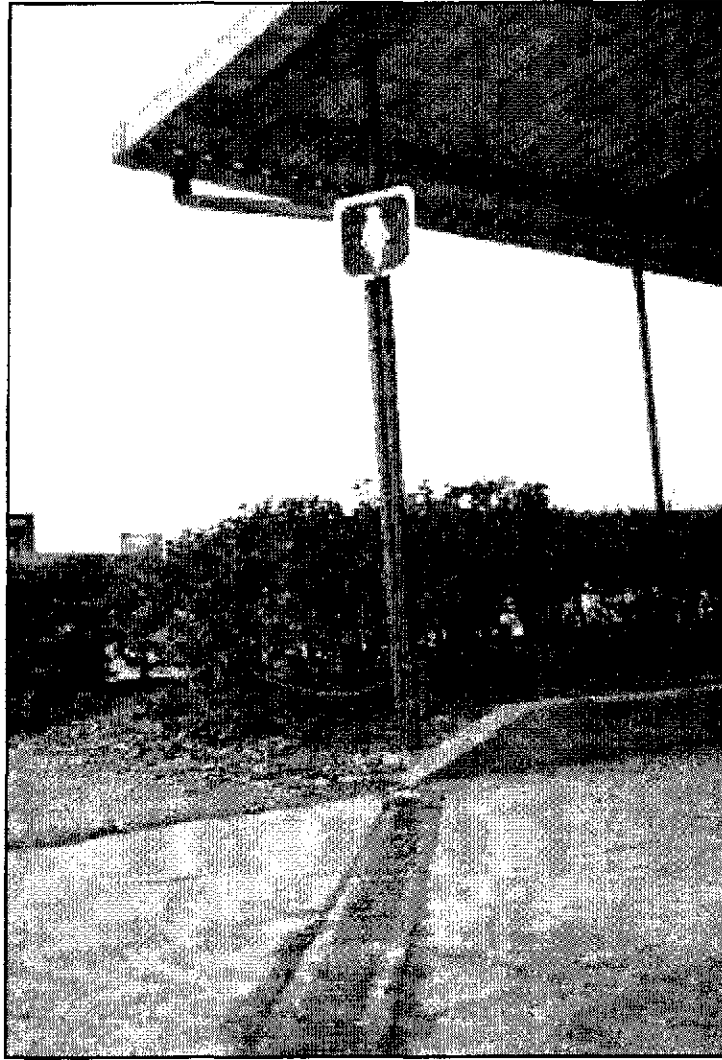
Figure 4.28: Monument Lodge, Concession Addition, southwest corner, downspout and drain.

The flat roof of the Concession Addition is supported by light-gauge structural steel channels. The 6-inch wide wood plank decking is covered with built-up roofing that is finished with a termination bar at the north and south edges. The roof holds mechanical and HVAC equipment as well as vent hoods (see figures 4.26 and 4.27). The eastern edge abuts the western elevation of the Monument Lodge where flashing is sporadically cut into existing masonry joints. The western edge of the roof forms a ridge at its junction with the west porch roof in order to direct water to the two roof drains, one each located at the northwest and southwest corners. Rainwater from these drains is directed to underground drainage through two hollow poles at the underside of the west porch roof. The west porch roof is formed aluminum with a K-style hanging gutter on the west, which directs water to a downspout at the southwest corner that drains to a channel drain in the sidewalk (see figure 4.28).

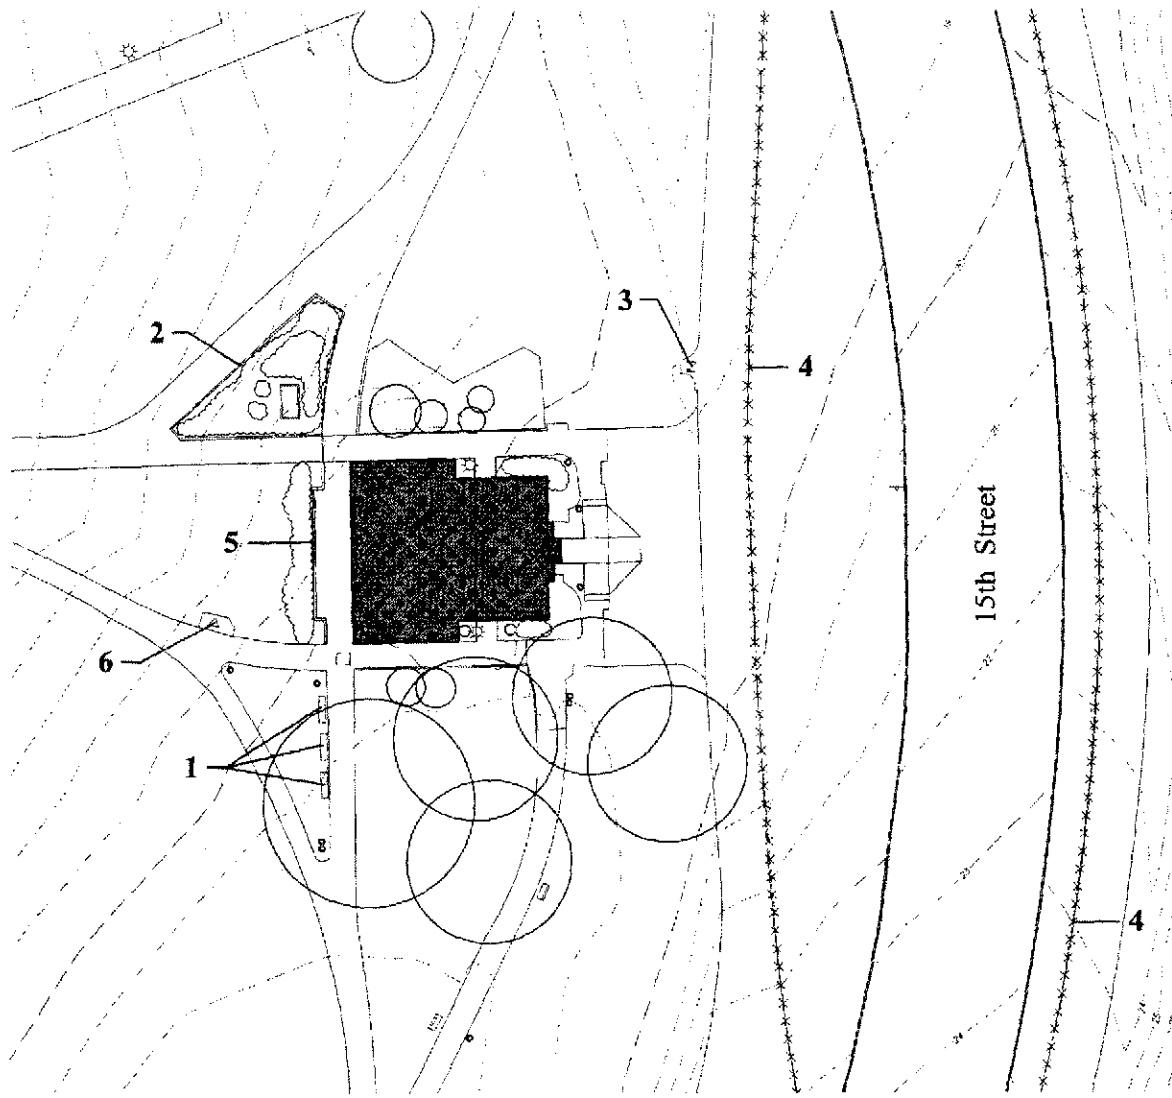
Figure 5.1: Monument Lodge Site Plan.

The associated concrete sidewalks of Monument Lodge are in fair condition (see figure 5.1); however, conditions such as uneven settlement have begun to cause cracking and further deterioration. Uneven settlement has caused pooling water, which when frozen in winter, causes life-safety hazards. The sidewalks do not date to the period of significance for the Monument Lodge. Further, since they have at least five periods of construction, the sidewalks do not provide

a uniform appearance. It is recommended that the sidewalks be replaced in their entirety as part of future improvements to the site.

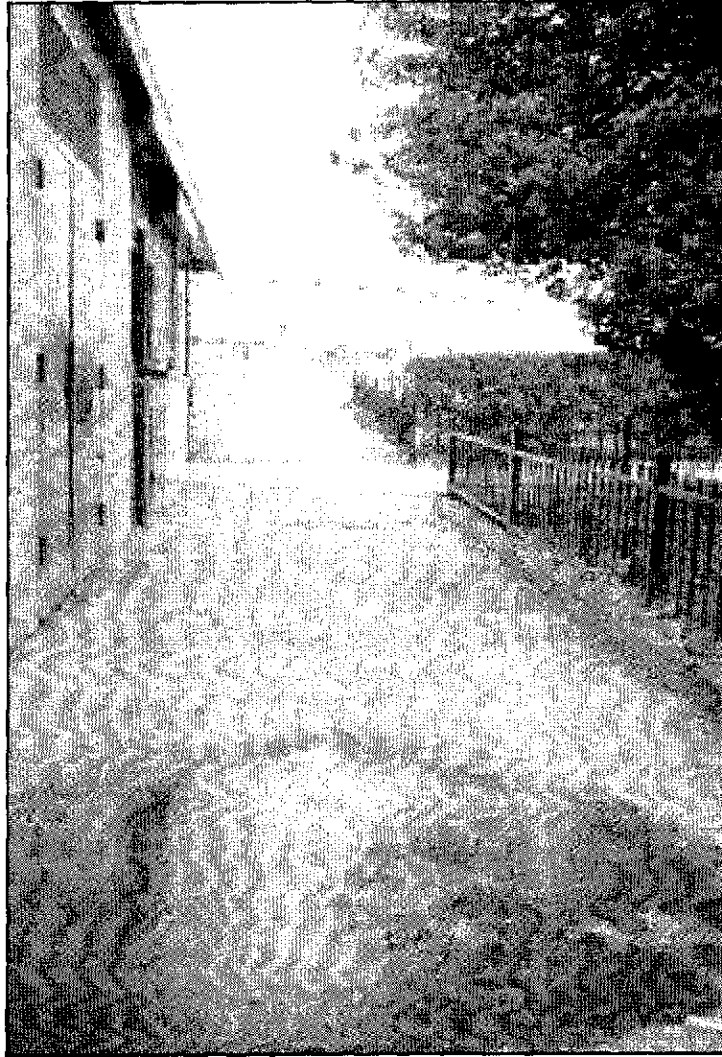
Along the north side of the lodge, the sidewalk has settled near the northeast corner of the Concession Addition. Water pools in this area; at the time of this survey ice had created a slipping hazard (see figure 5.2).

Figure 5.2: Monument Lodge, Concession Addition, north façade, uneven paving showing pooled water.

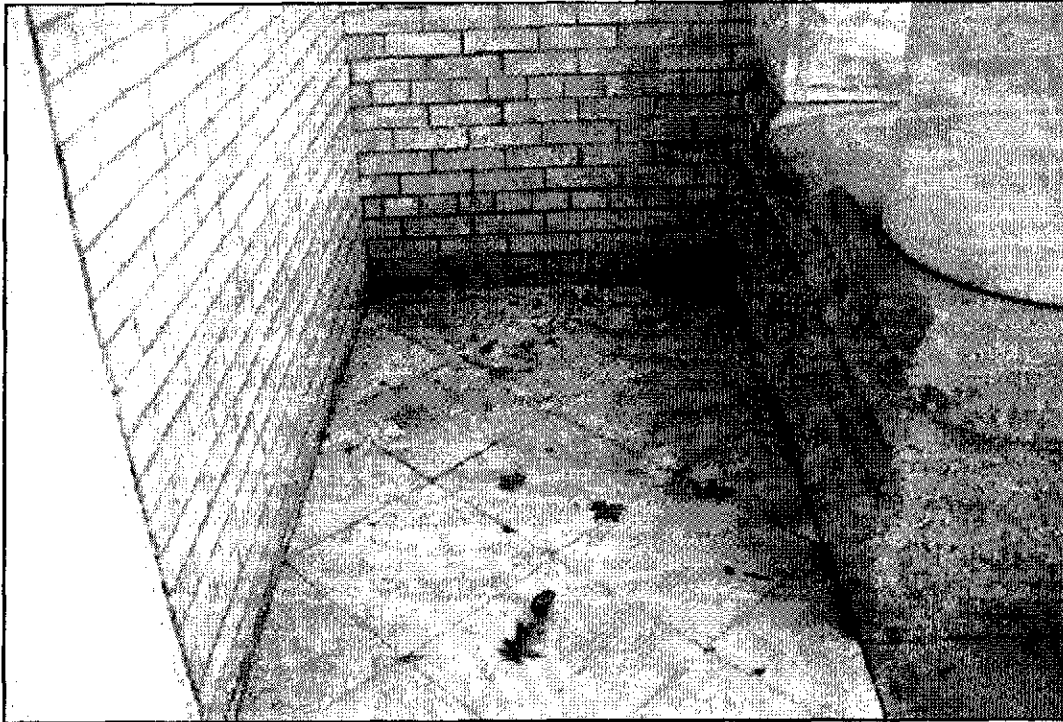
The brick masonry at the porch is in good condition. However, the decorative cornice molding at the ceiling vault provides an ideal roosting spot for birds and the molding and the marble pavers below are covered with bird-droppings. The droppings are encouraging biological growth at the base of the brick walls (see figure 5.6). The interior porch area requires cleaning with an appropriate non-acidic, biocidal cleaner to remove the biological growth.

Figure 5.6: Monument Lodge, east façade, northern end of portico paving, note biological growth on brick.

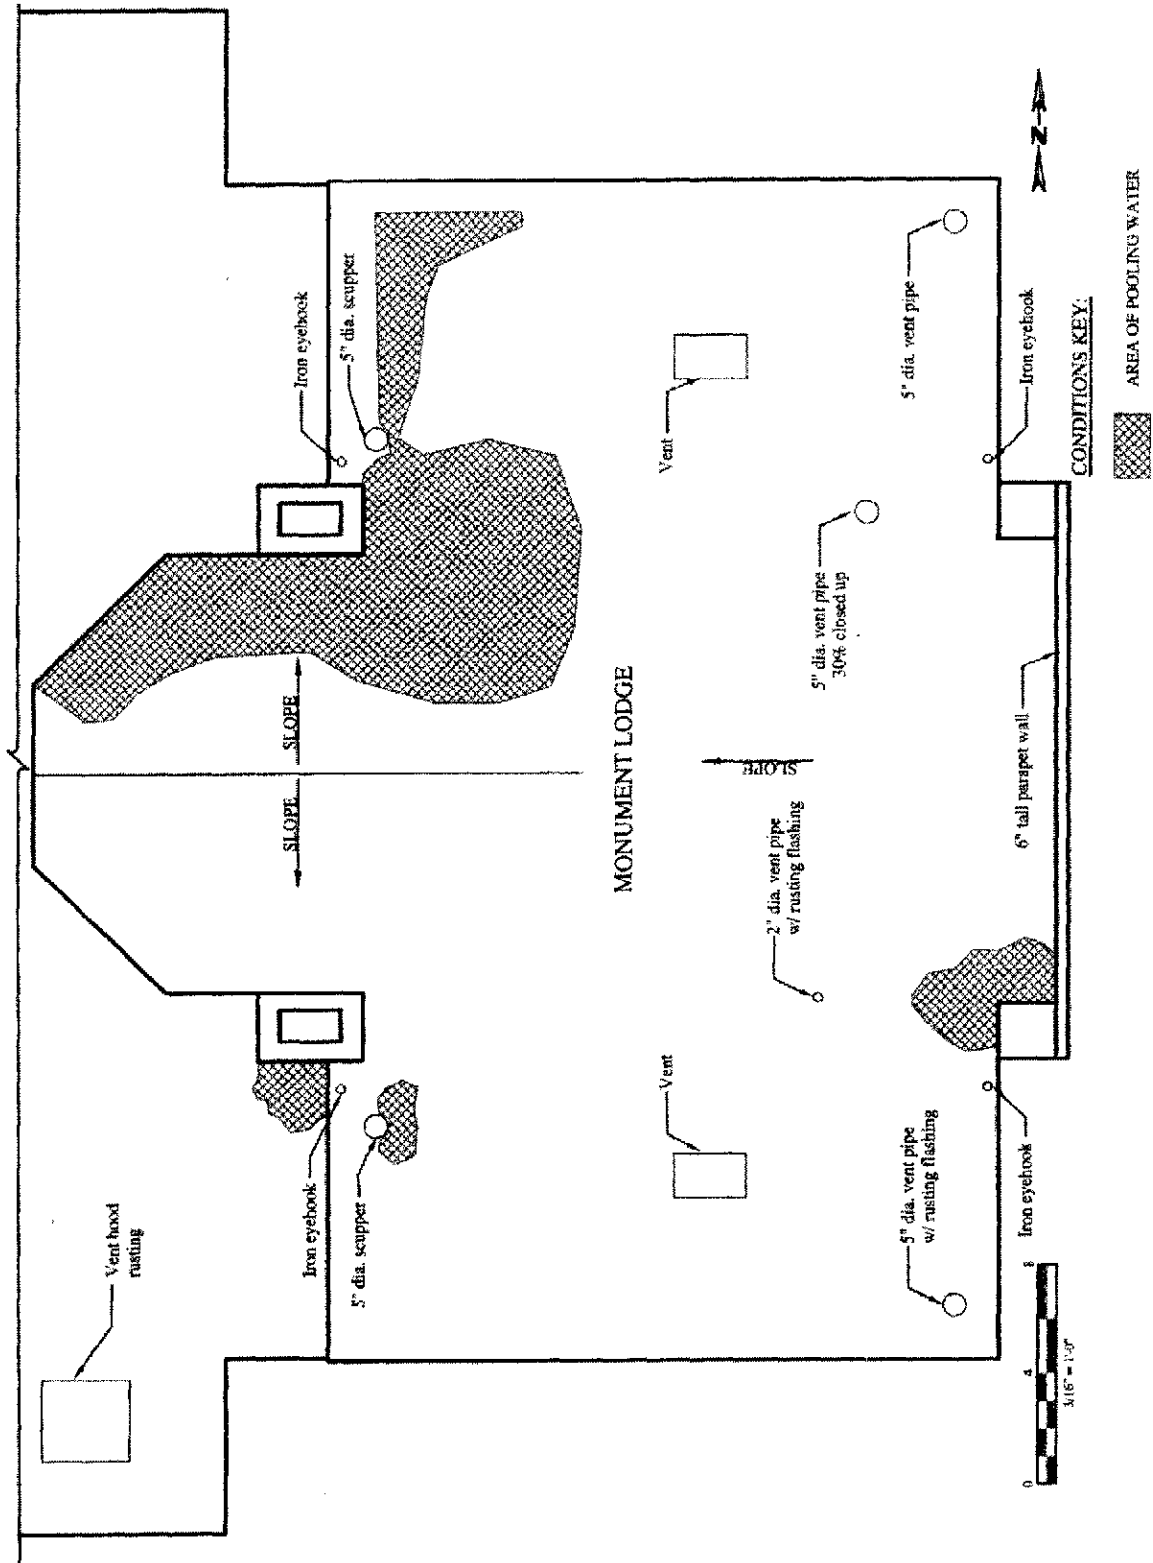
Figure 5.14: Monument Lodge roof plan. Drawing is provided for condition assessment information only and should not be considered an accurate measured drawing.

The existing built-up bituminous roofing and roof flashing are in poor condition and should be completely replaced (see figure 5.14). Seams continue to open in the built-up roofing despite recent seam repairs, particularly around the northwest chimney (see figure 5.15). The silver coating has alligator-cracking, particularly around the west chimneys and near the west scuppers, indicating it has reached the end of its service life. Water is pooling above the southeast corner of the east porch and at the northwest corner of the roof. Water appears to leak through to the underside of the east porch causing efflorescence at the brick vault below (see figure 5.16). Water staining on the acoustic-tile ceiling in the womens' rest room at the southwest corner indicates that water is leaking through in this location as well. Leaks at the northwest lodge roof are known to be a chronic problem, requiring routine replacement of stained acoustic-tile panels in the souvenir shop below and causing unknown damage to historical elements (see figure 5.17). The brown color of the staining on the acoustic panels in the souvenir shop may indicate that there is rusting metal in the roof or ceiling area above. Flashing at the southwest chimney has rusted and is no longer providing protection (see figure 5.18). Flashing is also rusting at the vent pipes near the southeast corner of the roof and should be replaced.

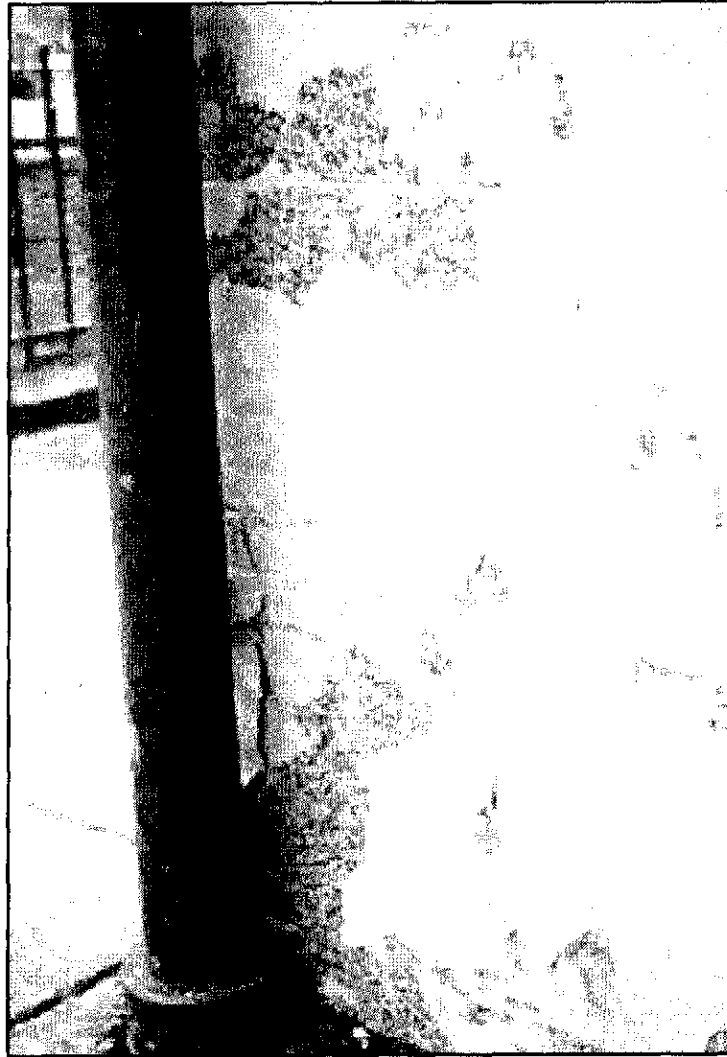
Figure 5.21: Monument Lodge, concession addition, northwest corner, detail of exposed glazed block/tile.

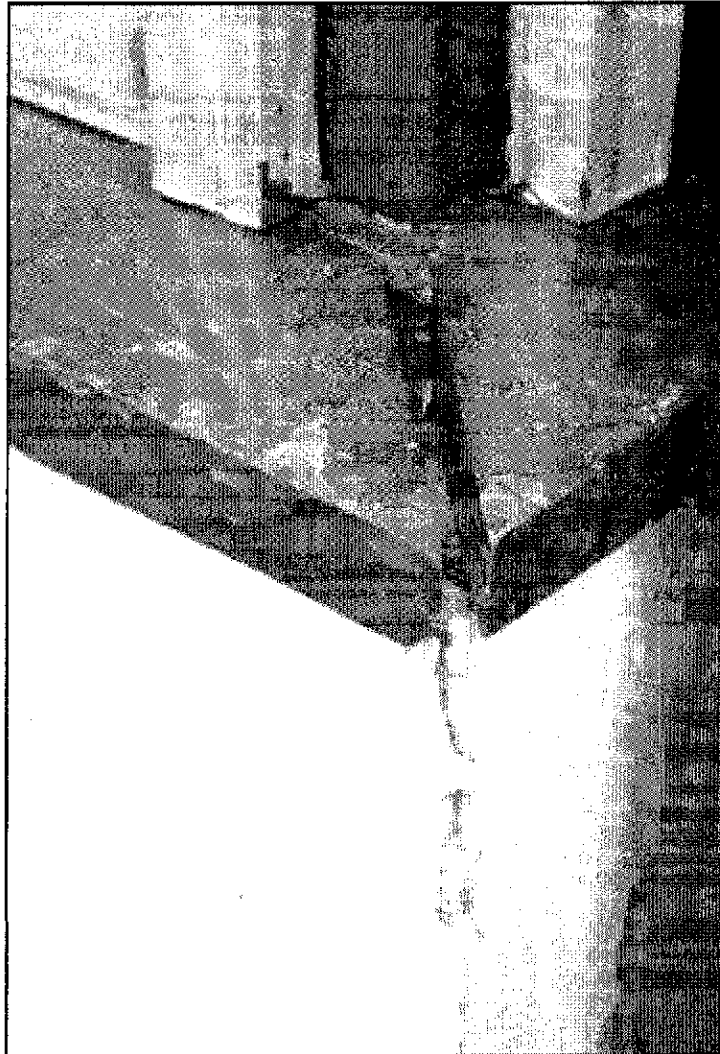
Overall the exterior masonry, windows, and doors of the Concession Addition are in fair condition, showing signs of deterioration from continual heavy use. There is evidence of movement in the concrete masonry unit walls, noticeably on the south façade and also at the northwest and southwest corners (see figure 5.20). Joints in these areas have failed and require repointing. The yellow paint is peeling at the glazed-tile facing on the west façade (see figure 5.21). At the west louver windows, the joints are open at the sill running under the windows (see figure 5.22). These joints should be sealed to prevent water infiltration.

Figure 5.22: Monument Lodge, Concession Addition, northwest corner, note open corner at counter.

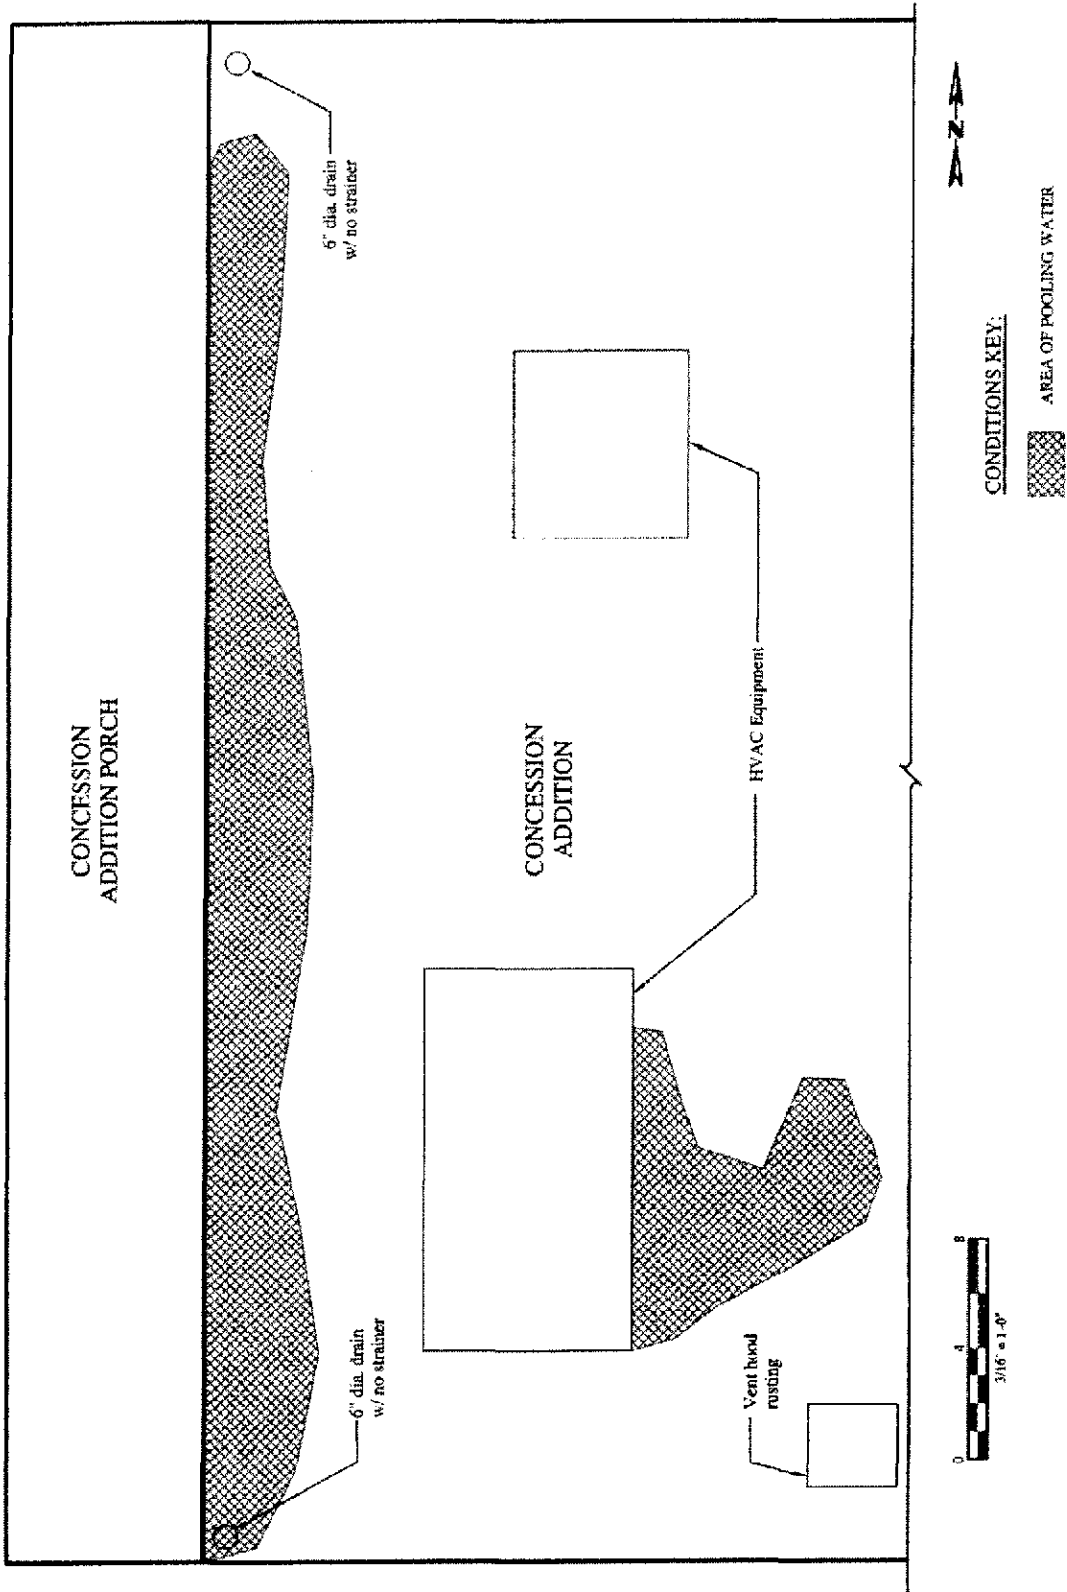
Figure 5.23: Monument Lodge roof plan conditions. Drawing is provided for condition assessment information only and should not be considered an accurate measured drawing.

The Concession Addition roof is in poor condition and water infiltration is causing damage to the interior of the structure (see figure 5.23). Further, the existing drainage system at the southwest and northwest corners of the roof, draining both Monument Lodge and Concession Addition roofs is inadequate. The roof requires another 3-inch diameter downspout to drain the combined square footage of both roofs. The flat roof also does not have sufficient slope to allow for proper water drainage. Water is pooling along the western edge of the roof where the slope is inadequate to direct water to the northwest and southwest drains (see figure 5.24). Neither of these drains is equipped with strainers and could easily clog. The pooling water is causing damage to the wood and metal at the concession porch beneath this area (see figure 5.25). Deterioration of the wood decking under the southwest drain indicates that pooling water is also leaking through to the interior (see figure 5.26). Water is also pooling around a small raised platform for rusting HVAC equipment near the southern edge of the roof. Damage from pooling water can also be seen directly under the southwest drain from the Monument Lodge roof. The wood decking of the Concession Addition roof has deteriorated in this location from chronic leaks in this area, though the damage does not appear to be ongoing at this time (see figure 5.27).

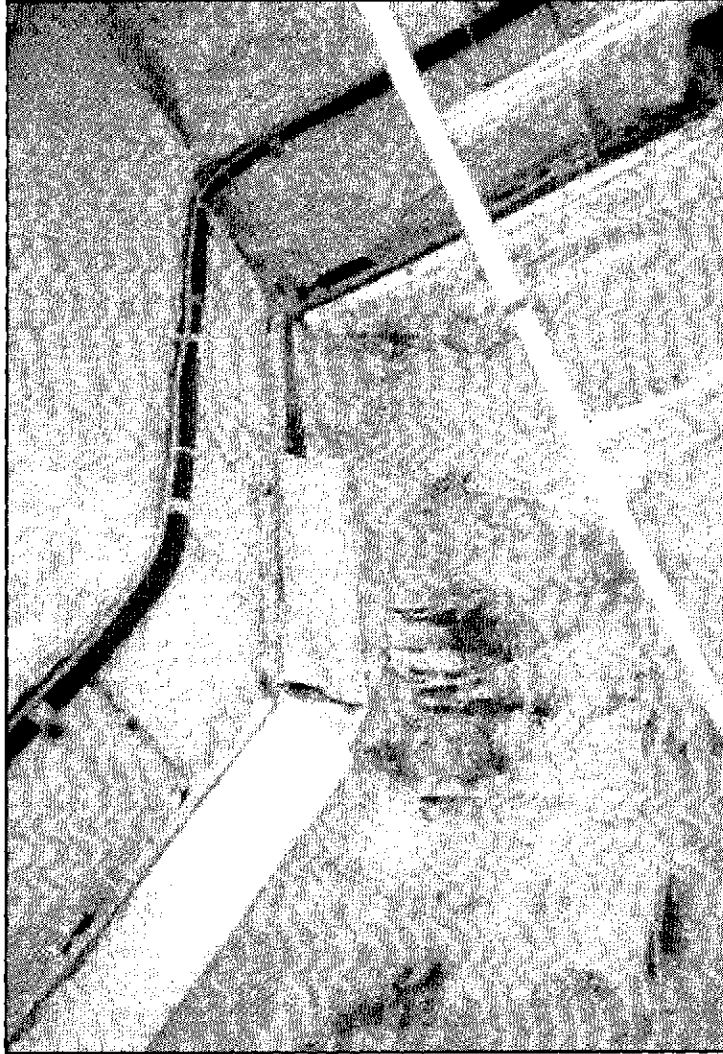
The roofing materials are also deteriorating. The built-up bituminous roofing is failing at the seams, and the termination bar at the edge of the north and south roofing edge is partially detached (see figure 5.28). The flashing and termination bars along the eastern edge of the Concession Addition roof do not provide adequate protection from water penetration at this junction (see figure 5.29). However the method of installing the flashing and termination bars at masonry joints has caused minimal damage to the masonry of Monument Lodge. It is recommended, if the Concession Addition is to remain, that the roof be completely replaced and redesigned to provide adequate slope and drainage.

Figure 5.29: Monument Lodge, Concession Addition roof, note sporadic flashing at east.
