**WASHINGTON MONUMENT AND ASSOCIATED STRUCTURES
HISTORIC STRUCTURE REPORT**

VOLUME II – MONUMENT LODGE

FINAL REPORT

PREPARED BY
John Milner Associates, Inc.
ARCHITECTS • ARCHEOLOGISTS • PLANNERS • LANDSCAPE ARCHITECTS
535 NORTH CHURCH STREET
WEST CHESTER, PENNSYLVANIA 19380
(610) 436-9000

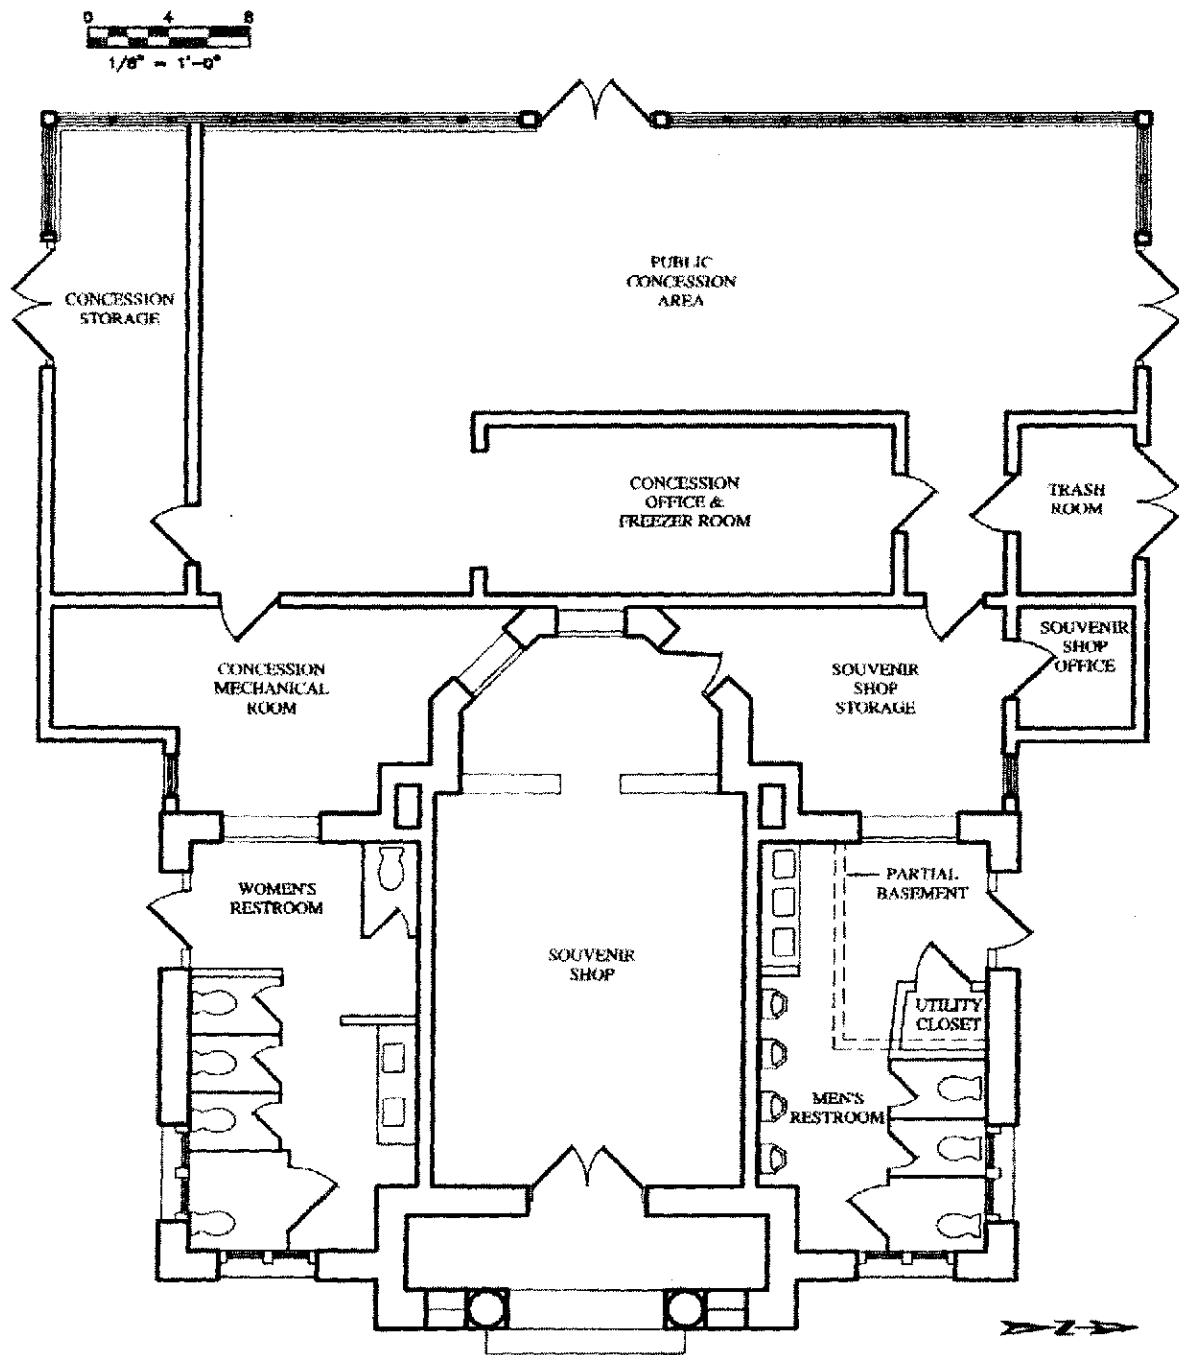
Figure 5.30: Monument Lodge floor plan. Drawing is provided for orientation purposes only and should not be considered an accurate measured drawing.

The interior of the 1889 Monument Lodge structure is in good condition. Many of the modern finishes are showing wear, particularly in the rest rooms (see figures 5.30 and 5.31). Historical elements that remain, such as the east entrance doors, east transom light, and terrazzo floor are in good condition requiring only basic maintenance to ensure their continued preservation.

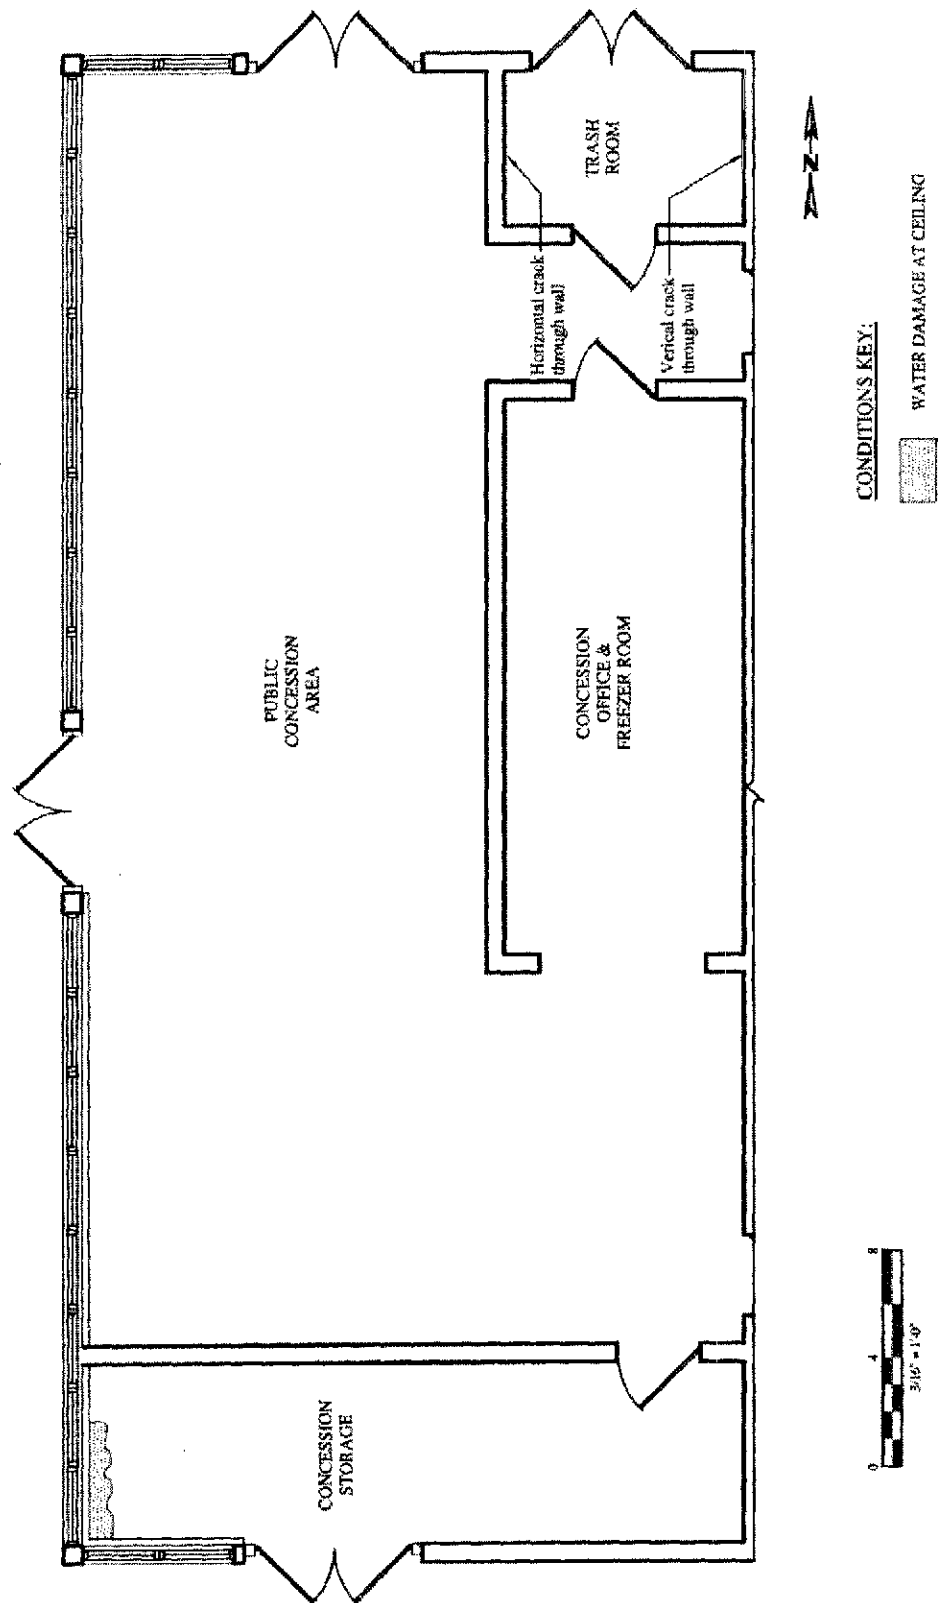
Figure 5.36: Monument Lodge first floor plan conditions. Drawing is provided for condition assessment information only and should not be considered an accurate measured drawing.

The interior of the Concession Addition is in good condition (see figure 5.36). Despite damage caused by water infiltration from the roof, the interior requires only maintenance-level repairs to maintain the existing structure.
