VILLAGE HALL

Women's Rights National Historical Park

Historic Structure Report

VILLAGE HALL
HISTORIC STRUCTURE REPORT
Women's Rights National Historical Park
Seneca Falls, New York

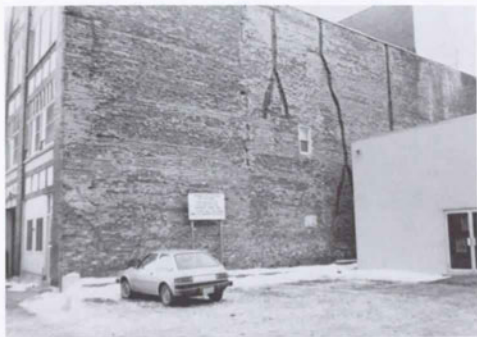
Fig. 17. Exterior East Wall [1988].

Figure 11 further reveals that by 1955, the Fisher Theatre abutting the east wall of the Village Hall had been renamed the Strand Theatre. In April 1972 the theater caught fire. Evidently there was some "minor damage" to the Village Hall.²⁷ This can be seen today: a blackened header course at midpoint along the east wall, and charred framing members within the elevator penthouse on the roof. The old theater was replaced with the current concrete-block structure, but its outline remains visible on the east wall of the Village Hall.

In addition, three duct channels 8 inches wide furrow the wall. These may have been for fresh-air intake, or for vent pipes associated with plumbing fixtures. The south channel is located 30 feet from the south end. It begins just below the roof line and descends in a straight line before dividing and terminating at second-story ceiling level. The middle and north channels begin

at the roof line and descend to first-story ceiling level. The middle channel, located 45 feet from the south end, meanders slightly to the north before dividing at the bottom to form an inverted Y shape. The north channel, located 63 feet from the south end, runs straight up and down.

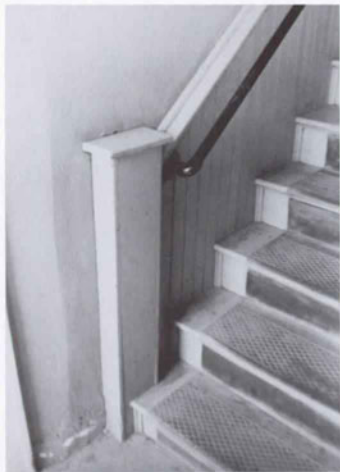
Fig. 24. Room 101 (Main Stairway) [1988].

The stairway leading to the second floor (fig. 24) is located in an enclosure along the south end of the east wall. The enclosure is bordered on the north and west by Room 102.

Floor. The concrete floor is unpainted.

Walls. The east wall of the stairway enclosure is the original east exterior brick wall. The south, west, and north walls are 1927 concrete-block walls. In the southeast corner is

a plastered brick protrusion containing the chimney flue. All walls are painted an off-white color.

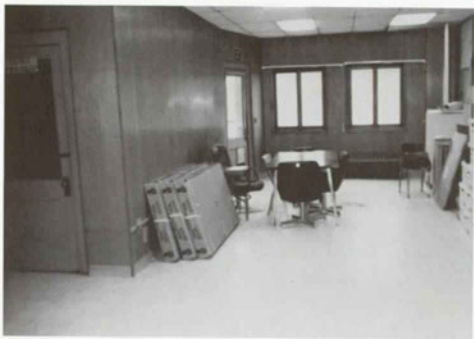
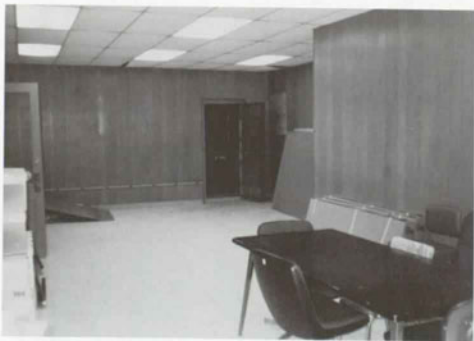
Figures 25 and 26 depict this space, which is located in the southeast corner of the first floor. The HABS drawings call it the Water Department, based on the existence of a Water Department display case on the west wall. No evidence suggests that the Village Water Department was ever located in this space, however. Rather, it functioned during the municipal era as the Village offices.³⁸

Ceiling. The existing hung ceiling consists of fiberboard panels suspended in a metal frame. Above this later ceiling can be seen the original concrete and steel ceiling elements, which are painted a light green color. Also visible are the remnants of the original north wall (see above).

Doorways. The room can be entered by three doorways. One at the south end of the east wall leads from Room 101. One on the north side of the east-wall stairway enclosure leads to the basement stairway. One in the west wall, north of the Water Department display closet, connects with Room 104. All three

Fig. 25. Room 102 (Village Office),
Looking South [1988].

Fig. 26. Room 102 (Village Office),
Looking North [1988].

doorways have Type-A architraves and contain wood doors. These doors have a solid recessed panel below a larger glazed panel holding wire-reinforced glass. A similar door hangs in the doorway of the Water Department display closet.

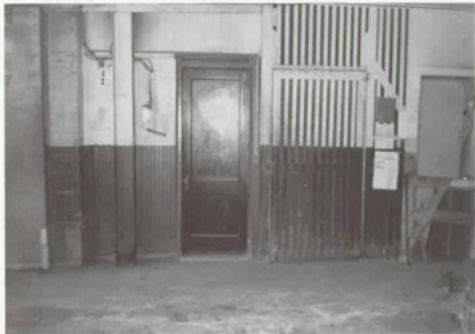
Fig. 35. Room 106 (Garage), Doorway
to Toilet [1988].

Doorways. The architrave of the doorway leading from the garage into the toilet is not the Type-A architrave that has been dated to 1927. This suggests that the toilet was not installed at that time, but rather earlier. The door here is a solid wooden door with two recessed panels: a square panel in the lower third and a rectangular panel in the upper two-thirds.

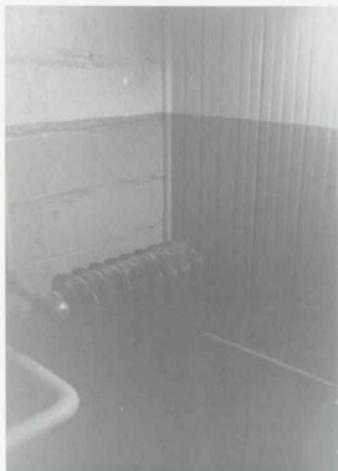
Fig. 36. Room 108 (Toilet),
Northeast Corner [1988].

Electrical Fixtures. One bare-bulb fixture is mounted on the west wall.

Heating and Plumbing System. Water pipes run vertically in the northwest and southeast corners; a horizontal water pipe runs north-south along the base of the east wall. A Type-F radiator is attached to the east wall. At the north end of the east wall is the ghost of a previous sink.

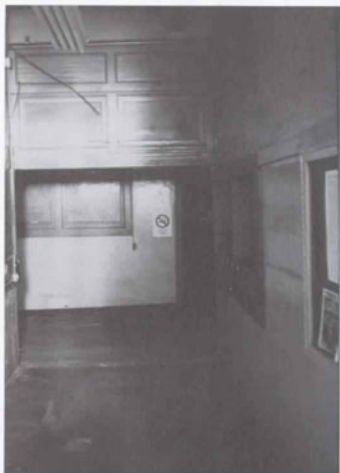
Fig. 43. Room 204 (Dispatcher Room),
Looking North [1988].

Doorways. Three doorways are located in the Dispatcher Room. A wide doorway opening comprising the north wall of the room leads to Room 202. It has a large overhead area that contains two transom windows holding clear glass and topped by two solid wood panels (fig. 43). There is no door here.

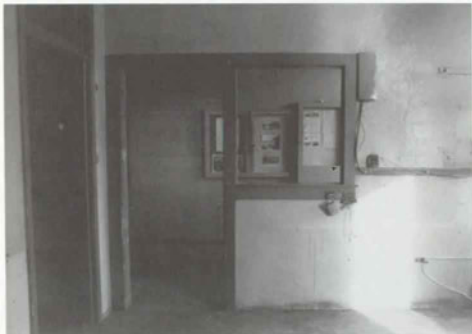
Fig. 44. Room 205 (Records Office),
Looking East [1988].

Doorways. The doorway to Room 204 (fig. 44) is located in the south portion of the room, at the north end of the east wall. Its architrave is a 4-inch-wide board that may postdate 1927, since it has only two finish layers. The doorway is missing its door.

The east wall of the Records Office contains--south of the doorway to the Dispatcher Room--a "pass-through" opening (see fig. 44). This opening is trimmed with a plain, 4-inch-wide board identical to that used around the adjacent doorway. One window opening is located in the partition wall at the same level as the adjacent doorway's transom windows. The opening contains three fixed lights, and was undoubtedly installed to bring more natural light into the north portion of the office. Its frame and muntins are painted a dark apple-green color.

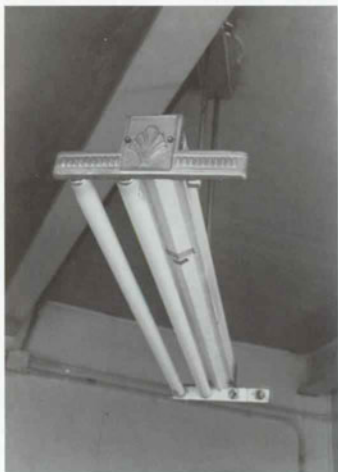
Fig. 45. Room 205 (Records Office),
Light Fixture Type FL-C [1988].

Electrical Fixtures. Each portion of the Records Office contains an early hanging fluorescent lighting fixture with end pieces rendered in the Art-Deco style (fig. 45). This type of fixture has been labeled Type FL-C in Appendix D. There are cable wires, transmitter boxes, and an electrical receptacle on the east wall.

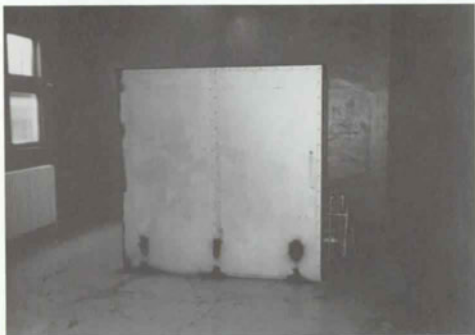
Fig. 50. Room 210 (Jail), Cell Block [1988].

The room containing the jail cells was created as part of the 1927 remodeling. A sheet-metal cell block in the north half of the room (fig. 50) held two separate cell units. The units at one time each contained a sink, a toilet, and a bed.

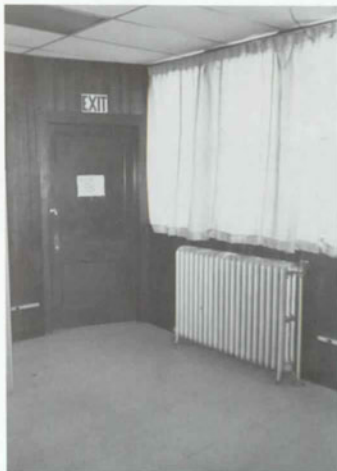
Fig. 51. Room 214 (Village Meeting Room), Northwest Corner [1988].

A second exit doorway leads into the north end of the rear stairway enclosure (fig. 51). A third doorway is located in the east end of the south wall, and leads to a closet. These two doorways share the same type of architrave profile: it simulates the Type-A molding, but is smaller (1/2-inch trim on flat board) and probably later. The door to the stairway enclosure is a solid two-panel door. The door to the closet is missing.

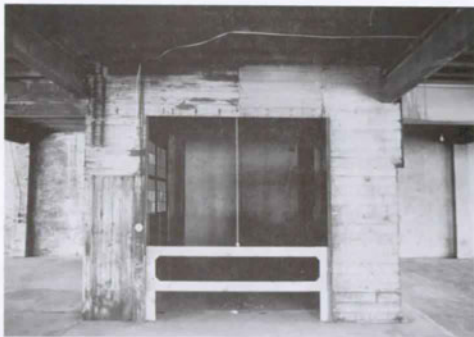
Fig. 58. Third-Floor Elevator Enclosure
[1988].

Walls. Much of the west wall of the enclosure is taken up by the main doorway to the elevator. The rest of the wall area consists mostly of horizontal tongue-and-groove flush-board siding (fig. 58). A section of vertical boards north of the doorway reveals the presence of another doorway (see "Doorways," below). The north and south walls of the elevator enclosure each consist of narrow, vertical, beaded, ship-lapped boards above and below a wide window opening. One steel column is located toward the west end of both walls, inside the elevator enclosure. The east wall of the enclosure is the exterior brick wall of the building. The walls have one deteriorated coat of white paint.

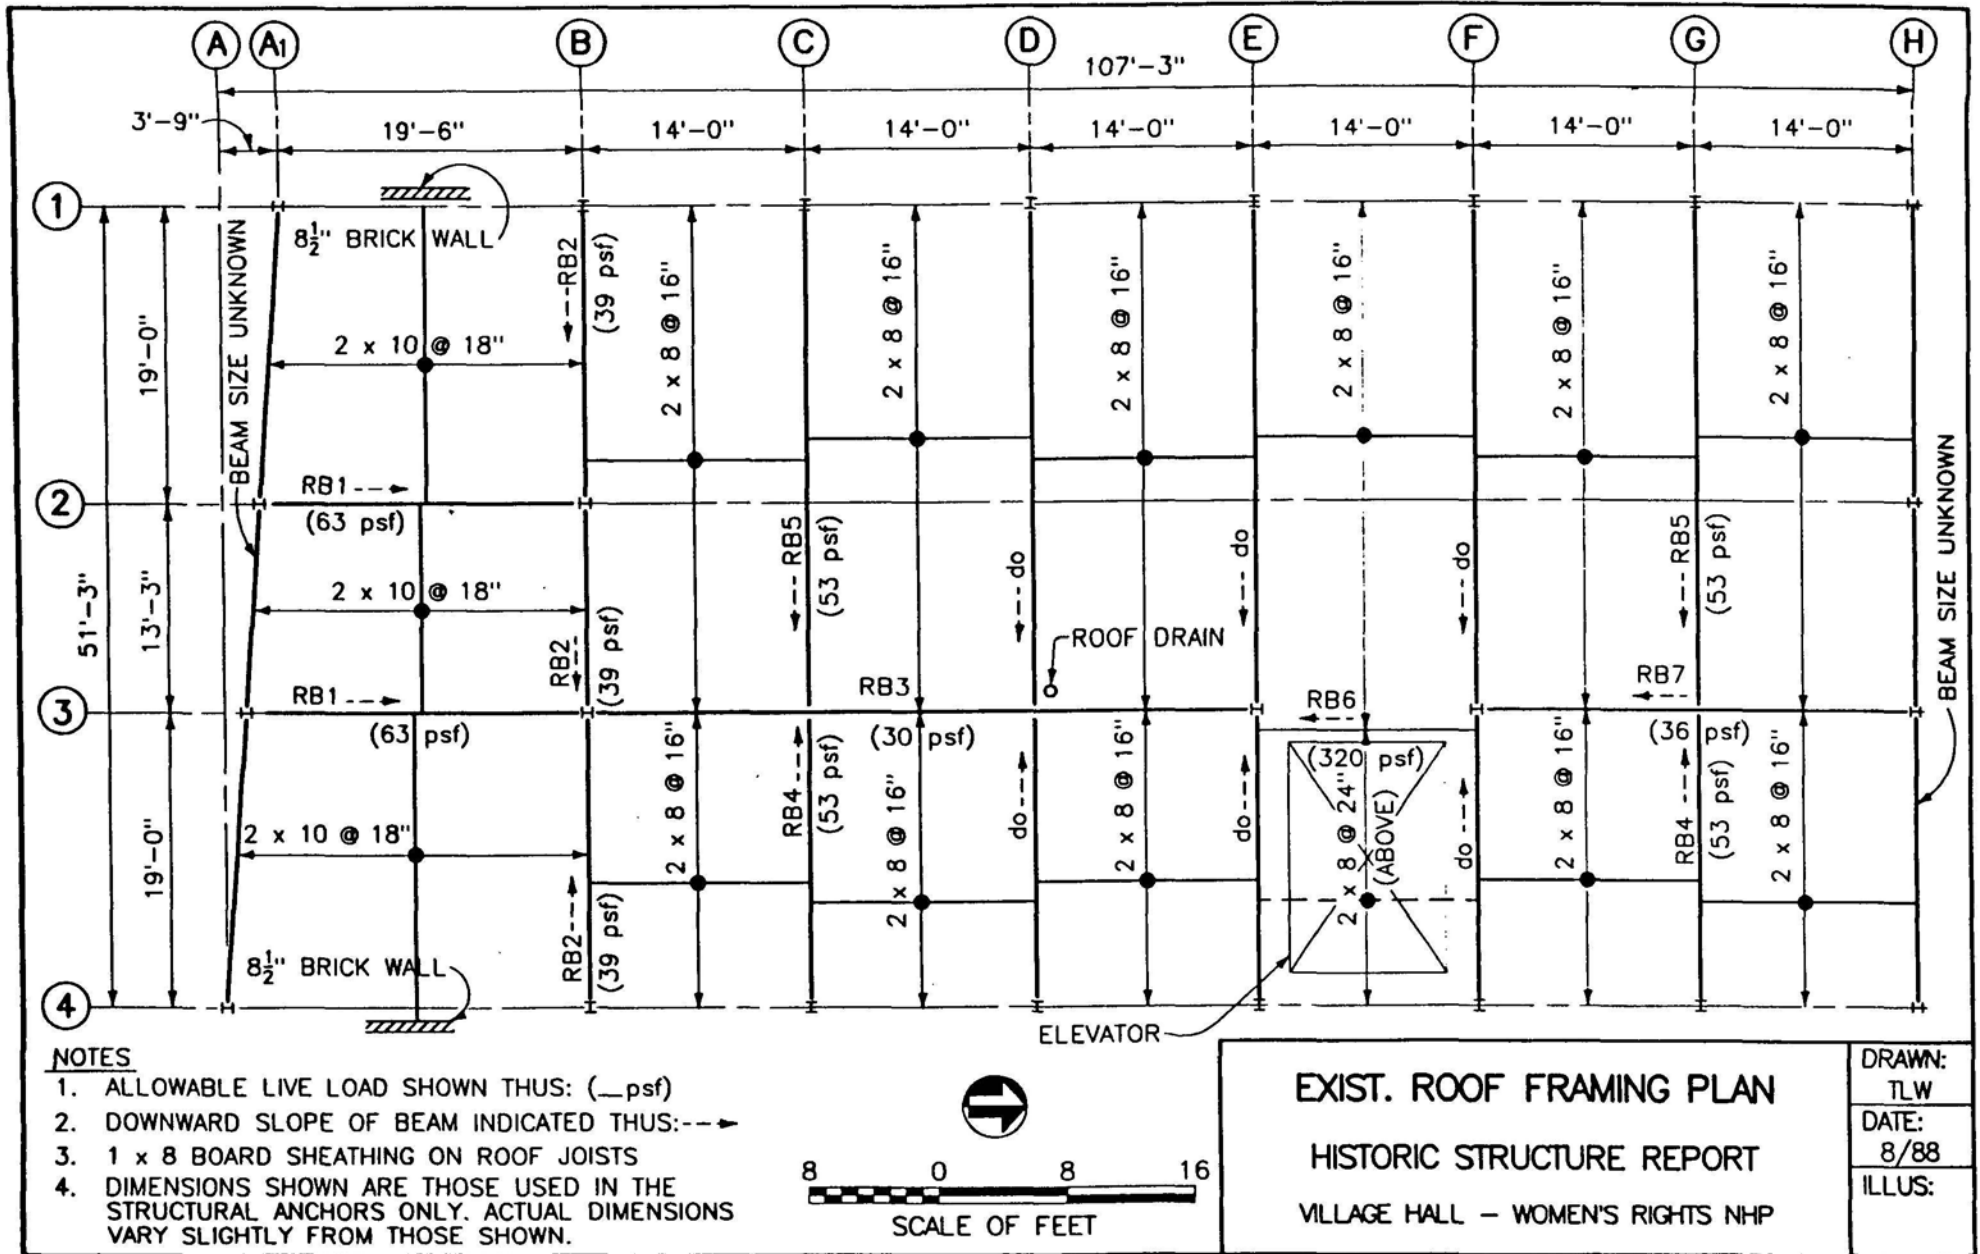
Fig. 63. Existing Roof Framing Plan [1988].

The flat roof system consists of a built-up roof on 1- by 8-inch sheathing boards supported by wood joists and steel beams. The wood joists measure 2 by 8 inches and 2 by 10 inches. The existing roof framing plan is shown in figure 63.

joists were not properly seasoned prior to installation, and in the absence of any blocking or bridging, movement occurred unrestricted. All of the steel roof beams are in good condition.

The elevator penthouse floor and walls are constructed of wood. Much of this framing is original, but the east side features newer framing. Apparently this later framing is replacement material for members that were burned during the fire at the adjacent Fisher Theatre in 1972. Both the original framing and the newer framing are in fair condition. There is no evidence of decay. Some of the framing has been modified by splicing, and these areas will require strengthening and/or reframing.

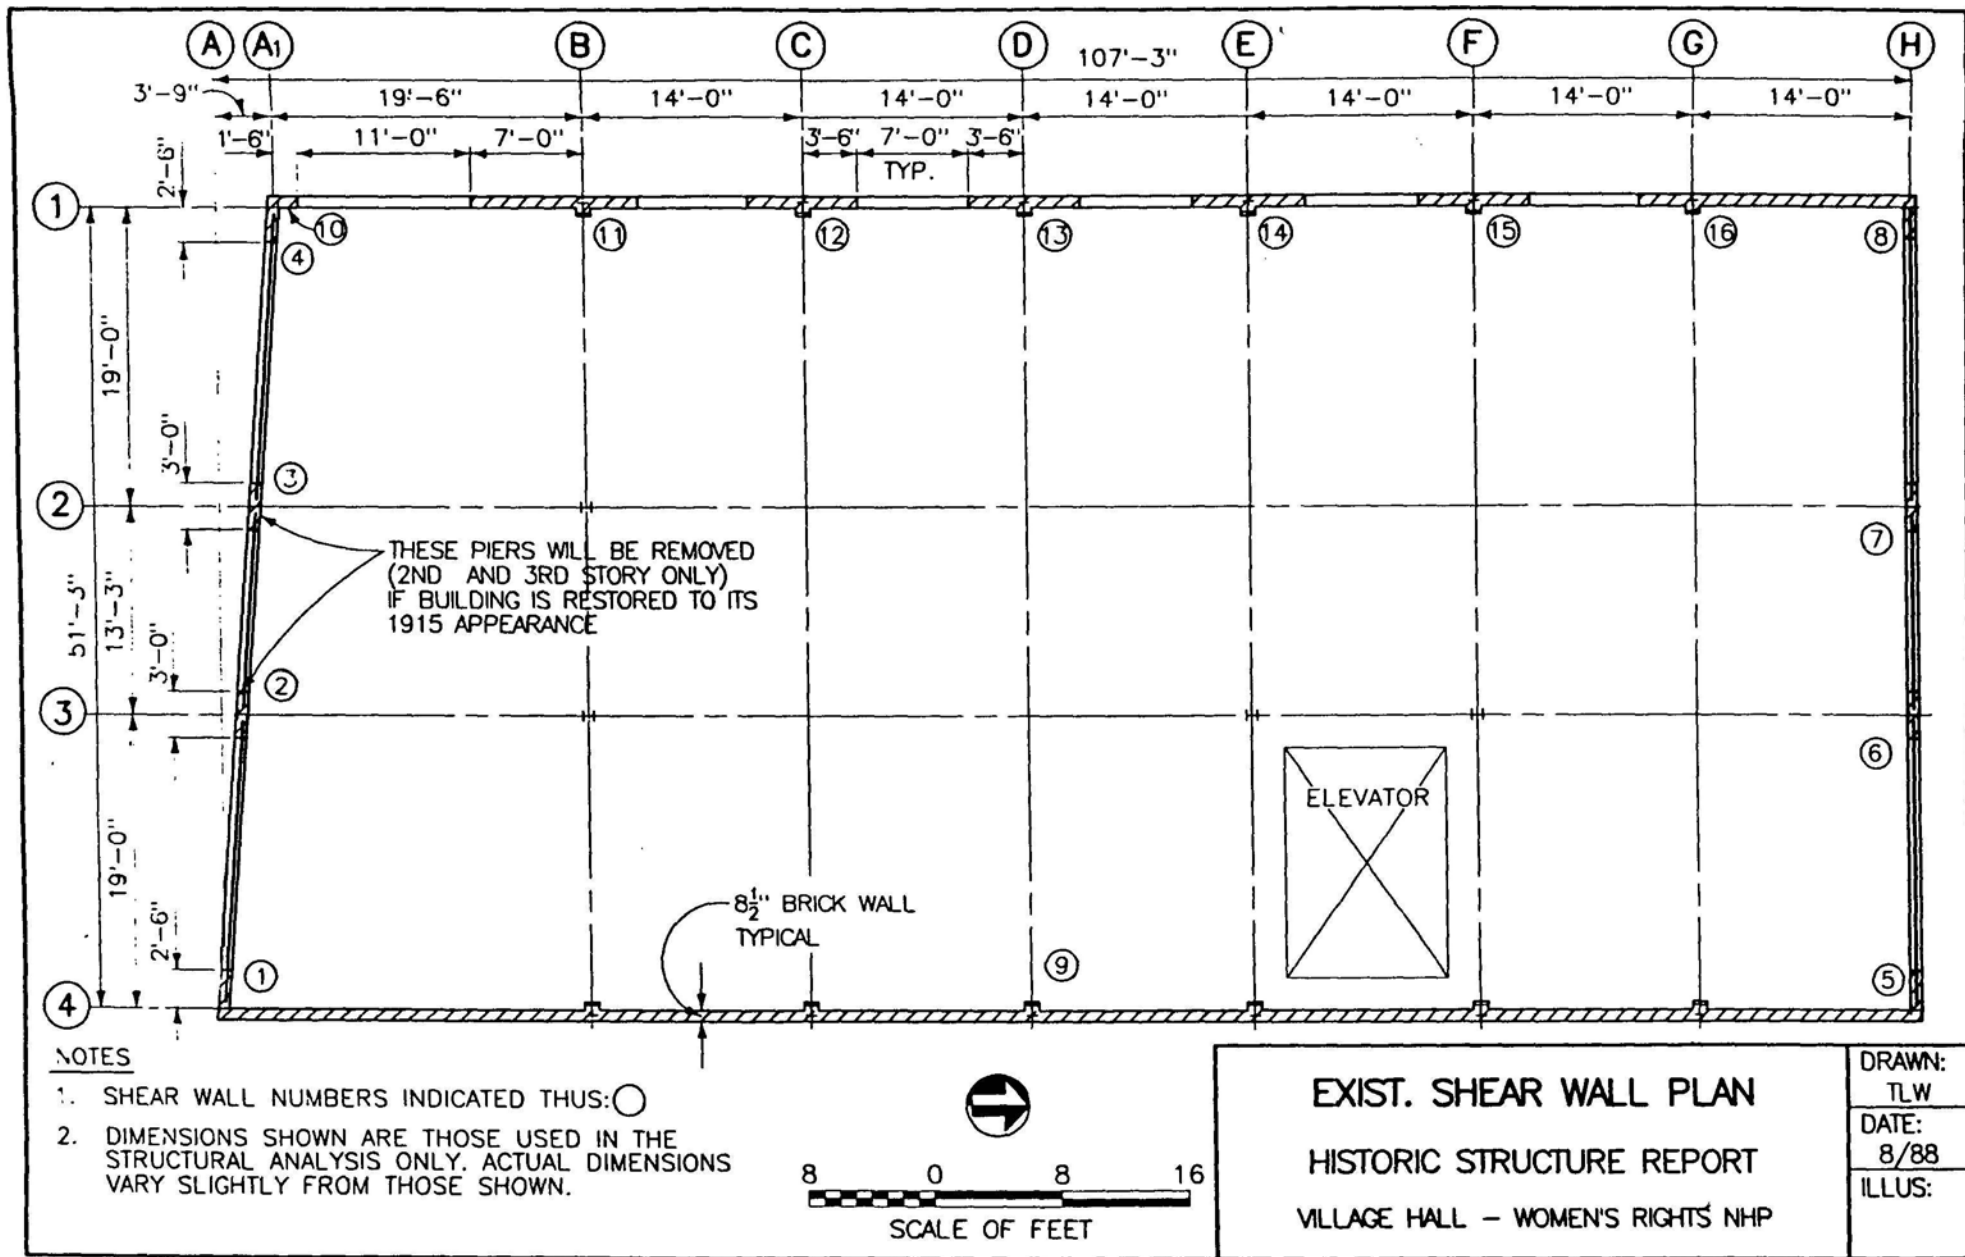
Fig. 65. Existing Shear Wall Plan [1988].

A lateral-load analysis of the structure was also performed. Due to the mass of the structure and the relatively high seismic coefficient (Z) of 0.5, seismic loads control over wind loads. The concrete floors were assumed to act as rigid diaphragms. Diaphragm action of the roof and adequate transfer of the roof shears to the walls was also assumed for the analysis. The roof is currently board sheathing, which is not recognized as a diaphragm by the code, although numerical values do exist in some publications. The shear wall locations are shown in figure 65.

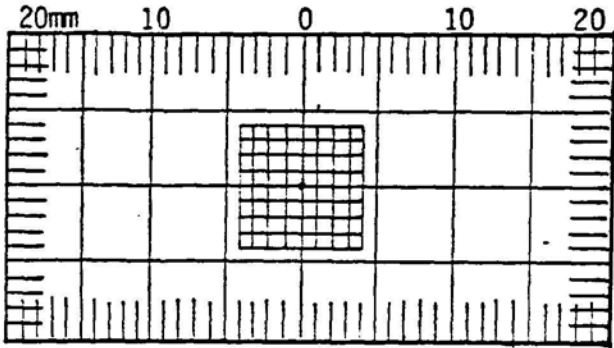
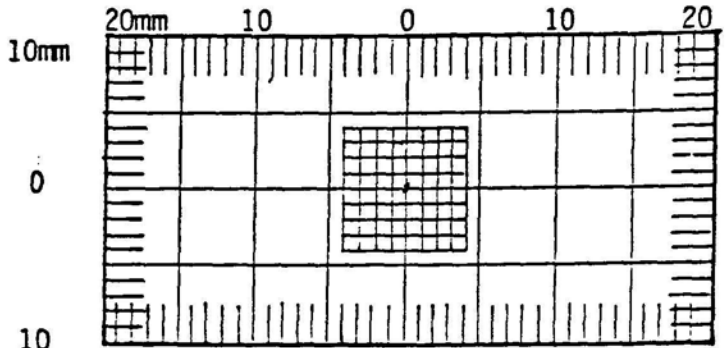
Location of Monitor Exter., N. Wall, 2nd Flr., NE Corner

Date of Reading: 11/18 @ 4:05 PM - 38°F
