**WRIGHT BROTHERS NATIONAL MEMORIAL  
VISITOR CENTER**

**HISTORIC STRUCTURE  
REPORT**

2002  
Historic Structure Report  
Wright Brothers  
National Memorial Visitor Center  
Kill Devil Hills, North Carolina  
LCS#: 91645

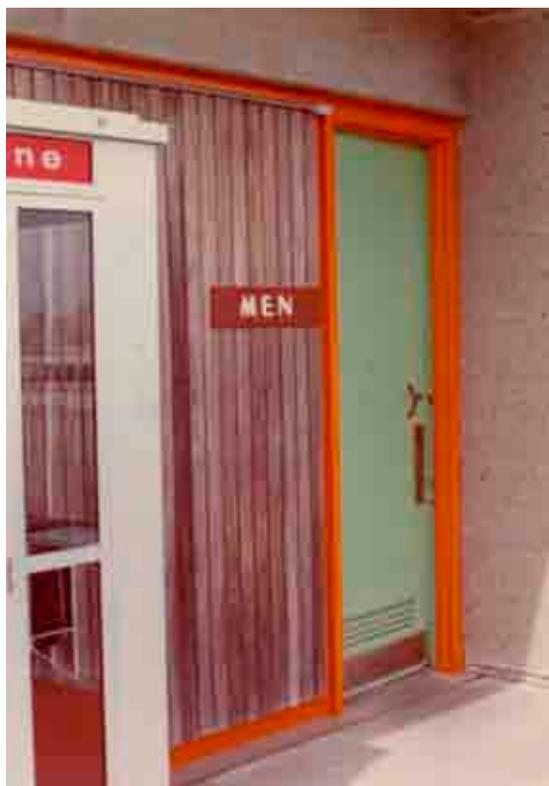
**Figure 12** View of entrance to Men's Room, showing original exterior materials, March 1975 (CAHA Contracting Files, Ft. Raleigh)

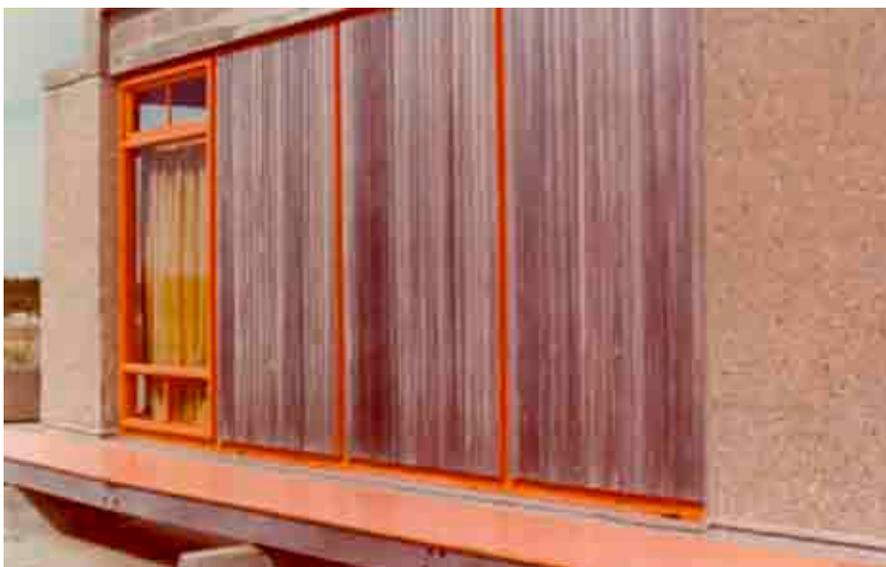
In 1989, the building's HVAC system was rehabilitated and expanded. This work resulted in the loss of the two windows on the north side of the Flight Room where two exterior bays were enclosed to house mechanical

**Figure 13** View of south end of Lobby showing original materials, March 1975. (CAHA Contracting Files, Ft. Raleigh).

equipment. A new air- duct system was installed around the perimeter of the Flight Room. The new ducts were covered by a soffit that extends the line of the exterior soffit several feet into the room, obscuring some forty percent of the corrugated concrete ceiling.

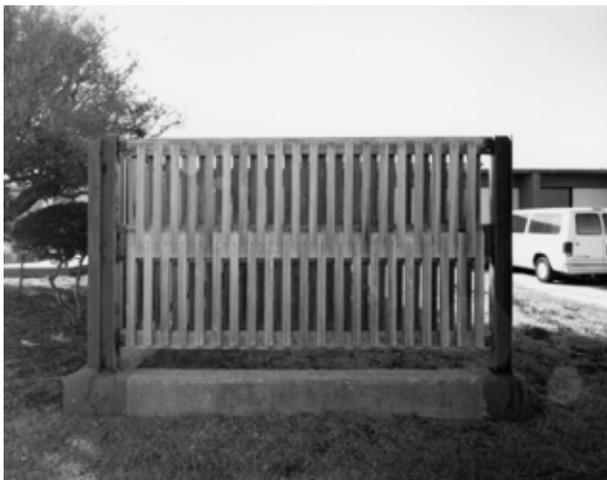
**Figure 16** View of fence along east side of employee parking lot (National Park Service, 2000)

There are three fences that mimic the original design but that were added within the last twenty years. One screens the non- original HVAC unit condenser and an above- ground fuel tank at the northeast corner of the building. The second is a fence along the east side of the staff parking lot. The third screens utility equipment east of the staff parking lot. All three of the non- contributing fence/screens have slats similar to the original design but with posts that are pressure- treated 6 x 6's.

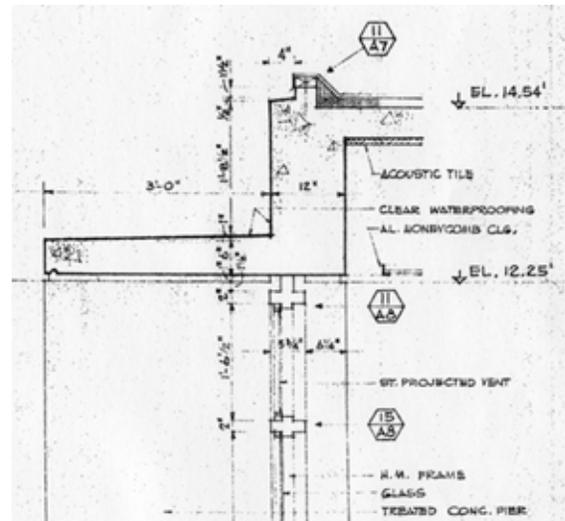
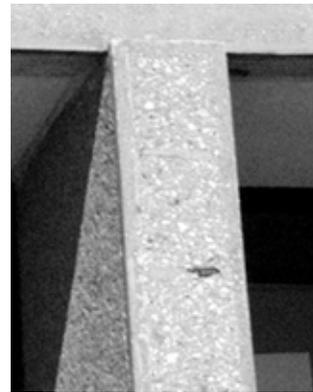
**Figure 19** Left, detail of typical pier showing exposed-aggregate panels with smooth-troweled border (National Park Service, 2000)

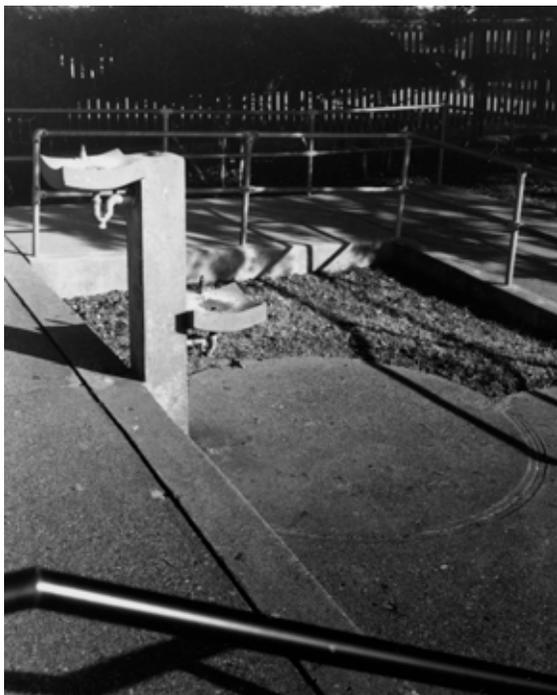
**Figure 21** Below, view of original, cast-concrete, water fountains on northeast side of entry terrace. Note original circular pavement at grade and modern ramp and railing. (National Park Service, 2000)

designed for the east side of the Entry Terrace near the rest rooms. No longer operative and now beginning to deteriorate, the fountain features two concave, squarish bowls, one accessible from the Entry Terrace and the other accessible from a semi- circular, ground- level, concrete pad along the east side of the Terrace.

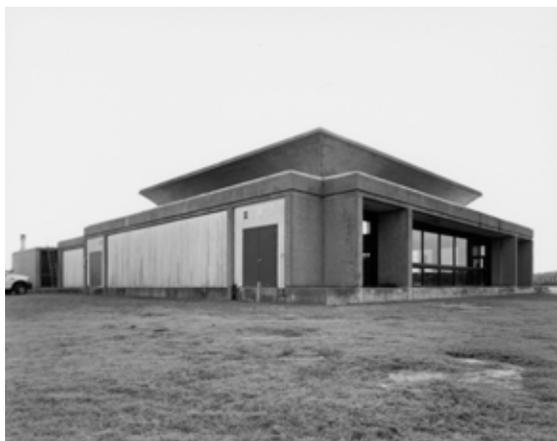
**Figure 25** Above, view of northwest corner of building showing modern window system at right, white "Shadowform" panels and infilled window bays on north side of building at left (National Park Service, 2000)

In 1976, in conjunction with replacement of the building's windows and doors, the exterior wood paneling was covered by the existing extruded- aluminum panels. Marketed under the name of "Shadowform" by Kawneer Architectural Products, who also produced the present window- wall system, these panels are finished with a white "Silica Bond" coating that was meant to mimic the appearance of textured concrete surfaces. The loss of the vertical wood paneling on the exterior is, with the window replacement, one of the most significant alterations to the structure's historic appearance.

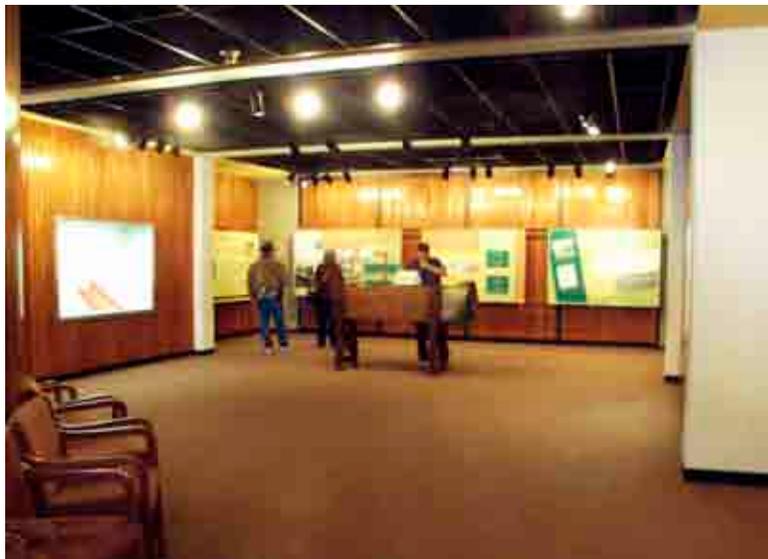
**Figure 31** Below, same view, today (National Park Service, 2000)

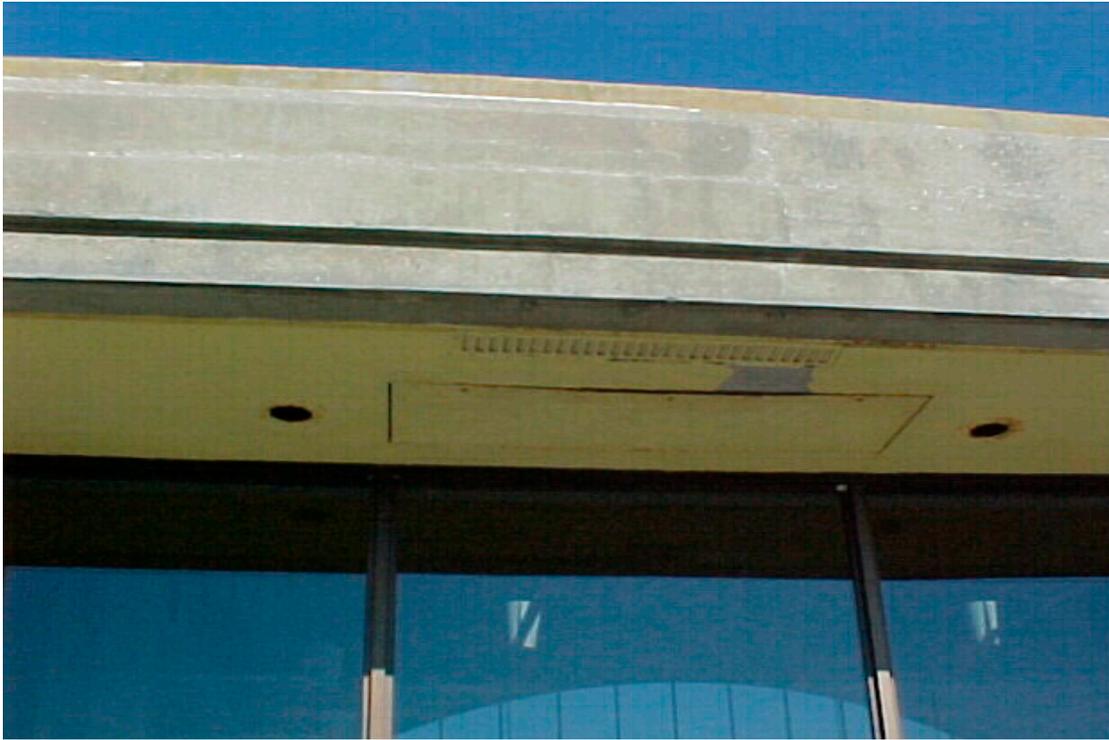
Analysis of paint sample P002 removed from the cement-based plaster soffit at the west side of the building indicates that this element of the building was originally painted light-yellow falling between Munsell colors 2.5Y 9/2 and 2.5Y 9/4 (2.5Y 9/3) and more closely matching Benjamin Moore "Moor-O-Matic" color #170. This finish was applied over a cream-white colored primer. The original light-yellow finish was subsequently replaced with a red-colored paint similar to the 4<sup>th</sup> paint layer found on the sample removed from the metal fence post (see item C below). In later years the red-colored finish was replaced with a bright-yellow finish, a light yellow-colored finish similar to the original finish and finally with the existing "canary" yellow-colored finish we see today.

**Fig. 1** Detail of Facia and Soffit of Wright Brothers National Memorial Visitor Center, West Elevation, (2000).

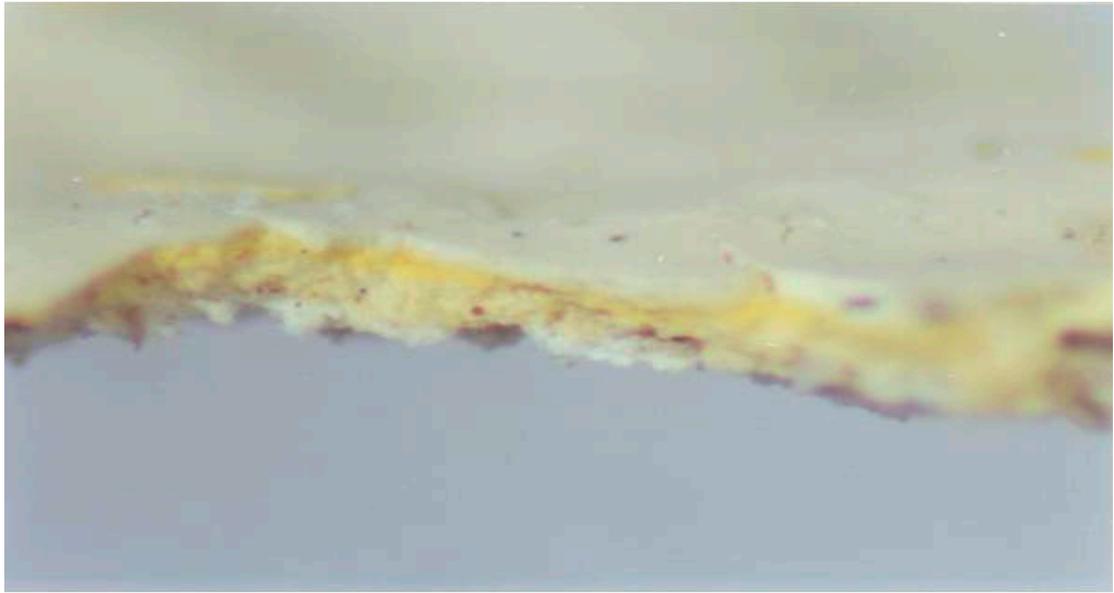
**Fig. 2 Paint Sample WRBR-VC-P002 removed from Exterior Facia of Wright Brothers National Memorial Visitor Center, Viewed at 30x. Note Original Light-Yellow Finish and Cream-White Primer Beneath Later Bright Yellow Finish (Intermediate Red-Colored Finish is not Visible in Photograph), (2000).**

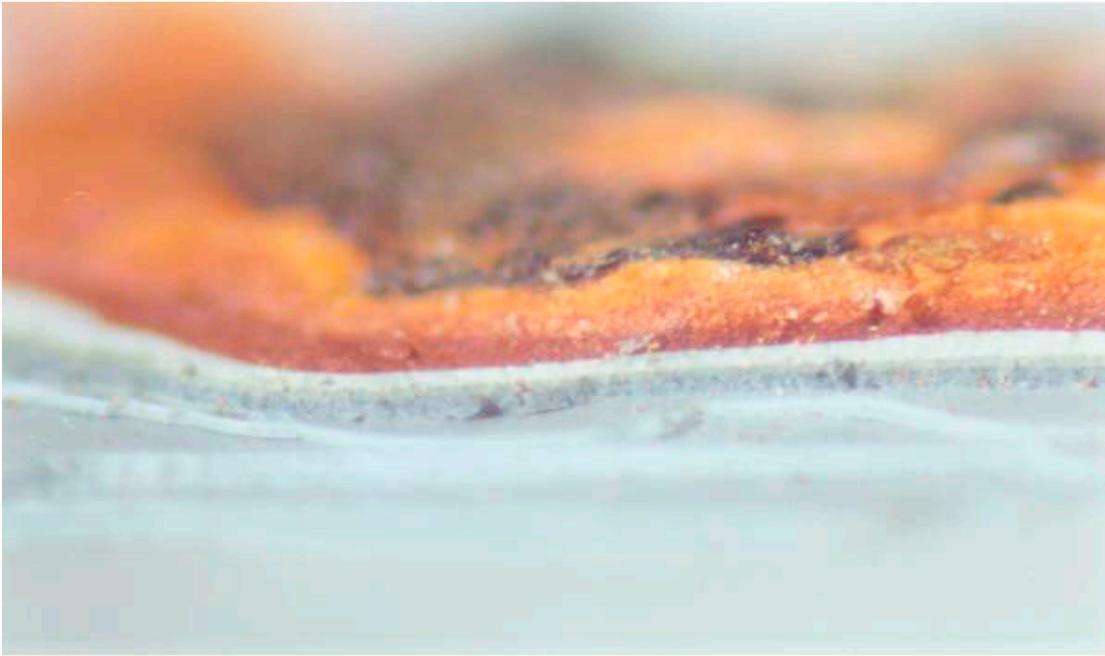
Original painting specifications for the building indicate that exterior ferrous metal elements were to be painted with a rust inhibitive primer and 2 coats of “Noxide” metal paint. Under microscopic examination of paint sample P003 removed from the western most metal fence post located east of the Visitor Center, a light orange-colored primer can be seen beneath what appears to be the 2-coat original finish applied to the fence posts. This original finish is an orange-colored paint matching Munsell color 2.5YR 6/16. This finish was subsequently replaced with a red-colored paint and later with a series of gray-colored paints. The red finish which matches Munsell color 10R 3/4 is very similar to the second finish found in the sample removed from the buildings exterior soffit and was likely applied in the late 1960's or early 1970's based on the number of subsequent paint layers found on these elements.

**Fig. 3** Paint Sample WRBR-VC-P003 removed from Fence Post East of Wright Brothers National Memorial Visitor Center, Viewed at 30x. Note Original Orange Finish and Primer Coats. Later Red-Colored Finish is Believed to Date from Late 1960's or Early 1970's, (2000).

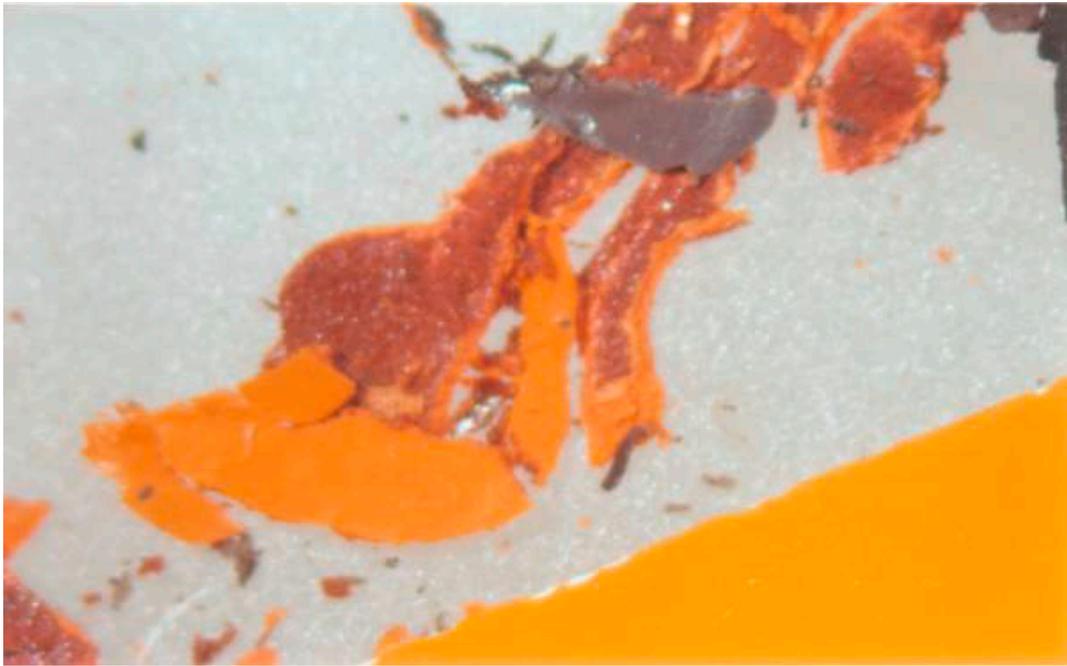
Analysis of paint sample P006 removed from the metal trim at the room's east wall indicates that these elements of the room were originally primed with a red-colored metal primer and an orange-colored paint primer. Over the orange paint primer was applied the element's original finish coat, which was an orange-colored paint matching Munsell color 2.5YR 6/16. This orange-colored finish was subsequently painted over with a dark brown-colored paint and later with the existing brown-colored paint we see today.

**Fig. 4 Original Orange-Colored Finish and Primers Found on Interior Metal Trim of Wright Brothers National Memorial Visitor Center (Munsell Color Chip 2.5YR 6/16 Visible in Lower Right Corner of Photograph), (2000).**

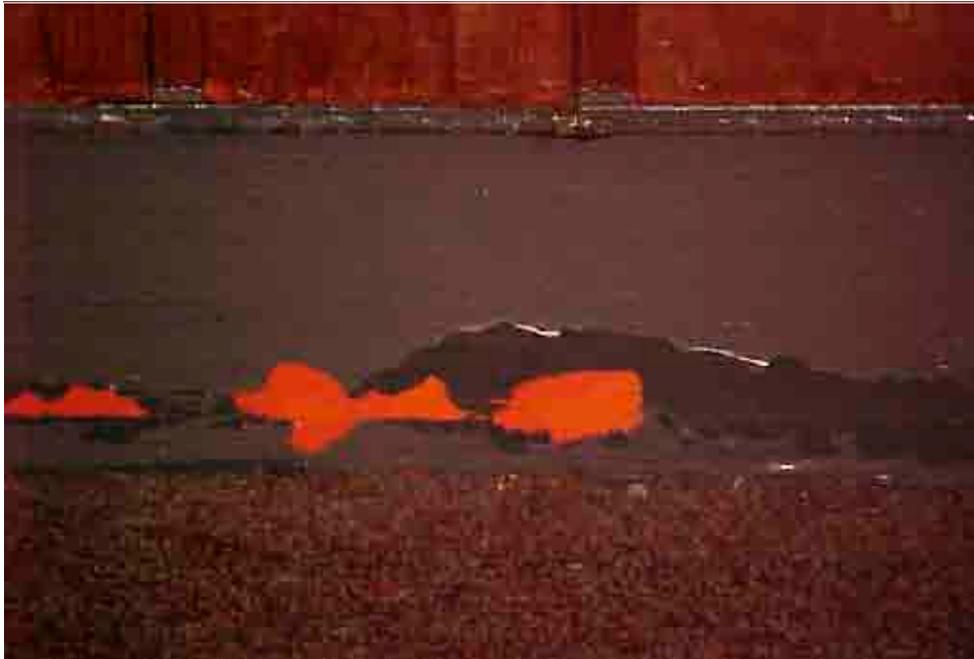
Analysis of paint sample P018 removed from the metal trim associated with the east wall of the room shows that this element was originally finished with an orange-colored paint matching Munsell color 2.5YR 6/16. Subsequent finishes found on this element of the room include an even brighter red-orange colored finish, as well as subsequent yellow-orange, dark brown and brown-colored paint finishes.

**Fig. 8 Detail of Metal Baseboard Trim in Assembly Room of Wright Brothers National Memorial Visitor Center. Note Original Orange Finish, and Later Red-Orange, Dark Brown and Brown-Colored Finishes, (2000).**

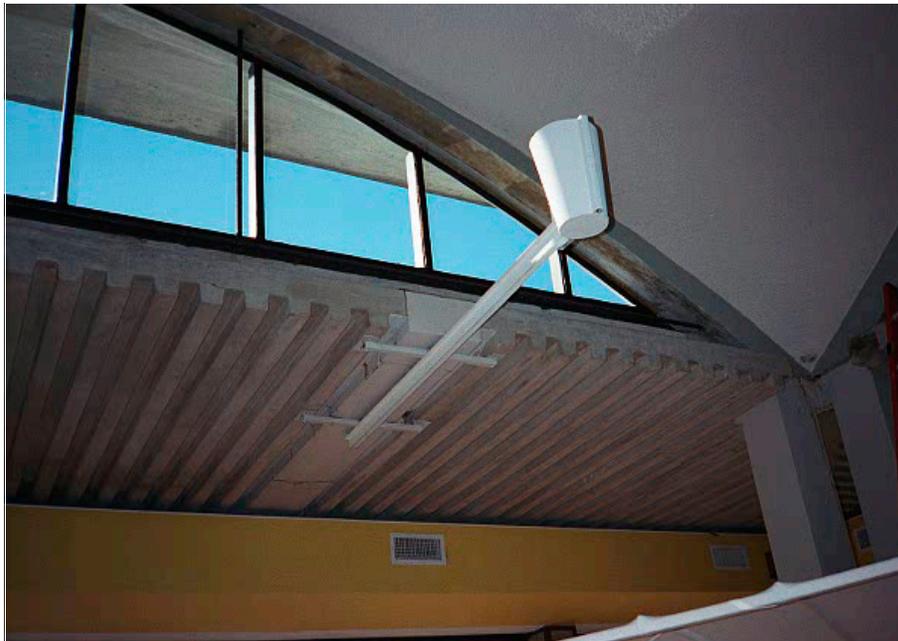
The soffit mounted lamps and support brackets found in the Assembly Room were originally finished with a dark blue paint matching Munsell color 10B 2/6. This finish was applied over a dark blue-colored paint primer and a gray-colored metal primer. The lamps were painted twice more in their history with an off-white colored finish and the existing white-colored finish.

**Fig. 10 Original Lamp, Mounting Bracket and Metal Conduit Box Located Beneath the Concrete Soffit of the Assembly Room, Wright Brothers National Memorial Visitor Center, (2000).**

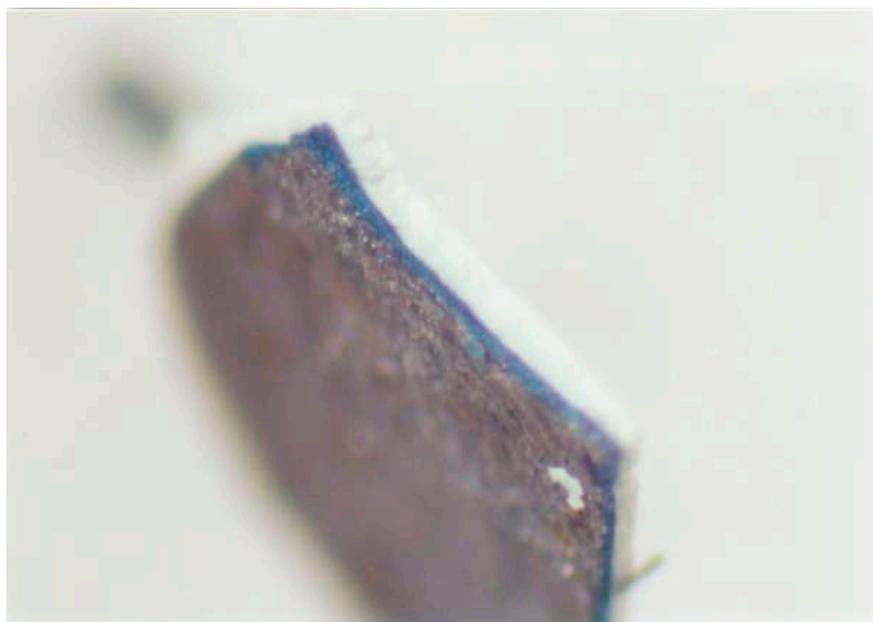
**Fig. 11 Paint Sample WRBR-VC-P024 removed from an Original Light Fixture in the Assembly Room of the Wright Brothers National Memorial Visitor Center, Viewed at 40x. Note Original Zinc Powder Metal Primer, Dark Blue Paint Primer and Original Dark Blue Finish, (2000).**

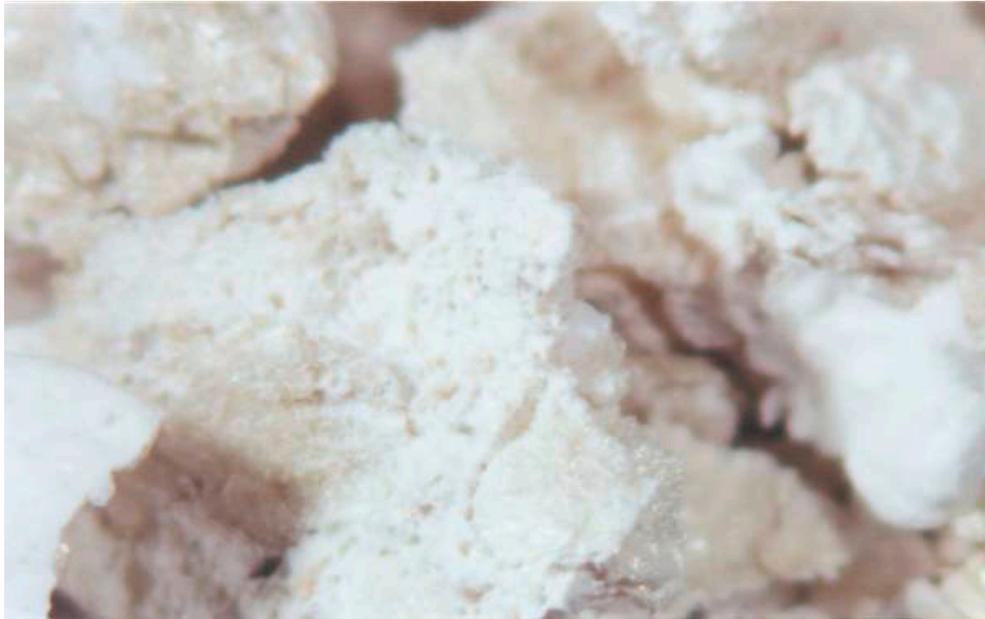
Paint sample P028 removed from the domed ceiling of the Assembly Room showed a single white-colored paint finish applied to what is believed to be replacement acoustical spray material consisting of mica, gypsum and possibly vermiculite materials. Examination of the sample under a polarized light microscope at 40X also verified the absence of asbestos fibers, which the original ceiling material is purported to have contained.

**Fig. 12** Replacement Acoustical Ceiling Material, Wright Brothers National Memorial, Visitor Center, Assembly Room, Viewed at 10x, (2000).

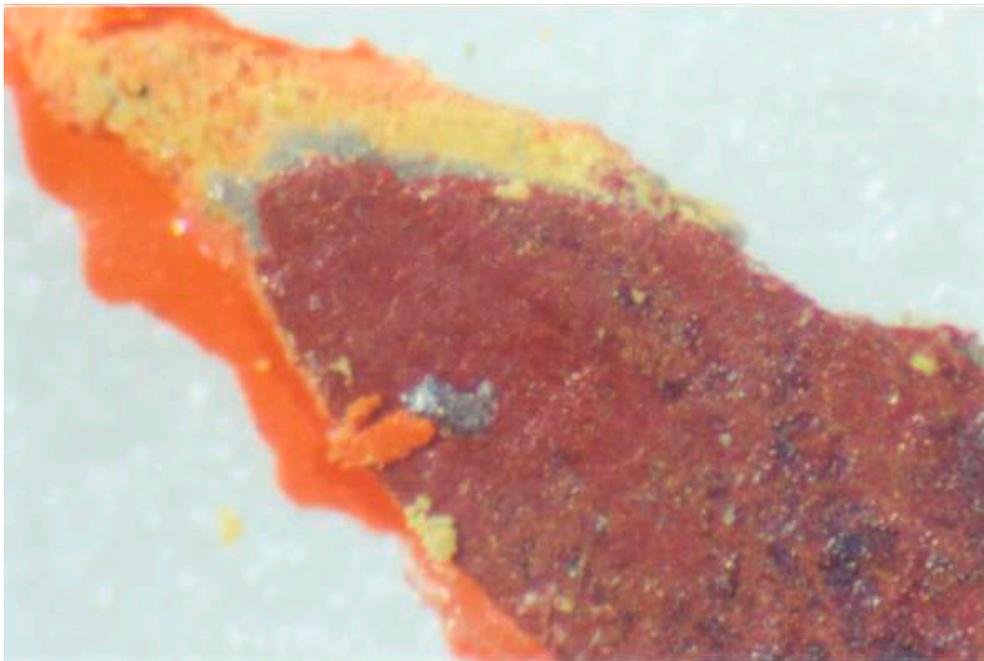
Analysis of paint sample P031 removed from the door jamb of the building's Janitor's Closet indicates that like all of the metal trim work found in the building, the door jambs of the Office Area were also originally finished with an orange-colored paint matching Munsell color 2.5YR 6/16. This finish was applied over a lighter orange-colored primer, as well as original light-yellow paint from the adjacent wall surface. Also present beneath the original orange-colored finish is a "shop" applied red-brown primer and what is likely a touch-up primer specified in the building contract at page 15-3 (Painting and Caulking). Subsequently, three other finishes were applied to this element; the brighter red-orange colored finish found as the second finish on the metal trim work throughout much of the building; a dark brown-colored finish; and the brown-colored paint we see today.

**Fig. 13 Paint Sample WRBR-VC-P031 Showing Original Red-Brown and Gray-Colored Primers, Yellow-Colored Paint Found on CMU Wall Surfaces, and Orange-Colored Paint Found on Door Jambs in Office Area of Wright Brothers National Memorial, Visitor Center (Viewed at 50x), (2000).**

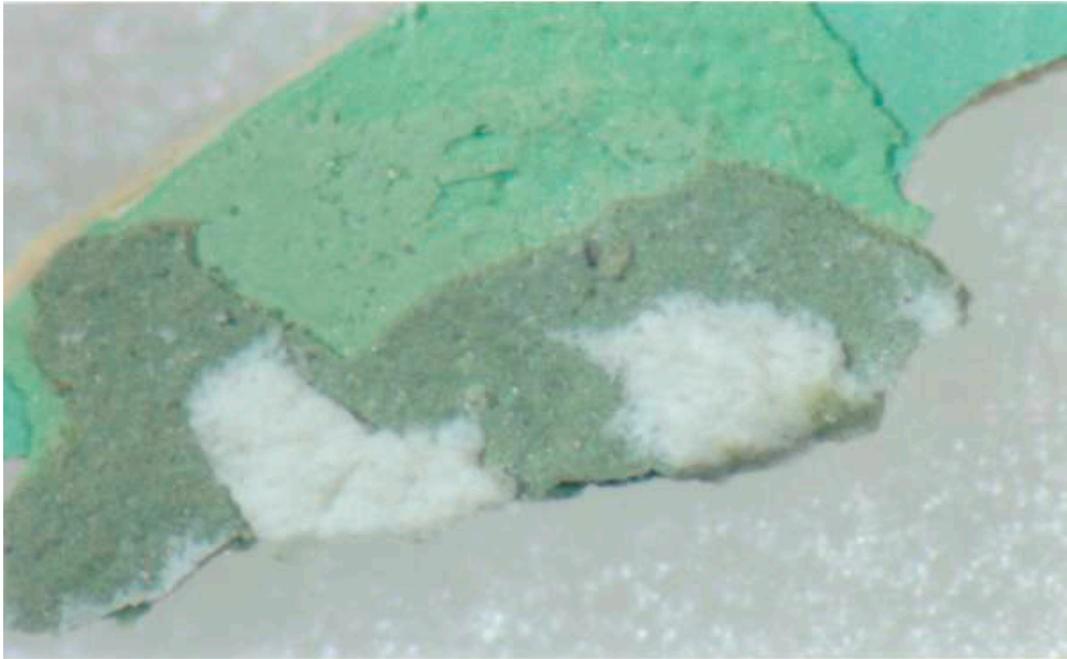
Analysis of paint sample P032 removed from the door of the Janitor's Closet shows that this element of the building was originally painted green matching Munsell color 7.5GY 5/2. Later finishes applied to the door's surface include two lighter green-colored finishes as well as a cream and the white-colored finish found on the door today.

**Fig. 14 Paint Sample WRBR-VC-P032 Removed from a Door in the Office Area of the Wright Brothers National Memorial Visitor Center, Showing Original Green-Colored Paint and White-Colored Primer (Viewed at 30x), (2000).**

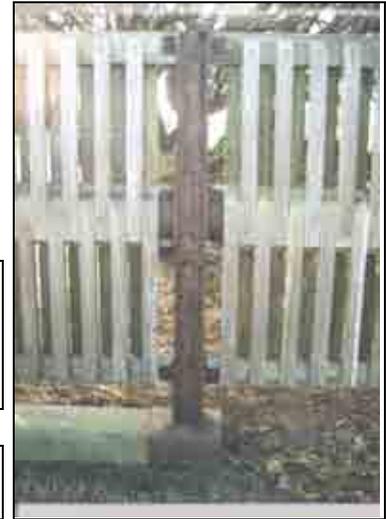
**Feature Condition:** Poor

**Deficiency:** Steel posts are substantially corroded and pitted due to exposure to the elements. Existing wood on remaining original section of fence may not be original but dimensions appear to be faithful to dimensions on original drawings. Wood to wood mechanical attachments appear to be new and either stainless or galvanized.

**Recommendation:** Replace original fence at two locations shown on original site plan to match details in original drawings.

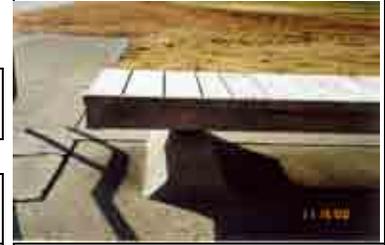
**Deficiency:** The wood bench is not original. The cove bases appear to be original.

**Recommendation:** Reconstruct bench to match original design and detail. Restore concrete bases.

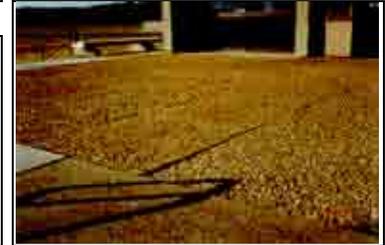
**Deficiency:** Surface deterioration in exposed coarse aggregate areas from freeze thaw and use. The fine aggregate band is inappropriately altered by the introduction of replacement panels that do not match the original in color or texture. The replacement panels are a cool light gray and textured with a broom finish.

**Recommendation:** Consideration should be given to the approach to improving the condition of the 4'x4' exposed aggregate units. Alternatives could range from concrete restoration to replacement. The 9" band of broom-like finished concrete should be replaced to match the original finish, unit dimensions and color. Reposition handicapped ramp to not intrude on front approach. Replace ADA railings at the front entry with rails of a design and detail more appropriate to the character of the original design.

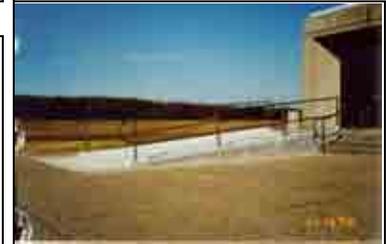
**Deficiency:** The condition of the ceremonial terrace is similar to the condition of the entry terrace. The lower level of the ceremonial terrace is exposed large aggregate, while the upper presents a fine aggregate exposure. The primary deficiencies include: eroded concrete in exposed large aggregate area, not critical but noticeable; inappropriate ADA ramp intruding into the plaza area; replacement of upper sections of slab with concrete of inappropriate color and texture; installation of inappropriate ADA railings in style of railing and method of insertion into the concrete surface.

**Recommendation:** The treatment of the ceremonial terrace is similar to the entry terrace. Consider the repair/replacement of the exposed large aggregate areas on the lower terrace where appropriate to match the historic character in texture, color and dimension. Remove and reconsider the ADA ramp to and from the building. Replace non-historic upper terrace concrete units to match original in color, dimension and texture. Remove handicapped railings and replace with detail more sensitive to the design of the original building.

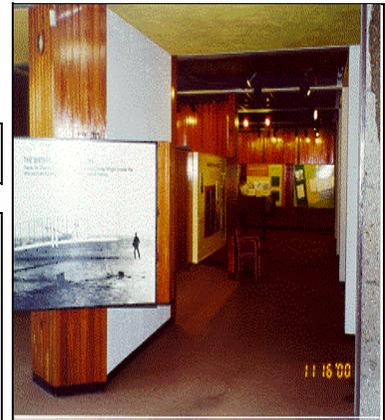
**Deficiency:** Only the deviation from the apparent original layout as stated above.

**Recommendation:** Preserve, protect, and, as appropriate, restore to match original. The exhibit issue is one for further discussion related to the expansion of the visitor center and museum. From a preservation standpoint, the exhibits appear virtually unchanged from those indicated in the original architectural drawings. It is significant to note that the exhibit design is a part of the architectural solution. However, a reconciliation between the preservation objectives and the interpretative objectives must be reached in defining an approach to the historic exhibits.

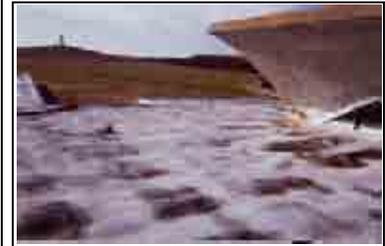
**FEATURE INVENTORY: ROOF****Surface - Structure - Chimney - Flashing - Downspout****All Estimable Items**

**Feature Description:** The roof is installed in two primary conditions, a flat horizontal application and an application on the dome. The material appears to be a blown on dense foam roofing material with white film coat over foam layer. The roof was installed in 1982. From a cursory review of the records, it appears the roof was a poor performer from the outset. A slight tapered insulation was installed with the roof, though any benefit the taper was to provide was lost in the gross distortion of the roof presumably caused by exposure to the elements. The on-site staff indicate the foam roof over-coating has been re-coated several times in recent years. From testing in several locations, the flashing at the roof edge is copper. It is either original flashing or the flashing application is of advanced quality than the existing roof type.

**Feature Condition:** P **Total Inventory:** 2,862 SF of Dome Area  
9,667 SF of Flat Area

**Deficiency:** Roof leaks. Emergency patching has taken place in recent weeks. However, this action should only be considered temporary and in the shortest term.

**Recommendation:** Replace existing roof with new roof. Follow original design intent with the consideration of modern variants of original built-up roof. Consider modified bitumen roof or "Hydrostop" type roof.

1. Investigate the full strata of the existing roofing material.
2. Appropriately remove and dispose of existing roofing components to original deck.
3. Repair structural deck if necessary and according to findings when roofing and, if present, insulation, is removed.
4. Design new roofing application. Coordinate with Flashing (See entry for Flashing below)
5. Install new roof membrane as per plans and specifications prepared in #4 above.

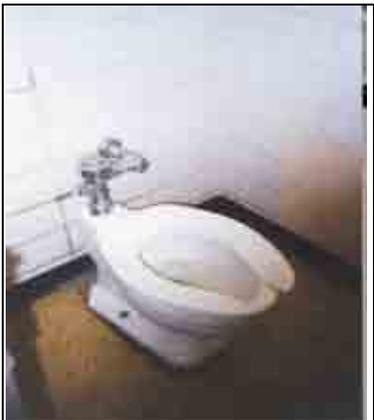
**Deficiency:** Water closet designated for handicapped is not mounted at proper height for handicapped accessibility.

**Recommendation:** Mount water closet at handicapped accessible height - 17" to 19" from floor to rim. If rough-in piping cannot be reworked, provide 3" seat for elongated bowl.

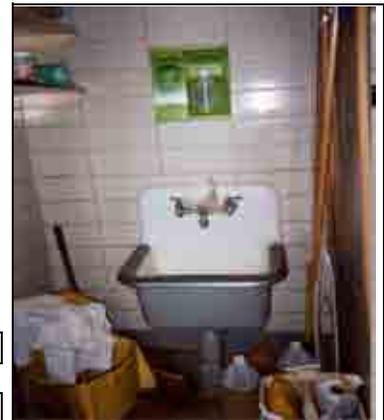
**BLDG/GRDS UTIL 5813 Plumbing Fixture - Water Closets in Employees' Toile**

**Feature Condition:** Good **Total Inventory:** 1

**Deficiency:** None

**Recommendation:** None

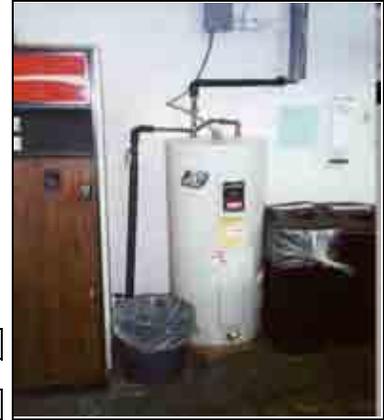
**Deficiency:** None

**Recommendation:** None

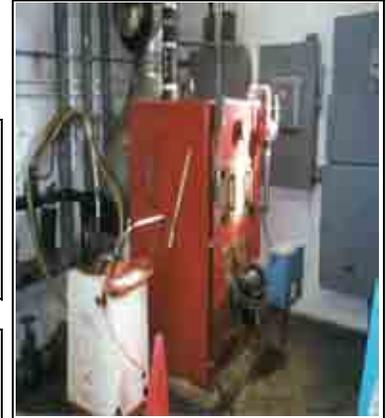
**Deficiency:** The boiler has been in operation for 32 years. Although the unit appears to be of sturdy construction, major replacement parts may not be available from the manufacturer. The expected service life of this type of boiler is approximately 35 years, based on conversations with the manufacturer's representative. It has reached the end of its serviceable life. Also, the boiler was installed less than 3 feet from the electrical panels, which does not meet code requirements for servicing.

**Recommendation:** Replace the boiler with a higher efficiency boiler large enough to satisfy the heating requirements of the building. Determine a new location for the boiler which would meet code servicing requirements or relocate the electrical panels.

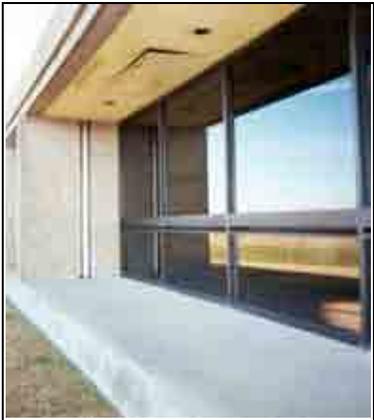
**Deficiency:** Deteriorating systems with inadequate capacity.

**Recommendation:** This is a critical issue due to the careful integration of the original system into the building design. Redesign of a system for this building should be accommodated in spaces that do not intrude on the character of the original spaces.
