CULTURAL LANDSCAPE REPORT, AQUATIC PARK

SAN FRANCISCO MARITIME, NATIONAL HISTORICAL PARK

**NATIONAL PARK SERVICE
PACIFIC WEST REGION
2010**

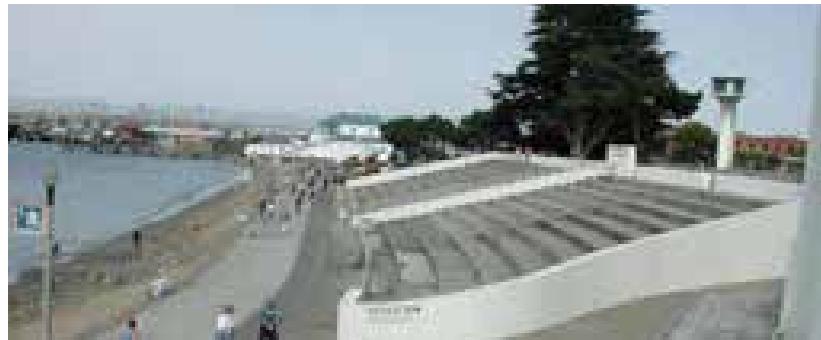
Figure 56. East Bleachers prior to rehabilitation work. View looking east. (NPS, 2007)

shower facility. It is now used for the park's exhibit staff office, workshop, and storage. The space under the East Bleachers includes the original hospital that was used by the NPS as a lifeguard station and now as an office for the facility management division. The rest of the space under the East Bleacher is used for a metal shop, machine shop, and facility maintenance storage. The West Bleacher measures 30 x 100 feet and comprises four rows of seats. The space beneath the West Bleacher is used as a ceramics studio by the Senior Center and was formerly office, work and storage space for the park's grounds crew. Once the bleachers are rehabilitated, grounds crew will move into the East Bleachers and their former space will become offices for park rangers. (Figure 56)

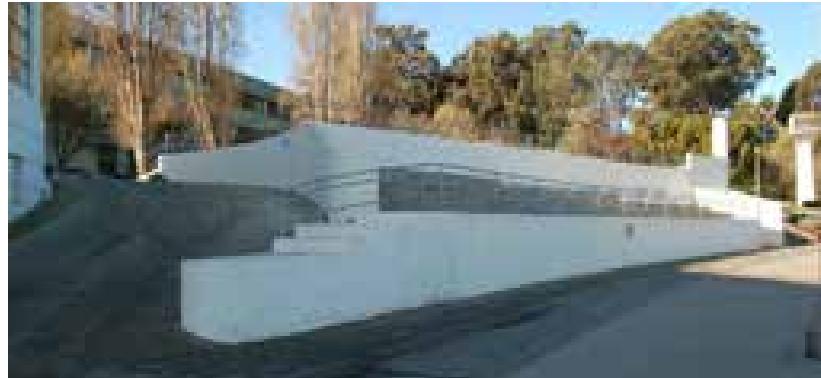
Figure 57. West Bleachers prior to rehabilitation. Note the ramp between the bleachers and the Bathhouse. View looking southwest. (NPS, 2007)

Between the Bathhouse and the bleachers, vehicular ramps lead from Beach Street to the Beach Promenade. (Figure 57) These ramps curve around the east and west ends of the Bathhouse, and repeat the elliptical forms characteristic of the complex of buildings and structures in Aquatic Park. Metal handrails, similar to those forming the Bathhouse parapet rails, separate the bleachers from the Beach Promenade and line the entryway, in the center of the east bleachers to the Bathhouse changing rooms.

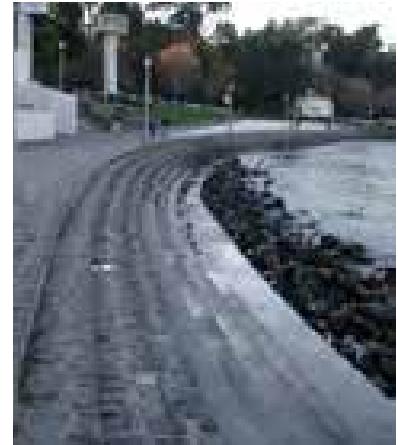
During initial development of Aquatic Park, the WPA designed and constructed a seawall along the cove to reinforce and stabilize the shoreline prior to excavation and construction of the Bathhouse. Concrete foundations were prepared, and between 1931 and 1933, thousands of cobblestones were transported to the site in order to construct the seawall. As built, the wall gradually rises from seven to ten steps as it moves westward, maintaining a level elevation along the top of the structure, following the shoreline of the cove to the base of the Municipal Pier. The earlier rubble and concrete seawall haphazardly constructed in 1931 near the Municipal Pier was torn down, and the base of this structure was used as the foundation for the new wall.¹⁰ Today the seawall extends from the east end of the park near the East Convenience Station to meet the Municipal Pier. (Figure 61) Where it meets the Municipal Pier, the seawall is largely above grade.

Figure 61. One of the earliest structures built by the WPA, the Seawall wraps around the cove, creating a hard edge between the water and the Beach Promenade. View looking west. (NPS, 2007)

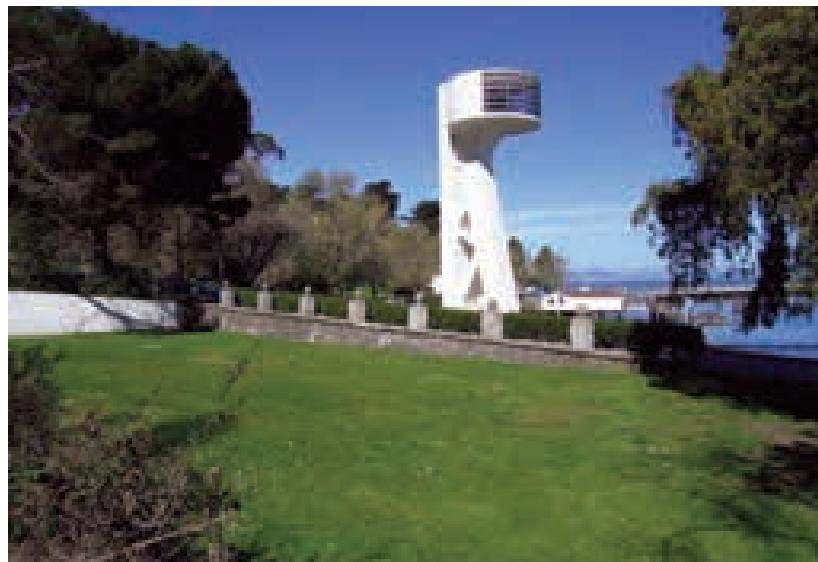
Figure 62. West Speaker Tower. View looking north. (NPS, 2007)

across the face. (Figure 62) A metal ladder providing access to the back of the speaker housing has been removed. The cover grille on the East Speaker Tower has also been removed (but will be repaired and replaced). Like other structures built by the WPA, the speaker towers were designed by William Mooser Jr. in the Streamlined Moderne style, and are integral structures in the designed landscape. Planting beds at the base of each tower historically incorporated plants that were maintained in a manner that reinforced the architectural character of the towers.

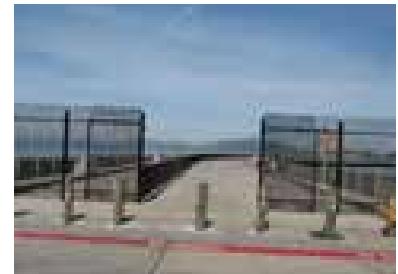
Today the pier is in very poor condition due to saturation by seawater and deterioration of metal rebar. In 2008, the park installed a fenced gate at the entrance to the pier for safety reasons, and in 2009 most of the west (bay) side of the structure was also fenced to prevent access to the most deteriorated portion of the structure. The National Park Service is in the process of planning a major rehabilitation project to repair and stabilize the structure. (Figure 64)

Figure 64. Fencing was added to the Municipal Pier in 2008 and 2009 to enhance safety until structural improvements can be completed. View looking north. (NPS, 2010)

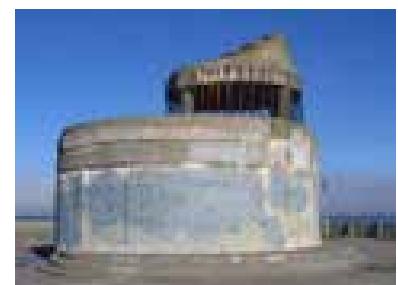
The convenience station and lifesaving station at the end of the pier was less than 50 percent complete when the WPA turned the project over to the city. These structures remain unfinished today. The circular building was designed to match the other two convenience stations in Aquatic Park. Only the rough concrete exterior was constructed. Access to the unfinished building is by bolted hatches on the roof. The interior rooms are currently filled with rubble and water. (Figure 65)

Figure 65. The unfinished convenience station at the end of the Municipal Pier. (NPS, 2007)

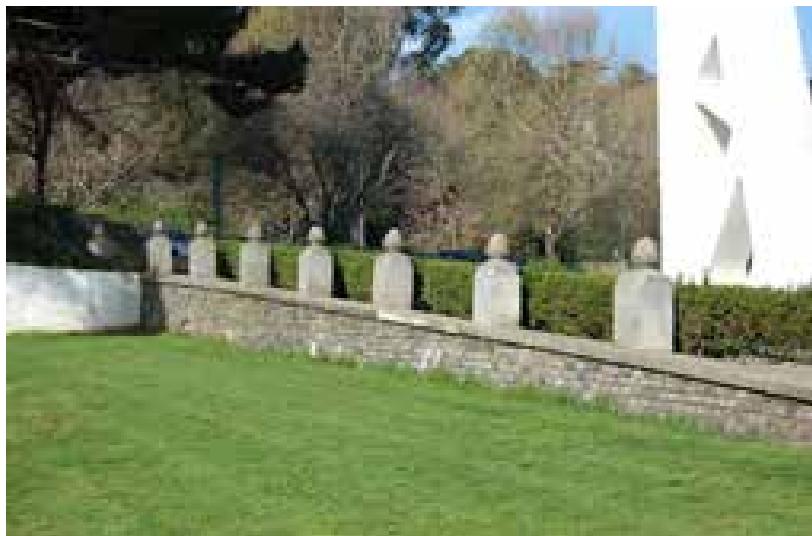
Figures 67. Stone masonry retaining wall as it appears today near the Bocce Ball Courts. A considerable amount of backfilled was used after the pumping station was removed to create a level grade on the south side of the structure. View looking west towards Van Ness Avenue. (NPS 2007)

exception of a single acorn finial, the east section of the wall is largely buried and the west side, including the curved portion of the wall, was removed at an unknown date. (Figures 66, 67)

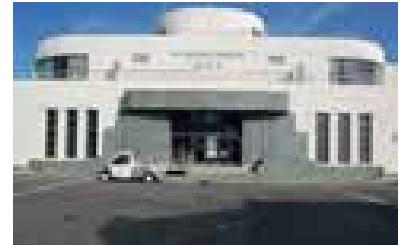
Figure 86. Front façade of the Bathhouse. View looking north. (NPS, 2006)

- Restore and maintain the historic slate façade on the south side of the building as the primary entrance to the building. (**Figure 86**)
- Restore the historic planting beds on both sides of the entry (see the section, “Recommendations: Vegetation, Bathhouse Plantings”).

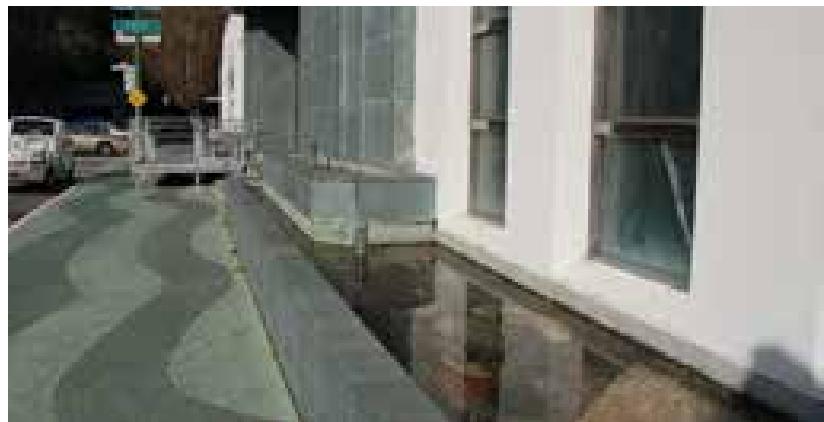
Figure 87. One of the two fountains that flank the entrance to the Bathhouse and could be restored as part of an overall landscape rehabilitation. (NPS, 2006)

- Complete rehabilitation of the fountains on the front (south) façade of the building and complete conservation of the stone and mosaics. (**Figure 87**)

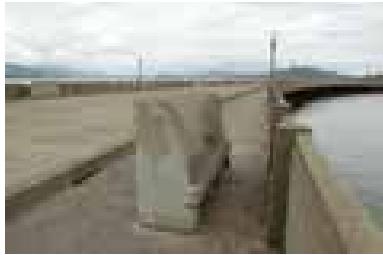
Figure 91. Historic concrete bench, parapet walls and curbing, light standards, and other site features associated with the Municipal Pier. (NPS, 2007)

- Consideration should be given to restoring and/or rehabilitating site furnishings along the decking of the Municipal Pier based on the preferred treatment for the structure. Replacement of these features with replica or “period” furnishings is not recommended. (Figure 91)

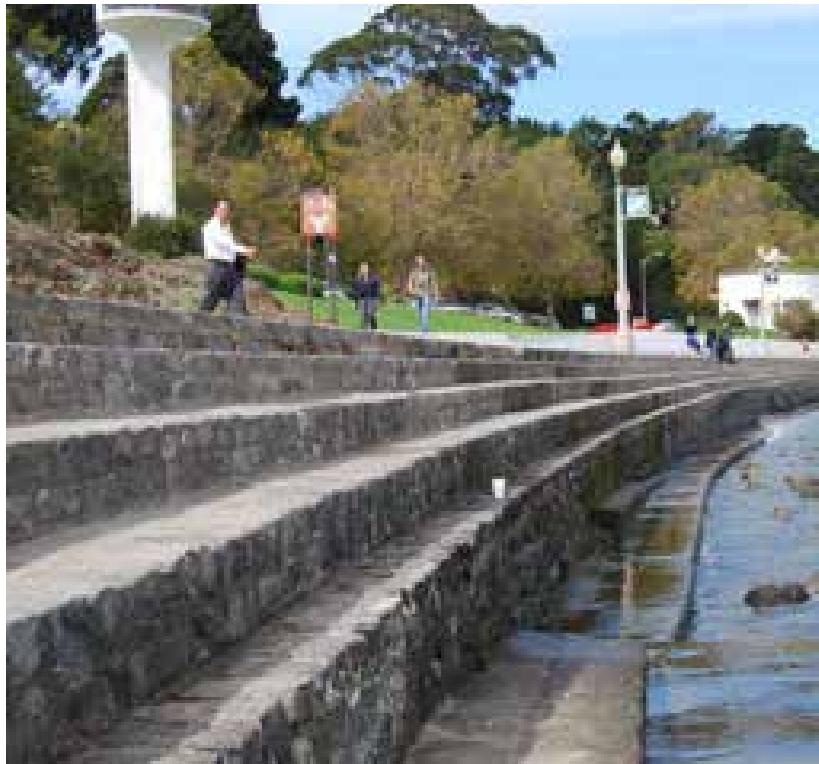
The Seawall and steps that extend the entire length of the cove from the East Convenience Station to the Municipal Pier are generally in good condition, with just a few cracked and missing basalt blocks. Stone curbs throughout the site are also in relatively good condition. Exceptions are a missing section of curb near the Sea Scouts building and damaged curbs near the West Convenience Station. Recommendations address repair and replacement. (Figure 93)

Figure 93. One of the earliest structures built during the historic period, the Seawall around the cove is in relatively stable condition. (NPS, 2009)

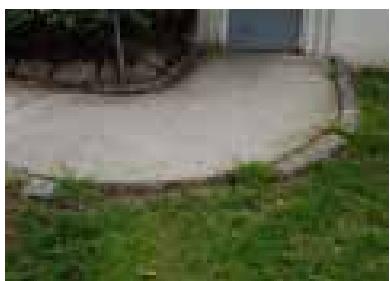
Figure 94. Missing block curbing at the West Convenience Station should be repaired using in-kind materials. (NPS, 2007)

- Replace the missing portion of the stone curbs as needed using compatible materials and appropriate restoration techniques. (Figure 94)
- Repairs to all historic stonework should be done in consultation with a historical architect or preservation mason.

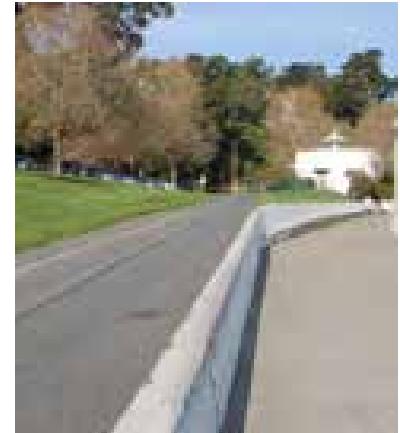
The low concrete retaining wall that borders the Beach Promenade from the West Bleachers to the West Convenience Station shows signs of wear, exposure, and damage resulting from use by skateboarders and bicyclists (“grinders”). Some of the hardware installed on the eastern portion of the promenade wall to discourage skateboarders has broken off, damaging the wall. Recommendations address repair and maintenance.

Figure 95. Concrete retaining wall between the Beach Promenade and the State Belt Railroad tracks. View looking west (NPS, 2007)

- Preserve and protect the integrity of the Beach Promenade Retaining Wall.
- Discourage recreational use by skateboarders. Maintain the use of deterrent bolts on the wall to prevent damage. Although currently damaged in places, existing bolts appear to deter many skateboarders. (**Figure 95**)

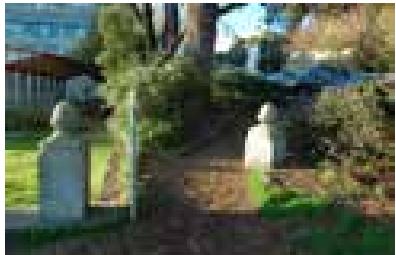
Figure 97. Remnant features of the original stone retaining wall as it wrapped around the park to Van Ness Avenue. View looking south. (NPS, 2008)

The stone retaining wall that borders the Bocce Ball Courts was one of the earliest structures built during initial construction of Aquatic Park. It was built to accommodate site grading for the extension of Van Ness Avenue and the State Belt Railroad grade. Based on historic photographs, the original wall was considerably longer than it is today and the grade difference from one side of the wall to the other appears to have been as much as 20 feet. The city water pumping station was located on the lower side of the wall where the Bocce Ball Courts are today. Photographs indicate that the wall was shortened in 1937 when additional grading was done to accommodate construction of new park buildings. Around 1942 the pumping station was removed and the area on the south side of the wall was backfilled, leaving only approximately 4 feet above grade at its highest end. The wall remains distinctive today for its stone construction and the granite acorn bollards on top of the wall. (Figure 97,98)

- Inspect the wall annually to identify potential structural issues and damage to the stone surface. Repair damaged components in kind, matching materials and finish.
- Integrate preservation maintenance activities for inspection and preservation of the wall into FMSS.
- Ensure that any future park development affecting the historic character of the stone retaining wall (such as development of historic

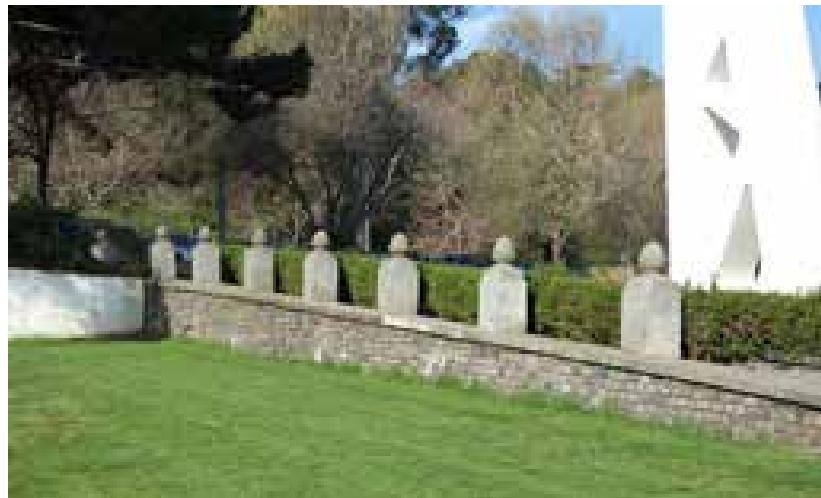
Figure 98. View of the stone retaining wall looking northwest from the lawn near the Bocce Ball Courts. The amount of exposed wall visible in the park today generally slopes to the east based on fill added to even the grade when the pump house was removed in the 1940s. (NPS, 2008)
