Tech Notes

WINDOWS

NUMBER 8

Thermal Retrofit of Historic Wooden Sash Using Interior Piggyback Storm Panels

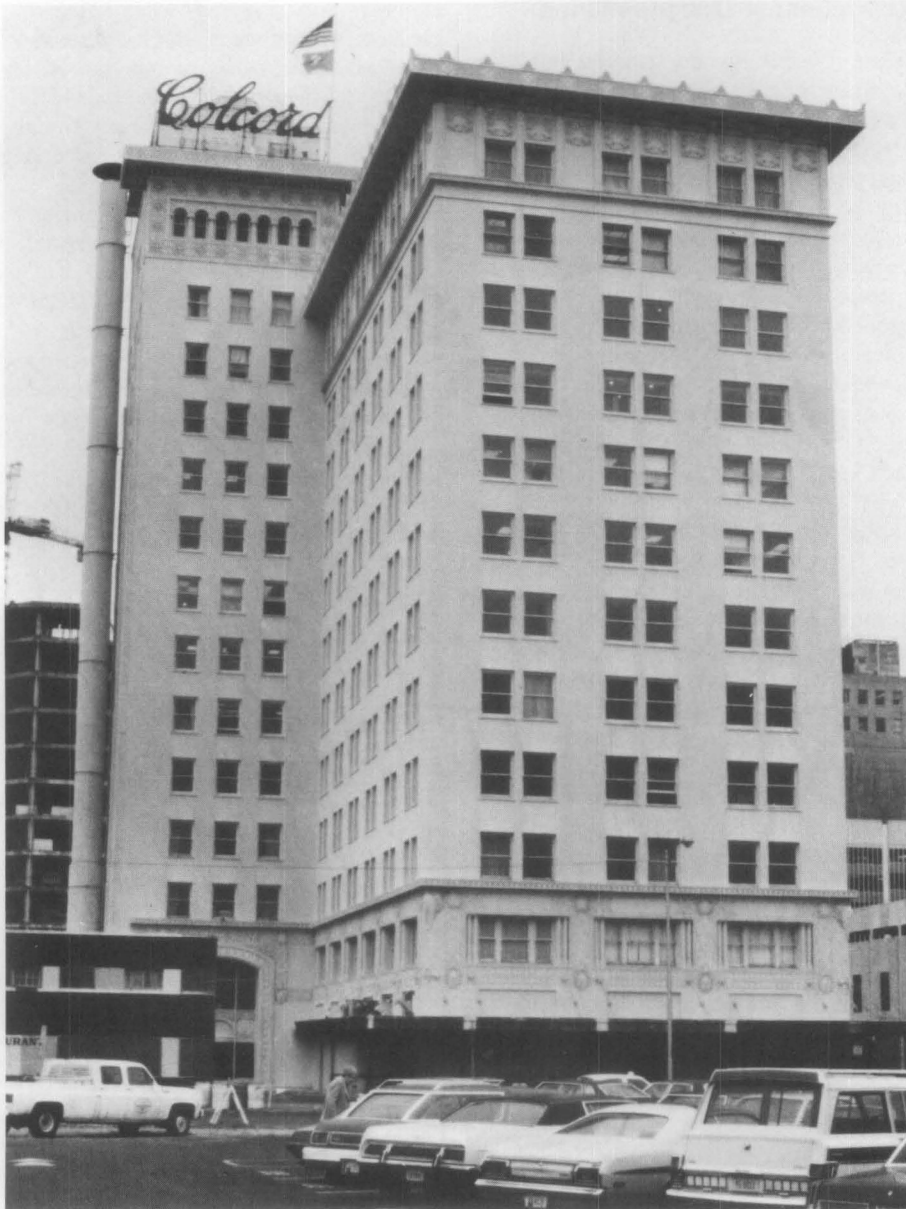
COLCORD BUILDING Oklahoma City, Oklahoma

The Colcord Building, constructed in 1910, is one of the few remaining historic office buildings in downtown Oklahoma City. Designed by William A. Wells, the 12 story concrete structure is elaborately decorated with ornamental terra-cotta panels at the first, second and twelfth floors. The bold scale and setbacks of the wooden windows surrounded by terra-cotta are significant design features of this National Register property (see figure 1).
