## CHALMERS UNITED CHURCH

# Tech Notes

### NUMBER 14

## Reinforcing Deteriorated Wooden Windows

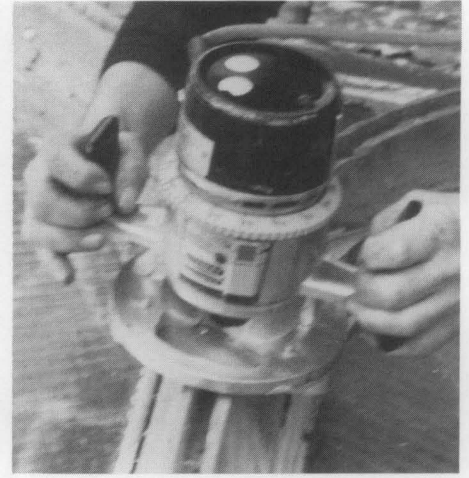
ting bit (see figure 4). Notwithstanding the usefulness of this apparatus, the real success of the operation can be attributed to the skill of the craftsman who guided the tool. The wooden mullions varied in size; on a typical 3 1/4" wide mullion, the outer edge where the groove was cut was 1 1/2" wide. In cutting a 1/2" groove on the outer edge, only 1/2" of wood remained on either side. A slight deviation of the tool could have seriously damaged the mullions.

After the grooves were cut, the wood was treated with a wood preservative on all exposed sides to prevent possible decay. The wood preservative had to be selected with special care because most such products are not compatible with the epoxy resins which were used for the stabilization work. Wood samples were treated with different types of preservatives and tested for compatibility with the epoxies

For reinforcement, 1/4" diameter steel bars (the same type used to reinforce concrete) were painstakingly bent to match the curves of the mullions. The shape of the bars had to be accurate, within a tolerance of 1/8" in any direction, in order to fit comfortably in the 1/2" wide grooves which followed the complex curves of the windows (see figure 5). Because of the deteriorated condition of the wood, the steel bars could not be forced into the grooves without the danger of splitting the frames apart. In a few instances where the steel rods could not be suitably shaped, braided fiberglass strands were used instead.
