**Sears Roebuck and Company Mail Order Store
(Landmark Center)
Boston, Massachusetts**

Preservation
Tech Notes

WINDOWS
NUMBER 20

**Aluminum Replacement
Windows for Steel
Projecting Units with
True Divided Lights and
Matching Profiles**

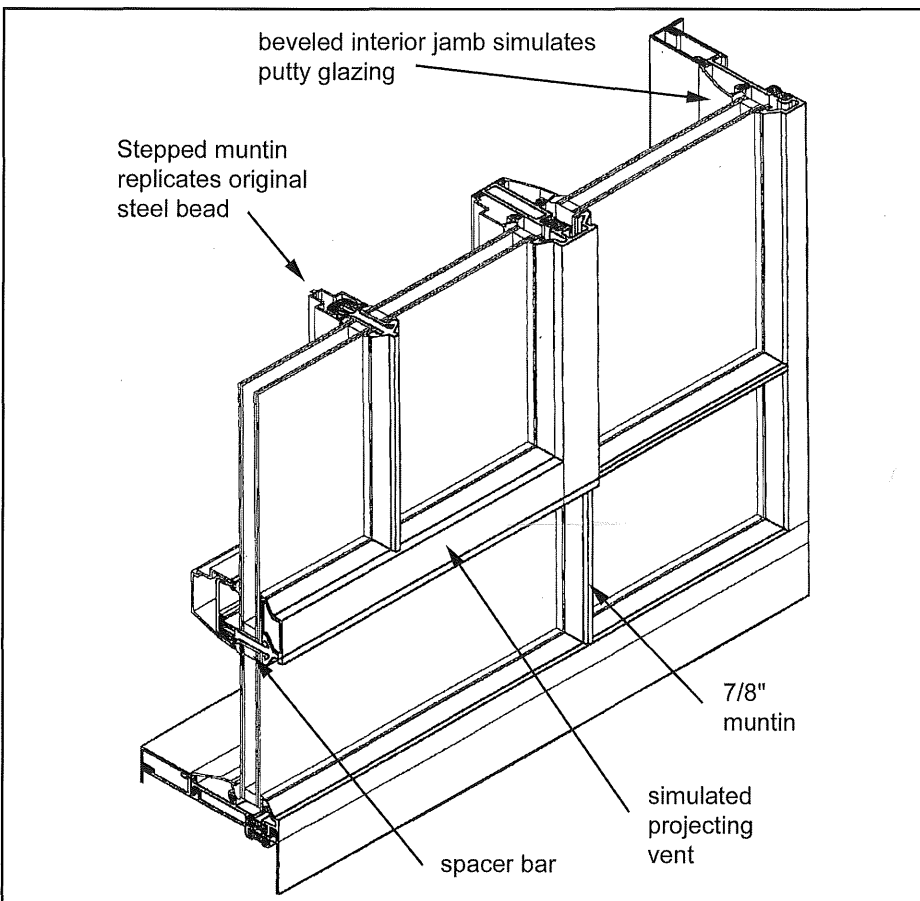
Figure 3. Isometric drawing of aluminum replacement window. Drawing: Greg Gibson.

Each replacement window developed for the Sears building was fabricated from over forty new aluminum extrusions. The large variety of custom designed elements allowed for a faithful reproduction of the original profiles. At the request of the developer, the replacement windows were not operable, yet their appearance suggested the functional nature of the original projecting ventilators. Tabs were added to resemble the weathering flange closed flush against the fixed outer frame, while drip caps shielded simulated hinges. The muntin, rail, head, sill and jamb profiles were also accurately reproduced. In order to replicate shadows cast on the original frames, the manufacturer included cosmetic bolt heads on the mullions running between each of the paired and tripartite window arrangements.
