**552-554 BROADWAY**  
New York, New York

# Preservation Tech Notes

## **HISTORIC GLASS** NUMBER 2

### **Repair and Rehabilitation of Historic Sidewalk Vault Lights**

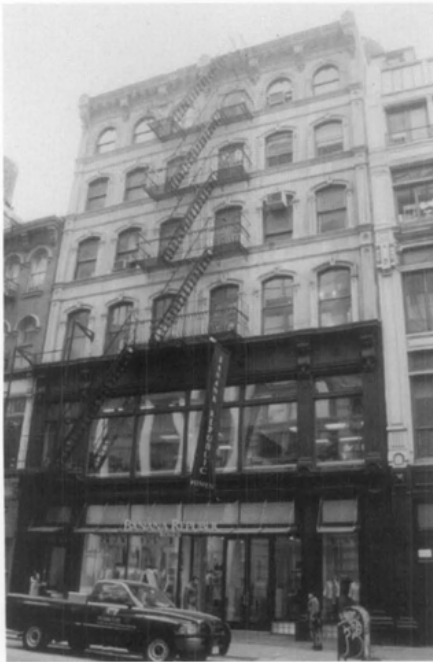
Figure 1. A cast-iron storefront was added to 552-554 Broadway in 1897. The storefront included a fifty-four foot long assembly of cast-iron vault lights set in the sidewalk. Glass lenses in the panels allowed light to enter the basement area, increasing rentable space for the building owner.

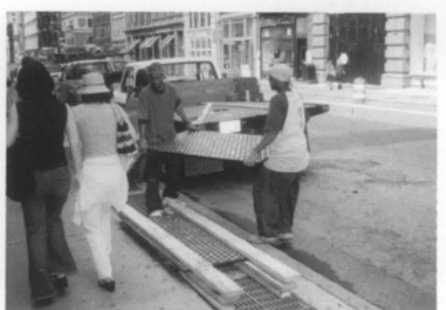
Figure 11. Just prior to installation, each panel was lifted by hand from the back of a truck and stacked on the sidewalk.

Following fabrication, the new panels were shipped to the contractor who set the new glass lenses and transported them to New York City for installation alongside the repaired panels (*see figure 11*).
