# Tech Notes

## WINDOWS

### Planning Approaches to Window Preservation

## MARQUETTE BUILDING

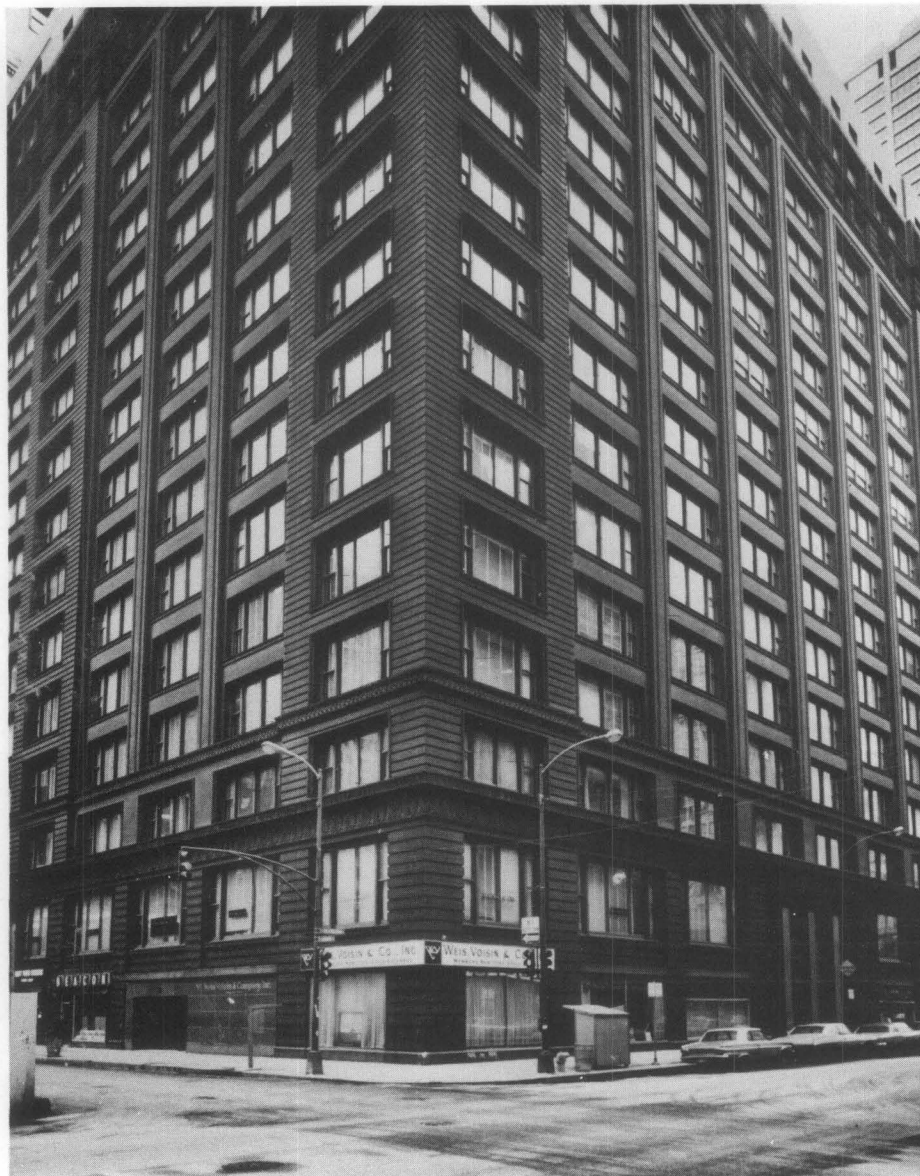
Constructed out of good quality mahogany, the windows were still in sound physical condition despite over ninety years of exposure to Chicago's winter weather and years of neglect due to deferred maintenance (see figure 2). While some of the sills needed repair, the windows primarily needed to be repainted and to have some interior trim replaced. Recaulking around the frames was necessary, but otherwise there was very little air infiltration. The windows had already proven to be very durable and, except for periodic painting, long-term maintenance was expected to be minor. The project architect, Walker C. Johnson, AIA, of Holabird and Root, estimated the life of the windows to be in excess of another ninety years. Even with this information, the architect and owner still had other factors to consider in examining alternatives for the repair or replacement of the windows.

**First Alternative—Window Repair** Repair work needed on the large windows consisted of: (1) repairing ten units where the vertical mullion dividing the two large fixed panes had been changed to accommodate interior partition alterations; (2) installing a fiberglass wrap on approximately 5% of the wood sills where deterioration was a problem; (3) installing approximately 1000 linear feet of new casing trim on the interior to match original trim that was damaged or that had been removed as a result of later partition alterations; (4) repainting the exterior and interior woodwork; and (5) reconditioning the chains, pulleys, sash weights, and hardware in case the windows ever needed to be opened. The estimated cost of this work was \$65,000, including the repair and reinstallation of fixed frames and glass in 28 windows where a material hoist and trash chutes were located during the rehabilitation.
