Tech Notes

WORTHINGTON HOUSE Monocacy National Battlefield Frederick County, Maryland

WINDOWS NUMBER 10

Temporary Window Vents in Unoccupied Historic Buildings

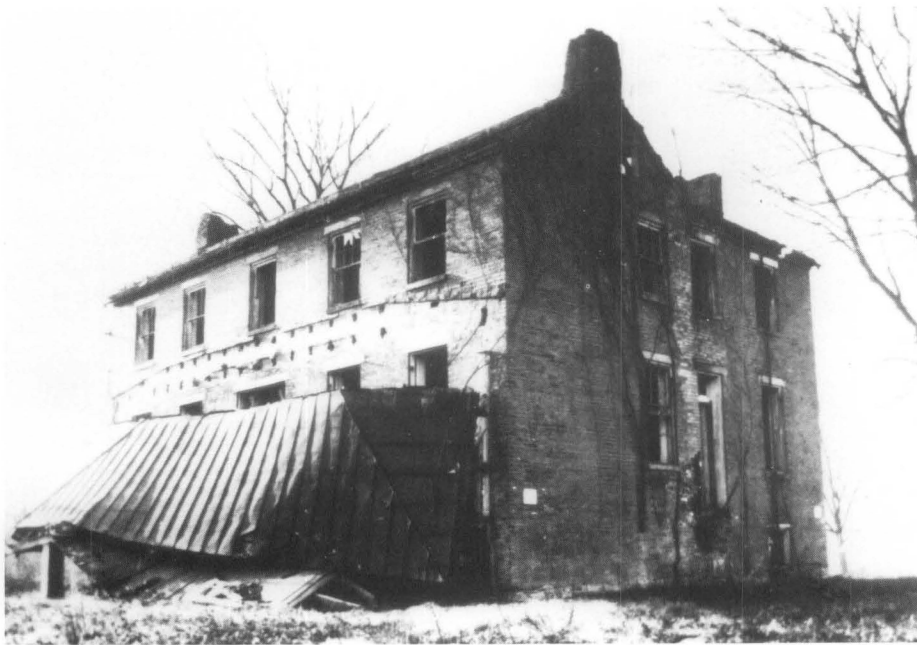
Special care should be taken to provide sufficient ventilation in unoccupied historic buildings to deter fungal decay and condensation damage.
