ALDRIDGE HOTEL
Shawnee, Oklahoma

Preservation Tech Notes

METALS NUMBER 6

Repair and Reproduction of Metal Canopies and Marquees with Glass Pendants

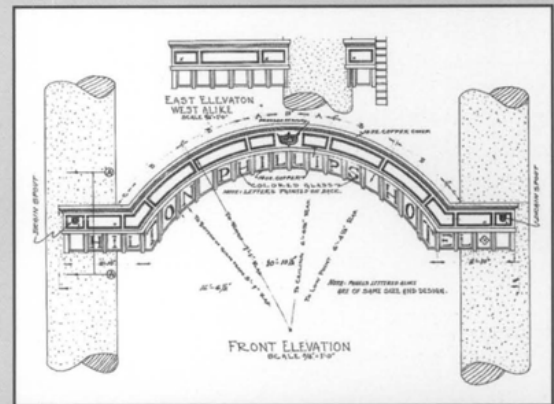
Figure 4. Original drawing for the main south entrance canopy for the Hilton Philips Hotel, later named the Aldridge Hotel. Note the lettering along the front glass panes. Drawing: Courtesy of the Hill Firm.

To install the new panes, a bead of clear silicone sealant was applied in the top and bottom of the metal frame, helping to secure the glass and prevent it from rattling in heavy winds. The glass was then slid into the top receiver and set into the bottom. The side tabs located on the back of the pendant frame were folded over to secure the glass. Since the original drawings showed the building's name painted on the back of the glass panes, this signage was recreated with the current name, the Aldridge Hotel (see figure 4).

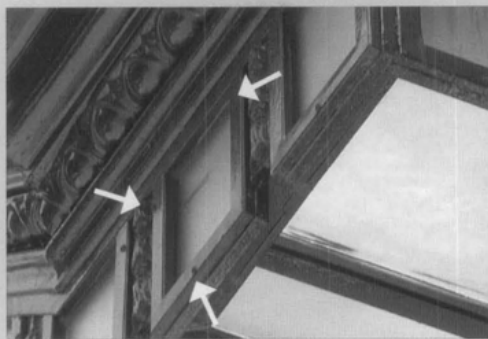
With the simple double-faced pendant frames on the left, the front and back faces are screwed directly to each other as indicated by arrows. The pendants on the right are single faced with the glass held in place by putty. Each pendant is secured to the top of the canopy and to adjacent pendants. Screw connections are indicated by arrows.
