MULTIDISCIPLINARY ACCIDENT INVESTIGATION TEAM NARRATIVE/DIAGRAM

NL-020-18

MAIT SUPPLEMENTAL

- A mechanical inspection of the Forest River to determine if there were any pre-existing conditions that caused or contributed to the cause of the mechanical failure, which potentially caused the fire

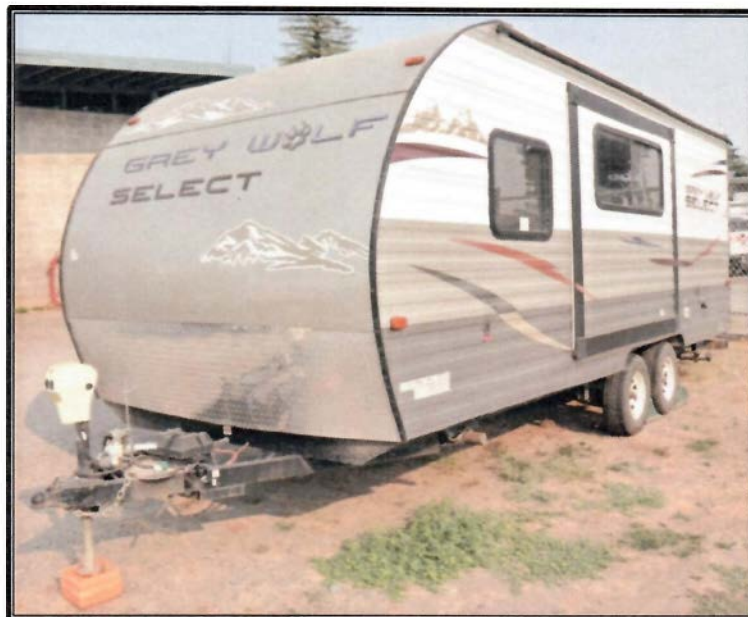
Left Side

The vehicle was a 2013 Forest River, Cherokee, Grey Wolf, T21RB, bumper pull travel trailer.

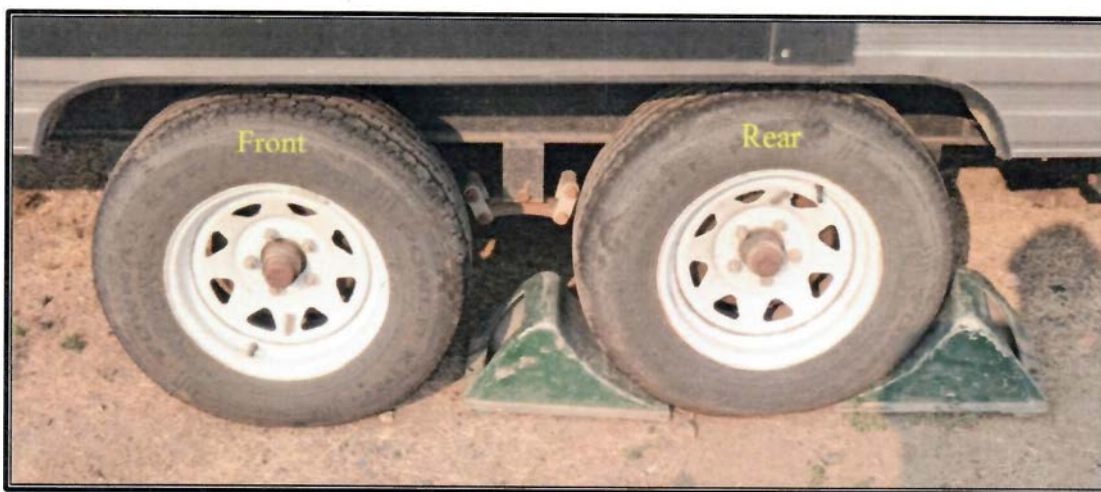
Left Side of the Axles

The vehicle had two, 3,500 pound capacity axles with drum style brakes. The outer ends of the axles had machined spindles that were welded to the axle tubes. The bearing assemblies, which were housed inside the brake hub, were seated on the machined spindles. The bearing assemblies and brake hubs are discussed later in this report. The axle tubes between the spindles were unremarkable.

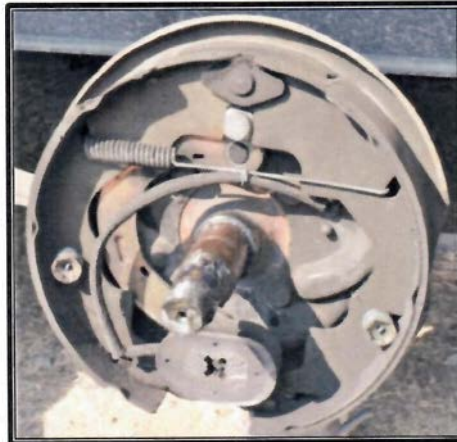
Left-Rear Brake Assembly

The vehicle was equipped with electric, drum style brakes. There were two brake assemblies per axle, for a total of four brake assemblies. The grease on the left-rear brake drum surface occurred when Investigator Patton removed the grease from the inner bearing race. The left-front and left-rear brake assemblies were unremarkable.
