Burnett Inlet Cannery

Current Condition

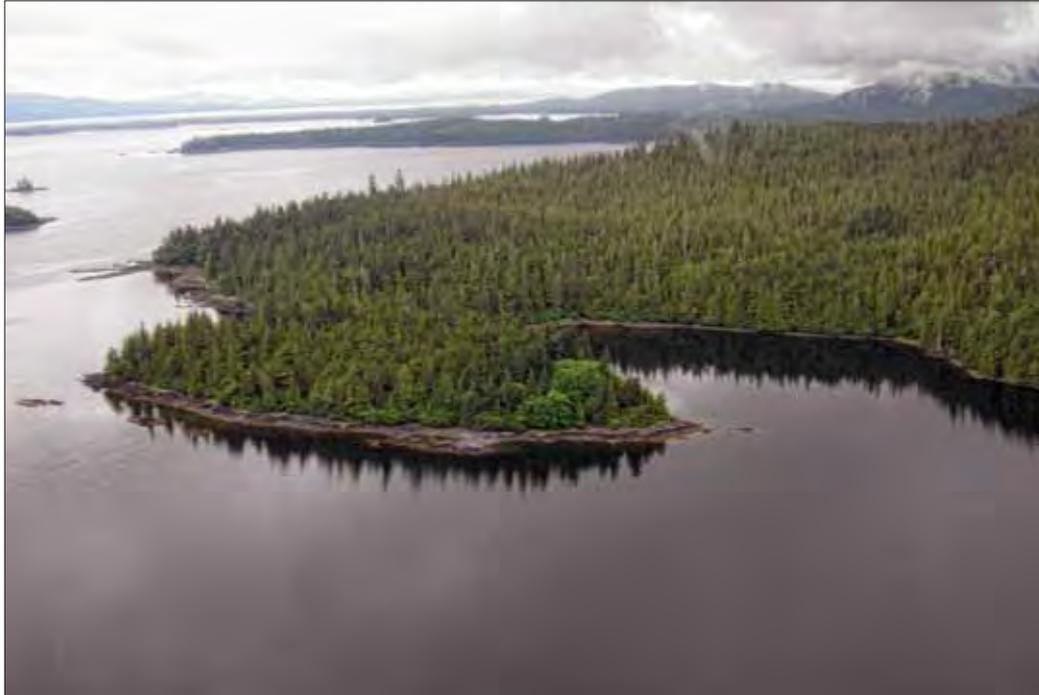
Figure 173.

The cannery and warehouses of the Burnett Inlet Salmon Company were wrapped around the shore of Cannery Point, facing the photographer (looking southwest), with other buildings on pilings tucked into the cove at right.

From the air the Burnett Inlet cannery is practically invisible – no building ruins are evident, and only a patch of second-growth alder hints at the former facility (Figures 173, 179). Except for that portion in the intertidal zone, the site is completely vegetated in mostly second-growth spruce, hemlock, and red cedar, and the aforementioned alder. Here and there stumps up to five feet in diameter sport notches for a springboard – the short plank wedged into the tree for the sawyer to stand on (Figure 180). One old-growth red cedar left standing has two small wood cleats nailed to its trunk to create a ladder (Figure 181), with a large ferrous staple affixed 20' above ground surface, suggesting the tree may once have had a radio antenna attached to it.

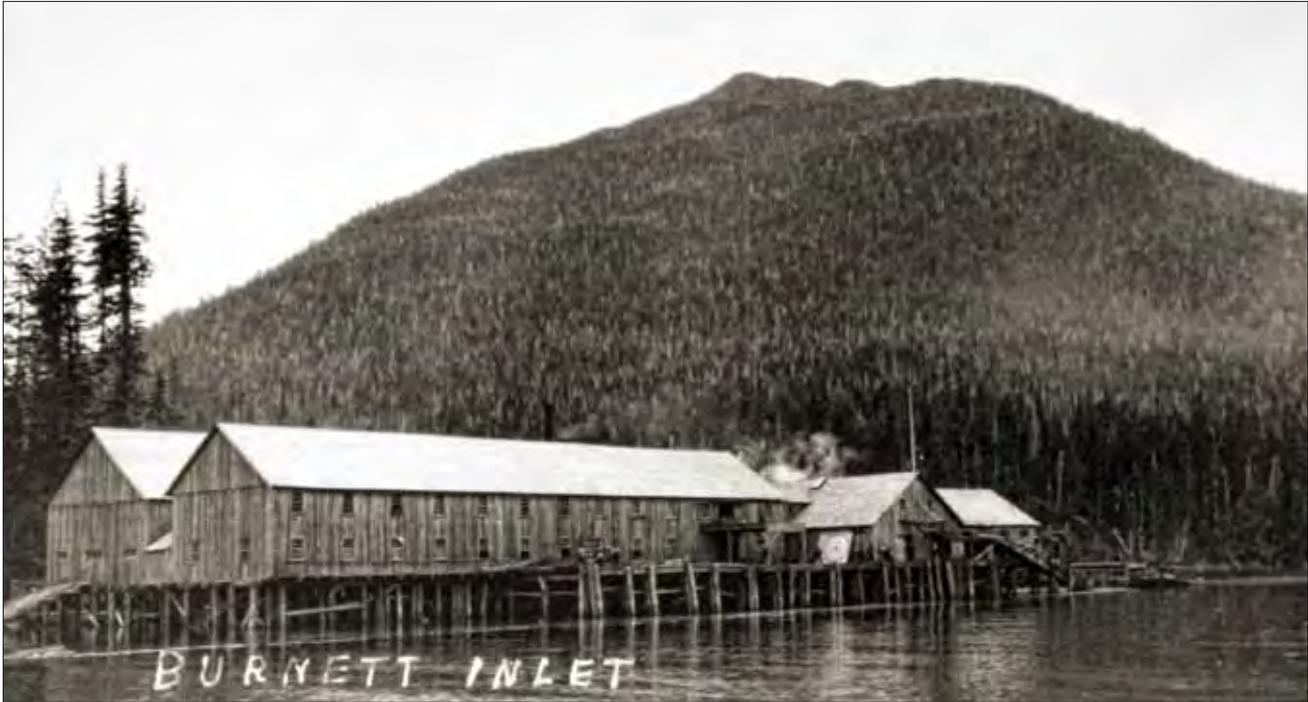
Figure 174.
One of the few pre-war images of the Burnett Inlet cannery looks northwest at the cannery and warehouses on Cannery Point.

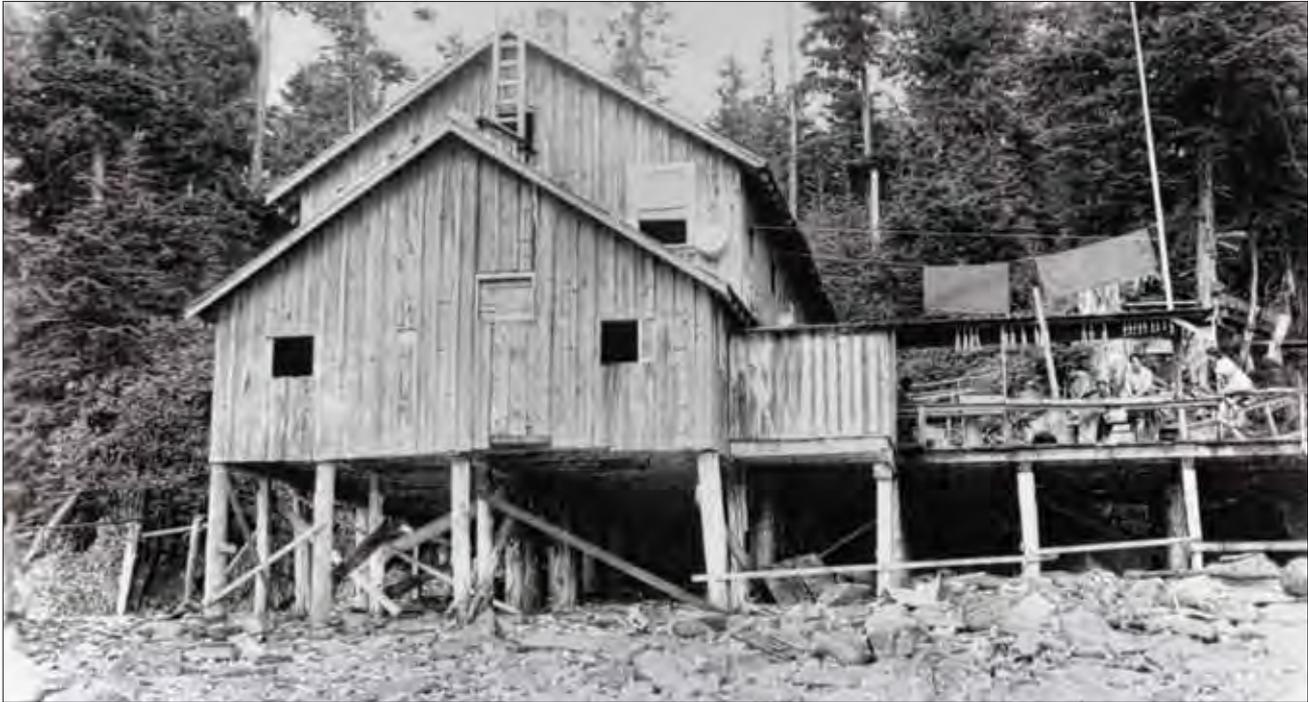
Figure 175.
A cannery bunkhouse that survived the 1940 fire became one of the housing units for Unalaska evacuees in 1942.

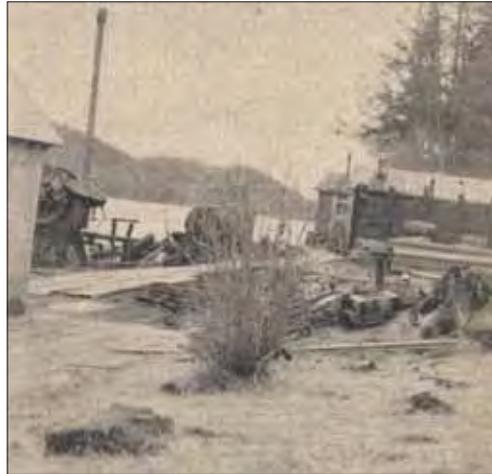
Figure 176.

By spring of 1943 new cabins (right) were built amid the burned cannery debris. View is south-southeast. Note boiler at center.

markings (Figure 195). The remains of the firebox indicate an oil-fired system rather than wood- or coal-fired. The foundation is not visible and the apparatus has sunk unevenly into the forest floor. The boiler is in its original location judging from a wartime photograph (Figure 176).

A large oil-fired boiler (Feature 15) remains in its wartime position just inside the treeline where the 1940 cannery fire dropped it through a burned floor (Figure 176).

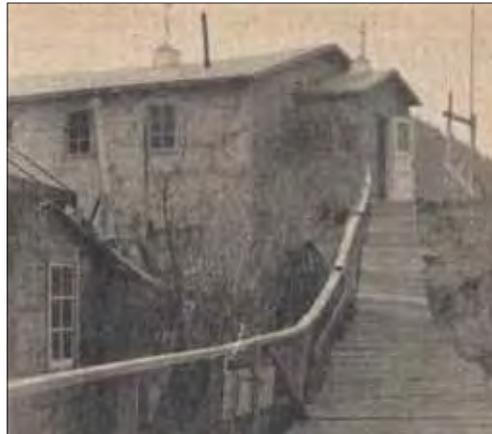
Figure 177.

The displaced Unalaskans built a church at Burnett Inlet. Compare skyline angle at right with that in Figure 174.

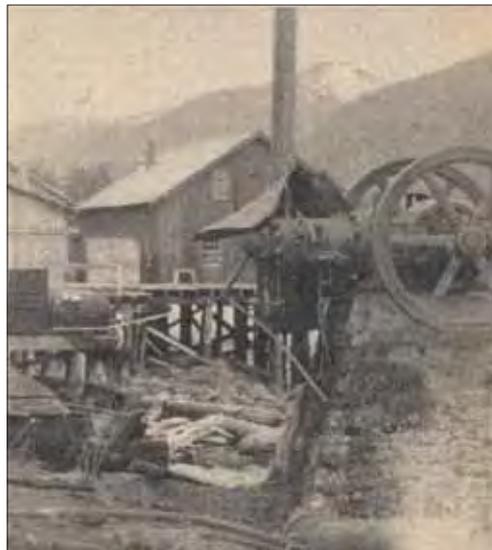
Figure 178.

The northernmost cannery buildings survived the 1940 fire. Note engine on concrete pedestal, looking north-northeast in 1943.

the 1940 cannery fire) shows in a 1943 photograph (Figure 178).

A concrete pedestal at the high tide line supports a large engine (Feature 14) – another survivor of the 1940 fire (Figure 178).

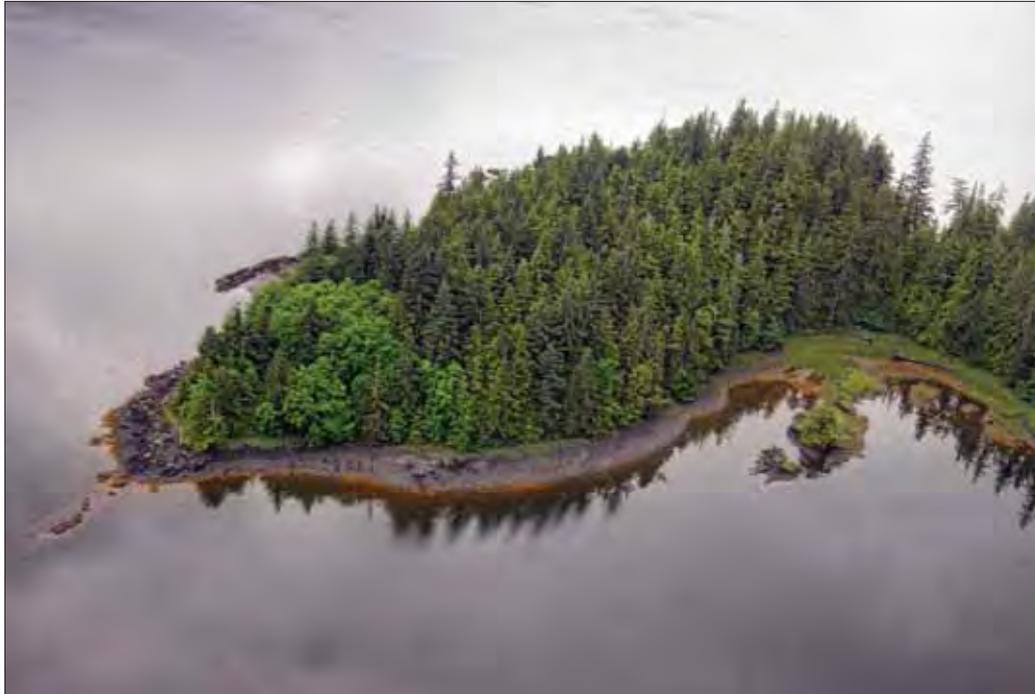
Figure 179.
Cannery Point at the mouth of Burnett Inlet, here looking southeast, cradles a small sheltered cove (right). Note absence of visible ruins, and alder patch at left.

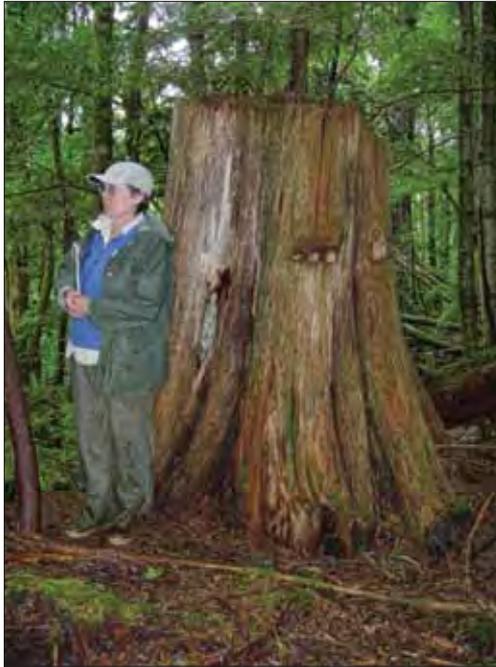
Figure 181.

A large old-growth red cedar spared by cannery development, 50' south of Feature 23, had wood cleats for climbing the trunk.

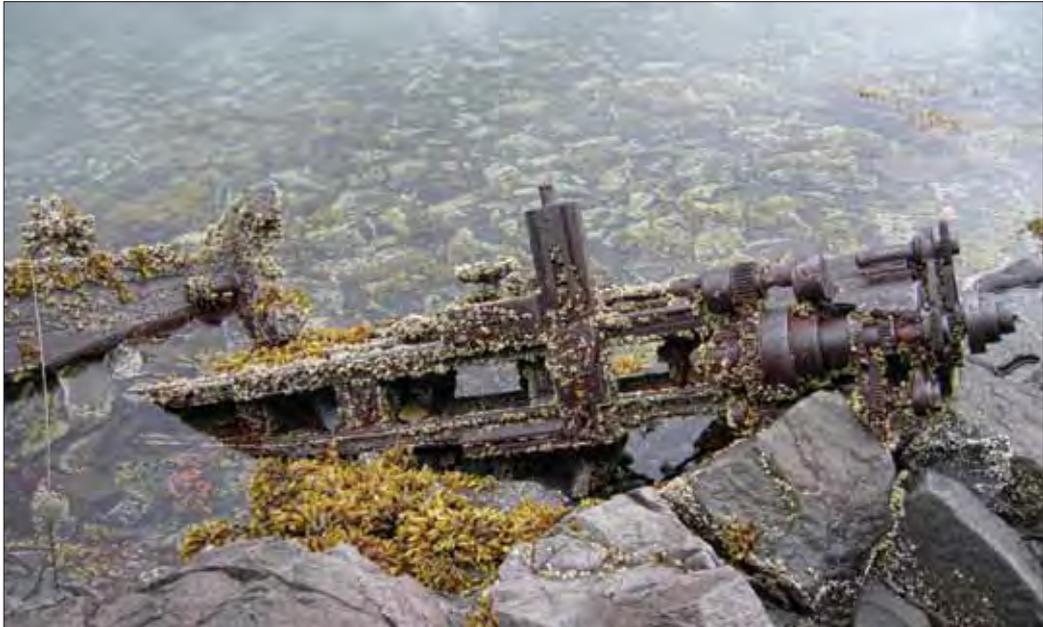
Figure 199.

Large metal machine pieces lie in the intertidal zone where the cannery's industrial buildings burned in 1940.

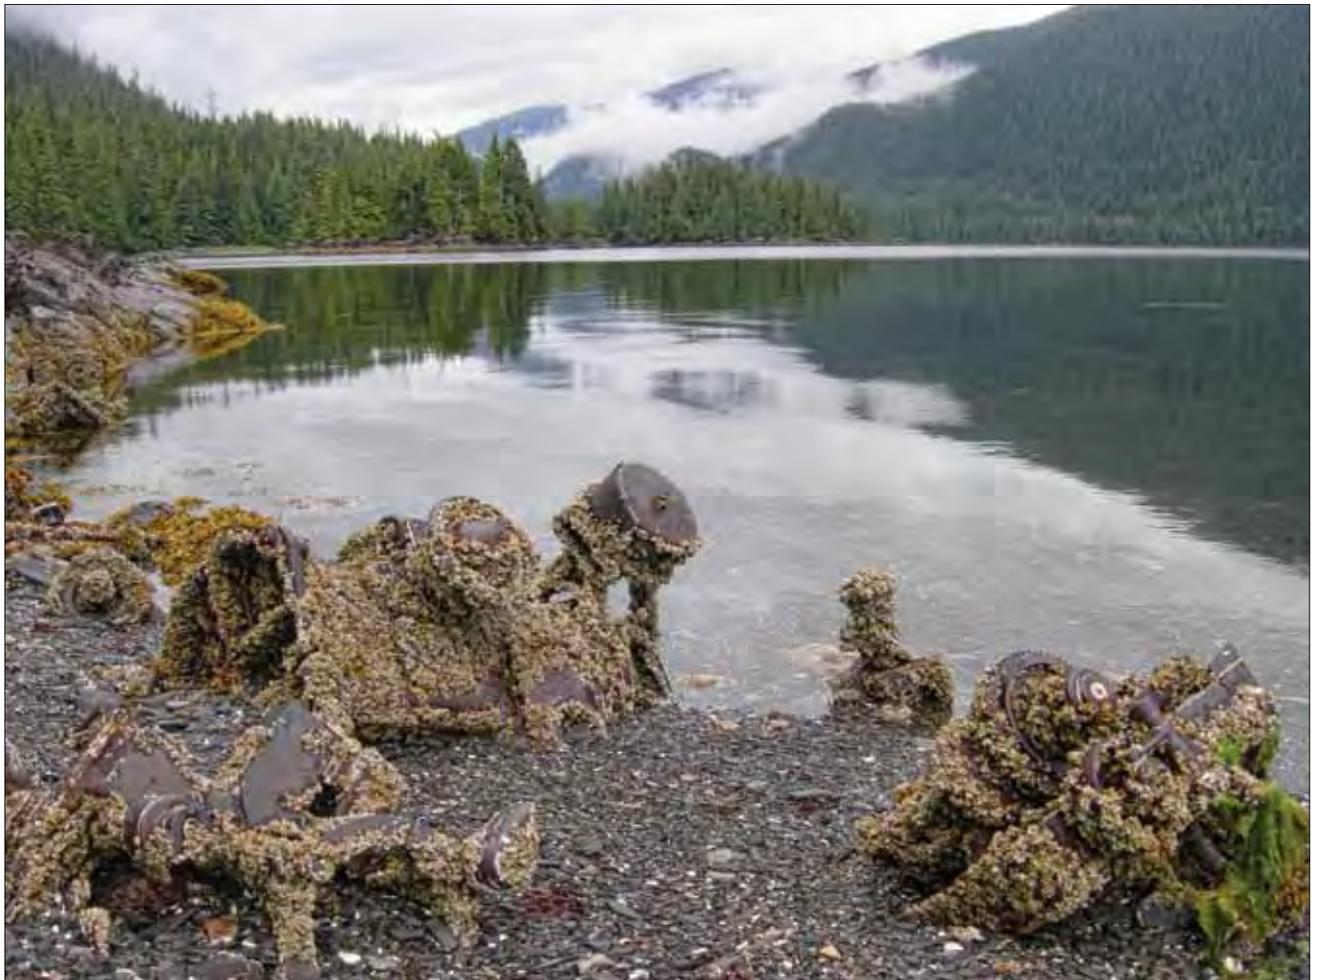
Figure 201.

Barnacles obscure many of the intertidal artifacts.
