EXISTING INTERIOR APPEARANCE

Keeper's Dwelling

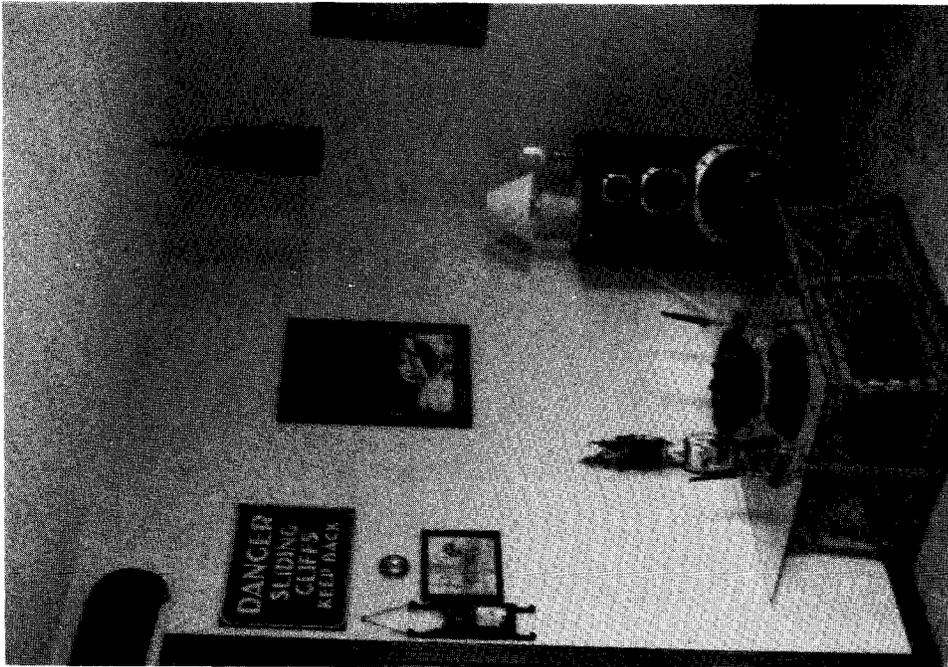
Walls. Interior walls (fig. 67) are covered with plasterboard and painted an off-white color.

Ceilings. Ceilings are covered with plasterboard and painted white (fig. 67).

Figure 67. Room 105, showing typical walls, ceiling, and floor.

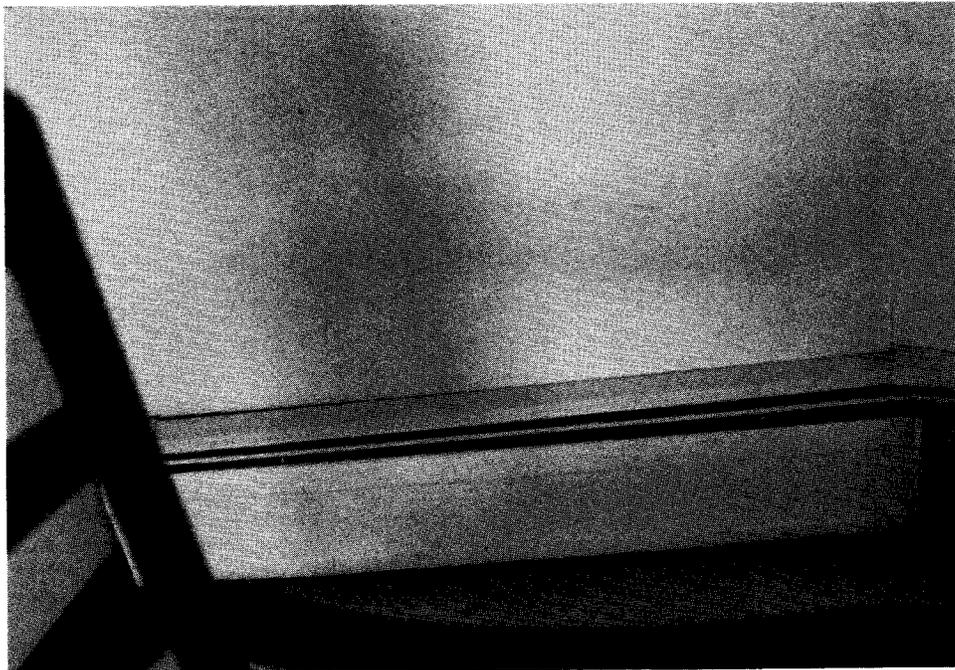
Heating Elements. Forced hot-water baseboard heating elements with metal white-painted covers (fig. 69) are identical throughout the house. This system was installed in 1957.

Figure 69. Room 102, typical baseboard heating unit.

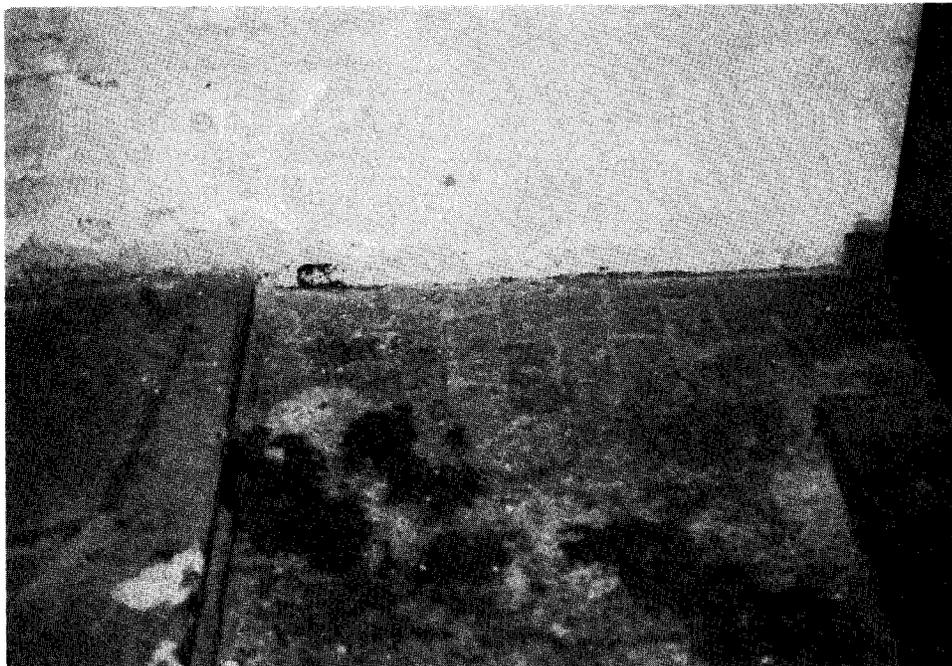
Floor. The basement floor is red-painted concrete. The concrete was poured over brick, which is exposed at the south wall near the east corner (fig. 71). In several places, level concrete pads have been poured that raise the floor level at their respective locations between 1 and 4 inches. These were probably for mounting station generators or emergency power generators, since it was typical in lighthouses to mount all generators on concrete pads.¹ A drain hole with a square metal cover is located near the center of the floor.

Figure 71. Room B01: floor bricks and raised concrete pads.

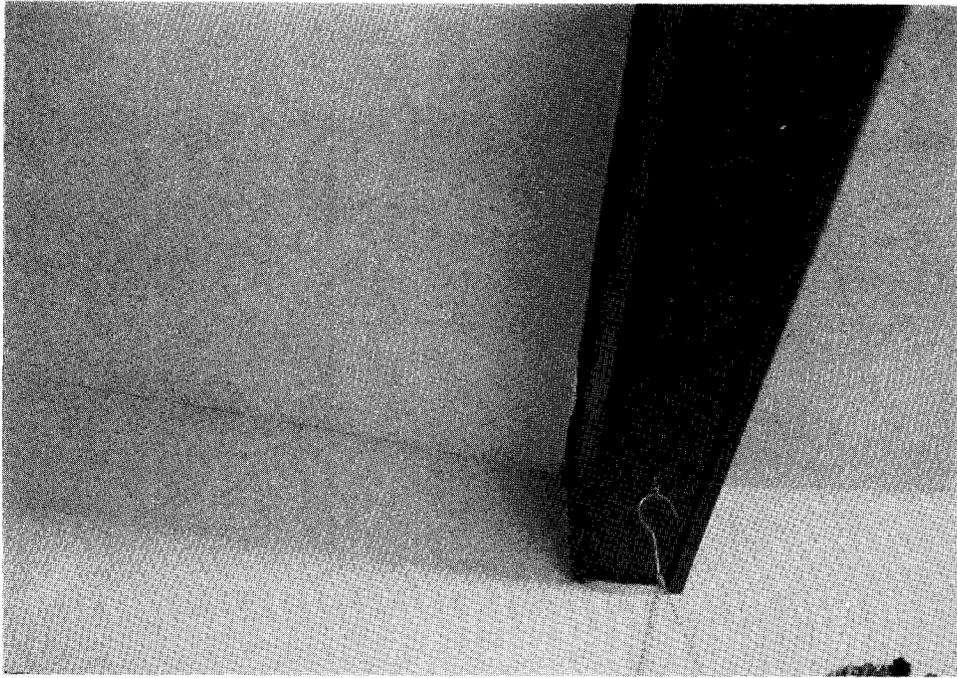
Ceiling. A single encased beam runs east to west near the doorway to the southeast room (fig. 73). It is darkly stained and does not appear to be original. The ceiling is otherwise typical.

Figure 73. Room 102, ceiling beam.

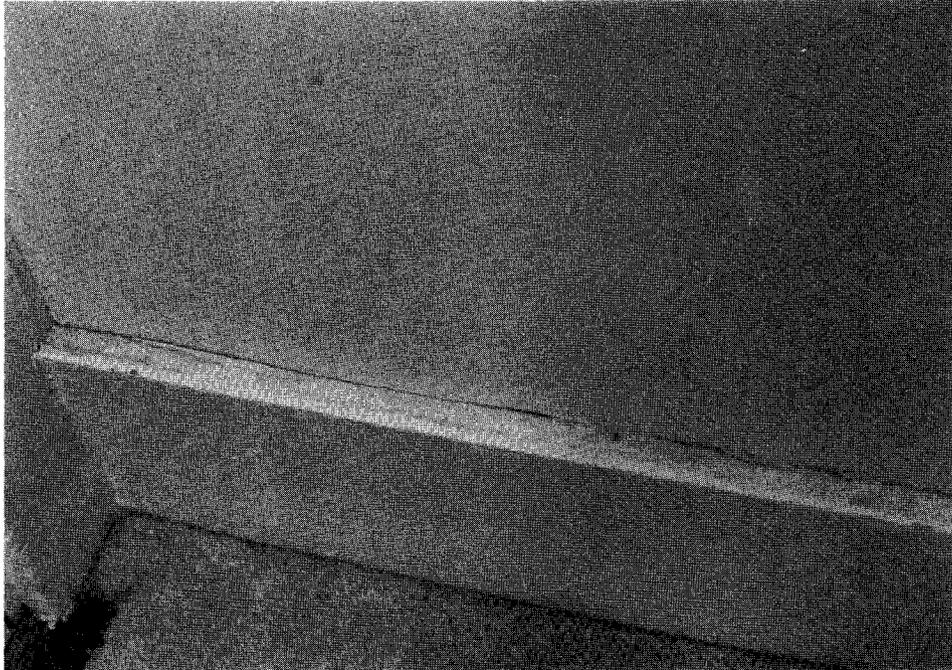
Walls. The walls are typical. A plain baseboard painted an off-white color exists along the west wall between the basement doorway and the stairway. Paint ghosts (fig. 75) on the top section of baseboard suggest that this fabric was not replaced during the renovation, but that a molded cap was removed. The stringers on either side of the stairway are also plain. They are the same height as the baseboard on the west wall, and also have paint ghosts. Two plain round handrails are attached with brackets to 3-inch boards. These boards are located on the outer wall of the stairway.

Figure 75. Room 104, baseboard with paint ghost.

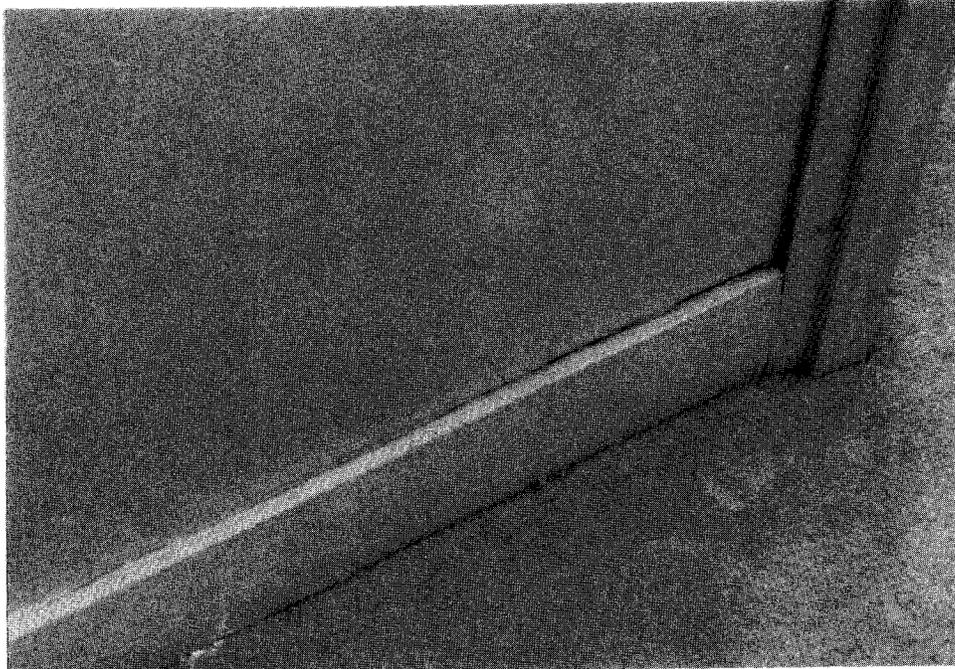
Walls. These are typical, with plain baseboards 3 inches high painted an off-white color on each wall (fig. 79). The baseboards were not replaced during the 1992 renovation; they may date from the 1900 renovation.

Figure 79. Room 201, baseboard along east wall.

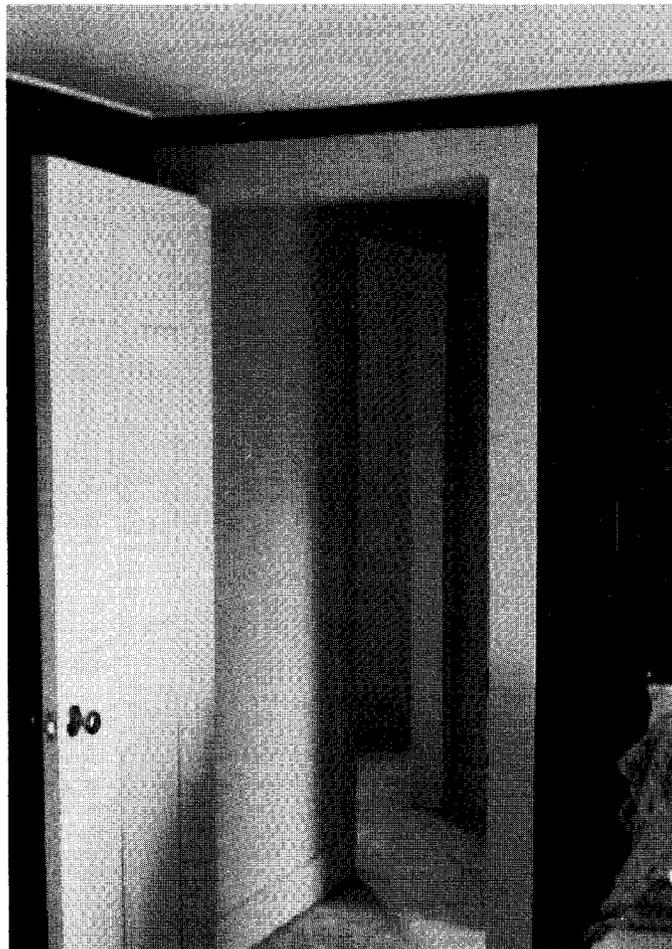
Doorways and Doors. The entrance doorway, at the west end of the north wall, and the west-wall closet doorway are typical. The trim around both doorways (figs. 83 and 84), painted off-white, does not match the trim found typically. It dates to the 1900 renovation.

Figure 83. Room 204, trim of north doorway (may date to 1900 renovation).

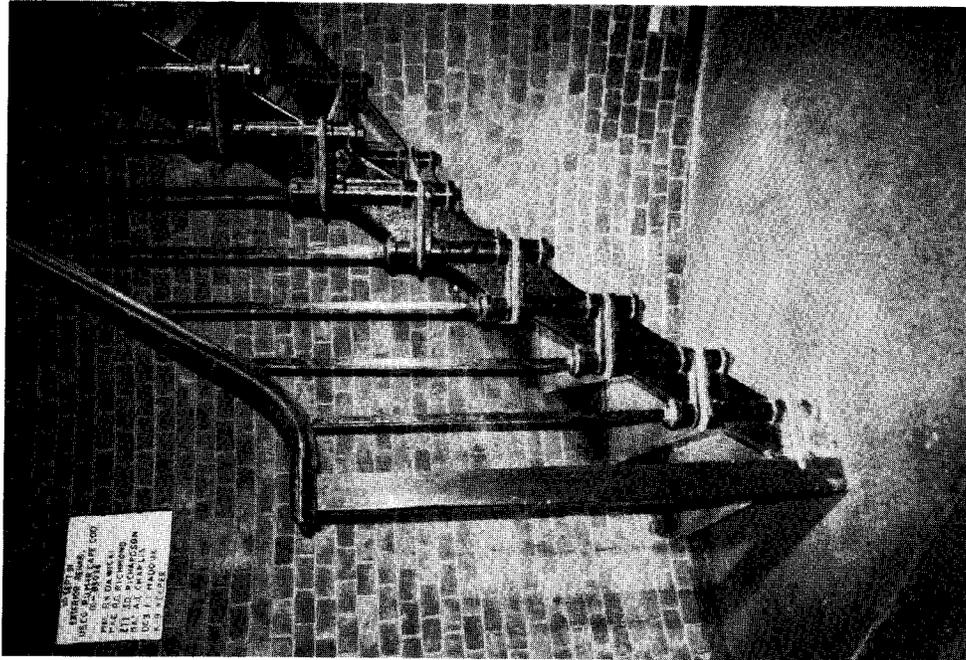
The stair balustrade has a wooden handrail and newel post, and wrought-iron balusters square in section. The handrail and newel (fig. 96) are unpainted; the balusters are painted black. The handrail shows signs of possible alteration. Its grooved underside has round holes where round balusters may have previously been fitted; the baluster spacing does not correspond to the existing spacing (fig. 97). The end of the rail near the newel post may have been cut.

Figure 96. Room 112, newel post and handrail of curved stair, First Level of Tower.

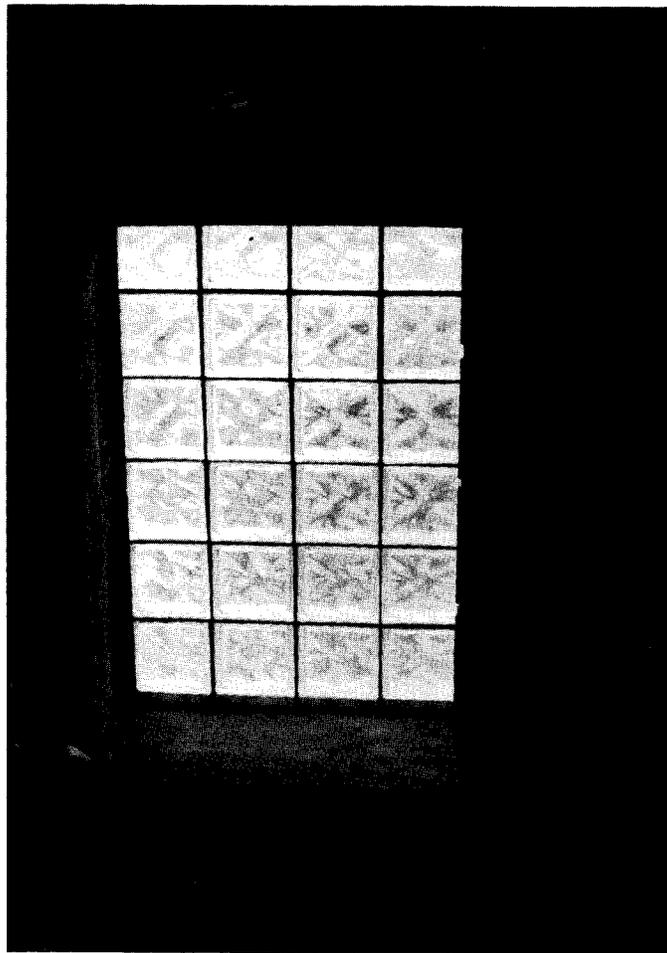
A single window opening exists on the northwest side of the Tower wall (fig. 103). The window is one course above the floor level, with a granite lintel 5 1/2 inches high. The window opening is 4 feet 2 1/4 inches high. Steel lintels, steel frame, and the ghost of a former frame indicate that a change occurred to this window opening. It is currently filled with a panel of glass blocks, four units wide by six units high. The panel is inset approximately 1 foot 6 inches into the opening.

Figure 103. Room 112, Weight Deck window opening in northwest wall.

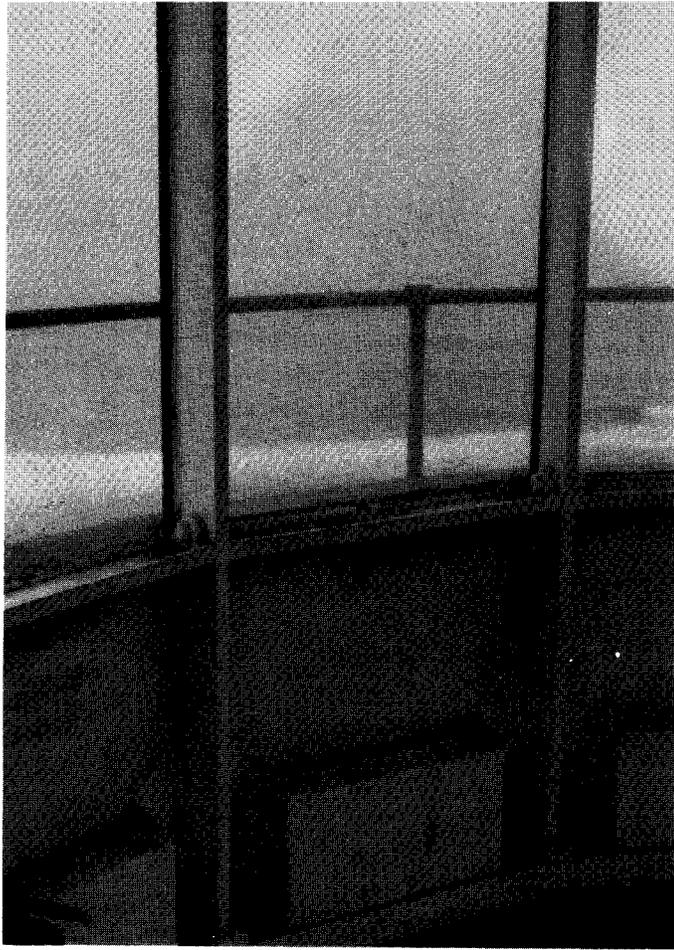
The "walls" of the Lantern consist of 16 panels of equal size rising from floor to ceiling. Each panel is divided into three horizontal sections. The sill of each panel is bolted to the floor, and intermediate horizontal mullions are bolted to the vertical members (fig. 115). The bottom sections of the panels measure 2 feet 7 1/2 inches high by 2 feet 1/2 inches wide, and consist of painted aluminum. Sheet-metal vent covers with filters are located at the base of each panel (fig. 116). The top two sections of each panel are filled with plexiglass; each measures 3 feet 4 3/8 inches high by 2 feet 1/2 inches wide. The tops of the panels form a continuous iron ring (fig. 117). A vent is centered above each panel. Iron pegs (fig. 118) pin the vertical mullions to the perimeter lintel. Attached to these blocks are eye hooks and eye bolts that may have been used for curtains. All of the metal is painted white.

Figure 115. Room 112, horizontal mullion of Lantern Deck window wall.

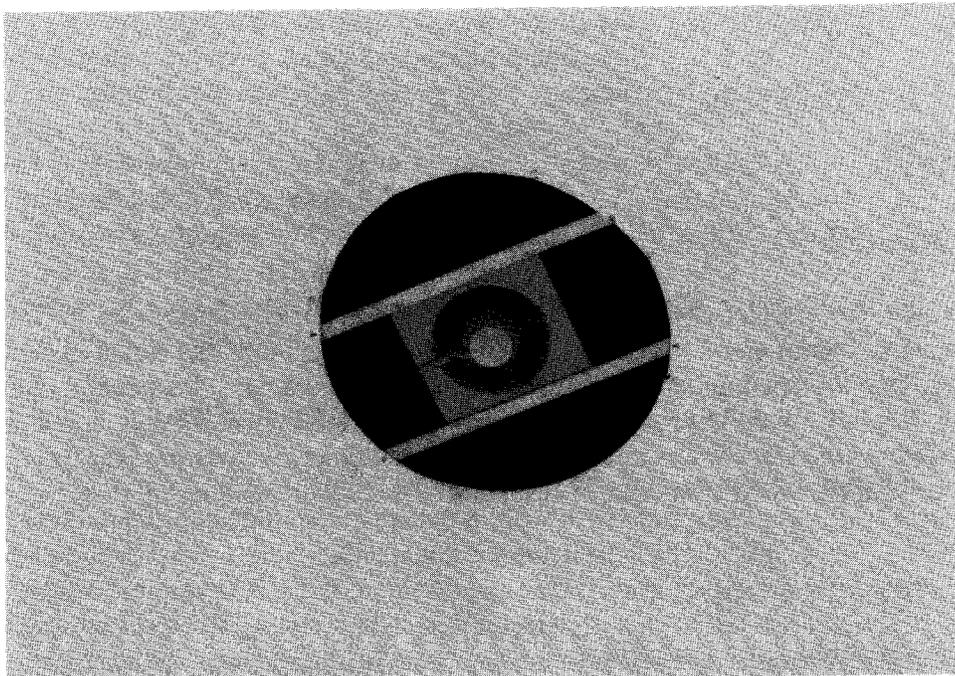
The ceiling is covered with sections of sheet metal that are painted white, the underside of the truncated cone spaced several inches below the underside of the roof. The lantern lining was replaced in 1906. The sheet metal is secured with bolts of alternating size. At the center of the ceiling, a circle is cut out for a ventilator (fig. 119).

Figure 119. Room 112, ventilator at center of Lantern Deck ceiling.

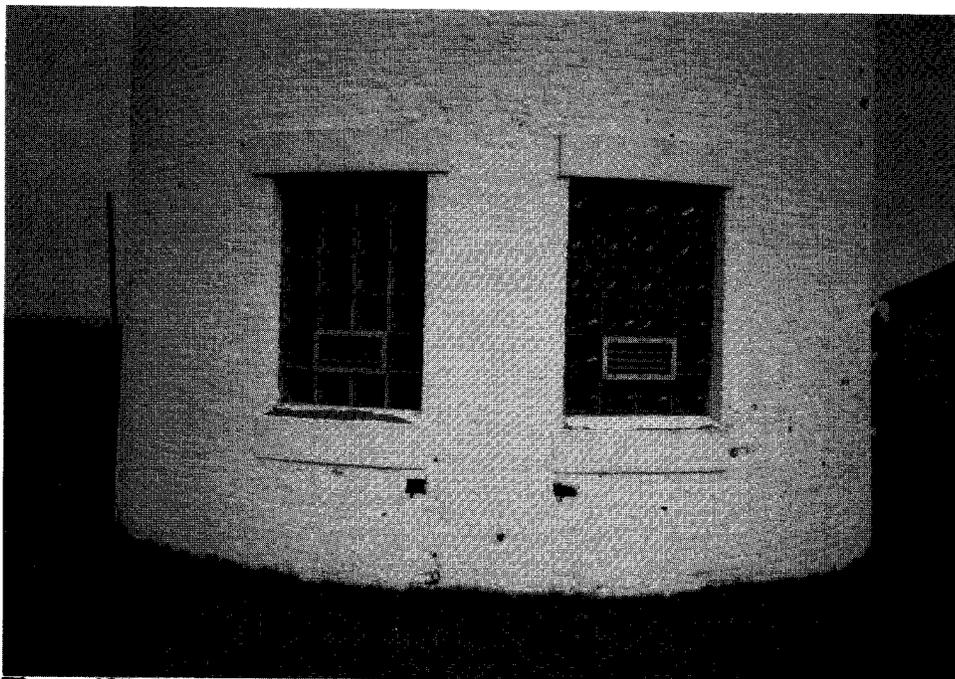
- There are two spalled brick ends below each window (figs. 137 and 138).

Figure 137. Tower, south elevation.

- Replace/consolidate spalled bricks and recoat them.
- Provide a more controlled means of ventilation to allow drying out of the interior after periods of high humidity.
- Use of a waterproof coating should be considered only if the problem persists after all other remedial and repair work is completed.

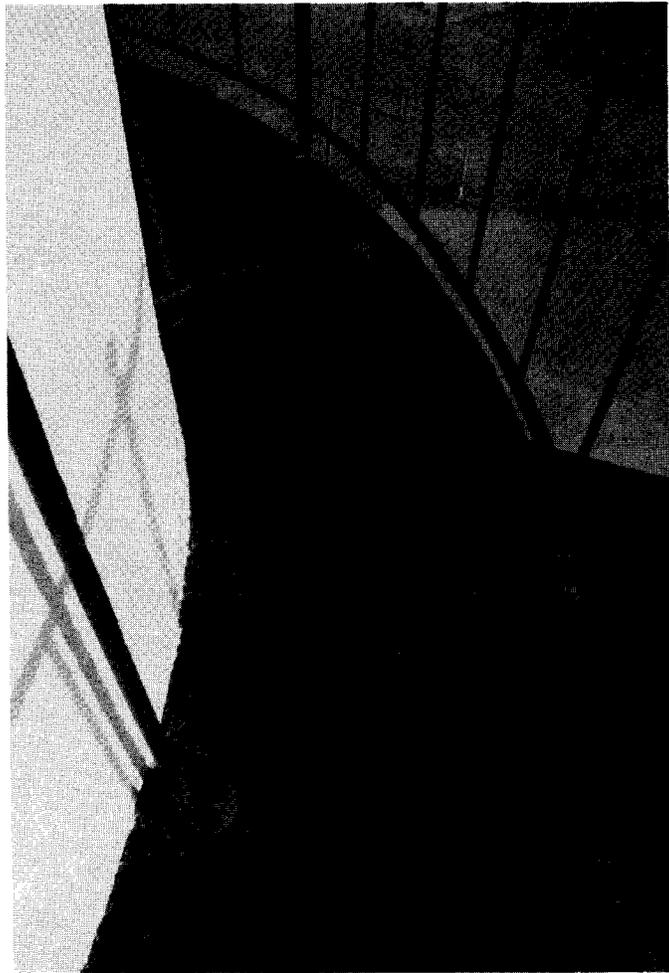
- The floor of the gallery is composed of 15 granite sections, sloping to the exterior, with strips of lead sheet over the joints (fig. 139).
- Sealant runs intermittently at a joint in the brick wall (located one course above the granite floor) where the edge of metal is visible, perhaps from through-wall flashing.

Figure 139. Tower, granite floor of Watch Gallery.

- Monitor the granite floor sections for movement.
- Verify the condition of the flashing at the granite joints, and at the juncture of the granite floor and the brick Tower wall.
- Apply sealant to open joints where metal wall flashing is seen.
- Grease exterior hinges to prevent corrosion at points of metal-to-metal contact.

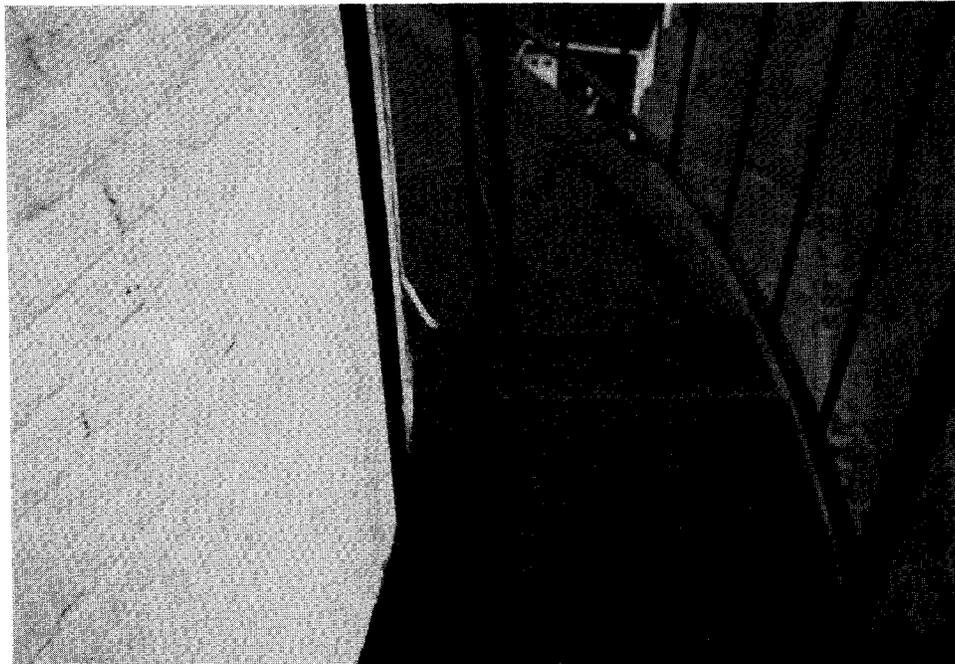
- Some of the granite floor sections (fig. 140) are not level with adjacent sections (e.g., the section under the south end of the ladder to the Lantern Gallery).

Figure 140. Tower, shifted granite section of Watch Gallery floor.

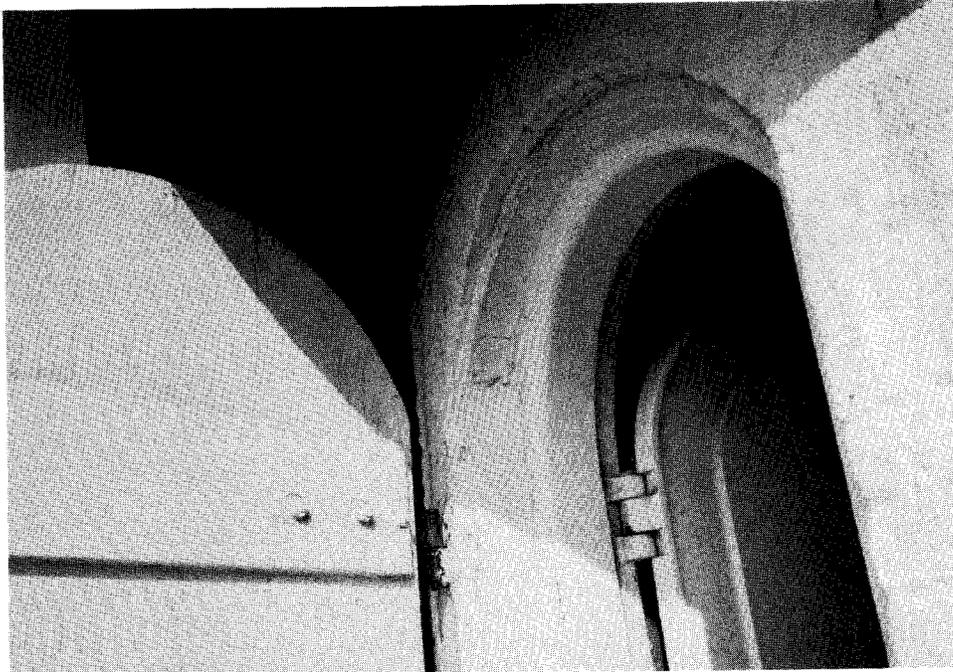
- The hinges of the exterior door in the doorway to the Watch Deck exhibit corrosion due to the wearing of paint surface coatings (figs. 141 and 142).
- The Watch Gallery railing appears to be original. Consisting of eight sections, it has flat metal handrails and bottom rails, and round metal balusters. The amount of corrosion visible is consonant with the severity of the location.

Figure 141. Tower, head of doorway from Watch Gallery into Watch Deck.

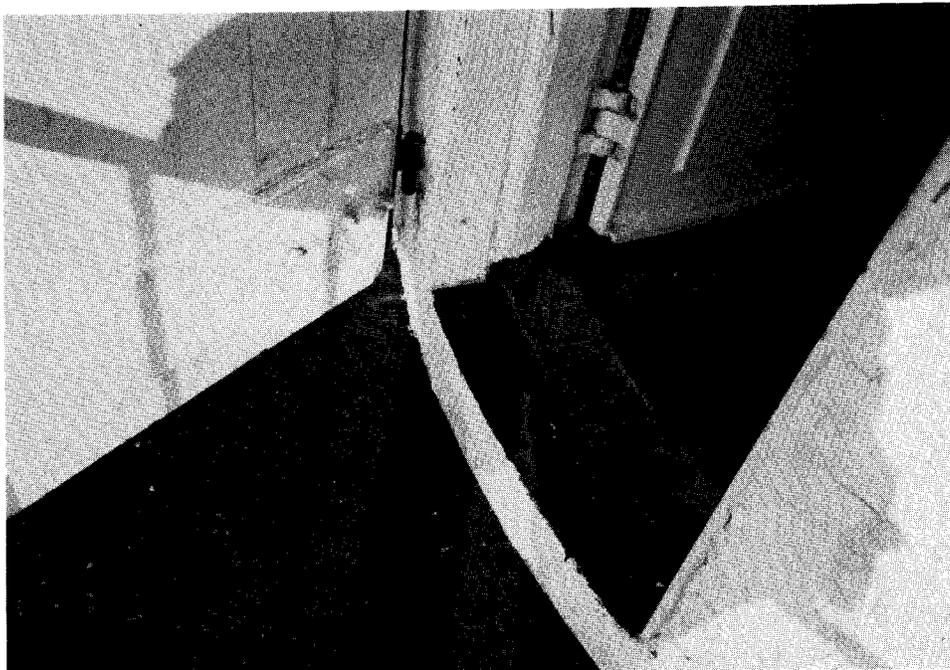
Figure 142. Tower, sill of doorway from Watch Gallery into Watch Deck.

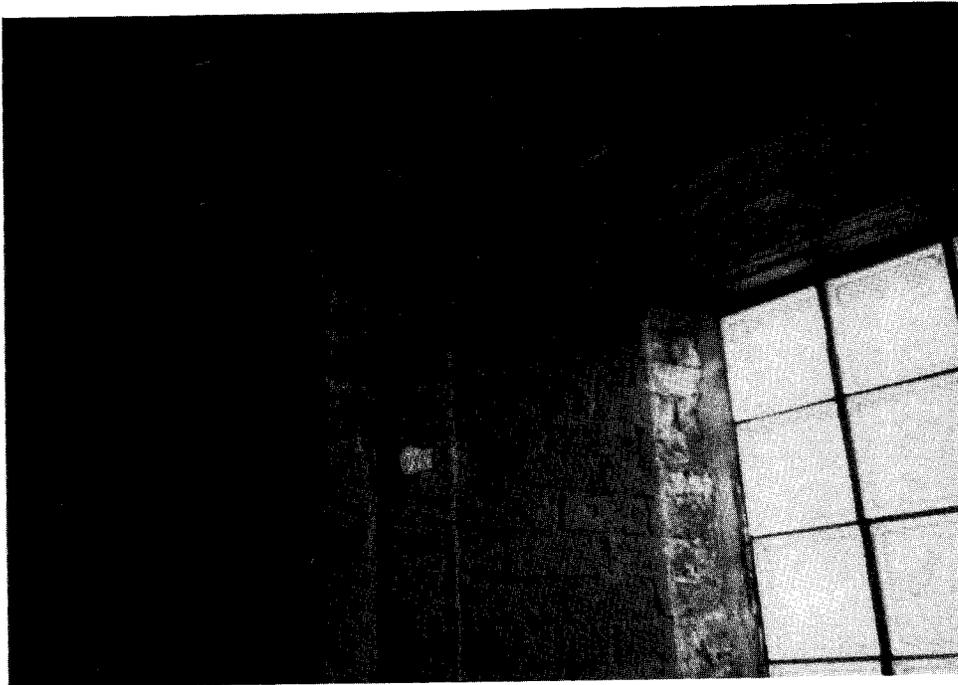
- Currently, the two window openings at this level are filled with glass blocks that replaced earlier double-hung sashes. The only means of ventilation are two fixed louver vents, one in each opening, that measure approximately 8 by 16 inches.
- There is substantial water leaking at both window heads through the steel lintels, particularly the east window (figs. 146-149). The windows' sills, and the areas of wall and floor below the sills, are wet during periods of rain. A salt tide line is evident below the east window sill (fig. 149). Two lintels are delaminating from the extensive corrosion (figs. 146 and 148).

Figure 146. Tower, head of east window in south wall, First Level.

- Apply a damp-proof course at the new Tower foundation during relocation.
- Determine the source of moisture penetration above the windows.
- Replace the deteriorated metal-angle lintel at each window head.

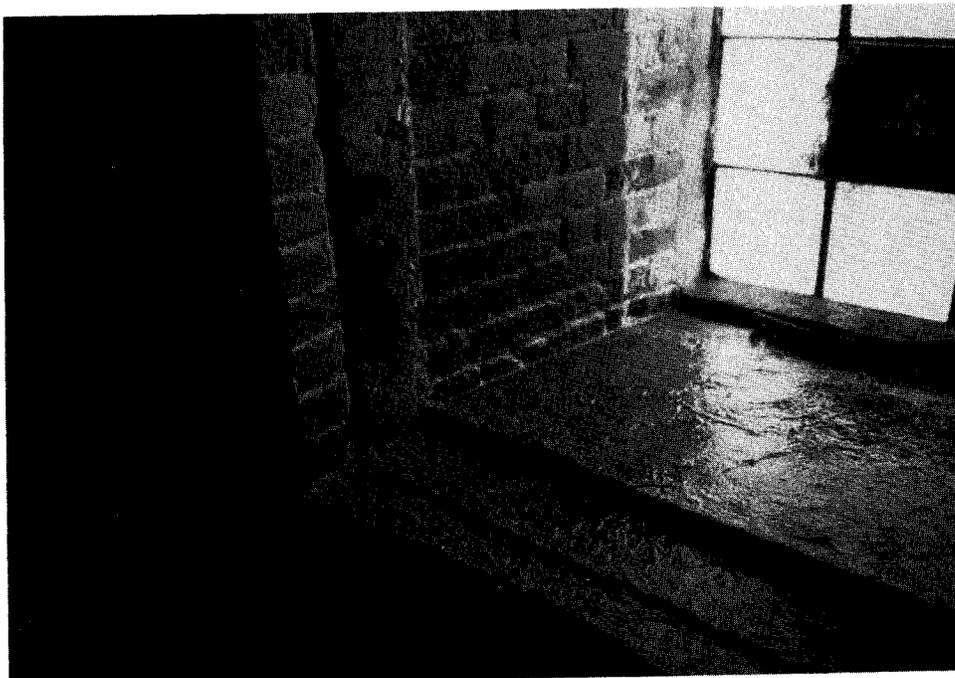
Figure 147. Tower, sill of east window in south wall, First Level.

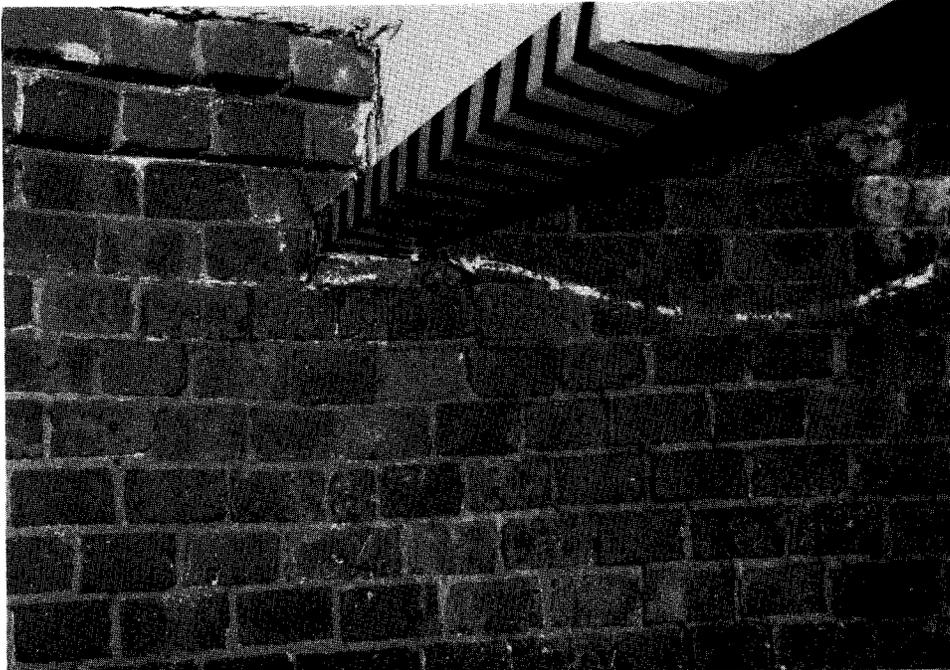
- This water penetration is especially severe where the beam over the stairway to the Watch Deck is set into the southeast wall (fig. 153). The entire wall below the beam pocket was saturated and glistening wet during the period observed.

Figure 153. Tower, beam pocket in south wall of Weight Deck.

- Scrape and paint all corroding metal.
- Repair the diagonal stepped crack in the masonry.
- Determine the source(s) of moisture penetration.
- Treat the ends of the stairway treads where they intersect the brick Tower wall, to provide a moisture barrier.

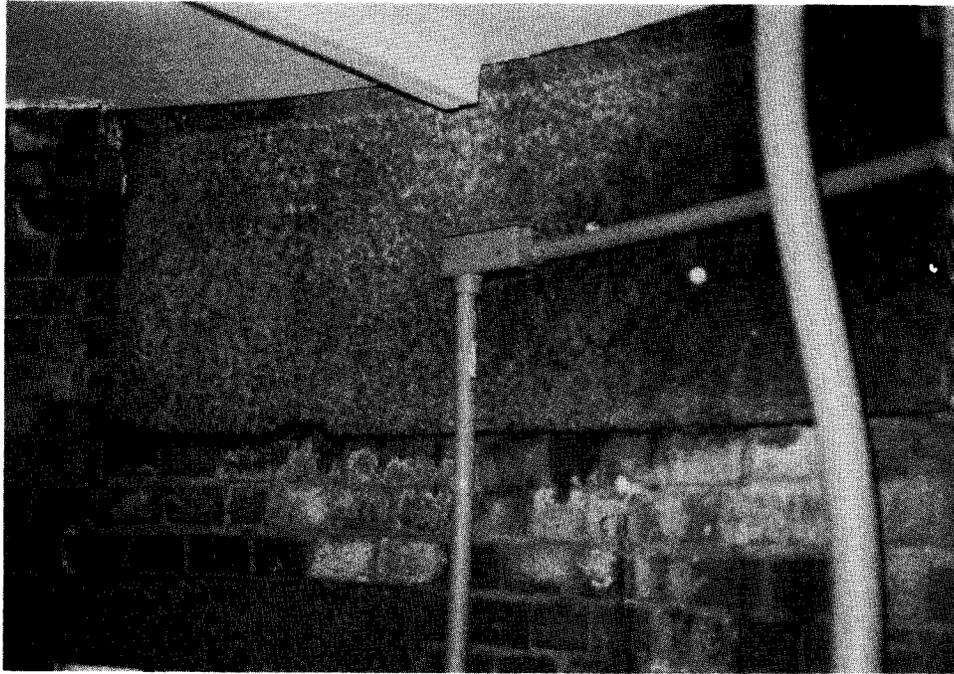
- There appears to be selective deterioration/spalling of brick units at various locations.
- Water is also leaking into the Tower underneath the granite sill of the doorway at Watch Deck level; this also runs down the interior face of the brick wall (fig. 155).

Figure 155. Tower, granite sill of Watch Deck doorway, as seen from Weight Deck.

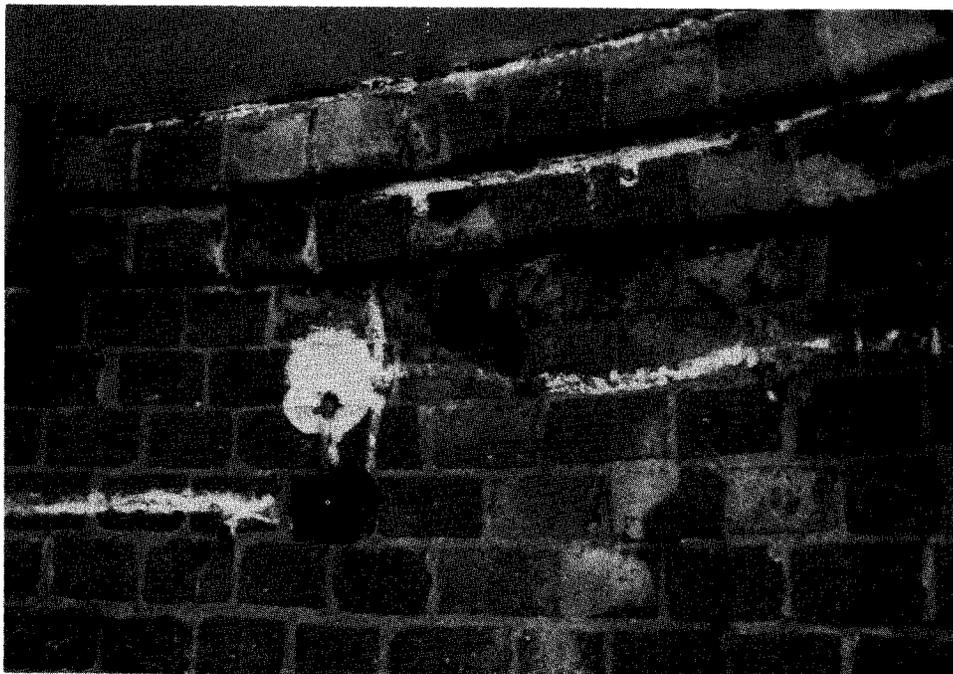
- An iron eye is located on the east elevation, four courses below the ceiling. Diagonal cracks in the brickwork emanate from the collar of the eye, due either to previous loading or to expansive oxidation forces (fig. 156).

Figure 156. Tower, iron eye set in east wall of Weight Deck.

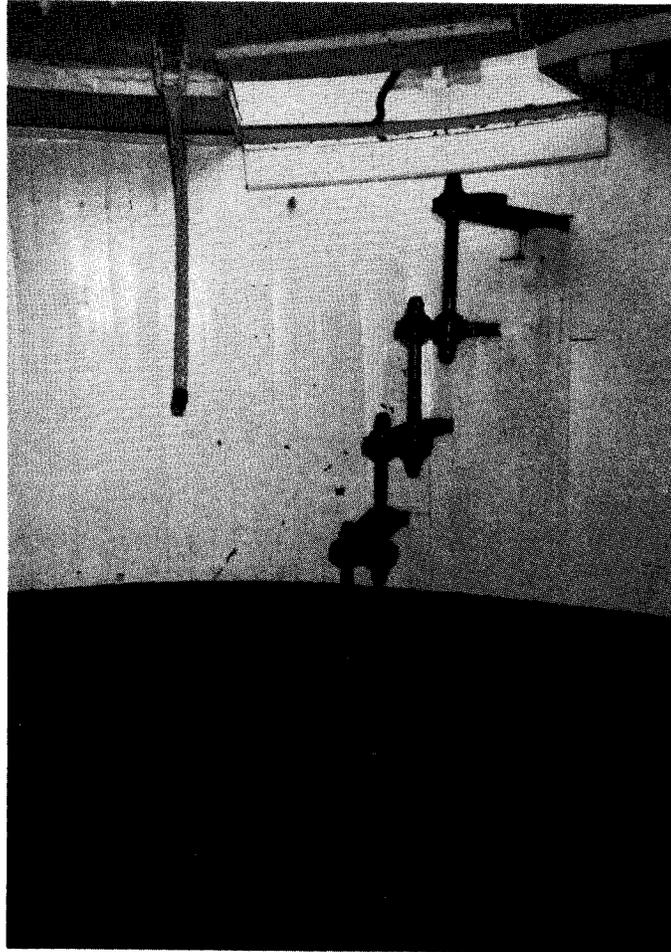
- Orange staining is visible emanating from behind the furred-out wooden interior wall where it is cut out for the top tread of the stairway to the Lantern Deck (fig. 157).

Figure 157. Tower, stair ascending from Watch Deck to Lantern Deck.

- Install an astagral seal at the perimeter of the steel door to the exterior Watch Gallery.
- Install hardware to assure tight closure of the door.
- Determine the source of moisture penetration and the consequent corrosion of the top tread of the stairway to the Lantern Deck.
- As a temporary measure to reduce the ingress of water, apply sealant to all of the exterior joints and seams of the four floor plates. Permanent repair of the corrosion evident between the flanges at the connections of the four floor plates will be problematic. To adequately clean the metal surfaces for application of new paint, the sections would have to be dismantled, which would require the Lantern to be lifted off entirely.
