HISTORIC STRUCTURE REPORT

THE ATWOOD-HIGGINS HOUSE

Cape Cod National Seashore

September 1980

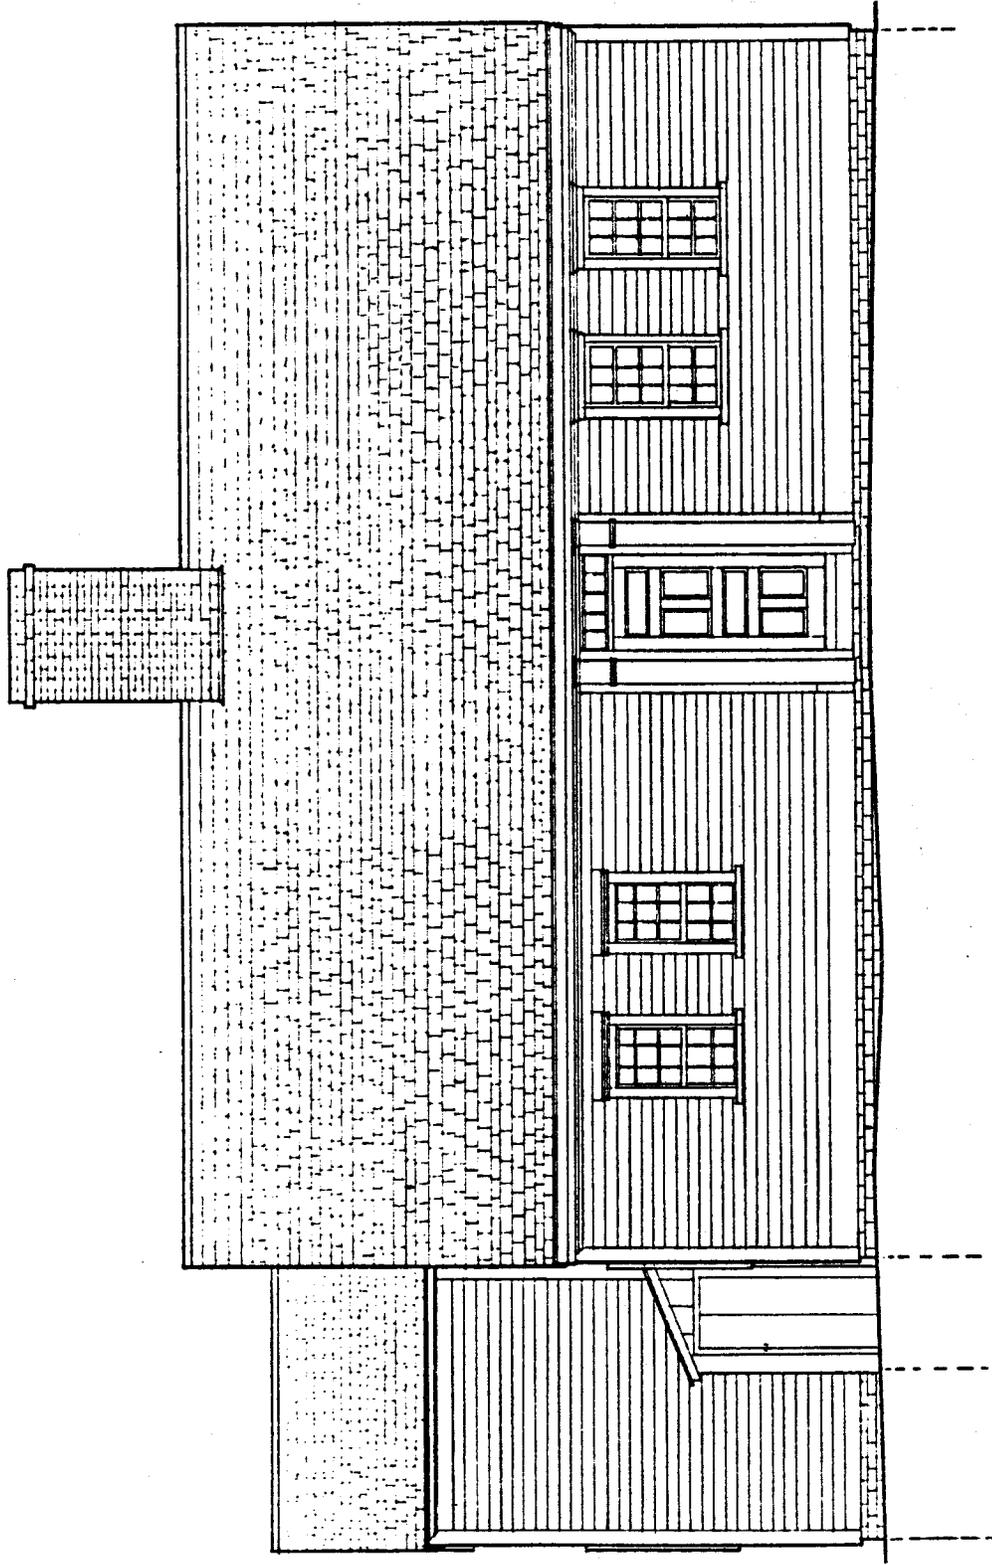
The south facade of the main house and of the northwest ell (Ills. 12, 13) are the only walls finished with wooden clapboards. The clapboards on the upper two-thirds of the main house are beaded on the lower edge of their exposure, which varies from 4 to 4-1/2 inches in width. They have feathered joints, and are painted light tan. The clapboards on the lower third of the main house appear to date from 20th-century sill repairs. This can be inferred from the fact that:

Illustration 12. Atwood-Higgins House: South (Front) Elevation.

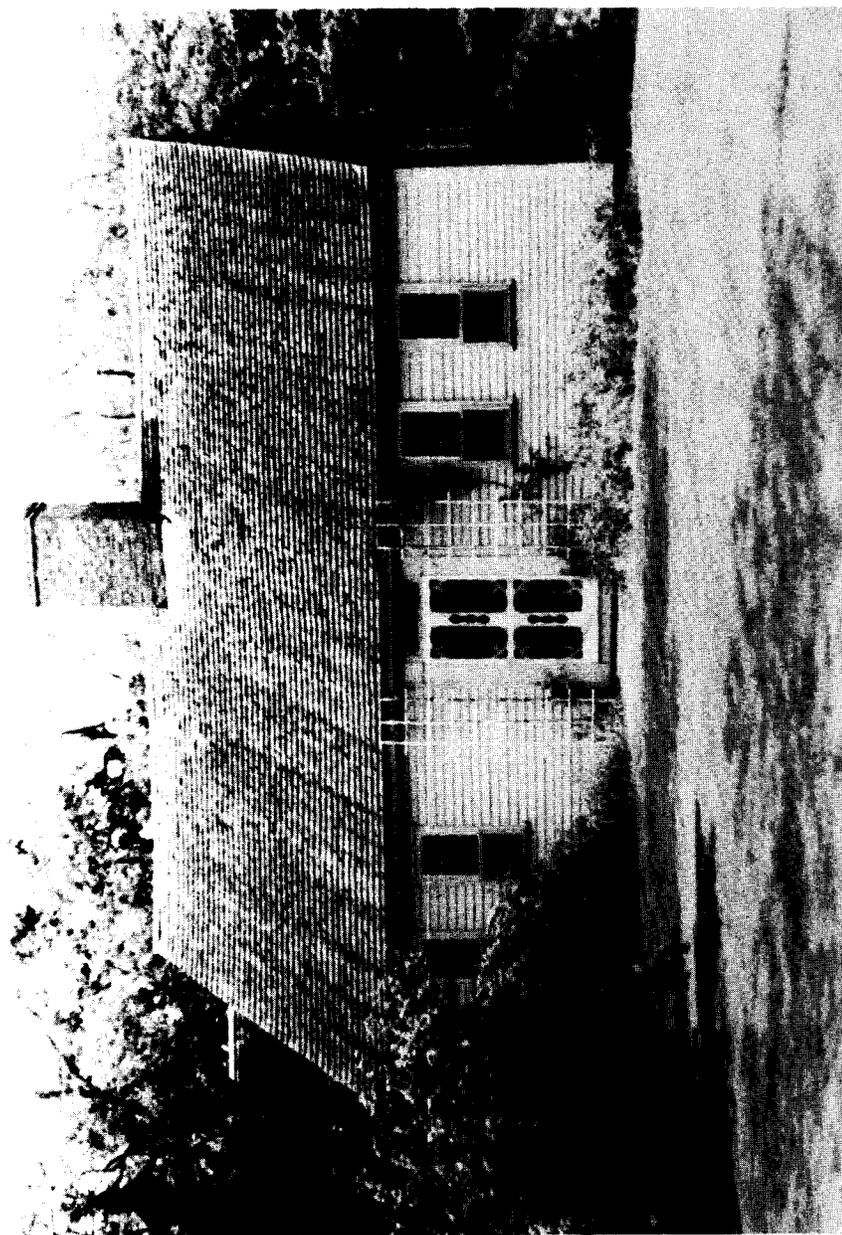
Illustration 13. Atwood-Higgins House: South Elevation.

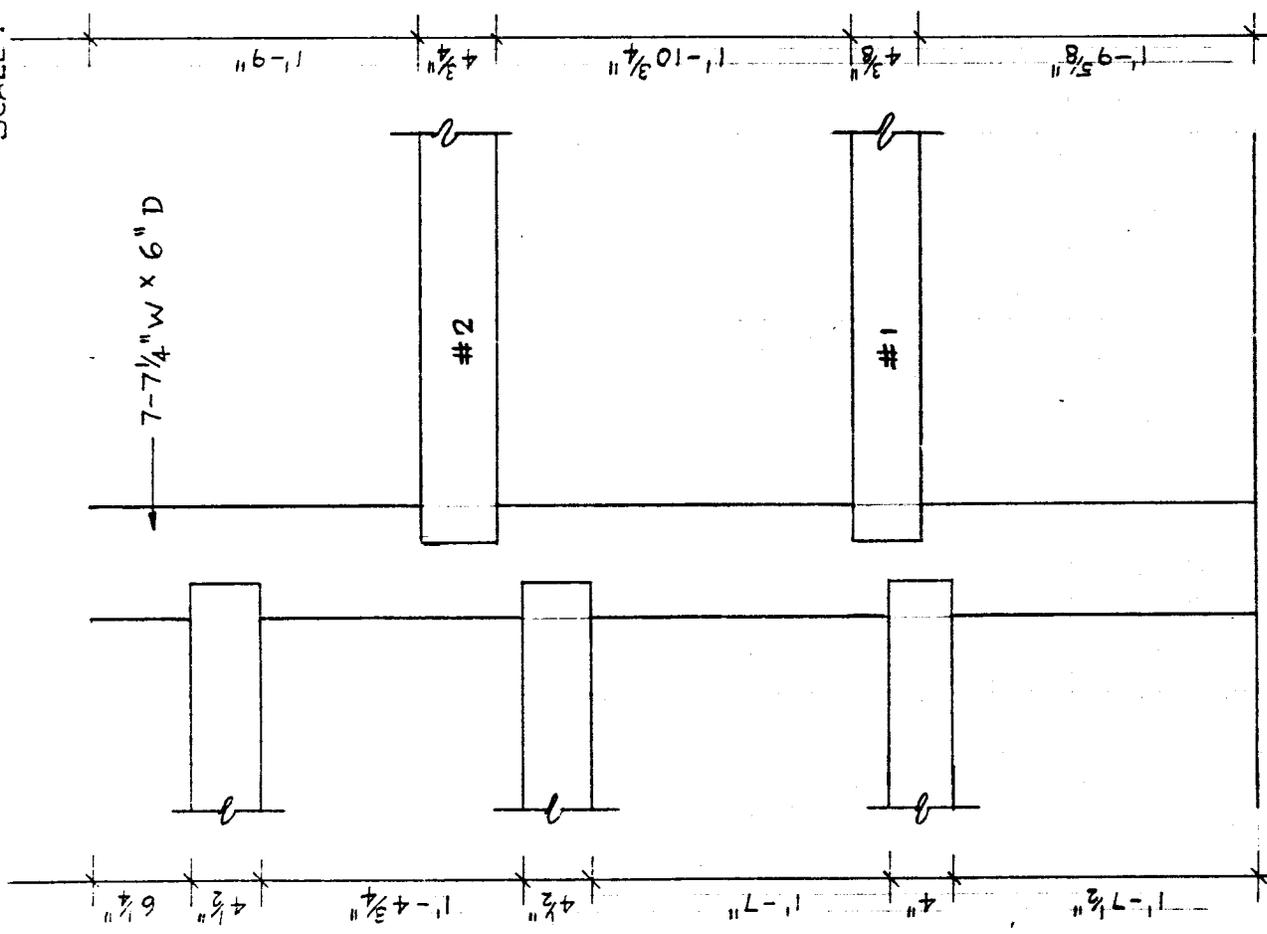
EAST FRONT ROOM 101 - S.W. CORNER
SCALE: 1" = 1'-0"

NOTE: ALL MEMBERS ARE
HANDHEWN. VISIBLE UNDER-
SIDES OF #1 AND #2 ARE
TO BE IN THE ROUGH.

Illustration 20. Atwood-Higgins House: Plan of First-Floor Framing, Southwest Corner of East Front Room.

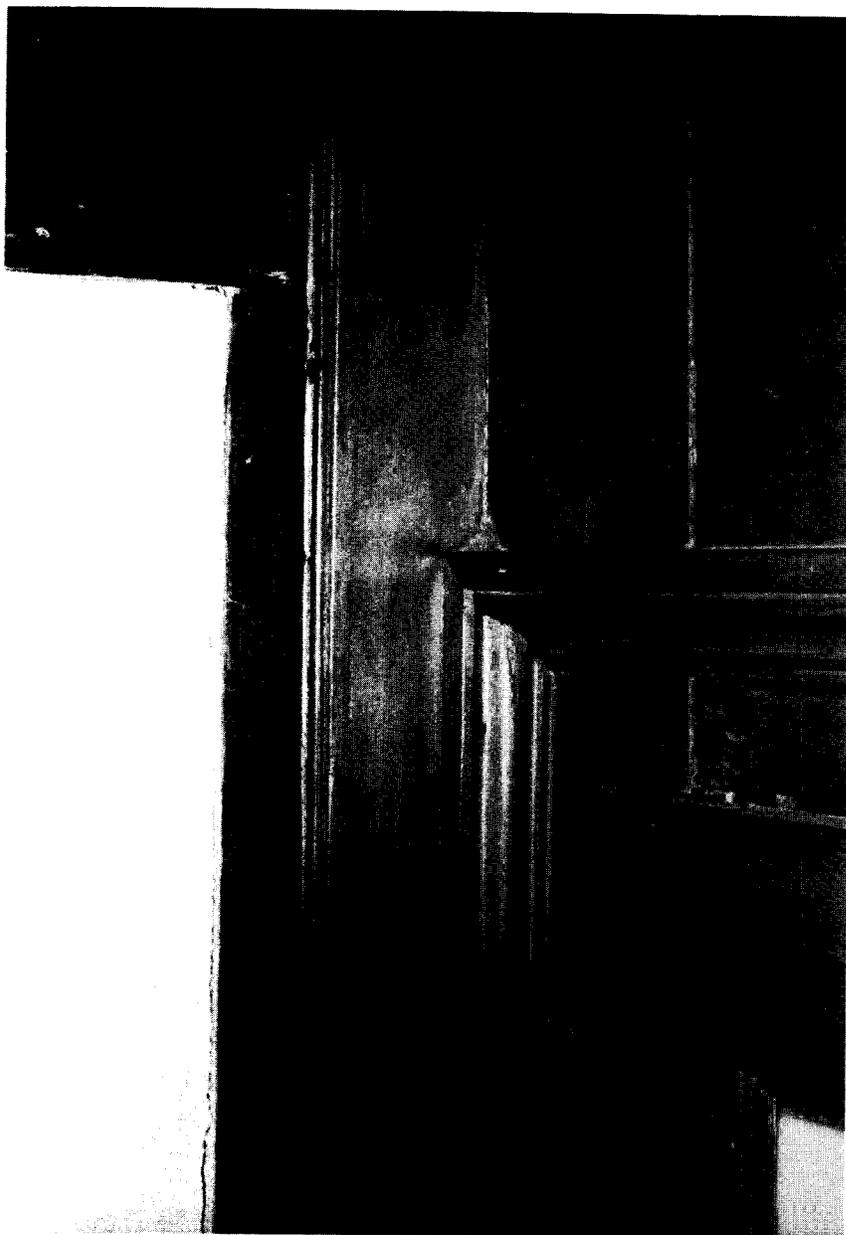
Another change in this room occurred when the three posts, two girts, and two summer beams were boxed in. All structural framing in the 1730 house is believed to have been exposed. This theory is based upon the whitewashed joists discovered in second-floor investigations above the East Kitchen 104 (Ill. 27), and the whitewashed chimney girt behind the present fireplace paneling. Casing the structural members probably occurred at the time of the c. 1775-1790 fireplace changes, or soon after. The beading on the casings (Ill. 35) is not all the same, but cannot be distinguished for dating purposes.

Illustration 35. Atwood-Higgins House: East Front Room, Beaded Casings of South Chimney Post and South Plate.

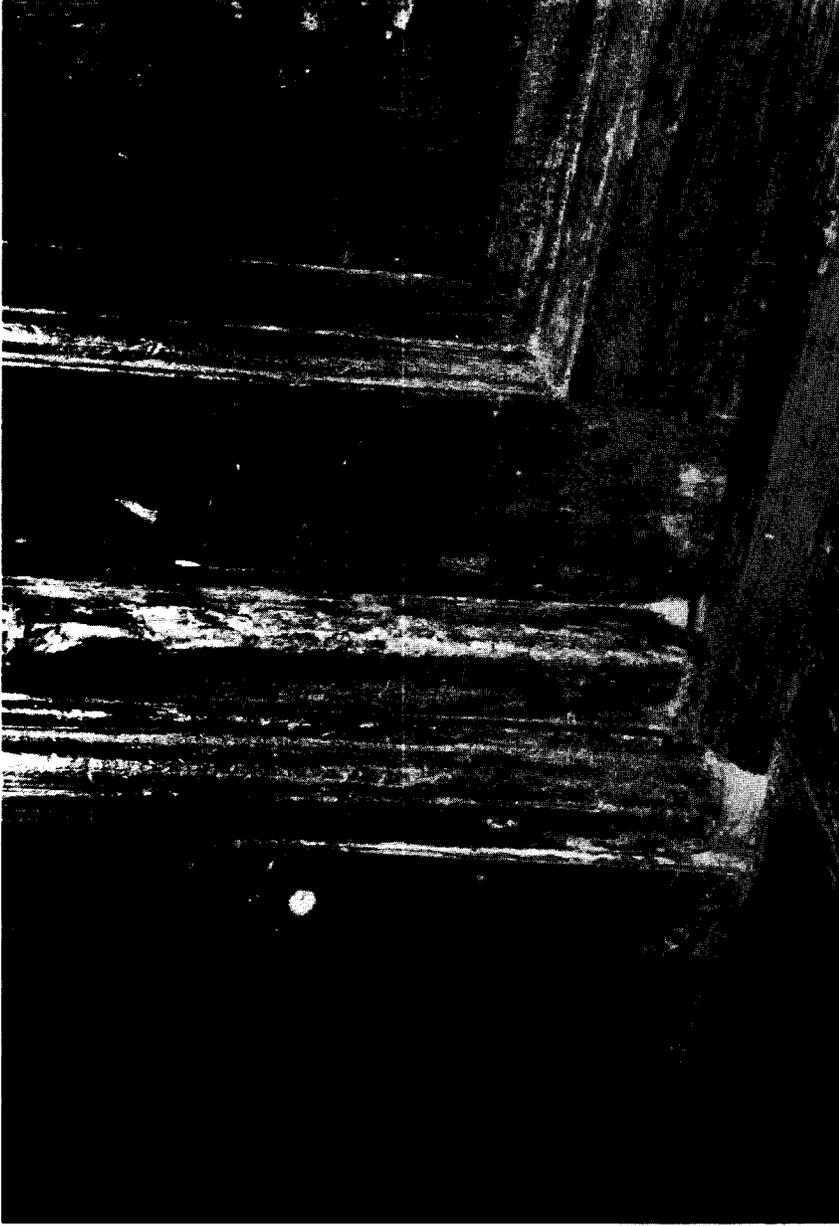
Illustration 49. Atwood-Higgins House: East Kitchen, Doorway Casing
104/103 and Door.

The next alteration to occur in this room saw the introduction of the northeast window's sash, c. 1840. Elements from the mid-19th century include the door 101/104, installed during the refurbishing of the East Front Room 101, and several baseboards. These baseboards are found on the north wall, west of the north chimney post; and on the east wall, north of doorway 104/103 (Ill. 49). These are the only wooden baseboards in the room.

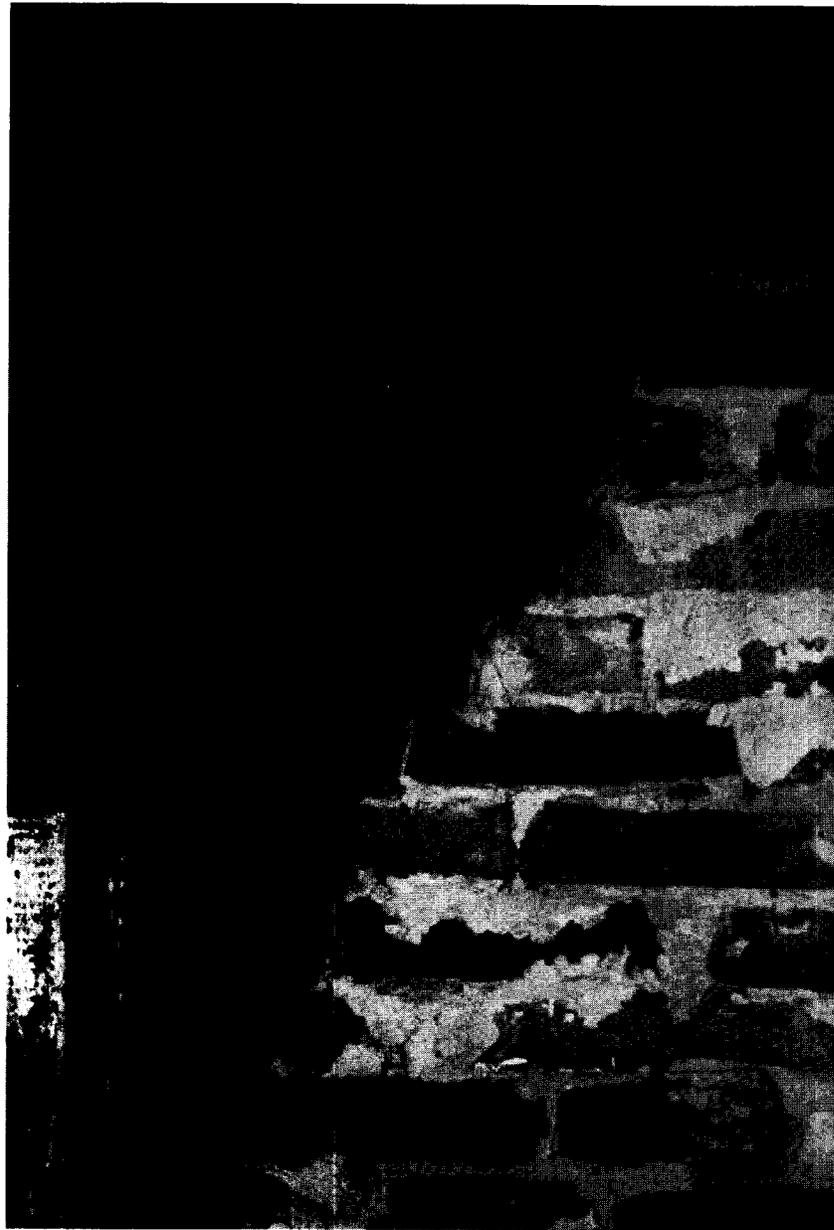
Illustration 56. Atwood-Higgins House: Central Chimney
Void, Stair Ghost on Rear Surface of
East Kitchen's Fireplace.

- stair ghosts on a vertical-board partition to the west of the East Kitchen 104 (Ills. 56-57), viewed from behind the chimney mass. The stair ghosts appear to be from a straight run of stairs ascending in an easterly direction; it may have included winders and a lower straight run ascending in a southerly direction.

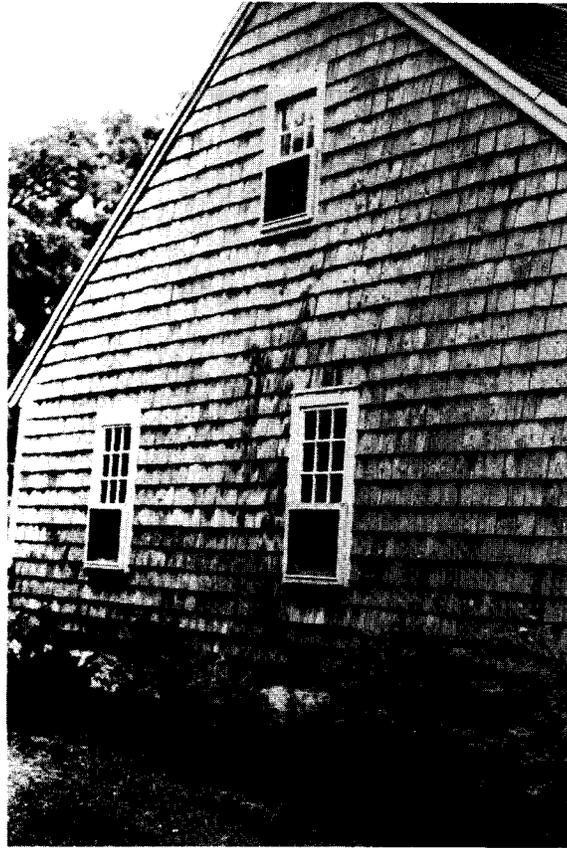
Illustration 101. Atwood-Higgins House:
East-Elevation Shingles.

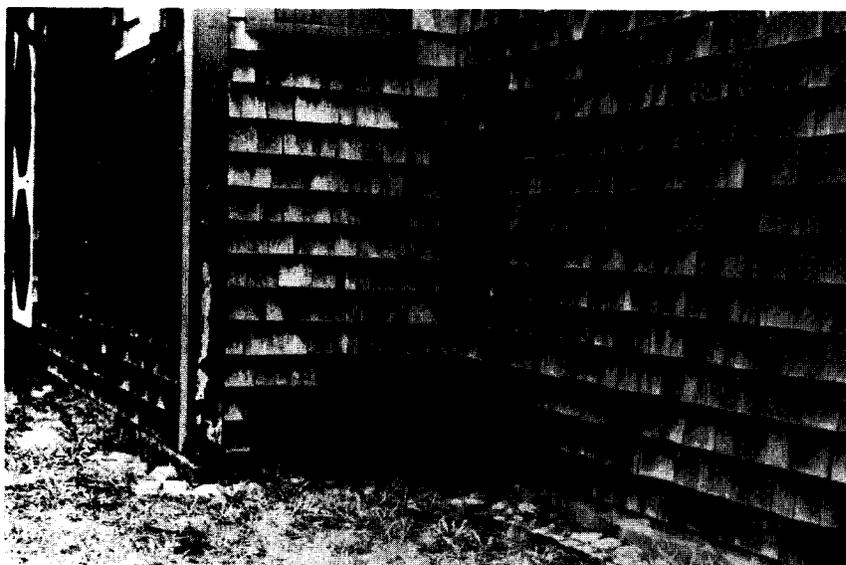
Illustration 107. Atwood-Higgins Country Store: Flaking Paint.
