VII. EXISTING CONDITIONS AND RESTORATION RECOMMENDATIONS

Completion Report, restoration of Captain Penniman House and Barn, historic structures, Eastham, Massachusetts, Cape Cod National Seashore. PCP B-3-2, FY-1963

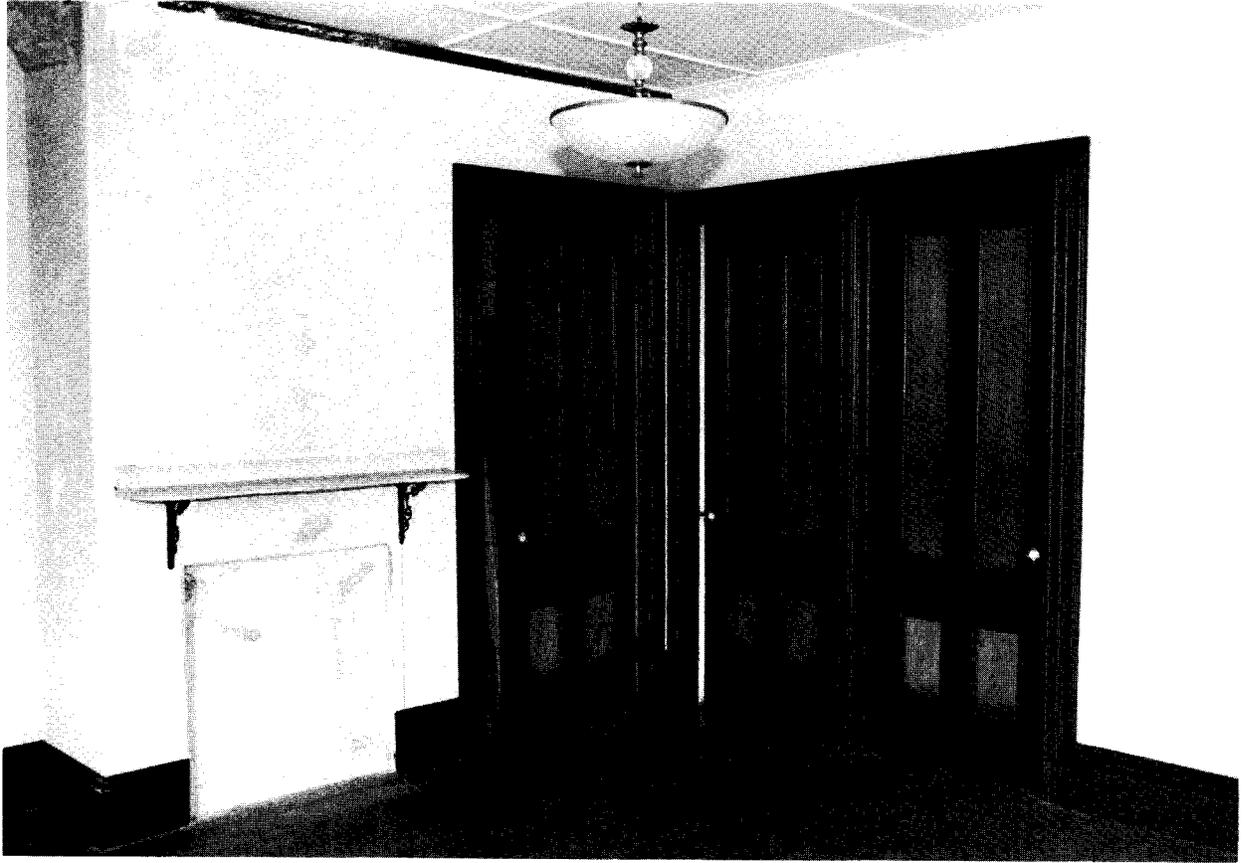
Illustration 104. Penniman House: Dining Room (Room 106), Northwest Corner, Showing Doorways to Closet, Front Hall, and Pantry (1984).

The ceiling light in the center of the room also may have been electrified at this time, although the existing fixture appears to be later. The switch for this light is located on the north wall. The pressed-board ceiling was installed ca. 1940.¹⁵ At this time, the cast-plaster medallion in the center of the ceiling was removed. The most recent alteration to the dining room was made ca. 1950, when the wallpaper was stripped from the walls and they were painted with a gray latex paint. Illustrations 104 and 105 show the present condition of the dining room.

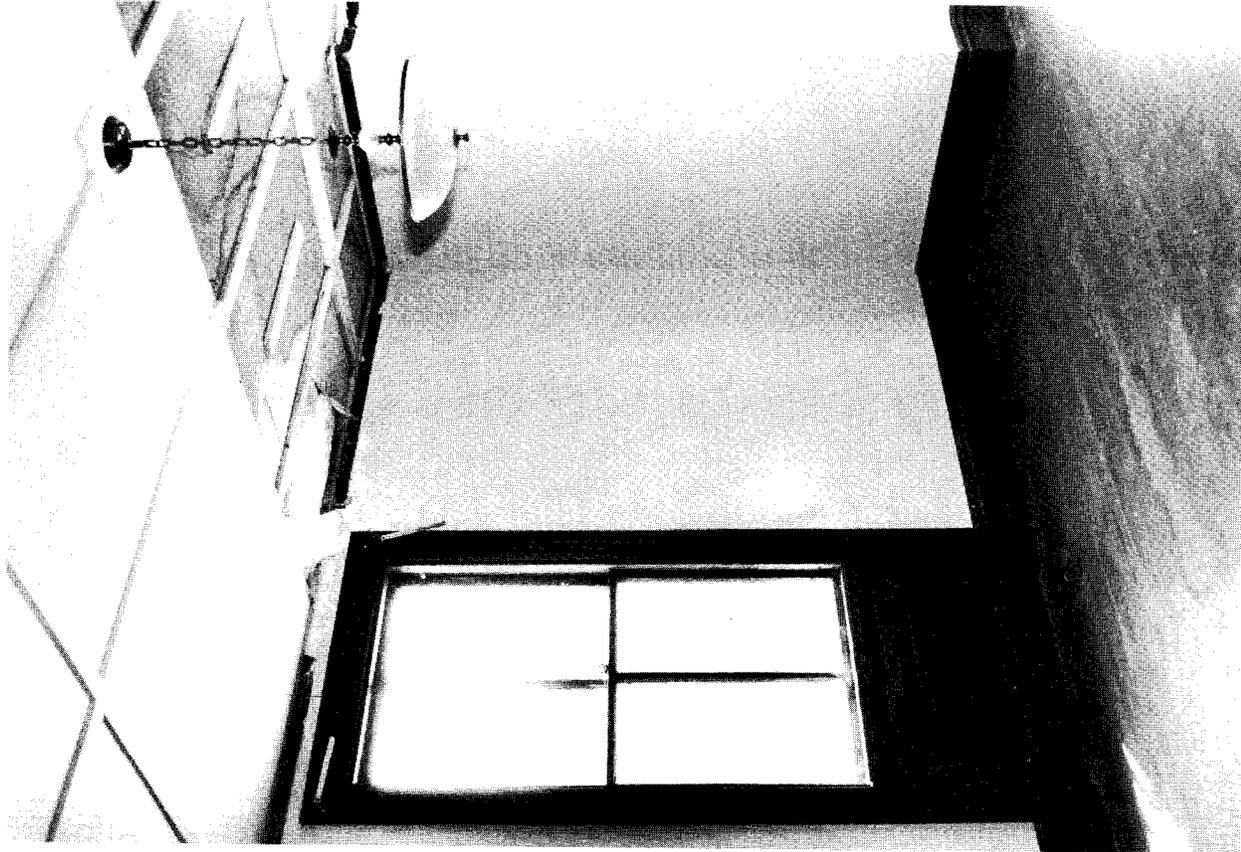
Illustration 105. Penniman House: Dining Room (Room 106), Southeast Corner (1984).

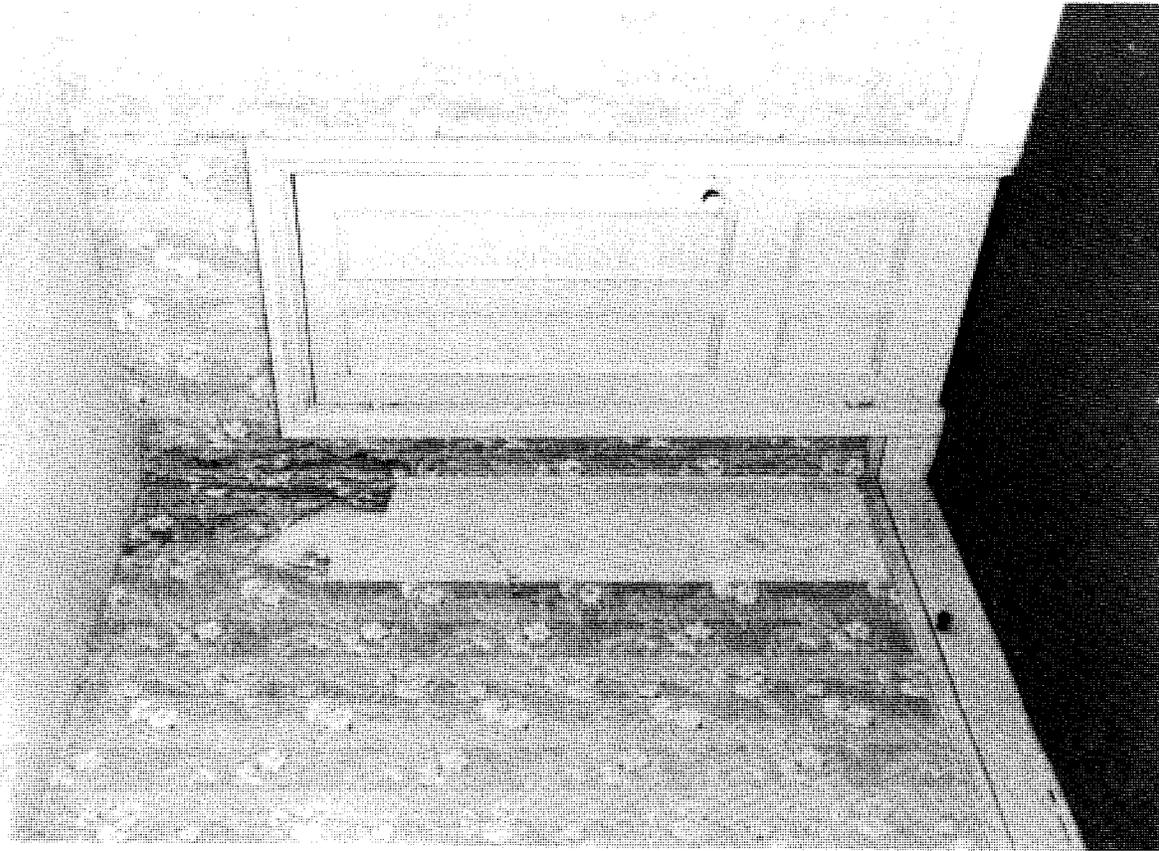
Illustration 110. Penniman House: Southwest Bedroom (Room 201), Northwest Corner (1984).

Figures 110-112 show the existing conditions in Room 201.

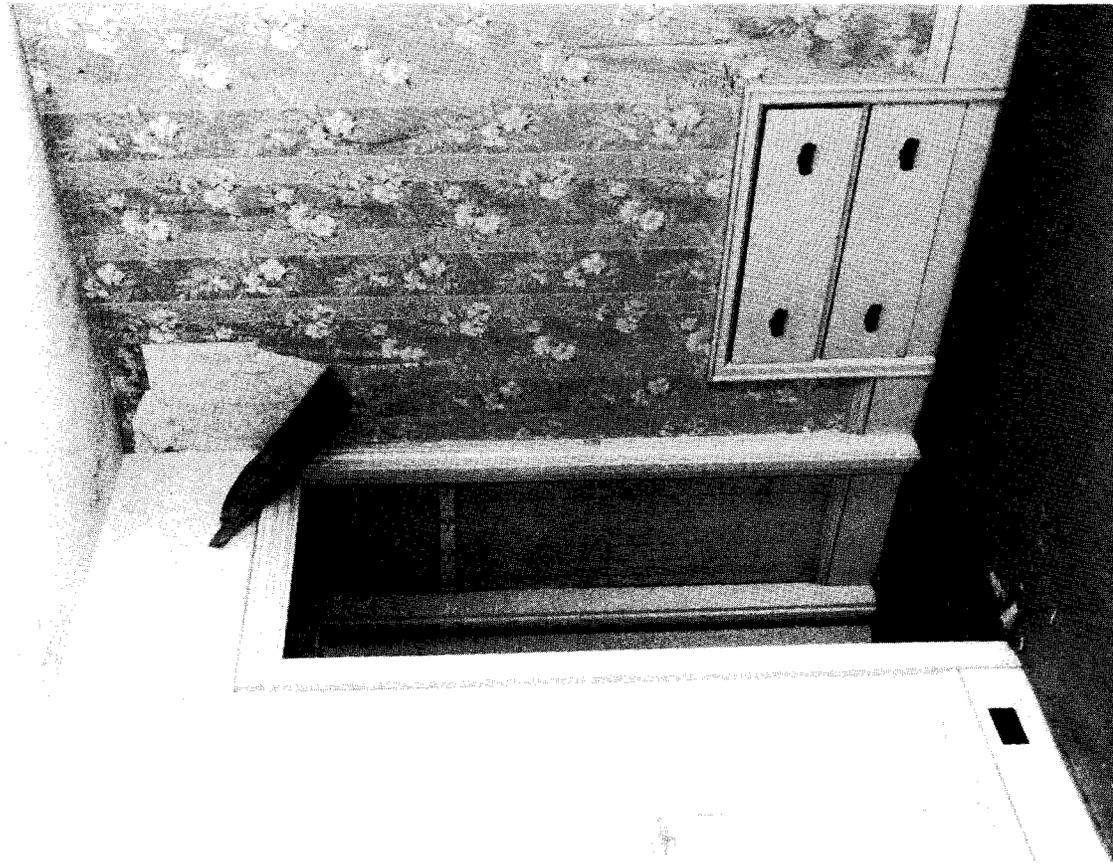
Illustration 111. Penniman House: Southwest Bedroom (Room 201), Southeast Corner (1984).

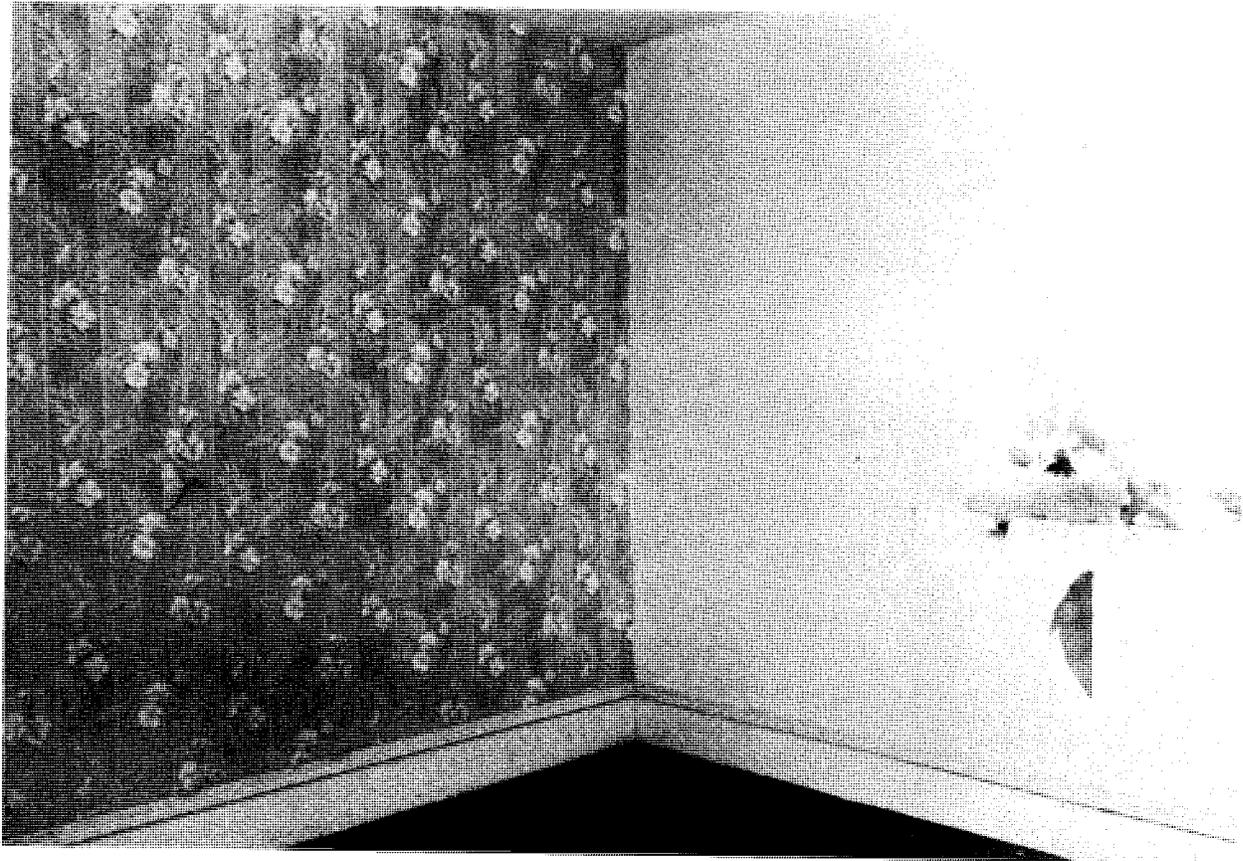
Illustration 112. Penniman House: Southwest Bedroom (Room 201),
Northeast Corner, Showing Former Location of Stove (1984).

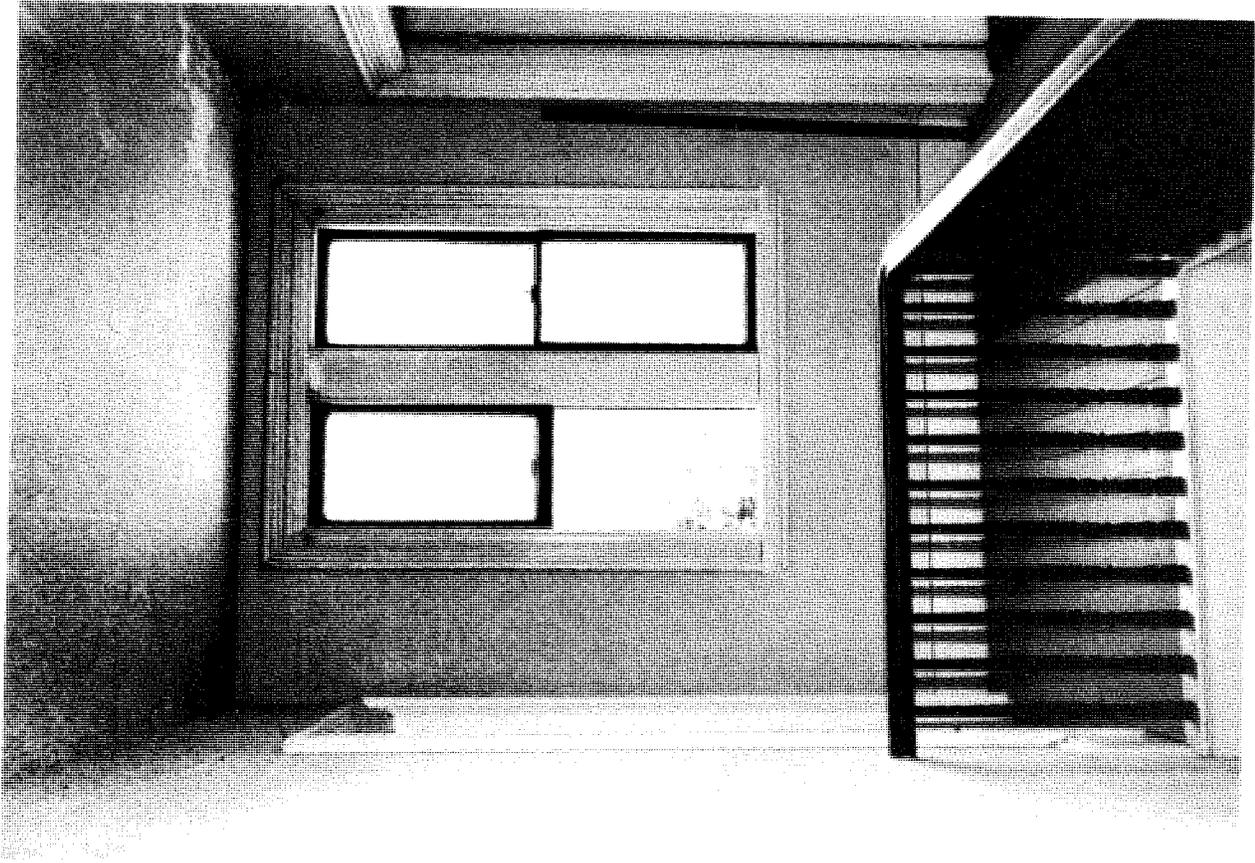
Illustration 114. Penniman House: Front Hall
(Room 202, West Wall, Showing Center Dormer
Window (1984).

Aside from redecorating, no significant alterations have been made to Room 202. Paint samples taken from the woodwork and ceiling reveal that they were painted two or three times. It seems likely that the walls also were repapered several times; however, none of the wallpapers from these decorating schemes has been found. The modern gray latex paint presently on the walls and ceiling was applied ca. 1950. Around 1930, an electrical outlet was installed in the north wall. Illustration 114 shows the existing conditions in Room 202.

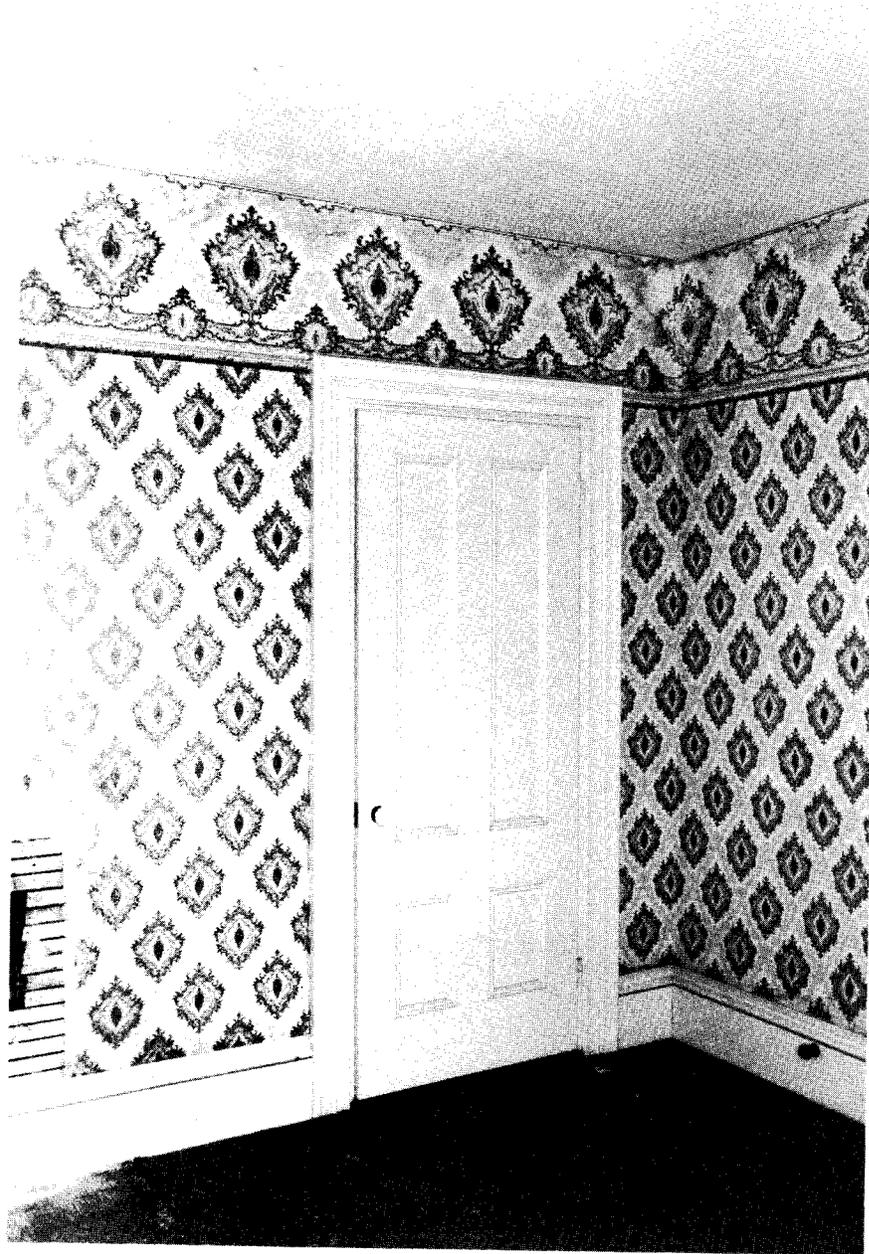
Illustration 115. Penniman House: Northwest Bedroom
(Room 203), Southeast Corner (1984).

Illustration 116, a photograph of Room 203 taken in 1962, shows many of the furnishings described by Mrs. Kahn. Illustrations 115 and 117 show the existing conditions in Room 203.

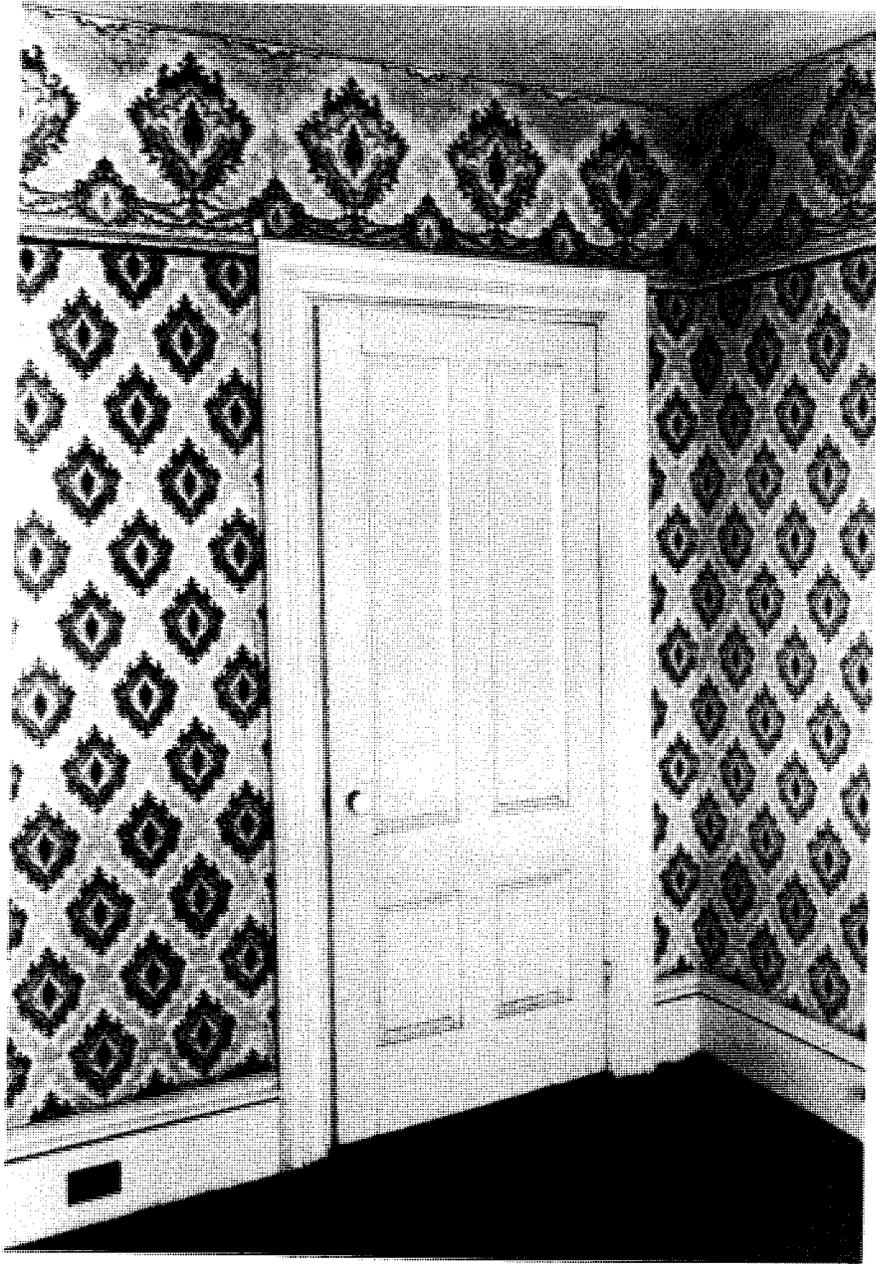
Illustration 117. Penniman House: Northwest Bedroom
(Room 203), Southwest Corner (1984).

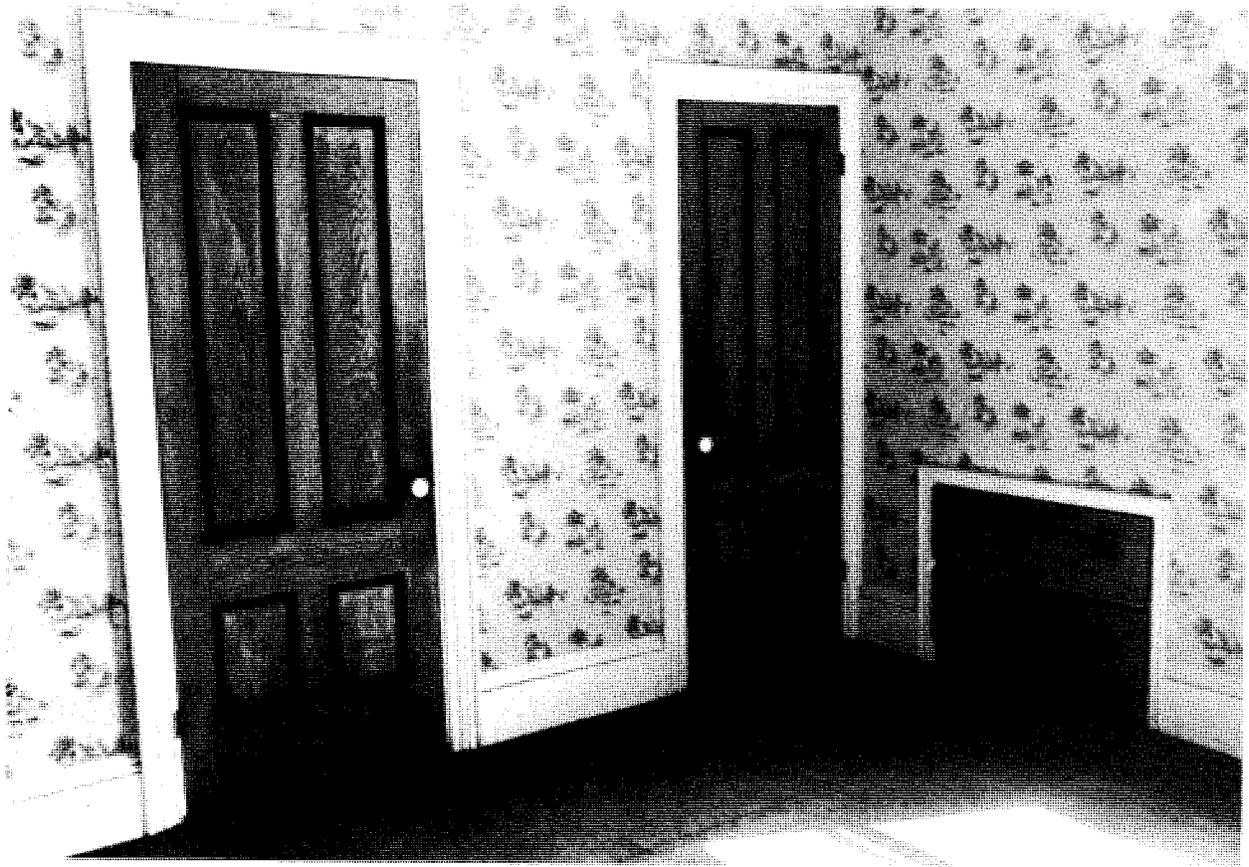
Illustration 122. Penniman House: Southeast Bedroom (Room 204),
Northeast Corner, Showing Doorways to Back Hall
and Bathroom (1984).

Illustration 121, a photograph of the room taken in 1962, shows many of the furnishings described by Mrs. Kahn. Illustrations 122-124 show the room's existing condition.

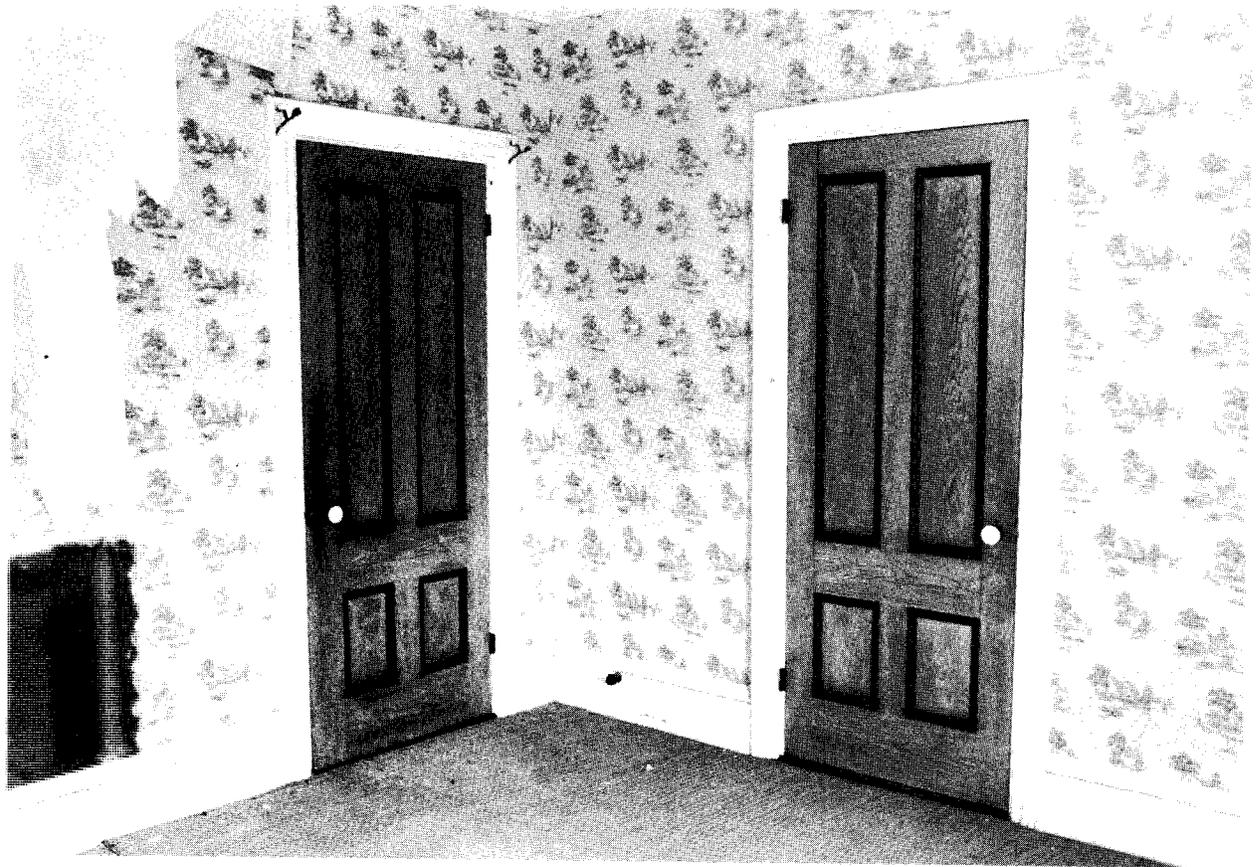
Illustration 123. Penniman House: Southeast Bedroom (Room 204), Northwest Corner, Showing Doorways to Closet and Back Hall (1984).

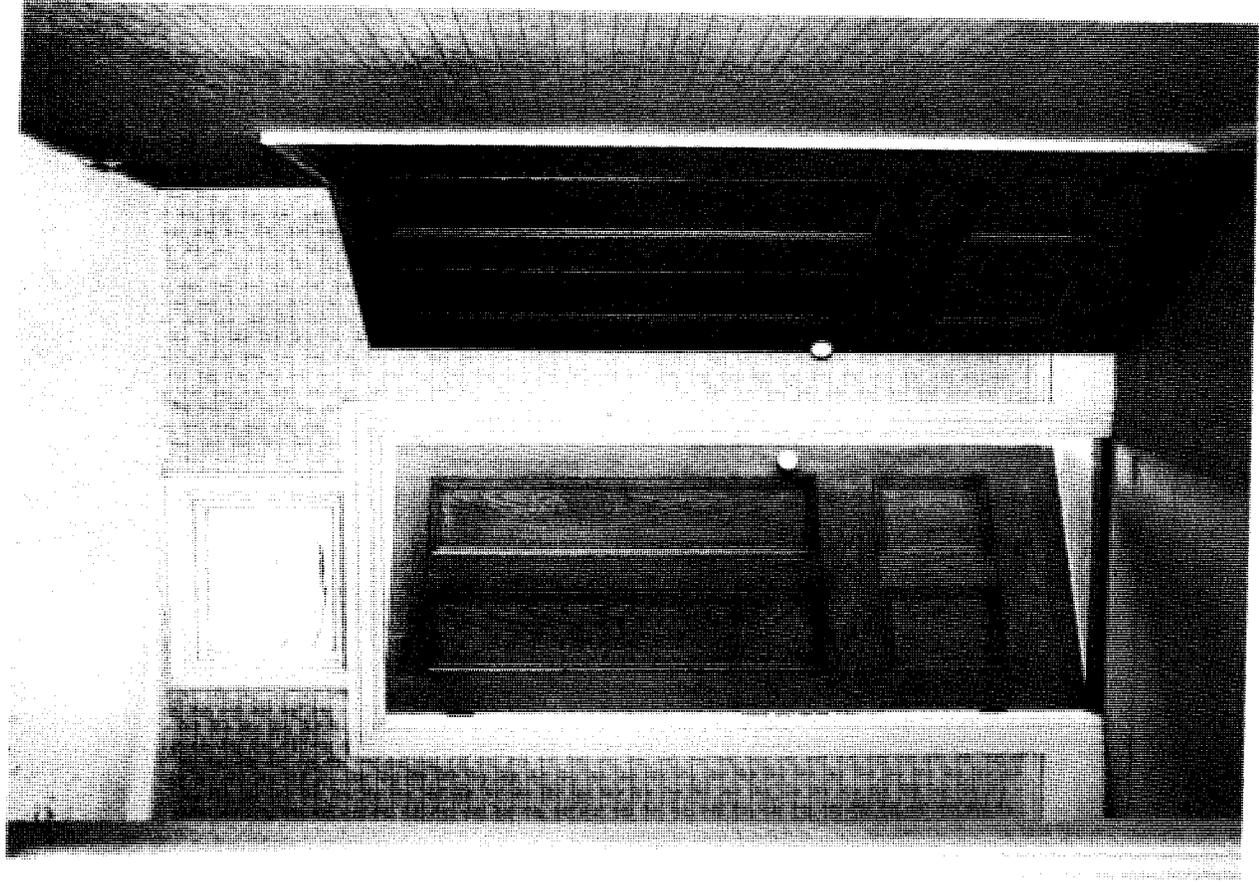
Illustration 125. Penniman House: Back Hall
(Room 205), Northwest Corner (1984).

Illustration 125 shows the existing conditions of Room 205.

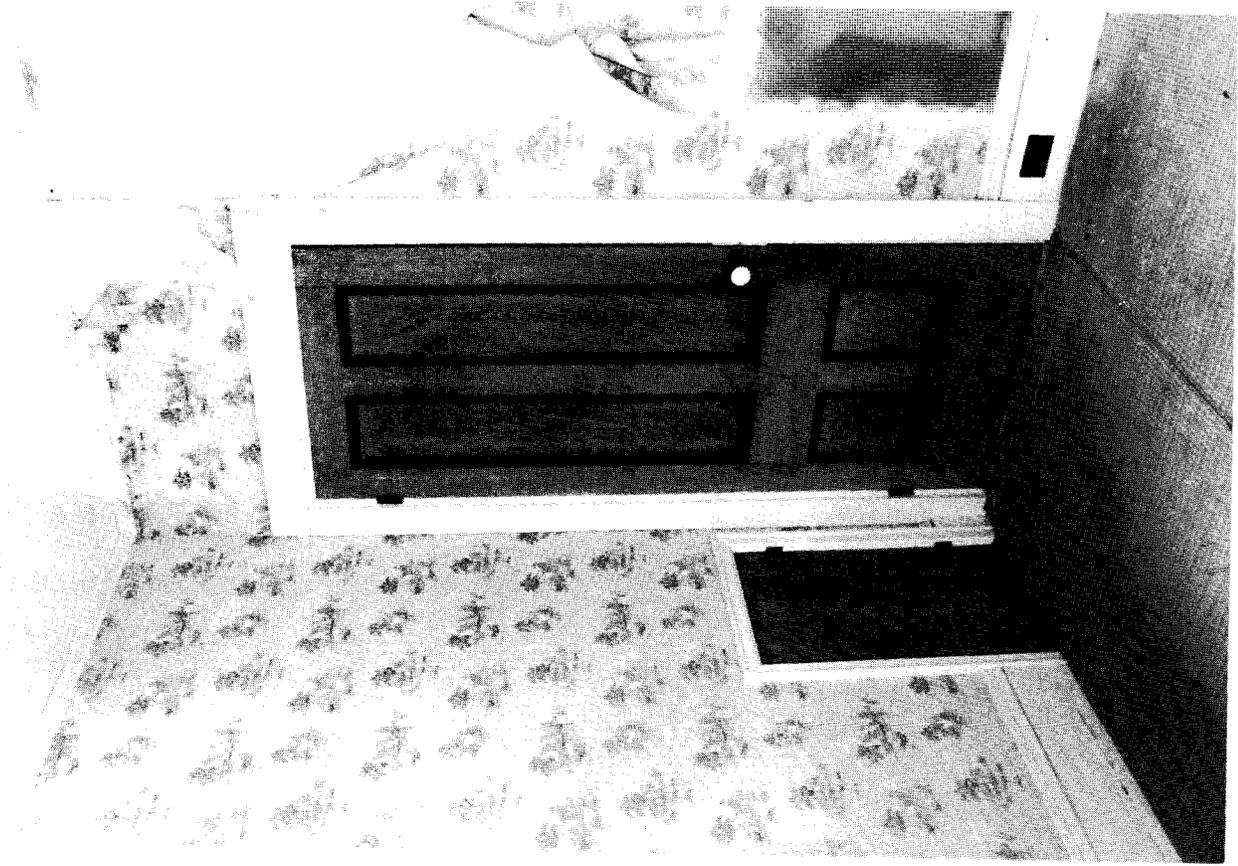
Illustration 124. Penniman House: Southeast
Bedroom (Room 204), Southeast Corner (1984).

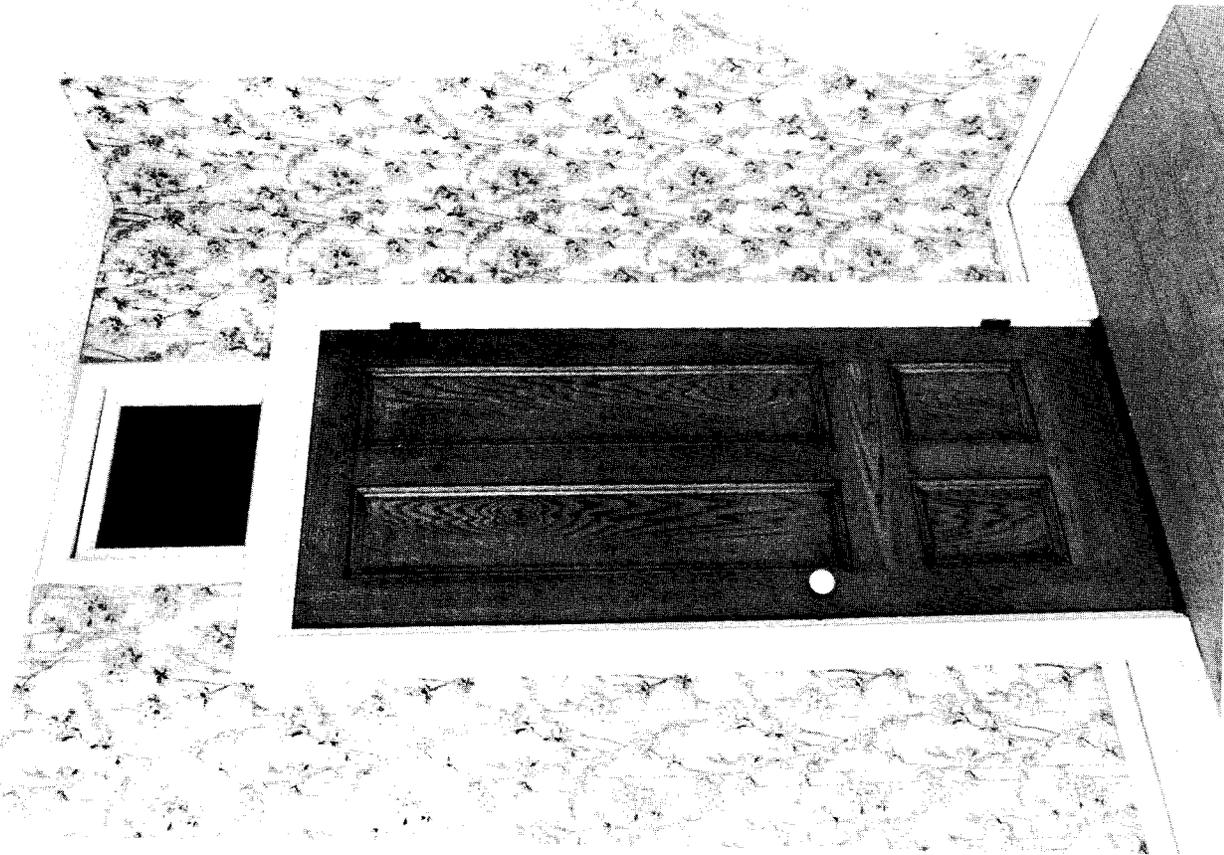
Illustration 128. Penniman House: Northeast Bedroom (Room 206), Southwest Corner (1984).

Illustrations 128 and 129 show the existing conditions in Room 206.

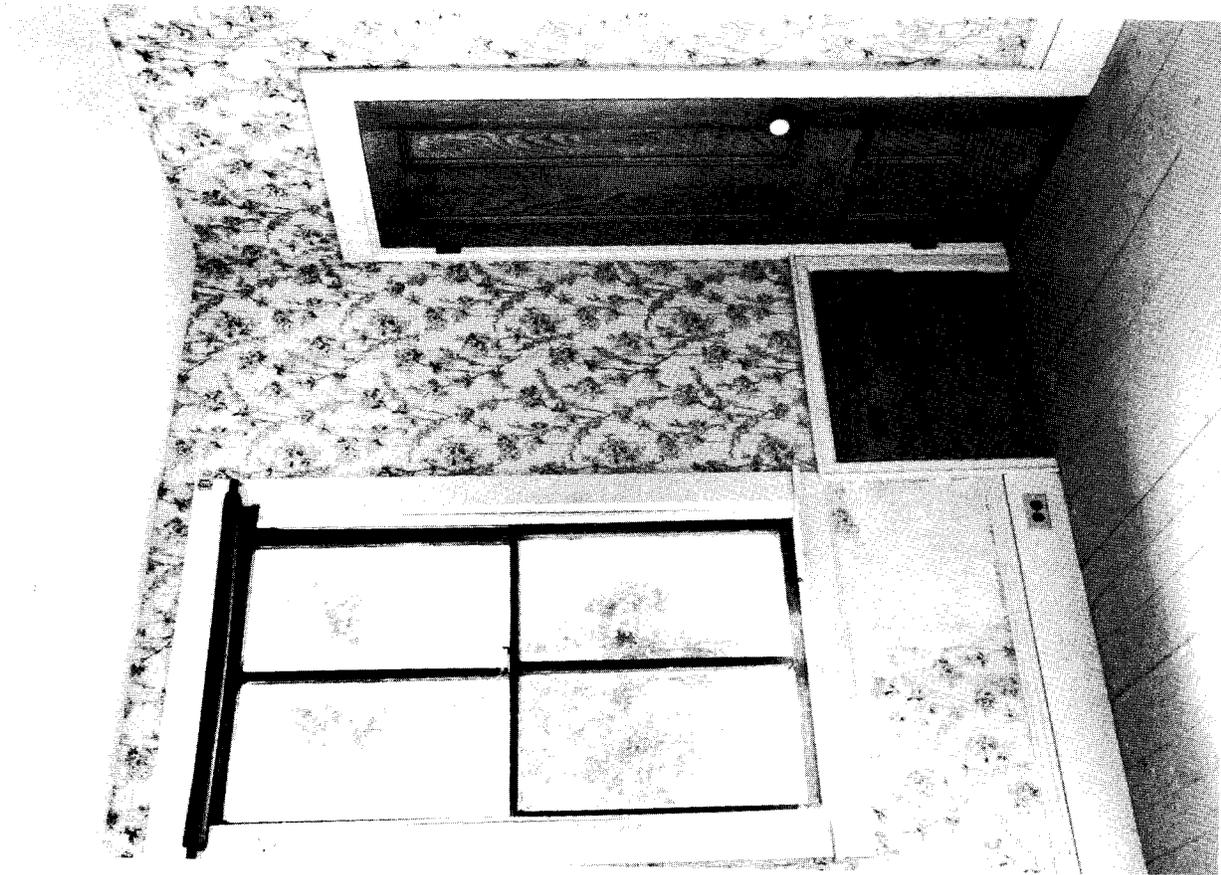
Illustration 129. Penniman House: Northeast Bedroom (Room 206), Southeast Corner (1984).

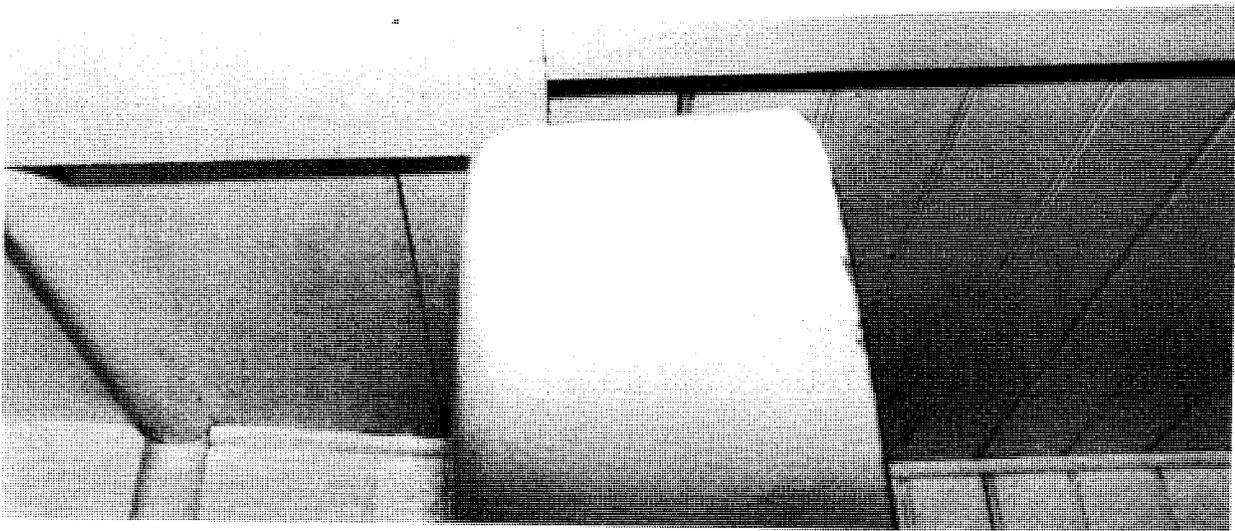
Illustration 131. Penniman House: Bathroom
(Room 207), South-Wall Wainscot
Patches (1984).

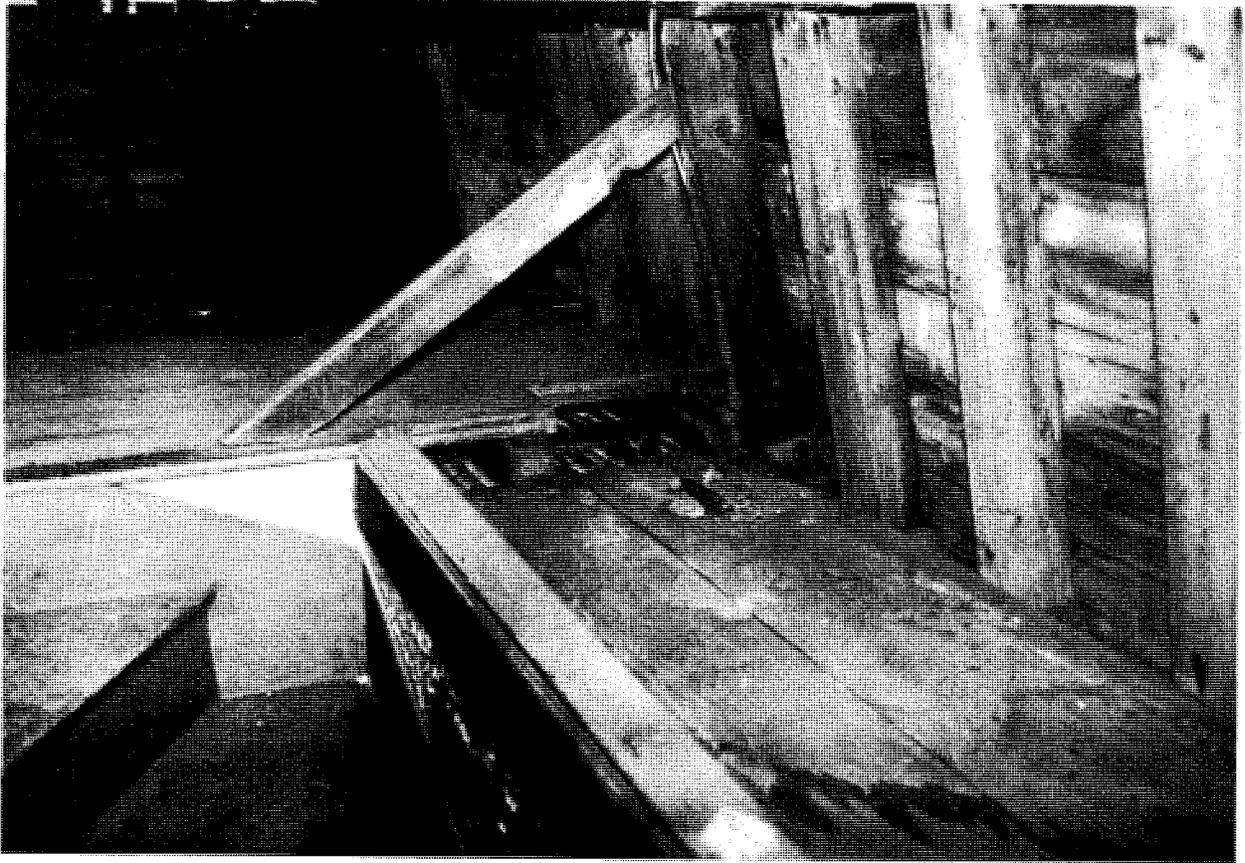
Illustration 134. Penniman House: Unfinished Attic Space (Room 301),
Lowered Portion of Floor Remaining from Attic Cistern (1984).

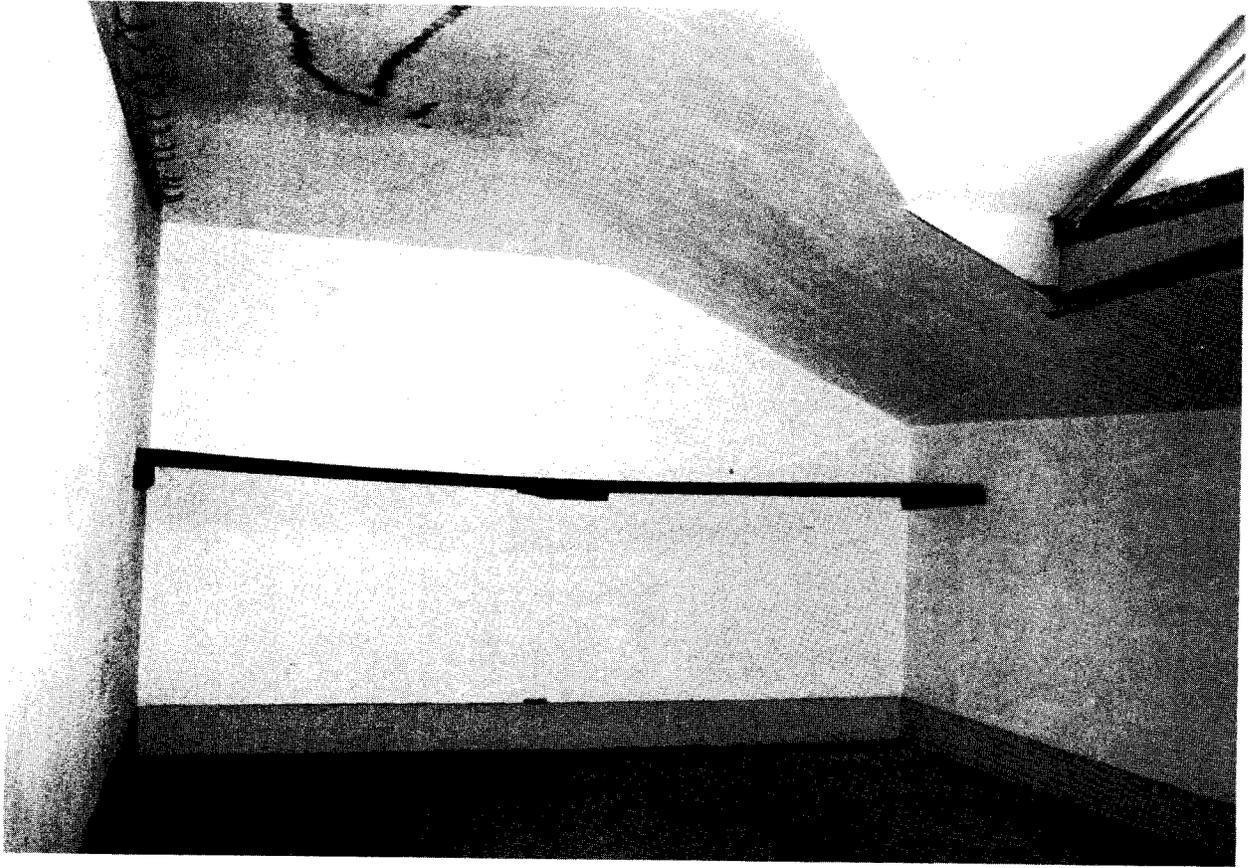
Illustration 139. Penniman House: Finished Attic Space (Room 302),
South Wall (1984).

Illustrations 139 and 140 show the existing conditions of Room 302.

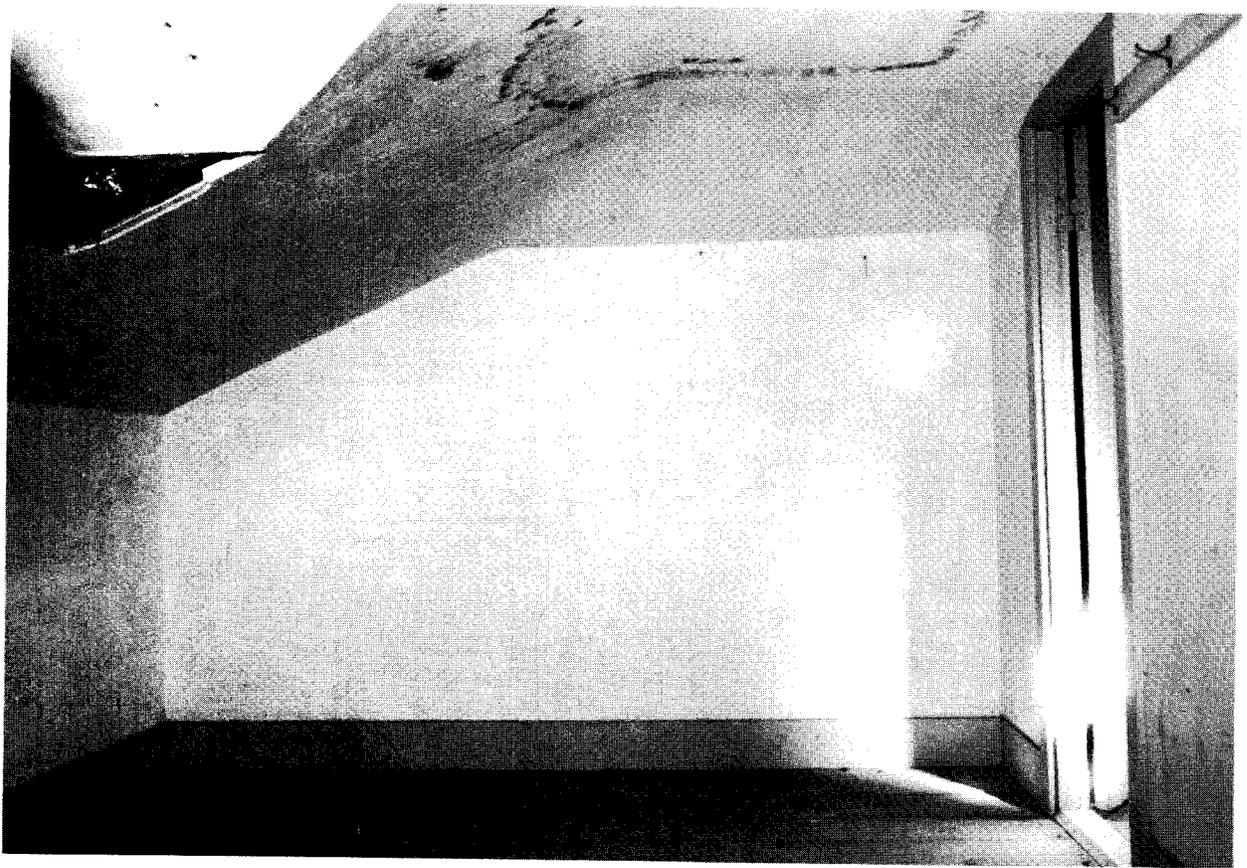
Illustration 140. Penniman House: Finished Attic Space (Room 302),
North Wall (1984).

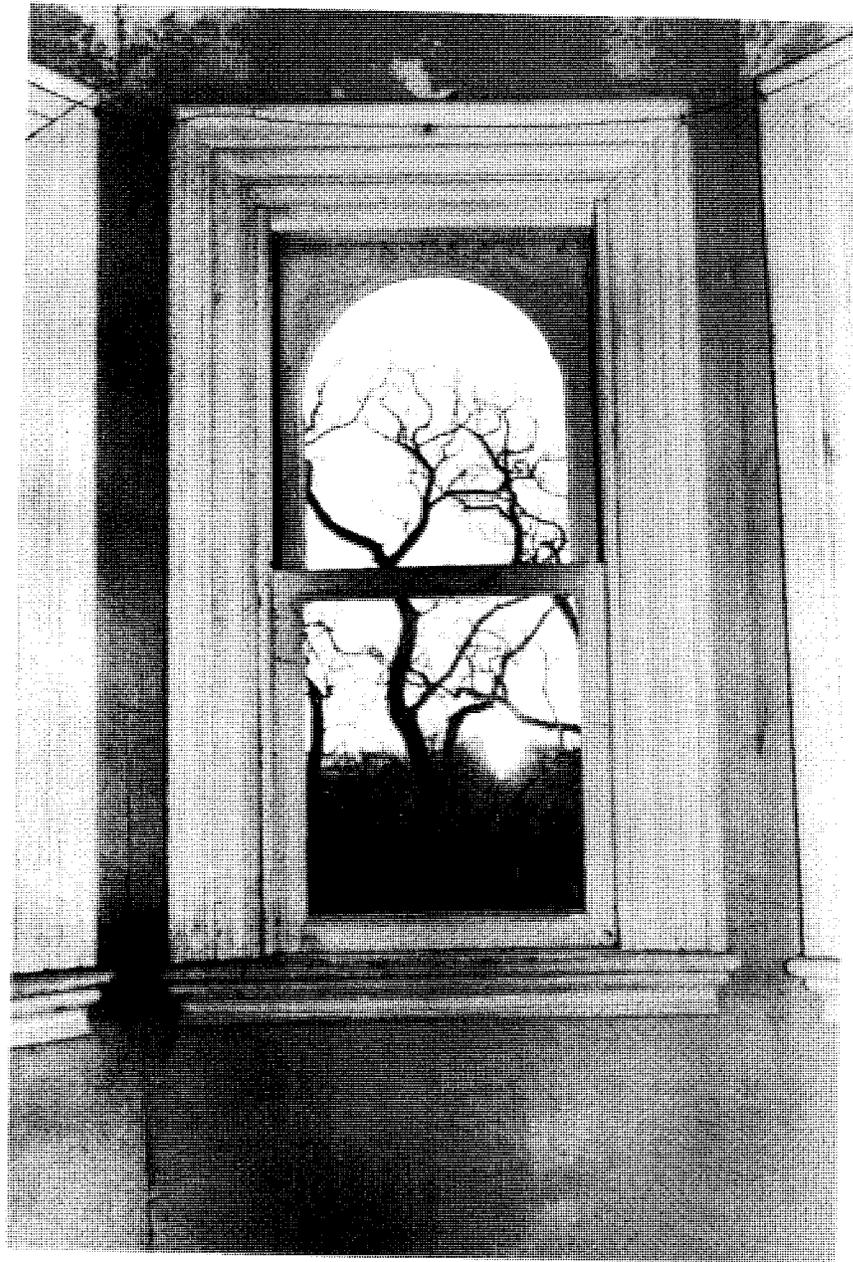
Illustration 141. Penniman House: Cupola,
East Window (1984).

Illustrations 141 and 142 show the existing condition of the cupola.

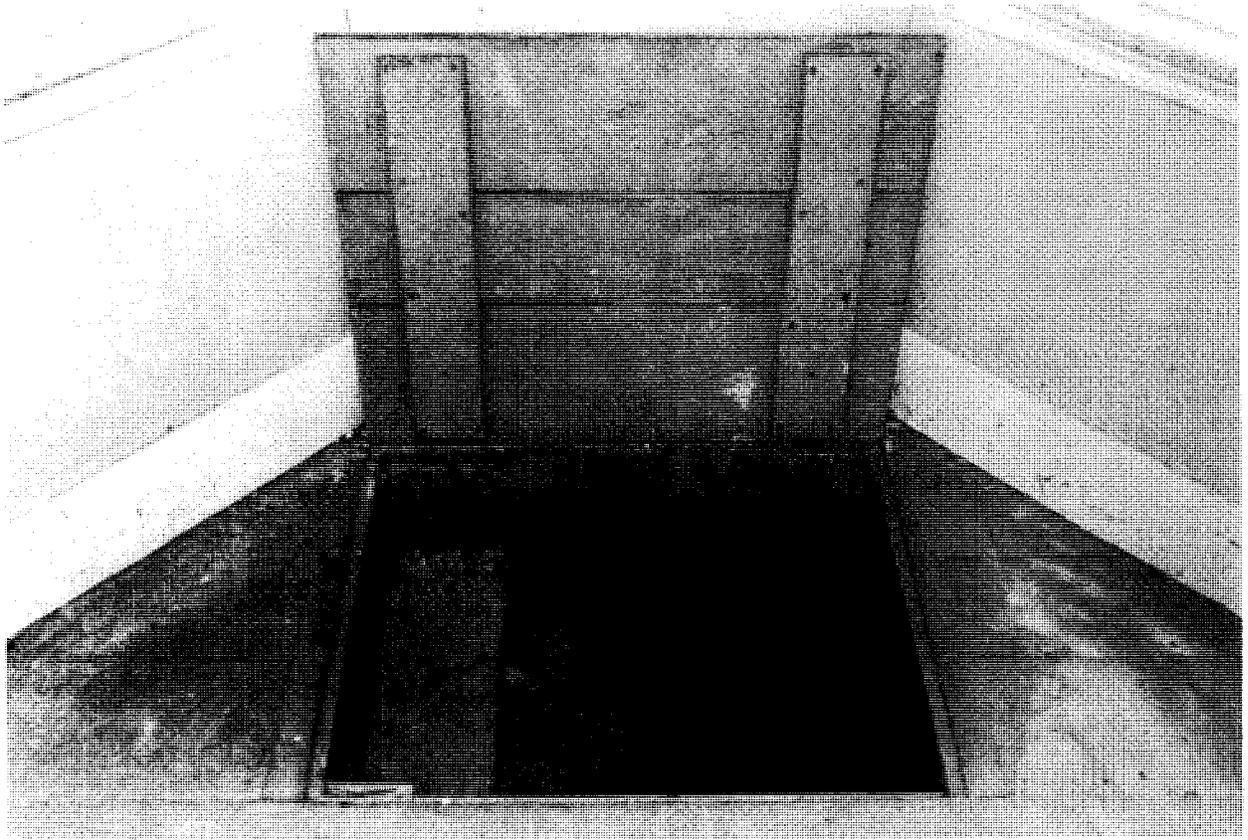
Illustration 142. Penniman House: Cupola, Trap Door in Floor (1984).

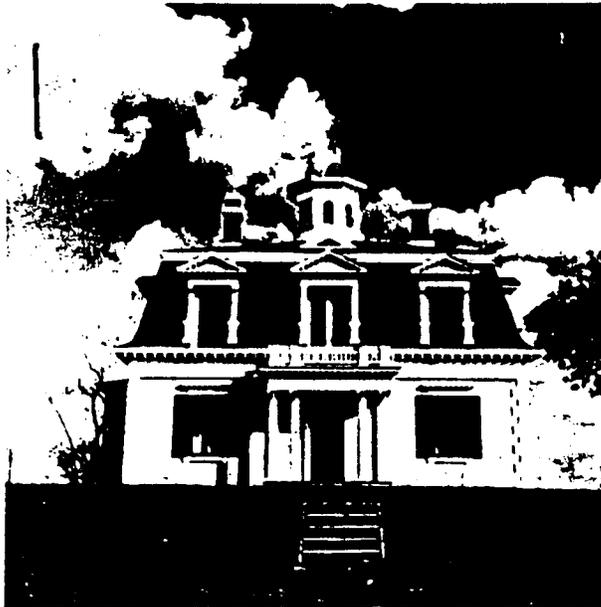
Front elevation after restoration was completed. See the following pages for extent of the replacement of existing construction, also refer to "As Built" drawings.

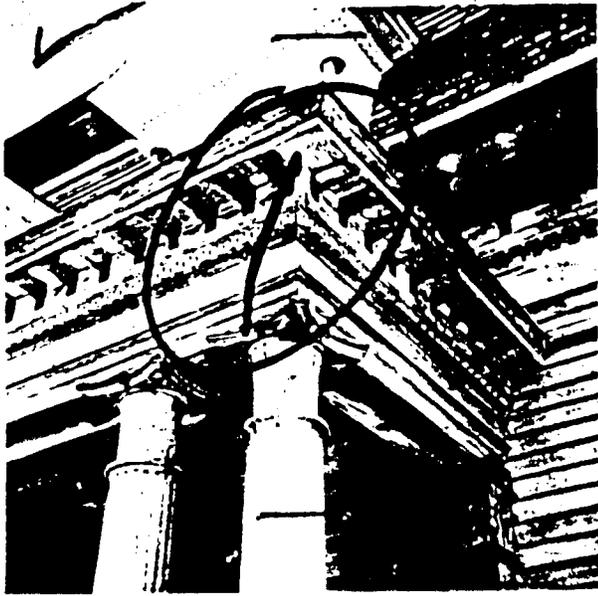
Corner of entrance porch after the carved leaves at columns and curved brackets at cornice had been removed for chemical removal of old paint.

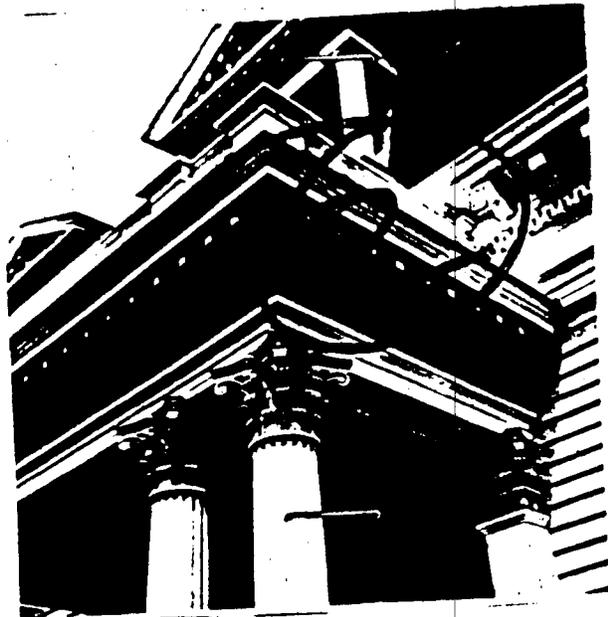
Corner of entrance porch after the leaves and brackets, also dentil mouldings had been set back in place and painted.
