VII. EXISTING CONDITIONS AND RESTORATION RECOMMENDATIONS

Completion Report, restoration of Captain Penniman House and Barn, historic structures, Eastham, Massachusetts, Cape Cod National Seashore. PCP B-3-2, FY-1963

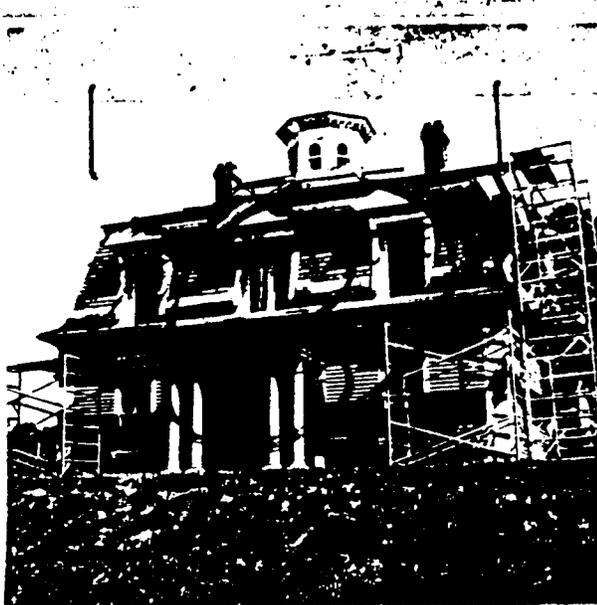
Stagings in place for removal of old shingles and rotted wooden members at front elevation.

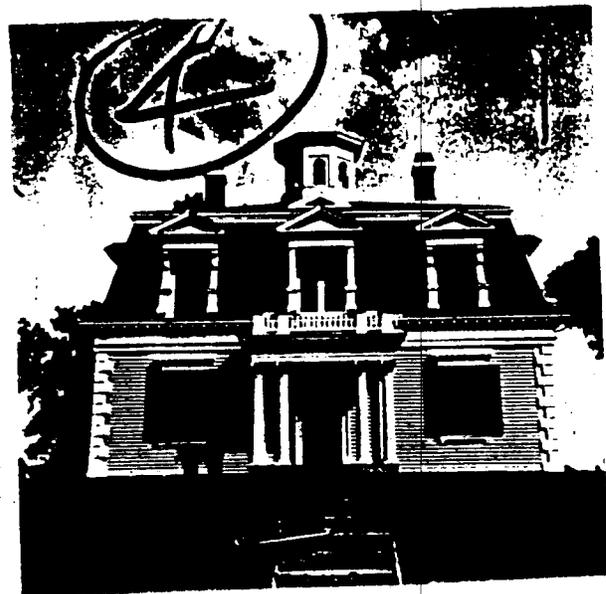
Front elevation after restoration. Roof shingles painted horizontal stripes of brown and red to match original colors. Clapboards painted warm yellow, with window blinds dark green.
