HISTORIC STRUCTURE REPORT
THREE SISTERS LIGHTHOUSES
CAPE COD NATIONAL SEASHORE
MASSACHUSETTS

by
A. Berle Clemensen
and
William W. Howell
with
H. Thomas McGrath
and
Elayne Anderson

January 1986

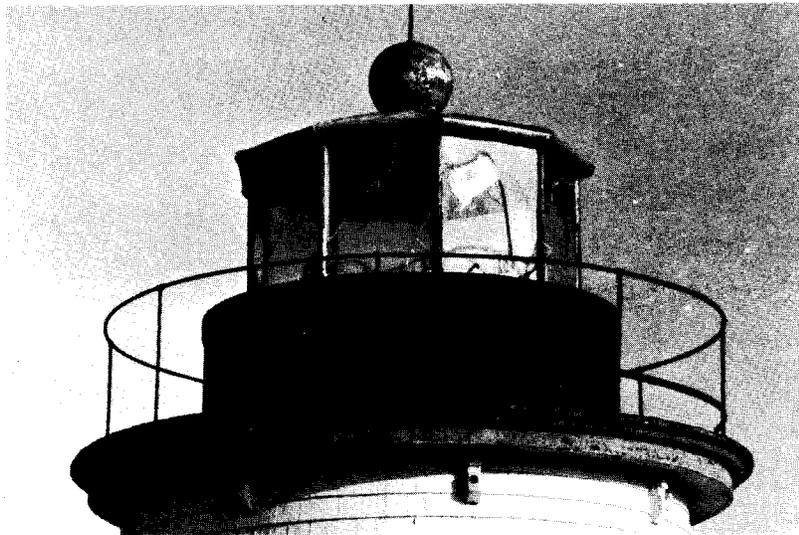
Figure 15

The lantern on the Beacon has survived to the present with minimal alterations (see Figure 15). The floor of the lantern consists of 2-3/4 by 7½ inch planks, grooved and joined with splines. The joints have been filled with oakum and caulked like the deck of a ship to prevent water penetration. The planks are face nailed to the supporting beams with large cut spikes which have elongated hexagonal heads with raised circle designs. The nails are countersunk and caulked. Areas of gray paint survive on the floor. This floor is continuous with the lantern deck outside, but that deck has been covered and could not be inspected for this report. The inside diameter of the lantern floor is 6 feet-5¼ inches.

The lantern at the Beacon

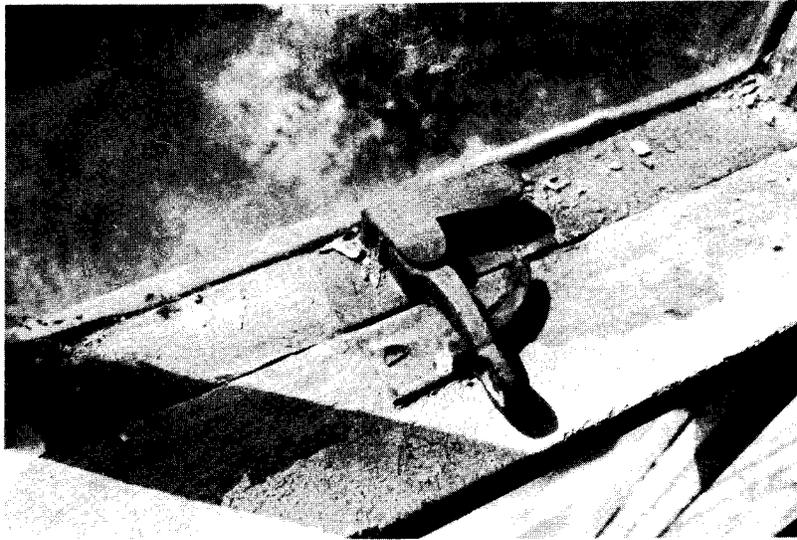
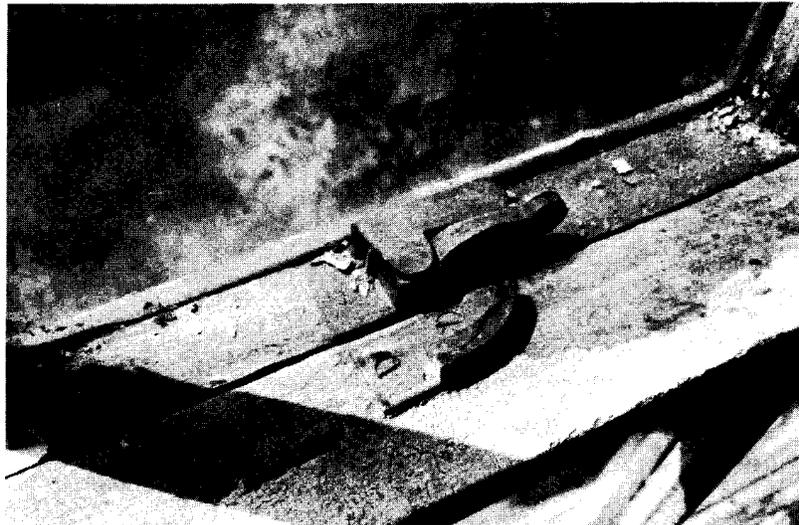
Figure 16

The historic windows are six-over-six single-hung sash. Sash fasteners are the helical spring type similar to Judd's patent as illustrated on page 77 in the Russell and Erwin Catalogue of American Hardware (see Figure 16). The sash pulleys are the standard iron sheaves mortised into the jambs. Historic pulleys have rectangular faceplates; the nonhistoric faceplates have rounded ends. Shutter hardware was found on the South Twin, but it is considered nonhistoric because there is no evidence of shutter hardware on the other towers and the historic photographs do not show shutters.

Historic sash lock (two views) in the North Twin
Photograph by W. Howell June 1983
