Building Number: 106
(Same as 102, 104 and 108)

Original Name: Family Housing

Site Access: Yes
 Demo Permitted?: Yes
 Project# 07394
 Location: Building #106

Project: Former Air Force Station
 Location: North Truro, MA

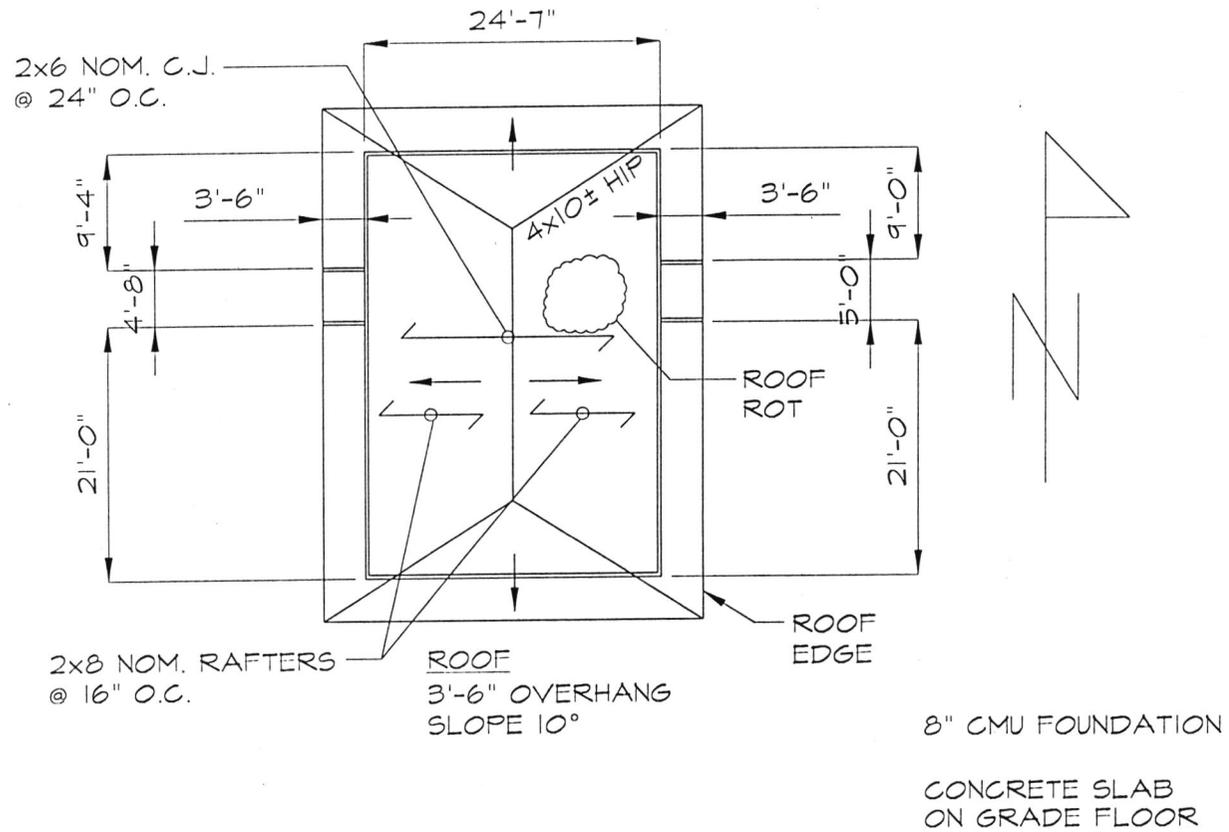
Building Number: 106

We have listed in Table 1 the location and estimated quantity, by square foot (sf), linear foot (lf), or other appropriate unit, of each type of ACBM identified at the site. We have also provided asbestos location drawings in Appendix B.

Type of Material	Location	Quantity
Yellow linoleum floor sheeting and underlying tan/green or gray 9" x 9" floor tile	Bedrooms, kitchen, corridor and living room	700 sf
Joint compound and associated gypsum wall and ceiling board	Throughout	2,280 sf
Black 3-tab roof shingles	Roof	1,100 sf

2. The gypsum wallboard must be treated as ACM due to cross-contamination by the joint compound. All joint compound and contaminated gypsum board must be removed by a licensed asbestos abatement contractor. We recommend that the joint compound be further analyzed by the point count method, a systematic analytical technique to determine if the material in fact does contain greater than 1% asbestos by composition.

3. We recommend TEM analysis of those floor tile mastic adhesives determined to contain a trace amount of asbestos via PLM analysis. TEM analysis is a more definitive method than PLM of determining the presence for asbestos in materials such as mastic adhesives, floor tiles, asphalt roof materials and other such resinously bound building materials.
