Existing Conditions

This chapter describes through narrative text, contemporary photographs, and labeled base mapping, the current conditions and extant landscape features associated with the Portsmouth Village Historic District. The purpose of documenting the park's existing landscape is three-fold. The primary role of the existing conditions documentation is to convey the range and breadth of landscape features by identifying, describing, and locating them on a map. This documentation serves as a baseline of information for the rest of the document. The second purpose is to generate an inventory of park features that can be utilized to develop several cultural landscape analyses and assess National Register eligibility and integrity. The final role is to provide a record of the landscape that may prove useful to future research efforts.

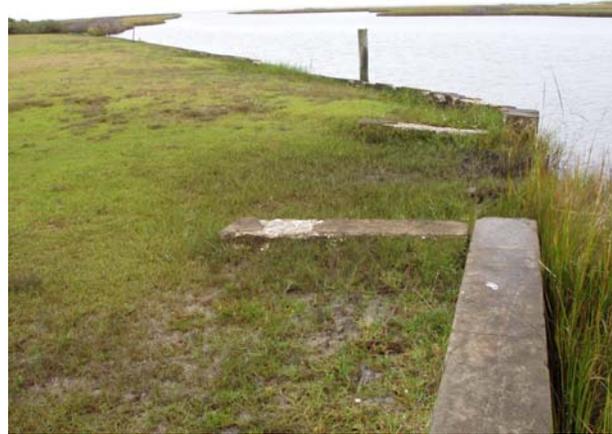
Coast Guard Creek. Coast Guard Creek extends south from the Life-Saving Station to Ocracoke Inlet along the eastern margin of the historic district (Fig. 27). This creek was an important consideration in the siting of the Portsmouth Life-Saving Station. While the building is sited far enough inland to be relatively sheltered, access to the coastal waters for the Life-Saving Station rescue boats was afforded via this creek. In 1908, the Life-Saving Station crew dammed the western end of Coast Guard Creek just east of the station and backfilled with sand, which significantly shortened the creek.¹³¹ A seawall and ramps were constructed in 1918 along the edge of the creek to facilitate access to the water for rescue boats. Siltation has occurred within the creek, evidenced by the portions of the seawall now embedded in its banks. Otherwise, this tidal creek appears to be in good condition.

FIGURE 27. View northeast along Coast Guard Creek.

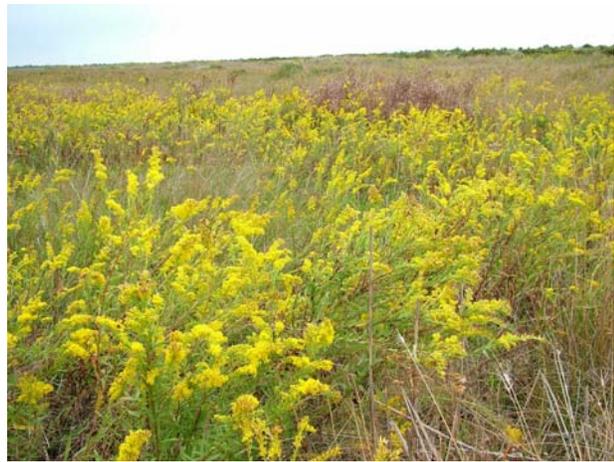
Grassland. Also present within the historic district are open grasslands dominated primarily by grasses and forbs (Fig. 33). These occur where woody growth is less apt to become established because of winds, salt spray, a lack of available soil moisture, and the potential for overwash or storm damage. Species characteristic of Portsmouth Village grasslands include: saltmeadow cordgrass, water pennywort (*Hydrocotyle bonariensis*), seaside goldenrod (*Solidago sempervirens*), fimbriatylis, and purple muhly (*Muhlenbergia capillaris*). The grassland areas serve as habitat for various birds such as the common Eastern meadowlark, mourning dove, boat-tailed grackle, and marsh hawk. This plant community type generally appears to be in good condition. No invasive alien plant species were observed to be threatening these communities during field investigations conducted for this project. Both the shrub and grassland communities generally appear to be migrating toward the tidal flats, forming very clear bands of vegetation. Scientific study is being conducted by local natural resource specialists to determine the cause of this unusual successional pattern.

FIGURE 33. An example of grassland vegetation near the tidal flats.

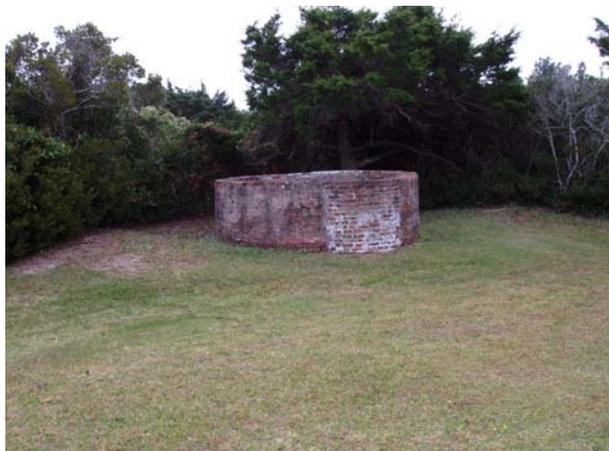
FIGURE 40. Cisterns like the U.S. Marine Hospital structure shown here are used to store rainwater on the island and are the primary source of fresh water.

Cisterns and wells. Most residents of Portsmouth Island derived their fresh water from the collection of rainwater stored in cisterns (Fig. 40). Most properties within the historic district have a cistern or water box. The condition of wells, water boxes and cisterns on the island and their ability to provide and store drinking water is not currently known.

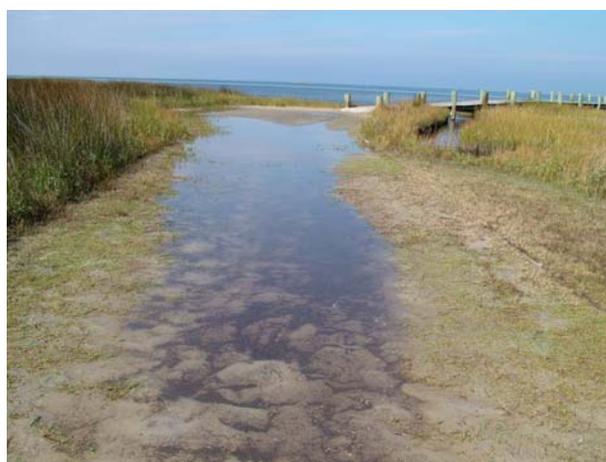
FIGURE 48. Haulover Point Road, as seen here, often exhibits ponding and standing water, which can be a problem for visitors.

condition, except for where ponding occurs near the boardwalk.

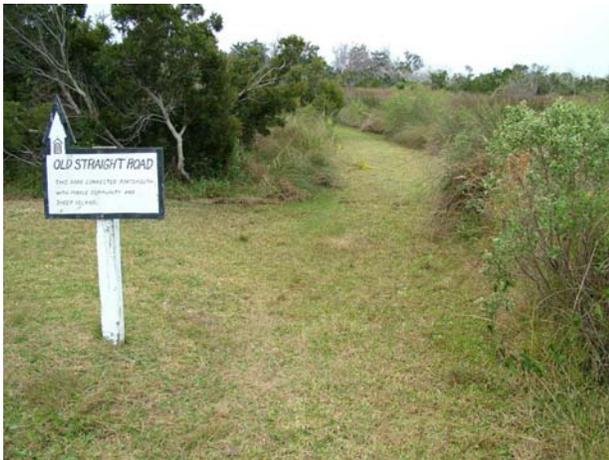
Old Straight Road. The Old Straight Road is the historic route of travel between Portsmouth Village and the Middle Community (Fig. 51). It joins Haulover Point Road near the Schoolhouse. This route has a mown grass surface. The portion of the road that is interpreted within the historic district is in good to fair condition, although it requires constant maintenance to remain unobstructed by vegetative growth. Beyond the historic district boundary, this road is difficult to follow due to overgrown vegetation.

FIGURE 51. View southwest along the Old Straight Road near the Schoolhouse.

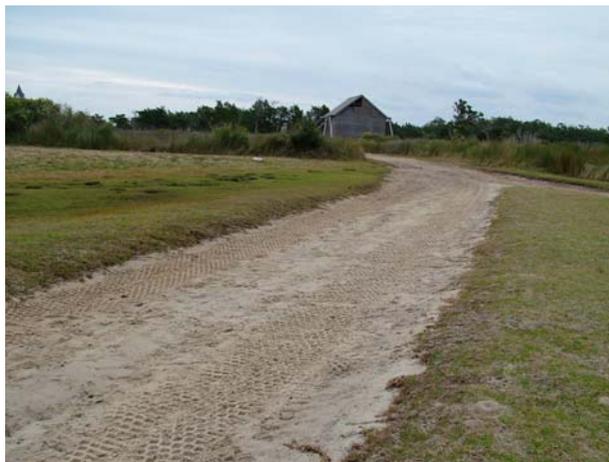
Access Road to Dixon-Salter House, Portsmouth Cemetery, and Will Willis House ruins. This access road leads west from Haulover Point Road near the Dixon-Salter House and the village crossroads (Fig. 52). The road splits; one branch leads to Portsmouth Cemetery and the other to the Will Willis House ruins. This road has a mown-grass surface. It is generally in good condition, but becomes increasingly overgrown near its terminus.

FIGURE 52. View southwest toward the village crossroads.

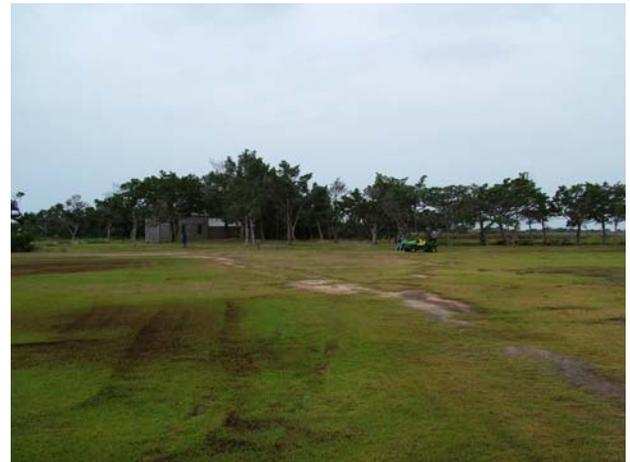
FIGURE 56. View east along the access road to the Ed Styron House.

Access Road to Ed Styron House. This access road leads northeast from the vicinity of the Portsmouth Methodist Church (Fig. 56). It has a mown-grass surface. The road has been damaged by heavy vehicles and the NPS is working to mitigate the damage.

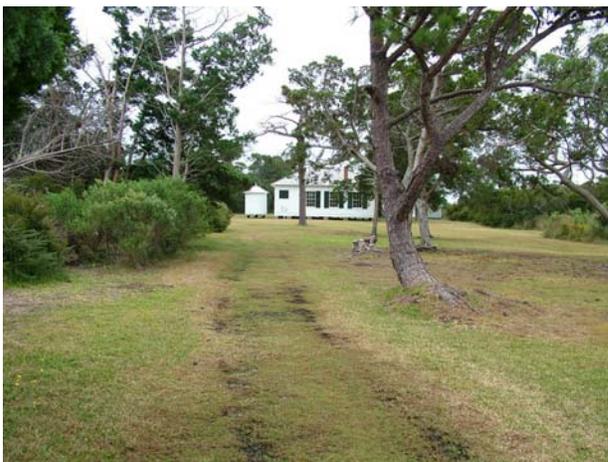
FIGURE 55. View south along the access road to the Schoolhouse and the Cecil Gilgo House.

Access Road to Schoolhouse and Cecil Gilgo House. This access road arises at the intersection of Haulover Point Road and the Old Straight Road (Fig. 55). It has a mown-grass surface and provides access to the Cecil Gilgo House and the Schoolhouse. This road is generally in good condition, although there is vegetation along its perimeter in some areas that must be maintained to keep the road passable.

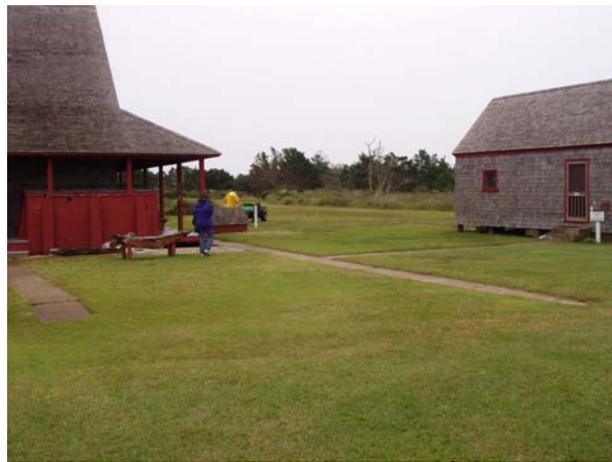
Concrete walks associated with the Portsmouth Life-Saving Station. Concrete walks approximately three feet wide edge the Life-Saving Station along its front facade and lead from the station to the summer kitchen, extend toward the stable, and edge the side of the building where two concrete ramps lead inside (Fig. 63). This system of concrete walks was built in 1914–1918, except for the walk to the summer kitchen, which was added in 1942. The paths are exhibiting evidence of deterioration, including cracking and spalling, and vegetative growth within many of the control joints. They are in fair to good condition.

FIGURE 63. Concrete walks extend between the Portsmouth Life-Saving Station and summer kitchen, as well as into the landscape.

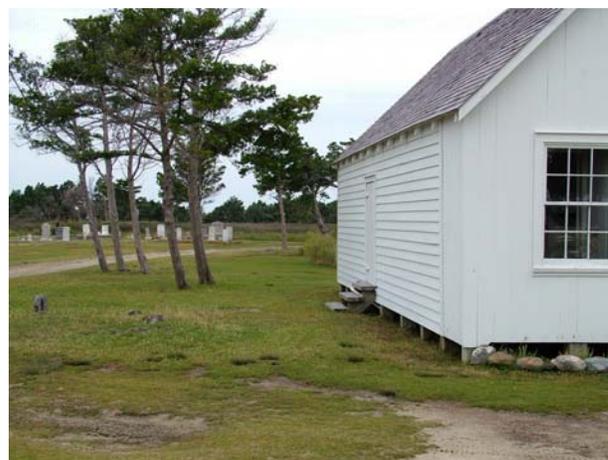
Eastern red cedars. There are Eastern red cedar trees located in association with most of the residential properties within the district. At the Post Office and General Store, for example, Eastern red cedars edge the building on two sides. Some of the trees in the line to the south appear to have recently been lost. (Fig. 68) Eastern red cedars are also a primary component of the landscape surrounding the Robert Wallace House. (Fig. 69) These native evergreens are also associated with many of the cemeteries within the district, including the Keller-Styron Cemetery. (Fig. 70) Many of the trees within the cemetery appear to be suffering from damage due to storms or salt spray and are stunted. They range individually from good to poor condition.

FIGURE 68. Eastern red cedars are prevalent throughout the historic district. Shown here is a line of trees that edge the Post Office and General Store.

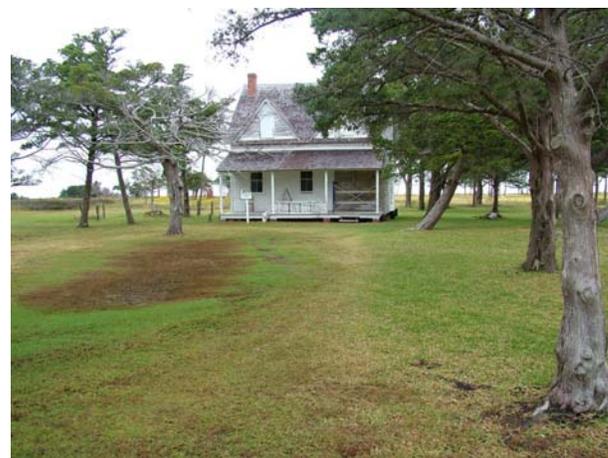
FIGURE 69. Eastern red cedars are also found in close proximity to many residences, such as the Robert Wallace House shown here.

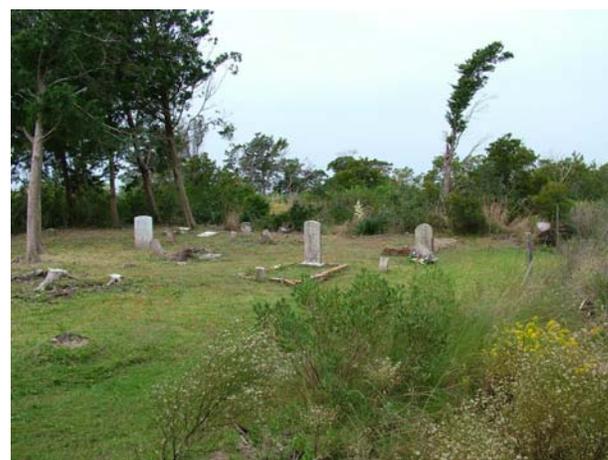
FIGURE 70. Eastern red cedars edge many of the cemeteries as well.

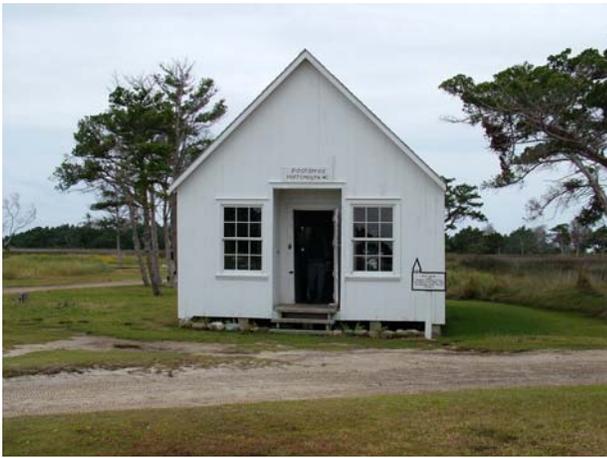
FIGURE 71. Irises are planted in the rock-lined bed in front of the Post Office and General Store.

Irises in planting bed at Post Office. What appear to be bearded irises were observed growing in the rock-lined planting bed in front of the Post Office and General Store in October 2006 during CLR fieldwork (Fig. 71). These bulbs appear to be in good condition.

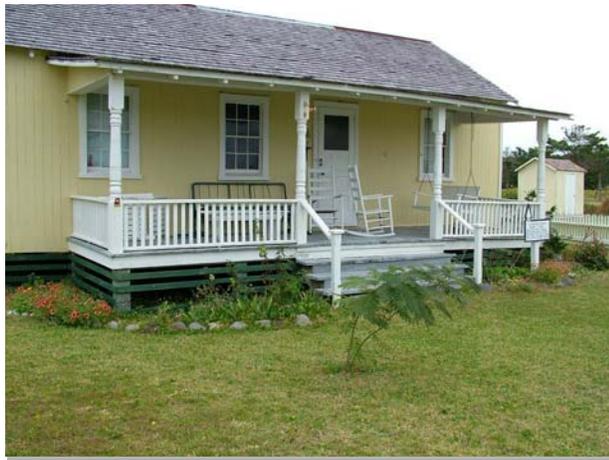
FIGURE 72. A rock-lined planting bed edges the McWilliams-Dixon House porch, and is planted with perennials such as gaillardia.

Perennials, annuals, rose bush in front of the McWilliams-Dixon House. A rock-lined planting bed edges the McWilliams-Dixon House porch, and there is a circular planting bed in the yard in front of the house (Fig. 72). Perennials such as gaillardia are growing in these beds. A rose bush has been trained on the picket fence in front of the house. What appear to be canna lilies are growing next to the steps leading to the back door. The stump of a poplar is also evident in the front yard. Except for the poplar, the plantings appear to be relatively well tended and in good condition.

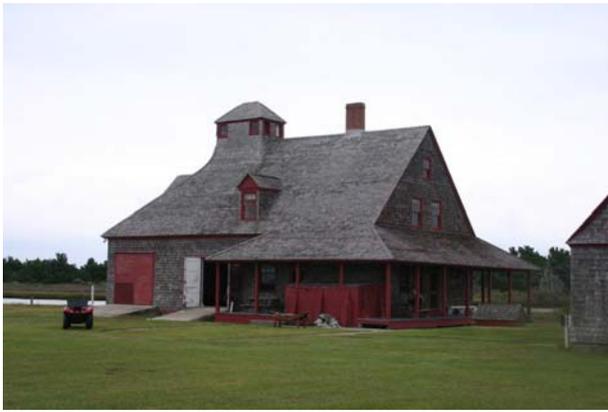
FIGURE 76. View of the Life-Saving Station from the southwest.

constructed in 1894. The station is rectangular in plan with a hip roof. A hip-roof porch is located at the south end of the station, wrapping around to the east and west sides. At the north end of the roof is the lookout tower. The exterior wall and roof surfaces are covered with wood shingles. Most of the windows are double hung units with divided lights. The building is supported on wood posts, and there is a central brick chimney. The station was restored in the early 1980s and was assessed in good condition in 2006 for the LCS.

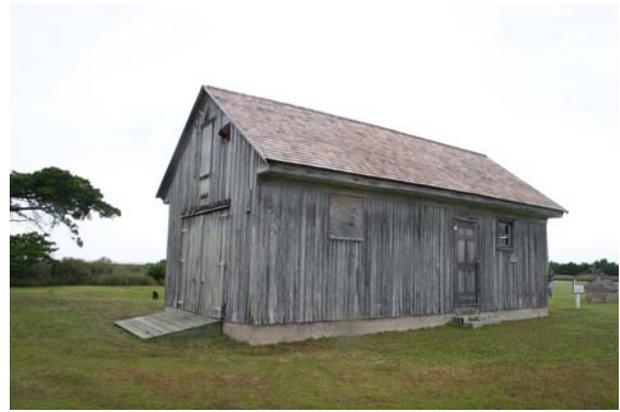
FIGURE 78. The stable at the Life-Saving Station.

The existing stable (Fig. 78, LCS 012534) was apparently constructed in 1928, replacing earlier stables destroyed by a hurricane. After the last horses left the station in 1932, the building was used for storage and as a garage. The stable is a rectangular gable-roof structure. The stable has a concrete foundation, board-and-batten siding, and a wood shingle roof. The stable was assessed in fair condition in 2006 for the LCS due to damage that occurred from Hurricane Ophelia in mid-September 2005.

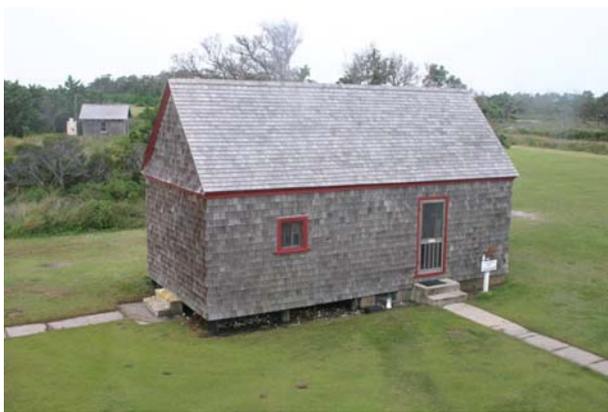
FIGURE 77. The summer kitchen adjacent to the Life-Saving Station. The generator shed is visible beyond at left.

The Life-Saving Station includes two ancillary outbuildings. The summer kitchen (Fig. 77, LCS 091745) was likely constructed in 1908 and originally consisted of a single room with shingled exterior walls. Circa 1942, the kitchen was extended east with a dining room addition that was finished

with shiplap siding. The kitchen is a gable-roof structure with wood shingles covering exterior wall and roof surfaces. The kitchen has small six-light rectangular windows. The older portion of the kitchen is supported on a concrete foundation, while the dining room addition is supported on wood posts. There is a brick chimney at the west gable end. In 1980, the NPS installed shingles over the entire building. The kitchen was assessed in good condition in 2006 for the LCS.

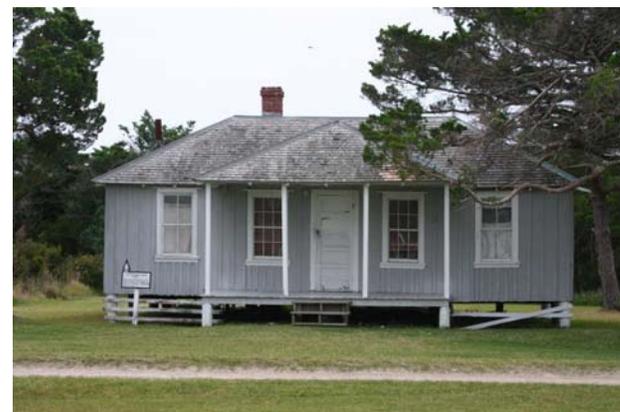
FIGURE 79. Roy Robinson House.

Roy Robinson House. The Roy Robinson House (Fig. 79, LCS 012513) was built circa 1926 on the foundation of the Marine Hospital and moved to its current site in 1935.¹³⁷ Roy Robinson was chief of the Portsmouth Coast Guard Station from 1925 to 1931. The Robinson House is a one-story, hip-roof structure supported on wood posts. The house is rectangular in plan with a hip-roof porch along the north front and an open platform porch at the

southeast rear corner. The walls are board-and-batten siding painted blue. The double-hung windows are generally two-over-two, aside from two windows at the front porch which are six-over-six. The roof is wood shingle, with a brick chimney; localized areas of the roof were replaced following Hurricane Isabel in 2003. The house was assessed in fair condition in 2006 for the LCS.

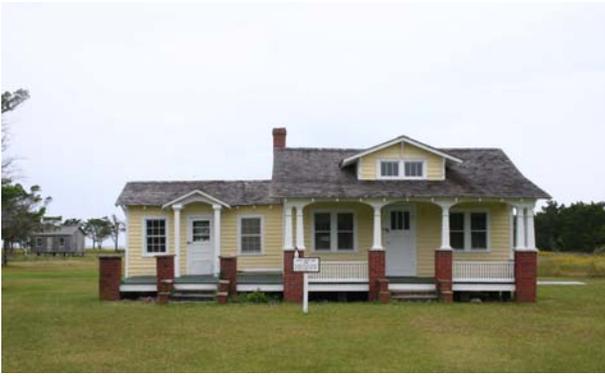
FIGURE 80. Dennis Mason House.

Dennis Mason House. Across the village road from the Robinson House is the Dennis Mason House (Fig. 80, LCS 012514).¹³⁸ The house was originally built circa 1895 with three rooms. Later, it was owned by Captain Dave Willis and by Harry Dixon. In the 1920s, Dixon remodeled the house extensively. The house is a dormer front bungalow with two small one-story wings, one to the west side and one to the rear (north). The house is supported on wood posts. The walls are clapboard siding painted yellow, and the windows are six-over-six double-hung units. The roof is wood shingle, with a

brick chimney. A large front porch with brick piers, partially covered, extends across the south front of the house. There is also a small rear porch at the northwest corner of the house. The house includes a number of Craftsman-style details, including tapered porch columns and eave brackets. The house was assessed in good condition in 2006 for the LCS. Behind the house is a small outbuilding on grade with unpainted board and batten siding and a wood shingle roof. The outbuilding is in poor condition, with large portions of the siding missing.

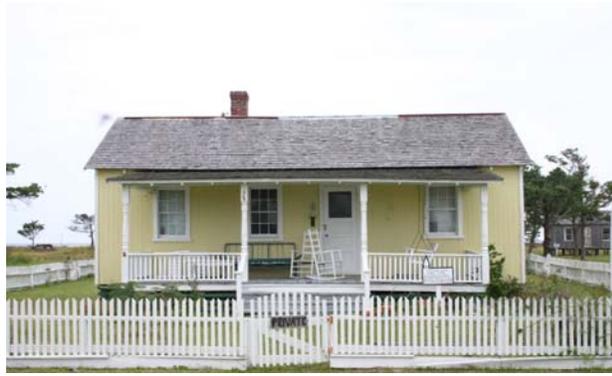
FIGURE 82. McWilliams-Dixon House.

McWilliams-Dixon House. Directly west of the Babb House is the McWilliams-Dixon House (Fig. 82, LCS 091779), constructed circa 1910 near the Life-Saving Station by Keeper Charles McWilliams. The house was moved to its current site circa 1937 by Ed Dixon. Elma Dixon, one of the last residents of the village, resided here until 1971. The house has a T-shaped plan and is clad with vertical wood board siding painted yellow and a wood shingle gable roof with a galvanized metal ridge cap. The house is supported on wood posts. The house has six-over-six double-hung windows and a porch across the south front with Queen Anne style posts. The house is surrounded by a wood picket fence, and within the enclosure behind the house is a cool house. A shed is located at the northwest corner of the fenced yard, and a privy is located behind the house. The shed was used as a wash house and was relocated from the George Dixon house site in the late 1930s.¹³⁹ The house was assessed in good condition in 1999 for the LCS. The cool house was assessed in good condition in 1998 for the LCS. The shed was assessed in good condition in 1998 for the LCS. The privy was assessed in fair condition in 2006 for the LCS.

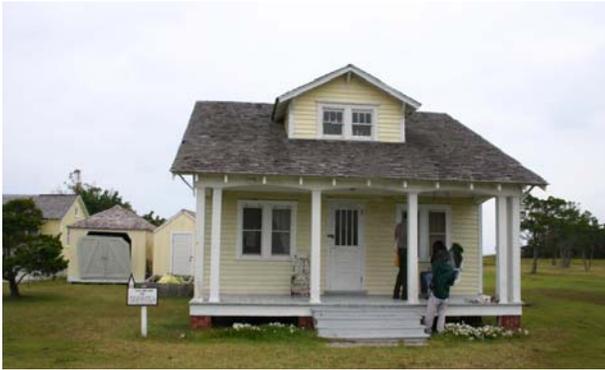
FIGURE 81. Jesse Babb House.

Jesse Babb House. The Jesse Babb House (Fig. 81, LCS 012515) is located west-northwest of the Dennis Mason House. Babb was a cook and machinist at the Coast Guard Station, and he built this house circa 1935. The house is a dormer front bungalow supported on brick piers. The walls are clapboard siding painted yellow, and the windows are three-over-one double-hung units. The roof is wood shingle, with a brick chimney. A large porch extends across the south front of the house, and there is a second porch at the northeast rear corner. The house includes a number of Craftsman-style details, such as eave brackets. The house was assessed in good condition in 2006 for the LCS. Behind the Babb House are a number of outbuildings including a kitchen, garage, generator shed, and privy. The outbuildings are typically raised on wood post foundations and have vertical wood board siding and wood shingle roofs. The kitchen is at the northwest corner of the house and has a front gable roof. The garage is located directly west of the kitchen and has a hip roof. The generator shed is north of the house and has a side gable roof. The

privy is located east of the house and has a front gable roof. The kitchen was assessed in fair condition in 1998 for the LCS. The garage was assessed in good condition in 2006 for the LCS. The generator shed was assessed in good condition in 2006 for the LCS. The privy was assessed in good condition in 2006 for the LCS.

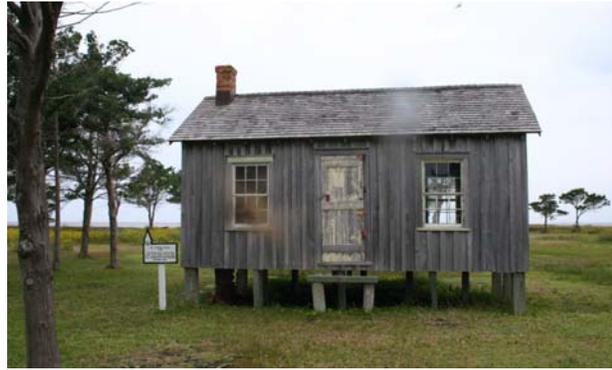
FIGURE 83. Ed Styron House.

Ed Styron House. North of the Dennis Mason and Jesse Babb Houses is the Ed Styron House (Fig. 83, LCS 012516). This house was constructed circa 1933 when the Styron family's previous house on Sheep Island was damaged by a hurricane. The house was restored in 2002. The house is a simple one-story cottage supported on wood posts. The walls are unpainted board and batten siding, and the windows are six-over-six double-hung units. The roof is wood shingle, with a brick chimney. An open platform porch extends across part of the north elevation. The house was assessed in good condition in 2006 for the LCS.

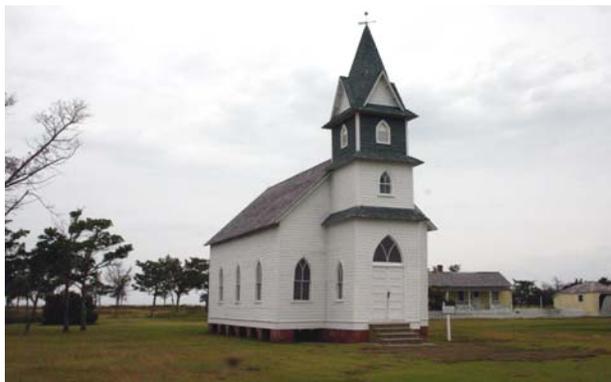
FIGURE 84. Portsmouth Methodist Church.

Portsmouth Methodist Church. West of the McWilliams-Dixon House is the Portsmouth Methodist Church (Fig. 84, LCS 012518), constructed in 1915 after the previous church

structure was destroyed in a severe hurricane on September 2–3, 1913.¹⁴⁰ The church is supported on red brick piers and has wood siding and a wood shingle gable roof. The steeple features decorative cut shingles. Gothic Revival-style elements include the divided light pointed arch windows and the pointed arch door opening. The main entrance to the church is in the steeple tower at the southwest end. The church was assessed in fair condition in 2006 for the LCS, due to a leaning foundation and brick piers urgently in need of repointing and repair.

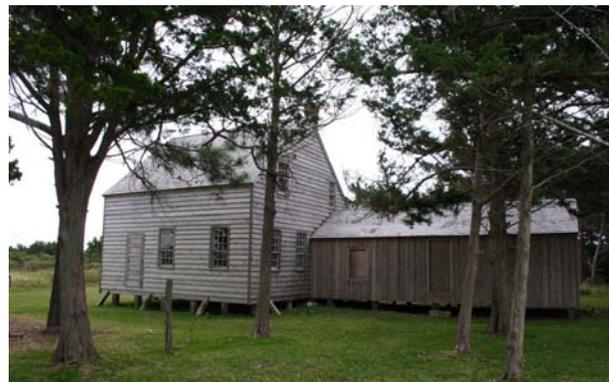
FIGURE 85. Washington Roberts House.

Washington Roberts House. South of the church on the opposite side of the village road is the Washington Roberts House (Fig. 85, LCS 091783), constructed in the late 1840s, with a kitchen/dining room wing added circa 1910.¹⁴¹ The wing was reconstructed by the NPS after it was destroyed by Hurricane Isabel in 2003. The house is supported on wood posts and is clad with unpainted clapboard siding and has a wood shingle gable roof. The windows are nine-over-six double-hung units. The house includes two building masses: a main 1-1/2-story gable roof portion and an attached one-story wing at the west end. Wood posts mark the location of a missing rear porch. The house was assessed in poor condition in 1998 for the LCS. Based on recent restoration work, the CLR assesses its condition as fair.

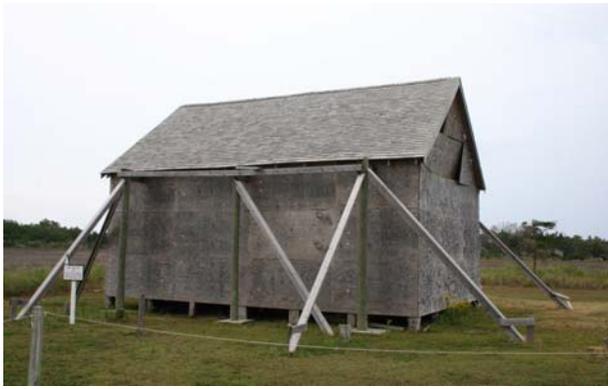
FIGURE 86. George Dixon House.

George Dixon House. The George Dixon House (Fig. 86, LCS 012519) stands along the Village Road in open marsh land west of the church and the Washington Roberts House. The house was built around 1887 by George and Martha Dixon. The house was severely damaged by Hurricane Isabel in 2003. Currently, the walls are completely boarded up with plywood, and wood structural shores stabilize the walls of the house. Prior to the hurricane, the house had asphalt composition siding, six-over-six double-hung windows, a brick chimney, and front and rear porches. The house historically also had a kitchen/dining room wing. In the late 1990s, the house had a wood shingle roof installed. The house was assessed in poor condition in 2006 for the LCS.

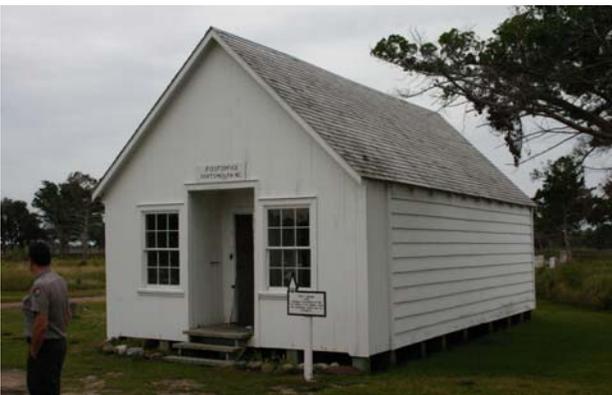
FIGURE 87. Portsmouth Post Office.

Store (Fig. 87, LCS 012526), constructed circa 1900, which stands at the crossroads of the village. The gable roof structure supported on wood posts has painted clapboard and vertical wood board siding, and a wood shingle roof with galvanized metal ridge cap. The front gable end has a central door and a pair of six-over-six double-hung windows. The house was assessed in fair condition in 2006 for the LCS.

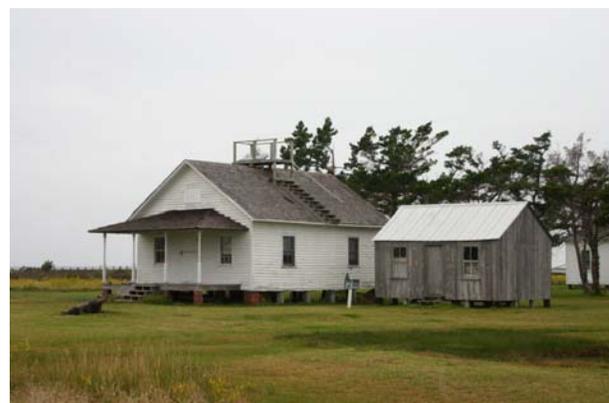
FIGURE 91. Carl Dixon House.

northeast to the Carl Dixon and Frank Gaskill Houses. The Carl Dixon House (Fig. 91, LCS 012528) was constructed circa 1930 as a front gable structure supported on wood posts. The front porch has a hip roof and is supported on brick piers. Directly adjacent to the house is a kitchen supported on wood posts. The walls of the kitchen are unpainted clapboard and the roof is sheet metal. The windows of both the house and kitchen are two-over-two double-hung units. Also adjacent to the house is a brick cistern. The house was assessed in poor condition in 2006 for the LCS. The summer kitchen was assessed in fair condition in 1998 for the LCS.

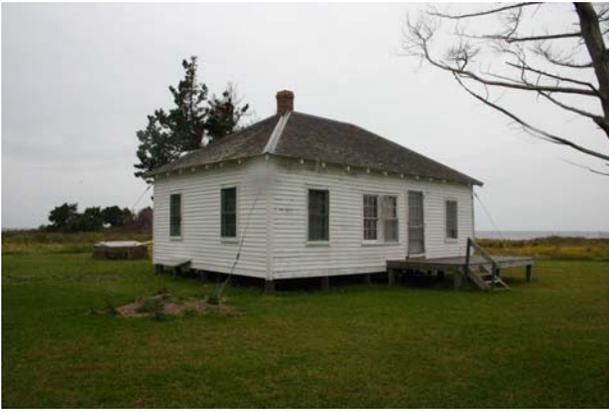
FIGURE 92. Frank Gaskill House.

Frank Gaskill House. The Frank Gaskill House (Fig. 92, LCS 012529) stands closer to the shore of the inlet. It was constructed circa 1930 and has a hip roof covered with wood shingles and galvanized metal ridge caps. The house is supported on wood posts and has painted clapboard siding. At the front door is an open platform porch. The house has a

brick chimney and six-over-six double-hung windows. Also part of the property is a shed with sheet metal walls, which is located at the shore of the inlet. The shed appears to be in good condition. The house was assessed in good condition in 2006 for the LCS.

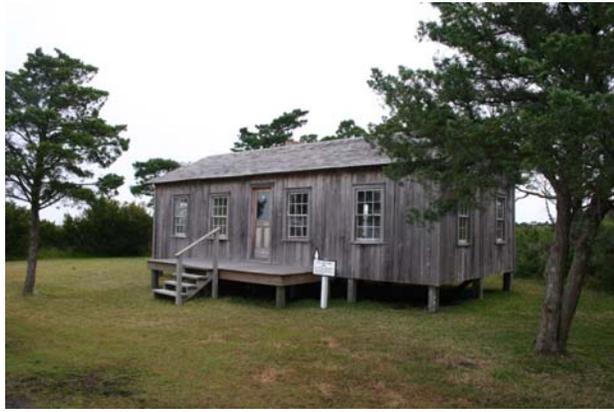
FIGURE 94. Cecil Gilgo House.

Cecil Gilgo House. From the village crossroads, the Old Straight Road runs southward. The Cecil Gilgo House (Fig. 94, LCS 091784) stands along this road and was constructed circa 1936 from salvaged materials. The house is a rectangular one-story structure supported on wood posts. The walls are clad with unpainted vertical wood board siding, and the gable roof is wood shingle with a galvanized metal ridge cap. The house has a brick chimney and six-over-six double-hung windows. There is an open platform porch at the front door. The house was assessed in poor condition in 1998 for the LCS.

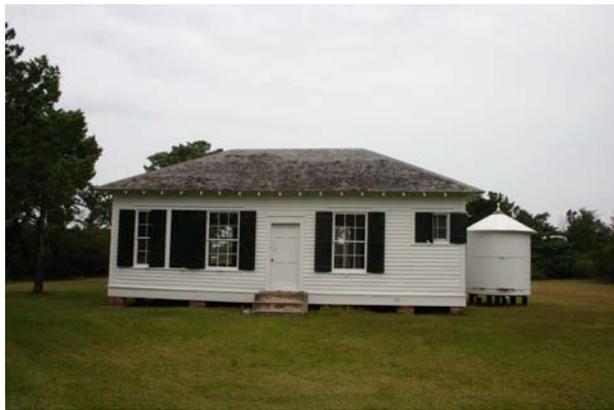
FIGURE 95. Portsmouth Schoolhouse.

Portsmouth Schoolhouse. Beyond the Cecil Gilgo House is the Portsmouth Schoolhouse, built in the 1910s (Fig. 95, LCS 012524). The hip roof structure is supported on brick piers and has walls clad with painted clapboard siding. The wood shingle roof has galvanized metal ridge caps. The windows are mainly six-over-six double-hung units with dark green painted shutters. The school has a brick chimney and sits adjacent to a cylindrical cistern. Near the school is a two-part shed: the front part has a brick foundation, clapboard walls, and a wood shingle roof; the rear part is supported on wood posts and has asphalt composition shingle roofing and wall cladding. The schoolhouse was assessed in fair condition in 2006 for the LCS. The shed was assessed in good condition in 2006 for the LCS.

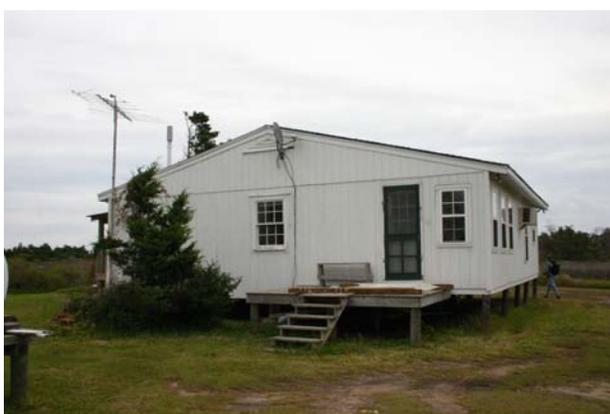
FIGURE 97. T. T. Potter House.

T. T. Potter House. A southwest branch off the road to the Styron-Bragg House leads to the T. T. Potter House (Fig. 97, LCS 012531) near the shore of the sound. This 1952 house is a larger, ranch-type house supported on wood posts. The walls are clad with composition board siding, and the roof is asphalt shingle. The house has a mix of window types and a large porch along the north side. Also on the site are two outbuildings, a contemporary plastic septic tank, and an outdoor fish cleaning table with sink. The house was assessed in good condition in 1998 for the LCS.

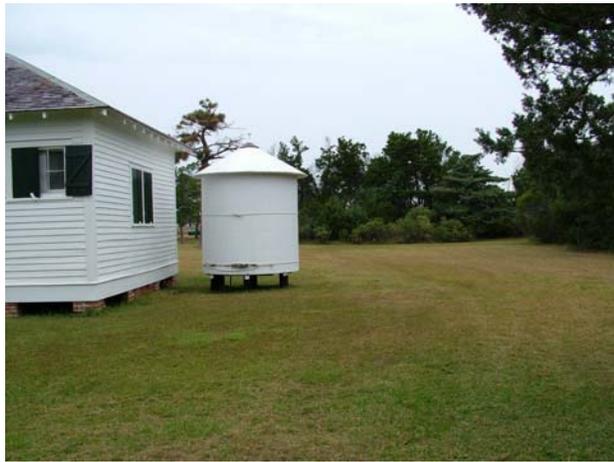
FIGURE 98. View north toward the Schoolhouse cistern.

Schoolhouse cistern. The Schoolhouse cistern is a cylindrical structure composed of vertical boards with a conical metal roof capped with a short metal pole (Fig. 98, LCS 091756). The structure is approximately eight feet in height, and sits on wooden posts one to two feet off of the ground. The structure is painted white. The cistern was assessed in good condition in 2006 for the LCS.

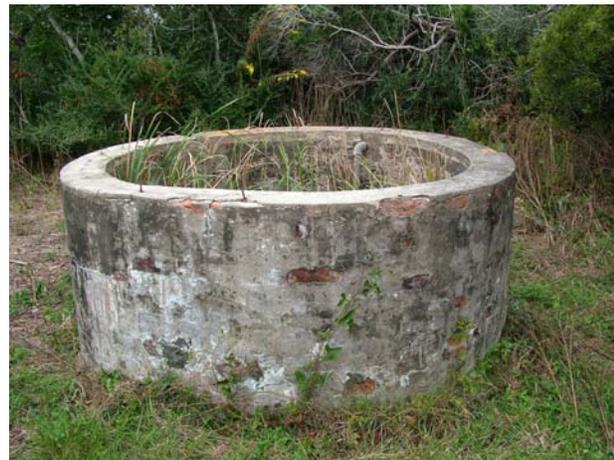
FIGURE 100. The Mattie Gilgo site cistern.

Mattie Gilgo site cistern. The cistern associated with the Mattie Gilgo site is a circular parged brick structure, similar to those located near the Keller-Styron Cemetery (Fig. 100). Approximately three feet tall and ten feet in diameter, the cistern is open to the air, and there are plants growing inside. It is exhibiting some signs of deterioration such as efflorescence, chipping of the mortar slurry that covers the brick and biological growth. It is in fair condition.

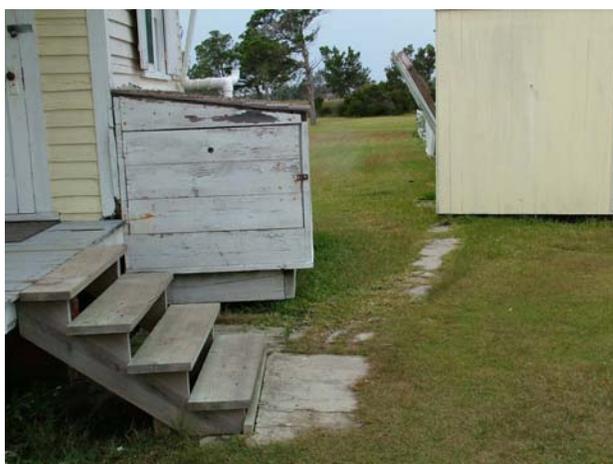
Jesse Babb water box. Similar to the McWilliams-Dixon House, the Jesse Babb House has a wooden water box that is connected to the roof gutters (Fig. 101). It is located adjacent to the rear facade of the building. This water box appears to be in relatively good condition.

FIGURE 101. The Jesse Babb water box is attached to the side of the house.

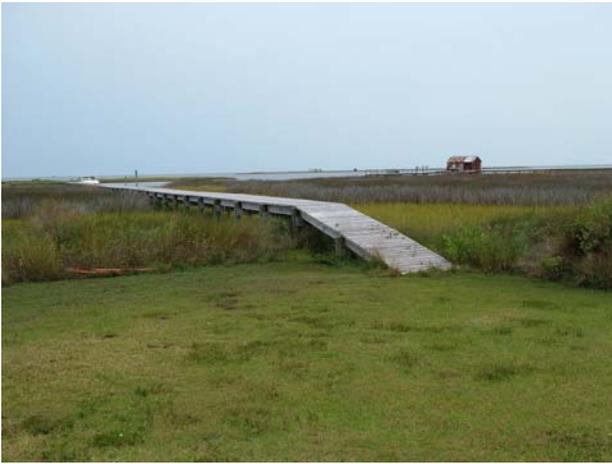
FIGURE 103. View north of the dock and boardwalk at the T. T. Potter House.

A second dock and boardwalk are located near the T. T. Potter House. The boardwalk extends across marsh land to a dock on Ocracoke Inlet (Fig. 103). The dock was established by the NPS for their use in

bringing equipment, housed in the T. T. Potter House sheds, to the island. This dock and boardwalk complex appear to be in good condition.

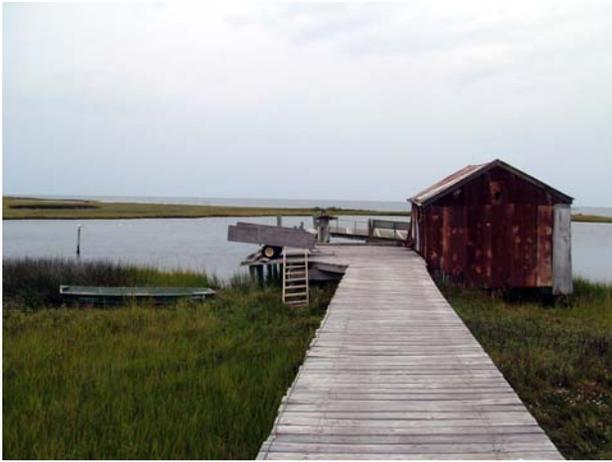
FIGURE 104. View northwest of the dock and boardwalk behind the Styron-Bragg House.

There is also a dock and boardwalk complex behind the Styron-Bragg House (Fig. 104) that appears to be in good condition except for one damaged section. Additionally, a dock extends into Doctor’s Creek behind the Henry Pigott House (Fig. 105). This dock appears to be in good condition.

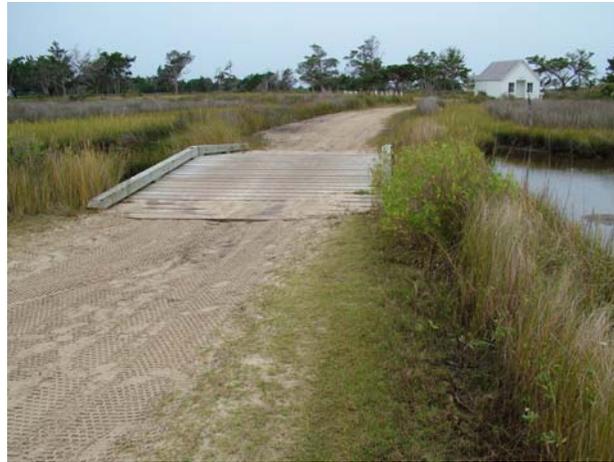
FIGURE 106. View west along the Village Road of one of the three wood bridges located within the village.

margins (Fig. 106). These bridges appear to be in good condition.

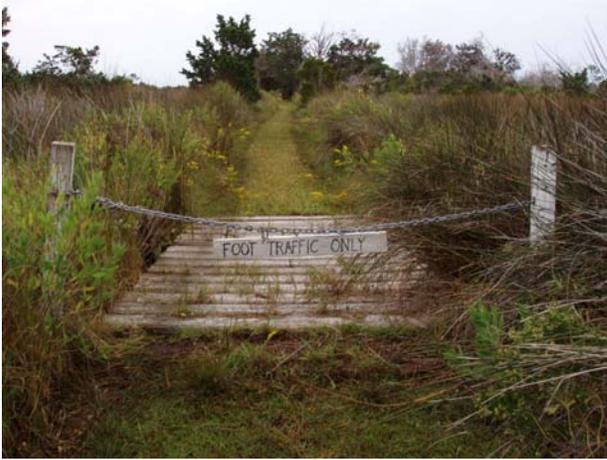
FIGURE 107. View northeast of the wooden bridge along the Old Straight Road.

Wooden bridge along Old Straight Road. A wood plank bridge is located along the Old Straight Road to provide access across a wet area (Fig. 107). This bridge has grass growth through its plank surface but appears to be in relatively good condition.

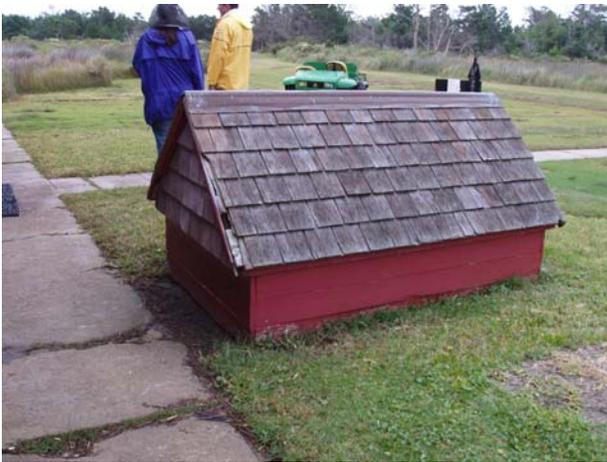
FIGURE 108. The pump house near the Portsmouth Life-Saving Station.

This small structure, set in the ground adjacent to one of the concrete walks near the Life-Saving Station, is composed of a concrete block base with a wood shingle gable roof (Fig. 108). The pump house is approximately eight feet long, three feet wide, and four feet tall. It appears to be in good condition,

although some of the shingles are in need of repair or replacement.

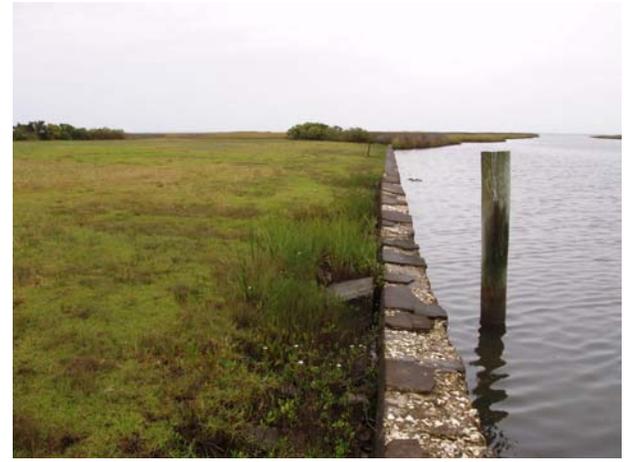
FIGURE 110. View along the concrete seawall and wooden mooring posts in Coast Guard Creek at the Portsmouth Life-Saving Station.

Concrete seawall and three ramps at Portsmouth Life-Saving Station. A concrete seawall with a cap of flat stones embedded in a mortar slurry with seashell aggregate edges Coast Guard Creek in proximity to the Life-Saving Station (Fig. 35 and Fig. 110). This wall was cast-in-place, as were the three concrete boat ramps that extend between the Life-Saving Station and the creek. The ramps and seawalls were constructed circa 1914–1918. Portions

of the wall have become embedded in marshland and silt. The ramps are evidencing some deterioration and are in fair condition. There is vegetative growth in some of the control joints and chipping of the concrete. The seawall is also evidencing some cracking and chipping.

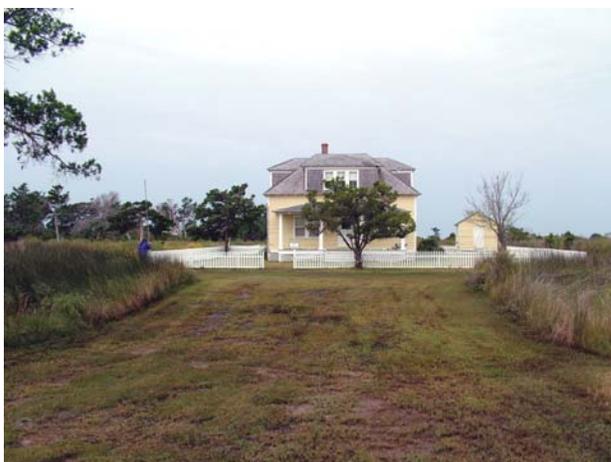
FIGURE 115. The picket fence around the Styron-Bragg House precinct.

White-painted picket fencing surrounds the Styron-Bragg House precinct (Fig. 115). The pickets are cut to rounded points at the top. They are nailed to two cross boards, one near their top, and the other along the base of the fence. Corner posts are set inside the fence sections. There is an opening in the front that is off-center from the door of the house; this may have included a gate at one time. Sections of the fence in the rear have been removed and are stored against the wall of the shed. This fence is in relatively good condition where it exists. The missing segments lower the overall condition rating to fair.

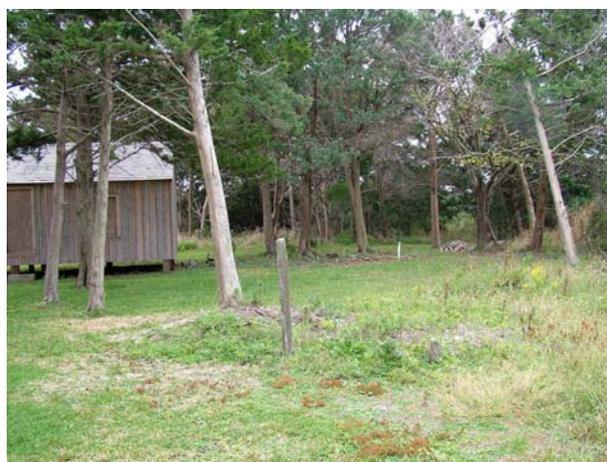
FIGURE 117. A remnant fence post west of the Washington Roberts House.

Remnant fence posts west of Washington Roberts House. Simple wood fence posts are also present near the house (Fig. 117). These posts are also remnants of an incomplete system that is in poor condition.

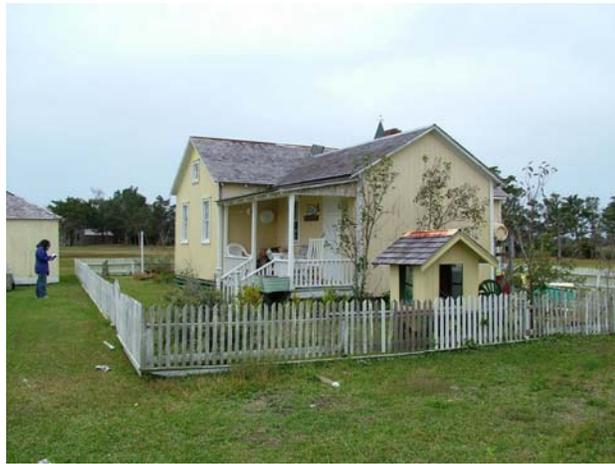
Picket fence around McWilliams-Dixon House precinct, four gates. This fence is similar to other picket fences within the district (Fig. 118). The fence is badly in need of paint, but otherwise appears to be in good to fair condition.

FIGURE 118. The picket fence around the McWilliams-Dixon House precinct.

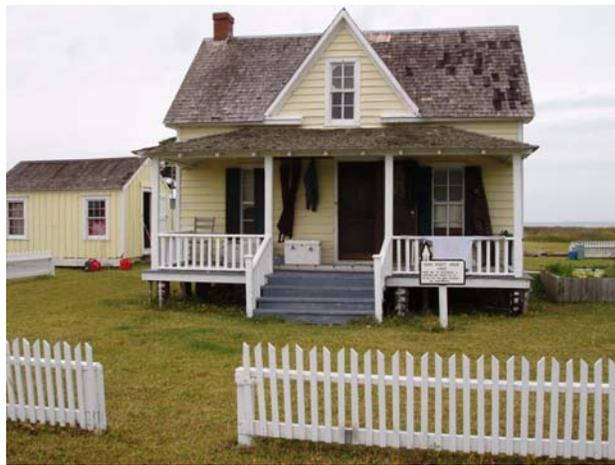
Picket fence with missing gate around Henry Pigott House precinct. This fence is similar to other picket fences within the district (Fig. 119). The fence is generally in good condition but is missing the front gate and some sections in the rear and is thus rated in fair condition.

FIGURE 119. The picket fence around the Henry Pigott House precinct.

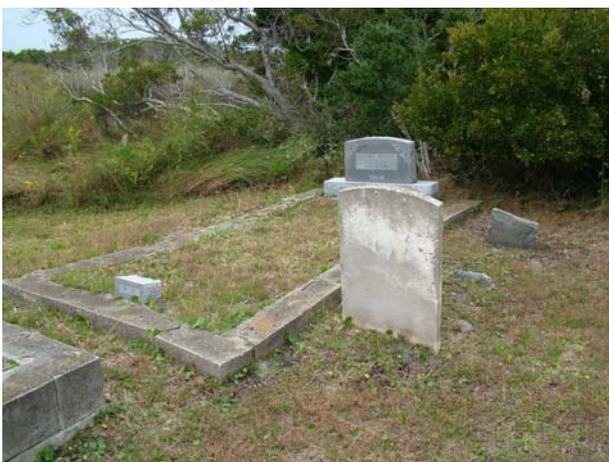
FIGURE 133. Some of the burials are surrounded by concrete block outlines.

(Fig. 132). There is no surrounding fence. Some of the burials are grouped together and surrounded by concrete-block edging, two blocks high (Fig. 133). The burials date between 1889 and 1960. Conditions observed at the cemetery include broken, leaning, eroded headstones. The cemetery is in fair to poor condition (Fig. 134).

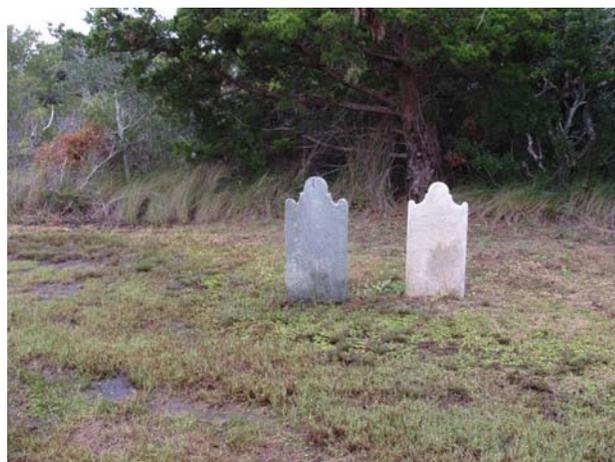
FIGURE 135. The headstones of the Two Seamen's Graves.

Two Seamen's Graves. The headstones associated with Two Seamen's Graves are relatively large and ornate in comparison with others within the district (Fig. 135). They include detailed funerary carvings. These gravestones appear to be in fair condition due to deterioration of the inscriptions.

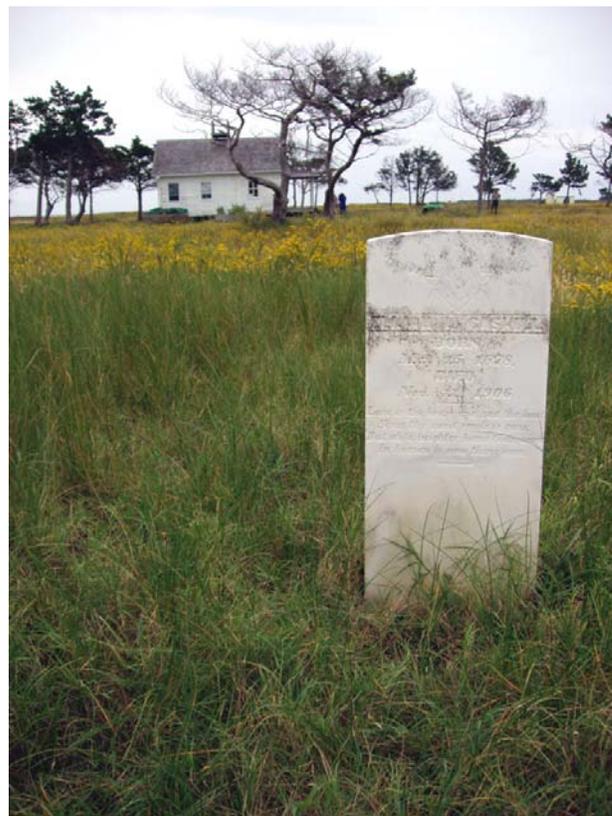
FIGURE 138. The Elijah Gaskill headstone.

Elijah Gaskill headstone. A single marble headstone marks the grave of Elijah Gaskill (Fig. 138). The grave is located near the Carl Dixon House. The headstone is in fair condition.

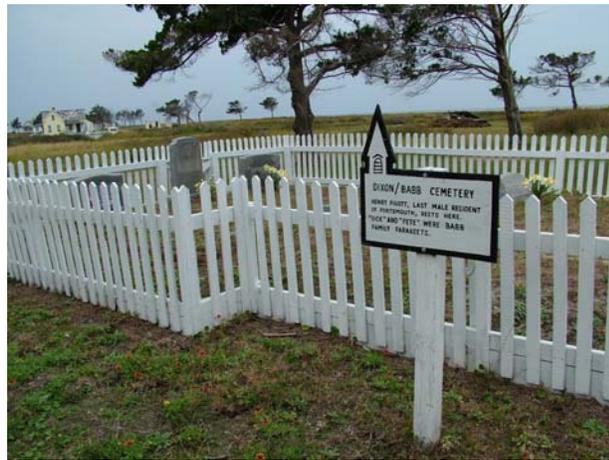
Painted wooden signs marking historic properties. A unified sign system is utilized within the historic district to identify historic structures and provide interpretive information. These signs are composed of painted square wood posts and painted wood boards nailed to them that have a rectangular area for text (Fig. 139). The rectangular area is oriented with the long dimension running horizontally. The upper left corner is punctuated by a carved extension fashioned to recall the Portsmouth Methodist Church steeple. They are generally in good condition. The signs are painted white, with a black border and black text. These signs are located:

FIGURE 139. One of the painted wooden signs that mark most of the historic properties within the historic district.

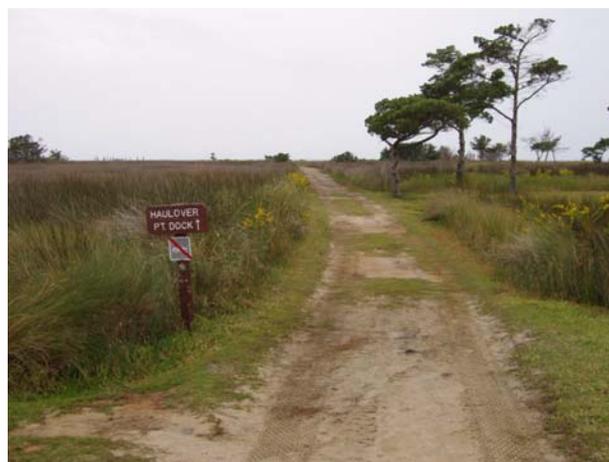
Directional sign noting “Haulover Point Dock” along road to dock. A brown painted wood sign indicates the route leading to Haulover Point Dock (Fig. 140). This approximately three foot high sign is set on a square wooden post painted brown. The text is routed letters and an arrow, painted white. A metal sign indicating that vehicles are not permitted within the district is also nailed to the lower half of the sign. The sign is in good condition.

FIGURE 140. One of the brown-painted wood signs with routed text located within the district.

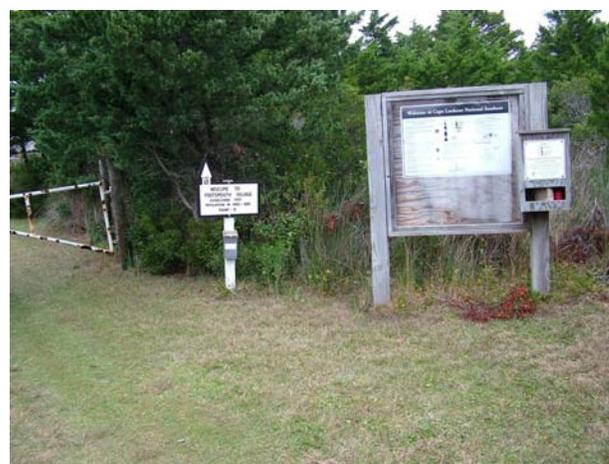
Identity sign at gate along Road to Beach. A larger identity sign (Fig. 141) located at the access control gate along the Road to the Beach welcomes visitors to Portsmouth Village and Cape Lookout National Seashore. The sign is in good condition.

FIGURE 141. An informational sign along the Road to the Beach provides guidance to visitors and in formation about the village.
