Existing Conditions

This chapter describes through narrative text, contemporary photographs, and labeled base mapping, the current conditions and extant landscape features associated with the Portsmouth Village Historic District. The purpose of documenting the park's existing landscape is three-fold. The primary role of the existing conditions documentation is to convey the range and breadth of landscape features by identifying, describing, and locating them on a map. This documentation serves as a baseline of information for the rest of the document. The second purpose is to generate an inventory of park features that can be utilized to develop several cultural landscape analyses and assess National Register eligibility and integrity. The final role is to provide a record of the landscape that may prove useful to future research efforts.

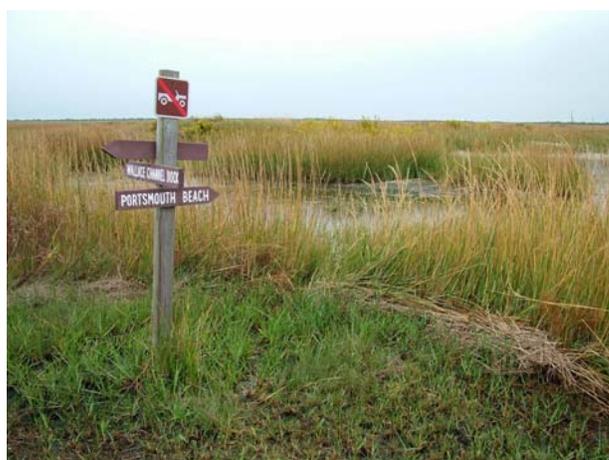
Brown painted wood sign indicating “Foot Traffic Only” along the Road to Beach. This sign is comprised of a small rectangular wood sign plate mounted on an unpainted wood post. The sign text is routed into the wood. The routed letters are painted white and the sign face NPS brown. The

FIGURE 142. This directional sign is located along the Road to the Beach.

sign stands approximately three feet in height. The sign is in good condition.

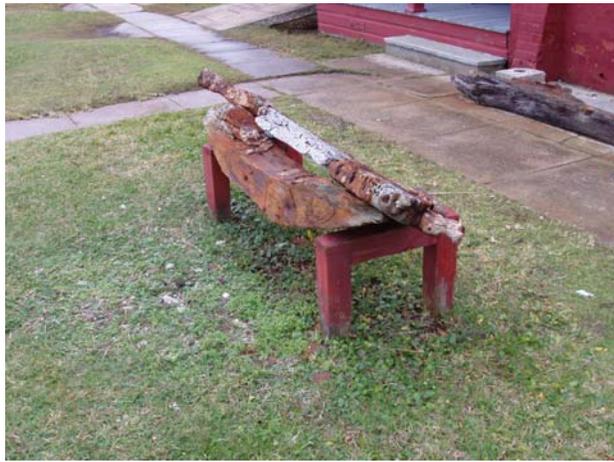
Wood boat relic, mounted for display near the Portsmouth Life-Saving Station. To the west of the Life-Saving Station building are artifacts associated with a boat wreck (Fig. 143). The remains are bolted to two wood posts. The exhibit is in good condition.

FIGURE 143. A shipwreck relic displayed near the Portsmouth Life-Saving Station.

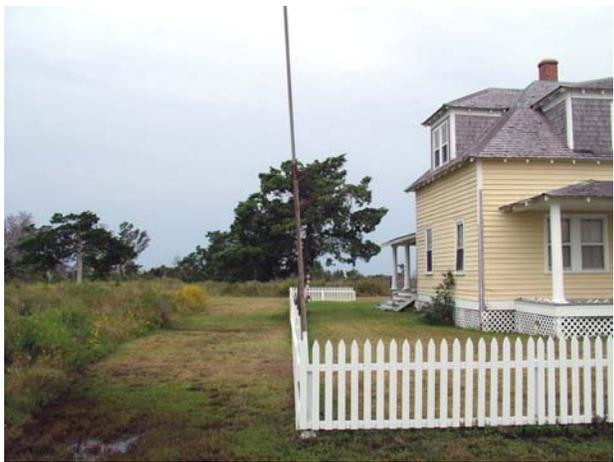
FIGURE 144. There is a flagpole within the Styron-Bragg House precinct.

Flagpole at Styron-Bragg House. At the corner of the picket fencing surrounding the Styron-Bragg House precinct is a metal flagpole that no longer includes flag-raising hardware (Fig. 144). The flagpole is rusted and is in fair condition.

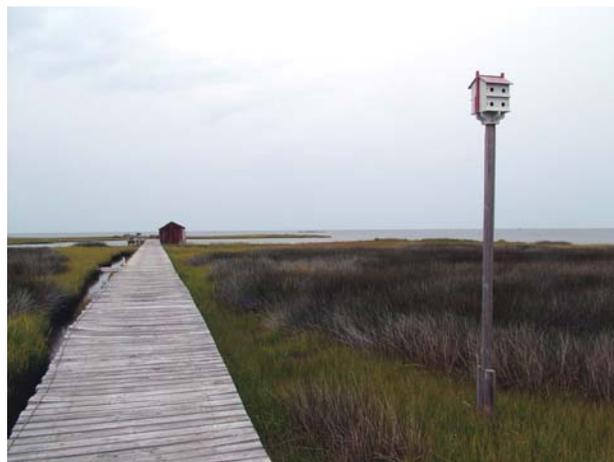
FIGURE 145. Along the dock behind the Styron-Bragg House is a bird house.

Bird house along the dock behind the Styron-Bragg House. Along the dock leading across the marsh west of the Styron-Bragg House is a large bird house set on a tall wood pole (Fig. 145). The house has four openings. It is fashioned to look like a two-story Colonial house with a brick chimney and a shingle roof. The birdhouse is in good condition.

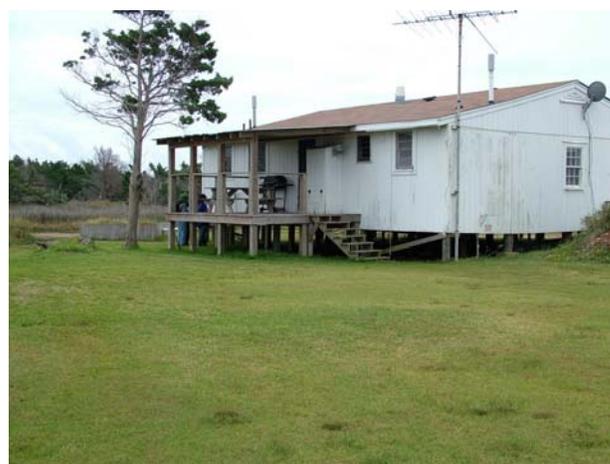
FIGURE 146. The T. T. Potter House includes a television antenna.

Antenna at T. T. Potter House. A metal television antenna is located along the rear facade of the T. T. Potter House (Fig. 146). This antenna appears to be in good condition.

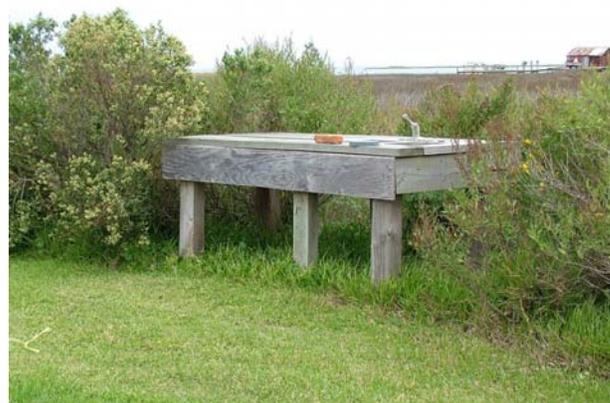
FIGURE 147. Near the T. T. Potter House is a fish cleaning table with a sink.

Fish cleaning table, T. T. Potter House. A simple wooden table on sturdy wooden legs sits to the side of the yard of the house (Fig. 147). A metal sink and faucet are set into the table. It is assumed that the table is used to clean fish. This table is in good condition.

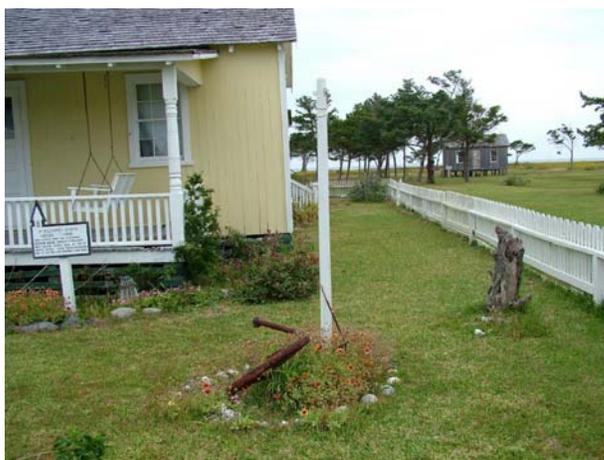
FIGURE 148. The yard in front of the McWilliams-Dixon House includes a rock-lined planting bed decorated with an anchor and a pole.

Metal pole and anchor set within a circular planting bed, McWilliams-Dixon House. A decorative feature in the front yard of the McWilliams-Dixon House is a circular planting bed edged with small round rocks, inset with a metal anchor, and a five foot tall wood pole (Fig. 148). It is not clear what function the pole serves. These features appear to be in good condition.

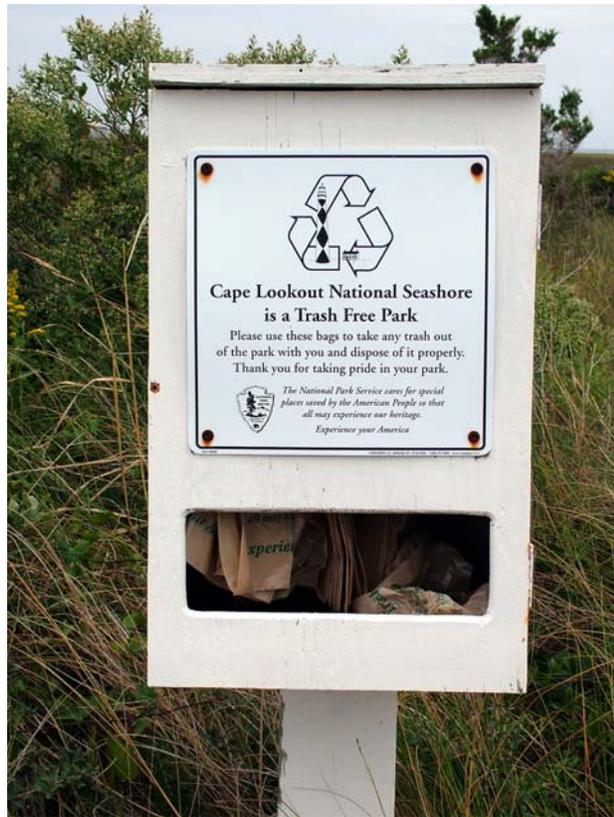
FIGURE 149. Trash bag receptacles are located along Haulover Point Road and the Road to the Beach.

Trash bag receptacles along Haulover Point Road and the Road to the Beach. Cape Lookout National Seashore is a rustic park that assumes that visitors will leave the park carrying any trash they may have generated during their visit. Along Haulover Point Road near the end of the boardwalk, and at the entrance into the historic district from the Road to the Beach, the park has placed trash bag dispensers where visitors may secure a bag for holding their trash (Fig. 149). A sign on the dispensers notes that "Cape Lookout National Seashore is a Trash Free Park." The dispensers are
