Cape Lookout National Seashore

Washington Roberts House

Historic Structure Report

October 2003

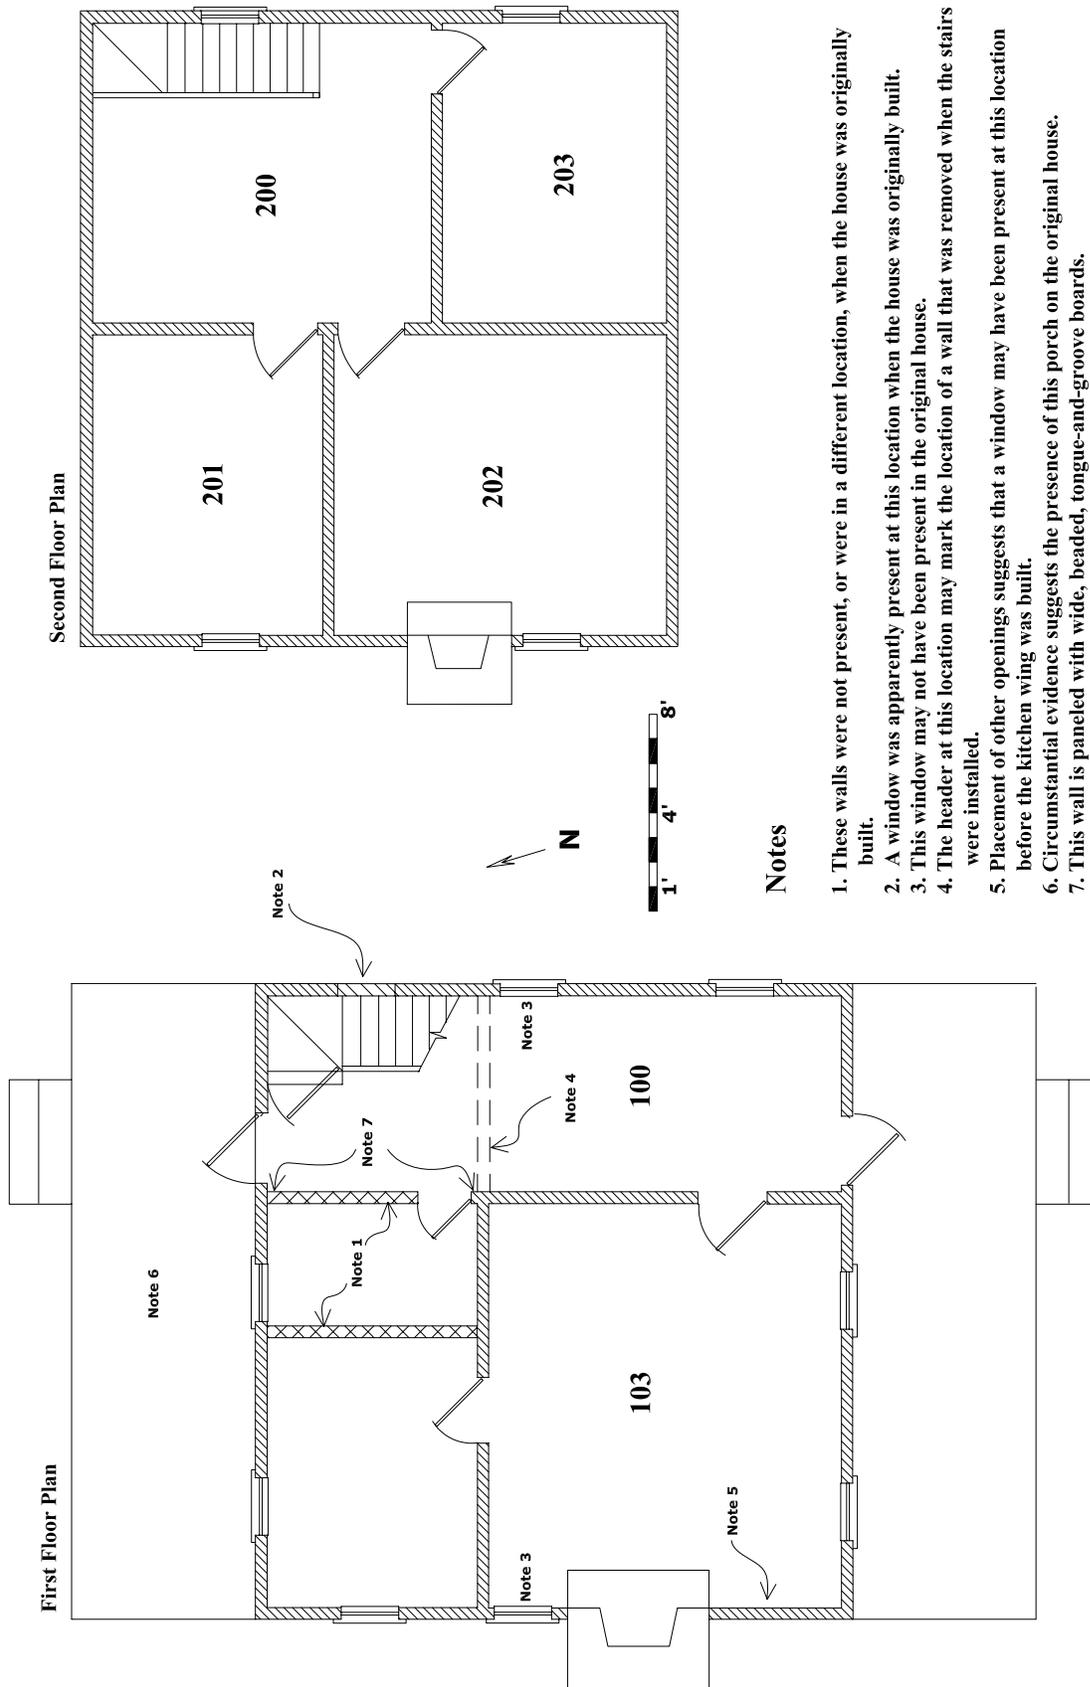
FIGURE 15. Plan explaining some of the changes to the original house. (T. Jones, SERO-CRD, 2003.

Less clear is the original floor plan of the house (see Figure 15). The fact that baseboards run behind the east and west walls of Room 101 suggests that those walls were relocated after the house was originally constructed. The east wall of Room 103 may be in its

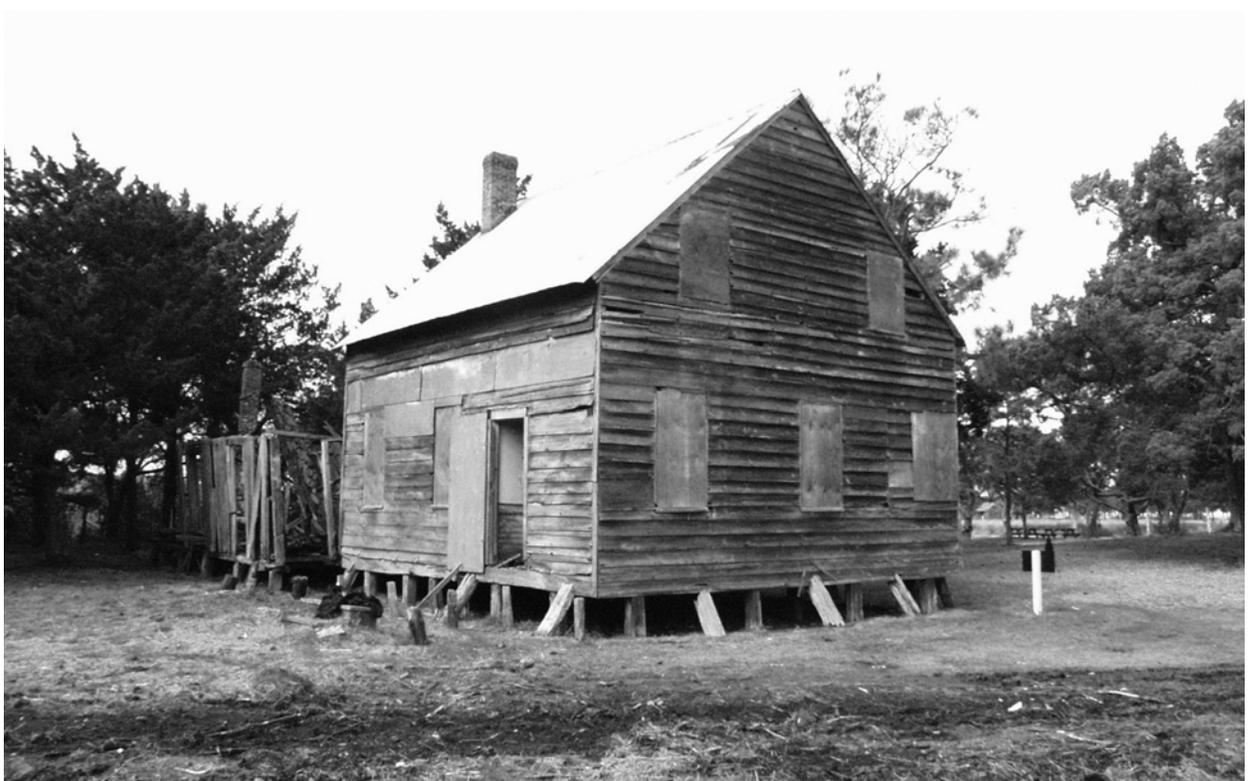
The house is badly deteriorated, with the kitchen wing in ruinous condition. The front porch was removed before the 1960s, all of the historic doors but one have been stolen, much of the plaster has been badly water damaged, and the windows, many of which are missing sash, have been covered with plywood. In spite of the losses, most of the

FIGURE 26. View northwest of Roberts House. (NPS-SERO-CR, 2002)

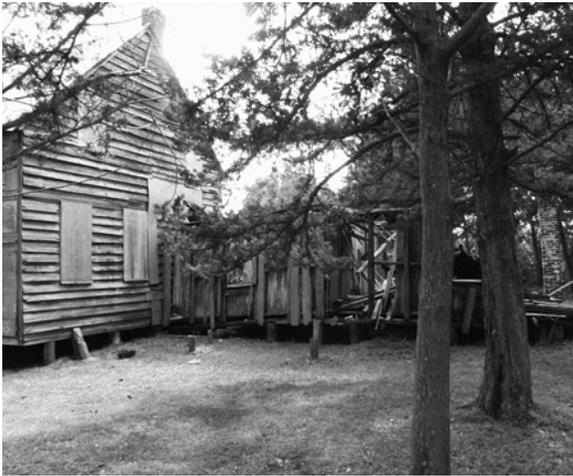
FIGURE 28. View west of west end of house and kitchen wing. (NPS-SERO-CR, 2002)

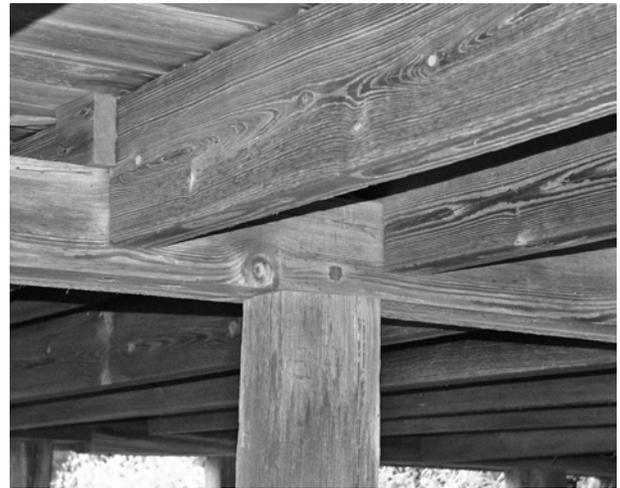
The added kitchen wing was built on creosoted pine piers, but these were toe-nailed, using wire nails, rather than mortised into the sills. Most of the piers appear to be original, but some are badly deteriorated, especially along the south side of the house.

FIGURE 30. View of typical joist and pier connections at center beam. (NPS-SERO-CR, 2002)

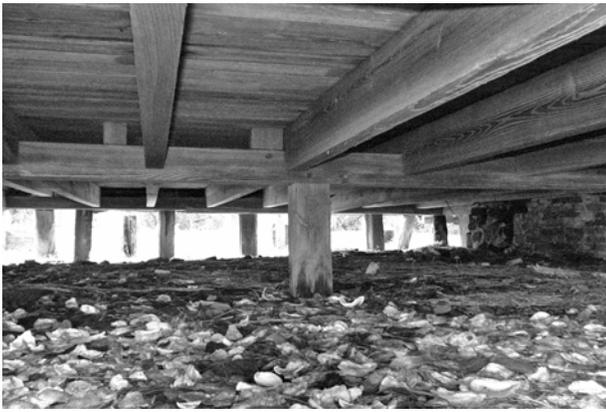
FIGURE 33. View southwest under main block of house, showing shells used to stabilize the ground under the house. (NPS-SERO-CR, 2002)

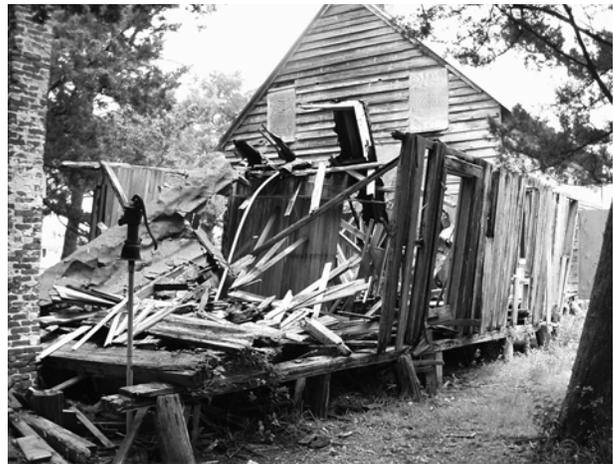
FIGURE 38. View south of kitchen wing. (NPS-SERO-CR, 2002)

Total neglect of the roof covering has subjected the kitchen wing to water penetration and resulting rot, so that the entire roof structure, the west end wall, and part of the south wall have now collapsed. Except for window sash and doors, however, the character and dimension of all of the original materials and the original floor plan can be identified in the the existing ruins of the building.

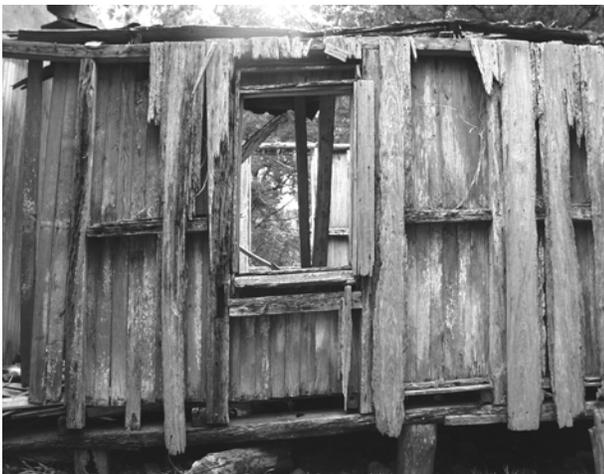
FIGURE 41. View of north side of kitchen wing at Room 104. (NPS-SERO-CR, 2002)

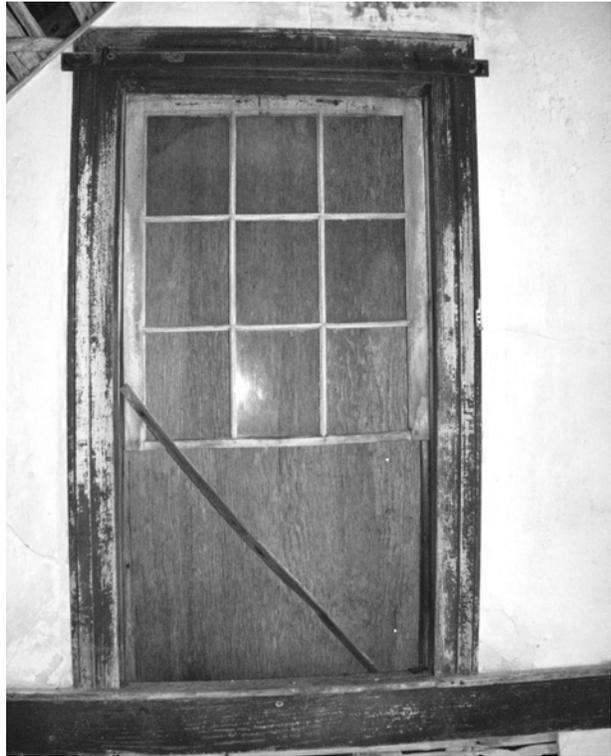
FIGURE 45. View of W-2 with sash and trim typical of first floor windows. (NPS-SERO-CR, 2002)

W-2: 2'-4" by 4'-6", six-over-nine sash, both sash missing; top of frame damaged; interior stop missing on right side and at header; interior casing and backband complete; one of two windows with exterior sill, casing and backband essentially intact, although badly eroded. This window appears to have been relocated at a very early date, probably when the present staircase was constructed.

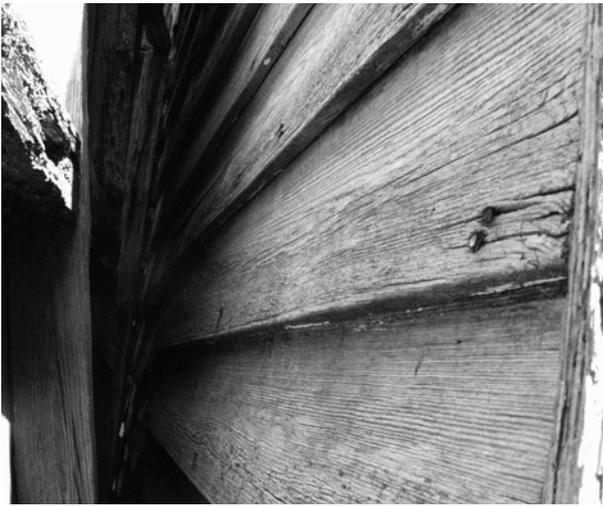
All of the siding is badly eroded, and the beading of the siding on the main block of the house has disappeared from all but a few of the boards that were protected by the kitchen addition. Nearly all of the siding on the north, east, and west sides of the house remains in place but badly deteriorated. On the south side of the house, however, the historic lap siding appears to have been relaid as flush siding using wire nails when cement-asbestos siding was installed in that area after the porch was removed in the mid-twentieth century. Siding on the kitchen wing is extremely deteriorated.

FIGURE 47. View of original beaded siding remaining on north west side of main block at kitchen addition. (NPS-SERO-CR, 2002)

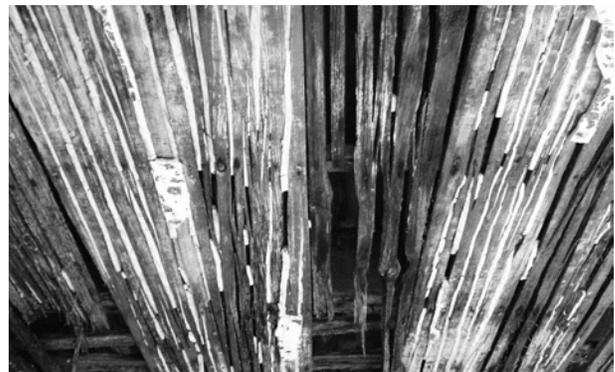
Ceiling. The ceiling is finished with typical plaster on split lath. There are large areas of the plaster that have been lost due to water penetration. At the head of the stairs, a beaded joist transverses the ceiling, apparently serving as a header for the stair stringers.

FIGURE 50. View of ceiling in Room 101, showing typical split-board plaster lath. (NPS-SERO-CR, 2002)

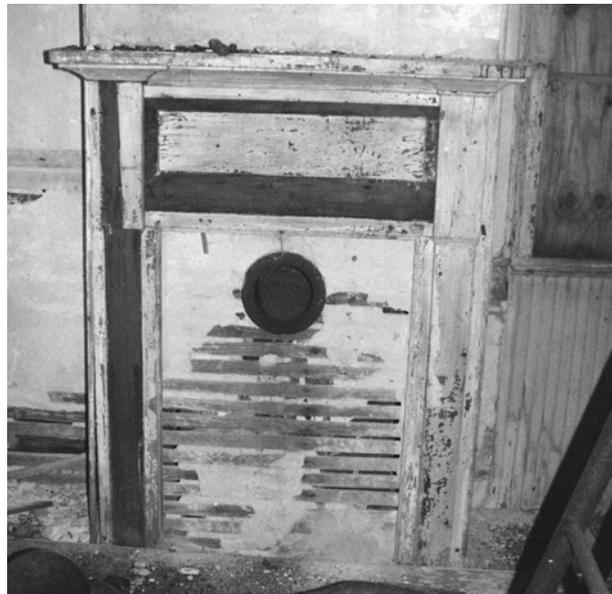
FIGURE 59. View of fireplace and mantel in Room 103, probably installed along with construction of the kitchen wing in the late nineteenth or early twentieth century. (NPS-SERO-CR, 2002)

Fireplace. The original fireplace in the house appears to have been replaced by the existing 6" terra cotta flue and brick chimney in the 1890s or early 1900s. Built to accommodate stoves, this chimney never had fire boxes. Walls were framed around the chimney using 1-3/4" by 3-3/4" circular-sawn studs finished with plaster over sawn lath.

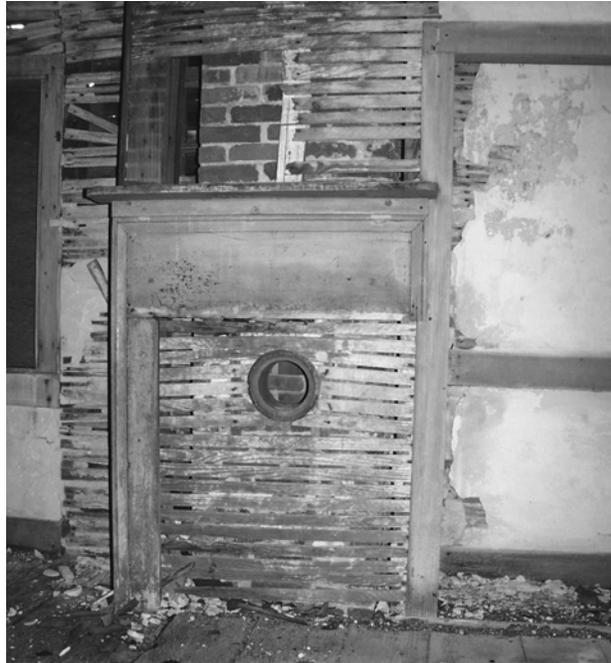
Miscellaneous. When the present brick chimney was constructed, a 6" terra cotta flue for a wood-burning stove was included in this room. As it was downstairs, the chimney was enclosed by a wood-framed wall with plaster on sawn lath. The use of

FIGURE 66. View of added mantle and chimney in Room 202. (NPS-SERO-CR, 2002)

wire nails in constructing the enclosure is an indication that the chimney was built after the 1880s. The mantle is plain, with a mantle shelf 1" by 6-3/4"

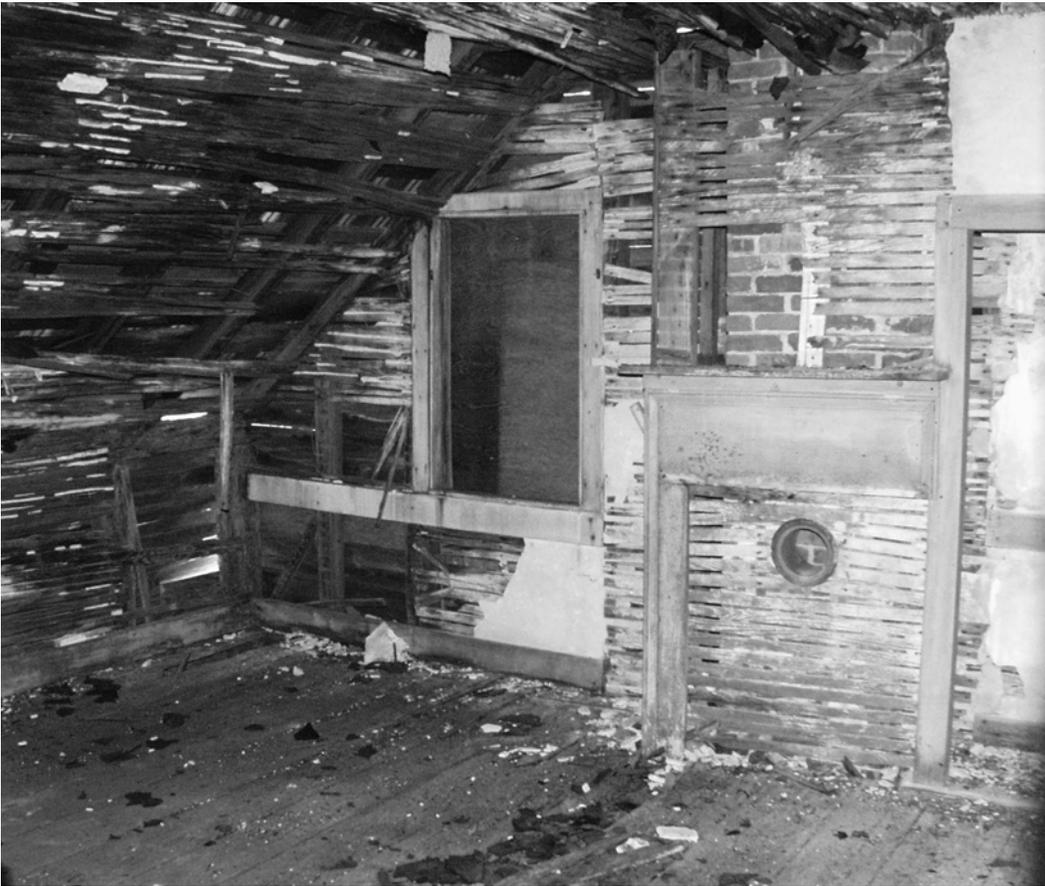
Water penetration has seriously damaged much of this room. Measuring 12'-3" by 13'-5", this is the largest of the three bedrooms and the only one that was heated. The fireplace and the closet were apparently added along with the new fireplace on the first floor.

Floor. Flooring is a random mixture of tongue-and-grooved boards, 8" to 12-1/2" wide, with significant damage from water penetration along the west side of the room.

FIGURE 67. View west in Room 202. (NPS-SERO-CR, 2002)

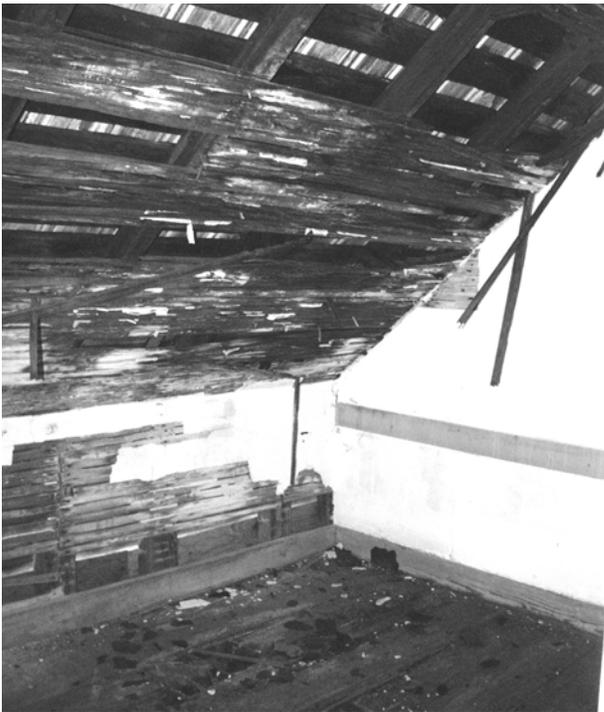
FIGURE 68. View southwest in Room 203. (NPS-SERO-CR, 2002)

This room measures 9'-1" by 12'. Water penetration from a failed roof-covering has caused major damage, and in some areas the floor is not safe.

Walls and Ceiling. Walls and ceiling were plastered over split lath, but most of the plaster has been lost from the ceiling and the south and east walls.

Window. The single window in this room is missing both sash as well as the interior sash stop.
