Portsmouth Village Cultural Landscape Report

Cape Lookout National Seashore
Carteret County, North Carolina

Cultural Landscape Report

December 2007

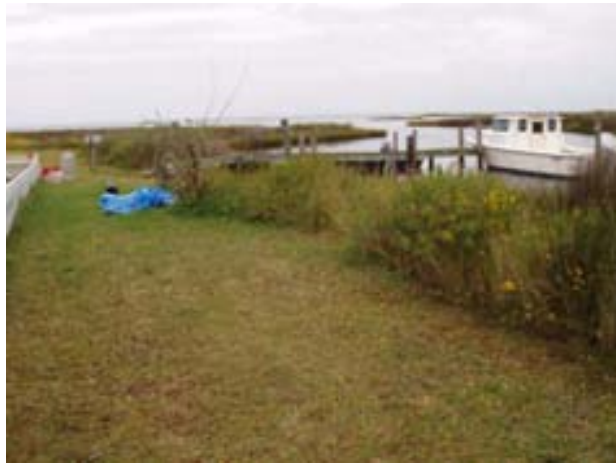
Doctor's Creek. Two tidal creeks extend from the heart of the village to the shoreline. These include Doctor's Creek and Coast Guard Creek. Doctor's Creek is located in the central part of the village below Haulover Point (Fig. 26). The Henry Pigott House was constructed along the creek margin to take advantage of the boat access once afforded from this location. A dock extends from the house precinct into the creek. Pigott was once the mail carrier for the island and received mail deliveries at this dock. The creek has two branches that extend to the main east/west roadway and converge west of the McWilliams-Dixon House. Wooden bridges carry the road over these branches. This tidal creek appears to be in good condition, although sand deposits have made it very difficult to access this part of the island, and the creek likely does not serve boat traffic as well as it did in the past.

FIGURE 26. View northeast toward Doctor's Creek from the Henry Pigott House.

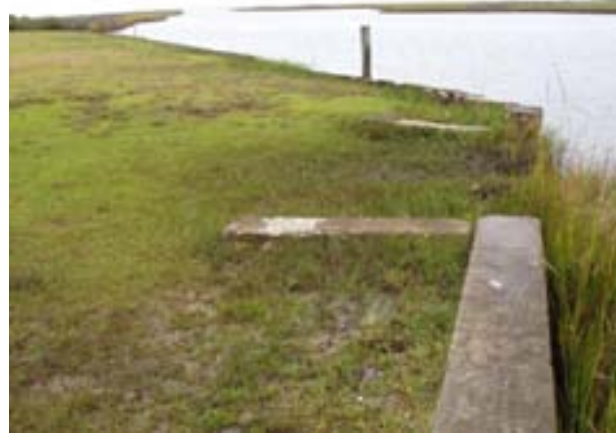
Coast Guard Creek. Coast Guard Creek extends south from the Life-Saving Station to Ocracoke Inlet along the eastern margin of the historic district (Fig. 27). This creek was an important consideration in the siting of the Portsmouth Life-Saving Station. While the building is sited far enough inland to be relatively sheltered, access to the coastal waters for the Life-Saving Station rescue boats was afforded via this creek. In 1908, the Life-Saving Station crew dammed the western end of Coast Guard Creek just east of the station and backfilled with sand, which significantly shortened the creek.¹³¹ A seawall and ramps were constructed in 1918 along the edge of the creek to facilitate access to the water for rescue boats. Siltation has occurred within the creek, evidenced by the portions of the seawall now embedded in its banks. Otherwise, this tidal creek appears to be in good condition.

FIGURE 27. View northeast along Coast Guard Creek.

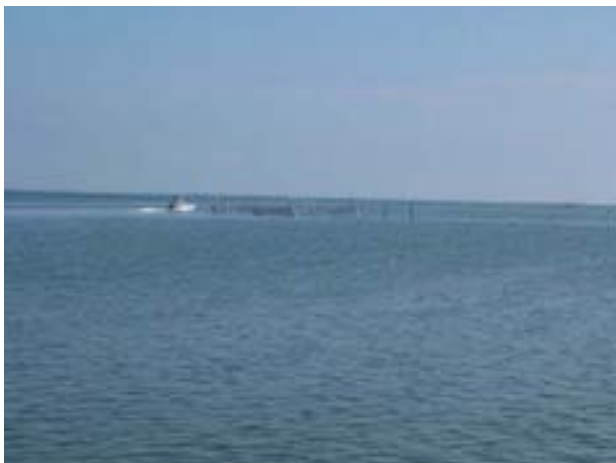
FIGURE 28. View northeast of Ocracoke Inlet from north of Portsmouth Village, and a fishing structure.

Ocracoke Inlet. This water body extends between Ocracoke Island and Portsmouth Island (Fig. 28). The inlet, while currently too shallow for most boat traffic, once served as a primary shipping thoroughfare between Pamlico Sound and the Atlantic Ocean. Casey Island is located to the northwest of Portsmouth Island at the edge of the inlet; Shell Castle Island sits further to the west within Pamlico Sound. Wallace Channel sits within the inlet and extends outside of the historic district. It can be reached via a pedestrian path that arises from the Road to the Beach. A dock is located along the edge of the channel.

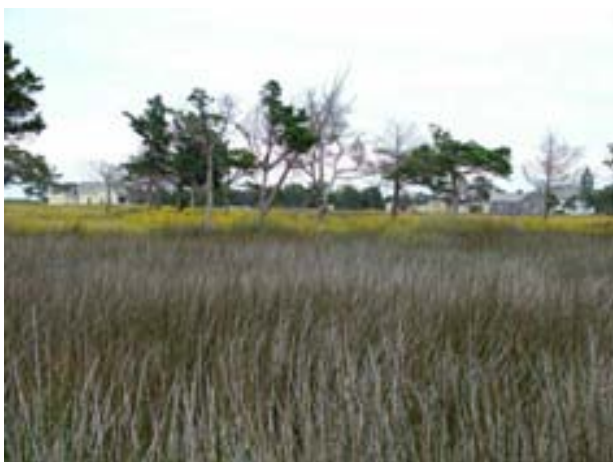
FIGURE 29. View southeast from Haulover Point Road of one of the marsh areas dominated by black needlegrass.

Salt and Brackish Marshes. Salt and brackish marsh occupies much of the western portion of the district, its southern margins, and the margins of Doctor's and Coast Guard Creeks (Fig. 29 and Fig. 30). These naturally-occurring plant communities arise over areas that are regularly inundated with salt water due to tides. The primary species characteristic of the low marsh are smooth cordgrass and saltwort (*Salicornia perennis*). Other glassworts, sea lavender (*Limonium carolinianum*), and salt grass (*Distichlis spicata*) may also be present. The high marsh is more diverse, and characterized by saltmeadow cordgrass, sea ox-eye (*Borrchia frutescens*), and various rushes (*Juncus spp.*). Brackish marshes are dominated by saltmeadow cordgrass, fimbristylus (*Fimbristylis spp.*), little bluestem (*Andropogon virginicus*), foxtail grass (*Setaria geniculata*), and panic grass (*Panicum spp.*). Shrubby components of the marshes include marsh elder (*Iva frutescens*), silverling (*Baccharis halmifolia*), and sometimes wax myrtle. Needlegrass and sedges (*Scirpus americanus*) are also present in brackish marshes. These communities appear generally to be in good condition. No invasive alien plant species were observed to be threatening these communities during field investigations conducted for this project.

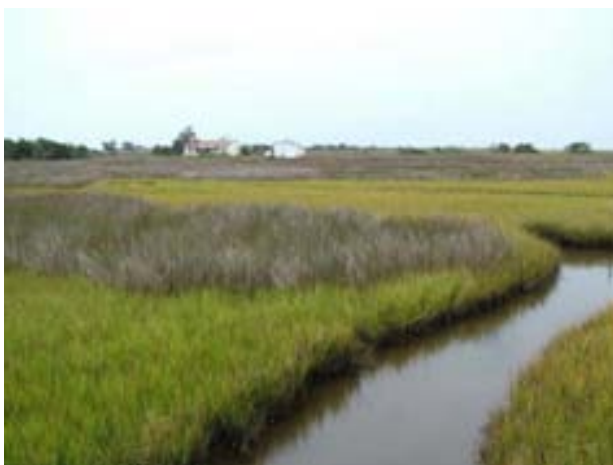
FIGURE 30. View southeast of one of the marsh areas dominated by salt meadow cordgrass. This marsh is located near the T. T. Potter House.

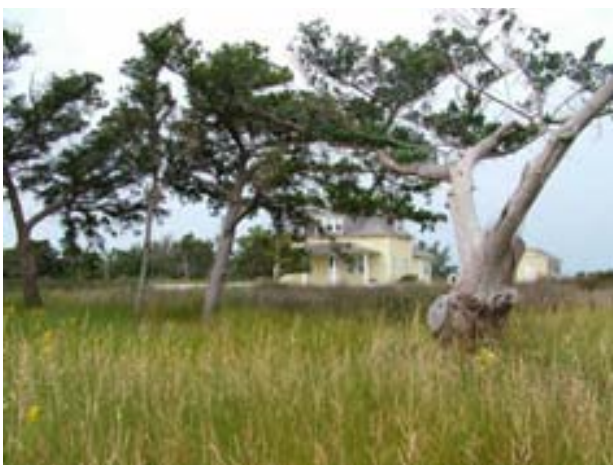
FIGURE 31. An example of shrub savannah vegetation near the Styron-Bragg House.

Shrub Savannah and Shrub Thicket. Shrub savannahs and shrub thickets are present over portions of the Portsmouth Village Historic District (Fig. 31 and Fig. 32). These plant communities are characterized by species such as Eastern red cedar, yaupon holly (*Ilex vomitoria*), and wax myrtle but differ in their degrees of woody plant cover. Additional species that may be present include persimmon (*Diospyros virginiana*), poison ivy (*Rhus radicans*), Hercules' club (*Zanthoxylum clava-herculis*), live oak, silverling, marsh elder, beautyberry (*Callicarpa americana*), red mulberry (*Morus rubra*), dogwood (*Cornus stricta*), bamboo vine (*Smilax laurifolia*), Virginia creeper (*Parthenocissus quinquefolia*), pepper vine (*Ampelopsis arborea*), and muscadine grape (*Vitis rotundifolia*). Savannah communities are characterized by grasslands dotted with open grown shrubs and small trees. Thickets include more woody vegetation, and arise in response to increased protection against wind and salt spray from the ocean and overwashes. Both of these community types generally appear to be in good condition. No invasive alien plant species were observed to be threatening these communities during field investigations conducted for this project.

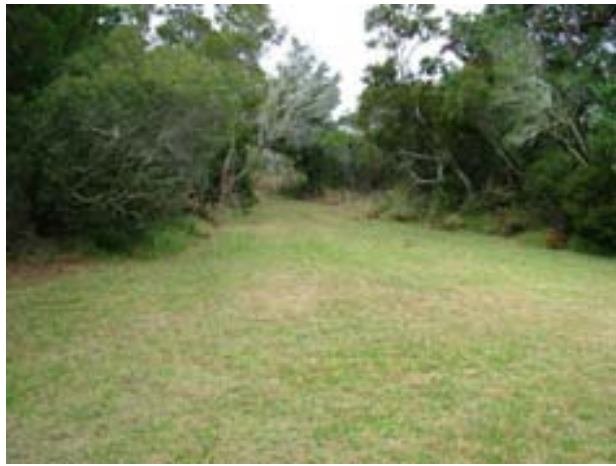
FIGURE 32. An example of shrub thicket vegetation near the schoolhouse.

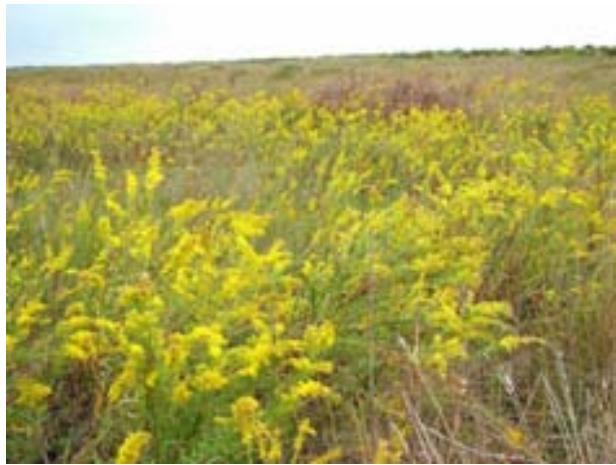
Grassland. Also present within the historic district are open grasslands dominated primarily by grasses and forbs (Fig. 33). These occur where woody growth is less apt to become established because of winds, salt spray, a lack of available soil moisture, and the potential for overwash or storm damage. Species characteristic of Portsmouth Village grasslands include: saltmeadow cordgrass, water pennywort (*Hydrocotyle bonariensis*), seaside goldenrod (*Solidago sempervirens*), fimbriatylis, and purple muhly (*Muhlenbergia capillaris*). The grassland areas serve as habitat for various birds such as the common Eastern meadowlark, mourning dove, boat-tailed grackle, and marsh hawk. This plant community type generally appears to be in good condition. No invasive alien plant species were observed to be threatening these communities during field investigations conducted for this project. Both the shrub and grassland communities generally appear to be migrating toward the tidal flats, forming very clear bands of vegetation. Scientific study is being conducted by local natural resource specialists to determine the cause of this unusual successional pattern.

FIGURE 33. An example of grassland vegetation near the tidal flats.

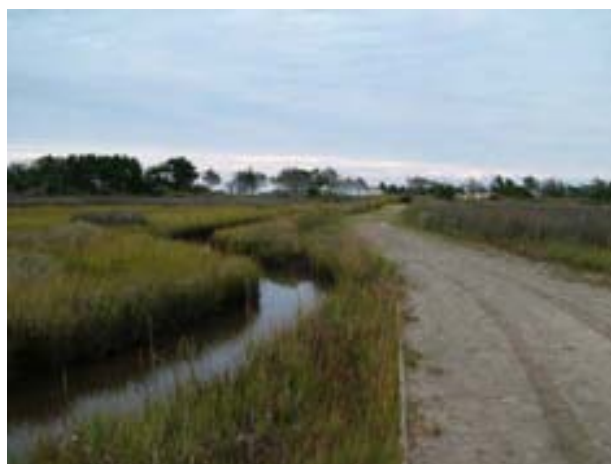
FIGURE 37. During the Works Progress Administration era, a pond and channels are said to have been excavated as a mosquito control measure within Portsmouth Village. This is a view southeast of one of the channels edging Haulover Point Road.

Fig. 38). The pond lies east of the road leading south from Haulover Point, and the channels edge Haulover Point Road and follow a portion of the Village Road. These features appear to be in good condition.

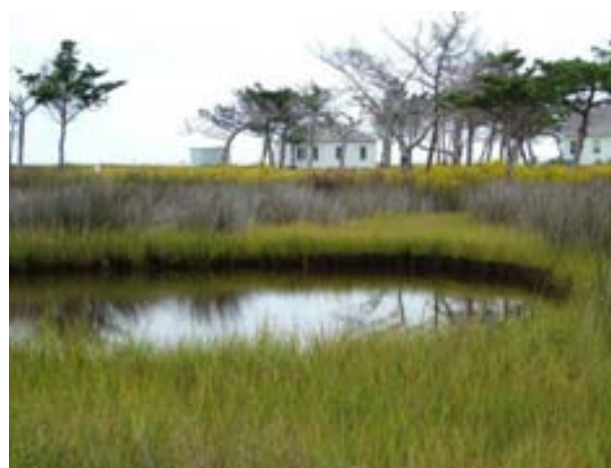
FIGURE 38. The pond purportedly excavated for mosquito control, shown here, is also located along Haulover Point Road.

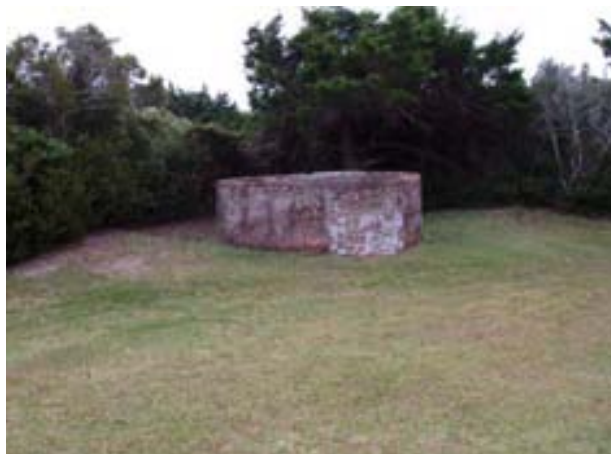
FIGURE 40. Cisterns like the U.S. Marine Hospital structure shown here are used to store rainwater on the island and are the primary source of fresh water.

Cisterns and wells. Most residents of Portsmouth Island derived their fresh water from the collection of rainwater stored in cisterns (Fig. 40). Most properties within the historic district have a cistern or water box. The condition of wells, water boxes and cisterns on the island and their ability to provide and store drinking water is not currently known.

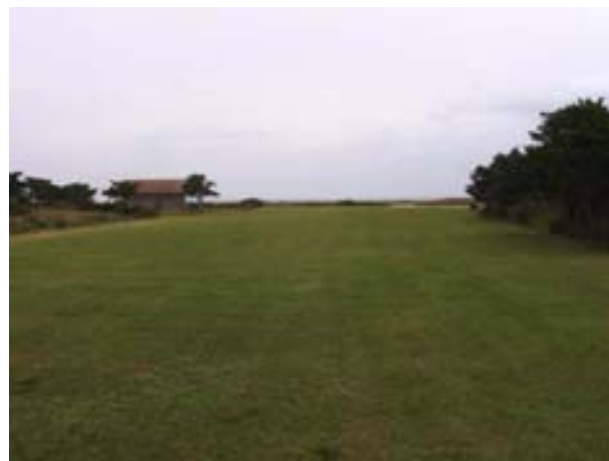
FIGURE 42. View northeast along the island's airstrip established in the 1940s with limited grading.

(Fig. 42). This landscape feature continues to be maintained in mown grass and is in good condition.

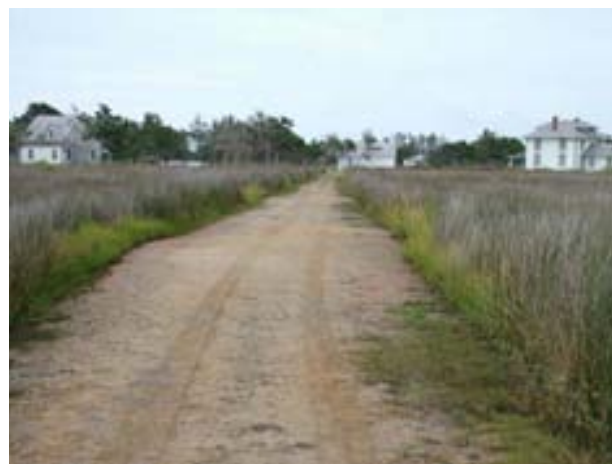
Haulover Point Road. This road is a long, straight, sand road that extends between Haulover Point and the Old Straight Road (Fig. 47 and Fig. 48). The northern portion of the road frequently floods, and remains wet, causing visitors difficulty when they arrive on the island. The road is generally in good

FIGURE 47. View south along Haulover Point Road.

condition, except for where ponding occurs near the boardwalk.

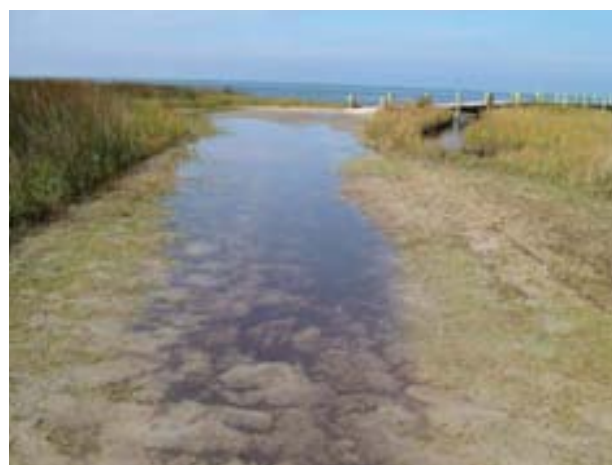
FIGURE 48. Haulover Point Road, as seen here, often exhibits ponding and standing water, which can be a problem for visitors.

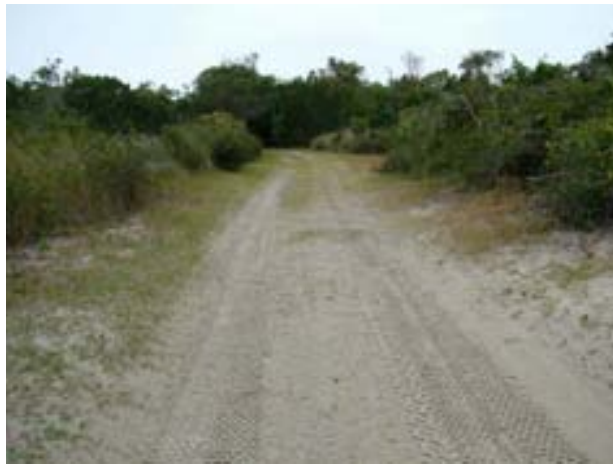
Road to the Beach. The Road to the Beach extends from the Life-Saving Station complex south to the beach and tidal mud flats that edge the historic district (Fig. 50). This road is variously surfaced with graded sand and mown grass. An access road leads to the two seamen's graves from the Road to the Beach. The road is generally in good condition.

FIGURE 50. View south along the Road to the Beach.

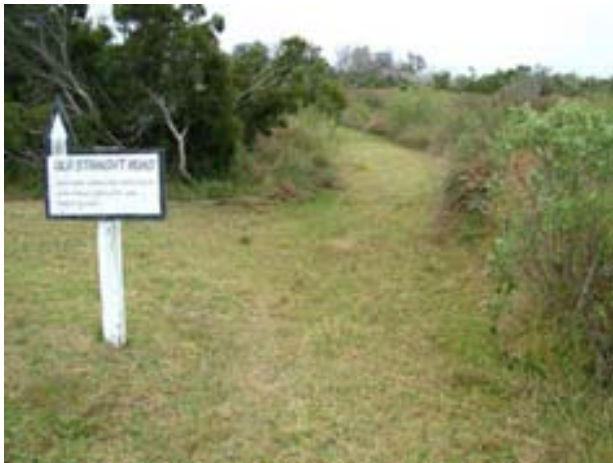
Old Straight Road. The Old Straight Road is the historic route of travel between Portsmouth Village and the Middle Community (Fig. 51). It joins Haulover Point Road near the Schoolhouse. This route has a mown grass surface. The portion of the road that is interpreted within the historic district is in good to fair condition, although it requires constant maintenance to remain unobstructed by vegetative growth. Beyond the historic district boundary, this road is difficult to follow due to overgrown vegetation.

FIGURE 51. View southwest along the Old Straight Road near the Schoolhouse.

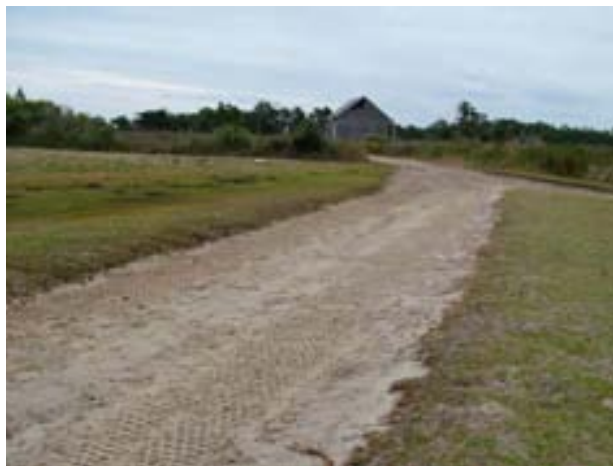
Access Road to Dixon-Salter House, Portsmouth Cemetery, and Will Willis House ruins. This access road leads west from Haulover Point Road near the Dixon-Salter House and the village crossroads (Fig. 52). The road splits; one branch leads to Portsmouth Cemetery and the other to the Will Willis House ruins. This road has a mown-grass surface. It is generally in good condition, but becomes increasingly overgrown near its terminus.

FIGURE 52. View southwest toward the village crossroads.

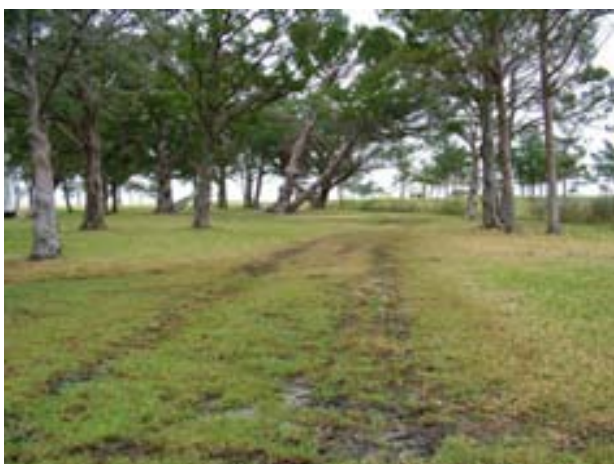
Access Road to Robert Wallace, Tom Gilgo, and Henry Pigott Houses. This road leads northeast from the Village Road and partially parallels the access road to the Carl Dixon and Frank Gaskill Houses (Fig. 53 and Fig. 58). It extends to the Henry Pigott House along Doctor's Creek. The road has a

FIGURE 53. View northeast along the access road to the Robert Wallace, Tom Gilgo, and Henry Pigott Houses.

mown-grass surface and is generally in good condition.

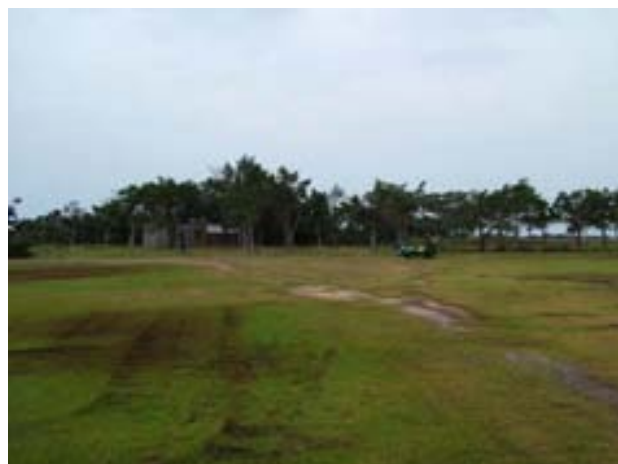
FIGURE 56. View east along the access road to the Ed Styron House.

Access Road to Ed Styron House. This access road leads northeast from the vicinity of the Portsmouth Methodist Church (Fig. 56). It has a mown-grass surface. The road has been damaged by heavy vehicles and the NPS is working to mitigate the damage.

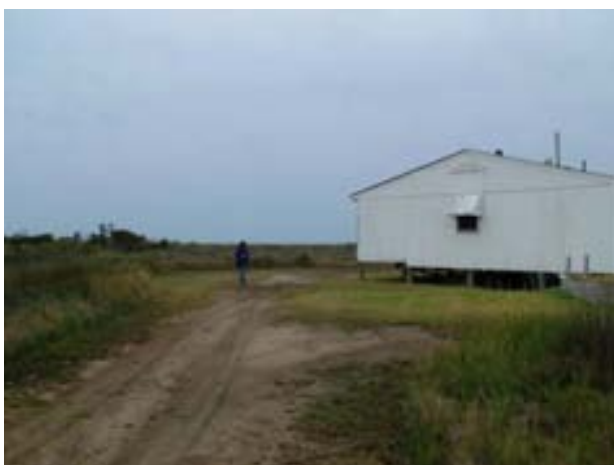
FIGURE 54. View west along the access road to the T. T. Potter House.

Access Road to T. T. Potter House, dock, and Keller-Styron Cemetery. This road arises near the Styron-Bragg House and leads south/southwest from the Village Road (Fig. 54). The sand- and grass-surfaced road splits; one branch leads to the Keller-Styron Cemetery, the other to the T. T. Potter House. This road is generally in good condition.

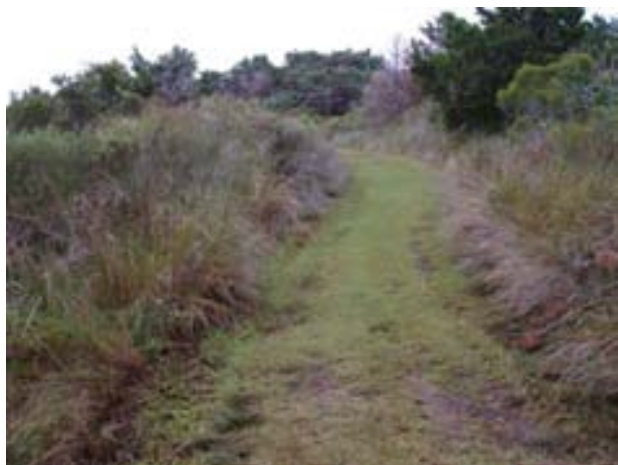
FIGURE 57. View northeast along the access road to the Two Seamen's Graves.

Access Road to Two Seamen's Graves. This modest access road has a mown-grass surface (Fig. 57). It leads north from the Road to the Beach to the site of two graves. This road is generally in good condition.

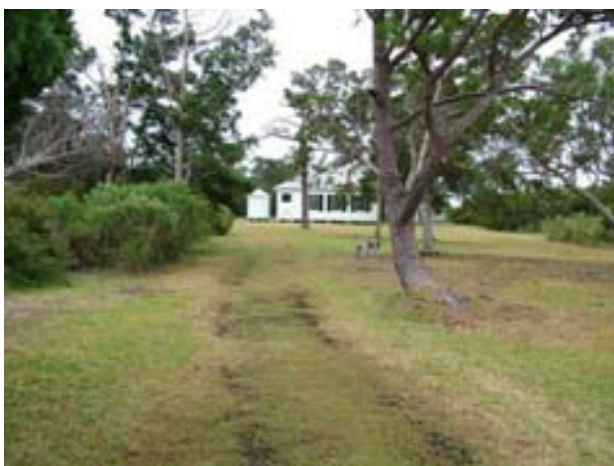
FIGURE 55. View south along the access road to the Schoolhouse and the Cecil Gilgo House.

Access Road to Schoolhouse and Cecil Gilgo House. This access road arises at the intersection of Haulover Point Road and the Old Straight Road (Fig. 55). It has a mown-grass surface and provides access to the Cecil Gilgo House and the Schoolhouse. This road is generally in good condition, although there is vegetation along its perimeter in some areas that must be maintained to keep the road passable.

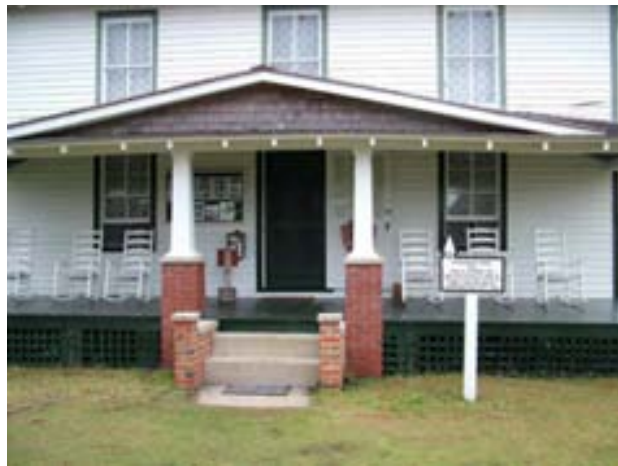
FIGURE 59. Brick and concrete steps lead to the Dixon-Salter House porch.

Dixon-Salter House, brick and concrete steps. A concrete stair, consisting of two risers with a ground-level concrete landing, provides access to the front porch of the Dixon-Salter House (Fig. 59). The stair is flanked to either side by 18-inch-tall brick walls capped with concrete. These steps appear to have been repaired recently and are in good condition.

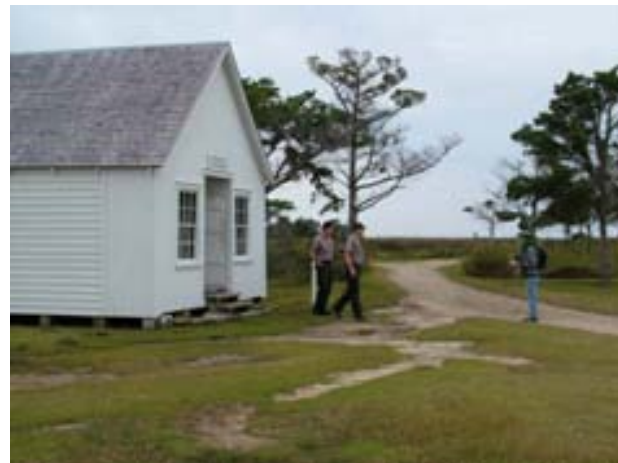
FIGURE 60. Wood steps lead to the entrance to the Post Office and General Store.

Post Office and General Store, wooden steps, front. A set of unpainted wood steps without handrails leads to the front entry of the Post Office and General Store (Fig. 60). The steps have three risers simply constructed of stringers and planks. The steps appear to be in good condition.

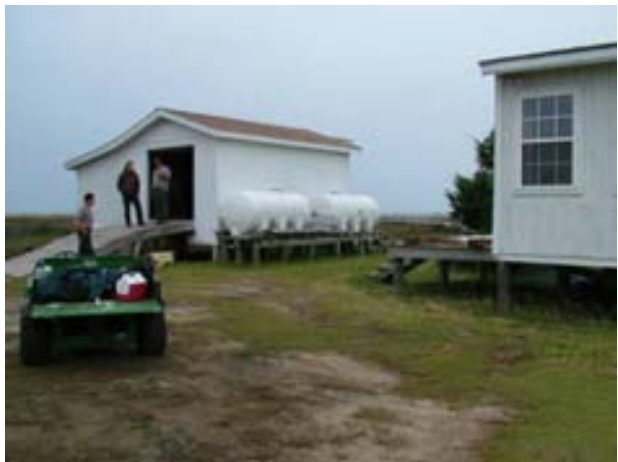
FIGURE 61. A wood ramp provides access for vehicles into the T. T. Potter Shed.

T. T. Potter, ramp to shed. A simple wood ramp, approximately eight feet wide, provides vehicular access into the shed (Fig. 61). The ramp is not edged in any way. This ramp appears to be in good condition.

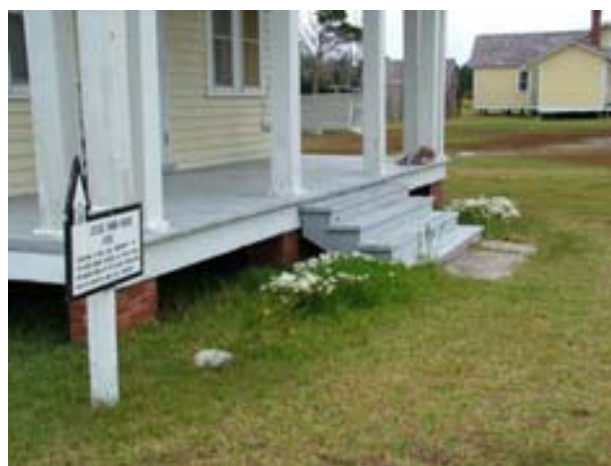
FIGURE 62. Steps lead to the porch at the Jesse Babb House.

Wooden steps leading to front porch, Jesse Babb House. A flight of four painted wood steps without handrails lead to the front porch of the Jesse Babb House (Fig. 62). A brick landing sits at the base of the steps. The steps appear to be in good condition.

Flowering bulbs in front of the Jesse Babb House. Fall flowering bulbs were observed in October 2006 growing to either side of the steps leading to the Jesse Babb House porch (Fig. 62). The plantings

appear to be relatively well tended and in good condition.

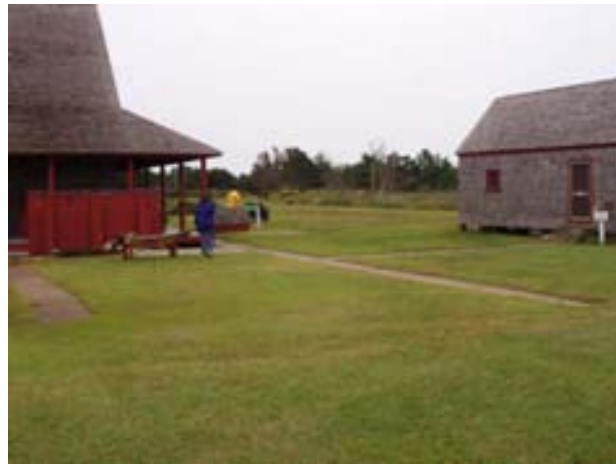
Concrete walks associated with the Portsmouth Life-Saving Station. Concrete walks approximately three feet wide edge the Life-Saving Station along its front facade and lead from the station to the summer kitchen, extend toward the stable, and edge the side of the building where two concrete ramps lead inside (Fig. 63). This system of concrete walks was built in 1914–1918, except for the walk to the summer kitchen, which was added in 1942. The paths are exhibiting evidence of deterioration, including cracking and spalling, and vegetative growth within many of the control joints. They are in fair to good condition.

FIGURE 63. Concrete walks extend between the Portsmouth Life-Saving Station and summer kitchen, as well as into the landscape.

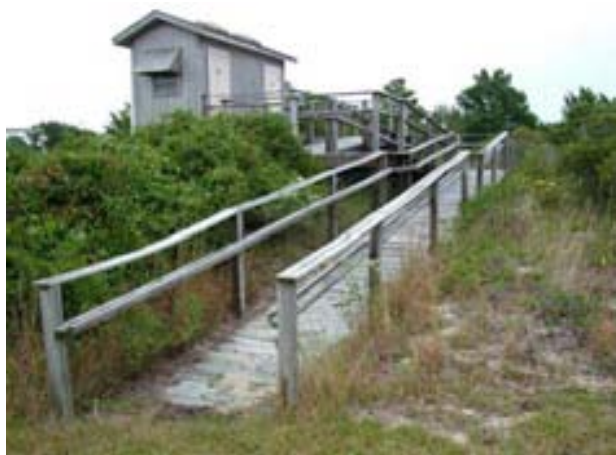
FIGURE 64. Wooden ramp and steps leading to the comfort station along the Road to the Beach.

Wooden ramp/steps leading to the comfort station along the Road to the Beach. A long ramp system and flight of wooden steps provides access to the

comfort station along the Road to the Beach (Fig. 64). These features include handrails at two heights, one for wheelchair accessibility. The ramp and stairs appear to be in good condition.

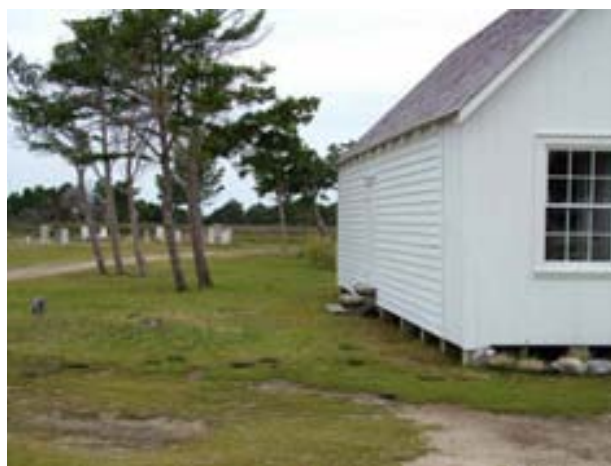
Eastern red cedars. There are Eastern red cedar trees located in association with most of the residential properties within the district. At the Post Office and General Store, for example, Eastern red cedars edge the building on two sides. Some of the trees in the line to the south appear to have recently been lost. (Fig. 68) Eastern red cedars are also a primary component of the landscape surrounding the Robert Wallace House. (Fig. 69) These native evergreens are also associated with many of the cemeteries within the district, including the Keller-Styron Cemetery. (Fig. 70) Many of the trees within the cemetery appear to be suffering from damage due to storms or salt spray and are stunted. They range individually from good to poor condition.

FIGURE 68. Eastern red cedars are prevalent throughout the historic district. Shown here is a line of trees that edge the Post Office and General Store.

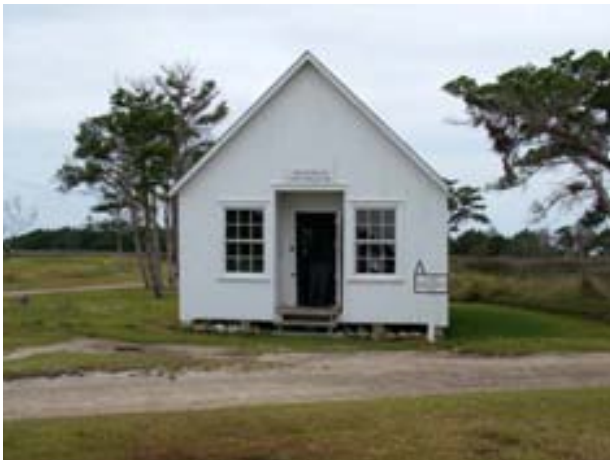
FIGURE 71. Irises are planted in the rock-lined bed in front of the Post Office and General Store.

Irises in planting bed at Post Office. What appear to be bearded irises were observed growing in the rock-lined planting bed in front of the Post Office and General Store in October 2006 during CLR fieldwork (Fig. 71). These bulbs appear to be in good condition.

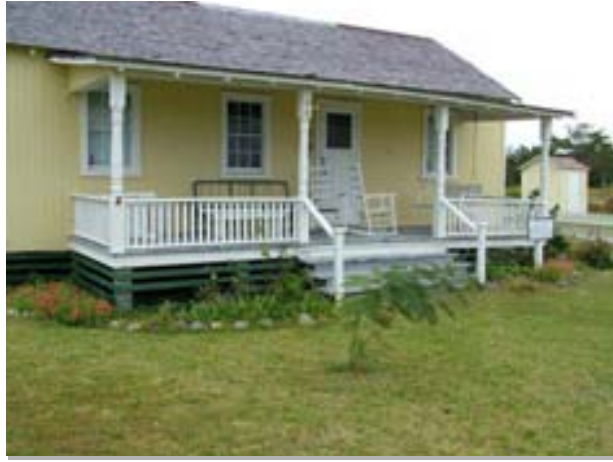
FIGURE 72. A rock-lined planting bed edges the McWilliams-Dixon House porch, and is planted with perennials such as gaillardia.

Perennials, annuals, rose bush in front of the McWilliams-Dixon House. A rock-lined planting bed edges the McWilliams-Dixon House porch, and there is a circular planting bed in the yard in front of the house (Fig. 72). Perennials such as gaillardia are growing in these beds. A rose bush has been trained on the picket fence in front of the house. What appear to be canna lilies are growing next to the steps leading to the back door. The stump of a poplar is also evident in the front yard. Except for the poplar, the plantings appear to be relatively well tended and in good condition.

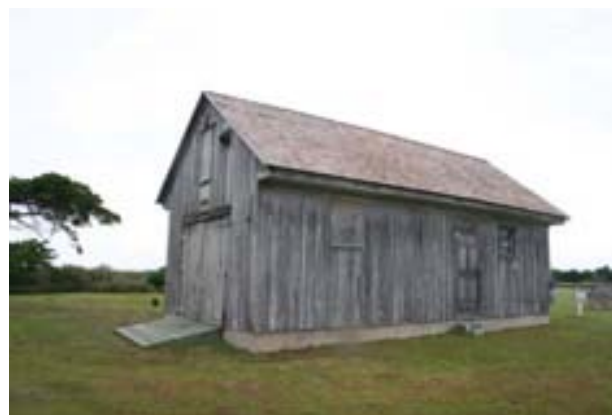
FIGURE 78. The stable at the Life-Saving Station.

The existing stable (Fig. 78, LCS 012534) was apparently constructed in 1928, replacing earlier stables destroyed by a hurricane. After the last horses left the station in 1932, the building was used for storage and as a garage. The stable is a rectangular gable-roof structure. The stable has a concrete foundation, board-and-batten siding, and a wood shingle roof. The stable was assessed in fair condition in 2006 for the LCS due to damage that occurred from Hurricane Ophelia in mid-September 2005.

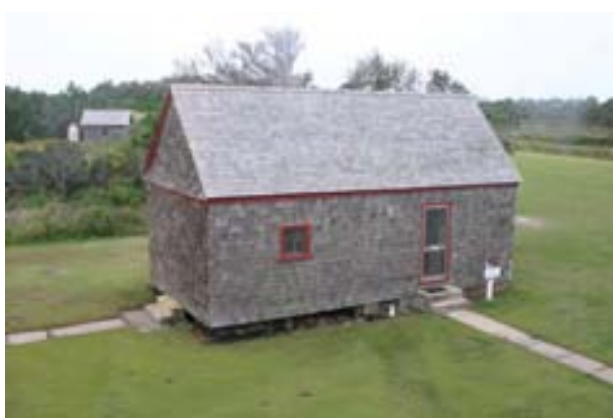
FIGURE 77. The summer kitchen adjacent to the Life-Saving Station. The generator shed is visible beyond at left.

with shiplap siding. The kitchen is a gable-roof structure with wood shingles covering exterior wall and roof surfaces. The kitchen has small six-light rectangular windows. The older portion of the kitchen is supported on a concrete foundation, while the dining room addition is supported on wood posts. There is a brick chimney at the west gable end. In 1980, the NPS installed shingles over the entire building. The kitchen was assessed in good condition in 2006 for the LCS.

Southwest of the summer kitchen is the generator shed, constructed by the NPS in 1982. This outbuilding consists of a small gable roof structure with a wood shingle roof and unpainted plywood wall cladding.

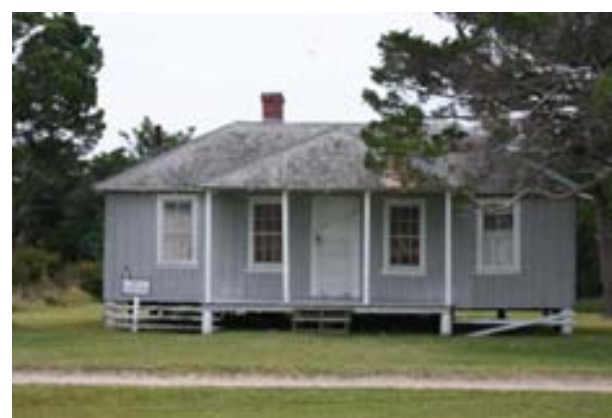
FIGURE 79. Roy Robinson House.

Roy Robinson House. The Roy Robinson House (Fig. 79, LCS 012513) was built circa 1926 on the foundation of the Marine Hospital and moved to its current site in 1935.¹³⁷ Roy Robinson was chief of the Portsmouth Coast Guard Station from 1925 to 1931. The Robinson House is a one-story, hip-roof structure supported on wood posts. The house is rectangular in plan with a hip-roof porch along the north front and an open platform porch at the

southeast rear corner. The walls are board-and-batten siding painted blue. The double-hung windows are generally two-over-two, aside from two windows at the front porch which are six-over-six. The roof is wood shingle, with a brick chimney; localized areas of the roof were replaced following Hurricane Isabel in 2003. The house was assessed in fair condition in 2006 for the LCS.

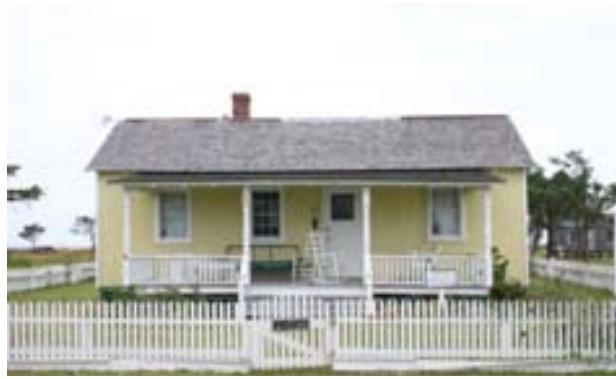
FIGURE 82. McWilliams-Dixon House.

McWilliams-Dixon House. Directly west of the Babb House is the McWilliams-Dixon House (Fig. 82, LCS 091779), constructed circa 1910 near the Life-Saving Station by Keeper Charles McWilliams. The house was moved to its current site circa 1937 by Ed Dixon. Elma Dixon, one of the last residents of the village, resided here until 1971. The house has a T-shaped plan and is clad with vertical wood board siding painted yellow and a wood shingle gable roof with a galvanized metal ridge cap. The house is supported on wood posts. The house has six-over-six double-hung windows and a porch across the south front with Queen Anne style posts. The house is surrounded by a wood picket fence, and within the enclosure behind the house is a cool house. A shed is located at the northwest corner of the fenced yard, and a privy is located behind the house. The shed was used as a wash house and was relocated from the George Dixon house site in the late 1930s.¹³⁹ The house was assessed in good condition in 1999 for the LCS. The cool house was assessed in good condition in 1998 for the LCS. The shed was assessed in good condition in 1998 for the LCS. The privy was assessed in fair condition in 2006 for the LCS.

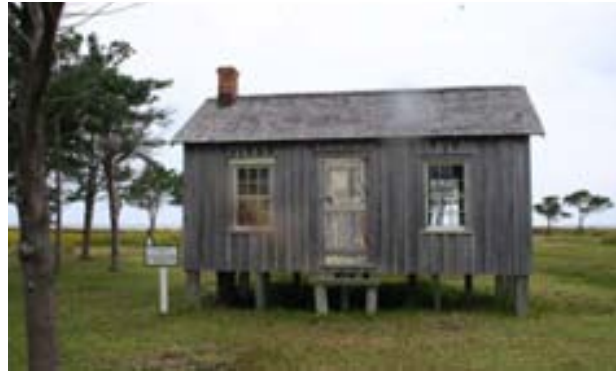
FIGURE 83. Ed Styron House.

Ed Styron House. North of the Dennis Mason and Jesse Babb Houses is the Ed Styron House (Fig. 83, LCS 012516). This house was constructed circa 1933 when the Styron family's previous house on Sheep Island was damaged by a hurricane. The house was restored in 2002. The house is a simple one-story cottage supported on wood posts. The walls are unpainted board and batten siding, and the windows are six-over-six double-hung units. The roof is wood shingle, with a brick chimney. An open platform porch extends across part of the north elevation. The house was assessed in good condition in 2006 for the LCS.

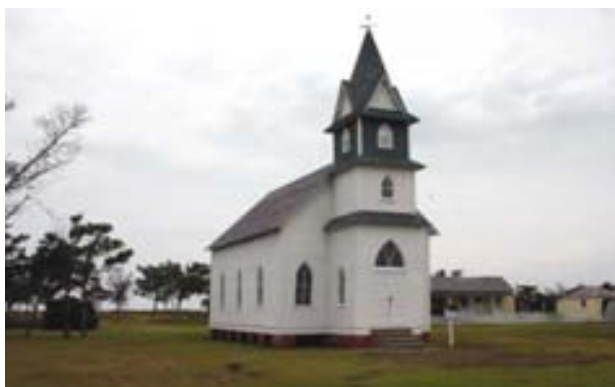
FIGURE 84. Portsmouth Methodist Church.

structure was destroyed in a severe hurricane on September 2–3, 1913.¹⁴⁰ The church is supported on red brick piers and has wood siding and a wood shingle gable roof. The steeple features decorative cut shingles. Gothic Revival-style elements include the divided light pointed arch windows and the pointed arch door opening. The main entrance to the church is in the steeple tower at the southwest end. The church was assessed in fair condition in 2006 for the LCS, due to a leaning foundation and brick piers urgently in need of repointing and repair.

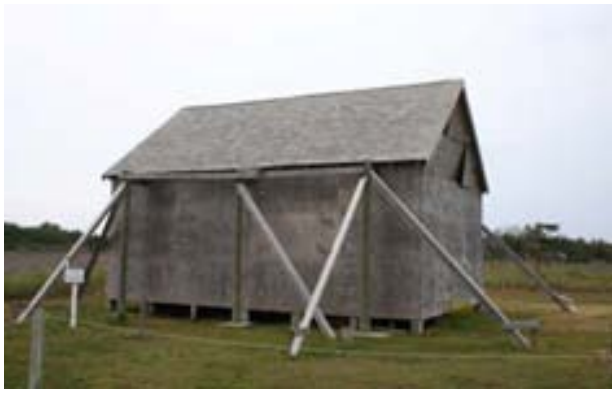
FIGURE 86. George Dixon House.

George Dixon House. The George Dixon House (Fig. 86, LCS 012519) stands along the Village Road in open marsh land west of the church and the Washington Roberts House. The house was built around 1887 by George and Martha Dixon. The house was severely damaged by Hurricane Isabel in 2003. Currently, the walls are completely boarded up with plywood, and wood structural shores stabilize the walls of the house. Prior to the hurricane, the house had asphalt composition siding, six-over-six double-hung windows, a brick chimney, and front and rear porches. The house historically also had a kitchen/dining room wing. In the late 1990s, the house had a wood shingle roof installed. The house was assessed in poor condition in 2006 for the LCS.

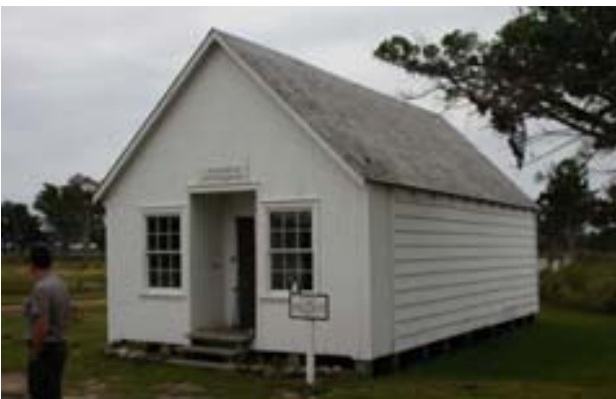
FIGURE 87. Portsmouth Post Office.

Store (Fig. 87, LCS 012526), constructed circa 1900, which stands at the crossroads of the village. The gable roof structure supported on wood posts has painted clapboard and vertical wood board siding, and a wood shingle roof with galvanized metal ridge cap. The front gable end has a central door and a pair of six-over-six double-hung windows. The house was assessed in fair condition in 2006 for the LCS.

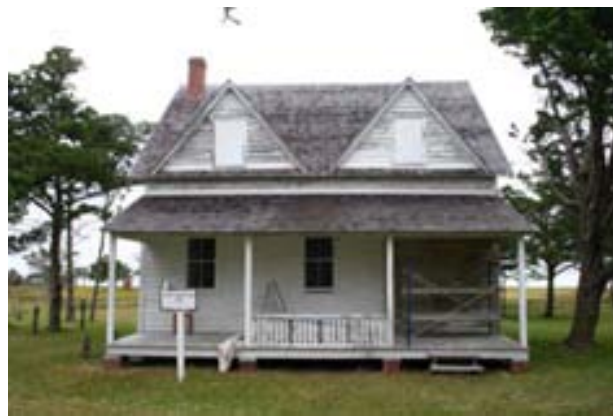
FIGURE 90. Robert Wallace House.

Robert Wallace House. Near the Post Office and General Store at the road to the Henry Pigott House is the Robert Wallace House (Fig. 90, LCS 012522), constructed circa 1850. The 1-1/2-story house is supported on wood posts. The house is rectangular in plan with two wide gabled dormers on the front and back roof plane. The exterior is clad with painted clapboard siding, and the building has a wood shingle roof. The house has a brick chimney. The windows are two-over-two double-hung units. A porch extends across the front of the house; the central portion of the porch includes a wood balustrade. The house once included a kitchen/dining room wing to the east. It was assessed in fair condition in 2006 for the LCS.

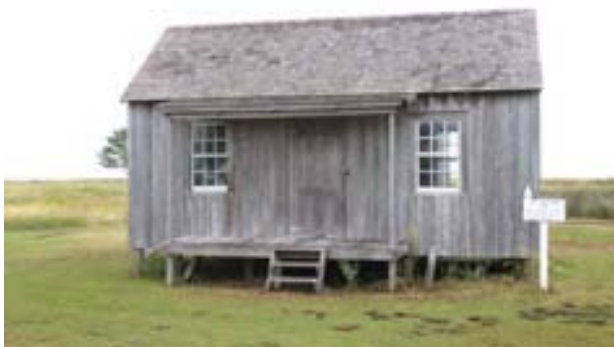
FIGURE 89. Tom Gilgo House.

Tom Gilgo House. Southwest of the Henry Pigott House is the Tom Gilgo House (Fig. 89, LCS 012521). The house was originally constructed in the mid-1920s near the Life-Saving Station and moved to this site in 1928. The small T-shaped house was substantially rehabilitated by the National Park Service in the 1990s. The house is supported on wood posts. The walls are clad with a mixture of unpainted board and batten and clapboard siding and the roof is wood shingle. A porch extends

across part of the front elevation. The windows are six-over-six double-hung units. The house was assessed in good condition in 2006 for the LCS.

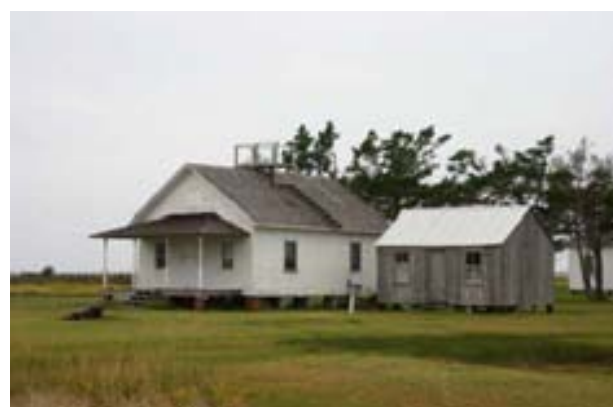
FIGURE 91. Carl Dixon House.

northeast to the Carl Dixon and Frank Gaskill Houses. The Carl Dixon House (Fig. 91, LCS 012528) was constructed circa 1930 as a front gable structure supported on wood posts. The front porch has a hip roof and is supported on brick piers. Directly adjacent to the house is a kitchen supported on wood posts. The walls of the kitchen are unpainted clapboard and the roof is sheet metal. The windows of both the house and kitchen are two-over-two double-hung units. Also adjacent to the house is a brick cistern. The house was assessed in poor condition in 2006 for the LCS. The summer kitchen was assessed in fair condition in 1998 for the LCS.

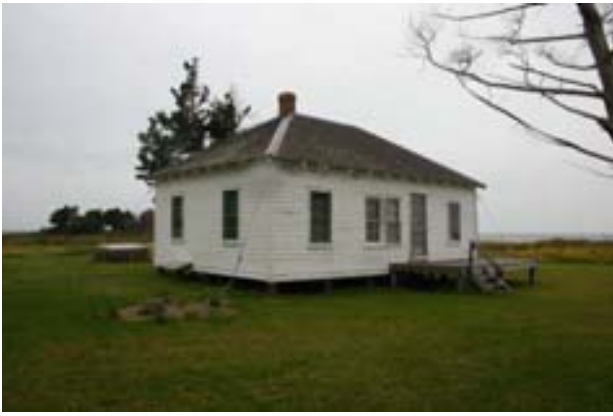
FIGURE 92. Frank Gaskill House.

Frank Gaskill House. The Frank Gaskill House (Fig. 92, LCS 012529) stands closer to the shore of the inlet. It was constructed circa 1930 and has a hip roof covered with wood shingles and galvanized metal ridge caps. The house is supported on wood posts and has painted clapboard siding. At the front door is an open platform porch. The house has a

brick chimney and six-over-six double-hung windows. Also part of the property is a shed with sheet metal walls, which is located at the shore of the inlet. The shed appears to be in good condition. The house was assessed in good condition in 2006 for the LCS.

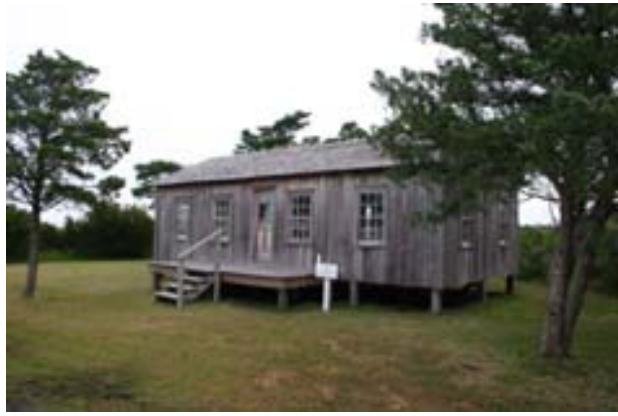
FIGURE 94. Cecil Gilgo House.

Cecil Gilgo House. From the village crossroads, the Old Straight Road runs southward. The Cecil Gilgo House (Fig. 94, LCS 091784) stands along this road and was constructed circa 1936 from salvaged materials. The house is a rectangular one-story structure supported on wood posts. The walls are clad with unpainted vertical wood board siding, and the gable roof is wood shingle with a galvanized metal ridge cap. The house has a brick chimney and six-over-six double-hung windows. There is an open platform porch at the front door. The house was assessed in poor condition in 1998 for the LCS.

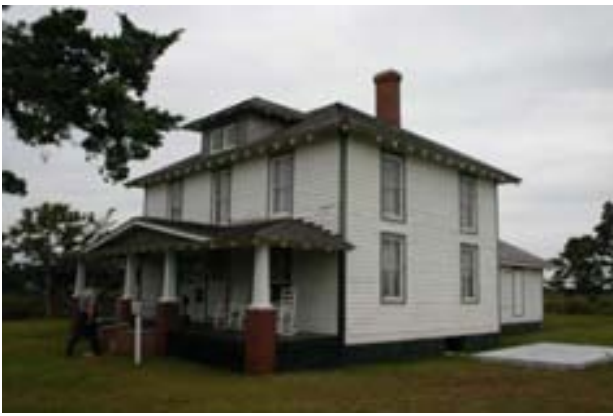
FIGURE 93. Dixon-Salter House.

Dixon-Salter House. Just northwest of the Post Office and General Store near the village crossroads, stands the Dixon-Salter House (Fig. 93, LCS 012527). This large two-story structure with rear one-story wing was constructed circa 1900 and moved to its current site circa 1930. The hip roof is wood shingled, and the walls are clad with painted clapboard. The house is mainly supported on wood posts but includes brick porch posts and several brick chimneys. The front porch has tapering wood columns and a front-facing gable on its hip roof. The windows are two-over-two double-hung units. Around the house are several outbuildings, including a cool house, a shed, and a privy. The

house was assessed in good condition in 2006 for the LCS. The shed was assessed in fair condition in 1998 for the LCS. The privy was assessed in fair condition in 1998 for the LCS. The cool house was assessed in poor condition in 2006 for the LCS.

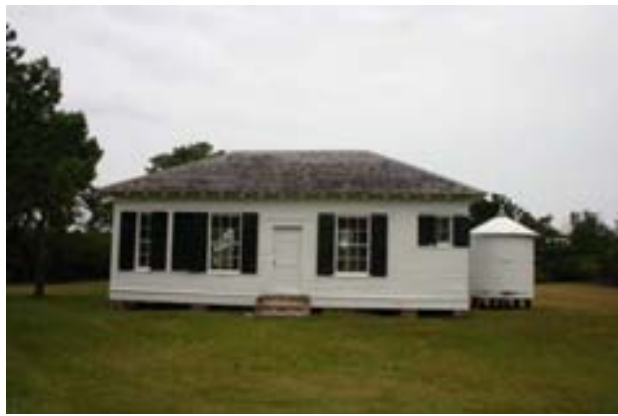
FIGURE 95. Portsmouth Schoolhouse.

Portsmouth Schoolhouse. Beyond the Cecil Gilgo House is the Portsmouth Schoolhouse, built in the 1910s (Fig. 95, LCS 012524). The hip roof structure is supported on brick piers and has walls clad with painted clapboard siding. The wood shingle roof has galvanized metal ridge caps. The windows are mainly six-over-six double-hung units with dark green painted shutters. The school has a brick chimney and sits adjacent to a cylindrical cistern. Near the school is a two-part shed: the front part has a brick foundation, clapboard walls, and a wood shingle roof; the rear part is supported on wood posts and has asphalt composition shingle roofing and wall cladding. The schoolhouse was assessed in fair condition in 2006 for the LCS. The shed was assessed in good condition in 2006 for the LCS.

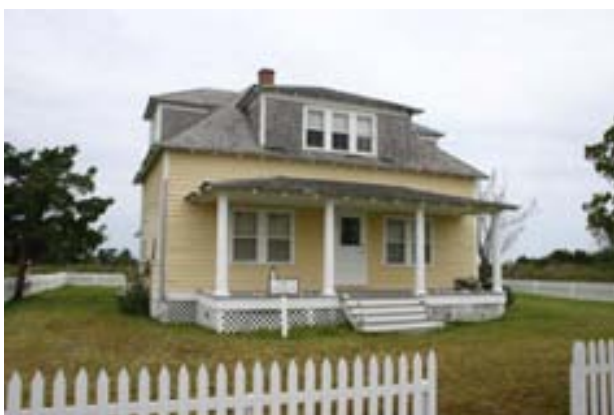
FIGURE 96. Styron-Bragg House.

Styron-Bragg House. From the village crossroads, a road runs west-northwest. West of the Post Office and General Store along this road is the Styron-Bragg House (Fig. 96, LCS 012530). The house was built circa 1928 as a sportsmen's lodge. The 1-1/2-story house with one-story rear wing has a wood shingle hip roof with four dormers and galvanized metal ridge caps. The walls are clad with clapboard painted yellow. The house is supported on wood posts and has brick chimneys, Colonial Revival type porch columns, and two-over-two double-hung windows. A painted wood picket fence partially encloses the yard, which contains a cool house, a shed, and a contemporary plastic septic tank. The house was assessed in good condition in 2006 for the LCS. The shed was assessed in good condition in 1998 for the LCS. The cool house was assessed in

fair condition in 1998 for the LCS. The LCS includes a privy associated with the Styron-Bragg but this structure does not exist.

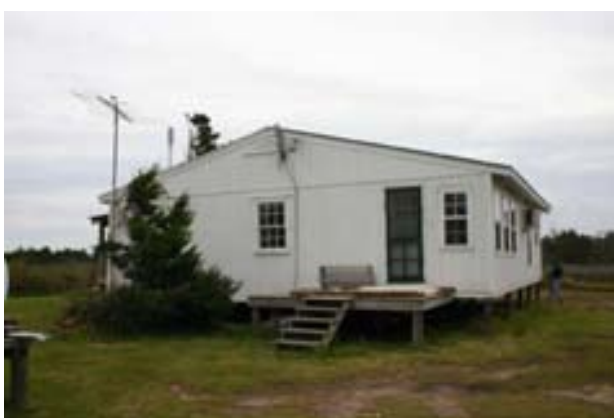
FIGURE 97. T. T. Potter House.

T. T. Potter House. A southwest branch off the road to the Styron-Bragg House leads to the T. T. Potter House (Fig. 97, LCS 012531) near the shore of the sound. This 1952 house is a larger, ranch-type house supported on wood posts. The walls are clad with composition board siding, and the roof is asphalt shingle. The house has a mix of window types and a large porch along the north side. Also on the site are two outbuildings, a contemporary plastic septic tank, and an outdoor fish cleaning table with sink. The house was assessed in good condition in 1998 for the LCS.

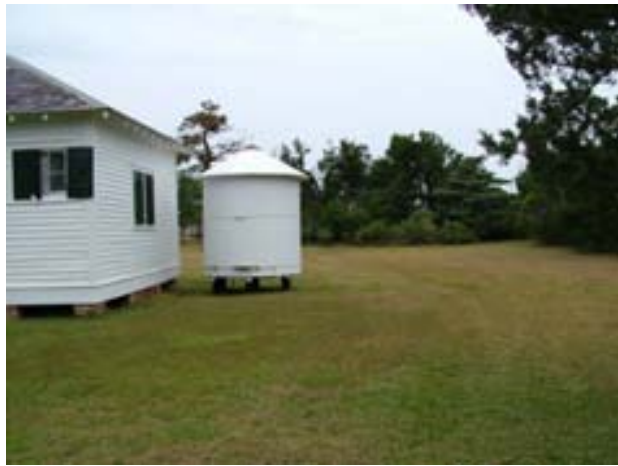
Schoolhouse cistern. The Schoolhouse cistern is a cylindrical structure composed of vertical boards with a conical metal roof capped with a short metal pole (Fig. 98, LCS 091756). The structure is approximately eight feet in height, and sits on wooden posts one to two feet off of the ground. The structure is painted white. The cistern was assessed in good condition in 2006 for the LCS.

FIGURE 98. View north toward the Schoolhouse cistern.

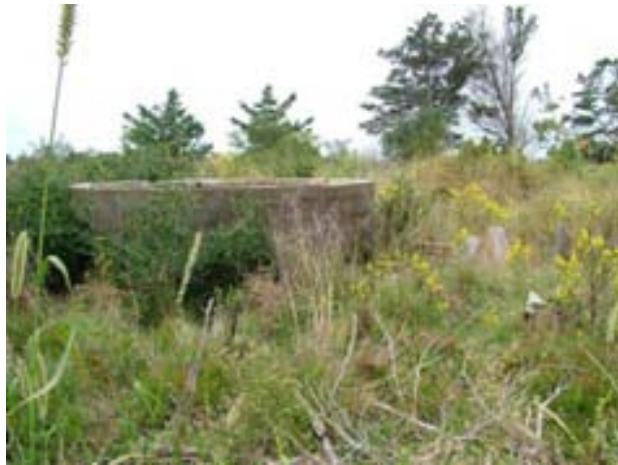
Keller cistern. In close proximity to the Keller-Styron Cemetery there are two round cisterns once associated with the Ed Keller House, now in ruins. The concrete cistern is approximately three feet high and ten feet in diameter (Fig. 99). The brick cistern is slightly smaller. They are currently open to the air. These cisterns are exhibiting some signs of deterioration and are in fair condition.

FIGURE 99. The concrete cistern near the Keller-Styron Cemetery.
