Portsmouth Village Cultural Landscape Report

Cape Lookout National Seashore
Carteret County, North Carolina

Cultural Landscape Report

December 2007

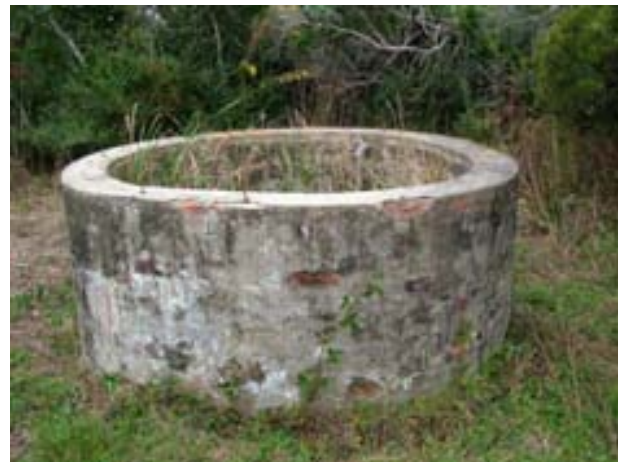
FIGURE 100. The Mattie Gilgo site cistern.

Mattie Gilgo site cistern. The cistern associated with the Mattie Gilgo site is a circular parged brick structure, similar to those located near the Keller-Styron Cemetery (Fig. 100). Approximately three feet tall and ten feet in diameter, the cistern is open to the air, and there are plants growing inside. It is exhibiting some signs of deterioration such as efflorescence, chipping of the mortar slurry that covers the brick and biological growth. It is in fair condition.

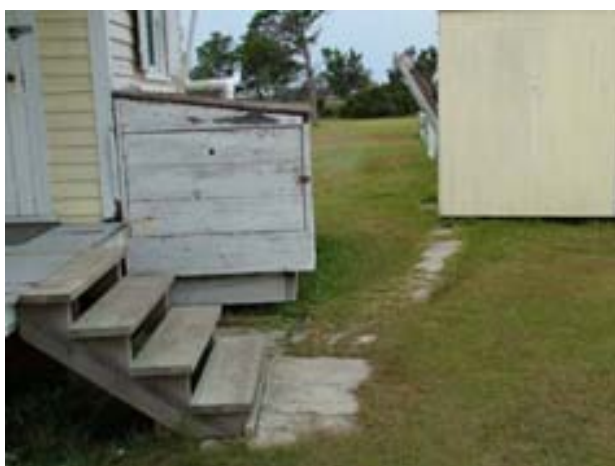
Jesse Babb water box. Similar to the McWilliams-Dixon House, the Jesse Babb House has a wooden water box that is connected to the roof gutters (Fig. 101). It is located adjacent to the rear facade of the building. This water box appears to be in relatively good condition.

FIGURE 101. The Jesse Babb water box is attached to the side of the house.

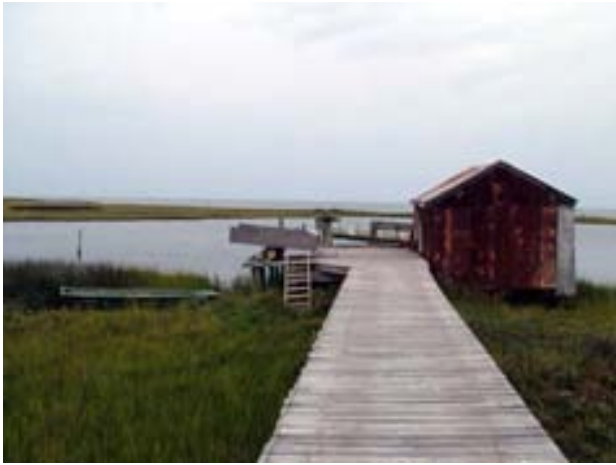
FIGURE 104. View northwest of the dock and boardwalk behind the Styron-Bragg House.

There is also a dock and boardwalk complex behind the Styron-Bragg House (Fig. 104) that appears to be in good condition except for one damaged section. Additionally, a dock extends into Doctor's Creek behind the Henry Pigott House (Fig. 105). This dock appears to be in good condition.

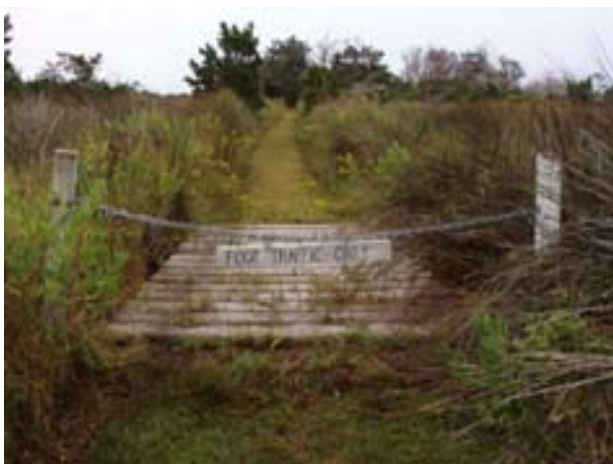
FIGURE 107. View northeast of the wooden bridge along the Old Straight Road.

Wooden bridge along Old Straight Road. A wood plank bridge is located along the Old Straight Road to provide access across a wet area (Fig. 107). This bridge has grass growth through its plank surface but appears to be in relatively good condition.

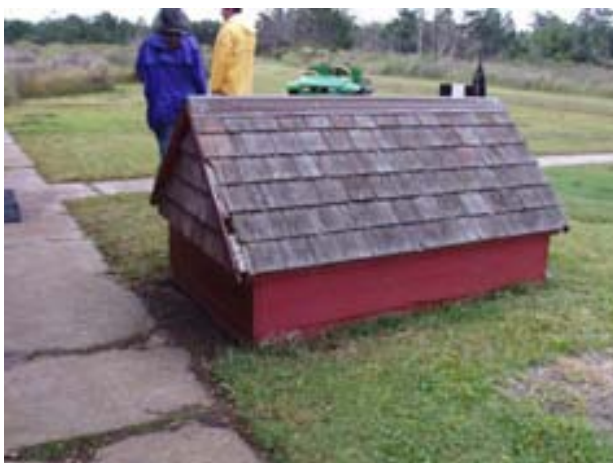
FIGURE 108. The pump house near the Portsmouth Life-Saving Station.

This small structure, set in the ground adjacent to one of the concrete walks near the Life-Saving Station, is composed of a concrete block base with a wood shingle gable roof (Fig. 108). The pump house is approximately eight feet long, three feet wide, and four feet tall. It appears to be in good condition,

although some of the shingles are in need of repair or replacement.

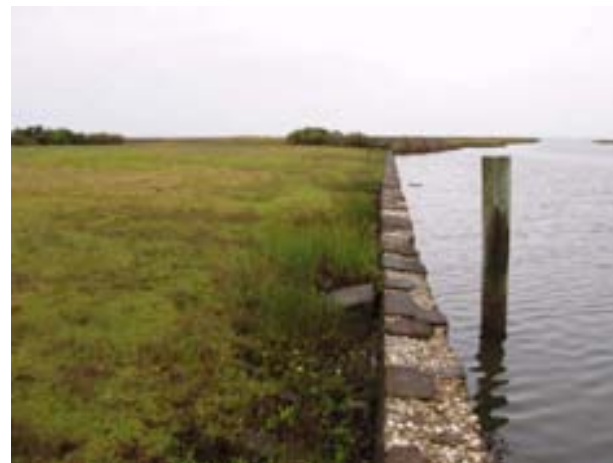
FIGURE 110. View along the concrete seawall and wooden mooring posts in Coast Guard Creek at the Portsmouth Life-Saving Station.

of the wall have become embedded in marshland and silt. The ramps are evidencing some deterioration and are in fair condition. There is vegetative growth in some of the control joints and chipping of the concrete. The seawall is also evidencing some cracking and chipping.

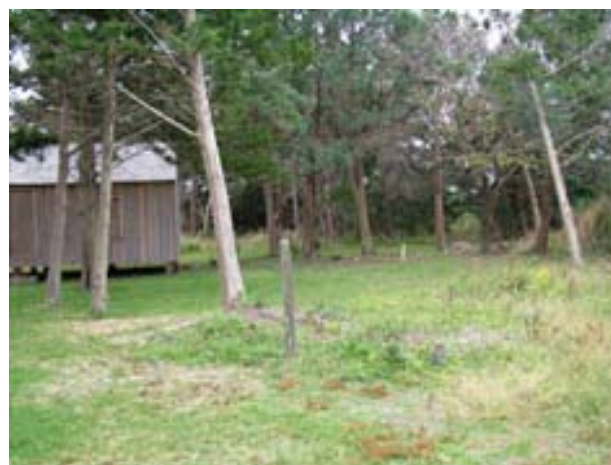
FIGURE 117. A remnant fence post west of the Washington Roberts House.

Remnant fence posts west of Washington Roberts House. Simple wood fence posts are also present near the house (Fig. 117). These posts are also remnants of an incomplete system that is in poor condition.

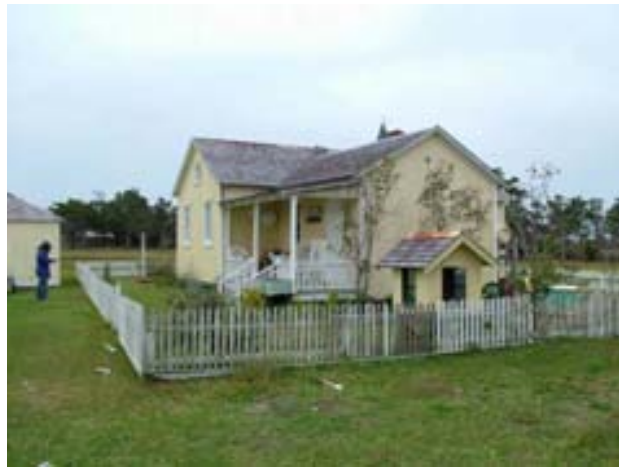
FIGURE 118. The picket fence around the McWilliams-Dixon House precinct.

Picket fence around McWilliams-Dixon House precinct, four gates. This fence is similar to other picket fences within the district (Fig. 118). The fence is badly in need of paint, but otherwise appears to be in good to fair condition.

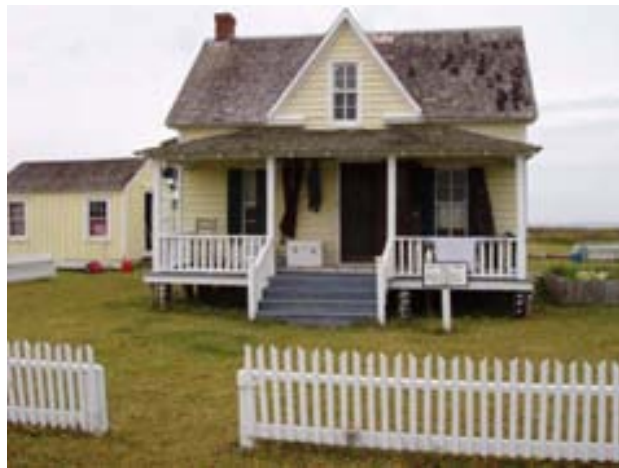
FIGURE 119. The picket fence around the Henry Pigott House precinct.

Picket fence with missing gate around Henry Pigott House precinct. This fence is similar to other picket fences within the district (Fig. 119). The fence is generally in good condition but is missing the front gate and some sections in the rear and is thus rated in fair condition.

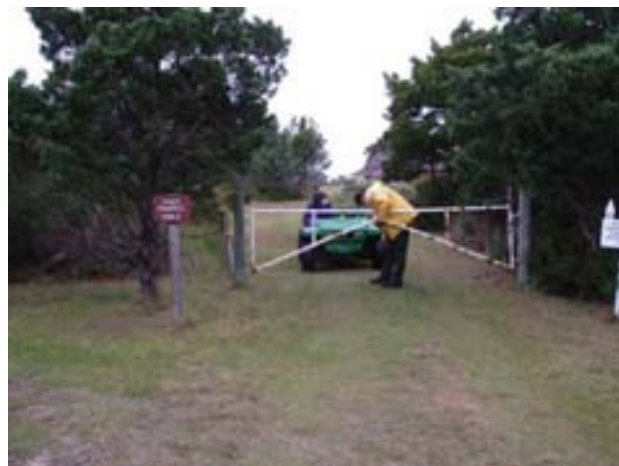
FIGURE 120. A metal gate and wood posts limit vehicular access to the village from the Road to the Beach.

Metal gate and wood posts limiting vehicular access to the village from the Road to the Beach. A metal gate hung on wood posts limits vehicular access to the historic district from the beach (Fig. 120). Wood posts with chains are set to the sides of the posts, providing a structure to support the gate when it is open and a means for securing it. This gate system is in good condition.

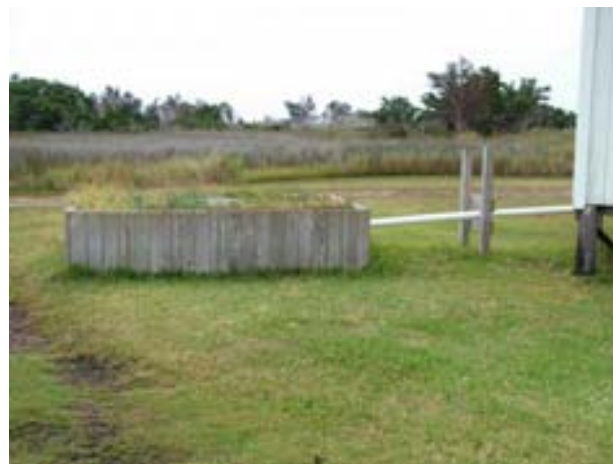
FIGURE 123. An above-ground septic tank at the T. T. Potter House.

Above-ground septic tank and wooden enclosure, T. T. Potter House. This septic system is similar to the Styron-Bragg cistern described above (Fig. 123). A long section of white PVC pipe leads from the house into the tank. This feature appears to be in good condition.

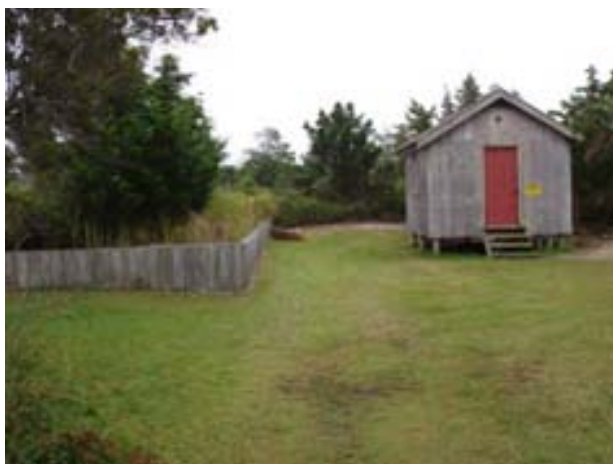
Septic leach field near airstrip. A large wood retaining wall is located near the generator shed associated with the Portsmouth Life-Saving Station (Fig. 122). The wall retains a raised soil area approximately 3-1/2 feet high used as a septic leach field. This feature appears to be in good condition.

FIGURE 122. The septic leach field shown at left is near the airstrip.

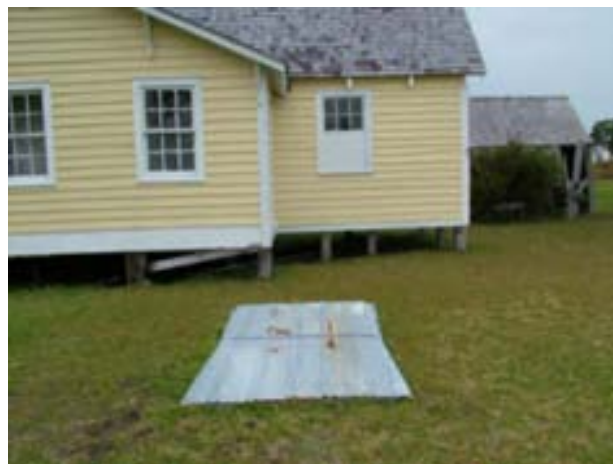
FIGURE 124. The Dennis Mason septic tank.

Dennis Mason septic box. A metal covering in the lawn adjacent to the Dennis Mason House suggests that there is an underground septic tank present (Fig. 124). This metal cover appears to be in good condition, although there is rust in evidence that should be treated and painted.

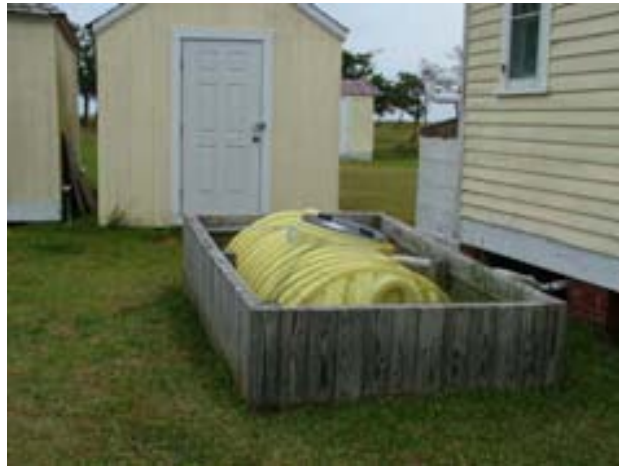
Septic tank and wooden enclosure, Jesse Babb House. This septic tank (Fig. 125) is similar to those described above. This feature appears to be in good condition.

FIGURE 125. An above-ground septic tank and wooden enclosure at the Jesse Babb House.

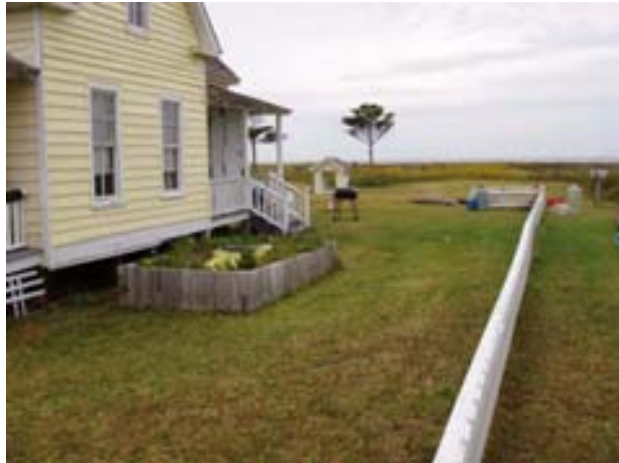
Septic tank and wooden enclosure, Henry Pigott House. This septic tank (Fig. 126) is similar to those described above. This feature appears to be in good condition.

FIGURE 126. An above-ground septic tank and wooden enclosure at the Henry Pigott House.

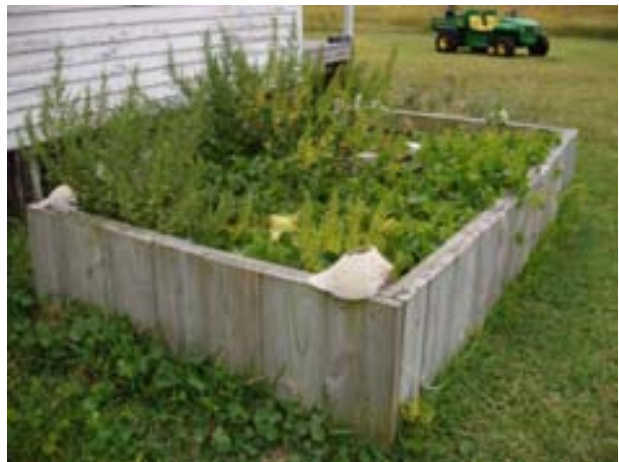
Septic tank and wooden enclosure, Carl Dixon House. This septic tank (Fig. 127) is similar to those described above. This feature appears to be in good condition.

FIGURE 127. An above-ground septic tank and wooden enclosure at the Carl Dixon House.

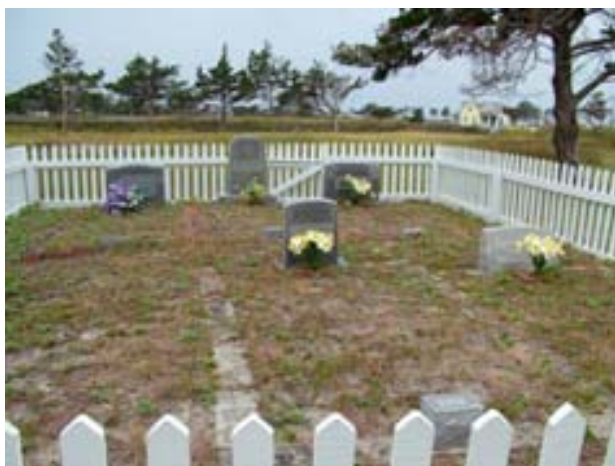
FIGURE 128. The Babb-Dixon Cemetery.

west of the McWilliams-Dixon House. This family cemetery includes seven burials. Three of the burials are set within brick-edged rectangular precincts, and two are set within concrete block precincts. The precincts also include granite headstones and footstones, and some are marked with silk flowers. The dates of the interments range from 1945 to 1971. Two of the burials are the tiny graves of pet parakeets. The features of the cemetery were listed in good condition on the 2006 LCS.

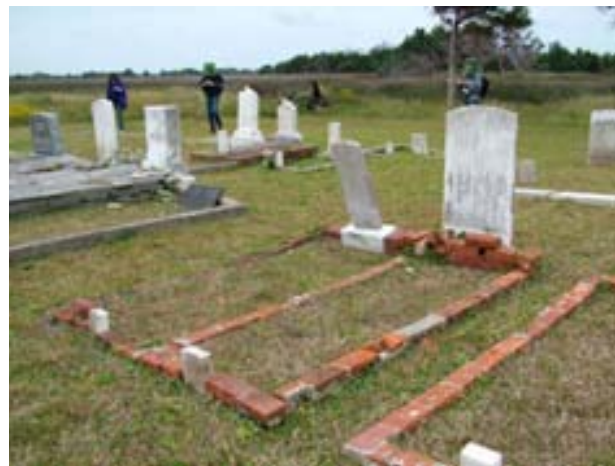
FIGURE 130. Many of the burials at the Community Cemetery are surrounded by brick edging.

At least two graves are unmarked. Most headstones are accompanied by footstones. Some of the burial plots are covered with a thin concrete vault cover. Many of the graves are grouped together in linear arrangements edged by concrete and/or brick bands (Fig. 130). There are also individual graves. Conditions observed at the cemetery include weathered headstones, broken and leaning headstones, cracked and displaced edging, missing or dislodged brick edging, and broken and cracked

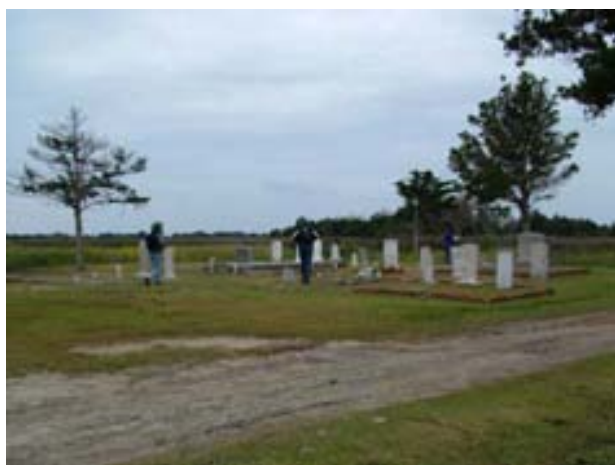
FIGURE 129. The Community Cemetery.

concrete vault covers (Fig. 131). The general condition of the cemetery as assessed in 1998 by the LCS is fair.

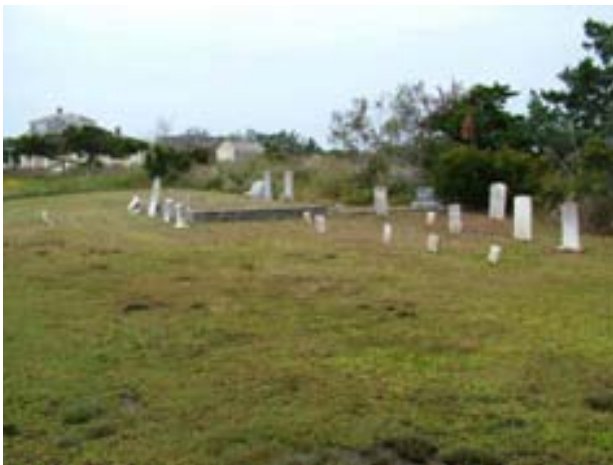
FIGURE 132. The Portsmouth Cemetery.

(Fig. 132). There is no surrounding fence. Some of the burials are grouped together and surrounded by concrete-block edging, two blocks high (Fig. 133). The burials date between 1889 and 1960. Conditions observed at the cemetery include broken, leaning, eroded headstones. The cemetery is in fair to poor condition (Fig. 134).

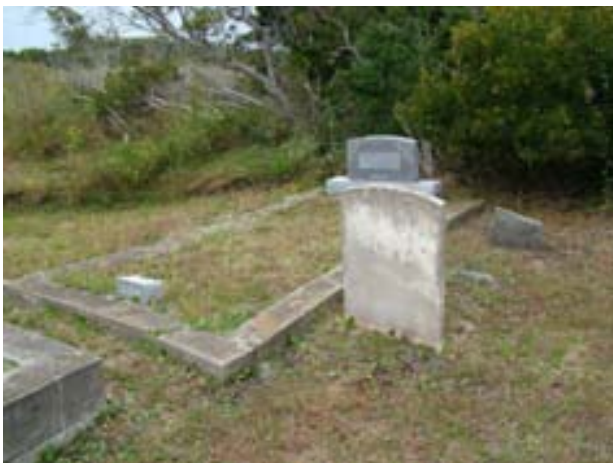
FIGURE 133. Some of the burials are surrounded by concrete block outlines.

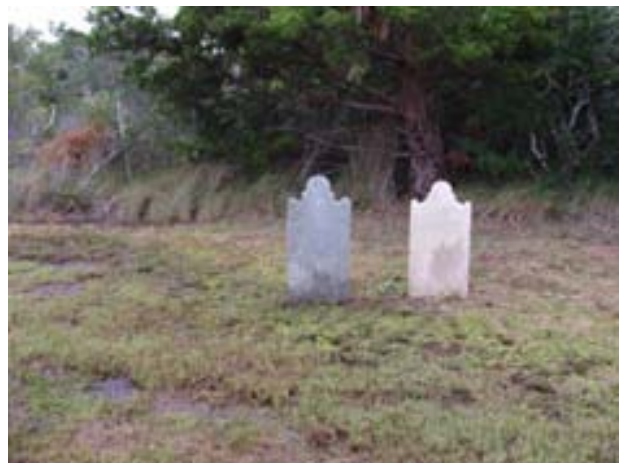
FIGURE 135. The headstones of the Two Seamen's Graves.

Two Seamen's Graves. The headstones associated with Two Seamen's Graves are relatively large and ornate in comparison with others within the district (Fig. 135). They include detailed funerary carvings. These gravestones appear to be in fair condition due to deterioration of the inscriptions.

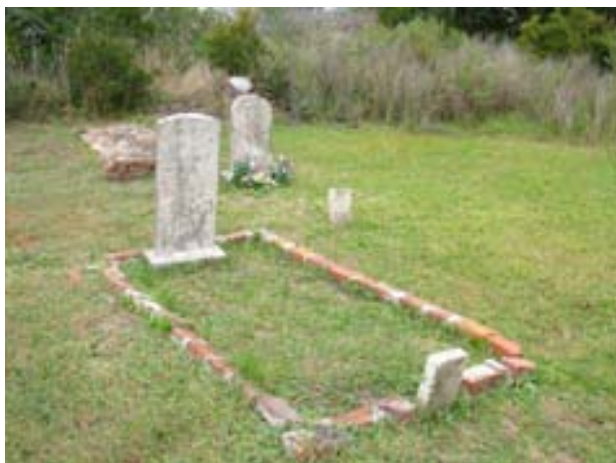
FIGURE 136. The Keller-Styron Cemetery.

graves. The burials date between 1866 and 1932. The headstones are marble and granite. There are a few footstones. One grave is outlined in a single row of mortared brick.

Some of the headstones are eroding. The brick outline is losing some of the bricks. Some of the headstones are broken, others are leaning. The cemetery is in fair to poor condition.

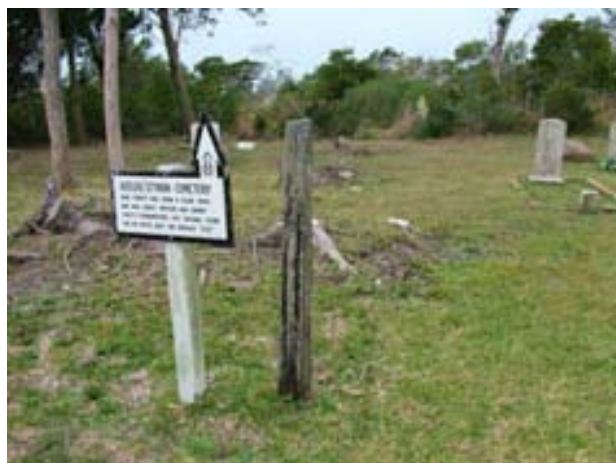
FIGURE 137. Remnant fence post at the Keller-Styron Cemetery.

Fence posts at Keller-Styron Cemetery. Several 4-inch by 4-inch wood posts mark the extent of a fence system that once enclosed the Keller-Styron Cemetery (Fig. 137). The fenced precinct appears to have formed a rectangle forty-two-and-one-half feet by fifty-seven feet in size. Remnants of wire remain attached to the posts, suggesting that the fence was used to limit access by livestock. The fence is in poor condition.

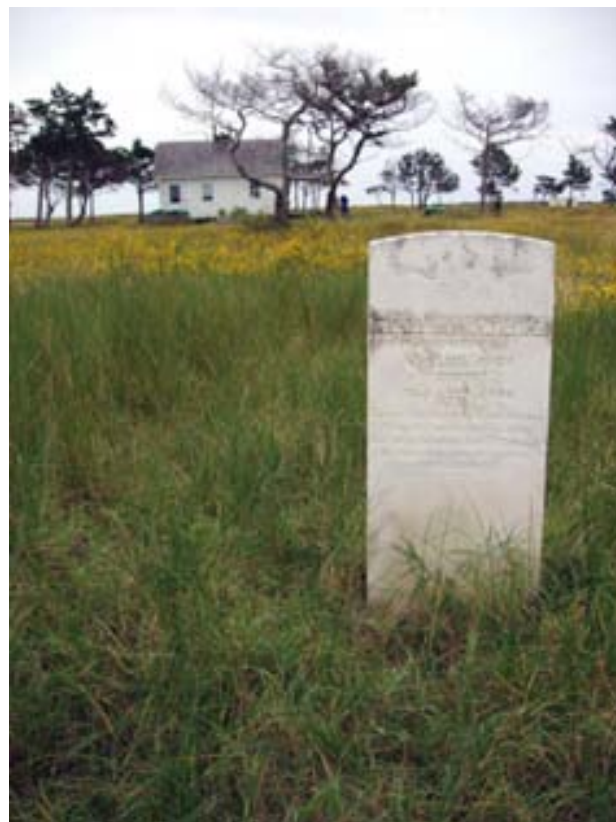
FIGURE 138. The Elijah Gaskill headstone.

Elijah Gaskill headstone. A single marble headstone marks the grave of Elijah Gaskill (Fig. 138). The grave is located near the Carl Dixon House. The headstone is in fair condition.

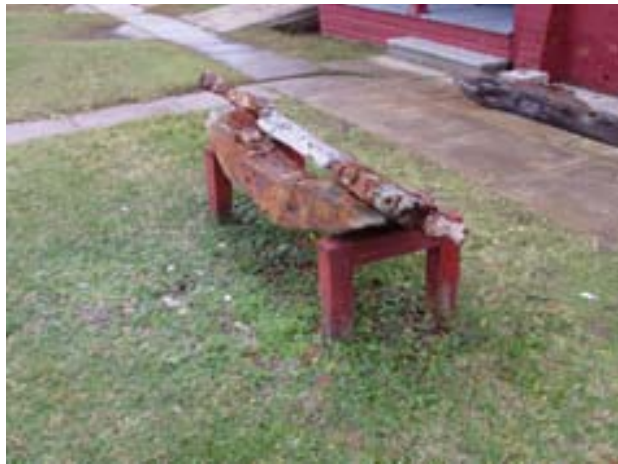
FIGURE 143. A shipwreck relic displayed near the Portsmouth Life-Saving Station.

Wood boat relic, mounted for display near the Portsmouth Life-Saving Station. To the west of the Life-Saving Station building are artifacts associated with a boat wreck (Fig. 143). The remains are bolted to two wood posts. The exhibit is in good condition.

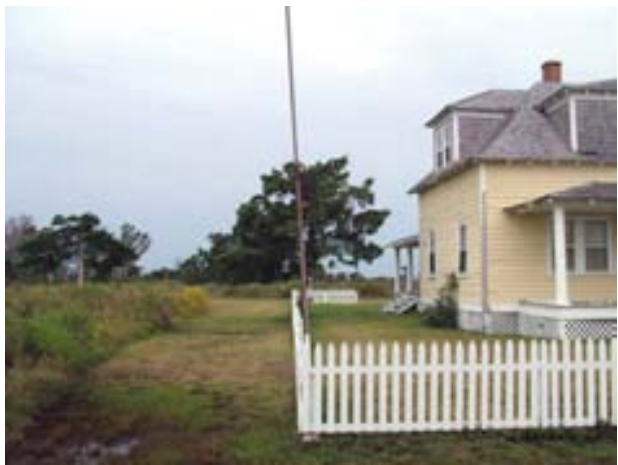
FIGURE 144. There is a flagpole within the Styron-Bragg House precinct.

Flagpole at Styron-Bragg House. At the corner of the picket fencing surrounding the Styron-Bragg House precinct is a metal flagpole that no longer includes flag-raising hardware (Fig. 144). The flagpole is rusted and is in fair condition.

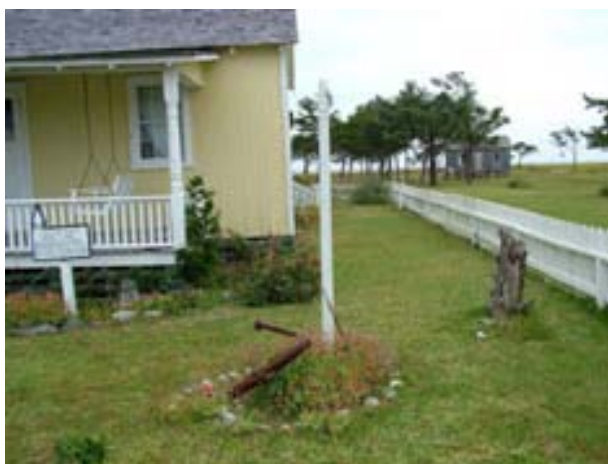
FIGURE 148. The yard in front of the McWilliams-Dixon House includes a rock-lined planting bed decorated with an anchor and a pole.

Metal pole and anchor set within a circular planting bed, McWilliams-Dixon House. A decorative feature in the front yard of the McWilliams-Dixon House is a circular planting bed edged with small round rocks, inset with a metal anchor, and a five foot tall wood pole (Fig. 148). It is not clear what function the pole serves. These features appear to be in good condition.

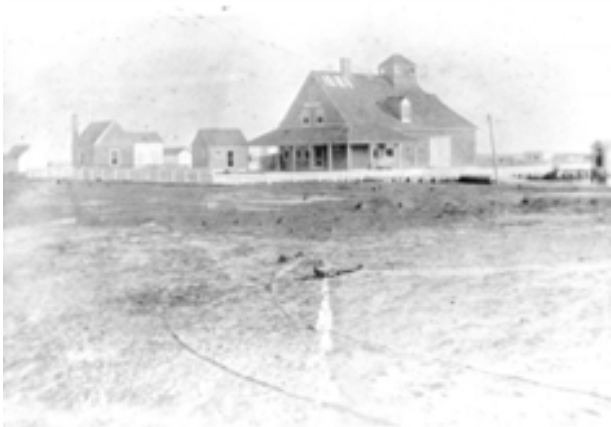
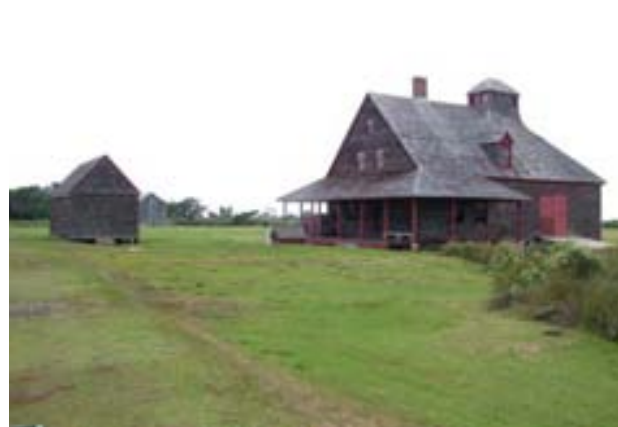
FIGURE 157A. Looking north toward the Portsmouth Life-Saving Station complex, circa 1920s.

FIGURE 157B. The same view in 2006 illustrating the loss of various buildings, such as, from left to right, the carriage or cart house, boathouse, oil house, and privy (far right), as well as the board fencing around the station precinct. The summer kitchen and stables survive.

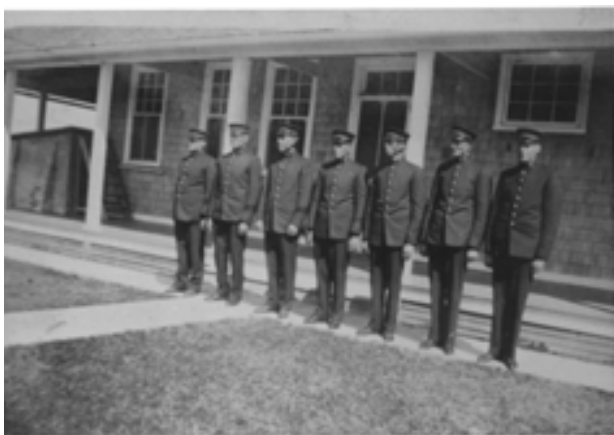
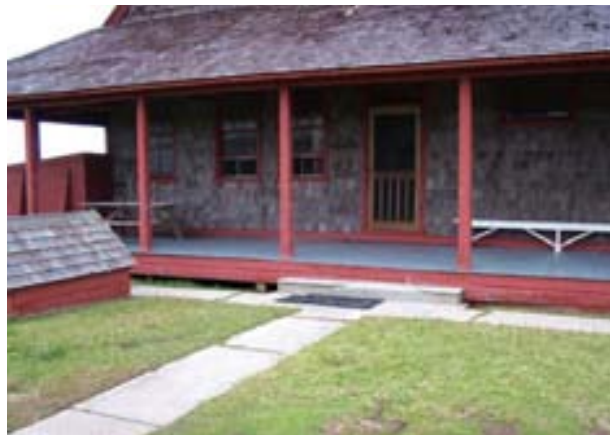
FIGURE 158A. A Coast Guard crew stands in front of the southeast porch of the Portsmouth Life-Saving Station, circa 1920s.

FIGURE 158B. The same view today. Note the addition of the pump house. Most of the other features remain remarkably similar.

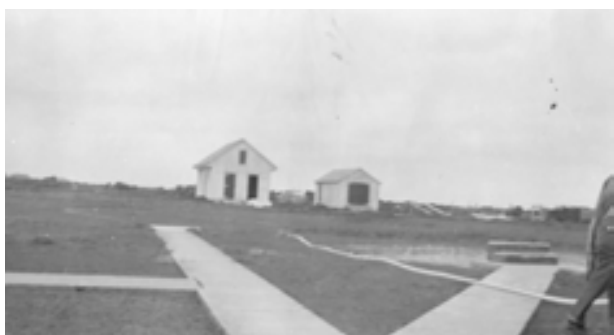
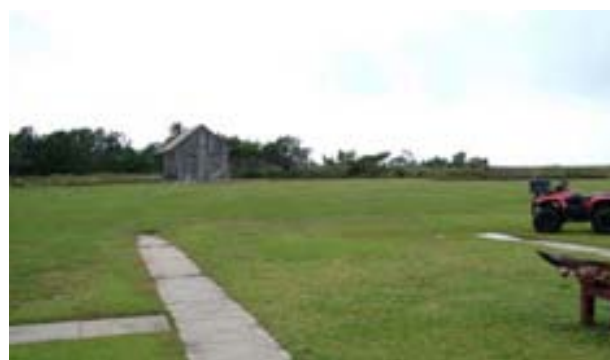
FIGURE 159A. Looking northwest toward the stable from the western corner of the Portsmouth Life-Saving Station, circa 1935.

FIGURE 159B. The same view in 2006. The paths and the stable remain relatively similar, but the shed that once sat to the right of the stables is no longer extant. There is much more vegetation in the vicinity of the complex today than during the period of significance. A portion of the concrete walk above has been lost since the earlier photograph.

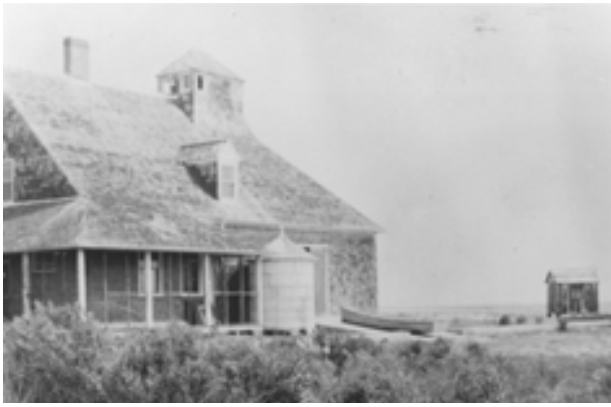
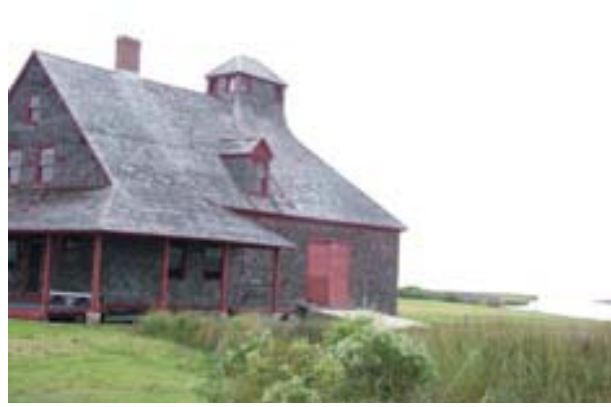
FIGURE 160A. View toward the southeast side of the Portsmouth Life-Saving Station, circa 1942.

FIGURE 160B. The same view in 2006. Changes apparent in the contemporary photo include the loss of a water tank near the ramp, and a small shed to the right of the station. This building is one of ten surviving examples of numerous Quonochontuag-style stations built during the late nineteenth/early twentieth centuries.

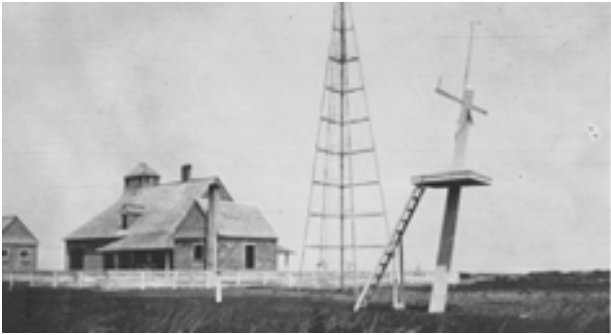
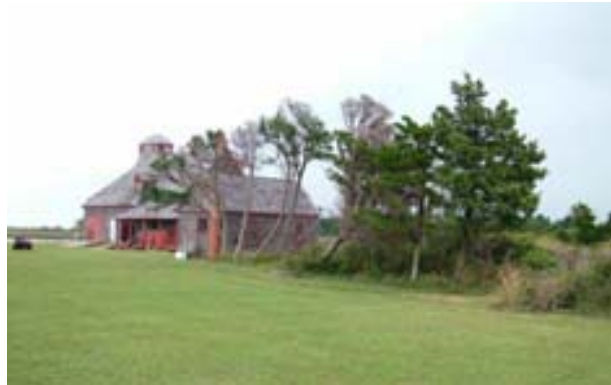
FIGURE 161A. Looking east toward the Portsmouth Life-Saving Station and kitchen, including the station's wreck pole, coastal warning display tower, and oil house, circa 1916. Wood board fencing enclosed the complex.

FIGURE 161B. The same view in 2006 indicating the loss of the wreck pole, warning tower, board fencing, and oil house. There is more vegetation within the vicinity today than during the period of significance.

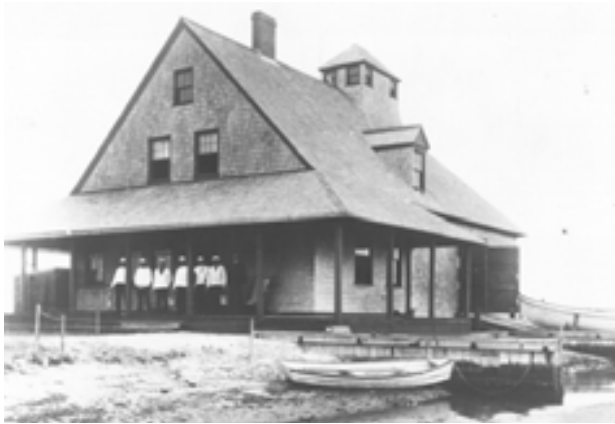
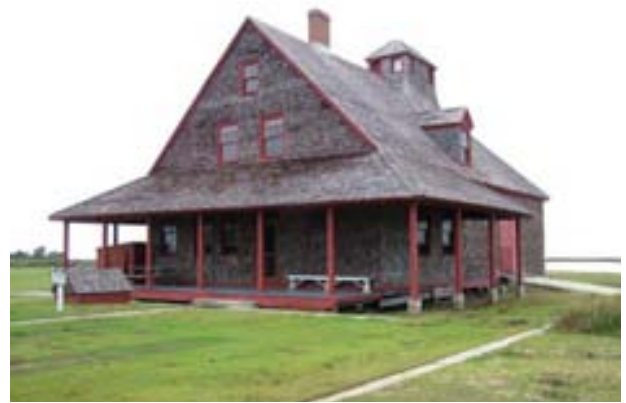
FIGURE 162A. Looking north toward the Portsmouth Life-Saving Station. The Coast Guard crew stands on the southeast porch, circa 1903–1915.

FIGURE 162B. The same view in 2006, indicating the filling of Coast Guard Creek that has occurred.

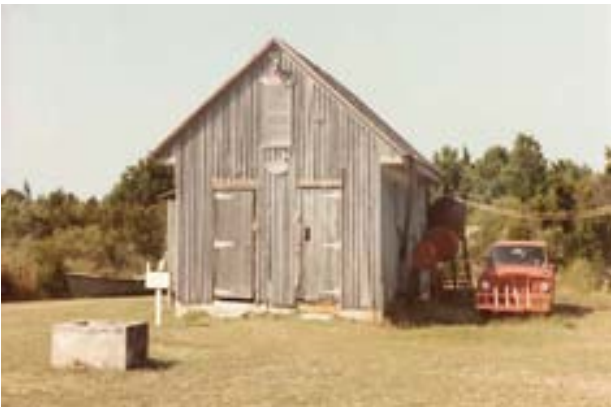
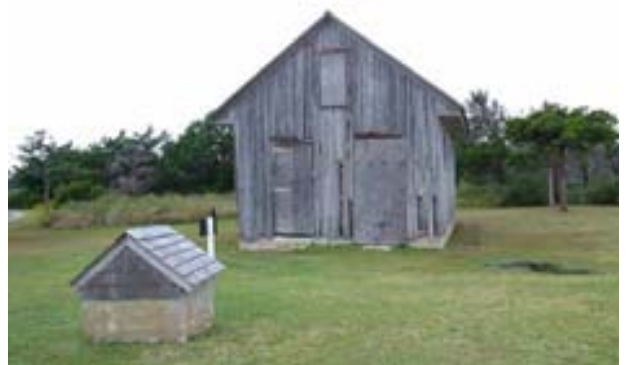
FIGURE 163A. The Portsmouth Life-Saving Station stable looking west toward Portsmouth Village, circa 1983.

FIGURE 163B. The same view in 2006, showing that the well house has been covered with a small wood roof.

Ophelia in 2005. The LCS prepared in 2006 noted damage from Hurricane Ophelia in 2005 to exterior siding, sills, and wall framing, and the need for repair of three windows and doors at this building.

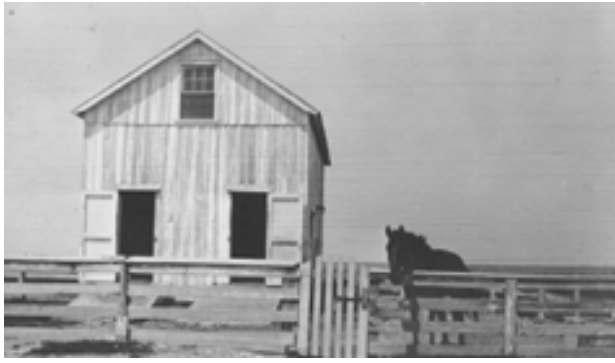
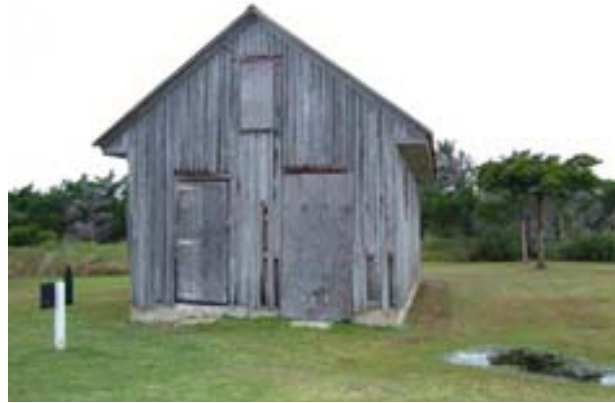
FIGURE 164A. Looking west toward the Portsmouth Life-Saving Station Stable, circa 1916.

FIGURE 164B. The same view in 2006 showing the 1928 stable built in the same location as previous stables. This view illustrates the loss of the four-board fencing associated with the use of the building as an active stable for horses.

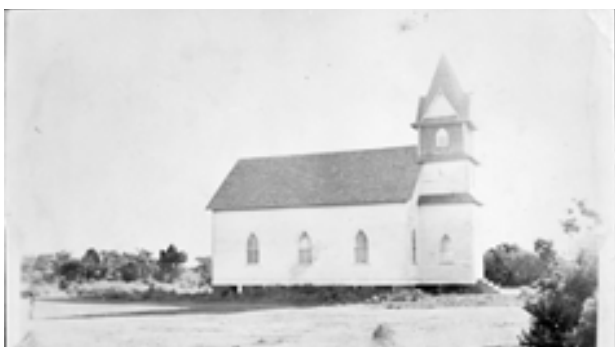
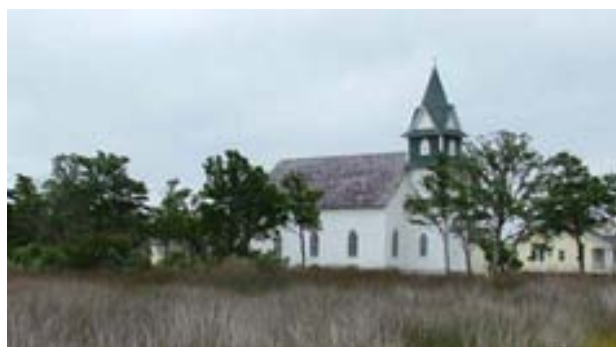
Portsmouth Methodist Church. This structure is also known as the Methodist Episcopal Church (Fig. 165 through Fig. 167). The original Methodist Church, established on the island as early as 1840 on land acquired from Dr. Samuel Dudley, was destroyed in a storm in 1913. The location of the original church is not currently known, although it is possible the existing church occupies the same site. The current church building was completed to replace the earlier structure by 1915. This wood building survives today and occasionally hosts services and ceremonies; services became irregular after 1950. The building is listing towards the southeast, causing separation of some of the window frames from the interior walls.

FIGURE 165A. Looking east toward the Portsmouth Methodist Church, circa 1946.

FIGURE 165B. The same view in 2006 illustrates the differences in vegetation that have occurred in the vicinity of the church.

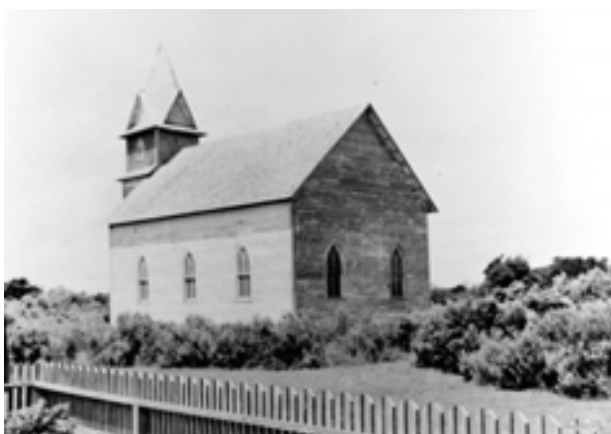
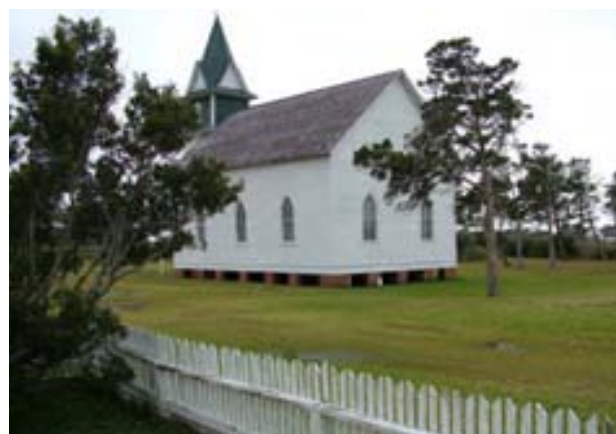
FIGURE 166A. Looking southwest toward the Portsmouth Methodist Church from the yard of the McWilliams-Dixon House, circa 1950s.

FIGURE 166B. The same view in 2006. Note the loss of shrubby vegetation around the church today, and the increase in trees.

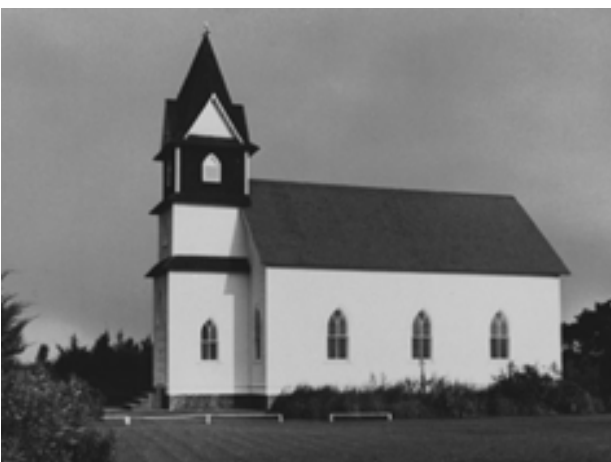
FIGURE 167A. Looking northwest toward the Portsmouth Methodist Church, date unknown.

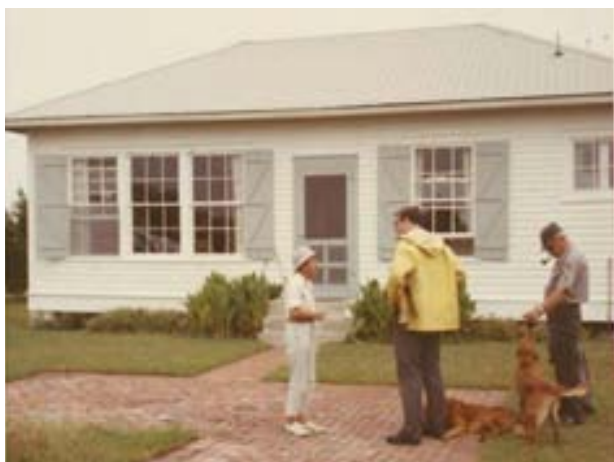
Schoolhouse. The Schoolhouse was constructed near the Old Straight Road circa 1910. It survives today and contributes to the historic district (Fig. 168 through Fig. 170). It may have replaced at least one, and possibly two, earlier schools on the island. A historic map from the early nineteenth century, references one of these as “the academy.” The other appears to have been located outside of the historic district closer to the Middle Community, according to local resident Chester Lynn (see Appendix A). The existing school closed in 1943. Its original entrance door, located on the end of the building adjacent to the cistern, was removed to accommodate rehabilitation of the building as a residence at some time between 1943 and NPS

FIGURE 168A. The north facade of the Schoolhouse, circa 1969.

acquisition of the structure in the mid-1970s. This building is currently vacant. A funding request was submitted for 2008 to restore the Schoolhouse, including leveling, reinforcing, and repair of walls, and repair or replacement of the roof, windows, and doors. Two outbuildings survive in association with the Schoolhouse: the cistern and a shed. A privy mentioned in the National Register nomination is no longer present.

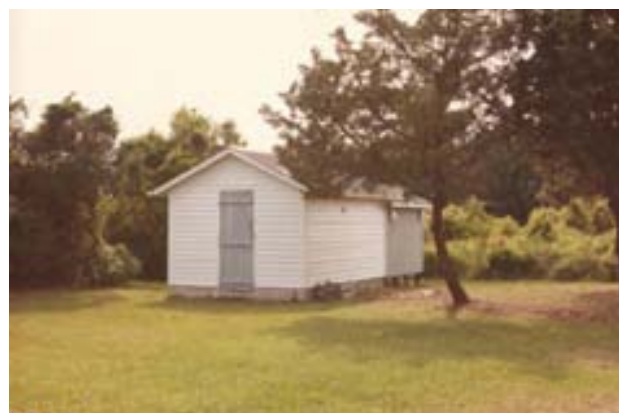
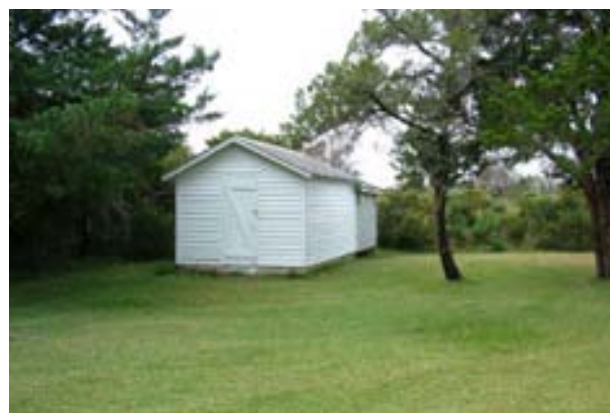
FIGURE 169A. The Schoolhouse shed, circa 1979.

FIGURE 169B. The same view in 2006. Although the door appears to have been replaced and the roof reshingled, the shed looks very similar today.

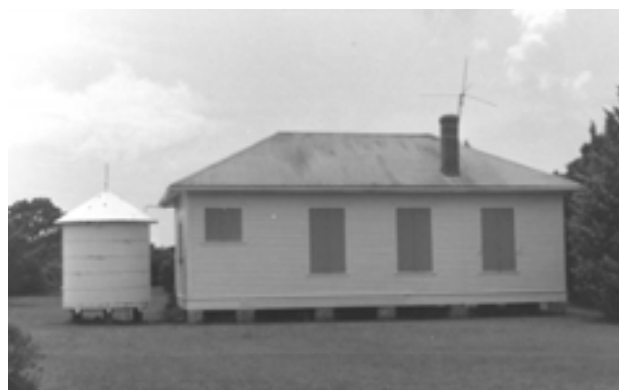
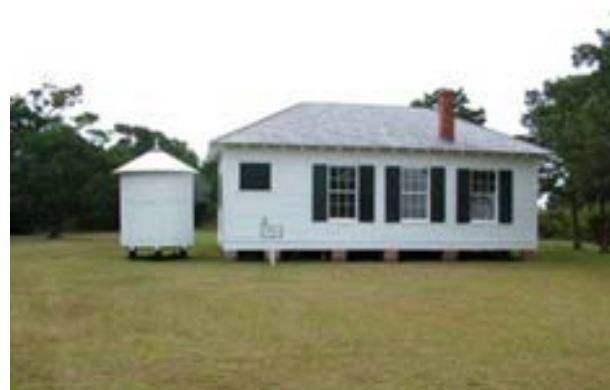
FIGURE 170A. Looking south toward the Schoolhouse and cistern, date unknown.

FIGURE 170B. The same view in 2006. Note that the windows are no longer boarded up and the antenna has been removed. Otherwise these features look very similar today.

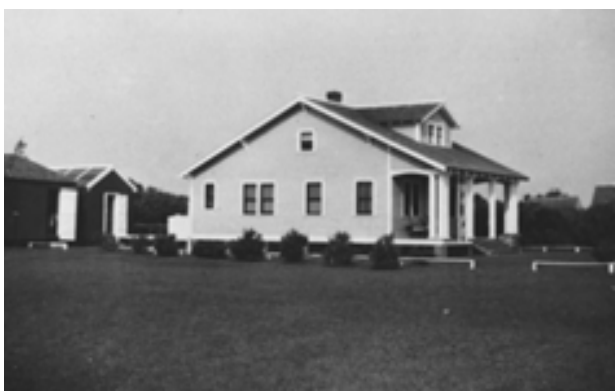
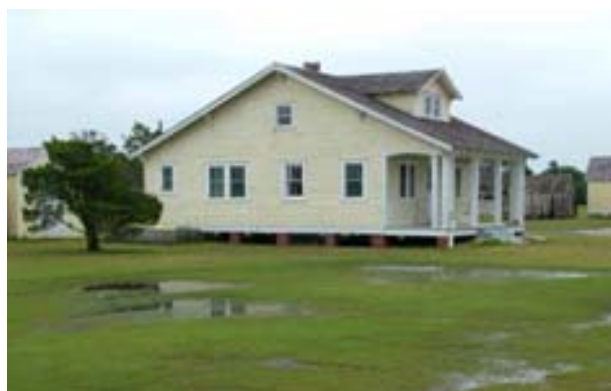
Jesse Babb House. This structure is also known as the Marion Gray Babb House (Fig. 171 and Fig. 172). The house was built circa 1935 by a cook and machinist employed at the Coast Guard Station. It is currently occupied through the historic leasing program. The septic tank was replaced in 2004. A barn associated with the property was recently lost to storm-related flooding. Its former location is marked by a scatter of shells.

FIGURE 171A. Looking east toward the Jesse Babb House, circa 1950s.

FIGURE 171B. The same view in 2006. Changes to the property include the loss of the low fencing, similar to that shown at the church, and the loss of the plantings edging the fence. The septic tank has been added since the earlier photograph was taken.

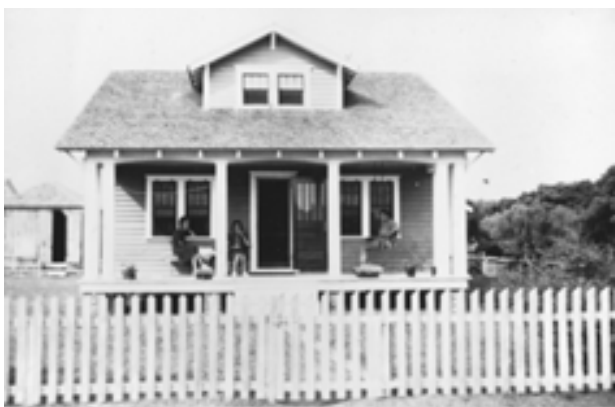
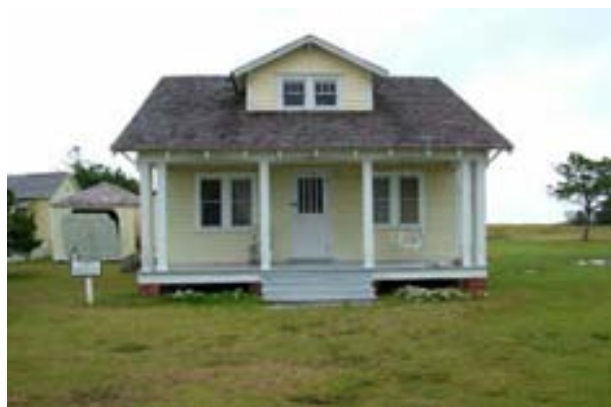
FIGURE 172A. Looking north toward the Jesse Babb House, circa 1940s.

FIGURE 172B. The Jesse Babb House is very similar today to its earlier appearance as shown left, although the picket fence is missing. Note also the loss of vegetation behind the house.

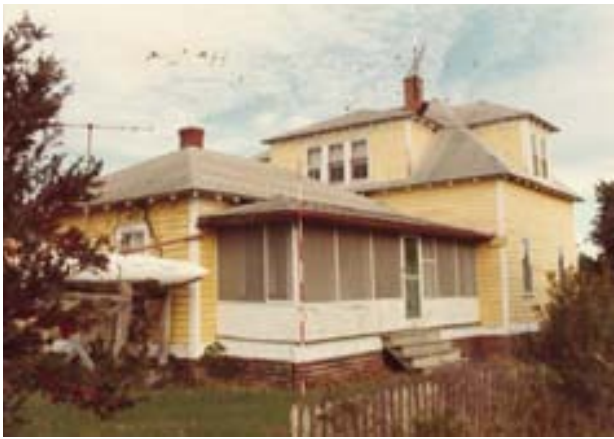
FIGURE 173A. The Styron-Bragg House, circa 1979.

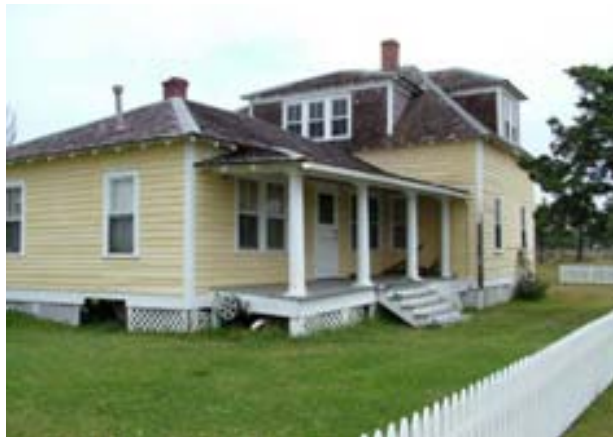
FIGURE 173B. The same view in 2006. Changes to the building include shingling of the dormers and removal of the screened porch. The picket fence has been painted white, and many of the trees are gone.

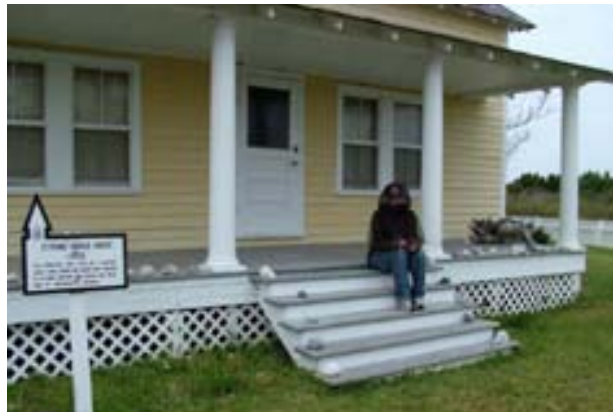
FIGURE 174B. The same view in 2006. Changes to the building include the removal of an air conditioning unit beneath the left-hand window, and the addition of new steps and lattice work under the porch.

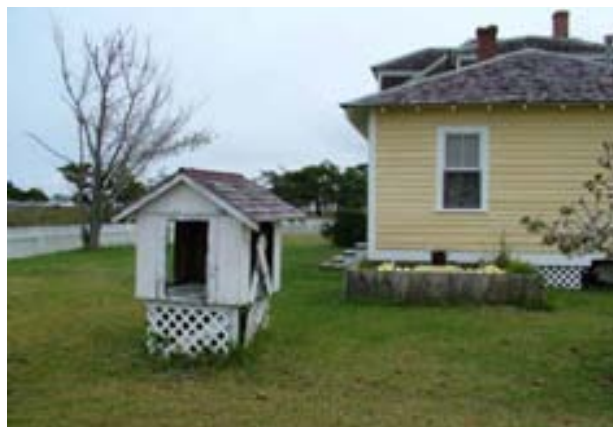
FIGURE 175B. The same view in 2006. Note the loss of the picket fence, as well as much of the vegetation around the house precinct.

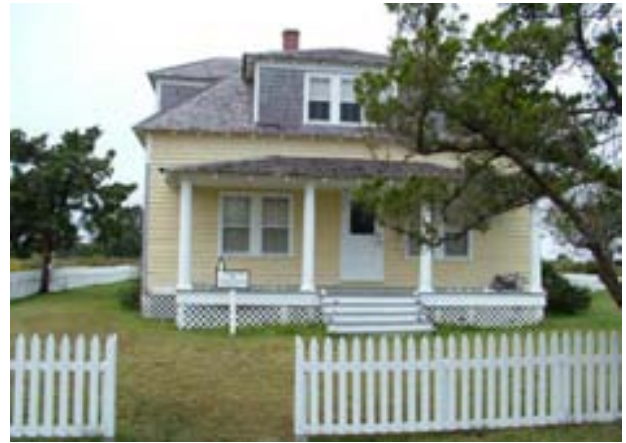
FIGURE 176B. The same view in 2006. Note the shingling of the second story, change in lattice under the porch, the addition of the picket fencing, and the loss of some

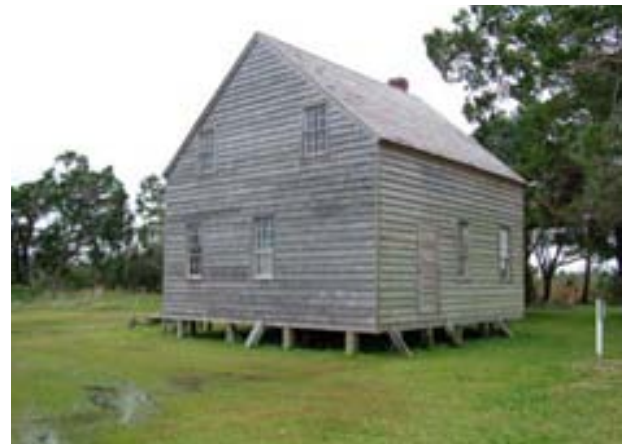
FIGURE 177B. The Washington Roberts House in 2006 is no longer boarded up. Many of the trees around the house have been lost, however.

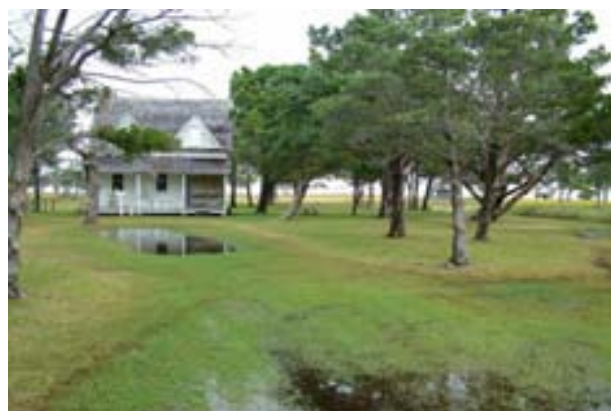
FIGURE 179B. The same view in 2006, illustrating changes in vegetation, and the loss of the long building extension (kitchen wing) to the right of the Robert Wallace House.
