Portsmouth Village Cultural Landscape Report

Cape Lookout National Seashore
Carteret County, North Carolina

Cultural Landscape Report

December 2007

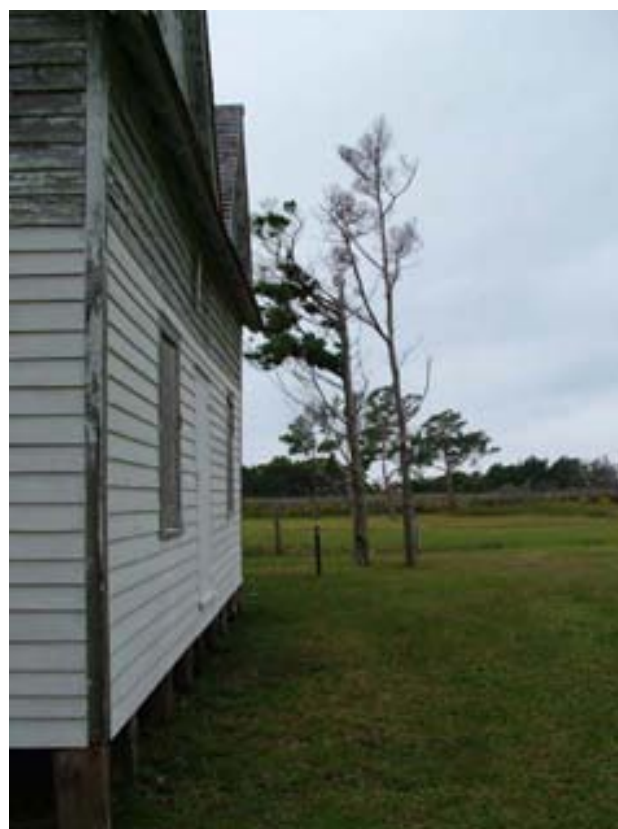
FIGURE 180B. The same view in 2006. The contemporary photograph illustrates changes in the building roof line, the loss of a step leading out of the building, and the dramatic loss of vegetation behind the house.

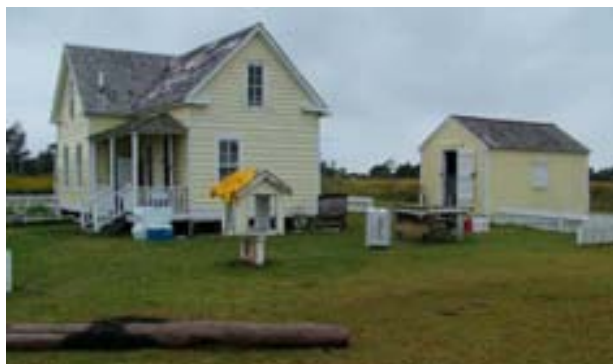
FIGURE 181B. The same view in 2006, illustrating changes to the property such as the loss of picket fencing in the rear, the chimney on the outbuilding, and the tree along the fence; deterioration of the Cool House; and replacement of the pink

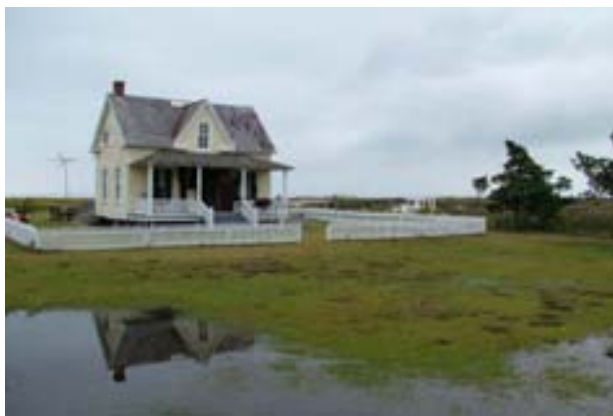
FIGURE 182B. The same view in 2006 illustrates that the property is much the same except for the exterior paint color, and the loss of the radio tower behind. NPS management of building precincts has led to a change in vegetative cover including replacement of warm-season grasses with cold-season grasses.

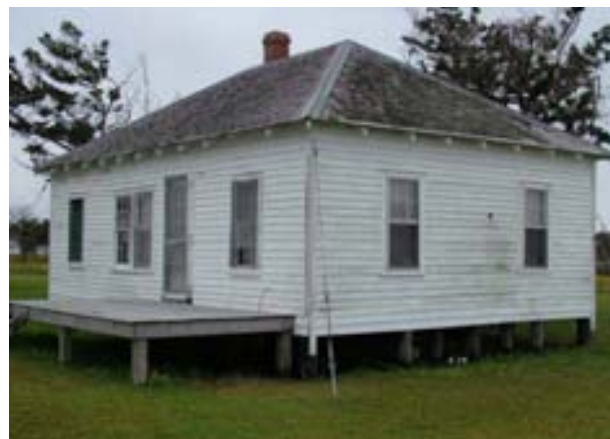
FIGURE 184B. The same view today. Note the loss of the roof overhang associated with the porch and the wood stair and landing along the side/rear of the house. The vegetation is now mown cool-season grass, whereas the earlier view suggests native warm-season grasses were present previously. Cabling is currently stabilizing the structure.

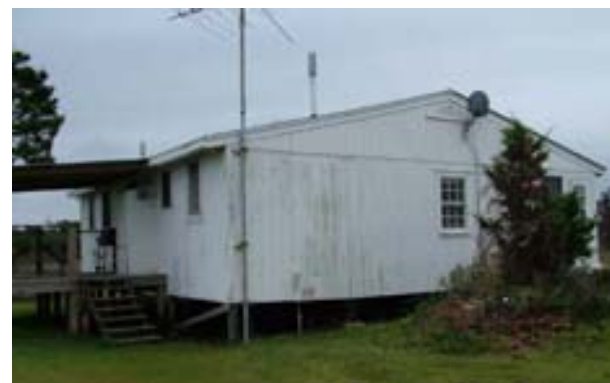
FIGURE 185B. The same view in 2006. Note the addition to the building along its rear facade, the removal of the screened porch, replacement of the siding, and the addition of a deck.

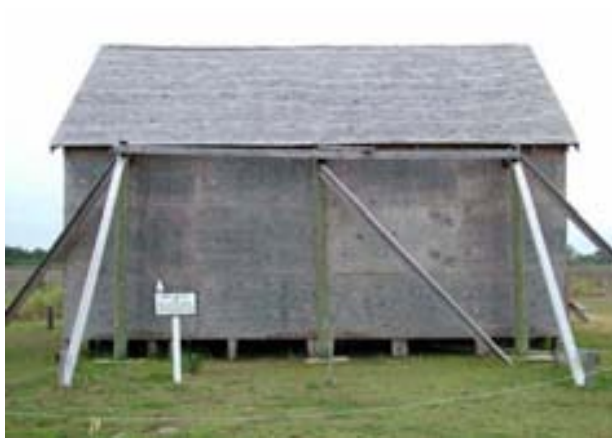
George Dixon House. The George Dixon House was constructed circa 1887.¹⁶⁴ It was severely damaged by the storm surge of Hurricane Isabel, and is currently in stabilized but in ruinous condition (Fig. 186). There is a wooden cistern present to the rear left of the dwelling. The 2004

FIGURE 186B. The George Dixon House in 2006 is mothballed following severe hurricane damage.

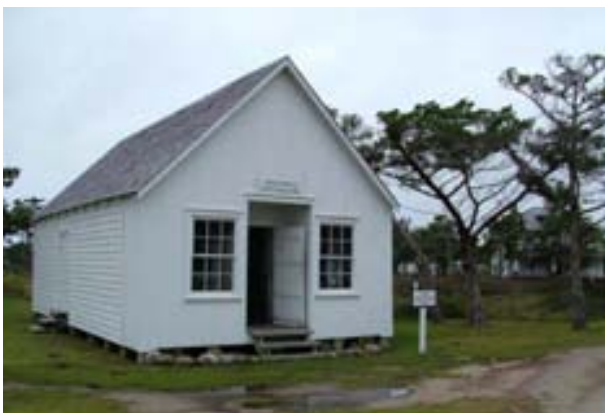
FIGURE 187B. The same view today. Changes since the 1930s include the loss of the addition, and removal of the porch and overhang. The vent pipe in the rear is also gone. The side door indicates the former connection between this building and the missing addition.

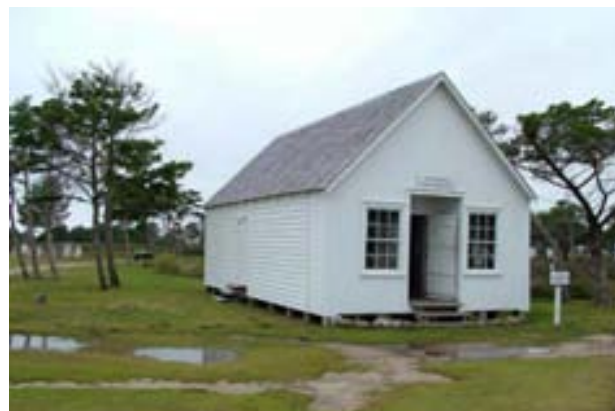
FIGURE 188B. The same view today. Changes since the 1930s include the loss of the addition, and removal of the porch and overhang. The vent pipe in the rear is also gone.

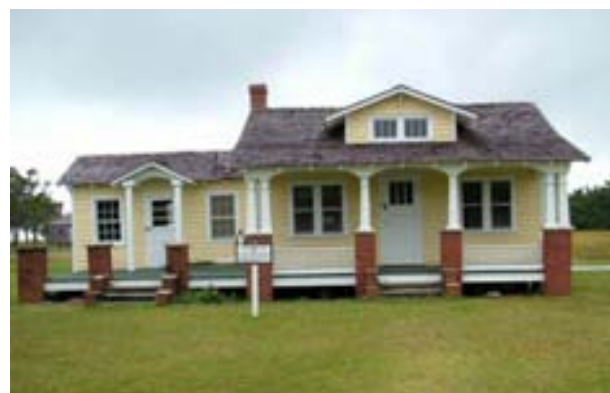
FIGURE 189B. The same view in 2006. Note the loss of the decorative trellis on the porch, the pickets along the side addition, the low fencing like that at the Babb House, and the change in mortar associated with the brick.

1920s. The house was restored in 1980–1985. Several capstones on the brick pillars on the front of the house have cracked or are missing material. One outbuilding is associated with the property.

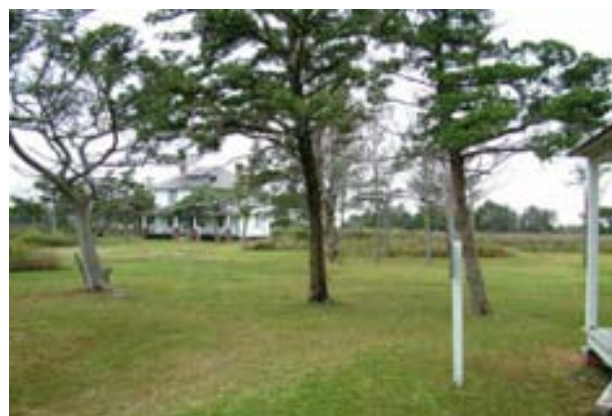
FIGURE 191B. The same view in 2006, illustrating the loss of the picket fence, growth of Eastern red cedar trees, and loss of shrubby growth between the two houses. An unidentified structure to the right is no longer present.

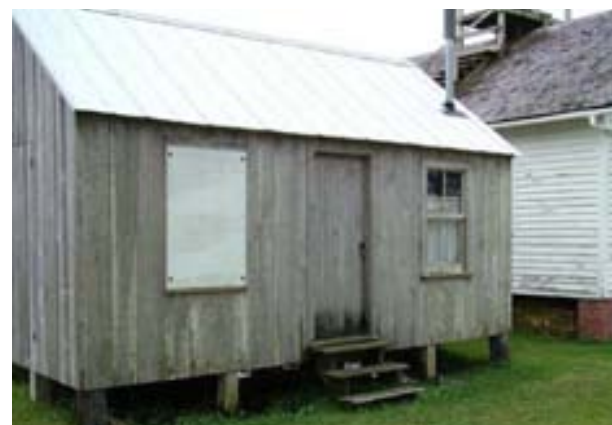
FIGURE 192B. The same shed in 2006. Changes visible between the photographs includes the boarded window, different cladding of the shed, the addition of a vent pipe, replacement of the door, addition of wooden steps, lack of paint, and the addition of the widow's walk to the roof of the adjacent Carl Dixon House.

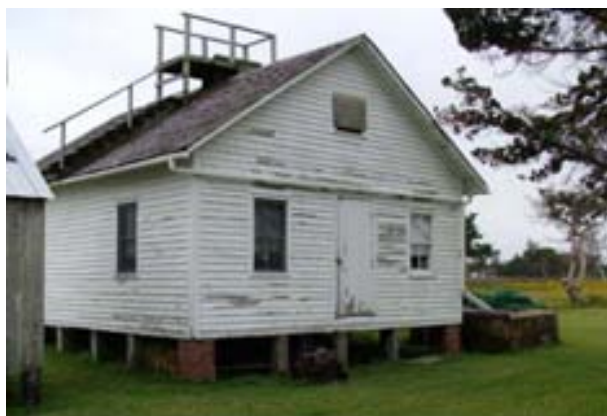
FIGURE 193B. The Carl Dixon House in 2006. Changes since 1979 include loss of the front porch, addition of the widow's walk, replacement of the roof, and a change in paint color.

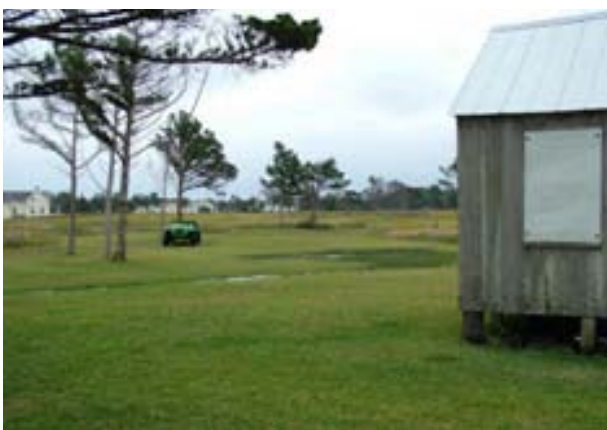
FIGURE 194B. The same view in 2006. Note the loss of the shed to the left of the existing outbuilding, as well as the dense vegetation behind.

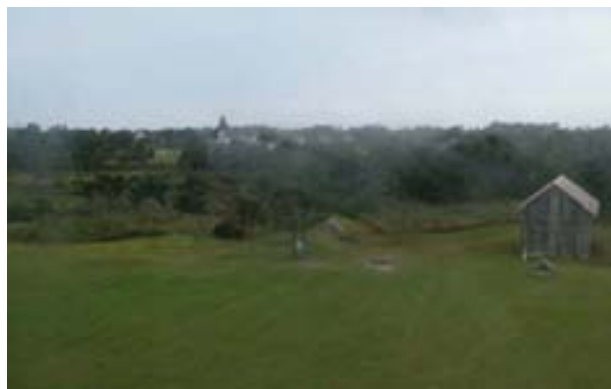
FIGURE 195B. The same view in 2006, indicating that there is more woody vegetation today that serves to obscure views present in earlier years between the two areas.

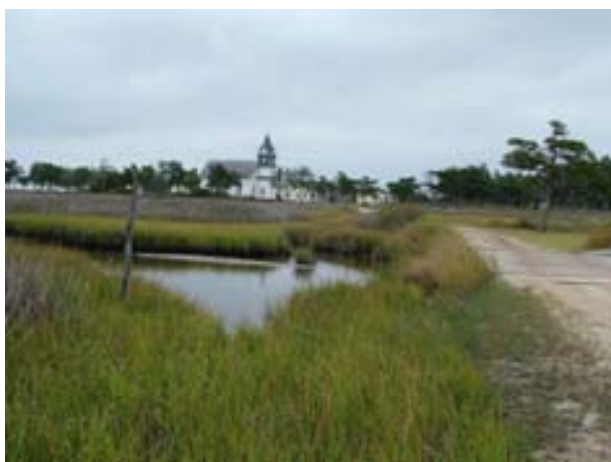
FIGURE 196B. The same view in 2006, which is very similar. A small dock or other type of structure visible at the edge of the water in the earlier photograph is no longer present.

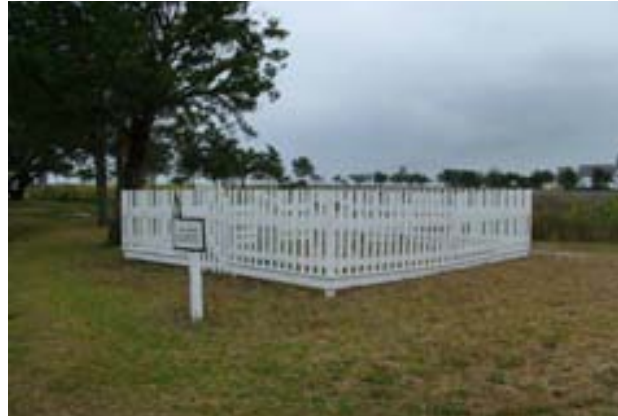
FIGURE 197B. The same view in 2006. Note the loss of much of the vegetation behind the cemetery, the addition of the interpretive marker, and the repair and painting that has been done on the fence.

Grace Cemetery. This cemetery is enclosed within a perimeter picket fence (Fig. 197 and 198). There are two single headstones and one double headstone. The cemetery was established in 1872.

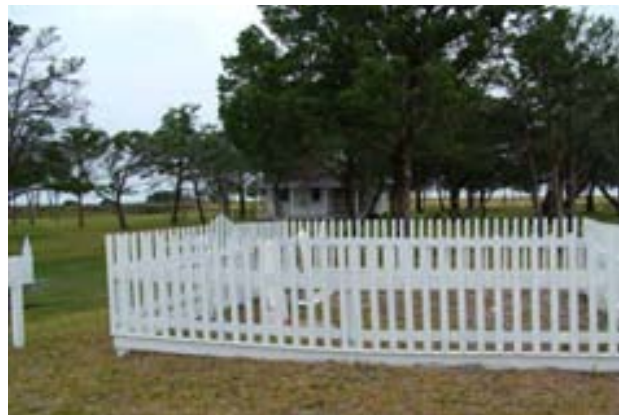
FIGURE 198B. The same view in 2006. Note the growth of Eastern red cedar trees currently blocking the view to the house.

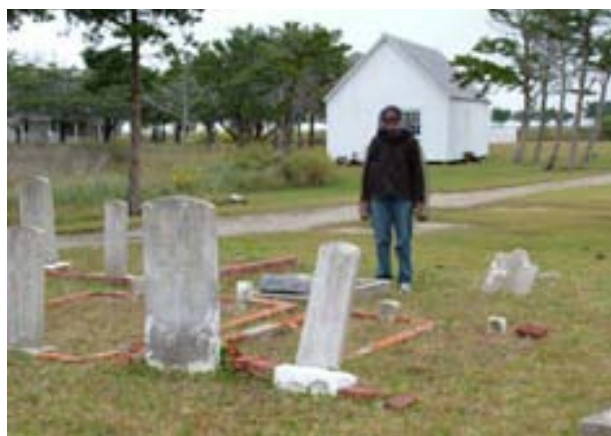
Community Cemetery. This cemetery includes thirty headstones associated with the graves of members of the Babb, Dixon, Styron, Williams, Daly, Gilgo, and Roberts families. There are twenty-four commercial headstones and associated foot markers and grave plots edged by brick and concrete borders (Fig. 199 and Fig. 200). The cemetery was established in 1885. Many features are in need of repair.

FIGURE 199B. The same view in 2006. Note the deteriorated condition of some of the headstones, and the change in the view behind the cemetery.

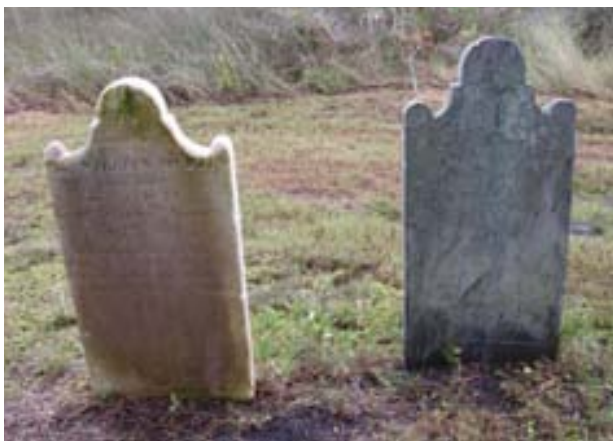
- *Displacement.* Markers may be out of plumb or not level due to installation, design problems, or environmental factors (Fig. 206).
- *General Soiling.* Soiling is caused by foreign matter (inorganic or organic) which accumulates on materials over time. Fig. 207 is a typical example of the type of soiling observed at Portsmouth Village.

FIGURE 207. General soiling affects many of the markers in the district, such as the two seamen's grave markers. Evidence of rising damp is also visible here.

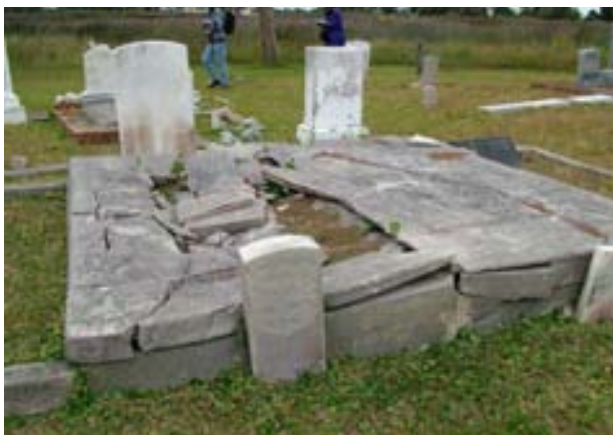
- *Open Joint.* This problem type refers to deterioration of a mortar joint between adjacent masonry units or materials. Fig. 208 is an extreme example at Portsmouth Village where the joint between the concrete top and base has opened and the entire piece has shifted.

FIGURE 208. Cracking and displacement of concrete vaults can allow water to pond, accelerating deterioration of the feature.

- *Ponding.* When water collects in pools on flat surfaces, it causes the saturation of surrounding materials and undue stress. At the vault shown in Fig. 208, the concrete top has partially collapsed and collects water.
- *Rising Damp.* This is the movement of moisture upward through permeable building materials by capillary action. Salts may be deposited in the voids, pores, and cracks, as shown in Fig. 209.

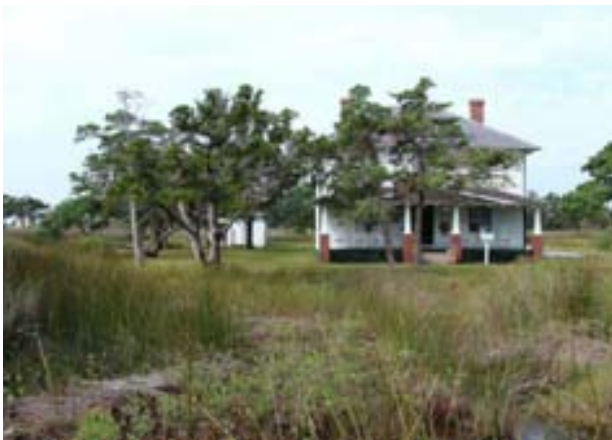
FIGURE 210. Views of the Dixon-Salter House are obscured by trees, as shown in this 2006 photograph.

Description. The amount of woody vegetation within the Portsmouth Village historic district has increased since the period of significance due to a lack of maintenance as the community declined prior to NPS acquisition of the property. There is also a pine plantation on the island, that may have been planted by the Boy Scouts or another well-intentioned group, which does not reflect the community's cultural lifeways. In many places, thickets of trees and shrubs have grown up, blocking historic views and changing the historic open character of the village landscape. The park has expressed a desire to reestablish the historic character of the village if inadvertent damage to the environment can be avoided. To this end, portions of the existing woody vegetation should be cleared or thinned to restore important sight lines and the predominant visual aesthetic present when the community was an active place. See Fig. 210 through Fig. 213 for examples of proposed clearing.

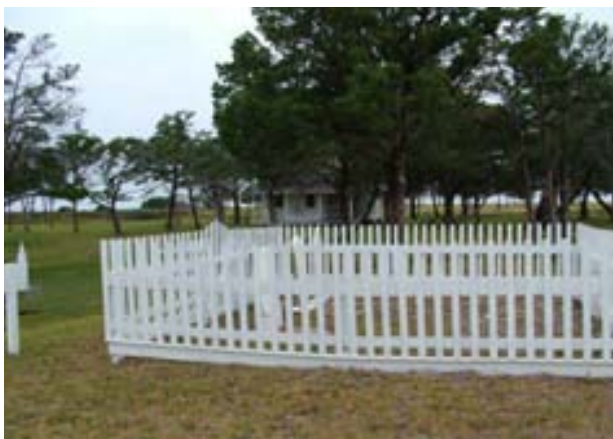
FIGURE 212. Views from Grace Cemetery to the Robert Wallace House are blocked by a stand of trees, as shown in this 2006 photograph.

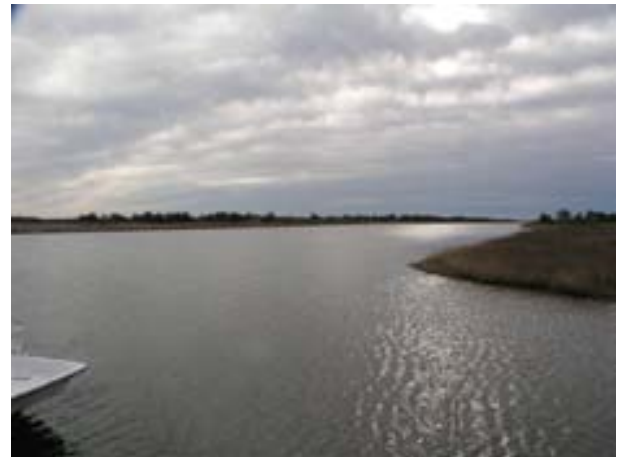
FIGURE A-11. Overview of Warren Creek showing approximate location of graves discovered, facing northeast.

Cemetery on Warren Creek. Recent storms have exposed a cemetery on the north side of Warren Creek (Fig. A-11). In the creek itself several tombstones and fragments had been observed and moved by local residents to the adjacent shoreline. The NPS recently moved the markers to the Community Cemetery in the Portsmouth Village Historic District (Fig. A-12). Clearly, Warren Creek has widened, but by how much remains unknown. The marsh adjacent to the creek has been subjected to considerable shoreline erosion,

most notably after Hurricane Isabel in 2003. The original location of the cemetery is believed to now be submerged. The graves are likely to have eroded away, but this is not known. There is no surface evidence of a cemetery along the shoreline adjacent to where the markers were found. Probing of the shore and the shallow creek bottom did not reveal any additional features.

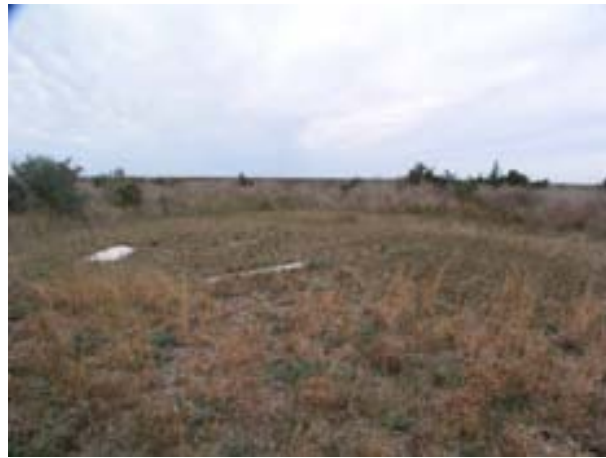
FIGURE A-13. Overview of the Wallace cemetery, facing southwest.

Wallace Cemetery on Sheep Island. The Wallace Cemetery is located on Sheep Island and is maintained by the NPS. The field team visited the site to map its location. The cemetery contains the vaults of George Wallace and his wife Rebecca and two other graves that could not be identified (Fig. A-13). The cemetery is located on a small landform elevated slightly above marshlands. No evidence of a boundary fence was observed.

Informants believe additional graves are present. Informal probing identified an additional headstone beneath the sod, several ballast stones, and a few bricks. The field team partially exposed the stone to confirm that it was in fact a tombstone. It had fallen face first onto the ground and no inscription was observed on the portion exposed. The presence of one buried headstone and other buried stones and bricks strongly indicate that additional unidentified graves are present.

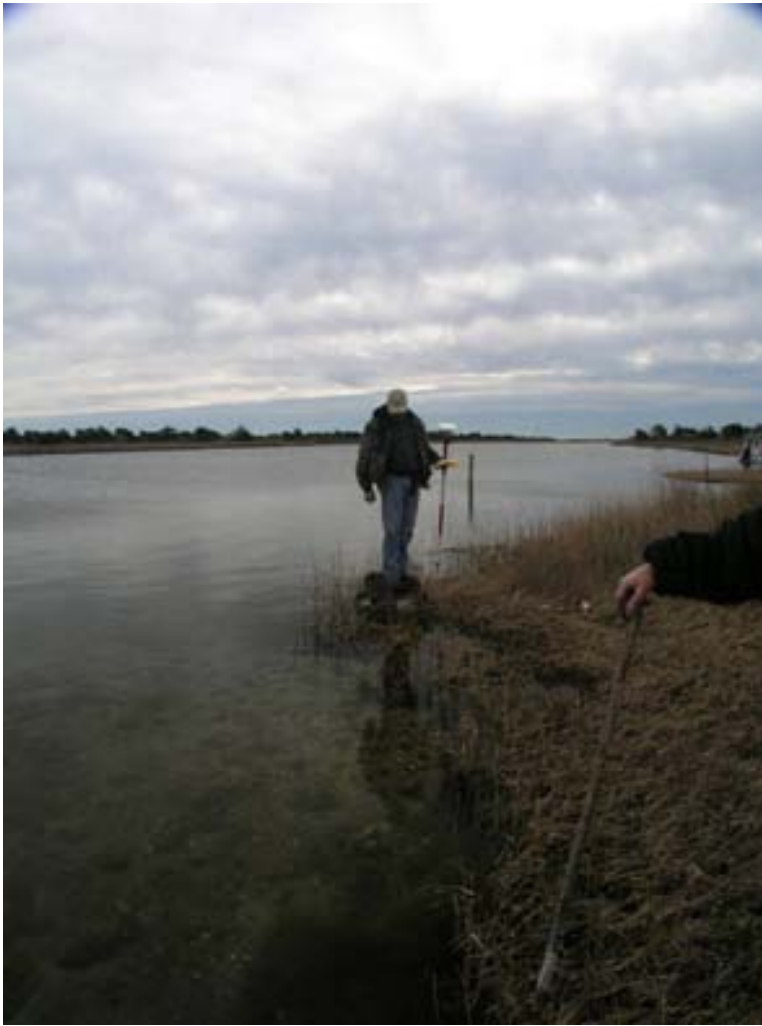
FIGURE A-14. Brick pier attributed to the Roberts House site on Sheep Island, facing northeast.
