HISTORIC STRUCTURE REPORT

Hoover Block

Dayton Aviation Heritage National Historical Park
Dayton, Ohio

January 1999
Final Report

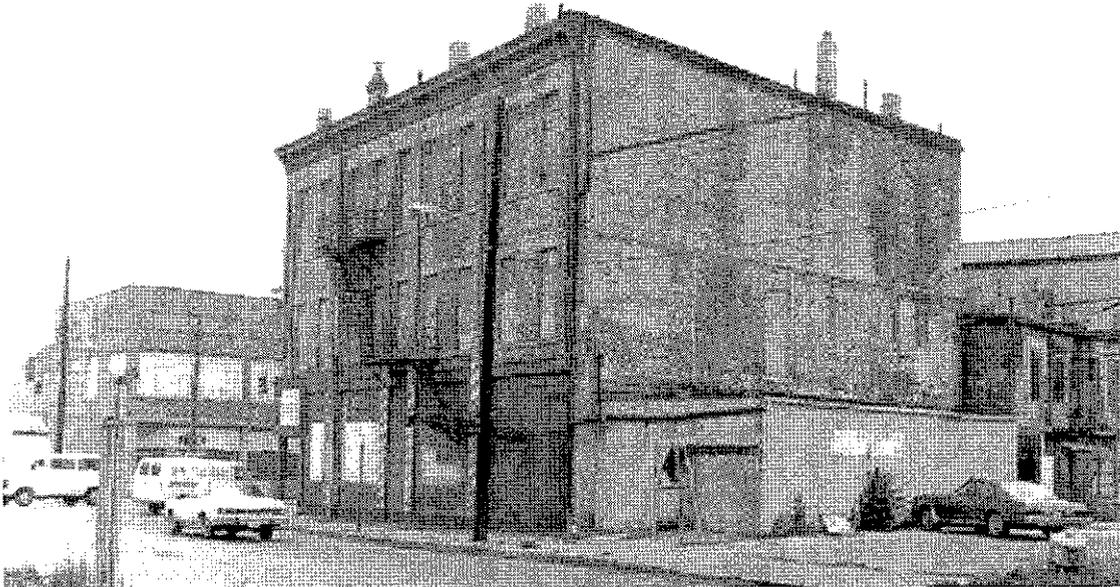
Figure 9 View looking northeast at the Hoover Block's west and south facades. Note the unadorned south facade. (Aviation Trail, Inc.)

The Hoover Block is a good example of these various facade treatments. Historically, the first floor of the main facade of the Hoover Block, which faces Third Street, featured large storefront display windows punctuated by recessed entries for each of the three shops. As was typically found in late 19th century commercial buildings, the visually heavy masonry upper stories appear unsupported by the glass storefronts (Figure 8). In the Hoover Block, this effect is exaggerated because the first story iron columns are offset from the brick pilasters of the upper two stories.²⁵ The Williams Street facade, or the west facade, is more austere although it "retains the basic pattern of the building's front. Both the face bricks and the bands of rusticated limestone window sills and lintels continue from the main facade...The east (Figure 6) and south (Figure 9) facades, which serve(d) as party walls with adjoining buildings, are not ornamented."²⁶

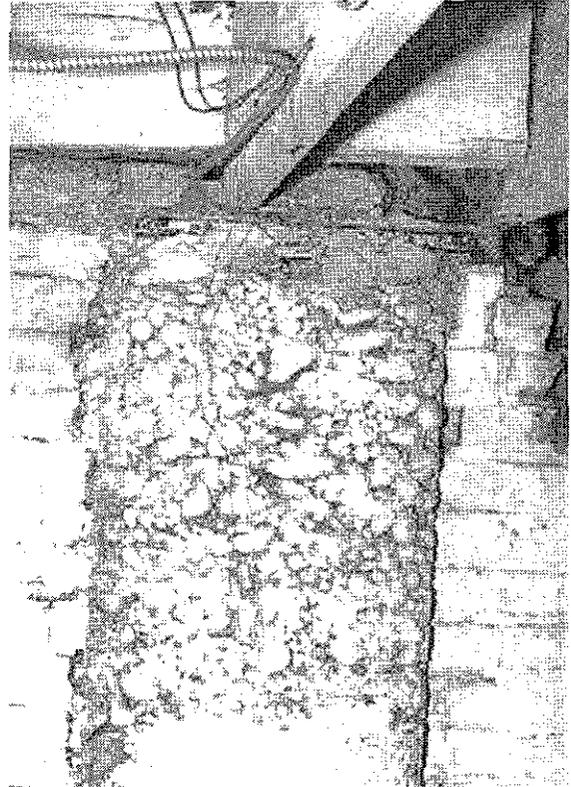
Figure 3 West interior basement wall, first concrete column from the north supporting steel column above; note extensive honeycombing (photo 2:27, Fitzpatrick Structural Engineering, P.C., October, 1996)

located at the north end of this wall line. Note the severe honeycombing on the face of this column which also occurs at other locations. Figure 4 shows another column condition in the west wall further to the south. The concrete at the top of this column appears to be sound without honeycombing. Honeycombing is due to poor or a lack of vibration of the concrete when it is poured. The vibration eliminates air pockets that weaken the concrete.

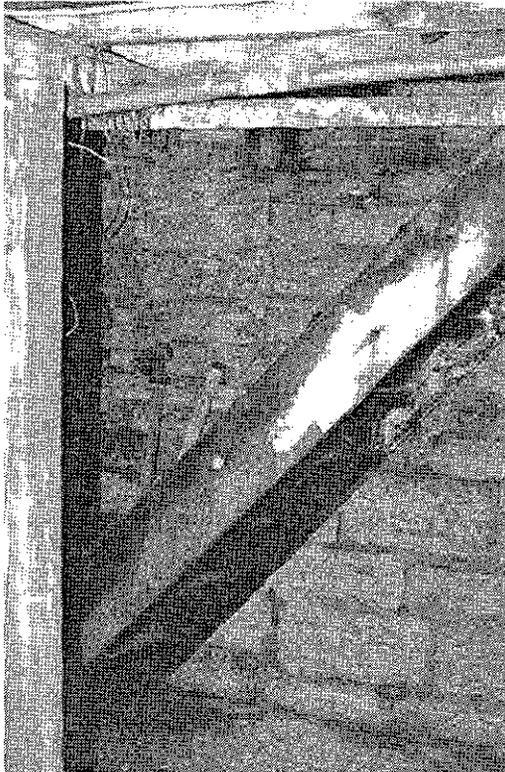
Figure 7 Stair remnant at middle basement south wall (photo 2:19, Fitzpatrick Structural Engineering, P.C., October, 1996)

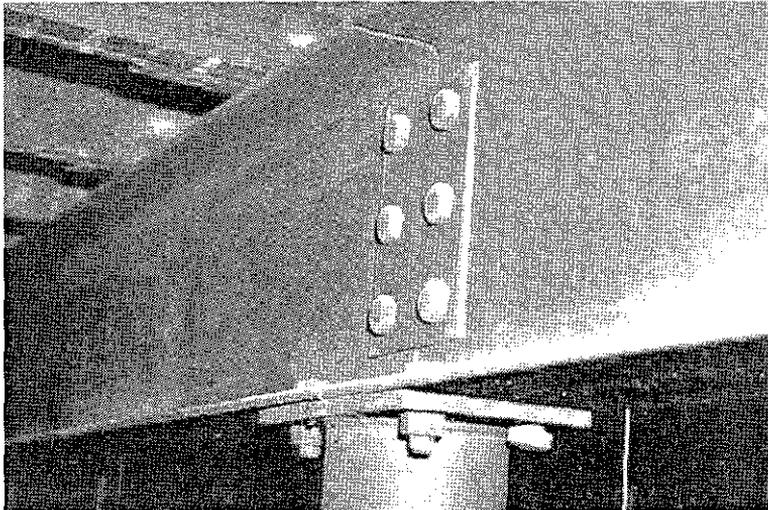
Figure 12 shows a beam column connection at the second floor structure along the east column row. Wood joists spanning east and west are supported on the top flange of the steel beam. Floor joists frame at a skewed angle to the beam since they are parallel to the south wall of the building. The joists are lapped over the beam and have square cut ends. No solid blocking between joists was observed. Blocking is usually required by modern codes in order to prevent the natural end rotation of the relatively thin and deep joist members when subjected to load. All accessible wood joists were in very good condition, with no apparent cracking, checking, shakes, or knots. Two steel beams frame over the column shown in Figure 12. The beams are connected to each other and to the column with hex head nuts and bolts. Beam spans were determined to be a single simple span from the north wall to the first column to the south, and two span continuous beams for the balance of the east beam row. The beam was measured using a metal tape and digital calipers. Beam depth is 12", and the flange width is $6\frac{1}{2}$ ". The inside of the flange is relatively flat which indicates that the beam is a standard wide flange type member. The flange thickness was measured to be between 0.37" and 0.40". Red primer paint has been applied to the steel. All east row steel members appear to be in excellent condition.

Figure 12 Steel beam to column connection at east column row, third column from the north (photo 3:3, Fitzpatrick Structural Engineering, P.C., October, 1996)

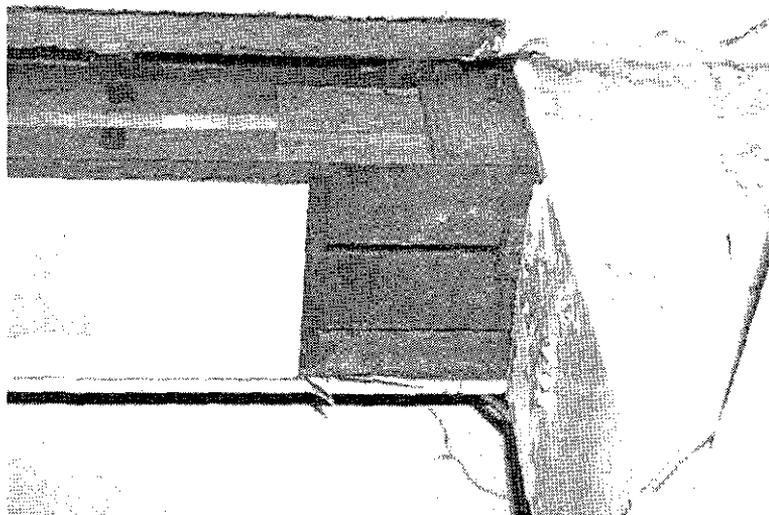
Figure 13 shows the bottom of the west beam row at the north bearing. This beam row is encased with wood trim, which was removed at this location to provide access for close inspection. Attempts were made to expose the beam at another location further to the south, but these efforts were only marginally successful. Determination of span continuity was not possible due to limited access. The beam along this row is actually two steel members placed side by side. Two 'Red Iron' bottom flanges can be seen in Figure 13. Note that the bolts that fasten the wood nailers to the beam are older square head type connectors. The interior of the flange of both members slope, which classifies the beam as an 'American Standard' or I section. Accurate measurement of flange thickness is not possible for sloped flanges. Beam depth was found to be slightly over 10". Standard I sections are always non-fractional, full inches in actual depth (e.g. 8", 9", 10"). The variation of the measured depth can be attributed to mill rolling tolerances and/or the red primer coat of paint. The flange width of each member was measured at $4\frac{9}{16}$ ".

Figure 13 Steel beam bearing at west column row, north end bearing on brick pier (photo 3:7, Fitzpatrick Structural Engineering, P.C., October, 1996)

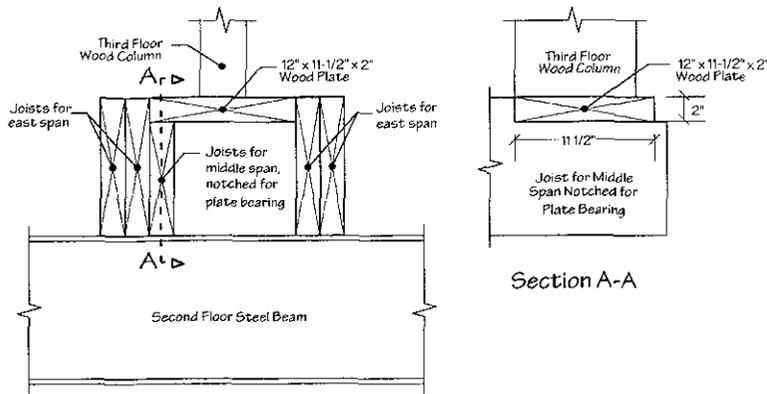
During the second physical investigation, the detailing of these wood columns bearing on the steel beams in the second floor structure was determined for the east bearing line. The west bearing line detailing could not be determined due to existing finishes around the second floor beam at the third floor column locations. The middle column in the west bearing line was investigated. As shown in Figure 17, the wood column bears on a wood plate which bears on a joist notched to accept the plate on the north end. There is no apparent connection between the wood plate and the floor joists at the south end of the plate. Oddly, the joists on either side of the plate for the east span are doubled. There may be spikes at the west span floor joists end-nailed into the wood plate. Nevertheless, this bearing condition results in an indirect load transfer between the column and the beam. Shimming directly below the column to the beam is a relatively easy fix for this location.

Figure 17 Sketch illustrating middle column in the west bearing. (Drawn by Cheryl Kryscynski, Fitzpatrick Structural Engineering, P.C., April 2, 1998)

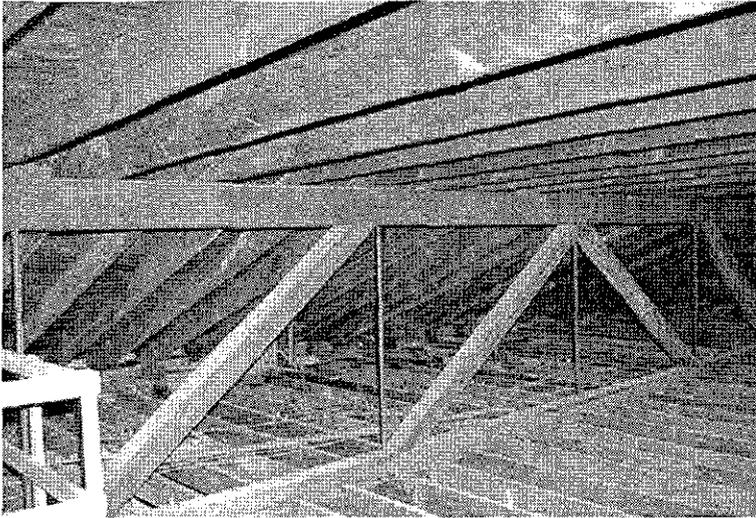
Figure 20 Truss 3 looking toward the west end; roof rafters supported on top chord; ceiling joists supported on ledger (photo 3:29, Fitzpatrick Structural Engineering, P.C., October, 1996)

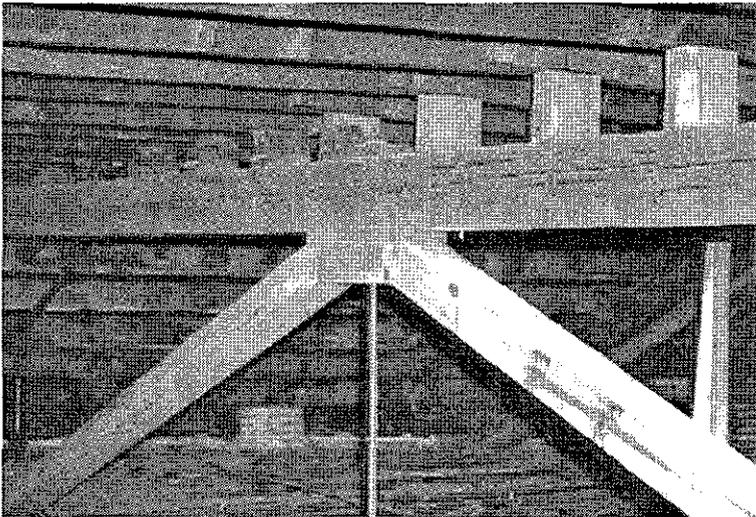
Figure 21 Truss 2 at middle panel point looking to the northwest; roof rafters raised with blocking to create slight slope (photo 3:33, Fitzpatrick Structural Engineering, P.C., October, 1996)

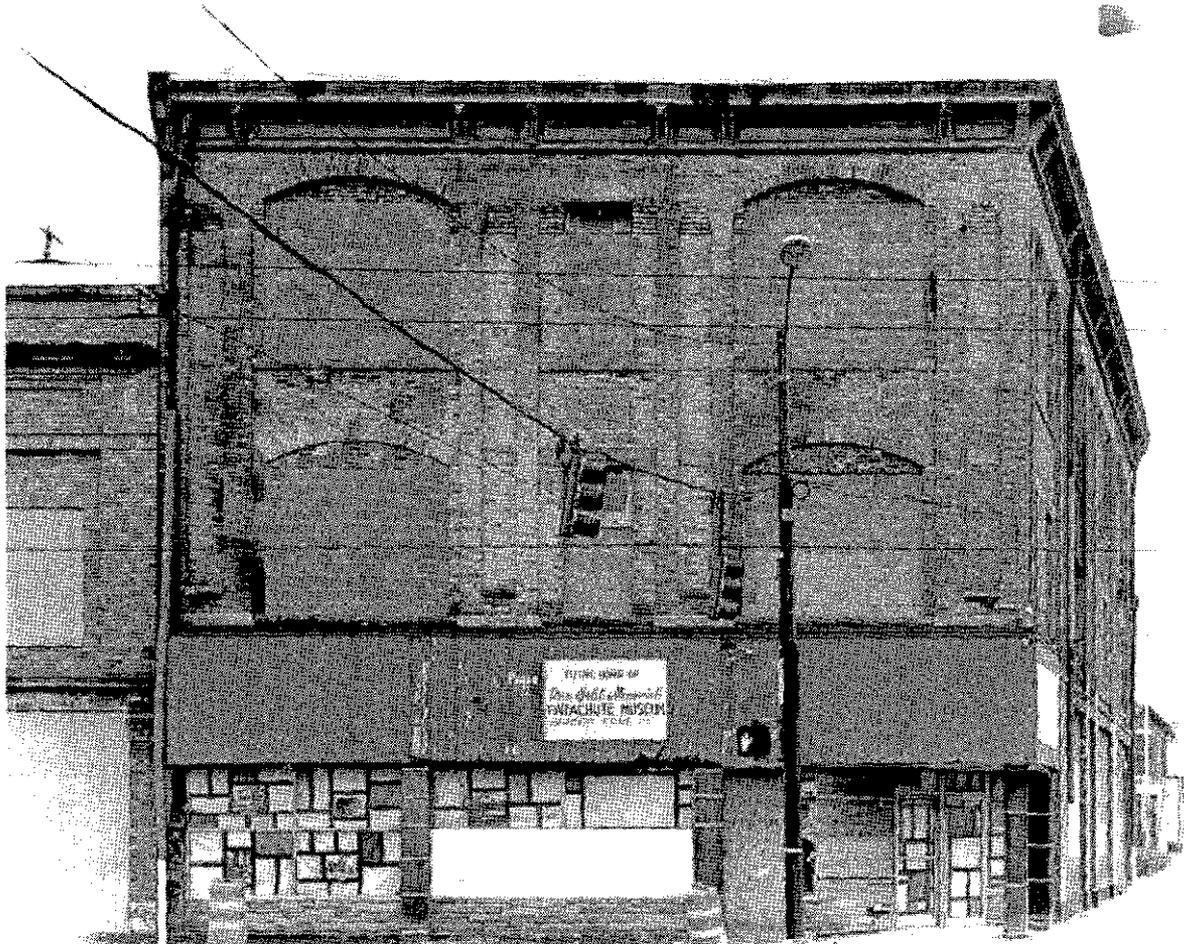
Figure 22 View of the north elevation of the Hoover Block (J. Miles Wolf, 1995).

At the north elevation (Figure 22), there is noticeable brick damage along the length of the downspout at the eastern edge of the elevation. There is also marked erosion of brick corners and mortar joints at the east edge of the second level's westernmost window opening. All of the arched window heads show open mortar joints from below. There are several open joints around the limestone in the central bay of the elevation. What paint finish the

brick seems to have had at one point has been weathered, and may itself have contributed to the trapped masonry moisture. The downspout to the east may be original near the roofline, but portions of it have been replaced; it seems in fair condition, though crooked. The cornice appears rusted and stained, but there are no readily visible holes. The only significant damage at the cornice seems to be an open seam at the northwest corner, where the two elevations meet.

The condition of the metal frieze is not completely known. Portions of the cornice which are visible above the wood paneling, and even behind portions of it, appear to have several layers of paint. Only one wrought iron column is visible, and it seems to have suffered some minimal damage from the faulty eastern downspout. The two column capitals, one on the north elevation and one on the west, that "book-ended" the frieze are missing. The plate window fronts and bases are not original and have been vandalized, though the glass doors and window frames seem in fair condition. The same can be said for the portion of the shop front that continues onto the west elevation at South Williams Street.

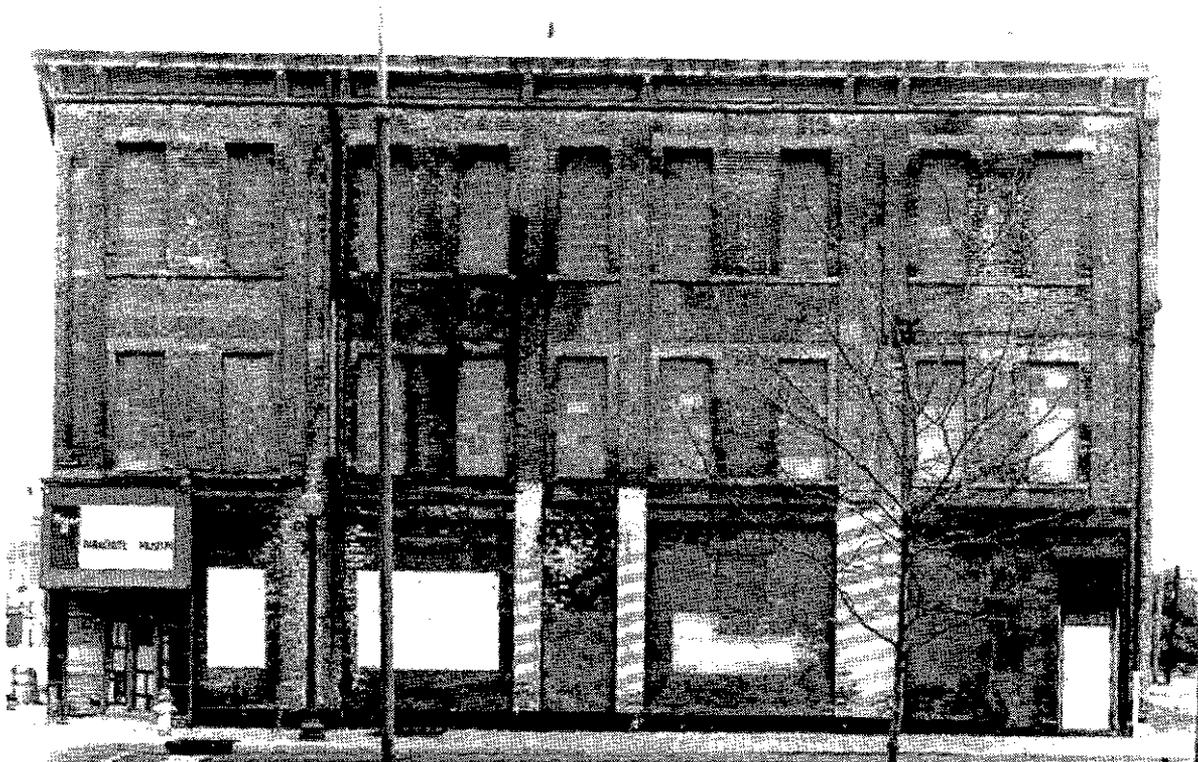
Figure 23 View of the west elevation of the Hoover Block (J. Miles Wolf, 1995).

The west elevation (Figure 23) appears to have endured more damage than the north, perhaps due to chimney stack damage, the presence of a fire escape, and a leaking gutter that may have washed portions of the elevation with runoff water. The entire face of the bay just north of center and half of the face of the center bay are extremely eroded; joints are missing for most of the second floor level, which would have been right under the third floor landing of the fire escape. These areas may have long been trouble spots, and may have been repointed, inappropriately; the mortar appears to be thick and discolored. Corners of brick and open joints are also visible between the windows of the bay just south of center. Bricks and portions of bricks are missing in nearly every bay; a piece of limestone is missing below the second floor window of the central bay. Of particular concern are the open joints between and around the brick cantilevering at the first floor ceiling line. There are telltale signs of efflorescence

at the heads and jambs of the windows in the southernmost bay. Often times it is hard to distinguish between brick salts, old paint and inappropriate repointing when viewed from the ground level. The damage at the ground level is masked by several coats of dark paint, but some more recent spalling and holes from the fire escape mountings are evident.

The two downspouts on this elevation appear to have had portions replaced, the northernmost of which seems to have suffered more weathering. The downspout to the south receives a tie-in from a downspout at the west edge of the south elevation. Portions of the cornice/gutter above the three central bays appear to have rusted through, when viewed from below. The gutter was relined with flexible sheet flashing by Aviation Trail, Inc. in 1993. In general, the cornice is riddled with rust.

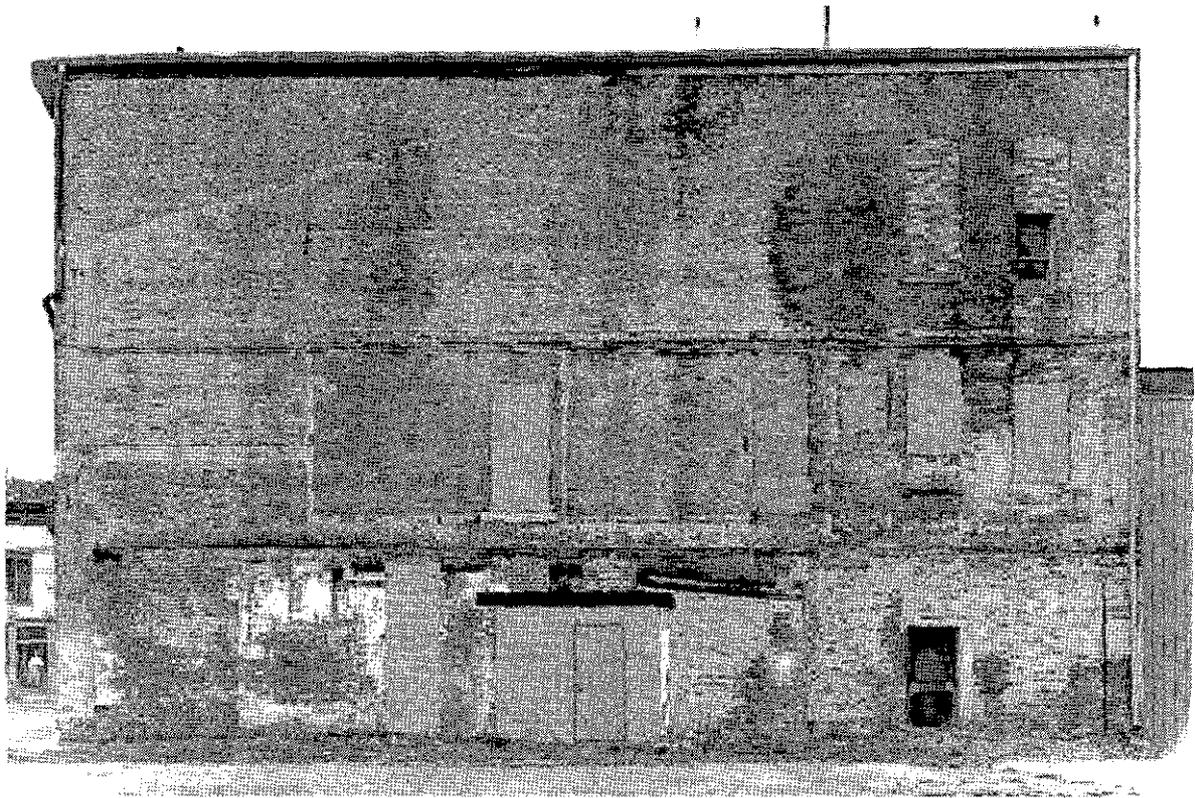
Figure 24 View of the south elevation of the Hoover Block (J. Miles Wolf, 1995).

The brick at the south elevation (Figure 24) has been most severely damaged at the eastern third of the elevation. Easily 60% of the brick in this area is spalling and suffering from efflorescence and open mortar joints. Other portions of the elevation appear to have been protected by their now missing additions. Great gaps in the brick fabric from missing and eroded brick are concentrated at this eastern third of the elevation. The damage to the rest of the elevation seems to be limited to efflorescence, some shallow joint erosion, and patches of paint and joist pockets for the additions. There have been extensive alterations to this elevation in terms of new openings being cut and older ones being filled in; the steel beam lintel, installed by a store owner in 1946, is still prominently visible in the fabric, over a cinder block filled opening. Of the two doors that appear in this elevation, one is metal and is located in this infilled opening, placed there by Aviation Trail, Inc. and the other is a two paneled wooden door that appears to be much older. Both are functional. The two downspouts at this elevation appear rather new, and it is known that the fascia board and gutter were installed by Aviation Trail, Inc. in 1993.

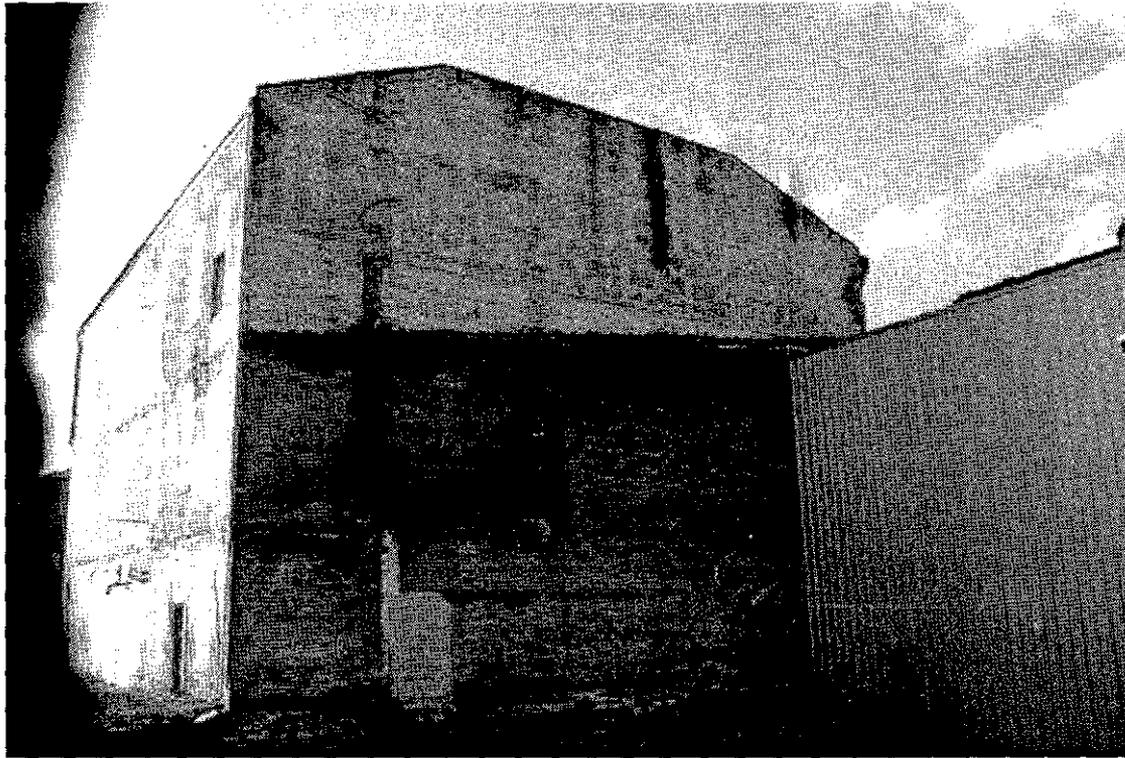
Figure 25 View of the east elevation of the Hoover Block (Quinn Evans/Architects, 1995).

The east elevation (Figure 25) is in relatively good condition, in part because Aviation Trail, Inc. repointed areas of damaged masonry in the fall of 1996. The lower two floors were protected by the former Setzer Building for most of the Hoover Block's life. The upper third of the elevation has had several advertisements painted across its elevation. Portions of the elevation were rebuilt when the chimney stacks of the neighboring Setzer Building were detached. The most damage appears to be at the north edge corresponding to the spalling and mortar erosion on the north elevation behind the downspout. There also appears to be another vertical area of spalling approximately one third of the elevation width from the south, which may correspond to one of the Hoover Block's chimneys. The only modification to this wall was an entrance to the south of the elevation that has since been filled in with cinder block.

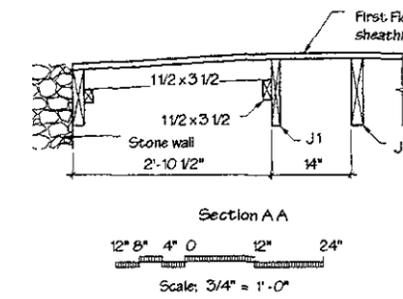
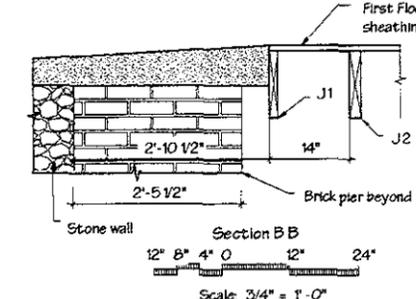
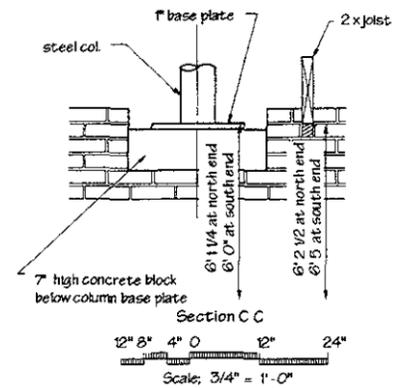
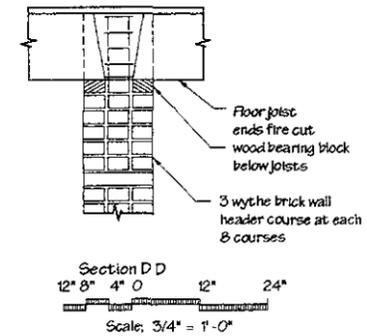
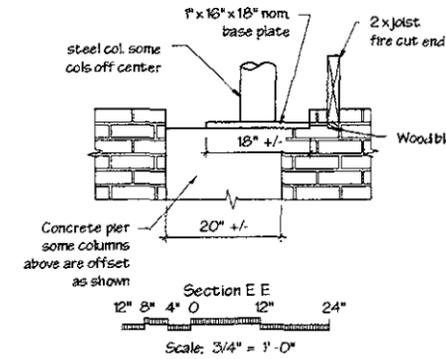
Joists: East Side of Basement			
Mark	Width Inch	Depth Inch	
J1	11/2	11 1/4	
J2	2	11	
J3	17/8	11 1/4	
J4	17/8	11 1/4	
J5	2	11 1/2	
J6	2 1/8	11 5/8	
J7	2	11 3/4	
J8	17/8	11 5/8	
J9	2	11 1/2	
J10	2	11 3/4	
J11	2	11 5/8	
J12	2	11 5/8

Joists have a 2" deep notch at bottom of joist at east wall bearing

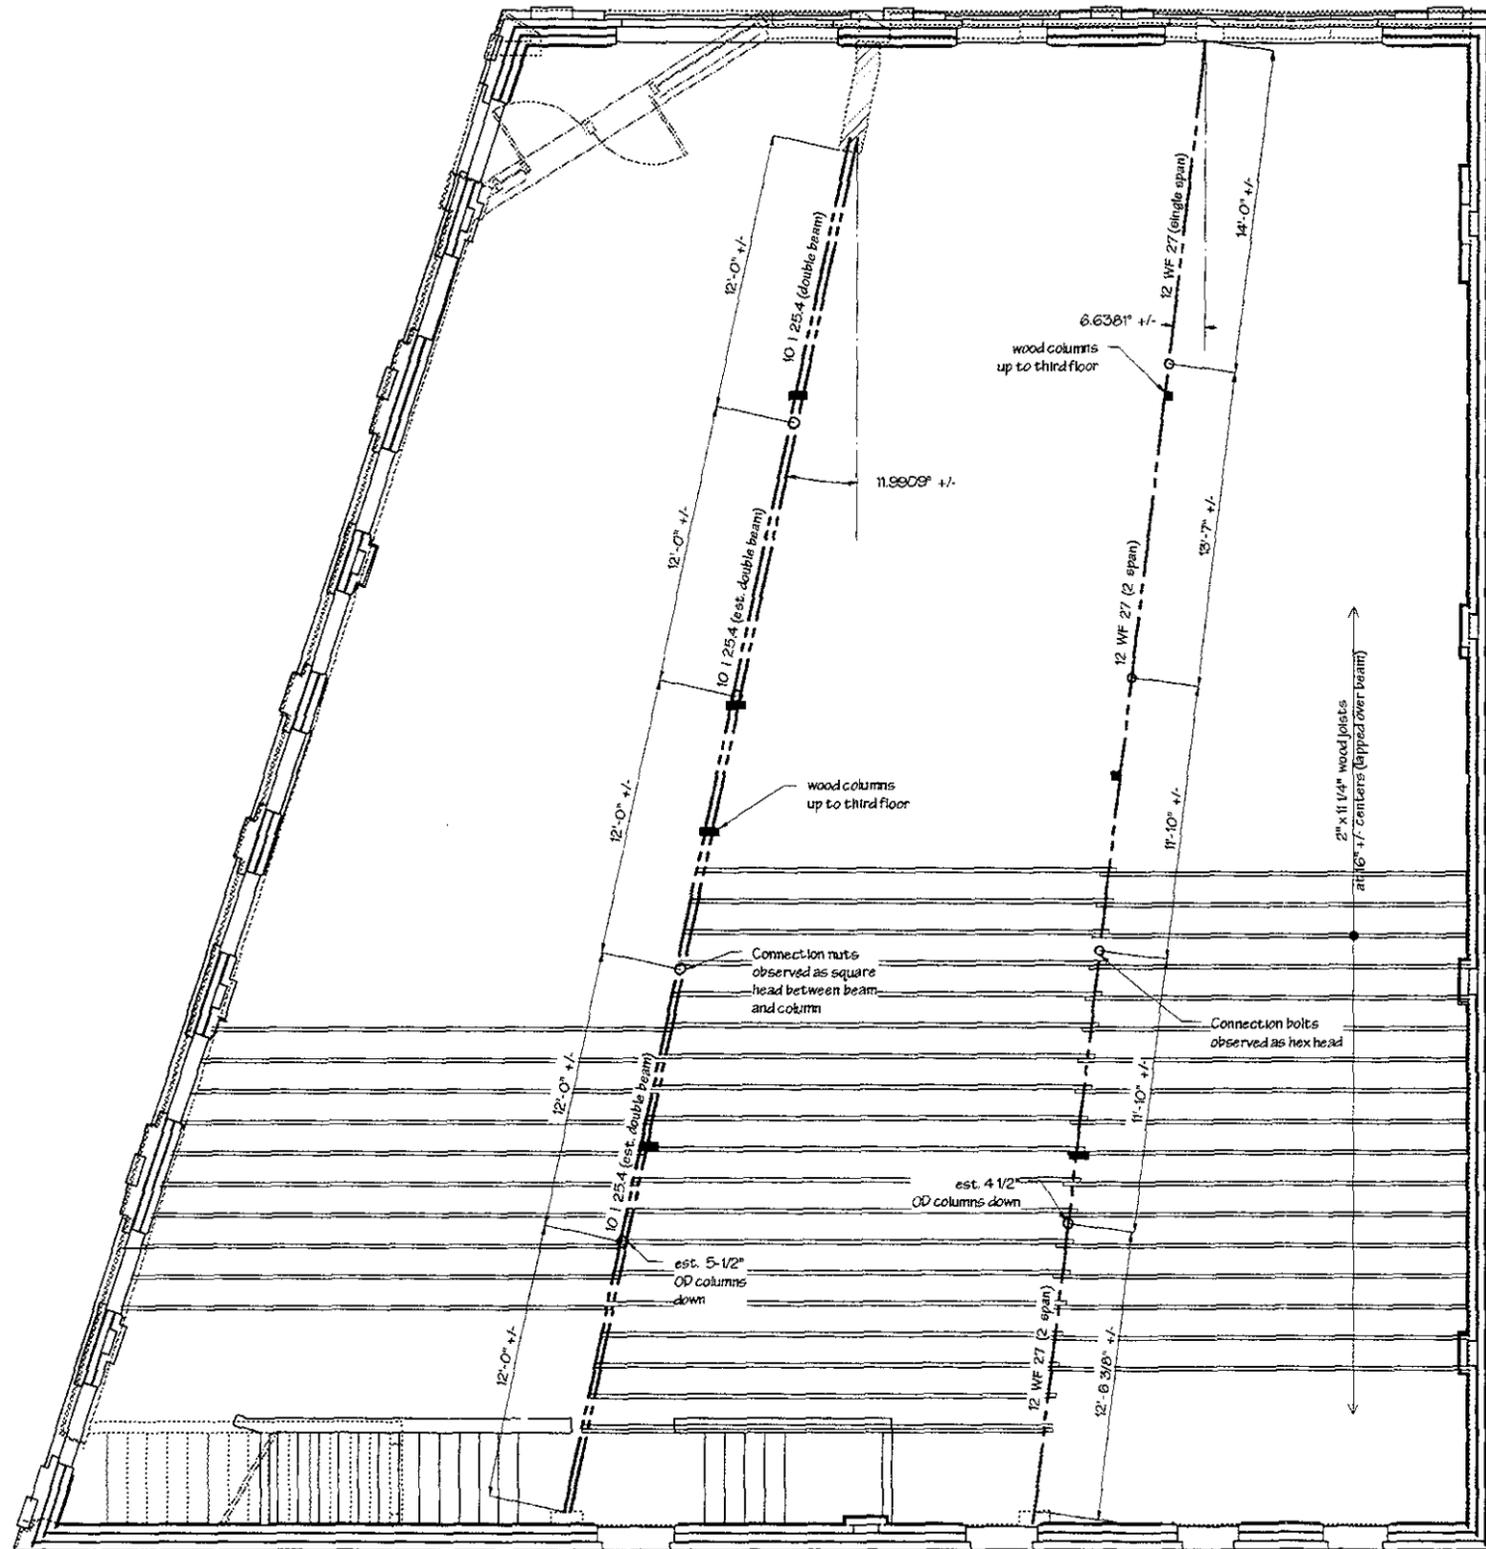
AUTOCAD FILE NO.
SUB SHEET NO.
EXS - 101

West beam line measured at north end near masonry pier. Double side by side beam was observed. Depth was measured on east side and was found to be slightly more than 10". The flange width was measured at about 4 5/16". The inside of flange sloped making it an I or "American Standard" section. Bolts were older square head type. Iron and Steel Beams 1873 to 1952, by AISI indicates that the section is a 10 I 25.4 rolled by various mills from 1931 through 1950.
