HISTORIC STRUCTURE REPORT

Wright Hall Carillon Historical Park

Dayton, Ohio

March 30, 2006
Final Submission

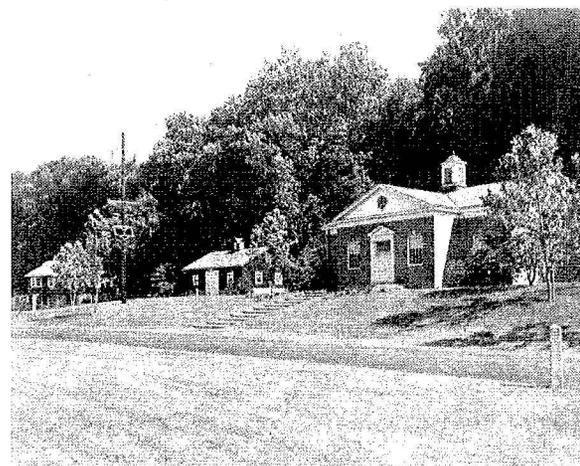
Figure 23: Wright Hall site, Dayton, Ohio (Carillon Park Archives)

The extant features of the cultural landscape surrounding Wright Hall include the spatial relationship to a paved pathway along the top of the south side of the canal prism, the steps into the building from the path, and the steps (with lower landing) up the side to the top of the prism (figure 23). The views to the Wright Cycle Company building and Wright Hall from the Kettering Family Education Center are significant, as are the views that are offered from various vantage points throughout the site. Currently, these positively influence the comprehension of the overall site.

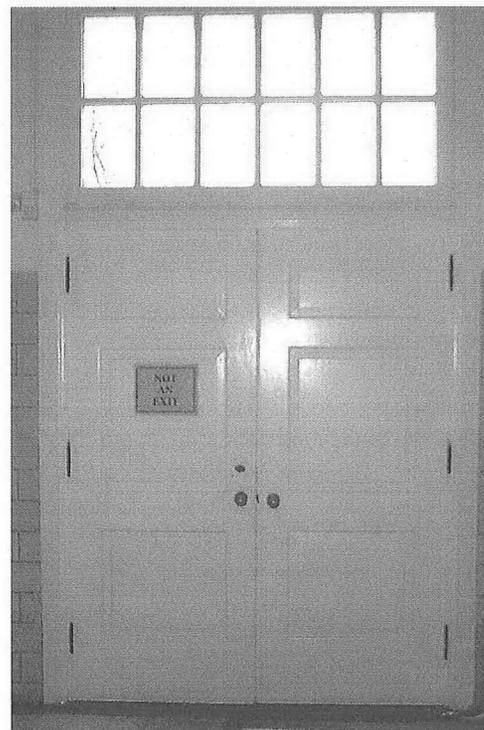
Doors: The main entry doors are solid wood rail and stile doors with three raised panels set into each (figure 31). The wood casing and trim appear to be in good condition with minor water damage at the lower left corner of the frame. The wood panels are in good condition. The handset, escutcheon plate and hinges appear to be original to the door. The thumb turnlock appears to have been modified, as there is some

Figure 31: Interior of entry door.

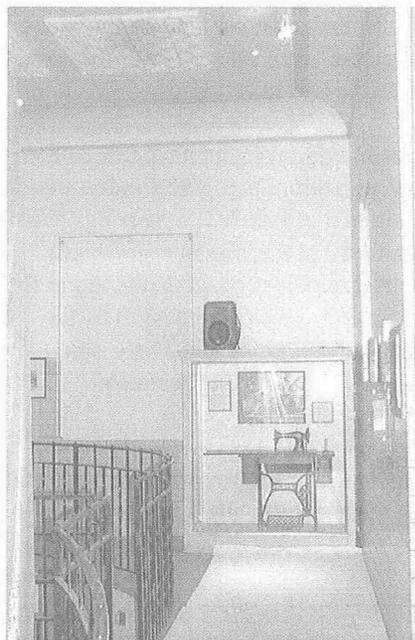
Doors: The new passage opening is a hollow metal frame with a wood trim profile different than the trim profiles utilized in the building. There is the appearance of a transom panel above the door that indicates the original height of the window. This opening is not trimmed out and is painted to match the wall color.

Figure 33: East interior elevation.

The recommendation is to maintain the east and west wing openings as doors and to modify the trim. In doing so, the trim should be simplified so that it is flat with a radius profile. The faux transom also should be trimmed out and the new opening replicated.

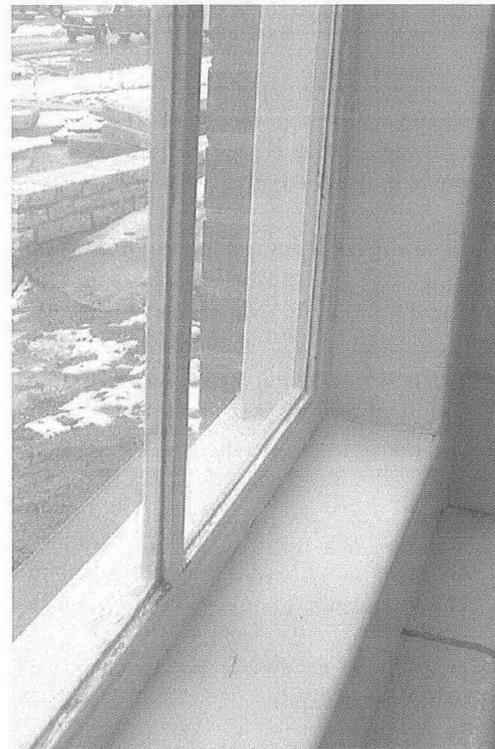
Figure 35: Steel window.

Windows: The two steel windows north of the new entrance are in good condition (figure 35). The condition of the windows is consistent with the north elevation, in terms of heat loss and deterioration of painted surfaces.

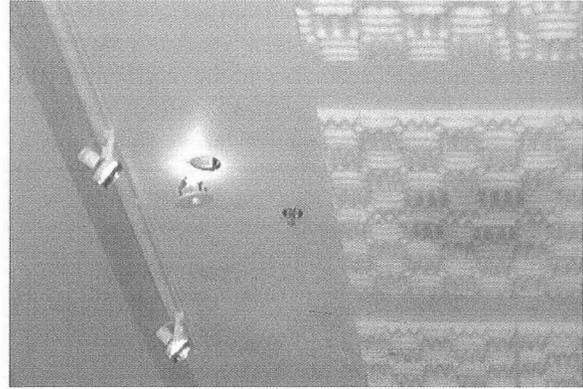
Figure 37: Ceiling and track lighting

Lighting: The current lighting is not original to the main space as seen from historic photographs (figure 22). The openings from the original ceiling fixtures remain and are evident from dust collection in the acoustical panels mounted over the openings. The current lighting of the hall central space, apsidal end and portico is covered in detail in the lighting analysis later in this section (figure 37).

The existing structure has been modified with the removal of the original lights and the insertion of acoustic pads. The current lighting system, which is a few years in age, consists of Halo (or equal) MR16 downlights and PAR30S trackheads (also Halo or equal). The trackheads are fitted with black egg crate louvers. (Refer to figure 37).

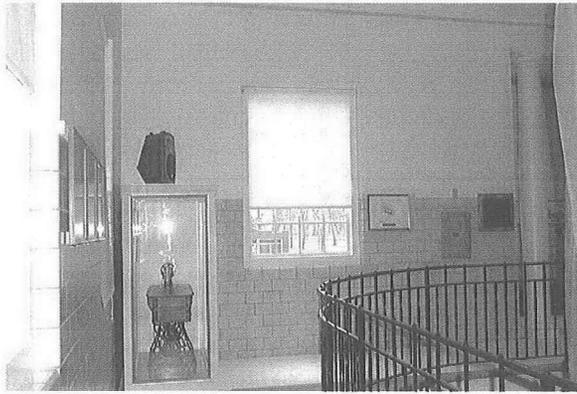
Figure 38: Interior corner showing railing

Railing: Visitors are protected from the three-foot drop to the lower floor where the Wright Flyer III is located by a transparent but strong railing. It is likely that the simple details and use of strong materials was intentional to allow optimal viewing of the Wright Flyer III without visual competition (figure 38). The railing is grounded in the terrazzo floor. There is some minor cracking at these locations.

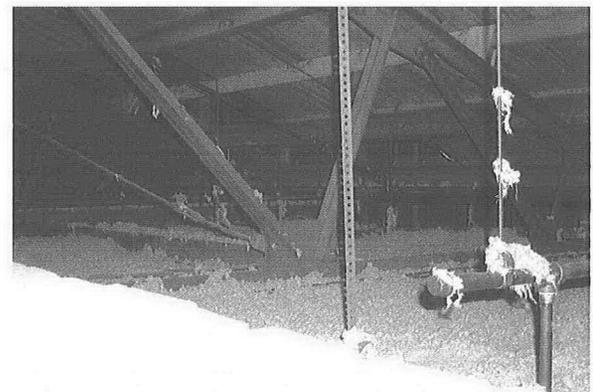
Figure 39: Attic

It appears that the attic was built as indicated in the drawings. The primary modification is the introduction of a blown cellulose insulation material (figure 39). The space is not heated and a draft is noticeable. An improvised drainage system made of a garden hose and visqueen can be seen under the cupola. It does not appear that much water drains through this system.

Floor: The structure remains exposed under the insulation material and the wood walkway running east-west in the attic is in stable condition. There is some evidence of earlier water staining under the cupola.

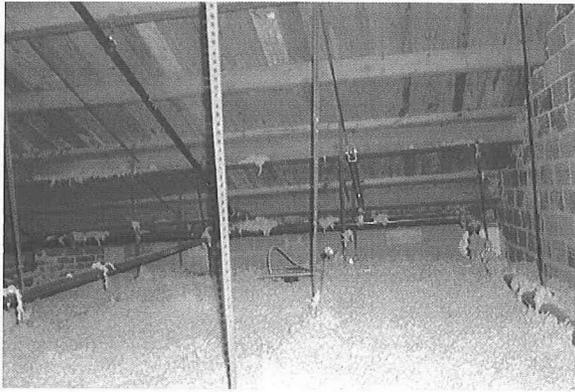
Figure 40: Wooden substructure in attic

Roof: The wood substructure and the wood and steel framing are all clearly visible and appear to be in generally good condition (figure 40). The only location where previous water infiltration is evident is at the framing between the flat and pitched roofs at the rear of the building. This is consistent with information obtained from photographs and the plaster condition below.

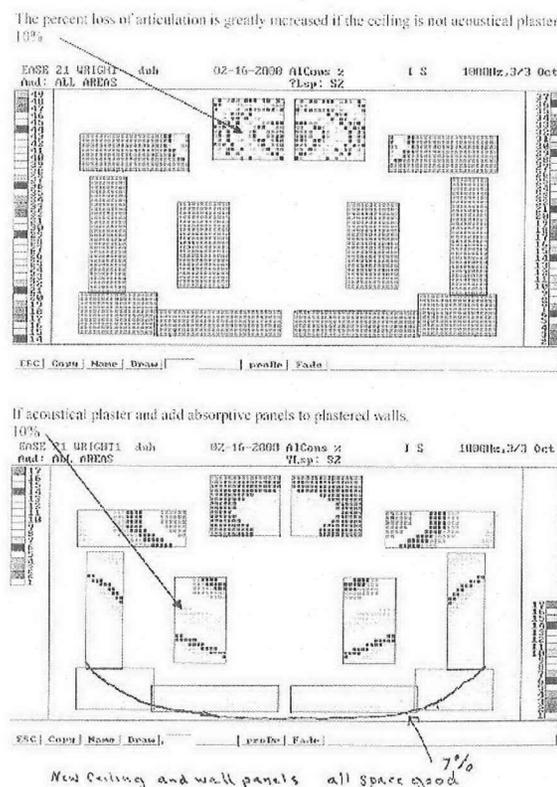
Figure 41: Acoustical reverberation information.

be controlled. Most acoustical plasters of this period were made of lime plaster mixed with a high percentage of asbestos fibers, the same fibers as were used for thermal insulation (although asbestos was not found in the Wright Hall ceiling). Originally, the ceiling in Wright Hall would have had a reverberation time of about 1.5 to 2 seconds, and one could communicate with an elevated voice level across the 30 feet of the flyer display (figure 41).

The only problem may have been in the winter when the heating system was active and the fan noise from the plenum along the pit may have been loud enough to interfere with speech communication at a distance. Therefore, when Wright Hall opened to the public, the acoustics were good. After the hall had operated for several years, the ceiling was repainted and some of the open surface of the acoustical plaster was sealed with paint. This resulted in a loss of sound absorption and a somewhat longer reverberation time in the hall, but probably only a marginal decrease in speech intelligibility.

absorbed. The effect would have been very noticeable, the reverberation time at mid frequencies may have been as high as 5 seconds and speech intelligibility could have been reduced by 25 to 30%. At some time within the last ten years, a plastic foam Somex was applied to the ceiling surface to restore the middle and high frequency sound absorption that had been lost over the years by the repainting of the ceiling. The reverberation time in the hall at this time is about the same as it was in the newly opened hall in 1950. However, a new heating system has added a high level of noise at about 51 dBA to the hall and non-amplified speech is non-intelligible at a distance greater than 15 feet.

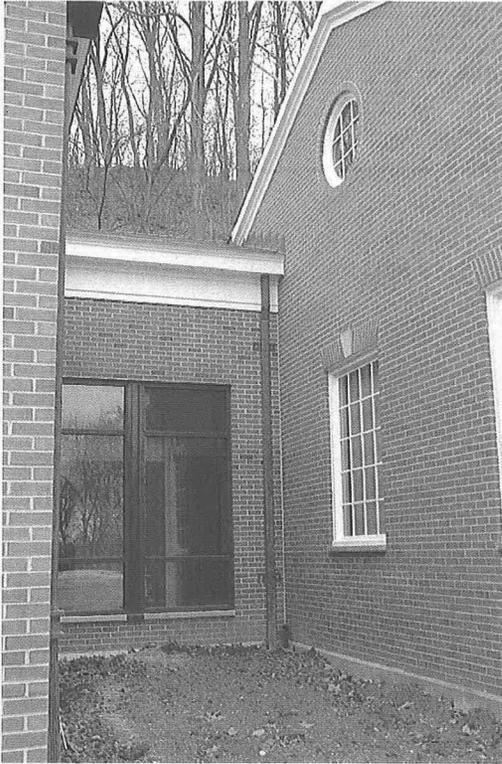
Figure 42: Connector Building

The connectors from the wing additions do and will continue to house the new mechanical units for Wright Hall. In general, there is good separation between the structures to prevent transference of vibration. (figures 42 and 43). The only exception to this is the block wall that separates the mechanical area from the corridor. The wall directly abuts the exterior brick of the Hall. The passage to the new

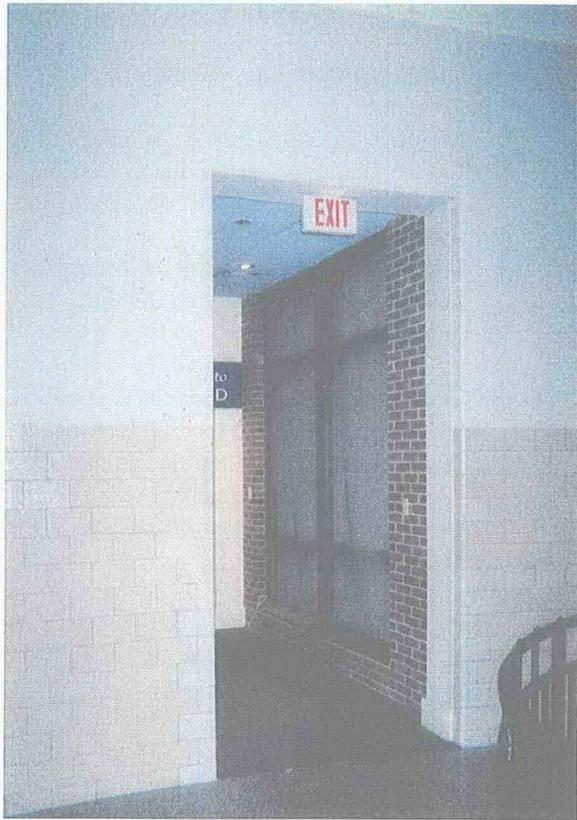
Figure 48: Actual opening installation (QE|A 2005)

Post-construction inspection revealed that treatment alternative 2 was implemented very successfully (figure 48)

The recommendation is to maintain the east and west wing openings as doors and to modify the trim. In doing so, the trim should be simplified so that it is flat with a radius profile. The faux transom also should be trimmed out and the new opening replicated (figure 47).

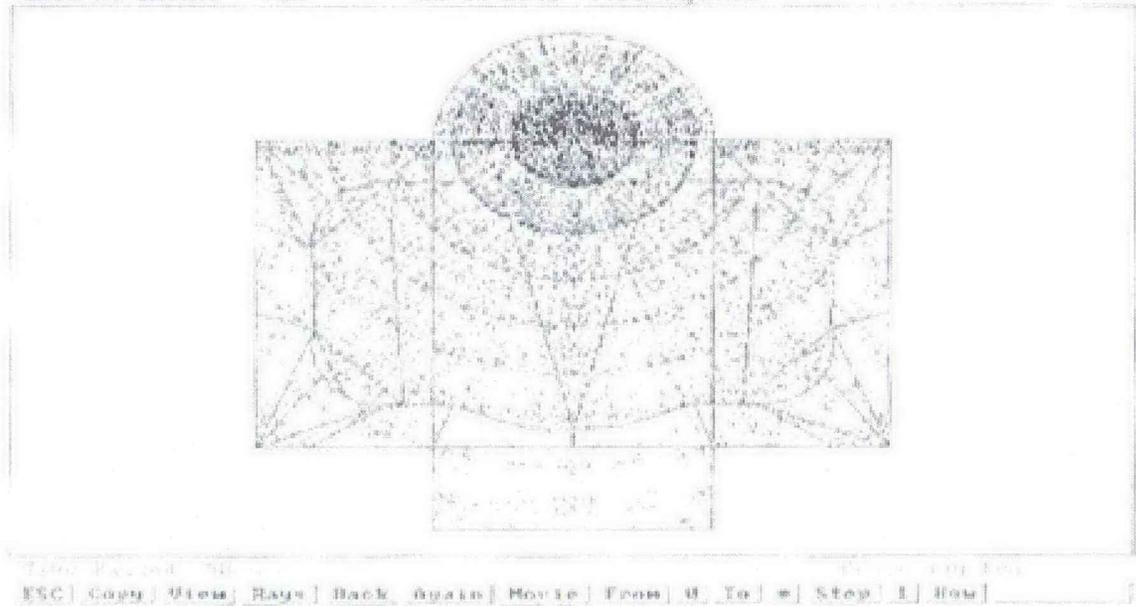
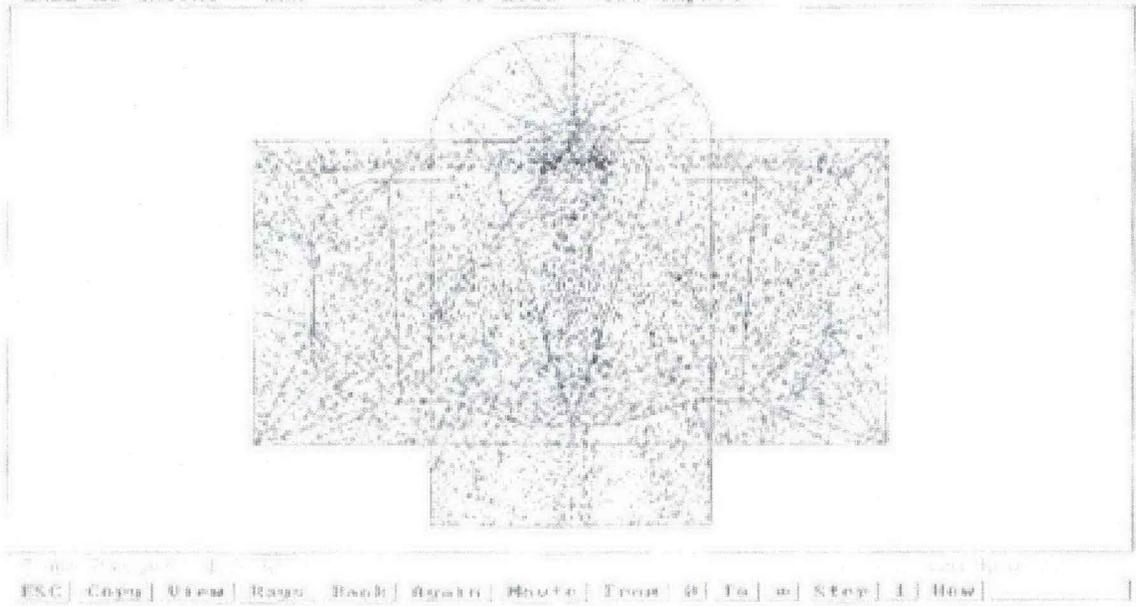
Figure 49: Acoustical Review of direct and reflected speech. (Geiger & Hamme, 2000)

The acoustic recommendations are made primarily with regard to improved voice acuity in the existing line space comprised of hard surfaces. This would require the addition of treatment to the walls and ceiling. The existing ceiling panels in the plenum space can be used. Wall detailing is also critical in terms of acoustic concerns. The material type, edge detail and configuration need to be sympathetic to the existing window details. These solutions respect the significance of the monolithic appearance of the wall plane. A scheduling of the wall treatments is recommended.

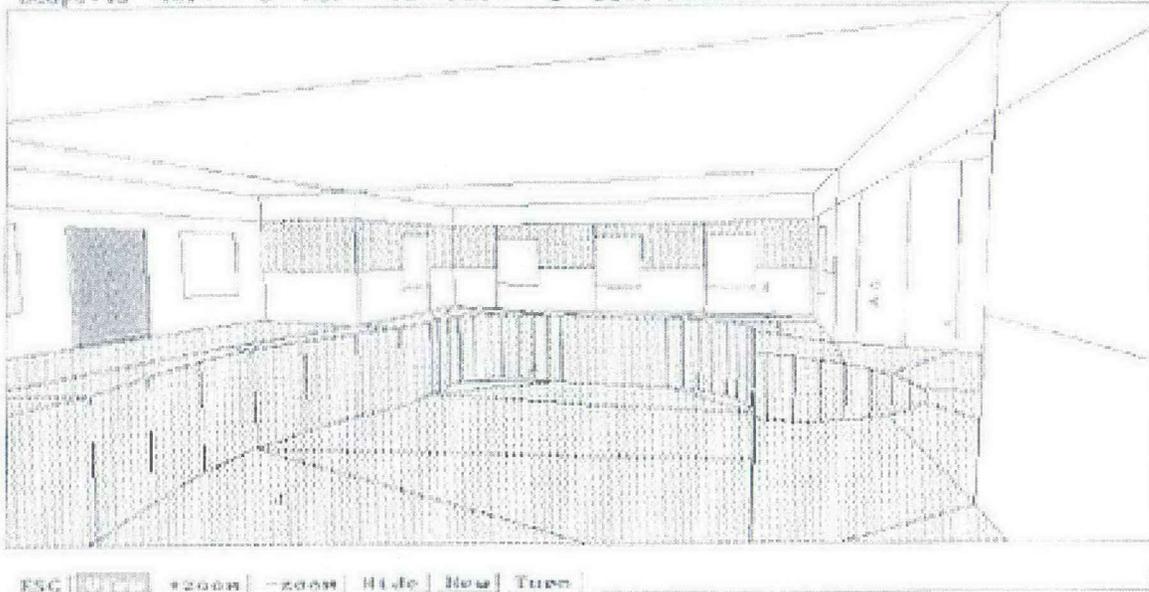
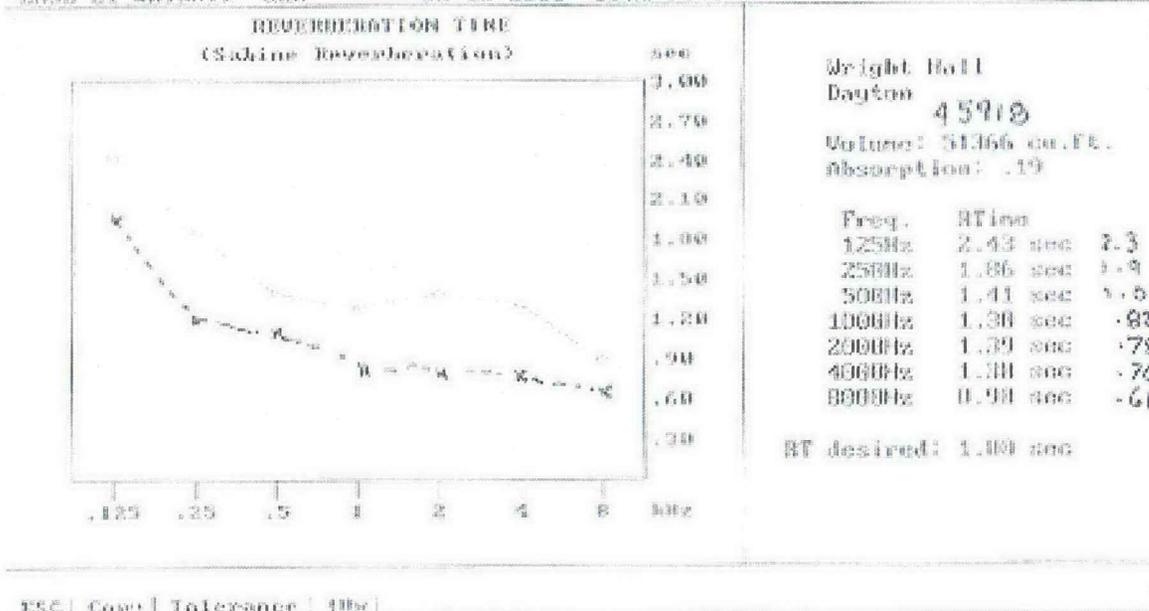
Figure 50: Acoustical Review with modified wall panels (Geiger & Hamme, 2000)

Because of the visual impact of an acoustical wall treatment, it is recognized that this recommendation will not be implemented.

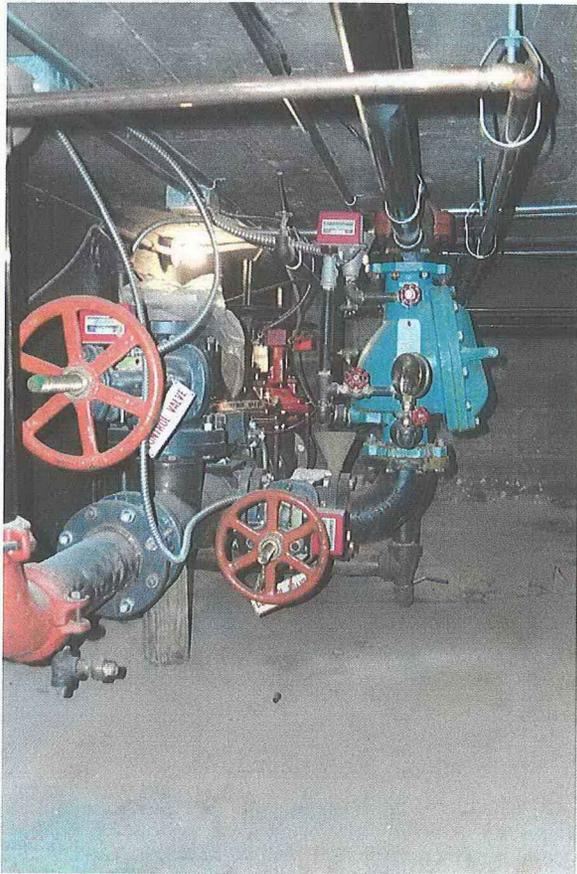
Wright Hall north plenum, east corner (QE\A 2000)
