historic structure report  
architectural data section

FREDERICKSBURG AND SPOTSYLVANIA  
COUNTY BATTLEFIELDS MEMORIAL  
CHATHAM

NATIONAL MILITARY PARK/VIRGINIA

Prepared by Gerald Karr  
Edited by Harlan D. Unrau

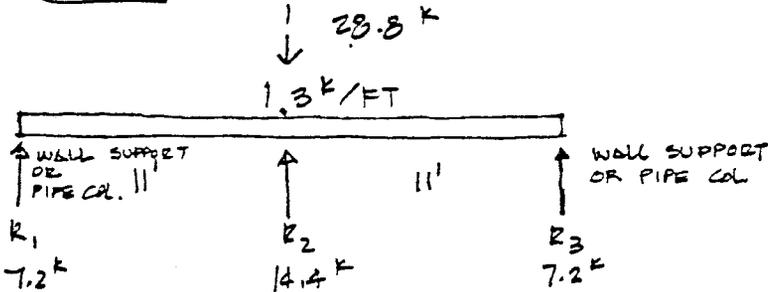
SINCE SOME OF THE SUMMER BEAMS HAVE CRACKS,  
 ASSUME THAT ALL OF THE LOADS WILL BE SUPPORTED  
 BY SOME OTHER STRUCTURAL SYSTEM. AT A LATER DATE,  
 SPECIFIC CALCULATIONS SHOULD BE DONE FOR EACH BEAM,  
 WITH CORRESPONDING SIZING OF SUPPORT MEMBERS

DESIGN OF SQUARE COLUMN TO SUPPORT 14.4 k LOAD  
 $l = 8'$        $F_c = 1250 \text{ psi}$

$$A_{4 \times 4} = 12.25 \text{ in}^2 > 11.52 \quad \therefore \text{USE } 4 \times 4 \text{ COL.}$$

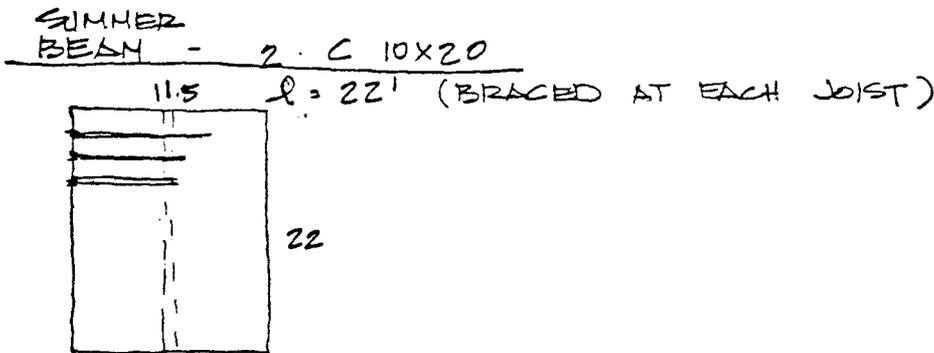
† NOTE: IT HAS BEEN NOTED THAT THESE SUMMER BEAMS ARE DEFLECTING AS INDICATED IN THE CEILING BELOW. SINCE DEFLECTION IS MINIMAL BY CALCULATION, IT IS RECOMMENDED THAT FURTHER INVESTIGATION BE DONE.

- A) EXIST JOISTS ARE ADEQUATE - IF POSSIBLE, INVESTIGATE CONDITION OF EACH JOIST.
- B) SUMMER BEAMS (2 10x20) - CALCULATIONS SHOW THAT THESE ARE ADEQUATE. HOWEVER, SINCE SOME DEFLECTION HAS OCCURRED, FURTHER INVESTIGATION SHOULD BE DONE.

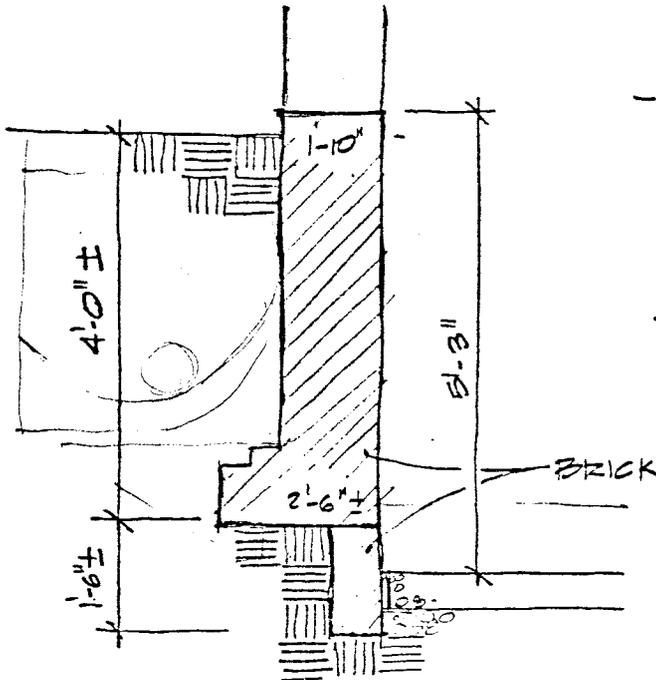
FOUNDATION SECTION

- SOIL - HARD CLAY  
SPEC 2900 ± p. 455 (UBC)  
† ALLOW FOR PRESSURE - 1500 PSF  
LATERAL BEARING - 150 lbs/ft

† THIS FIGURE IS CONSERVATIVE.  
MORE ACCURATE FIGURES SHOULD  
BE OBTAINED FROM A THOROUGH  
SOIL INVESTIGATION.

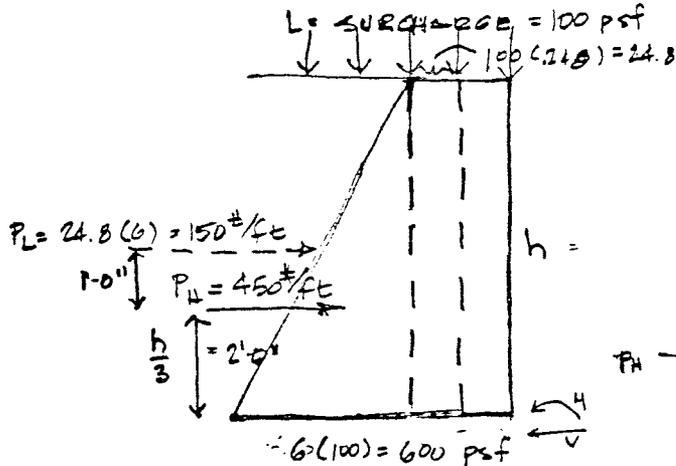
3) REPAIR OF BULGING FOUNDATION WALLS.

$h = 6.0' \pm$

EARTH WEIGHT - 100 pcf  
ALLOW. LATERAL BEARING. 150 lbs/ft.

- FOUNDATION STABILIZATION SYSTEM MUST BE ABLE TO RESIST A MAX. LATERAL PRESSURE OF  $150 + 450 = 600 \text{ #/ft}$ .

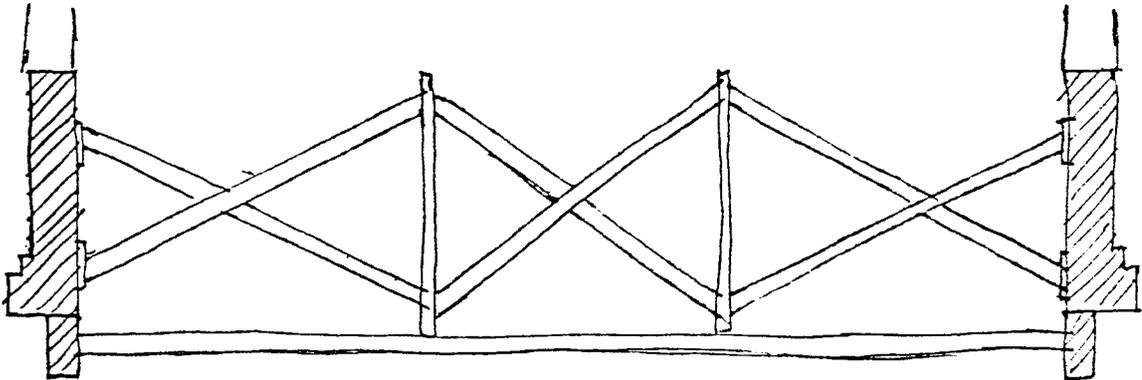
ALT. 4 - CROSS-BRACING

- LOCATIONS FOR EACH ALTERNATE VARY WITH EXTENT OF FAILURE

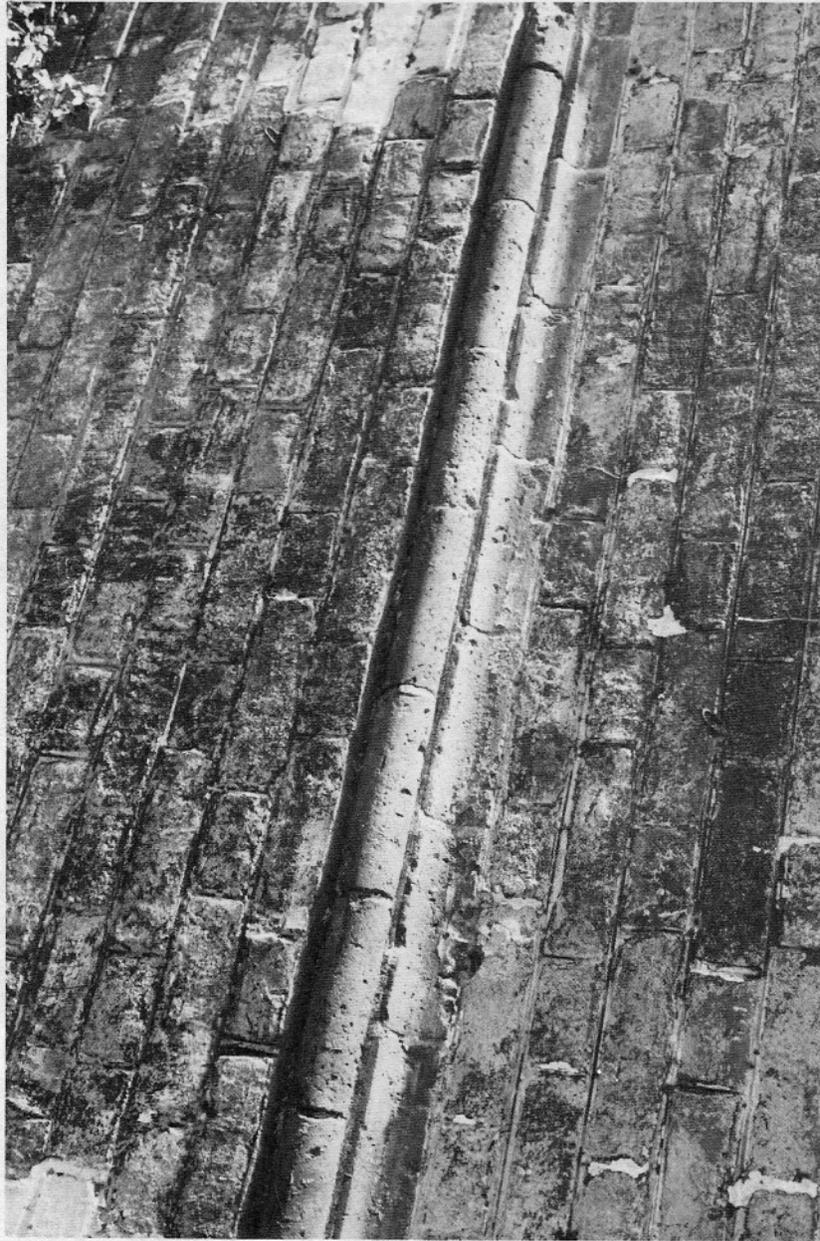
31. Chatham. Plantation House. East elevation. This section of ovolo and cove water is among the best preserved. Note that Flemish bond is employed below. Photograph by Gerald Karr, 1976.

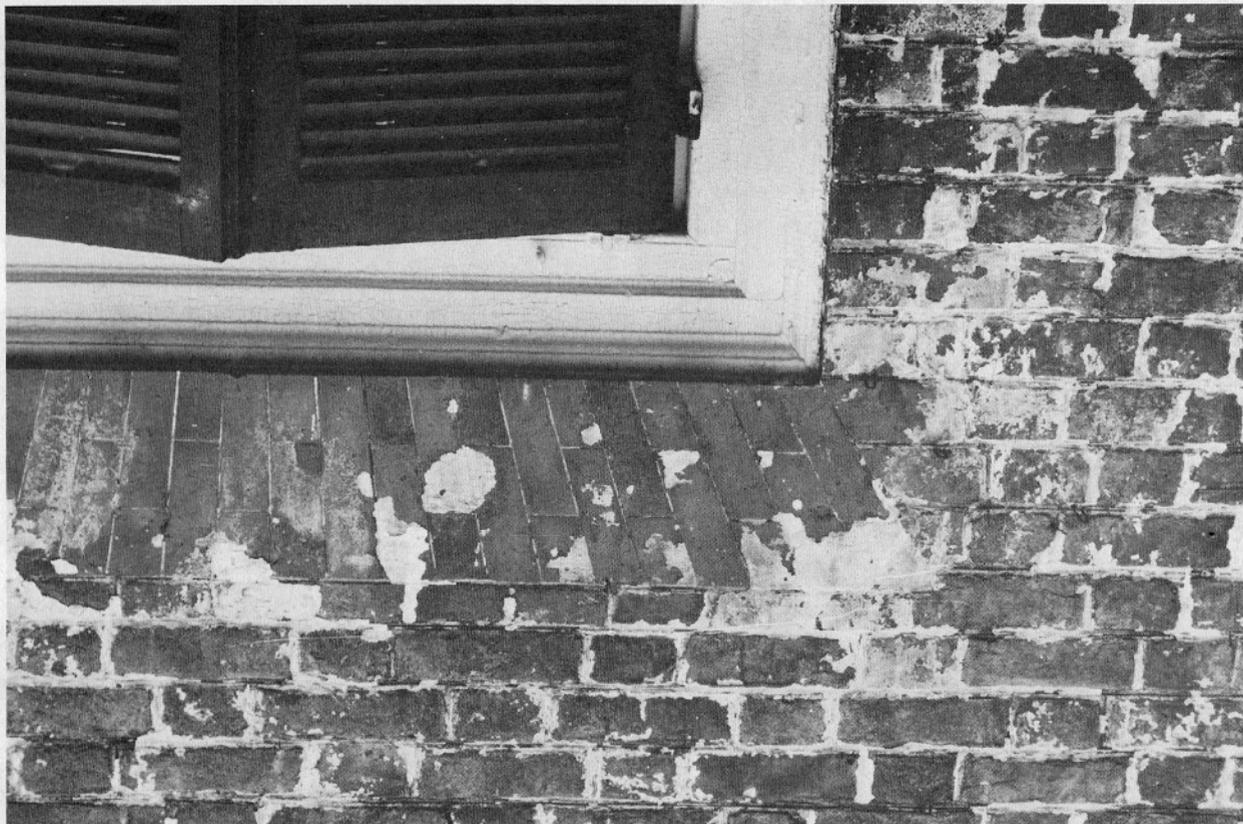
32. Chatham. Plantation House. Detail of jack arch over typical west window. The horizontal joints in the arch are merely inscribed in the brick to simulate mortar joints. Photograph by Gerald Karr, 1976.

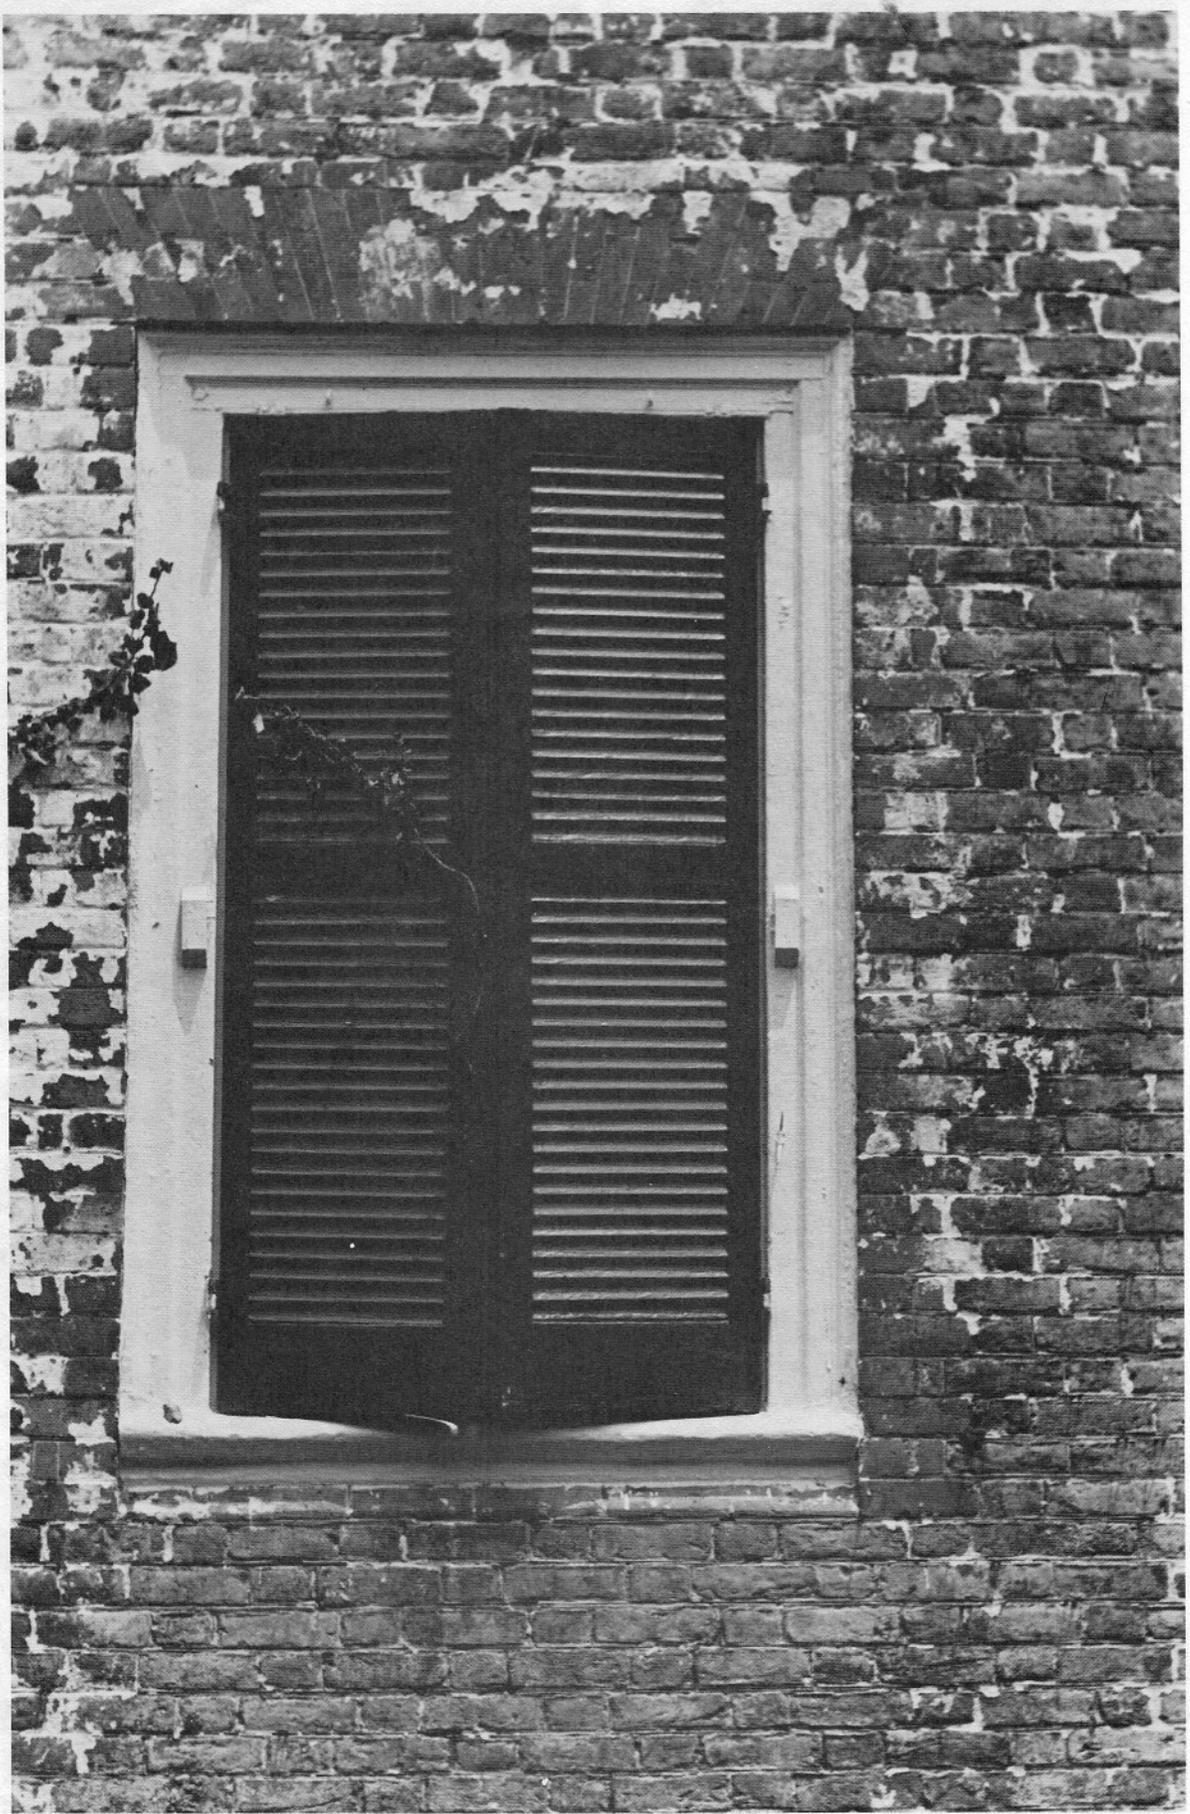
35. Chatham. Typical first-floor window. The frame, sill, and trim are original. Note the rubbed brick jack arch and jambs. Photograph by Gerald Karr, 1976.

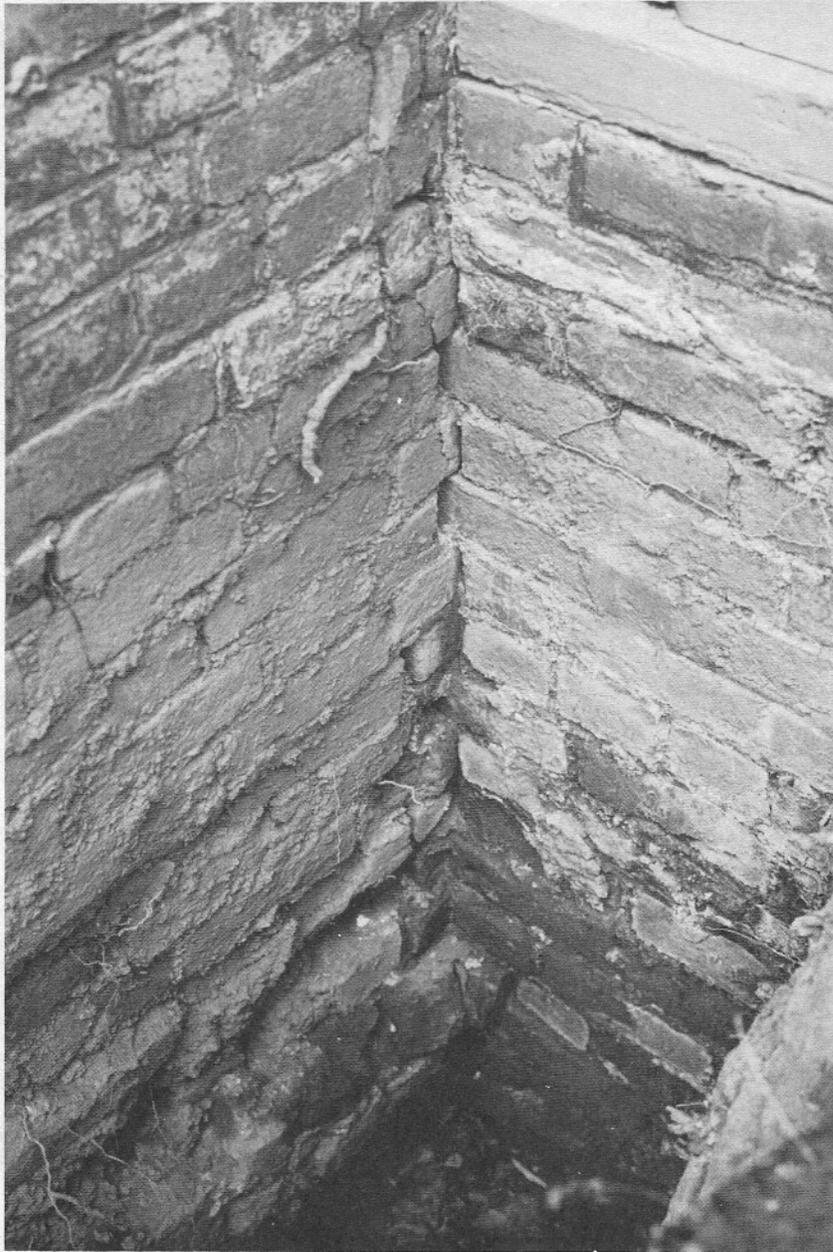
37. Chatham. Plantation House. Juncture of central portion of house with south passage below grade showing keying of brick courses at corner. Photograph by Gerald Karr, 1976.

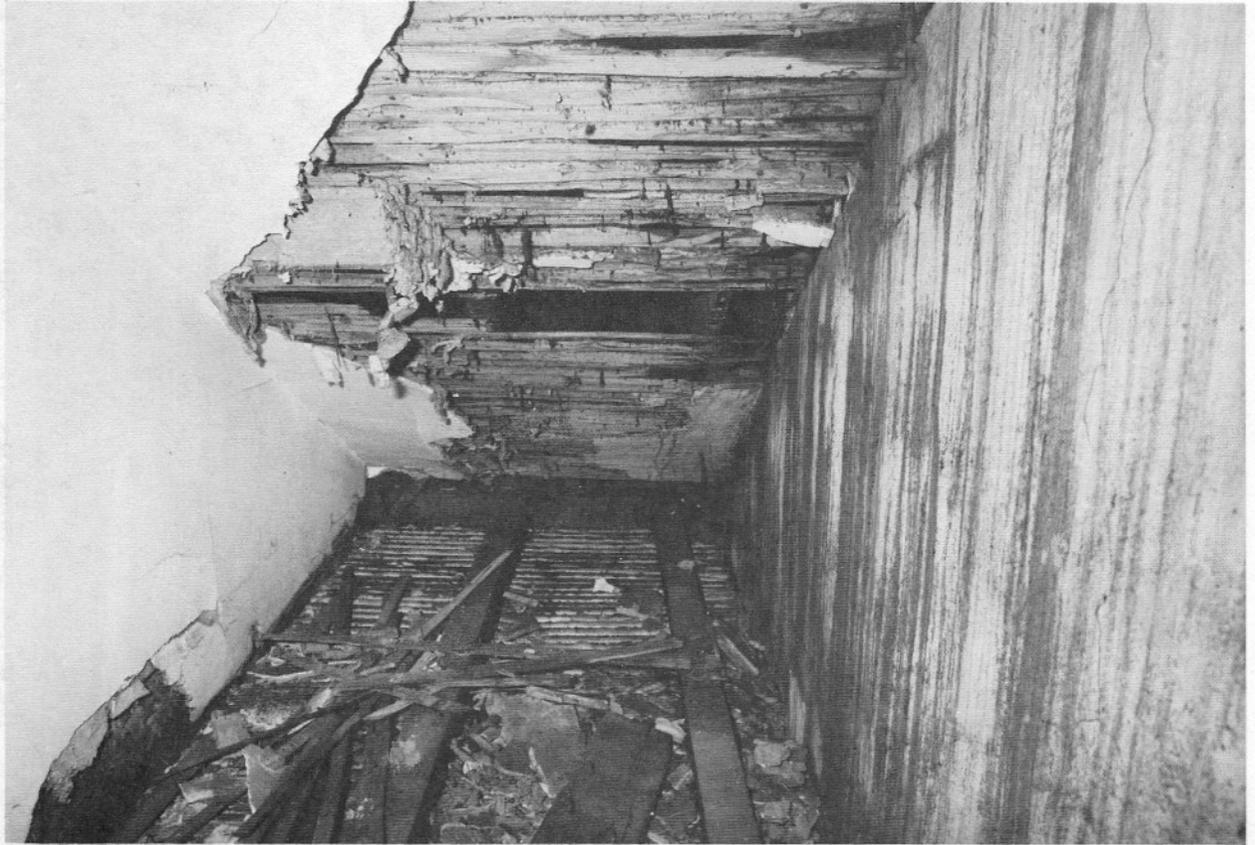
38. Chatham. Plantation House. Remains of original stair hall at the ceiling level. Photograph by Gerald Karr, 1976.

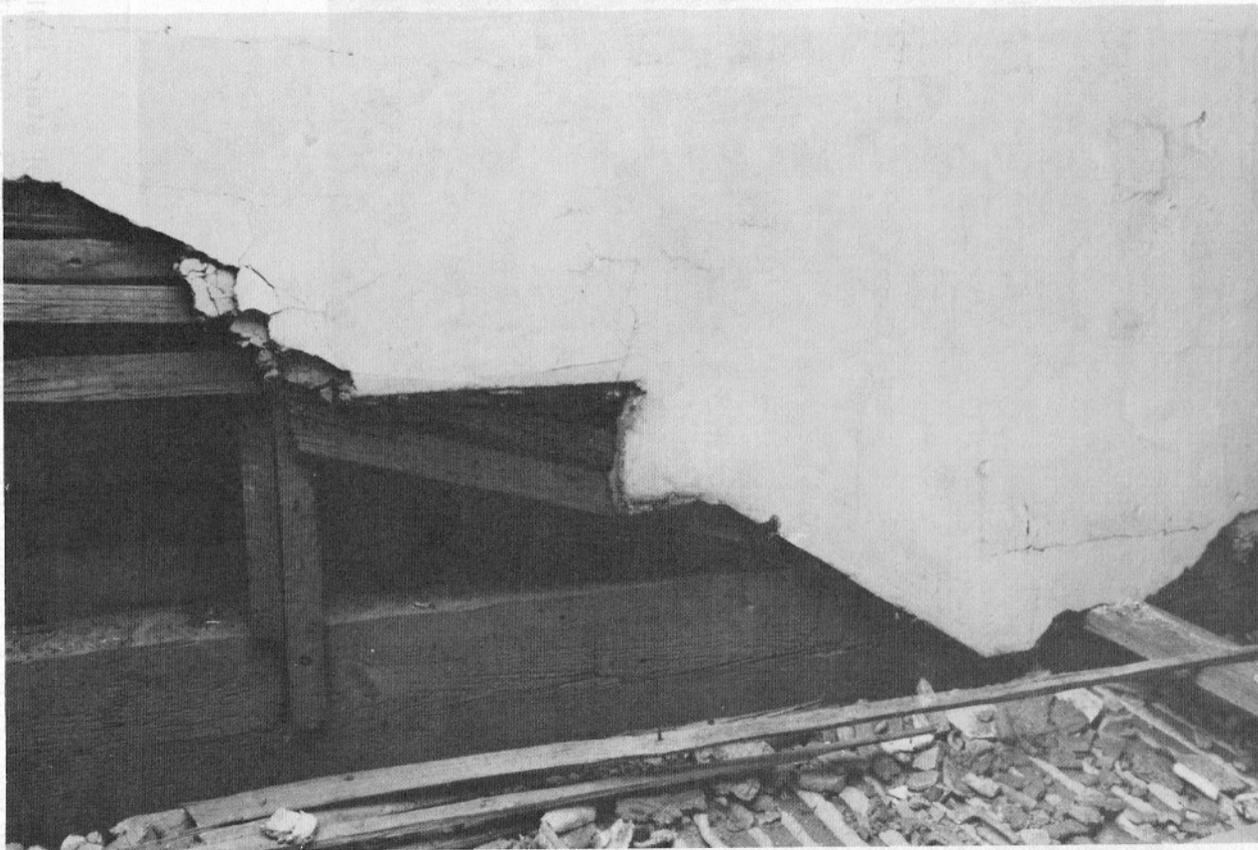
39. Chatham. Plantation House. Remains of original stair hall at the ceiling level. Photograph by Gerald Karr, 1976.

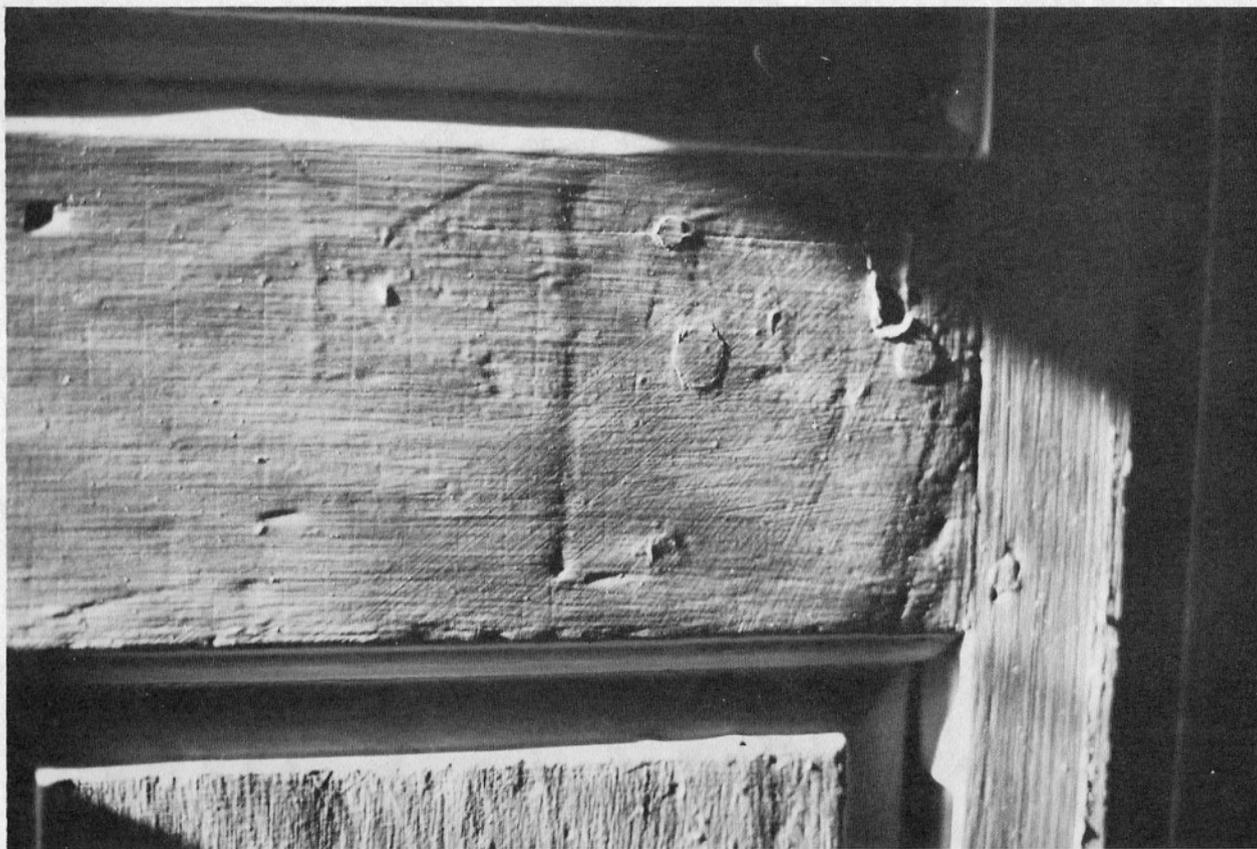
40. Chatham. Plantation House. This door, located on the south wall of Room 111, reveals marks of the original rimlock when subjected to raking light. Photograph by Gerald Karr, 1976.

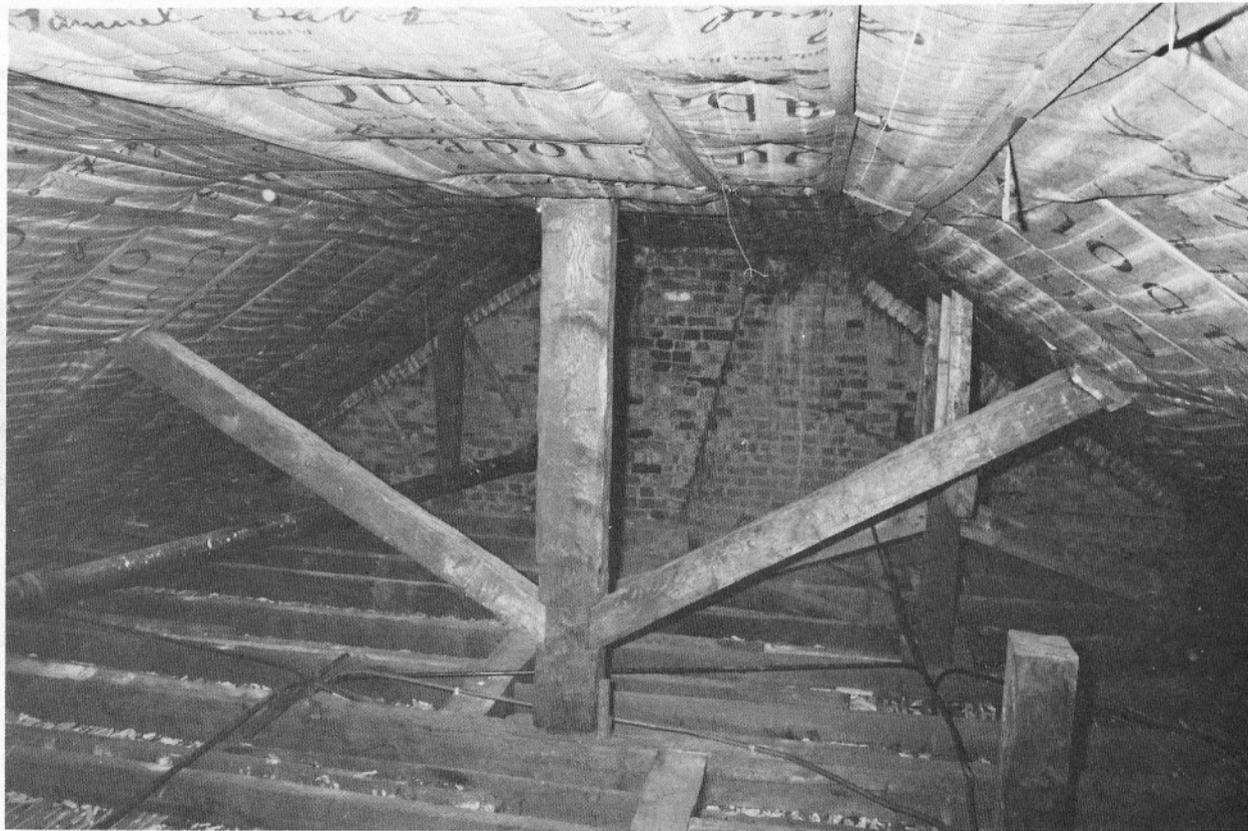
41. Chatham. Plantation House. Attic looking south showing original kingpost. Note that the post has pulled away from the summer beam below. The quilted seaweed insulation is also shown. Photograph by Gerald Karr, 1976.

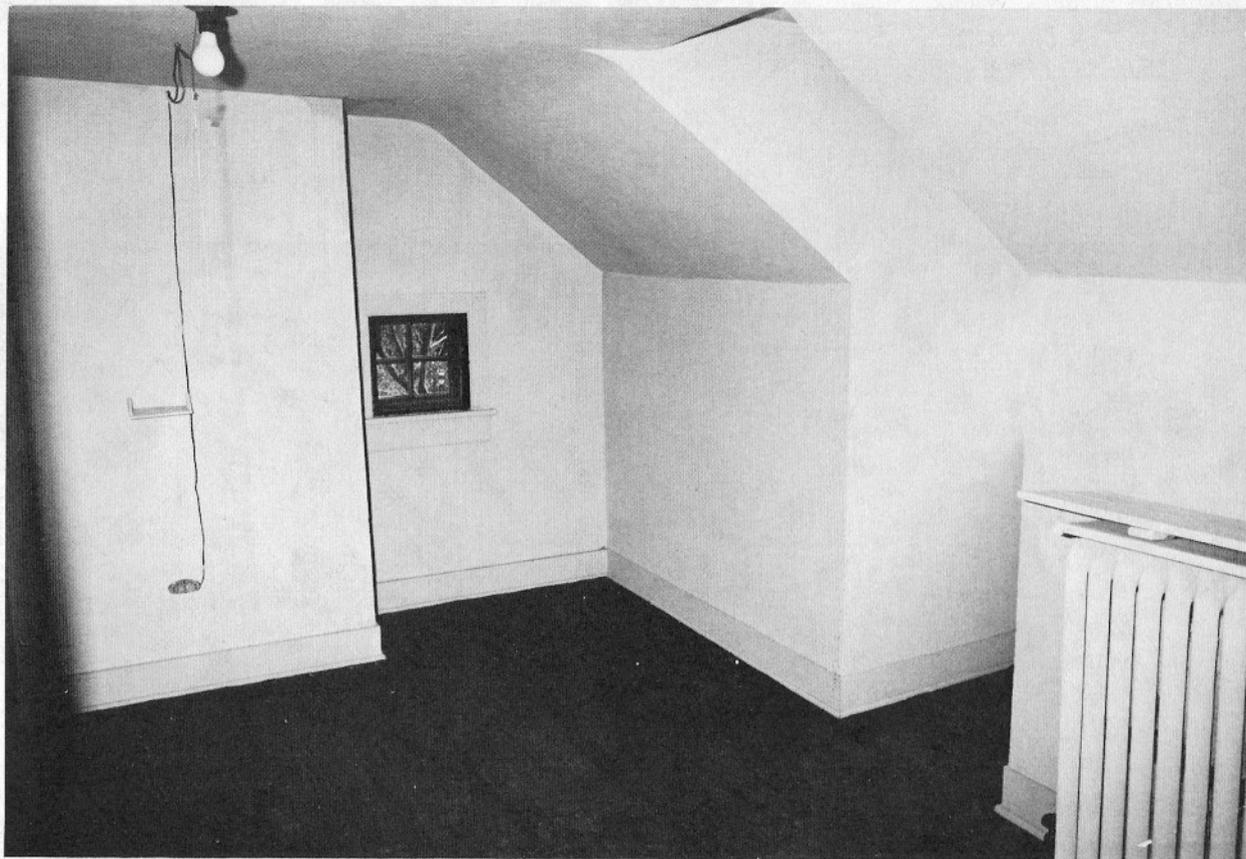
45. Chatham. Kitchen. Second floor, looking east. Note the makeshift wiring arrangement. Photograph by Gerald Karr, 1976.

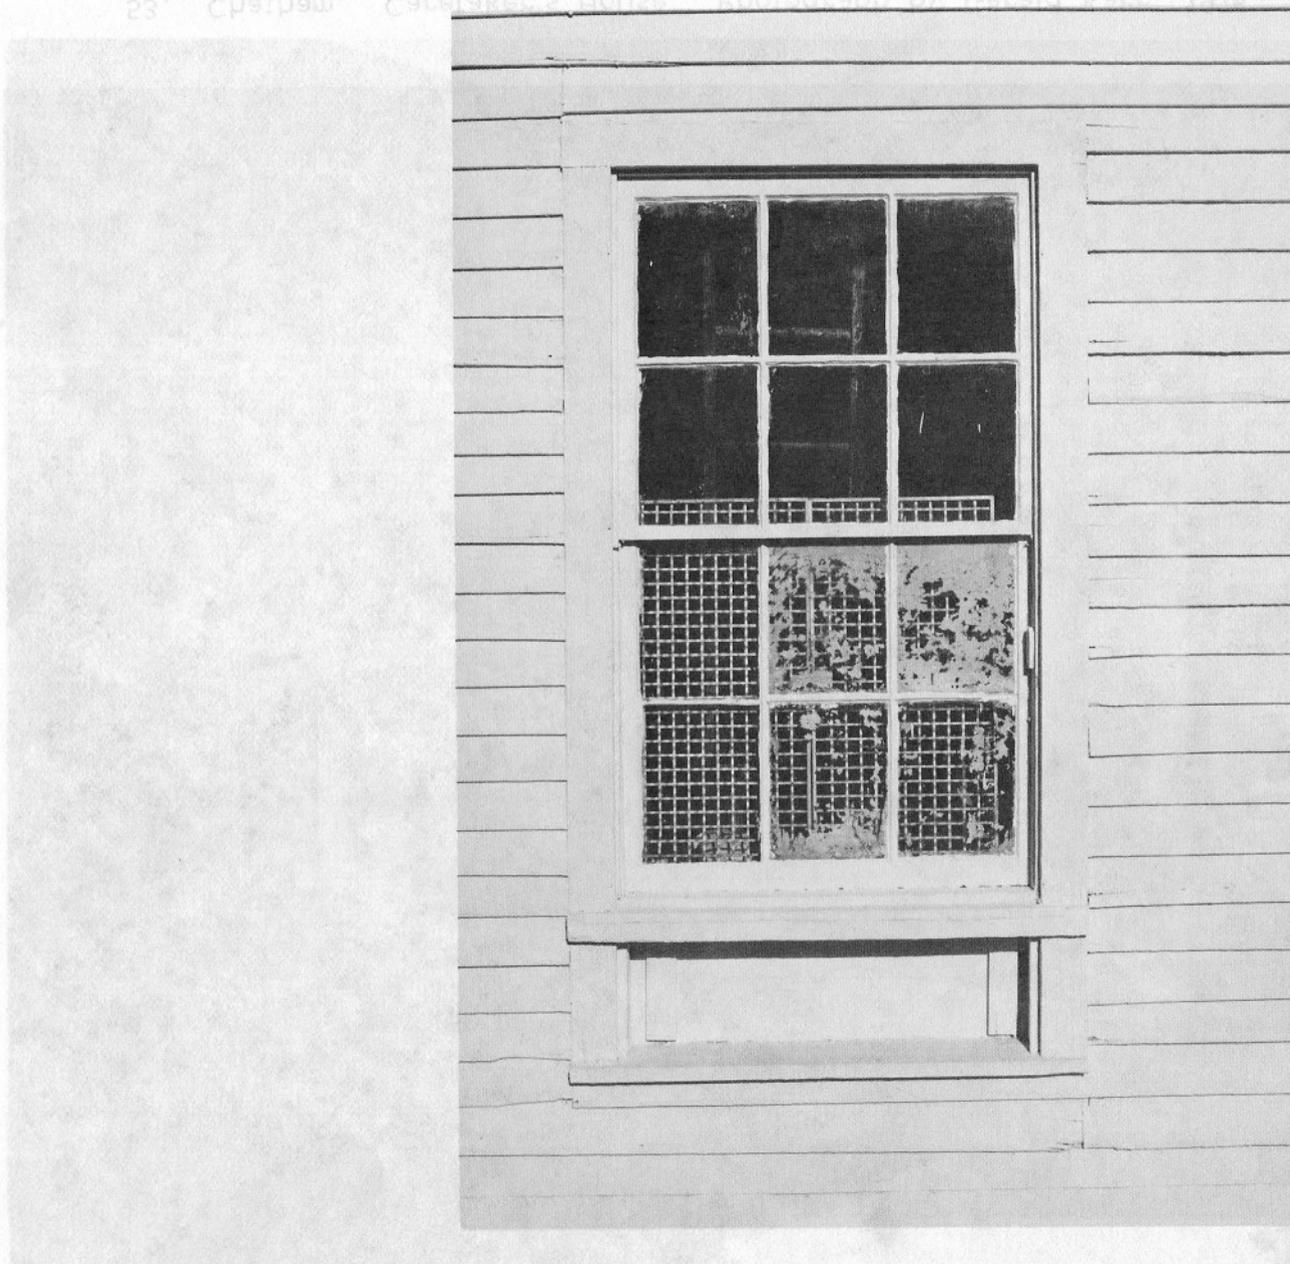
52. Chatham. Dairy Barn. Window detail showing the modified sill. Photograph by Gerald Karr, 1976.

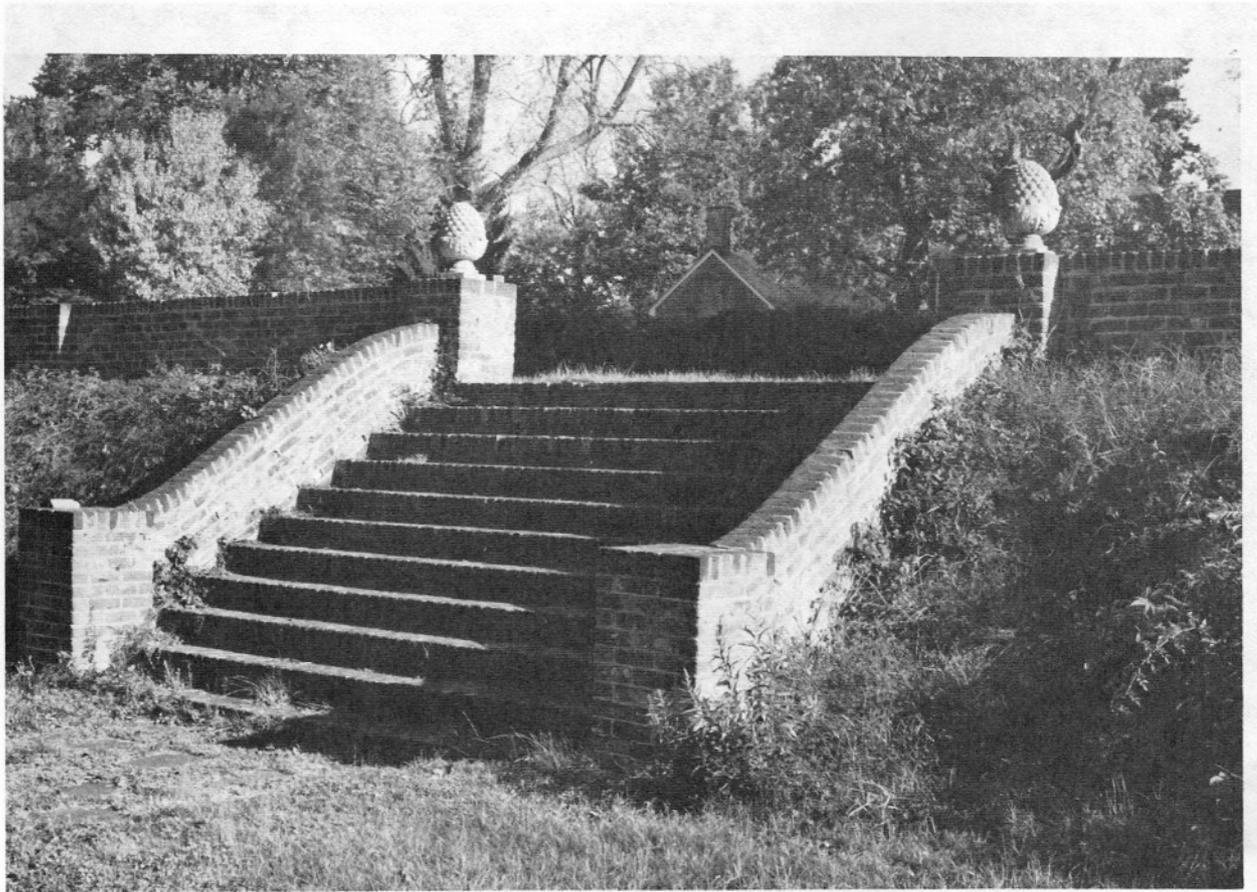
65. Chatham. Ha-Ha Wall. The ornamental pineapples are not fastened securely to the wall. Photograph by Gerald Karr, 1976.

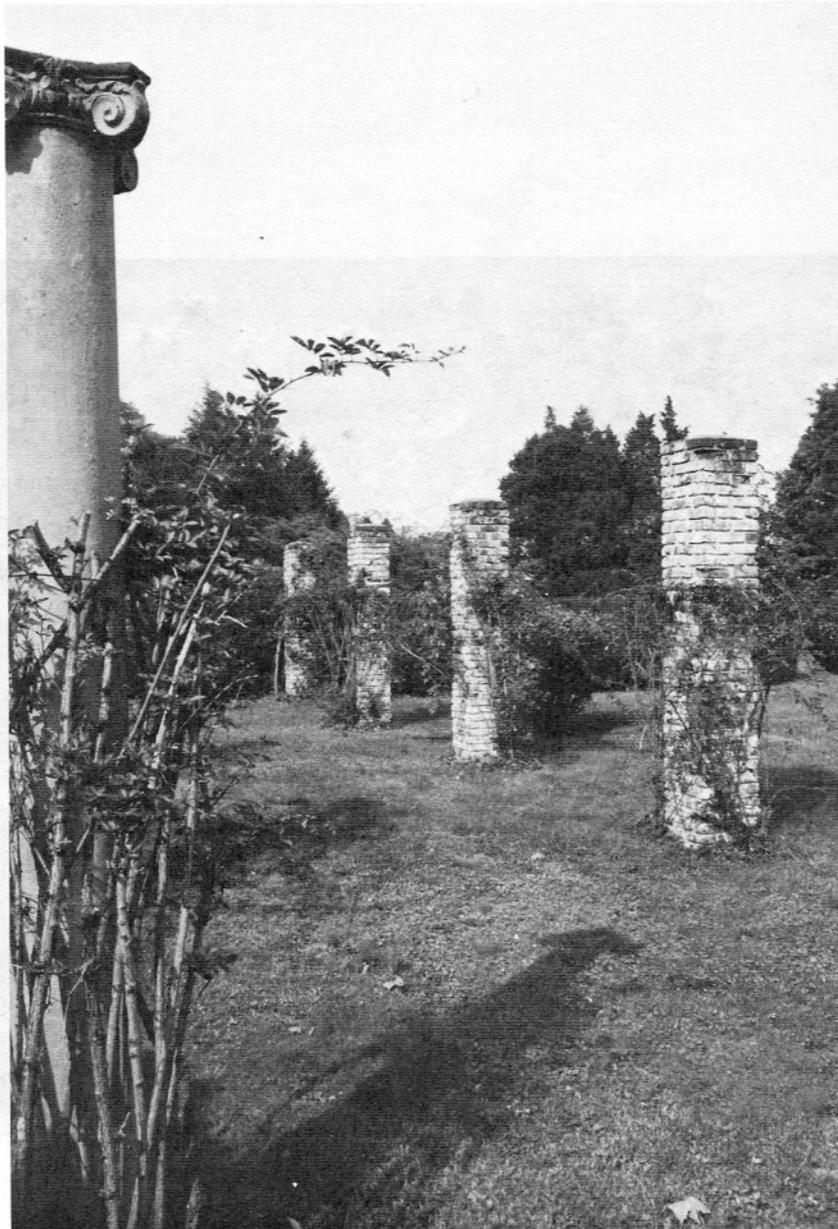
67. Chatham. Pergola. The lintels which spanned from the ionic columns, left, to the brick piers have been removed. Photograph by Gerald Karr, 1976.
