Alcatraz Barracks Building 64

Abbreviated Historic Structure Report

Produced by the
Cultural Resources and Museum Management Division
Golden Gate National Recreation Area
National Park Service
U.S. Department of the Interior
Washington, DC

September 2003

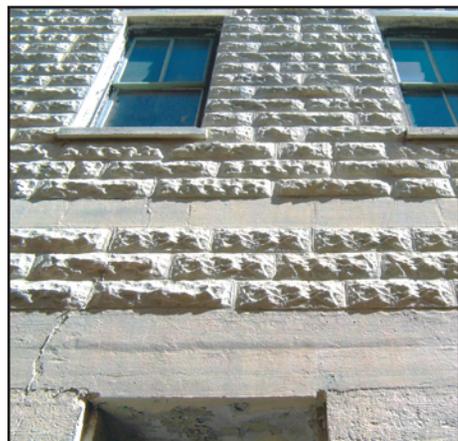
Bottom: Closeup of concrete block exterior wall, 2003 Photo Credit: John Martini.

The walls of the upper three floors are constructed of unreinforced hollow concrete masonry units approximately 10”x32” in a running bond pattern. The block at the first floor is 16” thick, the second 14”, and the third 12”. The hollow concrete blocks were molded with a rock-faced ashlar pattern on the outside. The resulting appearance is that of a stone barracks building. The block walls appear to be generally in good condition, however there is some localized damage to the block at the third floor on the southwest end of the building as a result of the recent windstorm and a previous fire. This area was repaired in February of 2003. Paint on the block walls is peeling and there is mold in several locations.

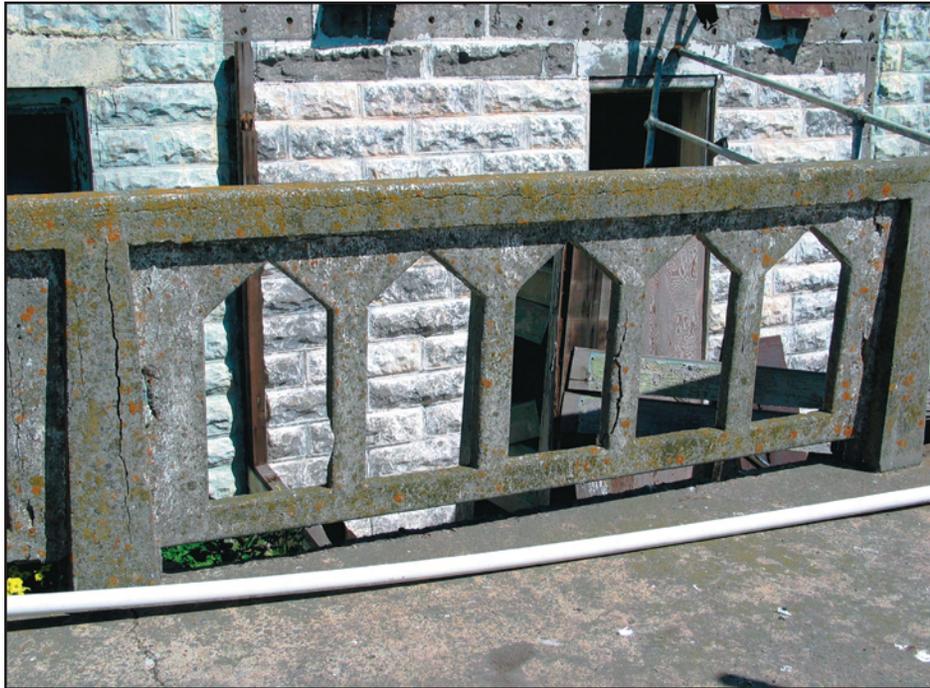
Top: View of historic concrete railing, 2003. Photo Credit: Jane Lehman.

concrete railings in this area were replaced in 2001. These are in good condition. Railings that were not replaced show large spalls with exposed and rusted reinforcement steel. One section of concrete railing in this area collapsed when roof debris fell on it during the November 2002 storm.

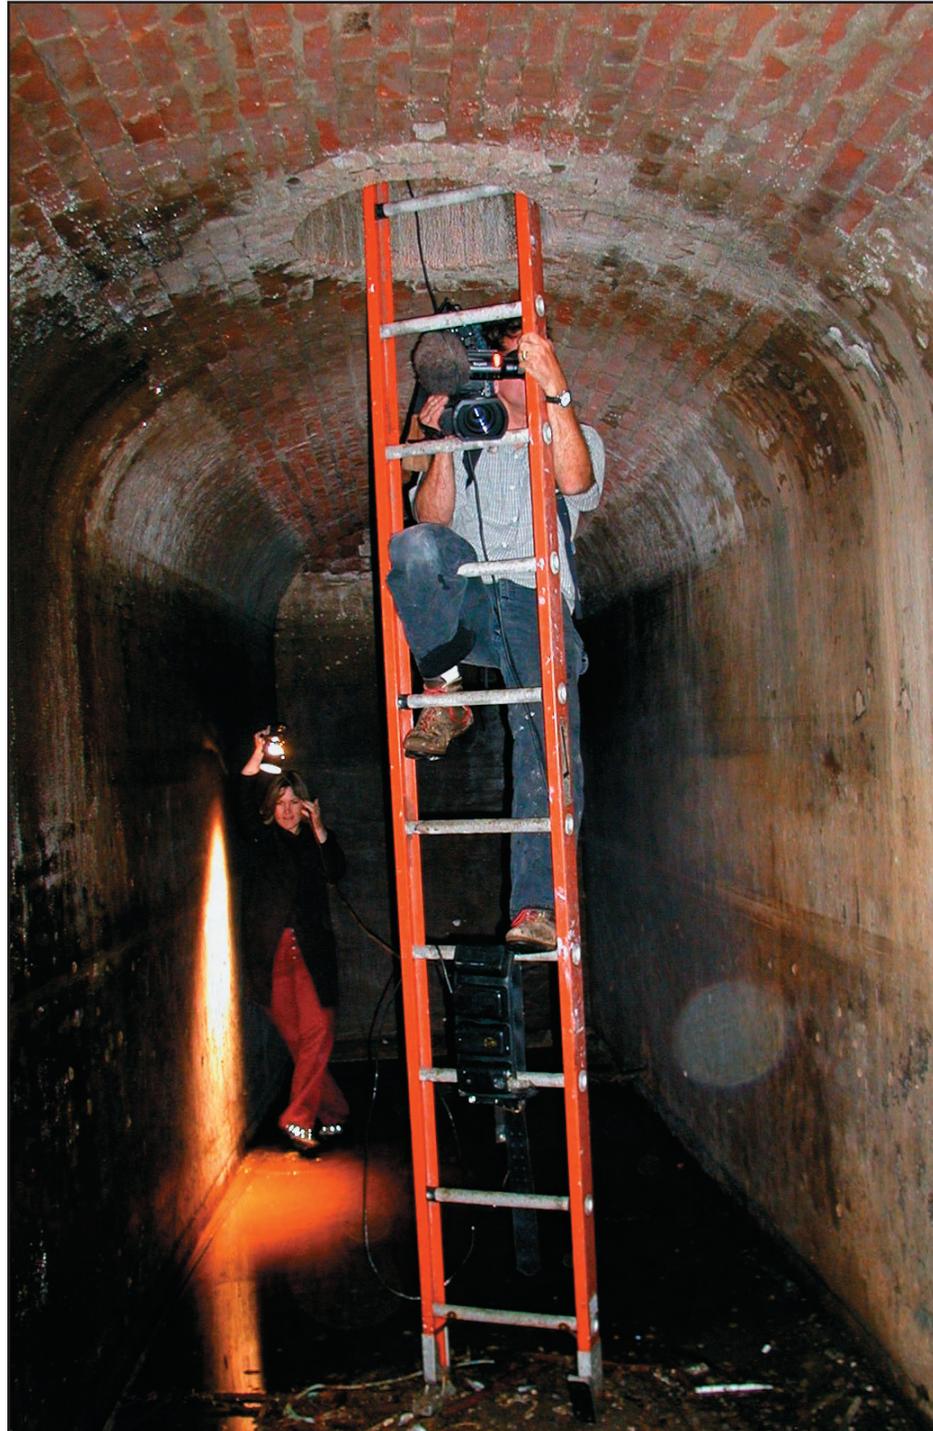
Interior of cistern behind Building 64.
Photo Credit: Martin Mayer .

Cisterns located behind Building 64 originally held potable water for the occupants of the building. The cisterns were abandoned and fresh water was supplied from the water tower after it was constructed at the top of the island. As was the case with the rest of the island, toilets in Building 64 were plumbed with seawater pumped directly out of the bay. The cisterns still remain in good condition. The condition of the piping for the building varies from good in certain interior locations to completely deteriorated in locations exposed to the marine climate.

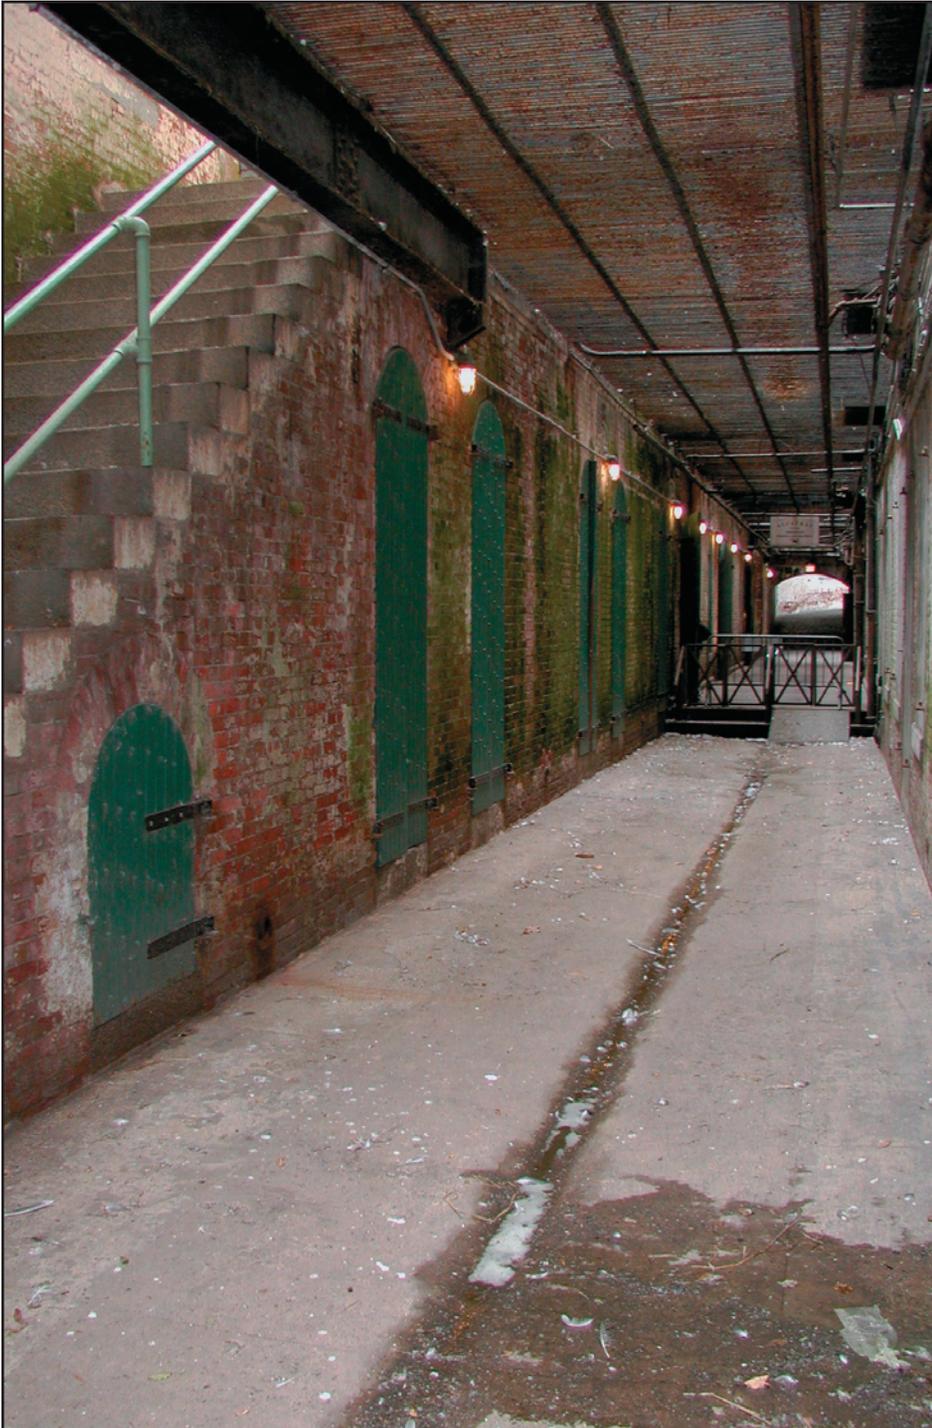
‘China Alley’ has a concrete floor with a channel drain that slopes to drain runoff into one large floor drain in the center of the alley. A raised wood deck has been added at the north end of the alley to make the floor levels between the storage rooms and the casemates contiguous, doing away with the need for stairs into and out of the alley and thus linking the alley rooms to an accessible path of travel for visitor use. This boardwalk is not adequately ventilated. Also, the drainage system in the alley is in need of repair, as it appears as though water in the alley does not drain properly. Since there are high spots that collect water, the water stagnates and foul odors consume the alley, creating a constant maintenance problem.

Left: Concrete floor in "China Alley", 2003. Photo Credit: John Martini.

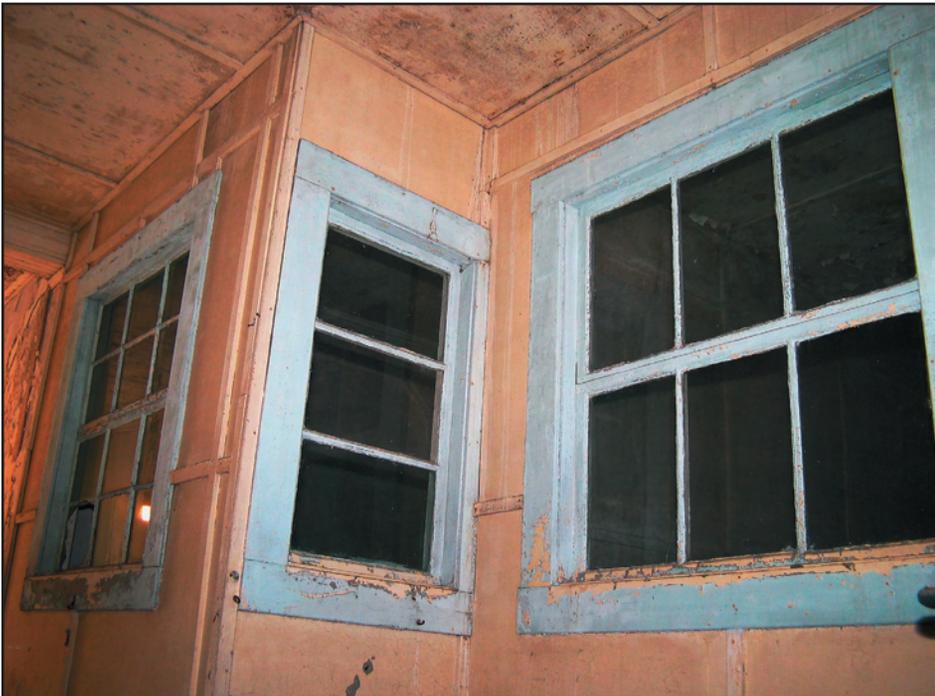
The condition of the walls on the upper levels ranges from poor to very poor. Paint is peeling extensively on the majority of the walls. Many walls have holes in them due to vandalism during the Indian Occupation. Some interior walls have been removed. The Third Floor walls have been damaged extensively by water penetration during several periods when the building's roof was in disrepair.

View of extensive ceiling damage at south end of third floor, 2003. Photo Credit: Jane Lehman.

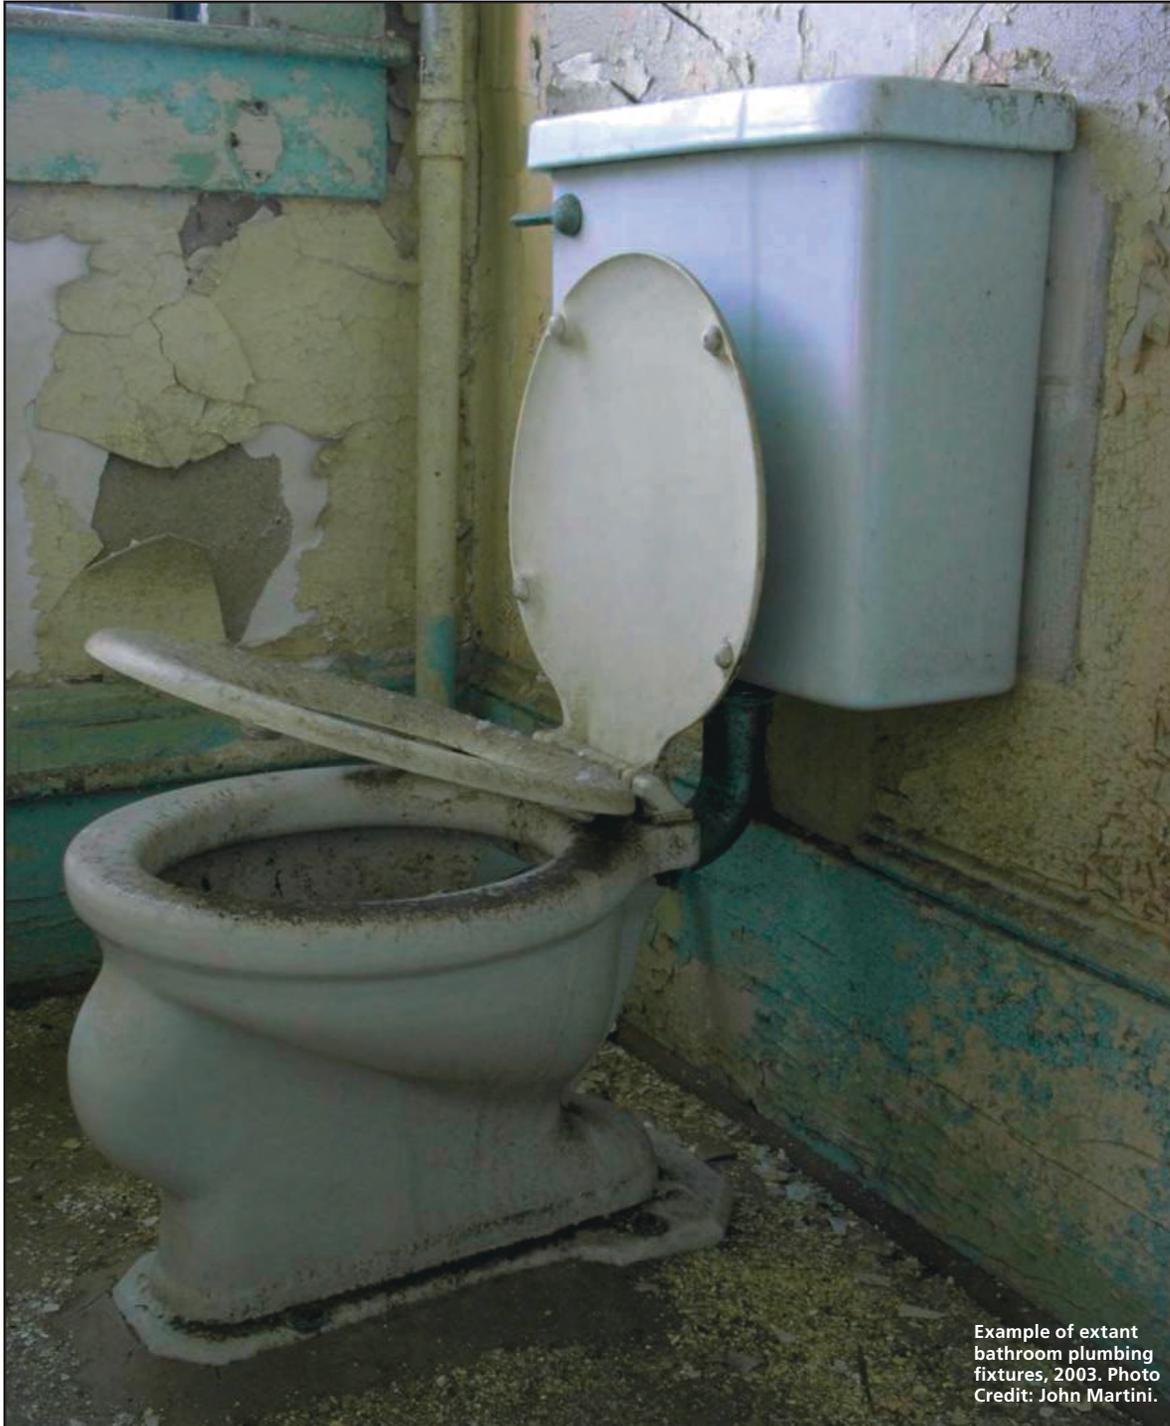
Example of extant bathroom plumbing fixtures, 2003. Photo Credit: John Martini.

floor-mounted bowls with wall-mounted tanks. The majority of the tanks are broken off the walls and the bowls are clogged with debris. In almost all cases, the wall-mounted sinks are broken off the walls.
