PART II: TREATMENT AND WORK RECOMMENDATIONS

GULF OF THE FARALLONES NATIONAL MARINE SANCTUARY, FORT POINT COAST GUARD STATION REHABILITATION OF THE MAIN BOATHOUSE/LIFE SAVING STATION (PE1903)

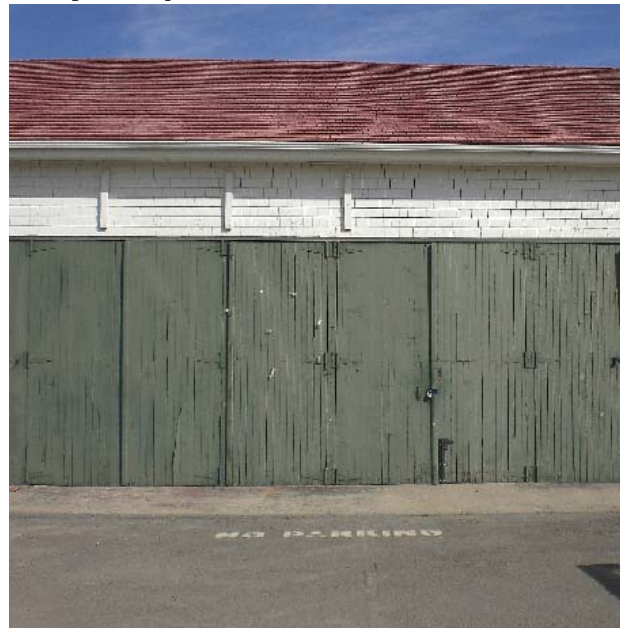
Fig. 48: Vertical tongue-and-groove wood doors at the Shop & Garage.

Condition: The doors are in fair condition. The wood doors have been altered slightly by the removal of the original locks and addition of modern dead bolts. Several do not close properly. Many of the thresholds are worn as well. The garage doors are in poor condition due to improper clearance between the doors and the concrete driveways. The vertical boards drag across coarse aggregate concrete driveways, resulting in mechanical damage. In addition they are regularly exposed to standing water.

Recommendations: Replace non-contributing doors with replicas of the originals. Repair existing doors as follows:

- Perform a detailed survey/inspection of all doors to identify specific repair locations.
- Remove all dirt, debris and miscellaneous attachments.
- Remove finish if necessary to perform repairs.
- Repair splits and separations with waterproof glue as required.
- Consolidate deteriorated with wood epoxy or perform Dutchman repairs. Replace extensively deteriorated components in kind.
- Install weather stripping.
- Recondition extant original hardware. Install new hardware, where missing, to match original.
- Ensure the smooth operation of the doors.
- Finish doors to appropriate interpretive period.
- Inspect doors regularly for deficiencies of finish and operation.

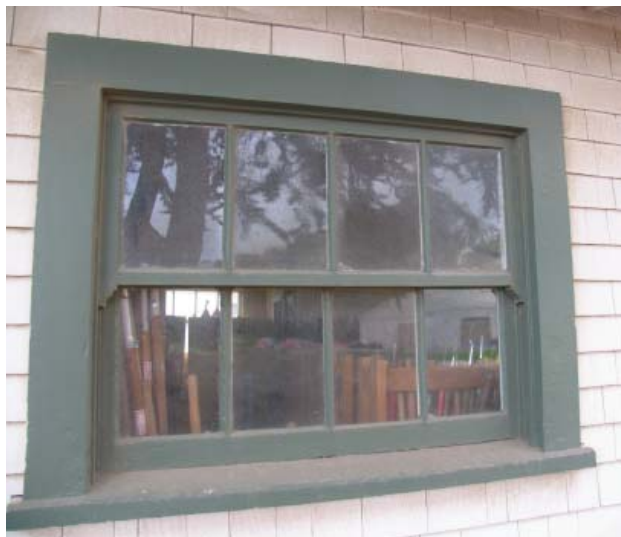
Fig. 51: Four-over-four lite windows at the Main Boathouse.

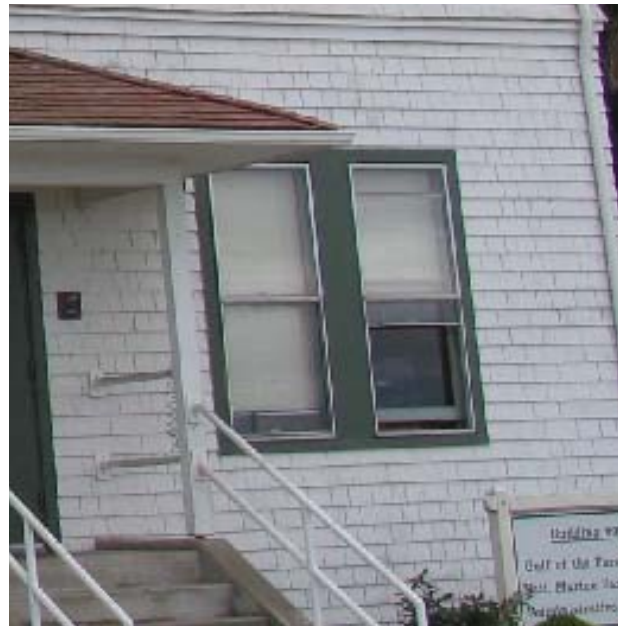
Fig. 54: Double-hung window at the Main Boathouse

Condition: The windows are in fair condition. Many have been altered over time, or have been replaced altogether with either inappropriate wood sash or with aluminum sash (see figures 22 & 33). Water intrusion was noted at south elevations, particularly where the windows have been altered or replaced. Several windows have been fixed in place, or are stuck. The exterior paint is deteriorating on many of the windows, and joint separation is occurring in some wood windows. Much of the glazing compound is dried, cracked or missing. Most hardware is intact.

Recommendations: Replace non-contributing windows, particular aluminum sliders, with replica wood windows to match those shown in early drawings and photographs. A number of replacement windows fall within the period of significance, therefore restoration would not necessarily warrant their removal or restoration to their pre-renovation condition. While it would be possible to restore the windows to the pre-renovation/replacement condition, it may be argued that these 60 year old replacements have acquired significance over time, and that they may help to tell the full story of the buildings. Finally, their removal may constitute intrusions to the historic fabric that would result in a net loss of historic fabric. Therefore, careful consideration of all of these factors is recommended prior to a decisions regarding the dispensation

- Survey and examine in detail the existing condition of all wood windows.
- Remove all dirt, debris and miscellaneous attachments.
- Remove paint to obtain clean surface where repairs are required.
- Remove existing glazing putty. If the existing putty contains asbestos, follow legal means for handling, removal, and disposal of contaminated material.
- Consolidate, repair or replace deteriorated wood elements in kind, where necessary.
- Restore window to proper operation.
- Install new hardware, where missing, to match original.
- Install new glazing, where cracked or missing.
- Prepare wood surfaces, prime and paint. Match historic finishes.
- Replace non-contributing wood and aluminum windows with new replica windows to match historic window types.

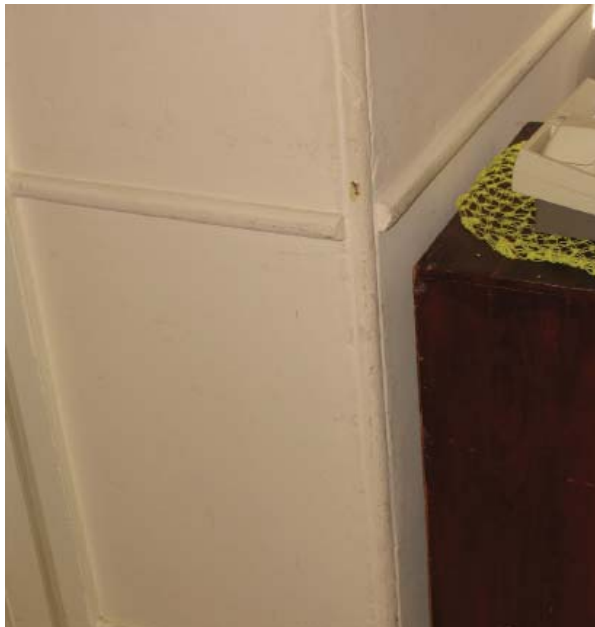
Fig. 59 :Flat plaster wall and corner bead at the interior of the Officer in Charge Quarters.

Condition: The conditions of the plaster walls is generally good. Some areas have been damaged by water infiltration.

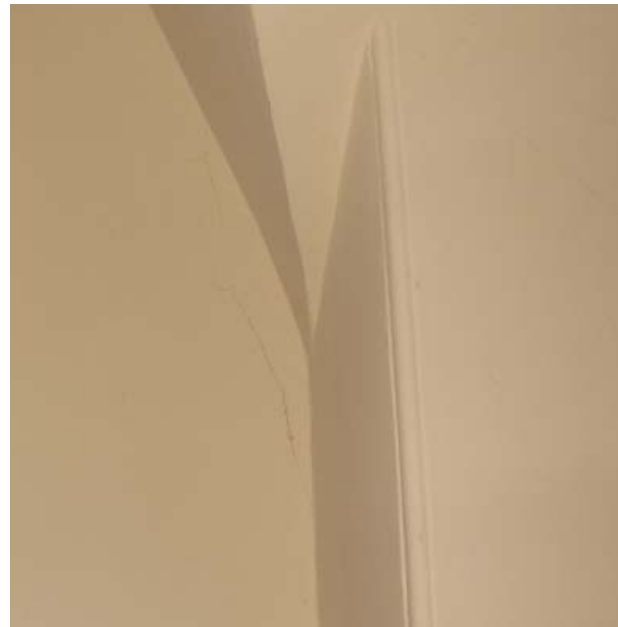
Fig. 60 :Flat plaster wall and corner bead at the interior of the Officer in Charge Quarters.

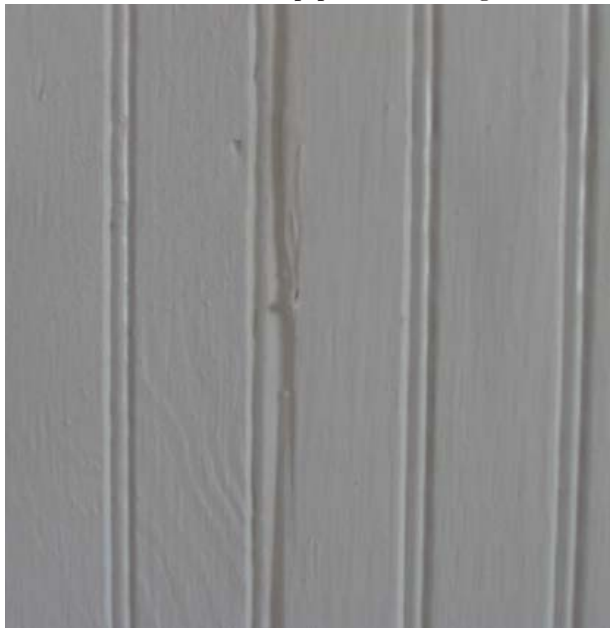
Fig. 61 : Beadboard wall cladding in the Buoy Shack.

Description: The walls of the Buoy Shack, the Tide Gauge House, and the Main Boathouse are vertical beadboard (see figure 61). The walls of the Shop & Garage, and the 1890 Boathouse are board (see figure 62). All of the walls are painted.

Recommendations: Repair wood wall cladding as follows:

- Conduct a detailed, wall survey to document condition of each elevation and determine, on an individual basis, required repairs.

- Remove paint and refinish to match original where necessary. Carefully remove, salvage, label and appropriately store any boards, hardware and trim that must be removed.
- Restore missing boards which have been removed during alterations. Match original with respect to profile, wood type and finish.

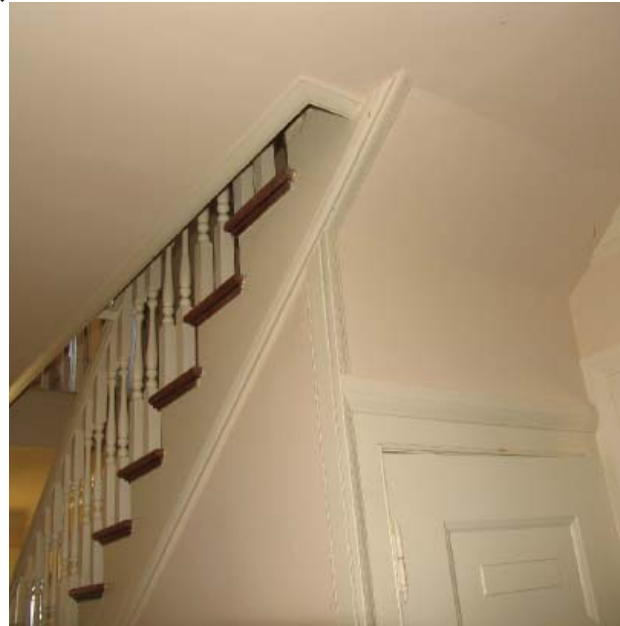
Fig. 64 :Painted wood stair, balustrade, and door at the Officer in Charge Quarters.

Description: All interior plaster and woodwork is currently painted (see figures 63 & 64).

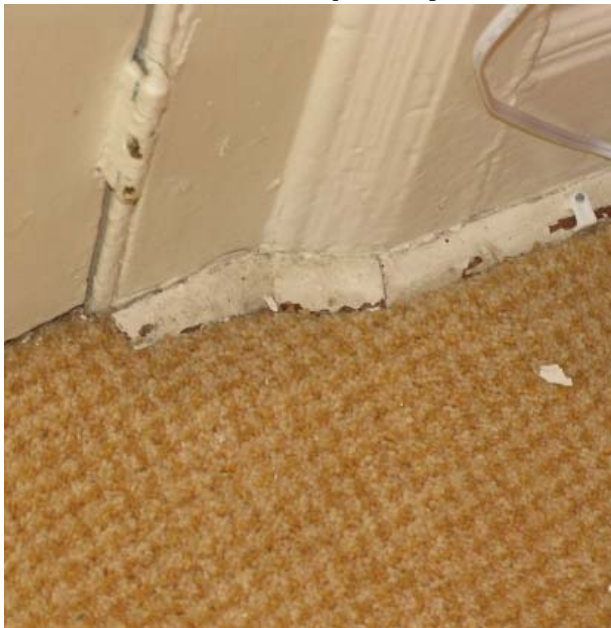
Fig. 65 : Wood baseboard, bead molding, and carpet at the Officer in Charge Quarters.

Description: Extant finish flooring of the Main Boathouse and Officer in Charge Quarters currently includes wall-to-wall carpet over an unknown substrate (see figure 65). The flooring in the 1890 Boathouse, Shop

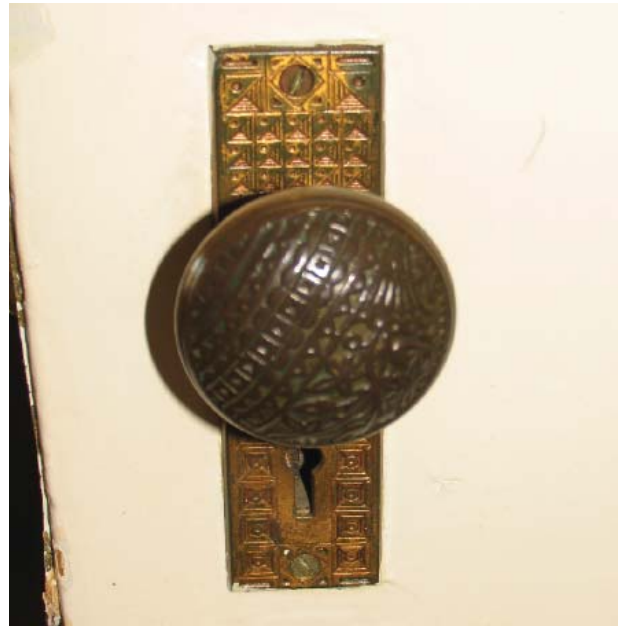
Fig. 70 :Original hardware at the Officer in Charge Quarters.

Description: The majority of the hardware is original and intact. It consists of bronze doorknobs, bronze faceplates and hinges, and bronze window catches (see figures 69 & 70). Several locks on the exterior doors have been replaced with modern dead bolt locks.

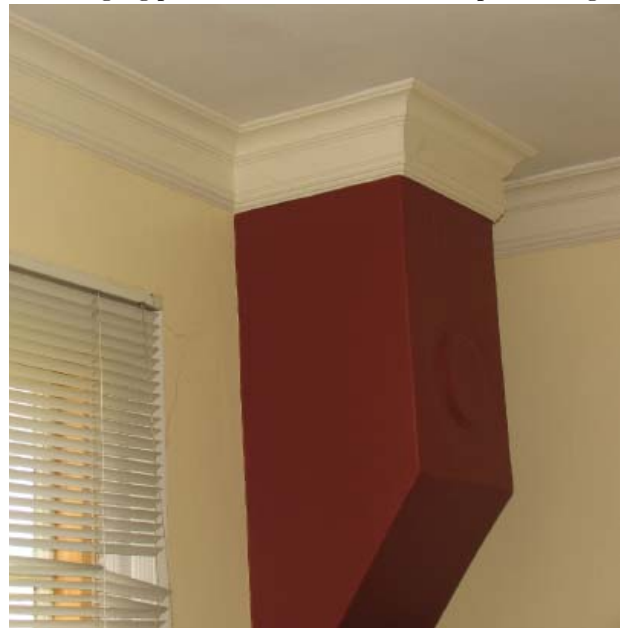
Fig. 74 : Flue and flue cover at the Officer in Charge Quarters, remnant of earlier stove heating system.

Description: The Officer in Charge Quarters was originally heated by stoves. Flue holes, covered over by plates, survive in many rooms, as do fireplaces in the parlors and dining rooms (see figure 74). A propane-fueled forced air system has been installed in the house, and grates are visible in the majority of the rooms. It is unknown whether or not any of the other structures were heated. The Officer in Charge Quarters appears to be heated by a propane-fueled forced air system.
