SAN FRANCISCO
PORT OF EMBARKATION
HISTORIC STRUCTURE REPORT

Golden Gate National Recreation Area
National Park Service

ARCHITECTURAL RESOURCES GROUP

February 1991

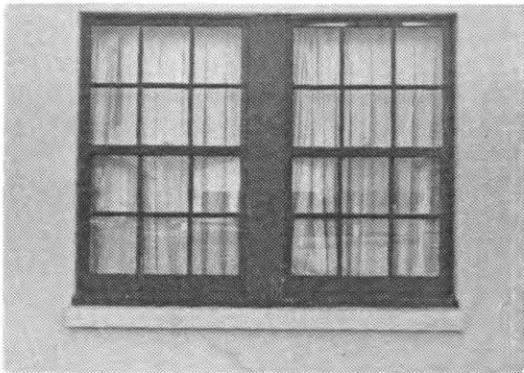
Factory sash in Pier Shed 3 with a bowed frame.

Missing muntins, sashes and frames should be replaced and matched to original.

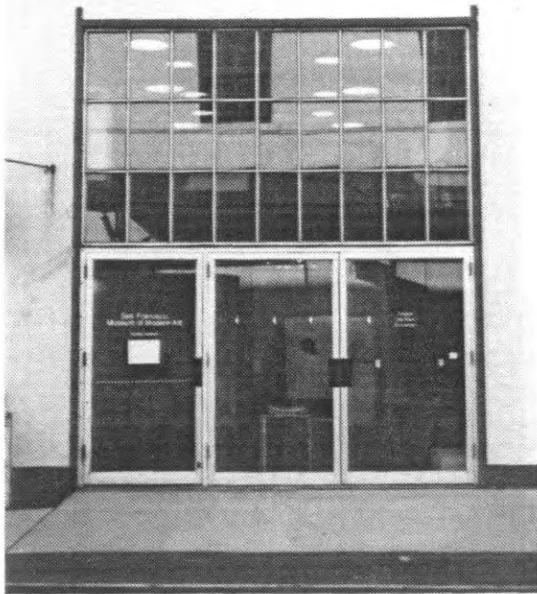
Storefront installed in the opening of a large door in Building A.

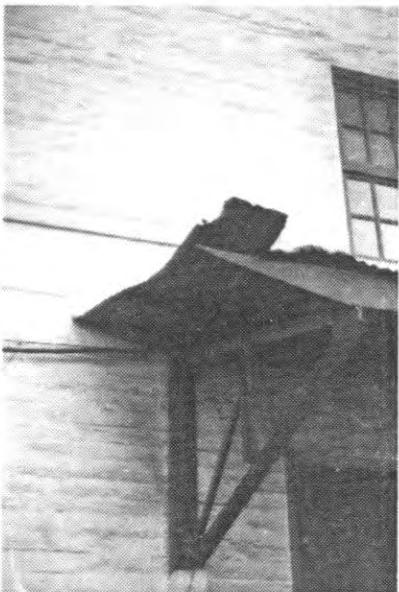
Damaged awning on Building 314

1. Repair or replace deformed awning components.
2. Scrape loose or flaking paint and remove all corrosion from metal by wire brush.
3. Prime bare metal and paint all metal using appropriate coating of the same system for use on exterior ferrous metals. Finish coat color should match existing.
4. Check all metal biannually for any areas of corrosion. Remove corrosion and re-coated surface.
5. Areas where birds roost should be covered with specially manufactured bird netting sensitively installed.

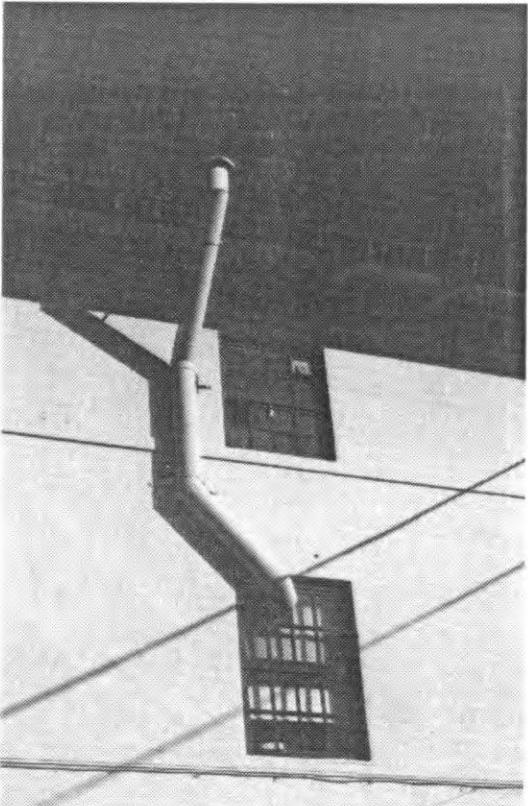
Duct attached to exterior wall of Building 314.

All non-functioning appendages should be removed from the buildings. The military orderliness should be replicated when appendages are added or re-configured. Standard designs should be adopted for conduit types, meters, vents, fire alarm boxes, etc.

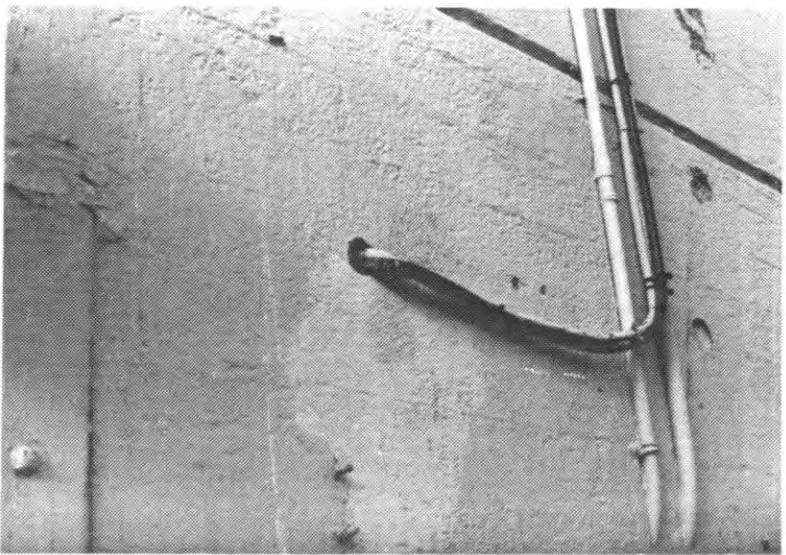
below -- Electrical conduit applied to and penetrating concrete wall.

1. Repair and replace broken gutters and leaders. Broken joints should be re-soldered. Patching, if necessary, should be done with copper of same weight, configuration, and temper secured in place by soldering.
2. Check all drains and clear obstructed roof drains. Check monthly for obstruction, and more frequently during periods of heavy rains.

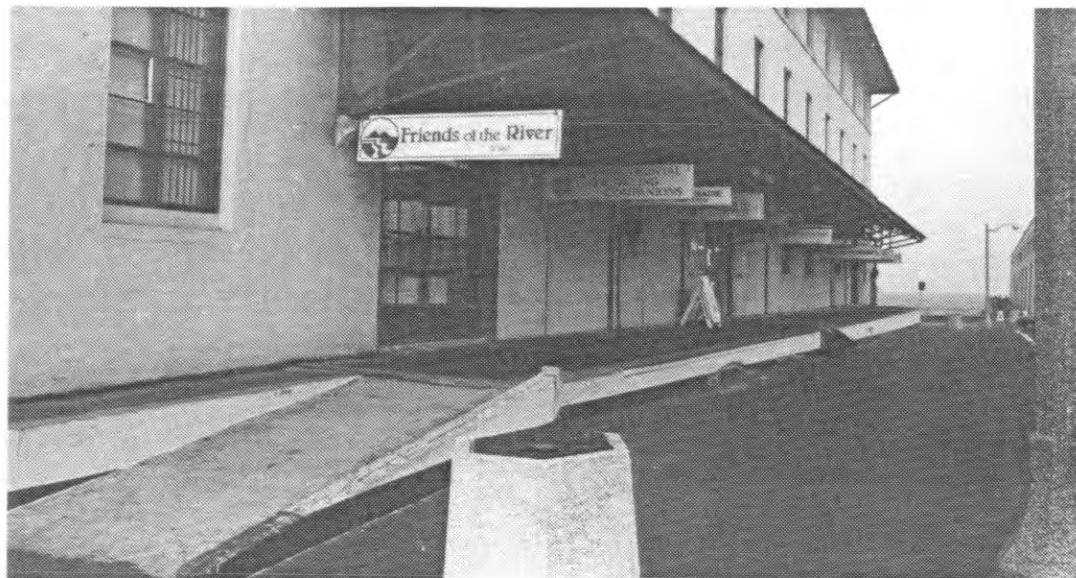
Settling on a loading dock caused by the 1989 earthquake.

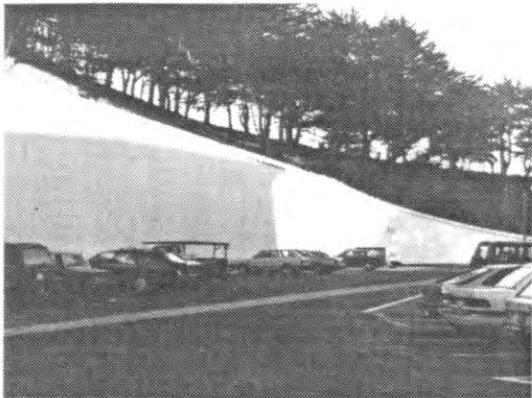
right -- Historic photo shows the sparsely vegetated hillside behind the foundation of Building 310, still partially exposed, October 31, 1910.

The eroded vegetation and built features on the hillside above Lower Fort Mason should be repaired and maintained. Any additions to the hillside, such as benches, stairs, railings, and flower beds should be constructed of materials used for similar elements elsewhere on the site and have a similar character.

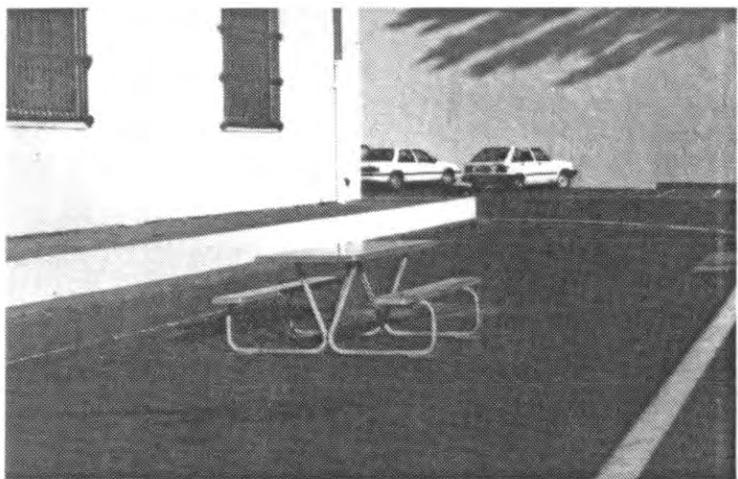
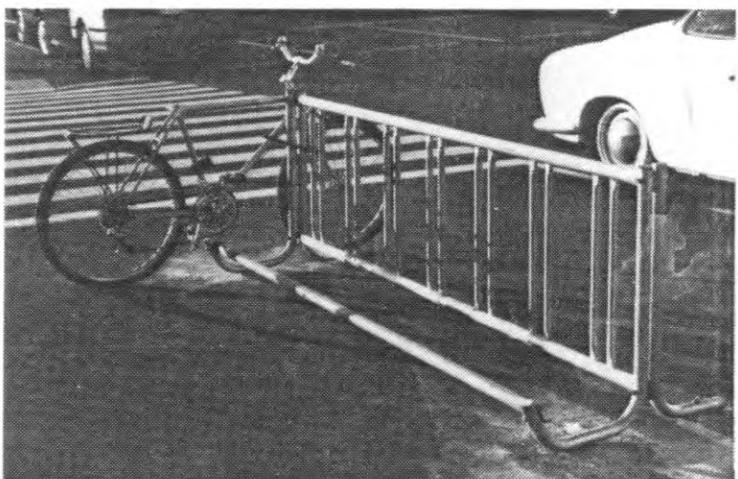
Photos above illustrate the inappropriate placement of picnic and bicycle facilities.

Benches and Picnic Tables. Existing benches and picnic tables are limited in number and therefore do not fully accommodate the needs of visitors to Lower Fort Mason. The benches along the piers which are permanent, comfortable, and well oriented appear to be the most successful installations. The site plan should designate areas where benches and picnic tables can be located without producing a significant change in the historic character of this site. Materials should be chosen which will

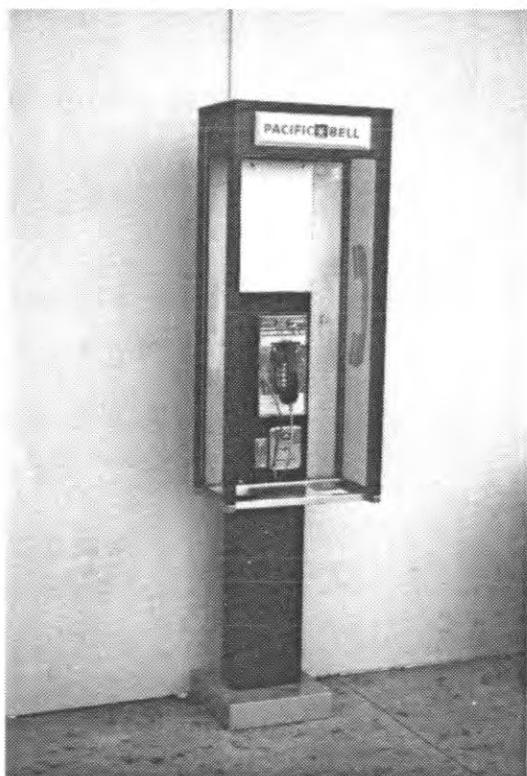
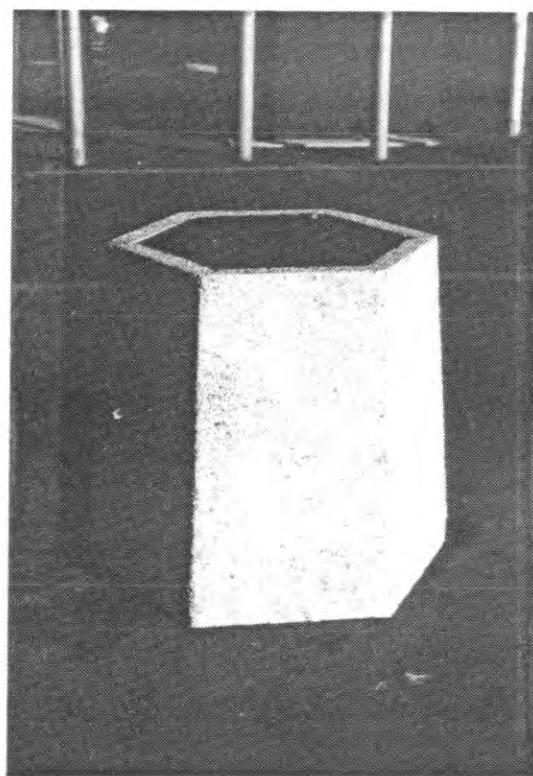
*left -- Public telephone
and trash container of
an inappropriate type.*

Trash Containers. Containers typically used in parks or public spaces are inappropriate as they detract from the character of the site. It is recommended that containers with an industrial character be used throughout the site.

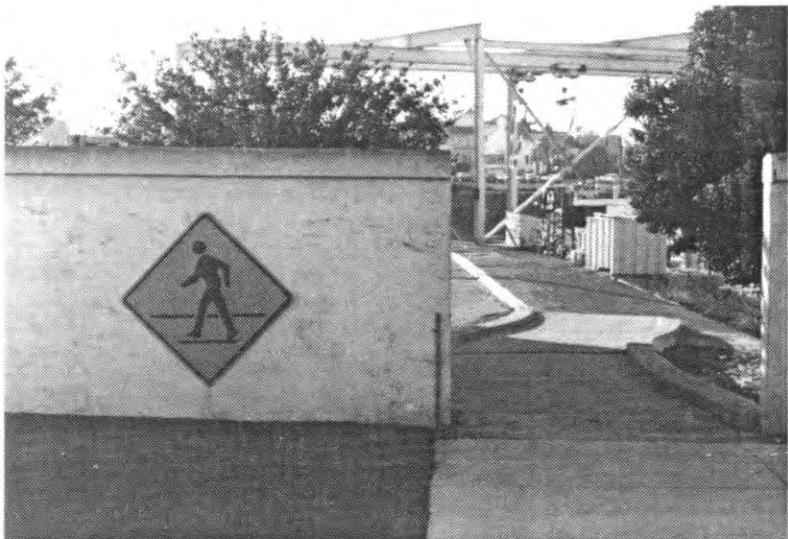
above -- A sign that is too large. In many situations smaller signs should be considered.

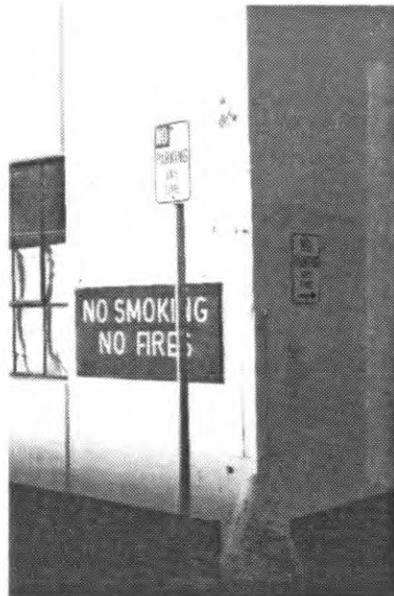
right -- Sign clutter is an unsightly problem ameliorated by an organized sign system, part of an overall site plan.
