Golden Gate Dairy (Lopes Brothers Dairy, Ranch M)

Cultural Resource Reports and Site Treatments: Cultural Landscape Report Historic Structure Reports Archeological Assessment and Treatment Report

June 10, 2013
United States National Park Service,
Golden Gate National Recreation Area
Division of Cultural Resources

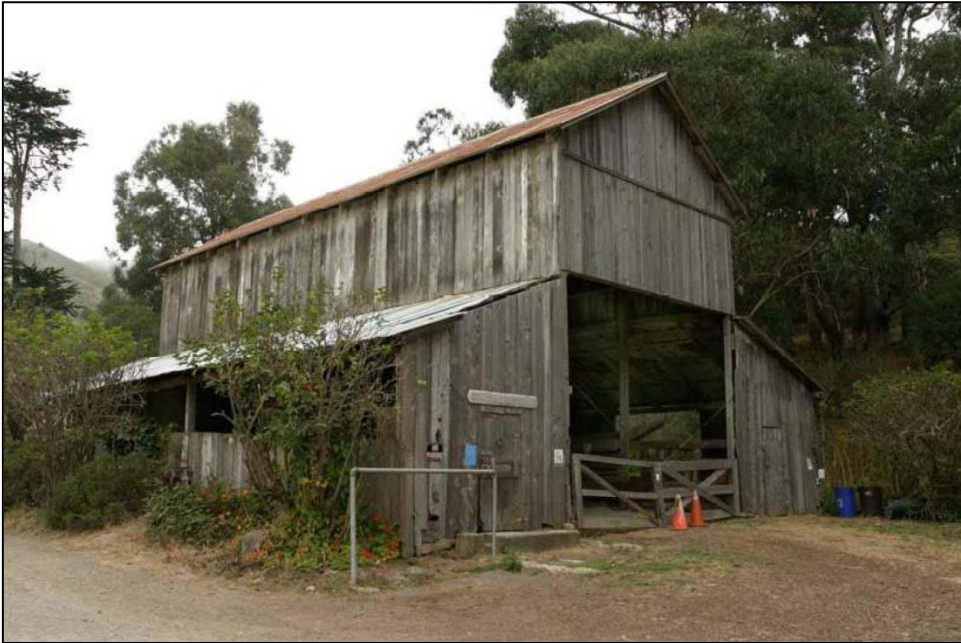
This multi-story building is a replacement for the original milking barn that burned in the late 1920s. It is of similar materials in the original location and measures 44 by 50 feet. It is constructed of vertical redwood board siding on a timber frame with a corrugated metal roof. Each side of the barn has wooden stanchions and concrete floor and drainage channels typical of local milking operations. Its interior is open to the roof with exposed timber framing and roof trusses. Its foundation is a combination of perimeter concrete

and concrete piers. A later addition to the south end collapsed in 1978 and has not been replaced. At present, the building is utilized for hay storage and horse boarding.

The original milking barn was destroyed by fire in the 1920s. This replacement was constructed during the period of significance, and is a contributing resource.

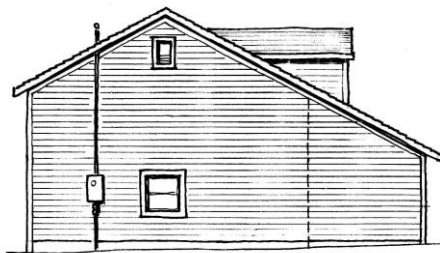
MBVFD Barn Remodel Concept Side (East) Elevation

Not Recommended: Changing the building form and shape by extending the north wall and modifying the roofline, adding a dormer; changing important elements of the building style (rake boards and corner returns).

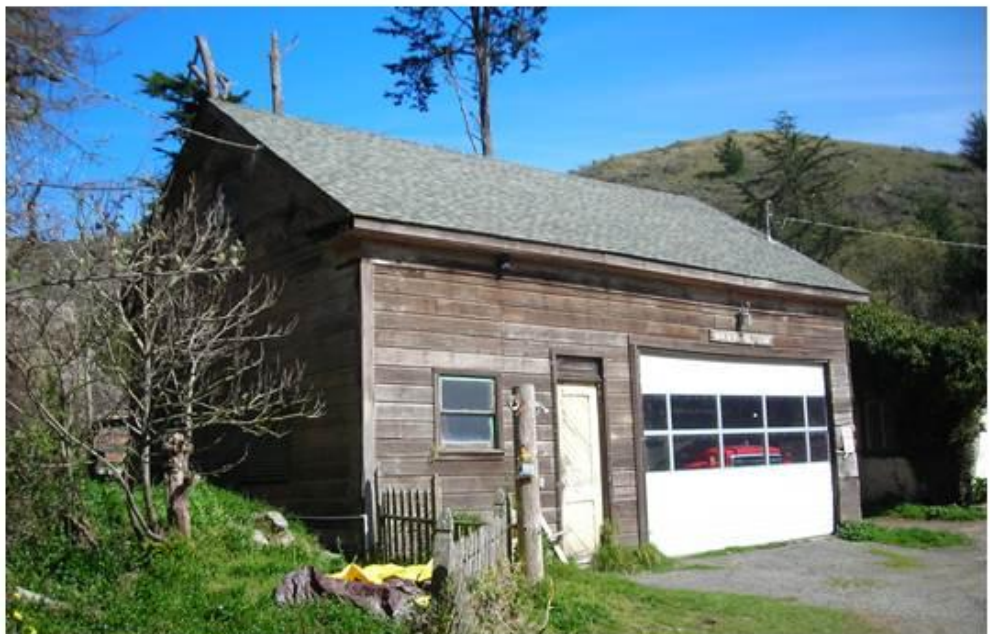
Golden Gate Dairy Creamery Building South Façade 2008

Note the window that appears to have been closed off but has shelves on the interior. Note also the lack of (or extreme foreshortening) of the door penetration in this location.

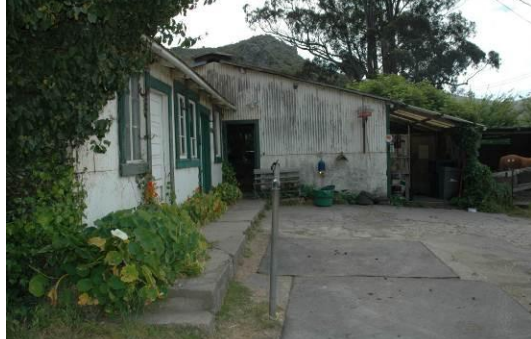
The 26'-0" long east wall is roughly 7'-6" tall to the top plate. On the farthest north end of the wall is located the 5'-0" square wood shed outhouse addition. The outhouse addition is founded on a concrete slab at ground level that appears to be integral with exterior concrete wall and/or floor slab. The shed addition encloses a small portion of the exterior building wall, where there is extant abandoned water piping – perhaps from a water heater on the opposite side of the wall. On the floor of the outhouse is a small raised housekeeping pad that could be a mount for an electric pump motor. Adjacent to the outhouse addition to the south is a small modern ramshackle wood shed roof porch

| <p>North room entry door (NPS Photo, 2012)</p> | | <p>Looking southeast at stable and shed addition (NPS Photo, 2012)</p> |

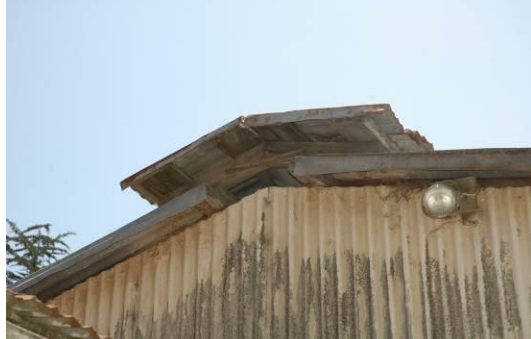
Window trim is 1x6 wood painted deep green and is in fair condition with one piece missing. Window sash and frames are painted white and are in fair condition. The roof has a full length ridge vent that is capped such that the vented opening and ridge cap is expressed on this façade. The majority of this wall was obscured by dense ivy at the time of survey and is presumed damaged, rusted or rotted. Ivy has intruded into the building and can be seen on the interior and in the attic space. In the northeast end of the gable is a patched 6" diameter hole from a vent stack – possibly from a water heater on the building interior. A corresponding section above the hole at the roof overhang is further evidence of the vertical chimney vent. Under the easternmost window is a full length crack in the concrete wall that is severe and may need extensive repairs. Window sash of this eastern window appears to be original, although it appears as though sash hinges on the interior have been replaced. Into the bottom trim under this window is an armored electrical cable protected ground for the electrical panel on the interior side of the wall. Adjacent to the east trim board of the westernmost window is a PVC conduit that runs into the ground. Window sash of this western window is a shoddy replacement. Somewhere above this window is presumed an historic wood mast for the electrical power supply to the Creamery, which formed support structure for the ivy but it was completely obscured by dense vegetation at the time of survey. This vegetation should be removed immediately and the electrical power supply and circuits inspected by a licensed electrician.

| <p>Northeast corner inside outhouse; abandoned water piping possibly from boiler or heater on opposite side; north room (NPS Photo, 2012)</p> | | <p>Capped ridge vent detail (NPS Photo, 2012)</p> |

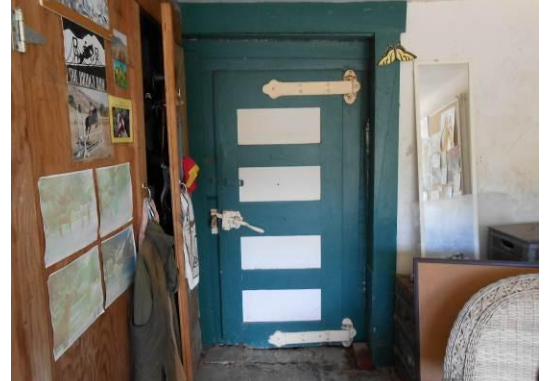
| <p>Milk room cooler door (NPS Photo, 2012)</p> | <p>Attic framing in ceiling of north room looking south at milk cooler room hatch and boxed duct (NPS Photo, 2012)</p> |

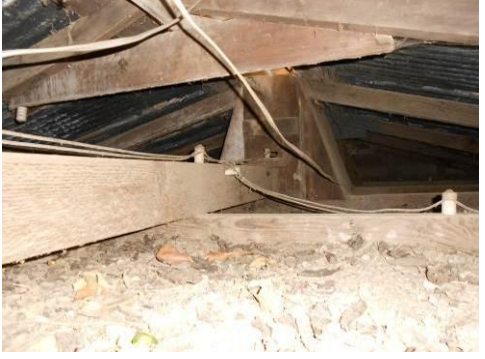
Above the three rooms that compose the low gabled north portion of the building is a low attic accessed by hatches in the room ceilings. Since no original ceiling hatch doors are extant, it is possible that the hatches had mesh covers to allow the gravity ventilation system of the full length ridge vent to function. The north room hatch opens to the attic and the ridge vent. The ceiling hatch openings in the milk cooling room and the room with raised floor are boxed-in with wood up to the ridge vent above (the attic space being open including at the eaves, except for the 3 wood box-ducts). The design must have made for sufficient cooling especially at night in the coastal climate. The 2x4 rafters are tied beneath the ridge by a 2x6 collar tie on alternating rafters, and by the ceiling joists at the bottom. A 2x6 stiffening member spans the full 26' on center from wood box to wood box, stiffening the ceiling from north to south.

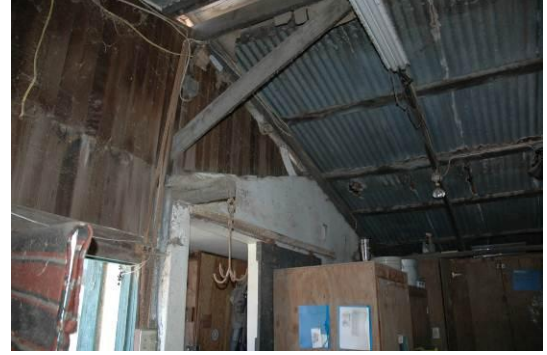
| <p>Milking stable north end gable showing ridge bracing and gabled end of milk house (NPS Photo, 2012)</p> | <p>Milking stable south gable showing beadboard wall finish, wood bracing and piping (NPS Photo, 2012)</p> |
