Historic Structure Report

1872 Neosho Colored School

639 Young Street
Neosho, Missouri

July 17, 2012
NPS PMIS # 174533

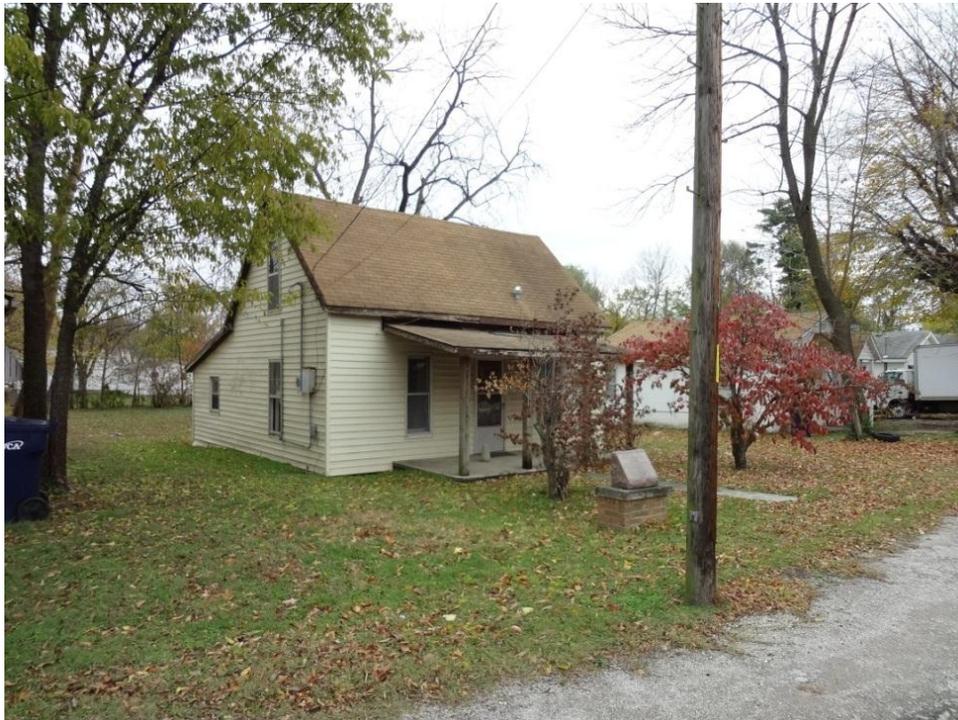
Figure 39. 639 Young Street, looking southeast at property. The two small trees in the front yard have been removed since this photograph was taken. (DS 2011)

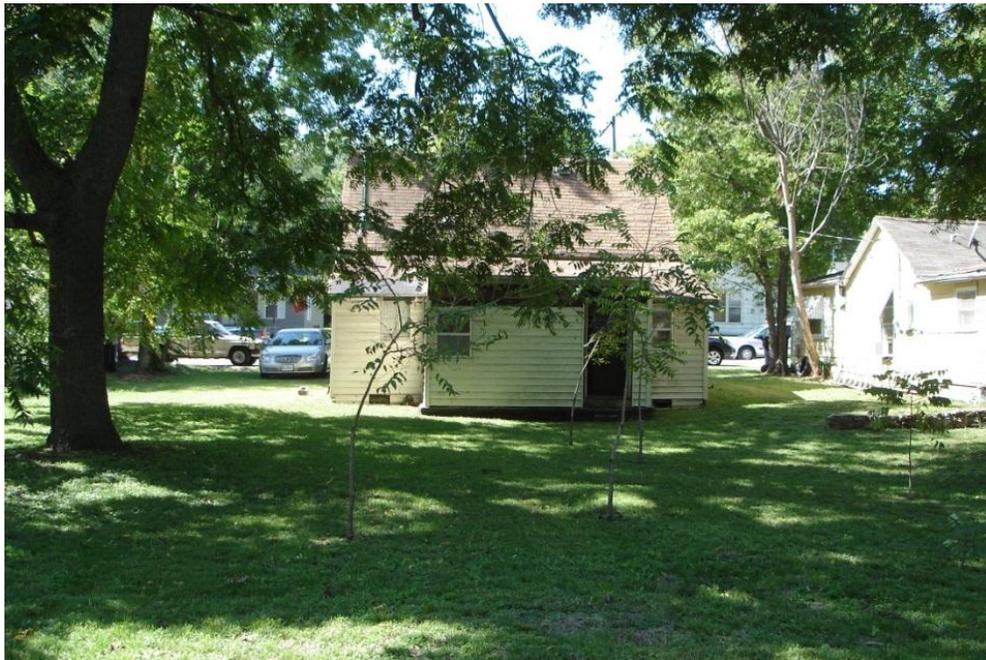
A very large walnut tree stands in the back yard, located just southeast of the rear of the house (Figure 40). The remainder of the back yard is dotted with voluntary walnut saplings, while the back fence is lined with various scrub growth. There are no other significant landscape features or plantings on the site.

Figure 40. Back yard, looking west. (DS 2011)

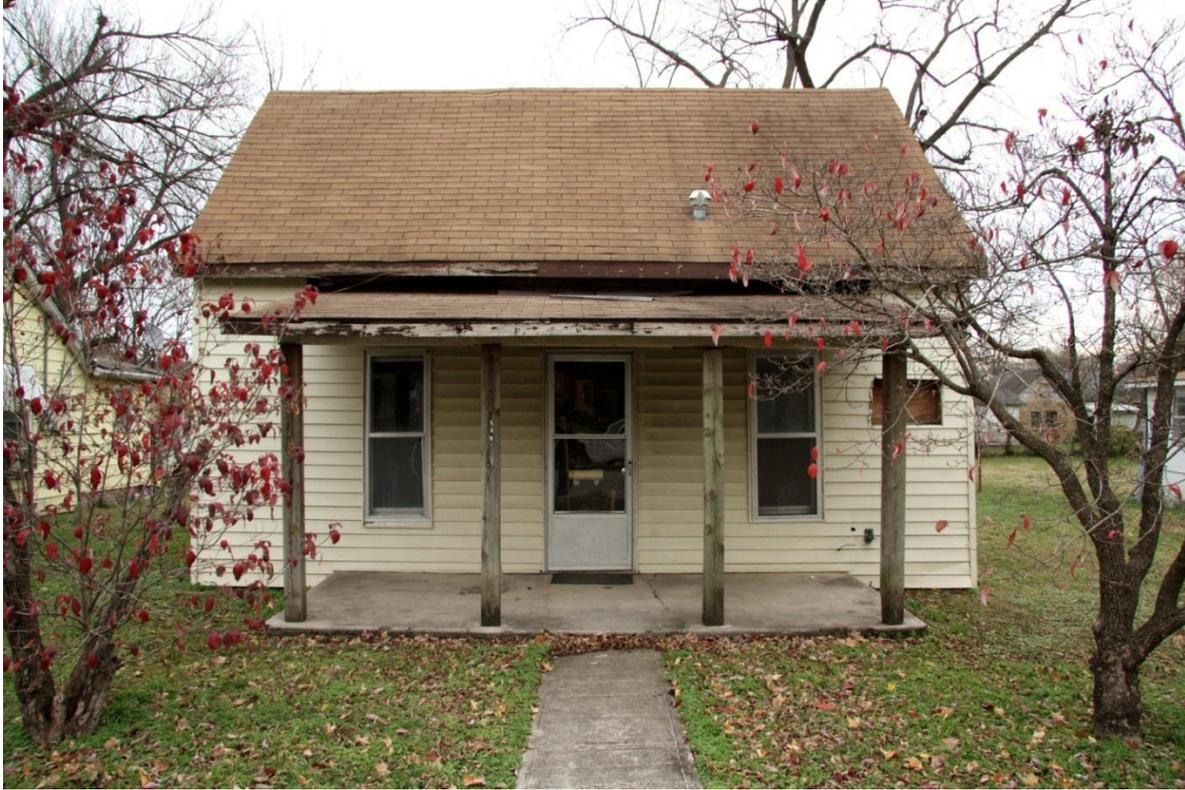
The front door is centered on the facade and is flanked by two matching window openings. This central doorway location is early or original, though it may have been widened and the height increased, slightly in a later episode. The front door is a modern wood replacement door and is protected with a narrower aluminum storm door. The windows were once wood double-hung, but have been removed and two sets of modern aluminum storm windows are infilled in the openings (one interior installation and one exterior installation). A small portion of the original wood trim and window frames can be observed at the edges of the storm windows. At the south end of the wall, an opening suggests a through-wall air conditioning unit was once installed in this location. The opening has been boarded over on the inside of the house. Through this hole, a cross section of the layers of exterior siding can be observed (Figure 43). The existing metal siding covers a thin layer of rigid insulation, a previous installation of wide fiber board siding and the original wood pine siding. From this opening, the historic pine siding can be measured to vary in exposure between 4.25" and 4.75".

Figure 41. Exterior west wall – primary entrance. (SRJA 2011)

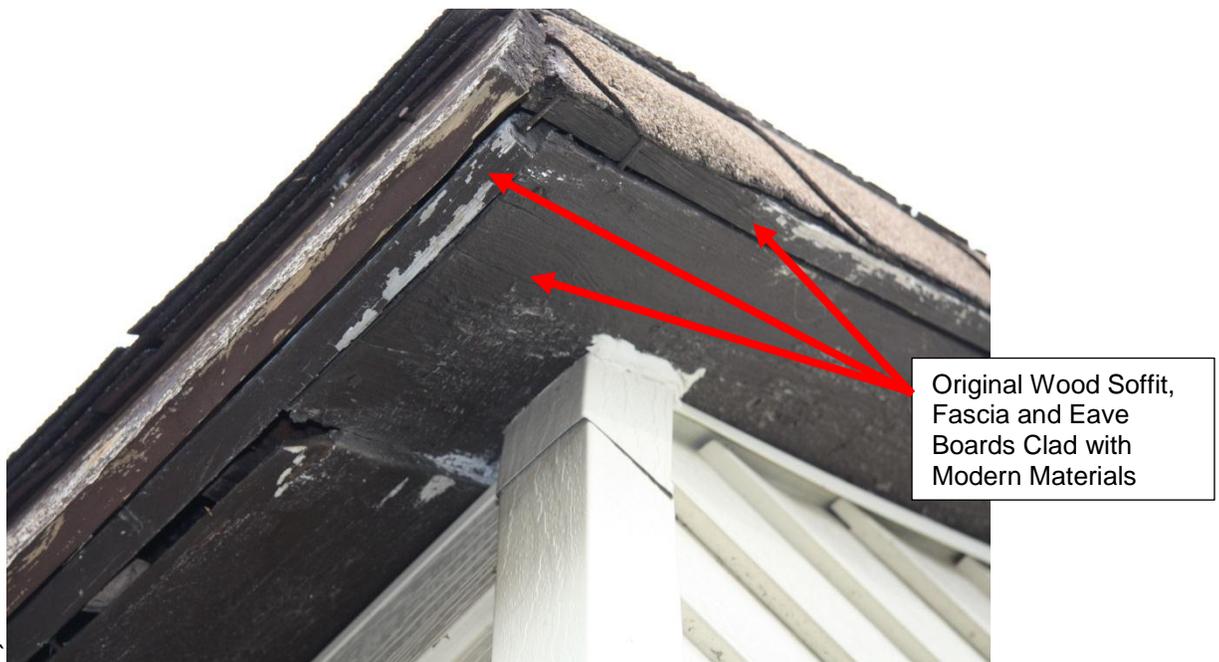
The steeply-pitched roof is covered in medium-brown asphalt shingles. A slight hump is visible in the roofing where the original chimney was removed. The roof is pierced with a galvanized roof vent, which is not connected to anything in the interior of the house. The only original exterior wood trim visible on this side of the house is the soffit. In Figure 42 below, the original soffit board and fascia board, as well as the rake boards, can be seen from below. The fascia has been clad with a newer fascia board. It is likely that all of this wood trim is in poor condition. The condition of the trim can be more easily inspected once the roof is rehabilitated and the modern materials are removed. The stone foundation is only visible in a few areas near the corners of the house, as the siding is very low along the wall and is almost in contact with the grade. Where the foundation is visible, the stones are dislodged from their original configuration and many are missing. There are no gutters or downspouts on either the main roof or the porch, nor does there appear to be evidence of previous gutter or downspout installations.

Figure 42. Southwest corner of the house, showing the original soffit boards, fascia, and rake boards, which are clad with a modern fascia and roofing materials. (SRJA 2011)

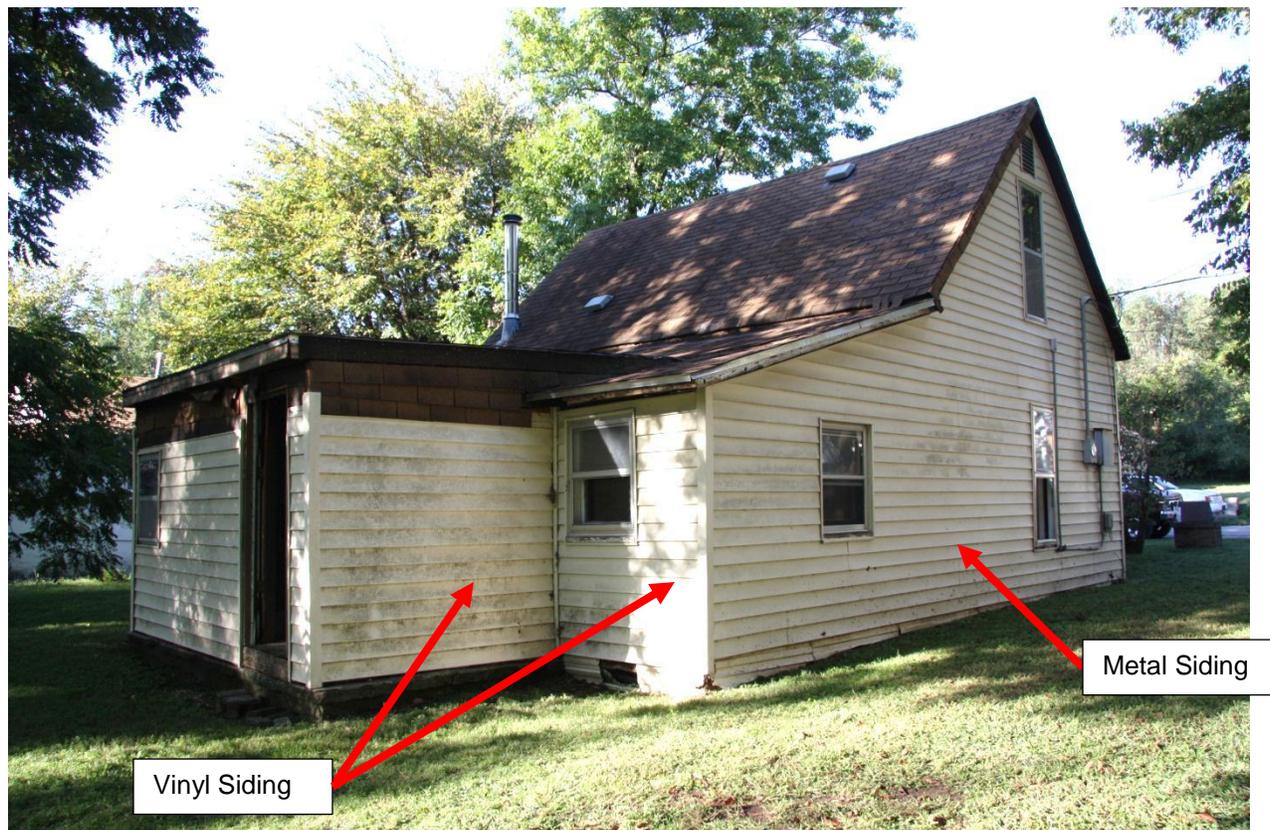
The north exterior wall of the house is comprised of the gable end of the original structure and the sides of the one-story rear additions (Figure 44). The entire wall is clad with either metal or vinyl siding. Original wood trim is visible around the edges of the storm windows. The first floor Window 103 is in the original location, though it may have been slightly altered vertically within the wall. This is discussed further in the Room 102 description. This window is slightly off center from the gable above. The second floor Window 201 was installed during the Episode 3 remodeling and is centered on the gable above. Both windows were wood double-hung windows at one time, but have been removed and replaced with aluminum storm windows. The fact that the first and second floor windows do not align with one another, suggests they were not installed at the same time.

Figure 44. East and north exterior walls, looking southwest. (SRJA 2011)

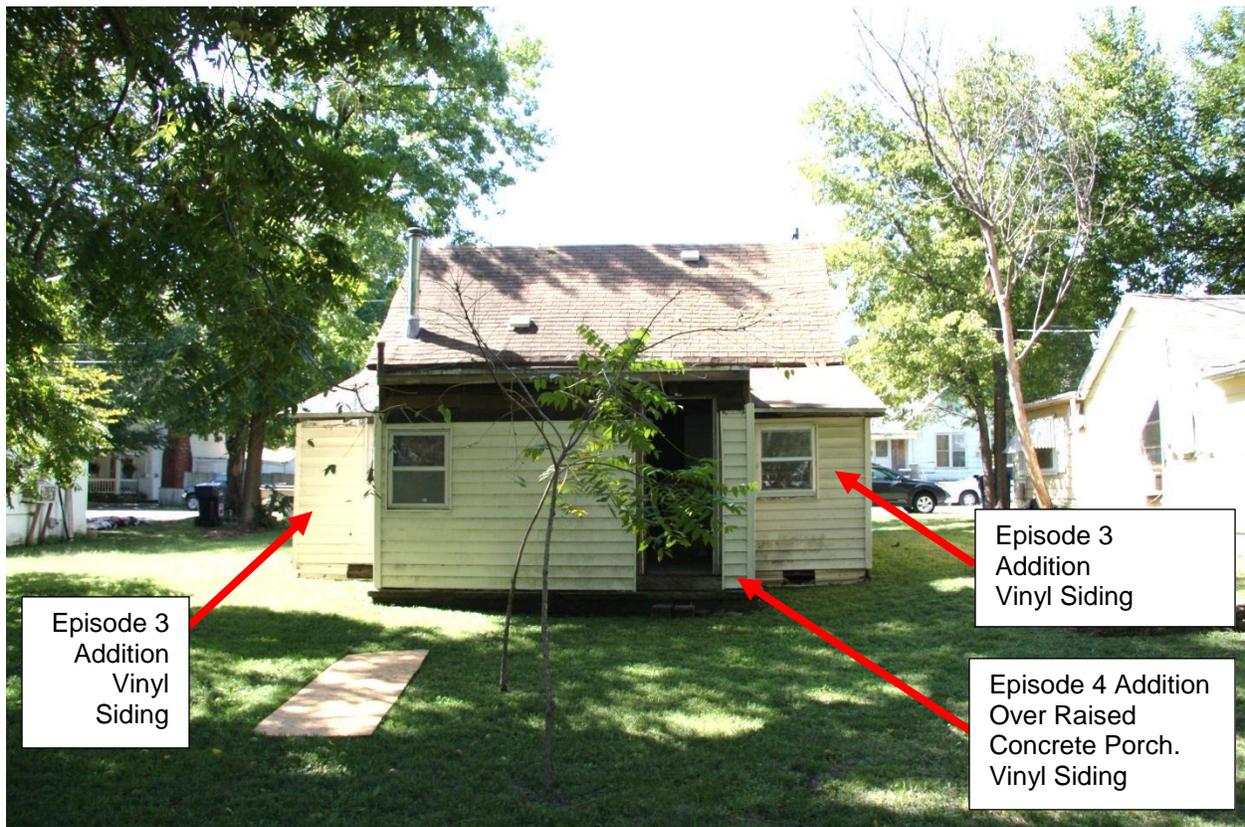
The east exterior elevation is comprised of building elements from all three episodes of construction (Figures 45 and 46). In the background, the original steep pitch roof with asphalt shingles is visible. Several roof vents can be seen, as well as a modern stove pipe. The one-story shed roof of the Episode 3 addition can be seen spanning the entire length of the rear of the house. The Episode 4 shed roof addition is constructed over the raised concrete slab and is centered on the building. The additions have low-slope roofs, covered with asphalt shingles. A double-hung wood window covered with an aluminum exterior storm window is installed in the north end of the wall, dating from Episode 3. In the Episode 4 addition a modern door and small window opening are seen at either end. The door is in poor condition and there is no threshold to protect the door opening from weather. A small wood casement window is installed in the south portion of the Episode 3 addition, though it is boarded over from the interior. The exterior walls are clad in vinyl siding. Only a portion of the stone foundation is visible in the north section of the east elevation and is in deteriorated condition. The concrete foundation under the Episode 4 addition is visible above grade. The roof and trim on both of the additions are in very poor overall condition.

Figure 45. East exterior wall. (SRJA 2011)

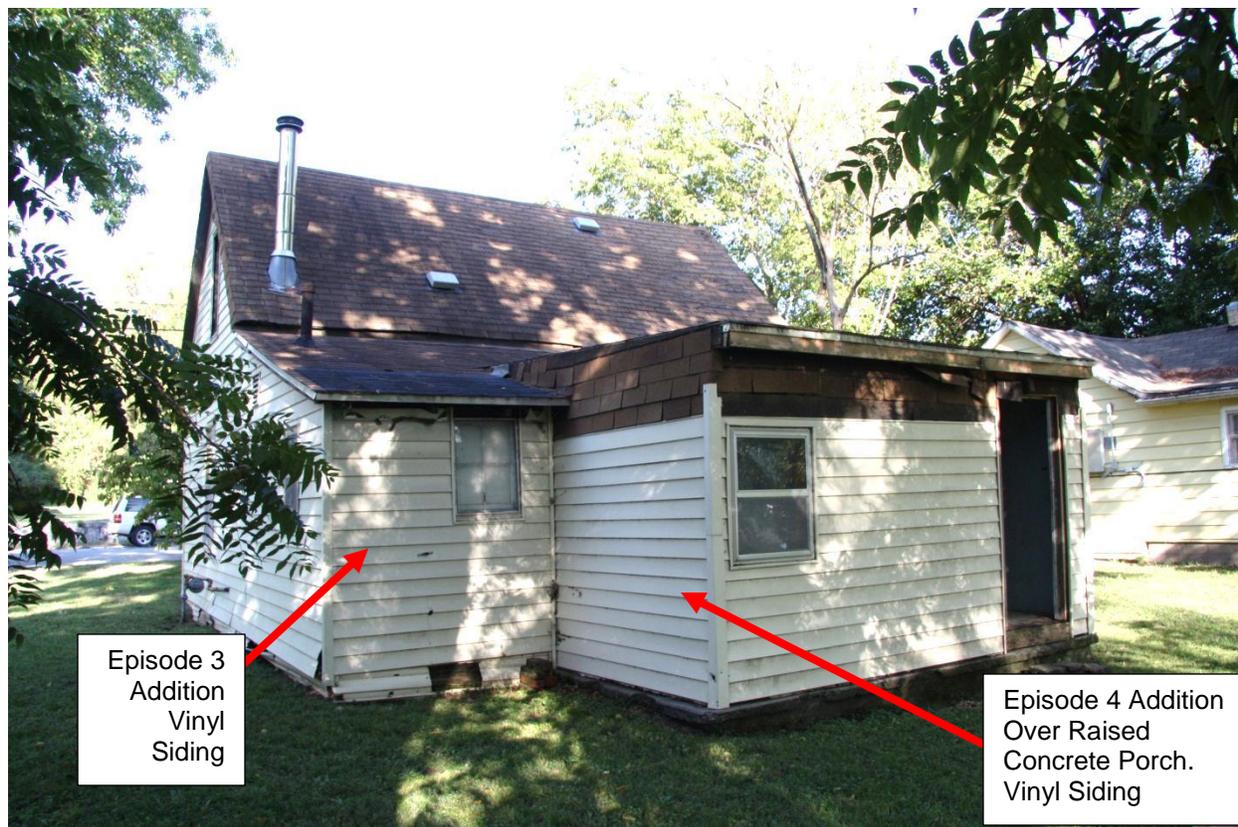
Figure 46. South and east exterior walls. (SRJA 2011)

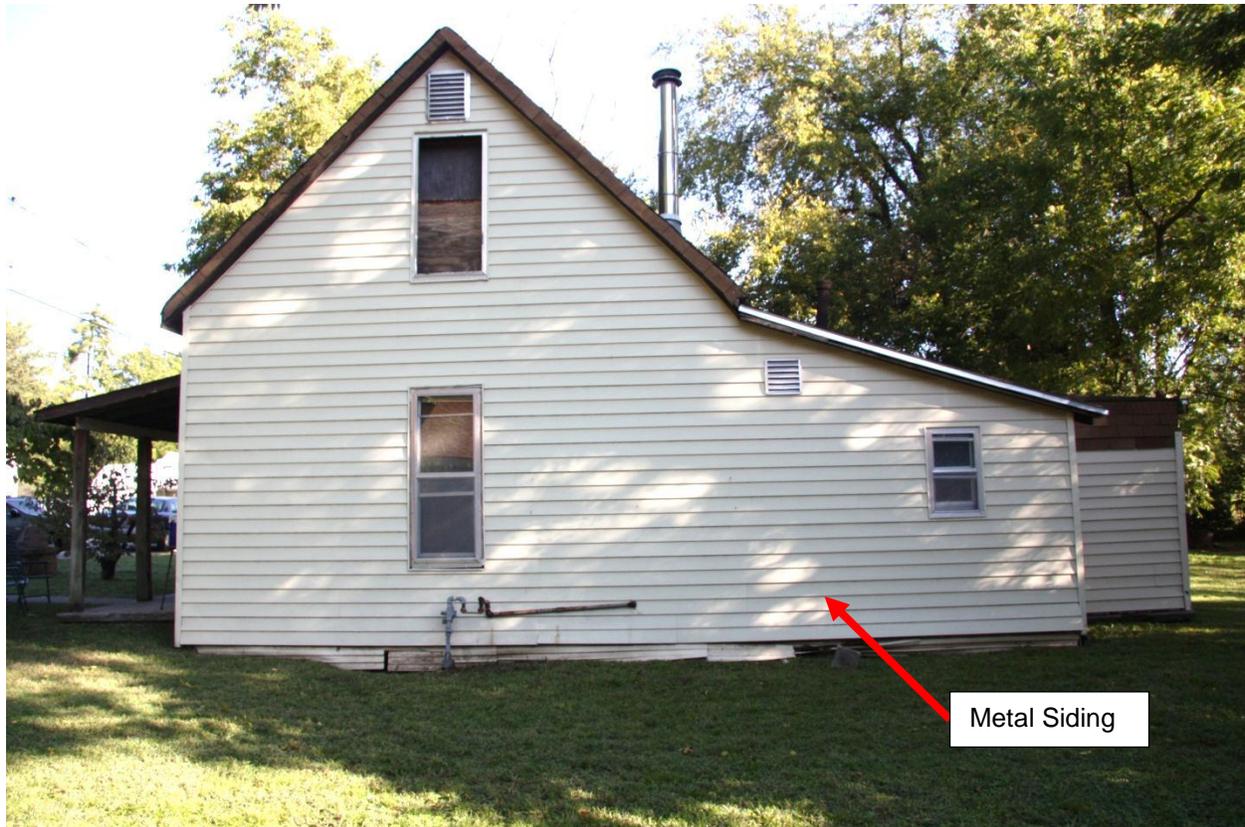
The south wall of the house is comprised of the original gabled structure on the west side, and the one-story additions with shed roofs dating from Episodes 3 and 4 on the east side (Figure 47). First floor Window 100 is almost centered on the gable, while a second floor Window 200 is centered on the gable. Both windows were wood double-hung windows at one time, but have been removed and replaced with aluminum storm windows. Wood trim is visible around the edges of the storm windows and may be original. The Window 100 opening is in its original construction location. The second floor window was installed during the Episode 3 remodeling. The entire south wall is clad in aluminum siding, installed over a fiber board siding, which is installed over the original wood pine siding. The original siding for the one-story addition from Episode 3 is a vertical board siding which is visible from the interior. An aluminum louvered vent is visible at the very top of the gable. A small aluminum louvered vent is located in the one-story addition, near the roof line. The wood soffit is painted brown, and is likely original material. The rake is covered with asphalt shingles. A wood double-hung window opening is located near the east side of the one-story addition and has been infilled with an aluminum storm window. The addition is roofed with a low-slope, asphalt shingle roof, which connects to the original structure under the eaves. The stone foundation cannot be seen on this side of the house, as it is covered with vinyl siding. The gas utility connection is roughly centered on the original portion of the house and enters directly into Room 101 through the exterior wall. The south portion of the crawlspace was accessed through removal of a small piece of siding and some earth in a depressed area adjacent to the gas service.

Figure 47. South exterior wall. (SRJA 2011)

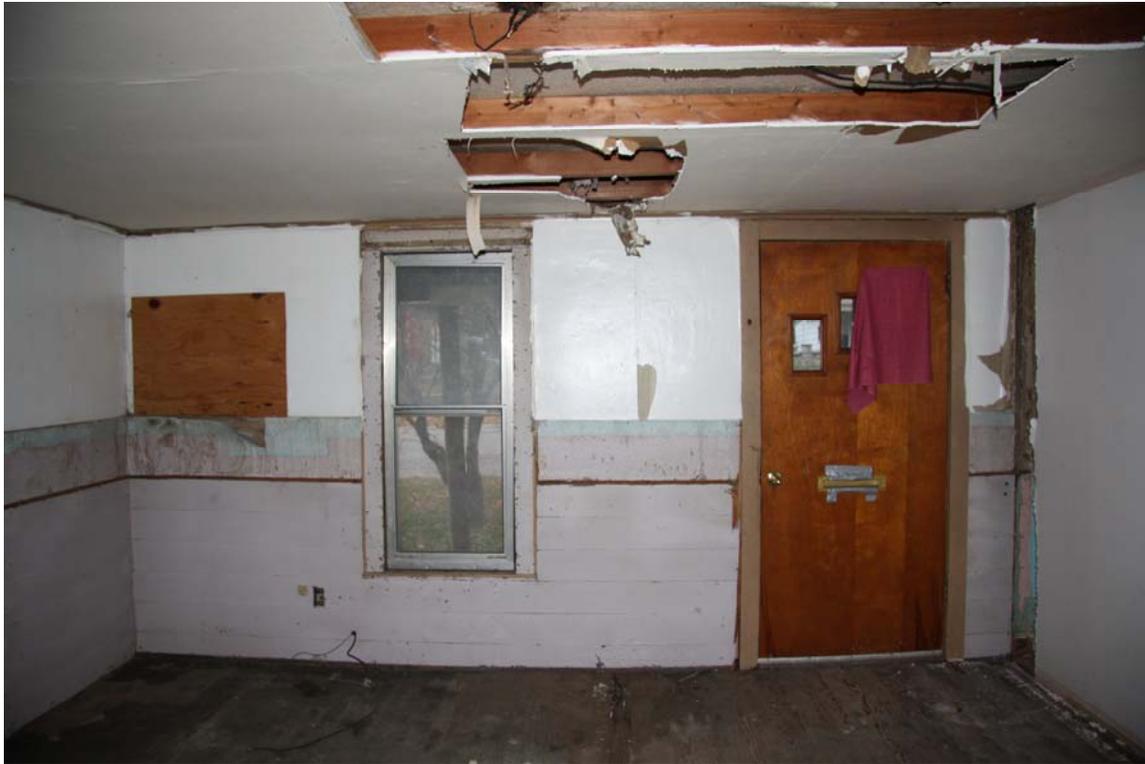
The front door is located in the west wall of Room 101. There is also an original window opening. As is typical throughout the house, the wood window sash are missing and the original frame is infilled with an aluminum storm window. In the wall just south of the window, a section of wall has been cut out where a through-wall window unit appears to have once been installed. The resultant hole in the wall has been boarded over. An original window opening is located in the south wall. It is curious to note that this Window 100 is not quite centered in the room, and is therefore, not centered on the exterior gable. The east wall has only an original Door 101/2, near the north end of the wall, which leads into the east building addition.

Figure 48. West wall of Room 101, looking west. (SRJA 2011)

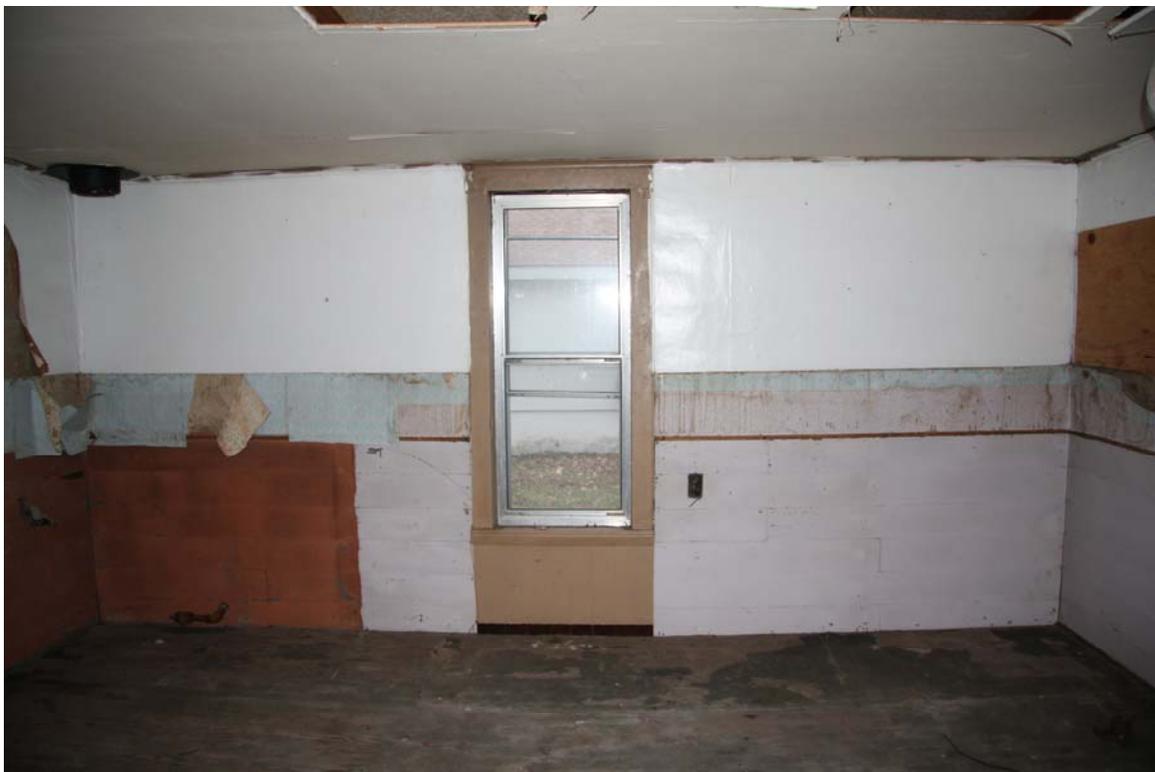
Figure 49. South wall of Room 101, looking south. (SRJA 2011)

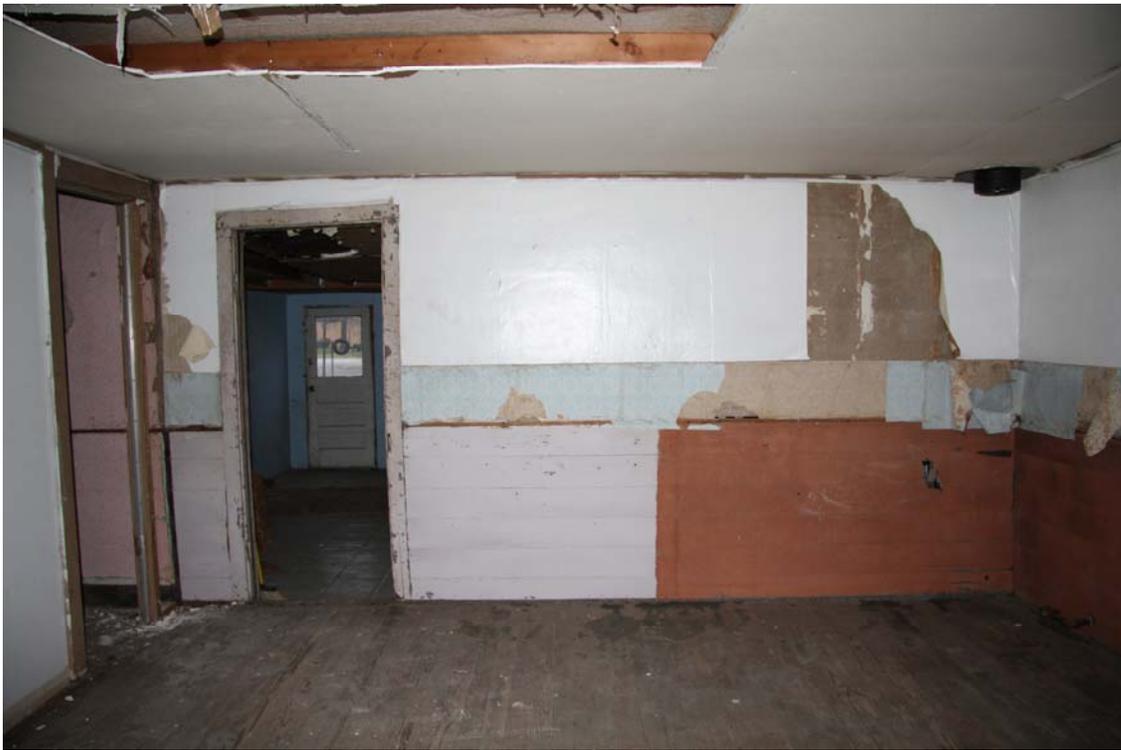
Figure 50. East wall, Room 101, looking east. (SRJA 2011)

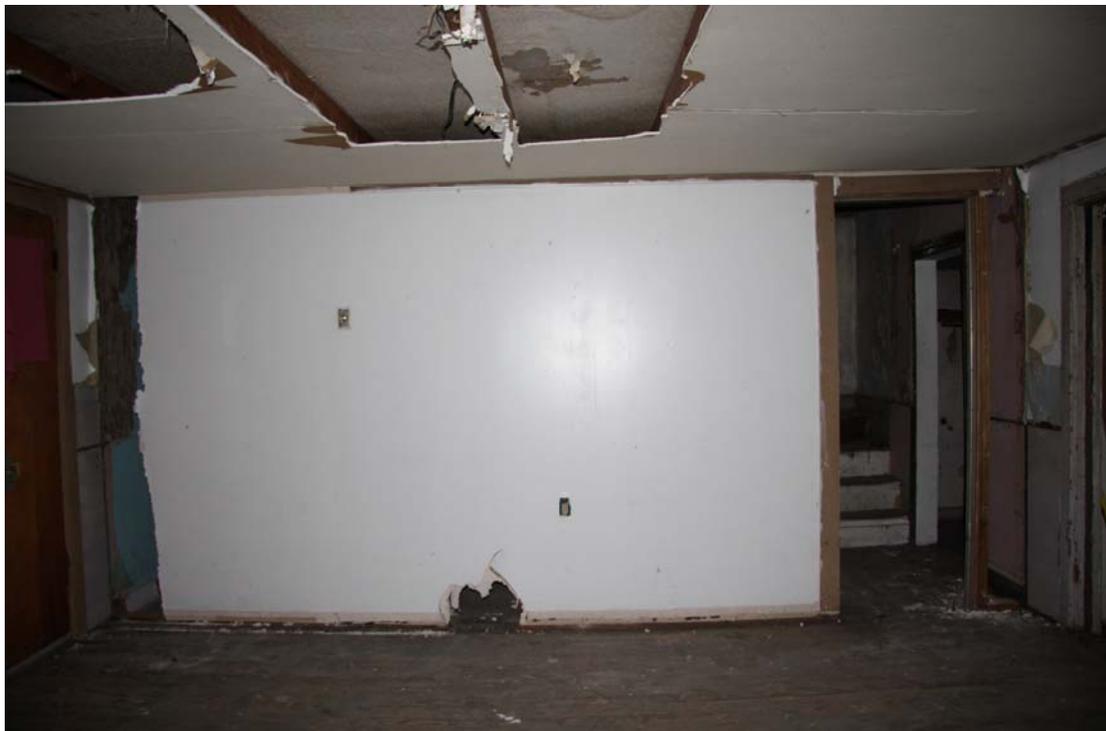
Figure 51. North (modern) wall, Room 101, looking north. (SRJA 2011)

The lowered ceiling in Room 101 is constructed of a modern 2x4 framing system and is partially covered with gypsum board. This lowered ceiling system was installed over the historic lath and plaster ceiling. Though a majority of the historic plaster ceiling is currently covered with the modern materials, areas are visible that are covered with floral wallpaper. The plaster also shows evidence of cracking, which is likely why the ceiling was papered (Figure 52).

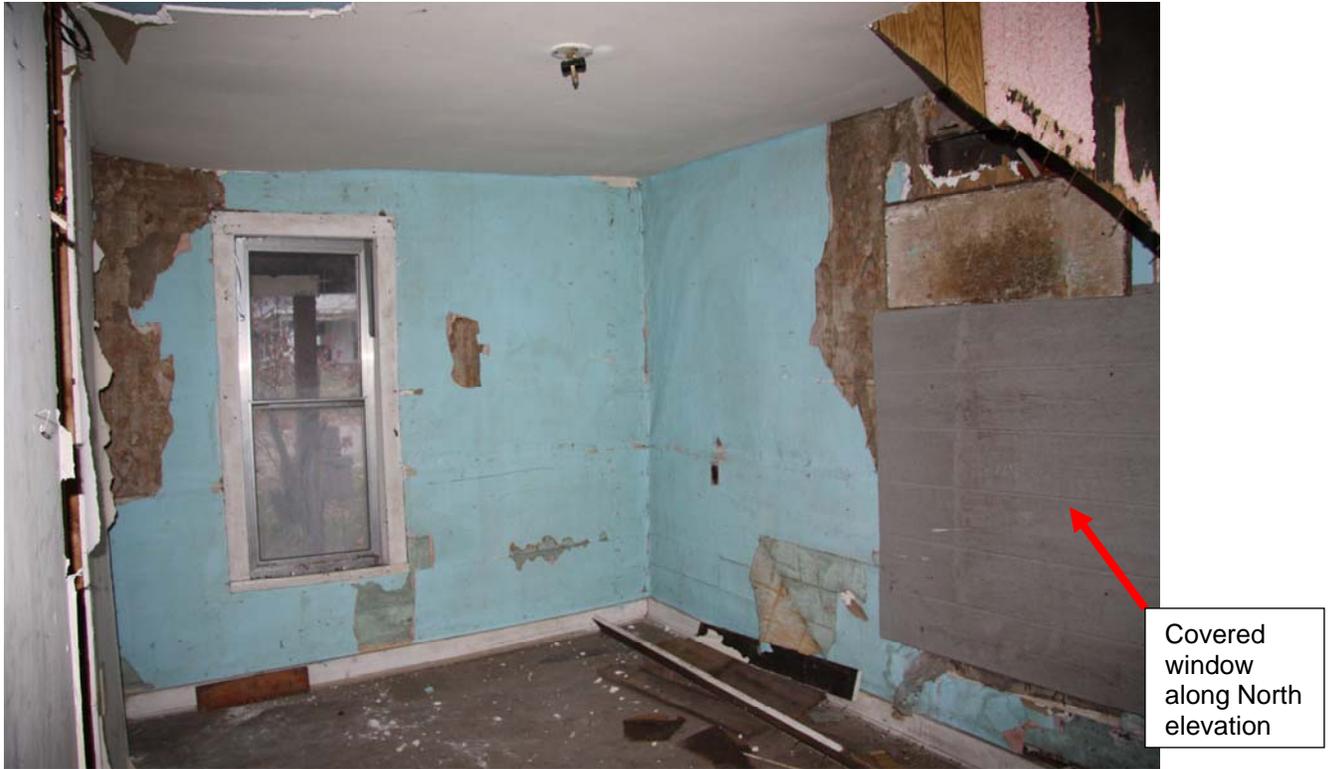
An original window opening with trim is located in the west wall (Figure 53). A window opening located in the north wall appears to be an original location, but is currently covered with plywood and cannot be inspected (Figure 53). A portion of the wall studs above the window opening can be seen, and it appears they do not come into contact with the wood window frame members below (Figure 55). There does not appear to be a lintel spanning the opening, though this may also be consistent with the framing utilized in this house. Alterations have been made to this opening at some point, but further investigation would be warranted once the exterior modern siding is removed and the interior finishes can be removed.

Figure 53. West and north walls, Room 102, looking northwest. (SRJA 2011)

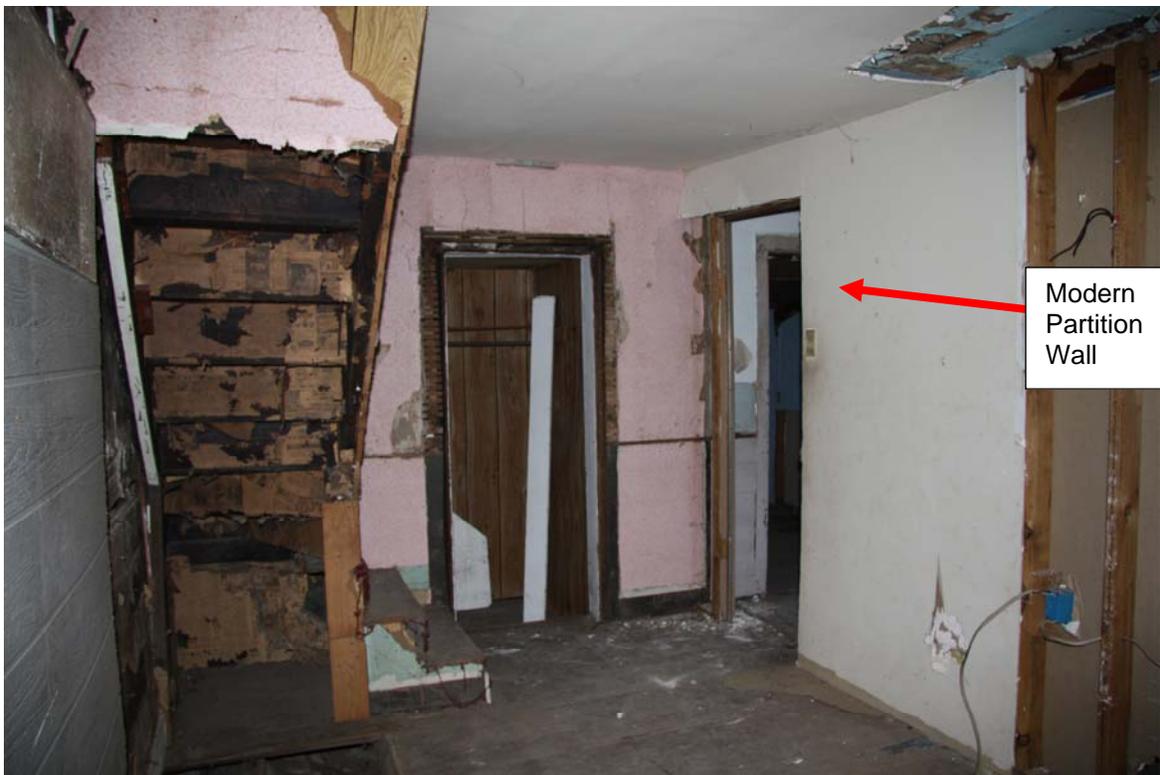
Figure 54. East and south walls, Room 102, looking southeast. (SRJA 2011)

Closet Door 105/1 is located in the east wall, adjacent to the stair (Figure 54). This door opening is not original to the construction of the house. The wainscoting has been cut to fit the door opening. The original wall stud was cut just above the door opening and moved to create a nailer at the south side of the door for trim installation. Door trim and a threshold were added to this opening. There is a step down of approximately four inches through this door into the east addition. Currently, this door leads to a modern closet which is discussed below. This door opening appears to have been constructed during Episode 3, when the east addition was added to the house. This likely led to the kitchen.

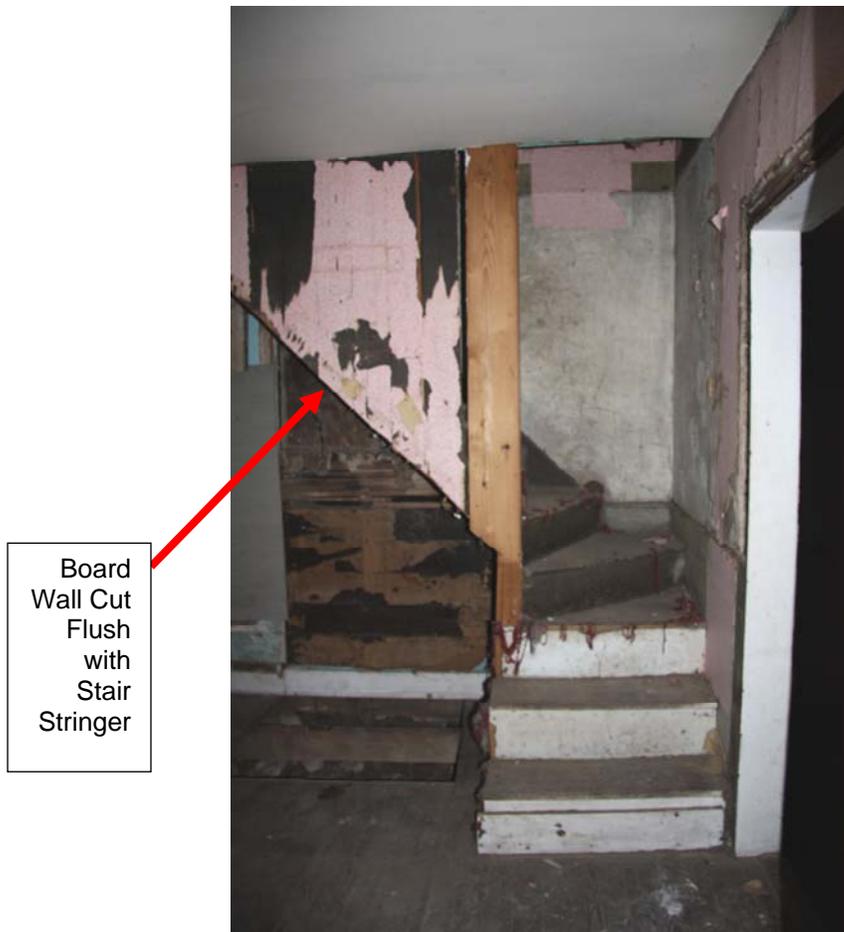
A small winding wood staircase is located in the northeast corner of the room, which leads to the second floor (Figure 56). This stair is constructed with wire nails, indicating it was likely constructed after the school had left the building, sometime during Episode 3 when the attic was renovated. The stair wall is a vertical tongue and groove construction, which at one time appears to have enclosed a small closet under the stairs. The boards have been cut off to match the slope of the stair stringer and are clad with layers of wallpaper and wood paneling. The underside of the stairs are papered with old Joplin Globe newspapers, some of which date to 1948 (Figure 57). Curiously, a portion of the tongue and groove wood flooring under the stairs does not appear to match the remainder of the flooring in Room 102. Perhaps a section of flooring was replaced in this room when the stair was built.

Figure 56. Stair, northeast corner Room 102, looking north. (SRJA 2011)

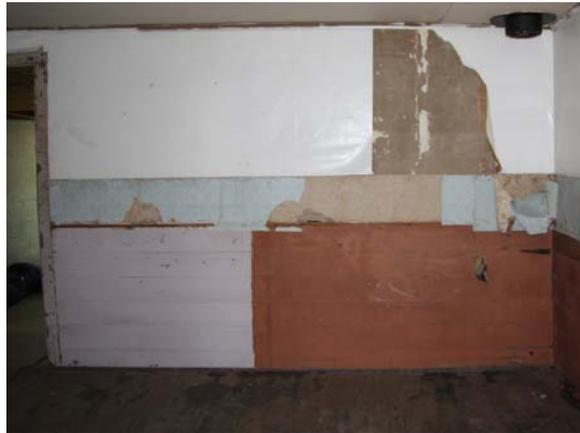
The horizontal wood wainscoting is original to the house's construction (Figures 59 and 60). The boards are tongue and groove, all the same width, with the exception of a smaller bottom board. They are stacked six high and are topped with a simple chair rail. The wainscoting between Rooms 101 and 102 is installed continuously between the two spaces, with no joints at the partition wall. The boards are fastened with cut nails and are the only finish ever applied to the wall studs indicating that they are indeed original to the construction of the house. The wood species was not tested, though it is likely long-leaf northern yellow pine which is prevalent throughout the building. The wainscoting was likely left unfinished, as indicated in Figure 63, though it has received several coats of paint through the years. The exterior of the house also appears to have been originally unfinished. This type of wood wainscoting is an unusual treatment for a residence for the 1870s, though it is a typical treatment for walls in schools during this period. At some point, the projecting face of the wainscoting chair rail was chopped off flush with the wall surface (Figure 60), most likely to install paneling. Only a small section of the original chair rail remains at the stair to the second floor.

Figure 59. Wood wainscoting in Room 101, looking east. (SRJA 2011)

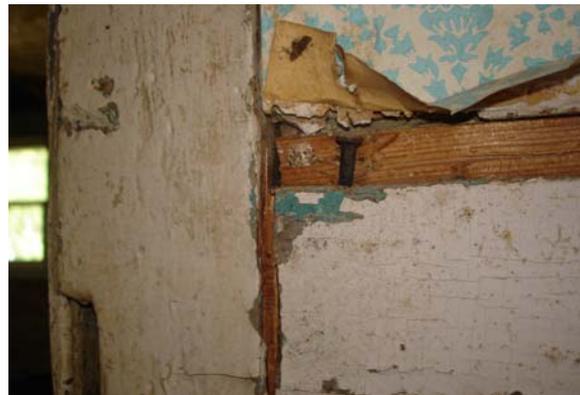
Figure 60. Detail wood wainscoting in Room 101. Note the cut finish nail which was used to fasten the chair rail to the wainscot. The chair rail face has been chopped off throughout the room. (DS 2011)

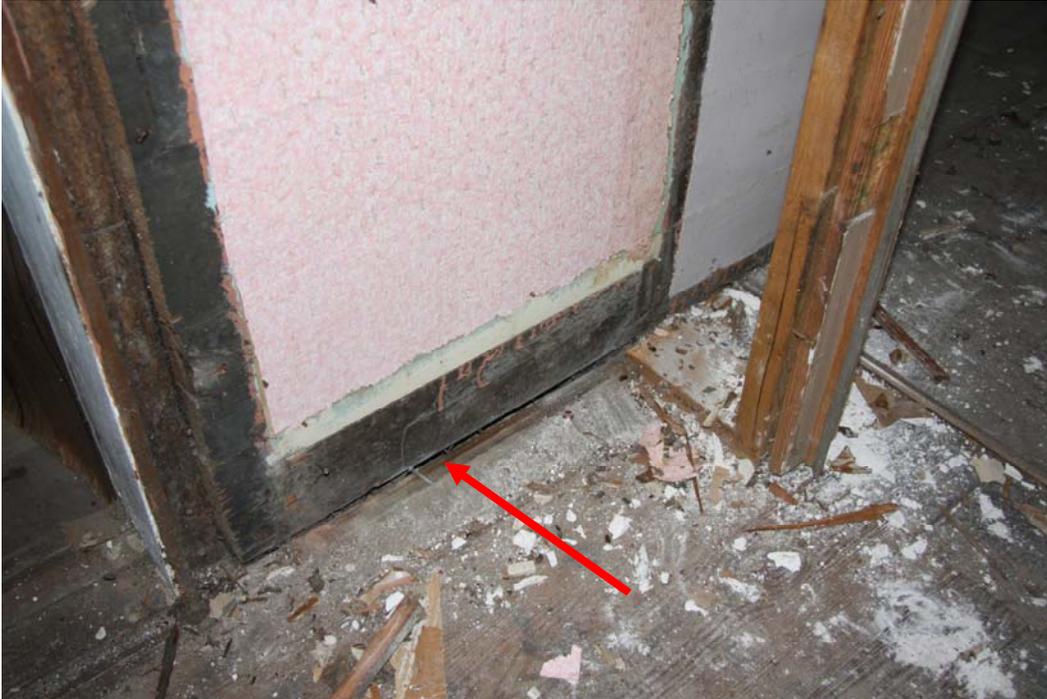
Figure 65. Detail at east wall, shadow in floor where later base was installed, along with gap between floor and wainscot, may indicate there was originally a shoe molding installed at this joint. (SRJA 2011)

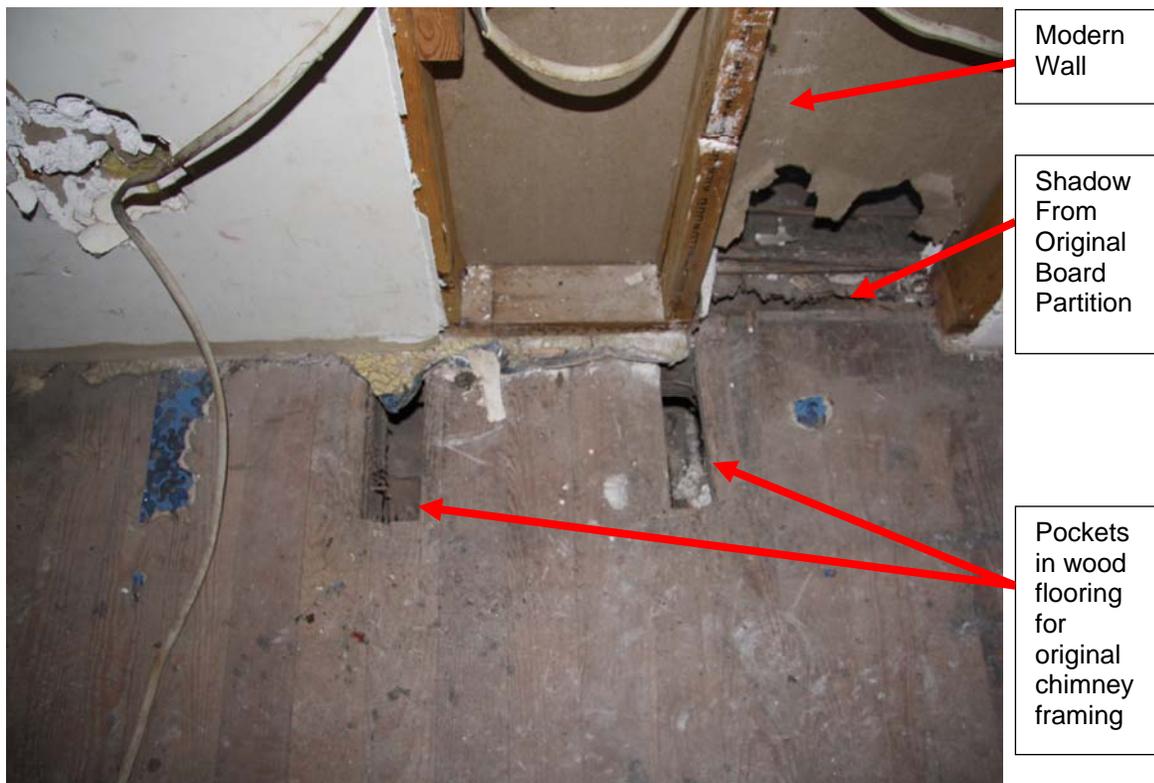
Though there is no extant chimney, historic photos, as well as Carver's own sketch of the house, indicate there was a small brick interior chimney in the house. The evidence for this chimney remains in Room 102, as well as above in the attic and the roof framing (Figure 66). In the floor of Room 102, adjacent to the existing modern partition wall, are two pockets through the wood floor where the original framing members for an interior bracketed chimney was likely anchored. Just below the floor, the original floor joists can be seen flanking the pockets, along with headers adjacent to each pocket. The chimney supports likely attached directly to the headers, which spanned between the floor joists. A remnant of the support can still be seen attached to one of the headers. The existing floor joist just south of the floor pockets, is unusual, in that there is another identical joist only inches south of this joist. This is likely due to the need for an additional chimney support, so that the joists under the original board partition wall adjacent to the chimney were essentially doubled to carry the additional load. These joists and headers appear to be original and are fastened through the use of cut nails.

Figure 66. Floor detail of chimney framing openings, Room 102, looking south. (SRJA 2011)

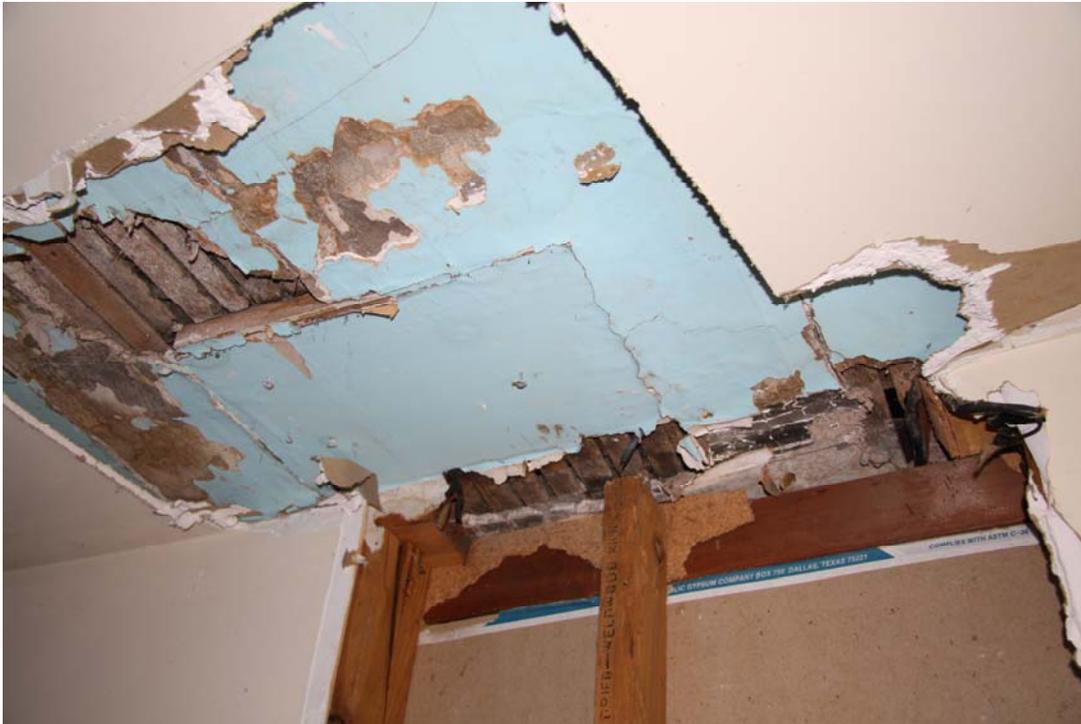
The lath and plaster ceiling in Room 102 has been infilled where the chimney once pierced through the second floor and then through the roof (Figures 67 and 68). The second floor wood flooring has been infilled, as well as the beaded board ceiling. Evidence of the original hole through the roof is present not only on the interior of the roof, but also the exterior of the house, due to the bow in the roof where the chimney was once located, as the roof framing and sheathing were never properly infilled. The section where the chimney was removed is only roofed over with tar paper and asphalt shingles.

Figure 67. Ceiling detail at original infilled chimney, Room 102.
See following Figure for detail. (SRJA 2011)

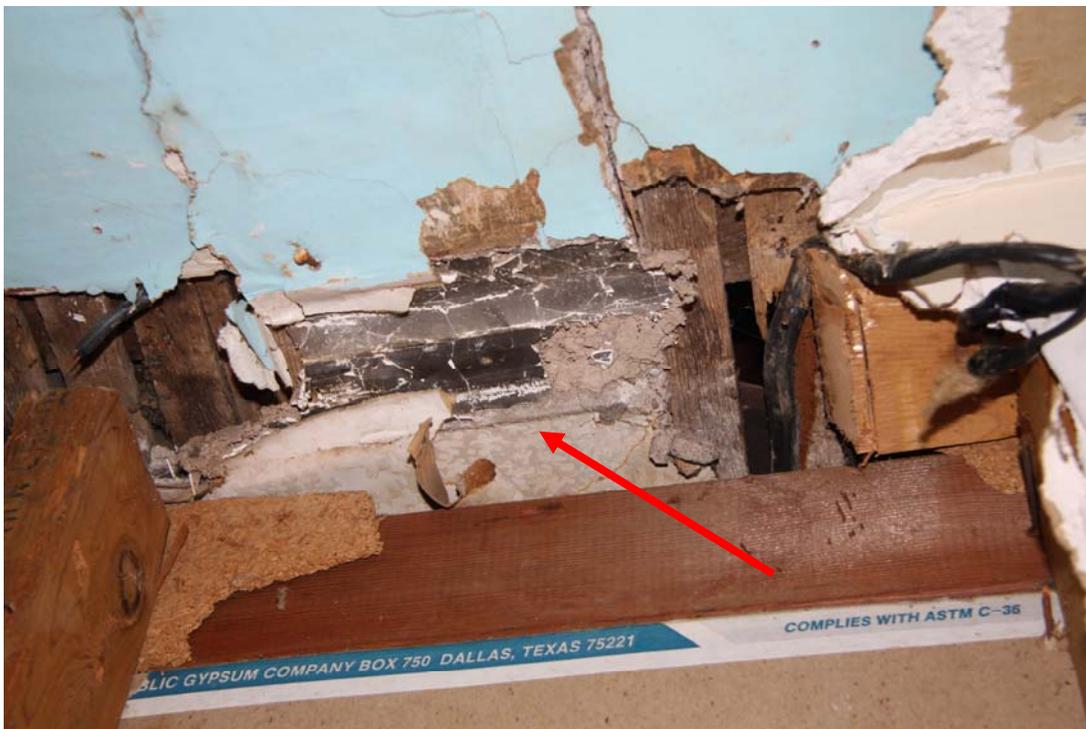
Figure 68. Ceiling detail at chimney infill in Room 102, adjacent to the modern partition wall.
The arrow is pointing at an impression in the plaster where the original board wall
was in contact with the ceiling. (SRJA 2011)

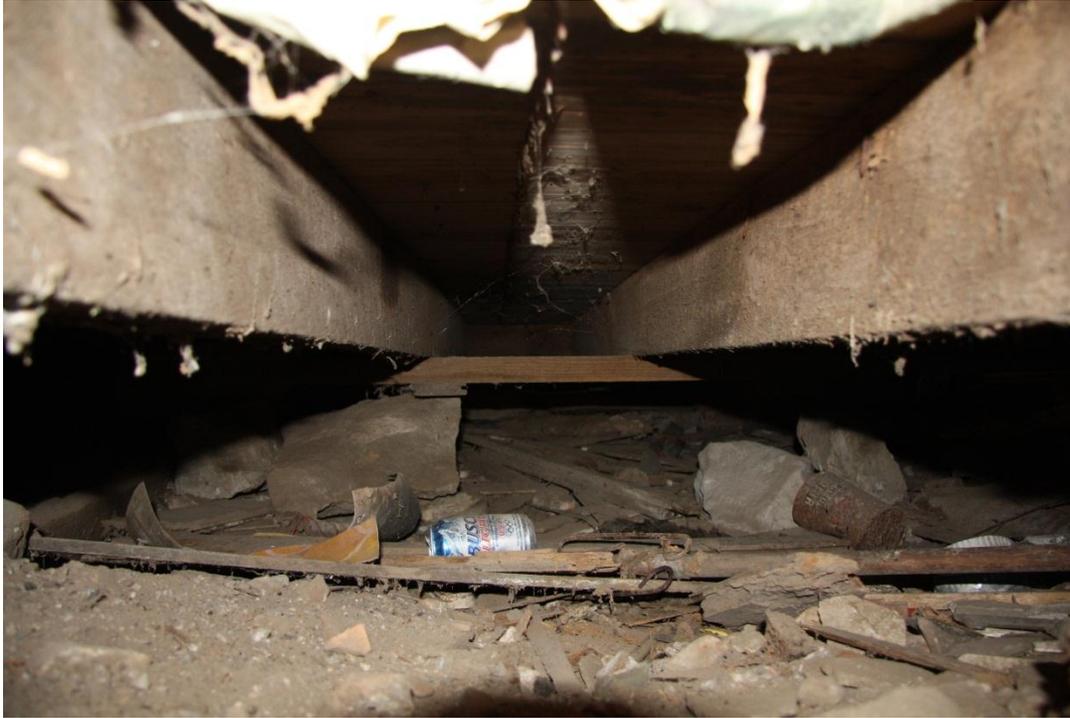
Figure 73. Crawlspace under north section of Room 103, looking west. (SRJA 2011)
