Historic Structure Report

1872 Neosho Colored School

639 Young Street
Neosho, Missouri

July 17, 2012
NPS PMIS # 174533

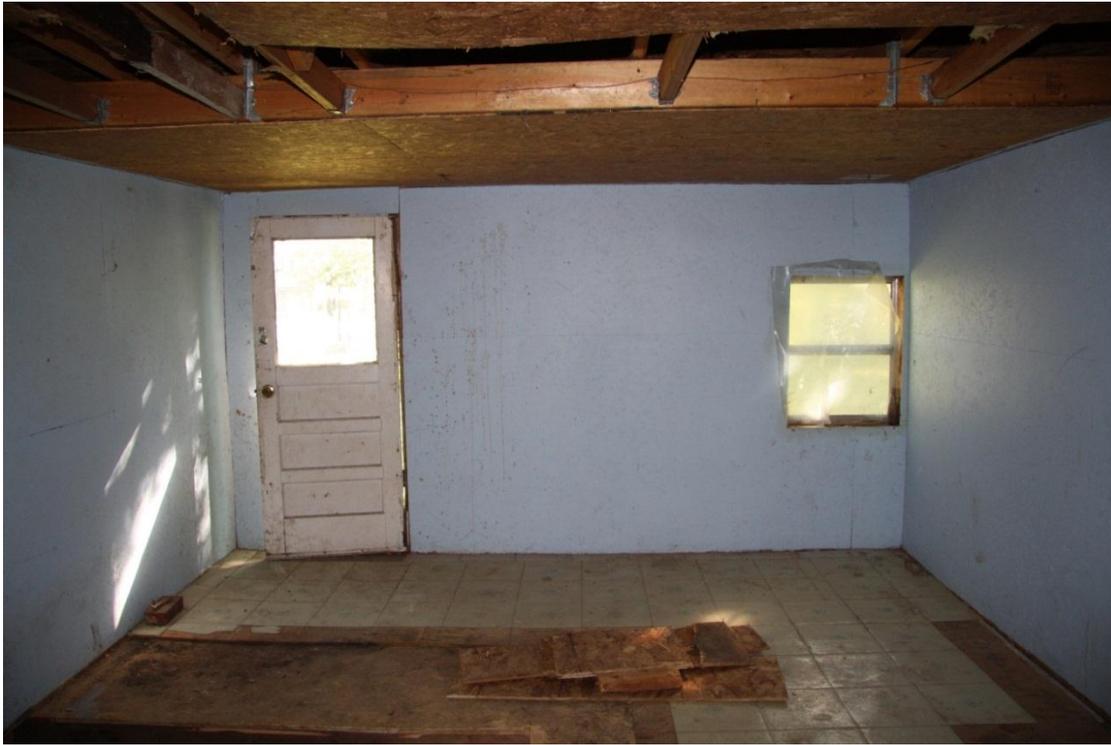
The eastern-most portion of the addition is constructed over a raised concrete slab and is much newer construction than the surrounding construction (Figure 77). This area was likely an exterior concrete porch built during Episode 4 and then over-built to expand Room 103 into a larger space. At this time, the Episode 3 porch roof framing over Room 103 was cut and re-framed to create a flat ceiling between the kitchen and the addition.

Figure 77. Room 103 east wall, looking east. (SRJA 2011)

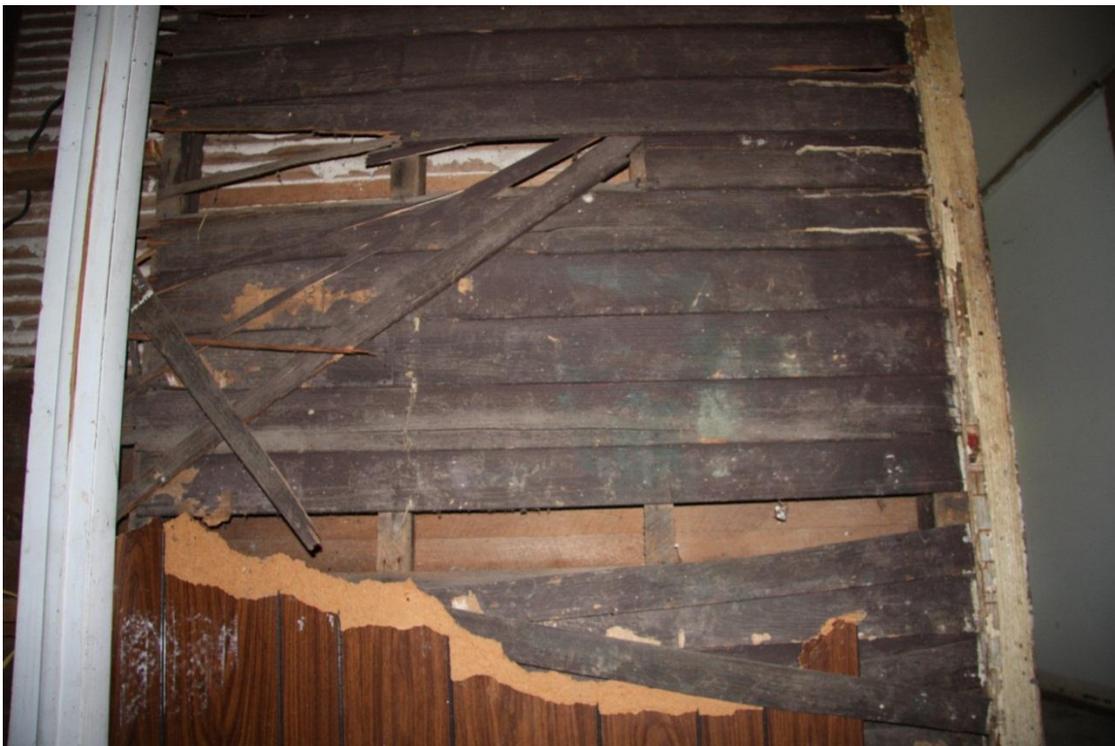
Figure 80. Room 103 west wall, wood paneling over original exterior siding and original Door 101/2 trim. (SRJA 2011)

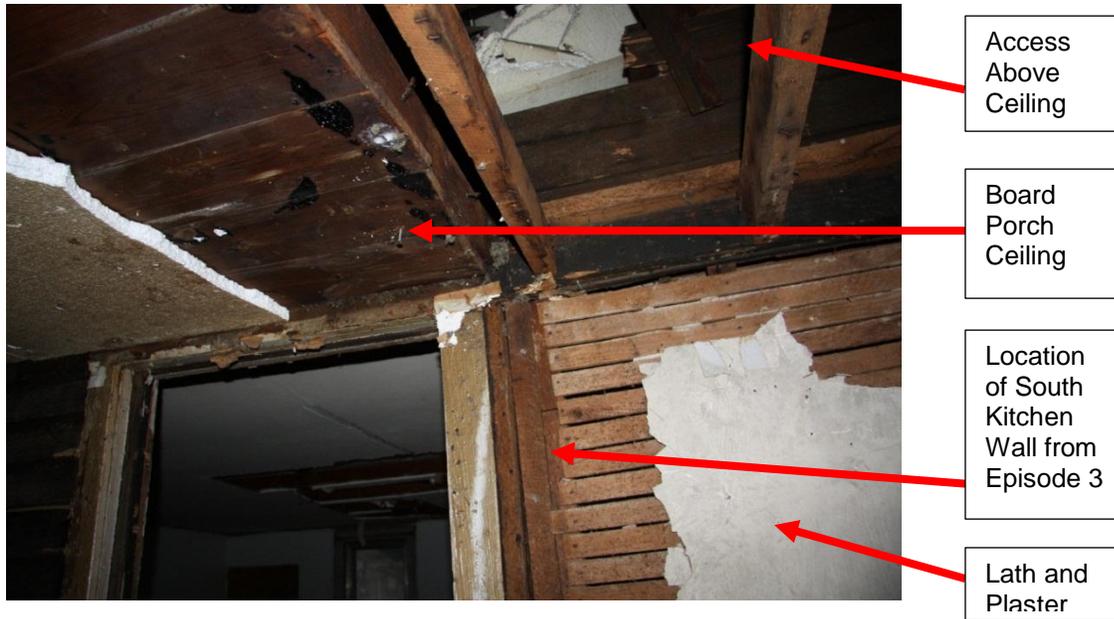
Figure 81. Room 103 west wall detail with porch board ceiling and kitchen south wall stud and lath and plaster walls. (SRJA 2011)

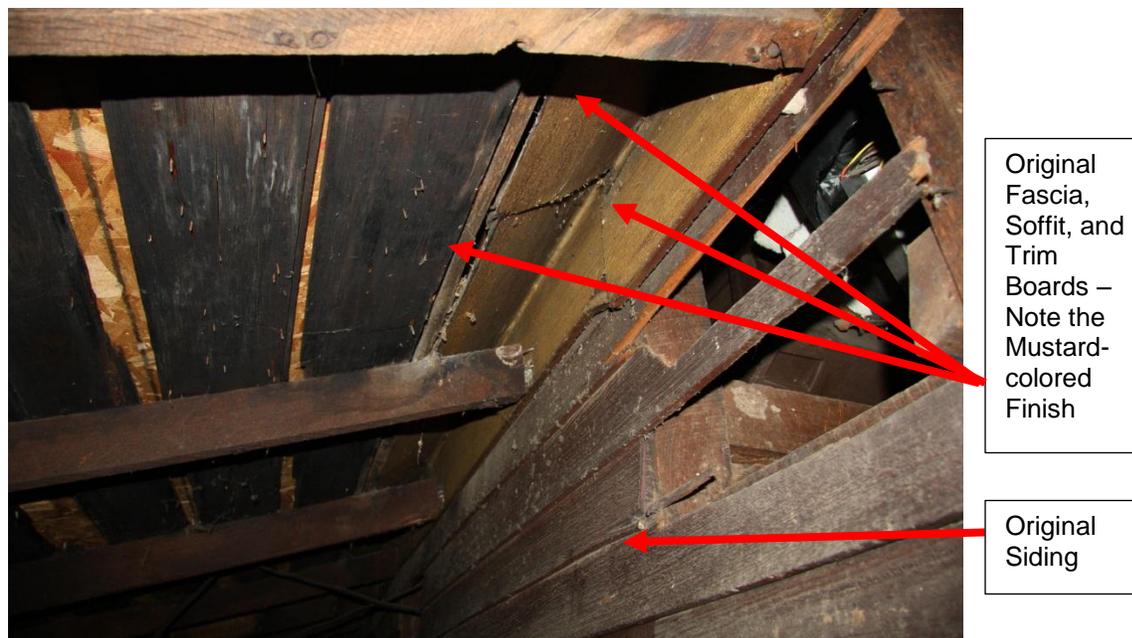
An access hole was made in the ceiling of Room 103 by removing a piece of particle board, in order to observe the framing above the ceiling. Here, it was observed that this entire addition was constructed by framing directly to the exterior siding of the main house east wall. There are a few holes through the siding, where the main house wall studs can be seen. The sloped roof rafters appear to all be of the same vintage, which would date the entire length of this addition to Episode 3, as stated earlier (Figures 81-83).

Figure 83. Ceiling and roof framing over Room 103, looking south. Note the original exterior siding in the right side of the photograph, as well as the original fascia, soffit, and trim boards. (SRJA 2011)

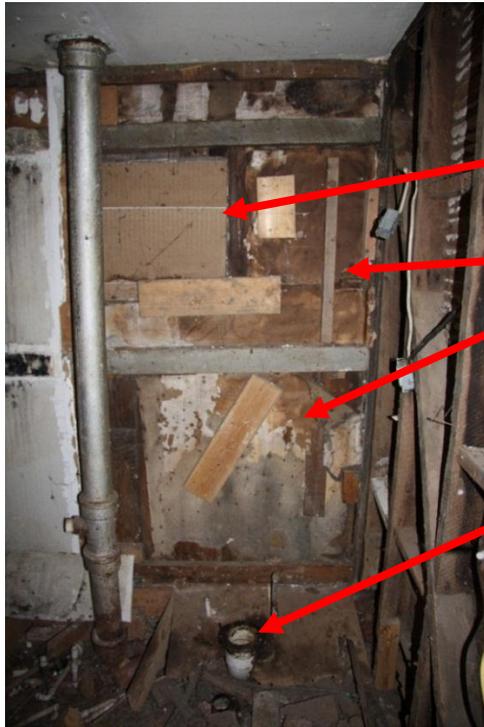
Bathroom 104 appears to be in a state of advanced deterioration, with many layers of historic and more modern materials exposed (Figures 84-88). The room is accessed from Room 103. The floor framing system has deteriorated and is no longer present, so upon entering this space, one is essentially walking in the dirt of the crawlspace. The flooring was missing even during the 2004 site survey. The floor area is littered with modern and historic framing materials, broken PVC piping, and an old sanitary connection. This room was constructed, along with the main portion of Room 103, during Episode 3, most likely as an exterior porch. This section appears to have been in-filled early, likely for use as a bathroom for the house. Portions of the old vertical board siding can be seen along the south bathroom wall. The stud framing for this wall is nominal 2x4's that are turned flat to create a very thin wall system (Figure 84). These studs appear to be a combination of older, rough sawn wood as well as newer, smooth wood. The south wall is a combination of this scabbed framing and is partially covered with moldy gypsum board. A modern window opening is located in the east side of the south wall with a storm window installed in the opening, while an older framed opening is boarded over in the west side of the wall.

Figure 84. South wall, Bathroom 104.
(SRJA 2011)

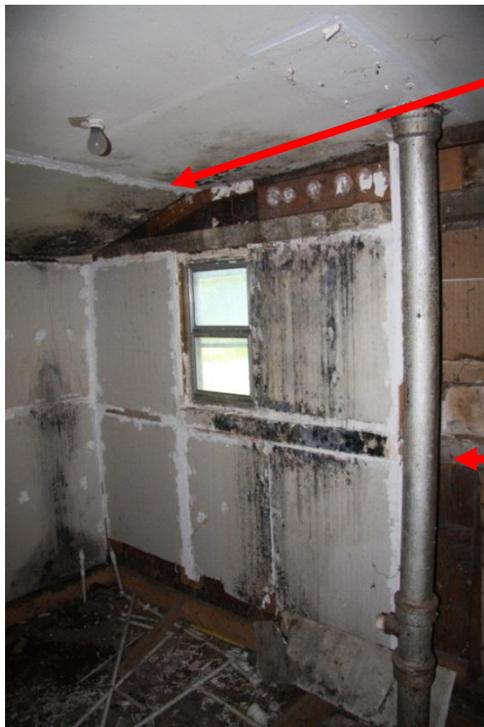
Figure 85. South wall, Bathroom 104.
(SRJA 2011)

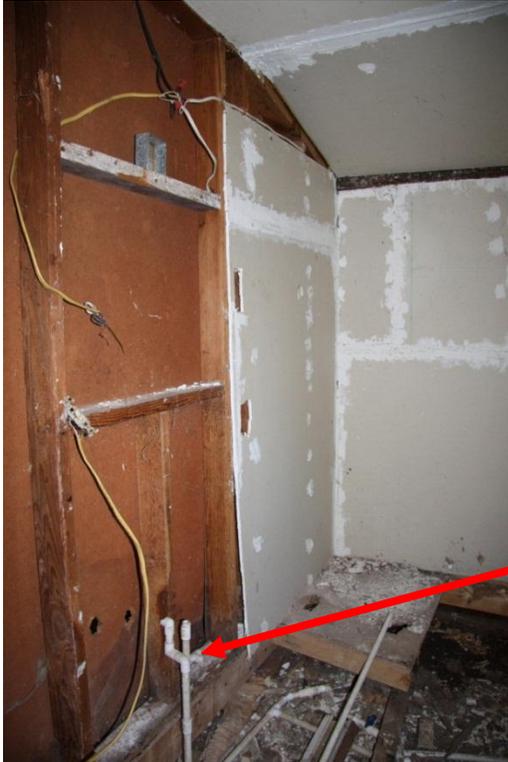
Figure 86. North and east walls, Bathroom 104.
(SRJA 2011)

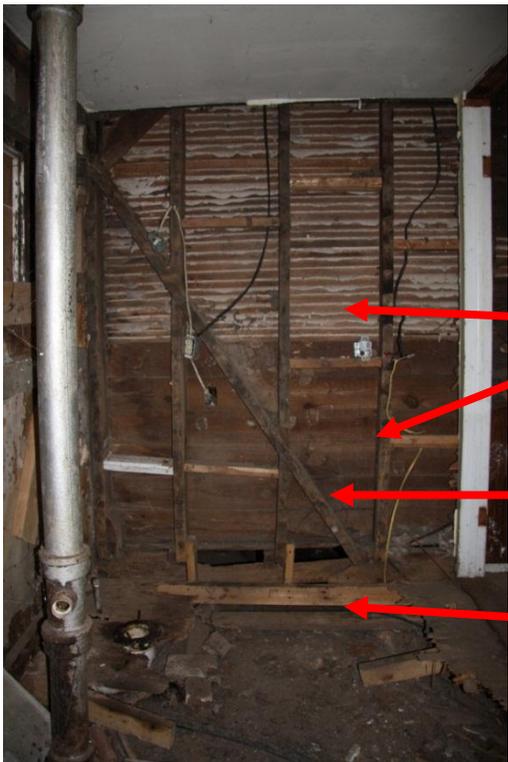
It is difficult to determine what type of foundation the exterior walls are resting on, as the grade in this room is in direct contact with the bottom of the walls. This area indicates there has been a great deal of water and/or moisture infiltration due to the extent of the mold growing on the gypsum board. The east wall is covered with gypsum board, though from the exterior of the house, an old wood window sash and frame are still installed inside this wall (Figures 85 and 86). The north wall is a modern 2x4 frame wall dividing the bathroom and Room 103 and is partially covered with gypsum board. The west wall of the bathroom is the original east exterior wall of the main house. The wall finishes have been demolished to expose the original house balloon framing system (Figure 87). This area also allows for good observation into the south crawlspace, as the 5 ½ x 5 ½ sill beam is deteriorated most of the way through in this location (Figure 88). This section of sill beam will need to be replaced under the main house and is

Deteriorated Original
Sill Beam

Figure 88. Deteriorated 5 ½ x 5 ½ original sill beam and original wall studs, partially supported by modern framing. (SRJA 2011)

discussed in the structural portion of this report. The ceiling in the bathroom is gypsum board and is framed to have the same continuous break toward the east side of the bathroom that is witnessed in the north part of Room 103.

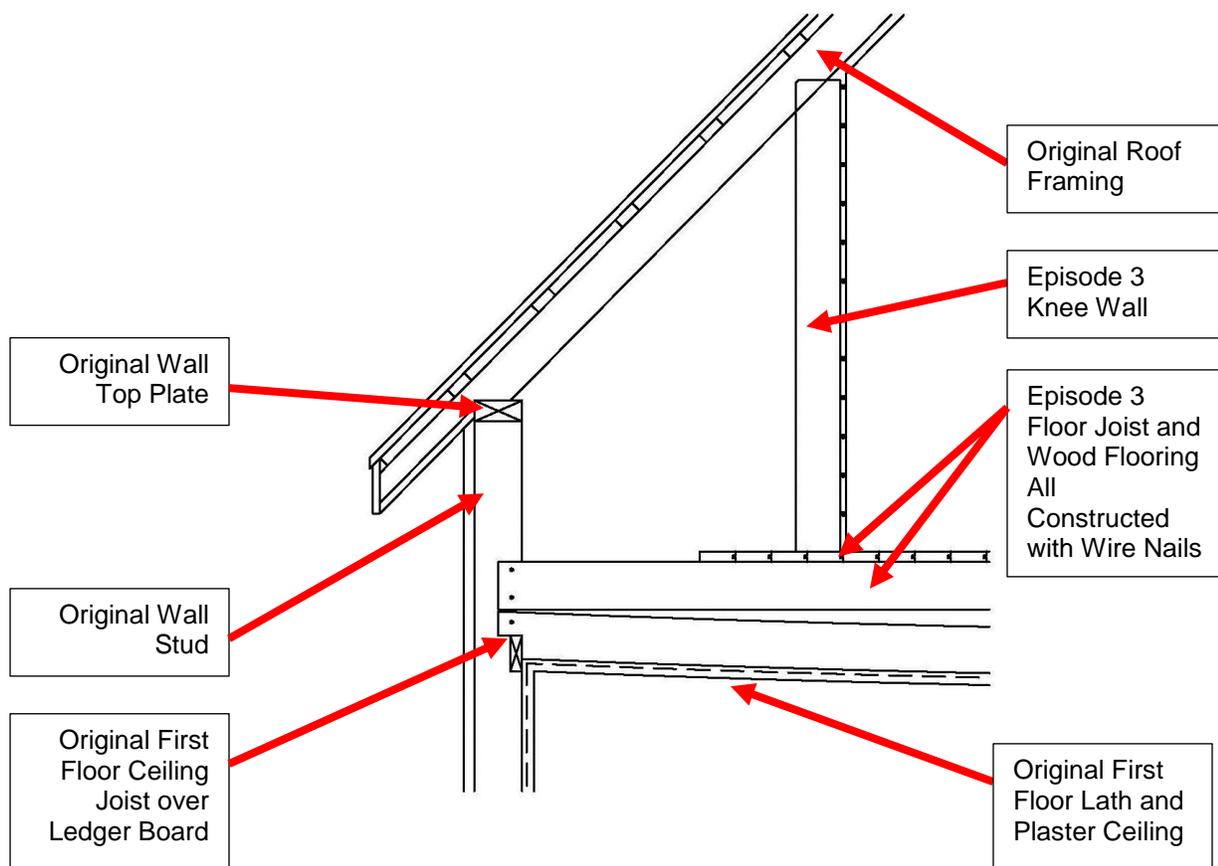
Room 201 was constructed during Episode 3, at the same time the stairs in Room 102 were built (Figures 89 - 92). This second floor space does not appear to have been utilized before this time, as there is no evidence in the original first floor ceiling joists of any previous flooring installation. In order for the second floor to be occupied, additional rough sawn 2" x 4" floor joists were installed directly over the original rough sawn 2" x 4" first floor ceiling joists to carry the live and dead load weight of the second floor, as the first floor ceiling joists were not adequately sized to carry both the ceiling and the flooring loads. This detail can be seen in Figure 89.

Figure 89. Typical section through west attic wall indicating changes made during Episode 3. (SRJA 2012)

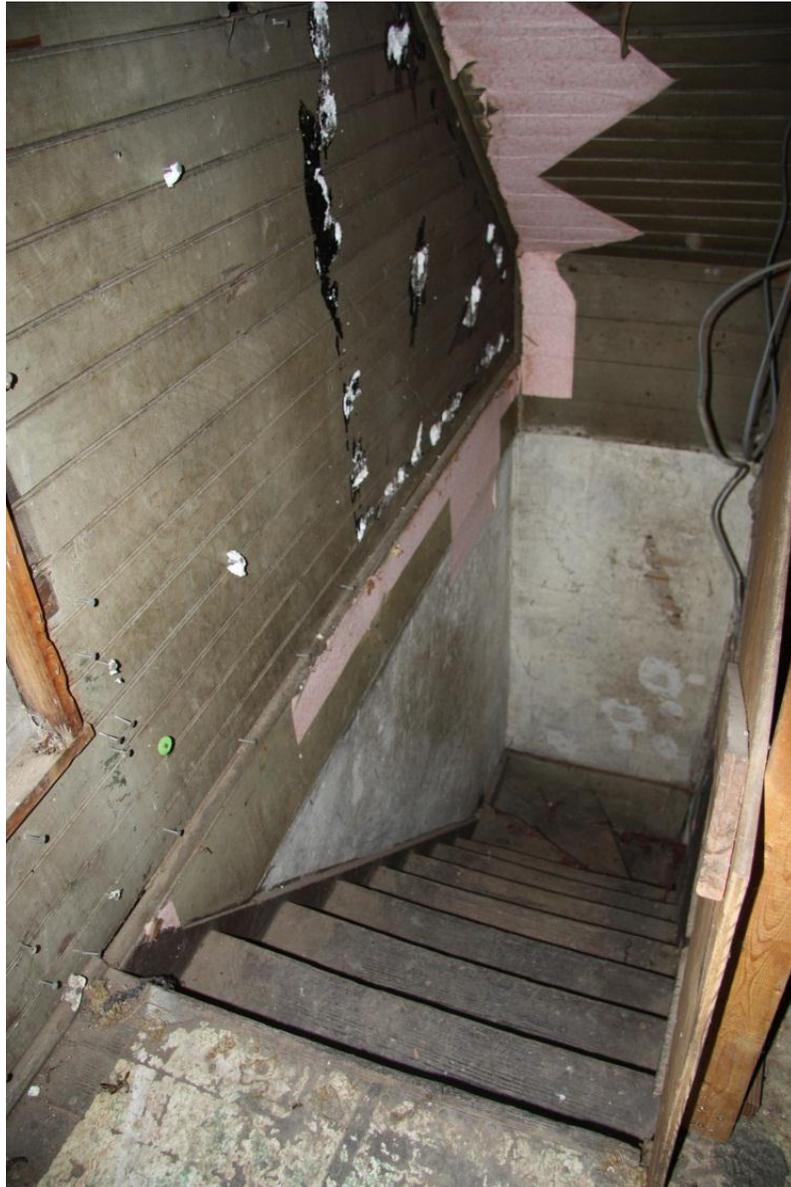
The winding stair from the first floor was constructed during Episode 3 and is constructed with wire nails, as opposed to cut nails (Figure 90). Wire nails were in production post-1895, and therefore, the stair and entire second floor date to this later period, after the school board sold the house. The stair appears to be constructed with pine, though wood analysis has not been conducted on these materials, as they were considered to be outside of the period of significance for the school house. The second floor is one large room with a ¾" x 3" tongue and groove wood floor. The knee walls and ceiling are covered in tongue and groove beaded boards which are 7/16" x 3 ¼". The knee walls along the east and west walls were constructed when the second floor was finished and bear on top of the wood flooring. The ceiling height is low, at only 6'-6" at the middle of the room. When this room was first built, the brick chimney from the first floor pierced through the center of the floor as it passed through the roof. Evidence of this chimney location can be seen in both the floor and the ceiling, where they have been in-filled with boards (Figures 91 and 92). It is possible that the second floor had an additional heating stove that could have also connected into the chimney. Window openings are centered on both the north and south walls, though only the wood frames remain, as they are in-filled with aluminum storm windows. The interior window trim has been removed. These

Figure 90. Stair to the first floor, looking east. (SRJA 2011)

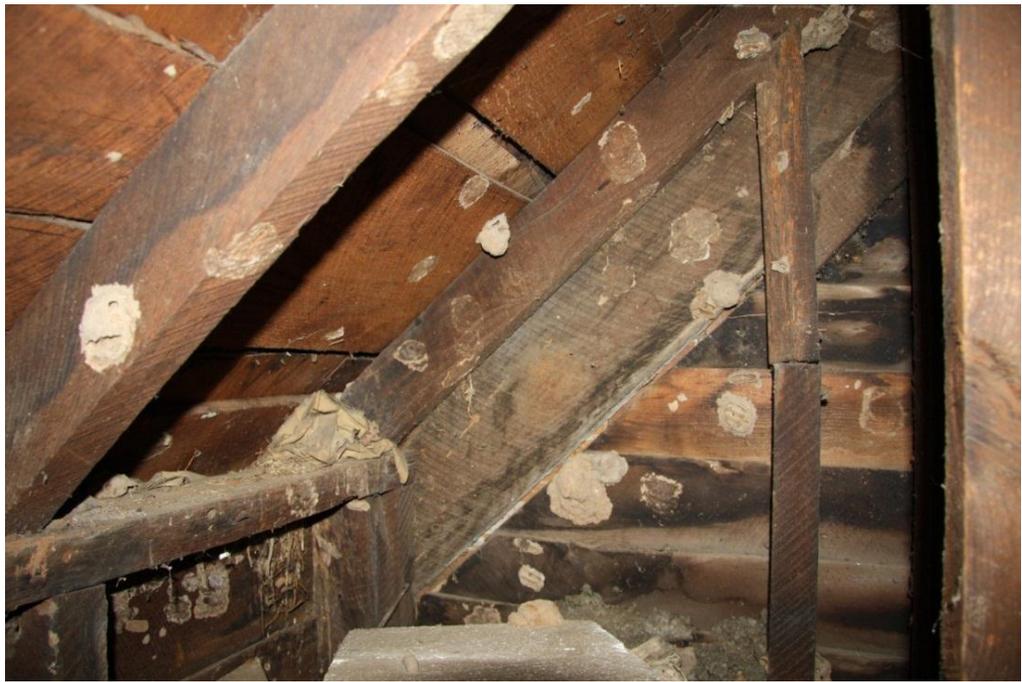
The roof framing over the main structure appears to be original, as it can be observed from a ladder in Room 201 (Figure 95). The 2"x4" rough sawn roof rafters are discussed in further detail in the structural portion of this report. The rafters are topped with random-laid skip sheathing and old wood shingles can be seen installed over the sheathing. The location of the original brick chimney can be seen, as this area was not properly repaired when the chimney was removed. The attic is vented through two existing modern aluminum louvers in the gable end walls. Blown-in rock wool insulation is installed across the collar ties. The roof slopes vary, depending upon which rafter is measured from 42 degrees to 45 degrees. This is due to the bowing and uneven dimensions of the rafters. Many of the rafters are full length, stretching from the exterior wall top plates to where they meet in the center of the roof. Other rafters are much shorter and are sistered with additional material to span the full distance to the center of the roof.

Figure 95. Attic rafters – note angled, sistered rafters. (SRJA 2011)

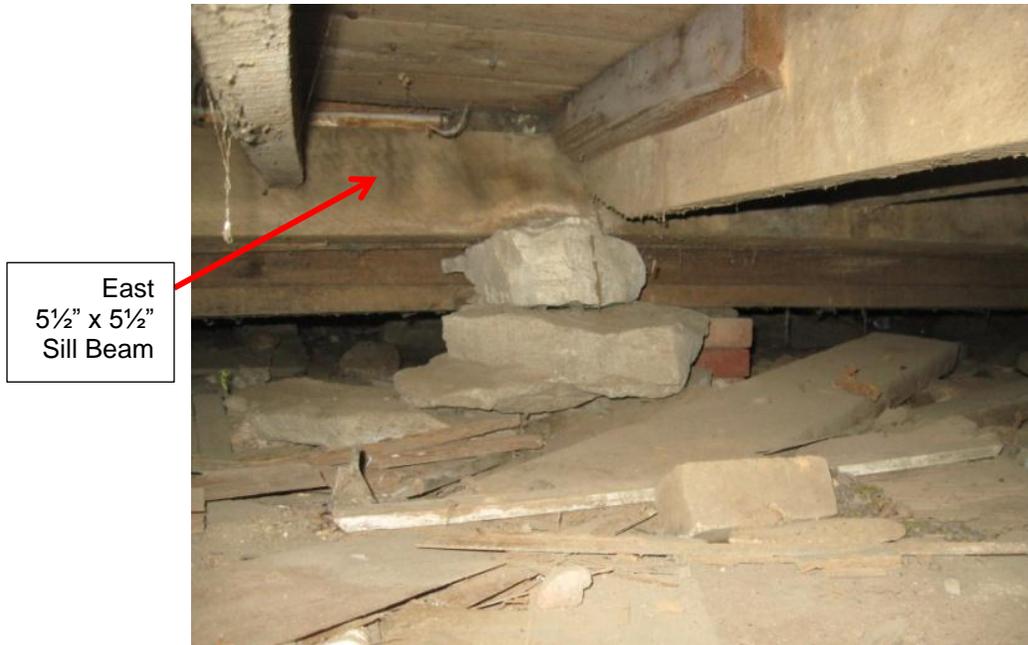
Figure 97. North crawlspace, looking east. (SEA 2011)

The stone foundation is in very poor condition. Due to the original dry-stacked, random sized stone wall construction, the foundation stones have shifted and settled. Erosion and animal intrusion have displaced many of the stones causing failure of the perimeter foundation wall in many locations. The present condition leaves areas of the upper frame walls and floor framing

unsupported. Due to the advanced deterioration, the stone foundation system is currently inadequate to provide support for the building. Damage to the frame building structure resulting from the stone foundation system deficiencies has been limited due to the light weight of the frame building construction and the “Box Effect” of the building wood structure transferring loads. Major repairs and alternations to the building foundation system are recommended.

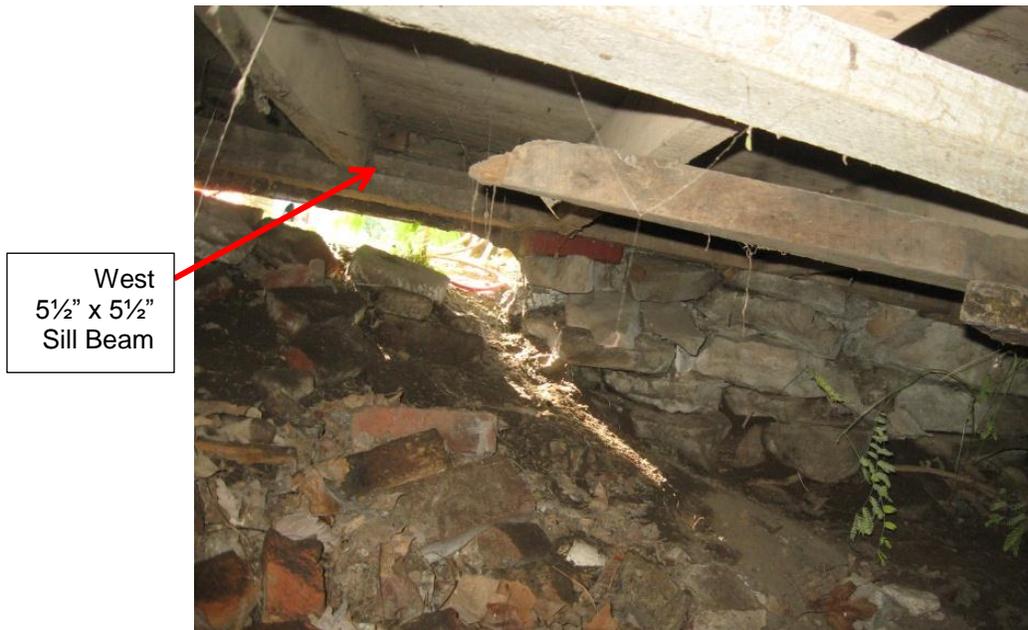
In the south portion of the crawlspace a low area was discovered beneath Room 101. This area was holding some moisture and erosion in the crawlspace dirt indicate ongoing water infiltration issues. Water is traveling from the west side of the structure at an opening in the foundation eastward through the depressed area and out the southern portion of the east foundation wall (Figure 98).

Figure 98. South crawlspace, looking west. (SEA 2011)

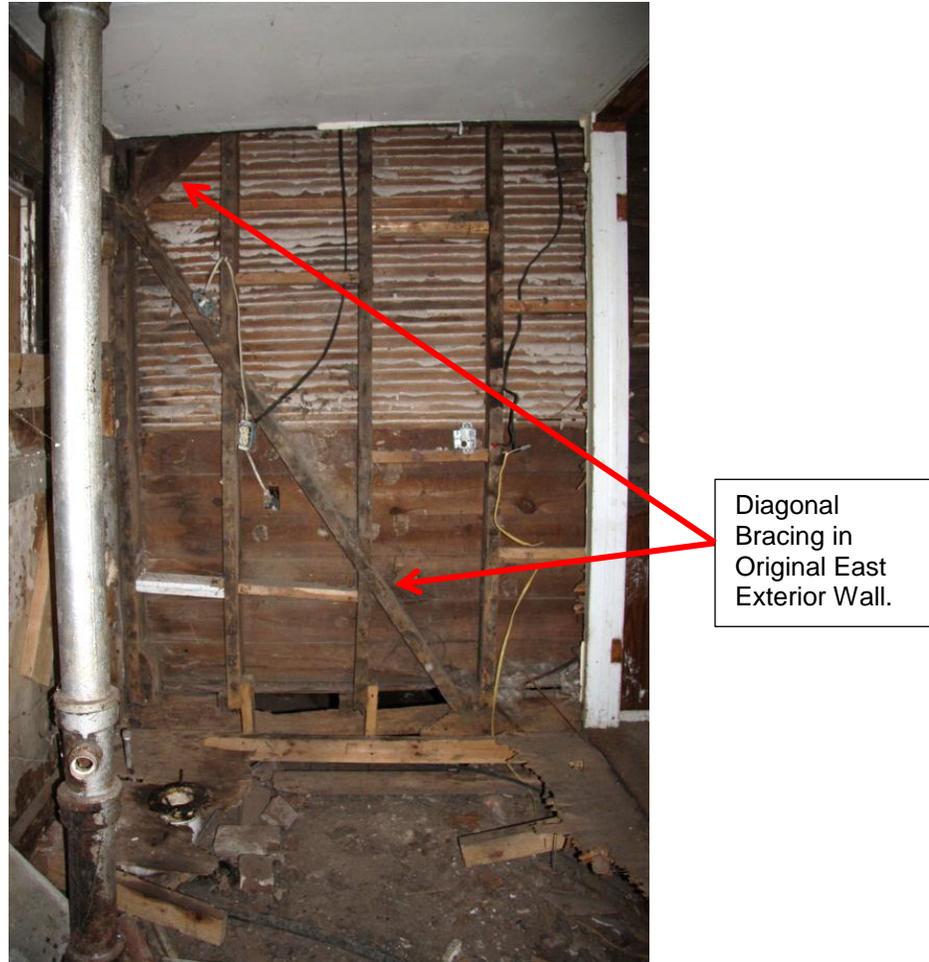
The studs on the east and west walls are founded on a 5½”x5½” wood sill beam which runs continuous on top of the stone foundation wall. The north and south wall studs are founded on a 2”x 5½” rough sawn wood rim joist. It runs continuous on top of the stone foundation wall. The 4” studs are notched and lapped over the rim joist and are therefore face-nailed into the rim joists (Figure 99). The exterior stud walls have diagonal bracing members at the tops and bottoms of each corner that the studs fit to top and bottom. Corner bracing is typical of this period of construction (Figure 100).

Figure 100. West Bathroom 104 wall
(original east exterior wall). (SRJA 2011)

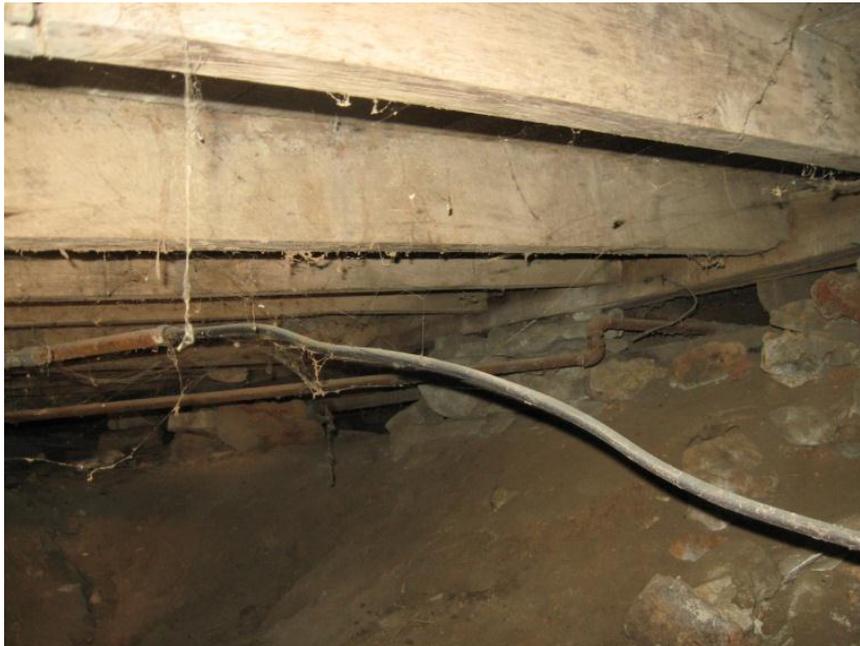
The floor joists clear span east and west to the exterior foundation walls. They notch over and bear on a 5½"x5½" wood sill beam that is supported on the stone foundation wall (Figure 101). The joists are doubled up with two joists under the existing modern partition wall between Rooms 101 and 102.

Figure 101. North crawlspace, looking northeast at the east sill beam. (SEA 2011)

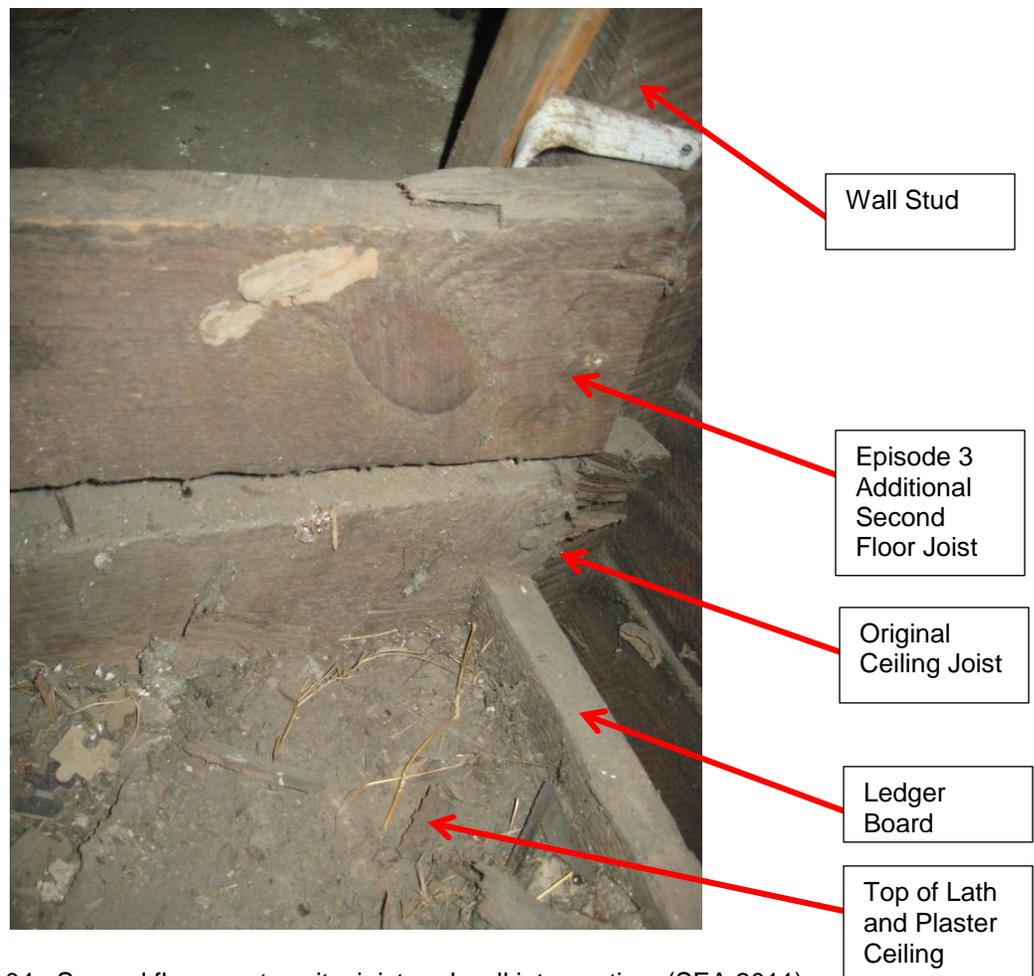
The building as originally constructed had a first floor ceiling with 2"x4" ceiling joists at 18" on center that spanned east-west to the exterior wall studs. It has a lath and plaster ceiling. The ceiling in Room 101 has been built over with 2x4 modern joists covered with gypsum board. The ceiling in Room 102 has been overlaid with a layer of gypsum board. The wood species of the original ceiling joists has been determined to be white oak from a sample taken at the building site. The ceiling joists notch over a 1"x3" ledger board that is recessed into the face of each wall stud and are nailed into the studs (Figure 104).

Figure 104. Second floor west cavity, joist and wall intersection. (SEA 2011)

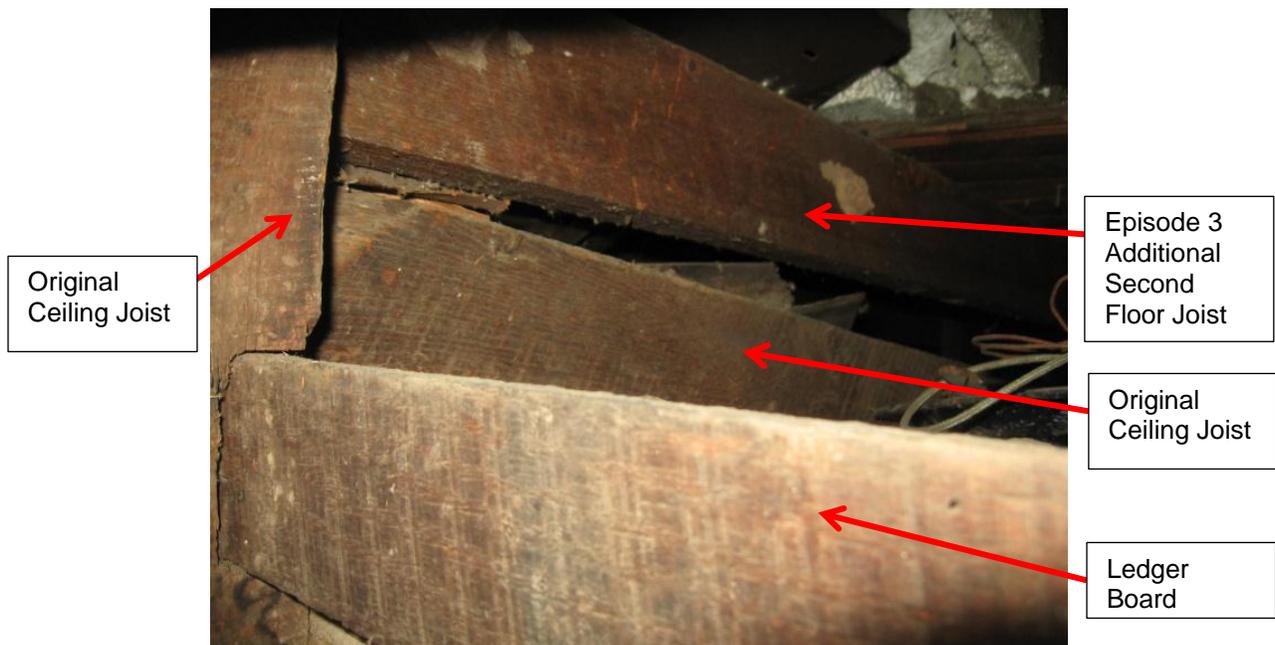
Figure 105. First floor ceiling cavity, perimeter joists, east end. (SEA 2011)

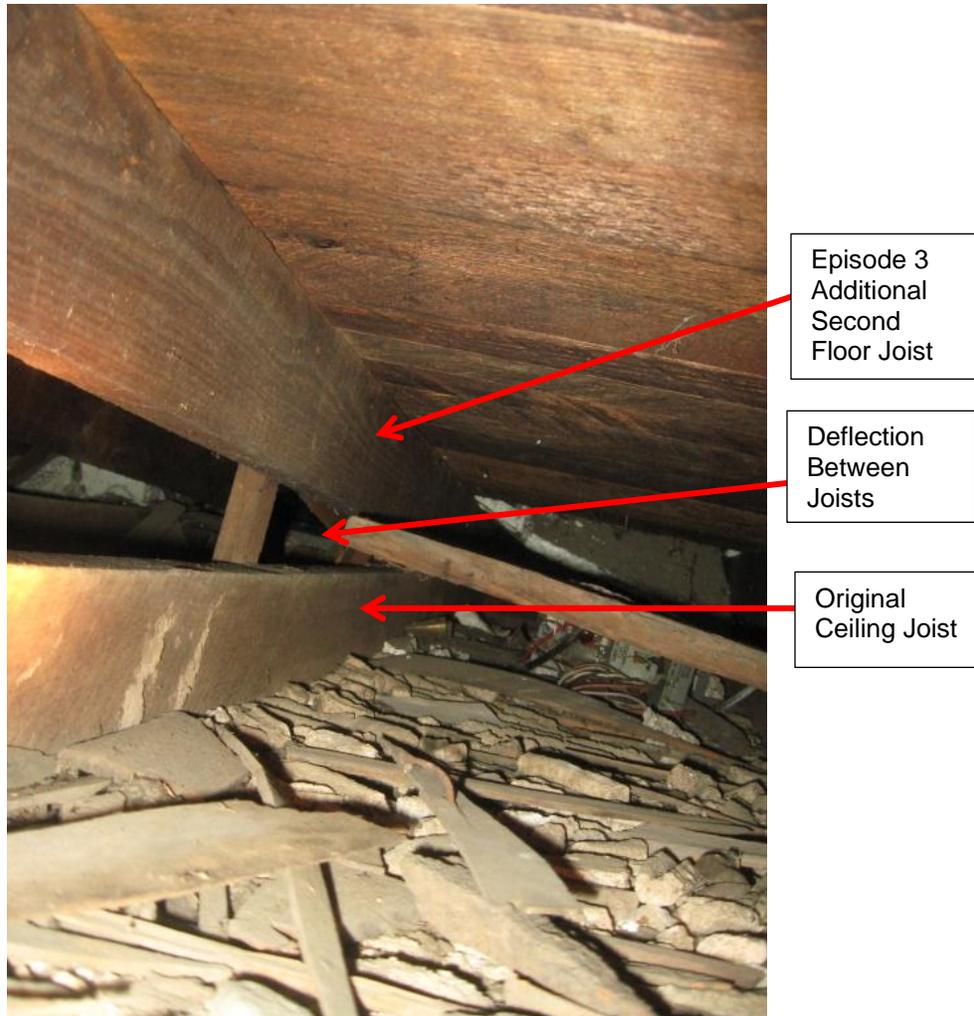
The analysis on the second floor capacity is based on the following criteria. First the original ceiling joists are not capable of any load due to their excessive deflection of 3 1/4" and they are supported now with vertical wood hangers from the newer second floor joists (Figure 106). Second the species of the second floor joists is not known but is assumed to also be white oak. The existing ceiling joist has a capacity of 3.18 pounds per square foot (PSF) for bending. They have a capacity of 89.52 psf. for shear and with an allowable live load deflection they have a capacity of 0 psf.

Figure 106. Interior first floor ceiling cavity, looking east. (SEA 2011)

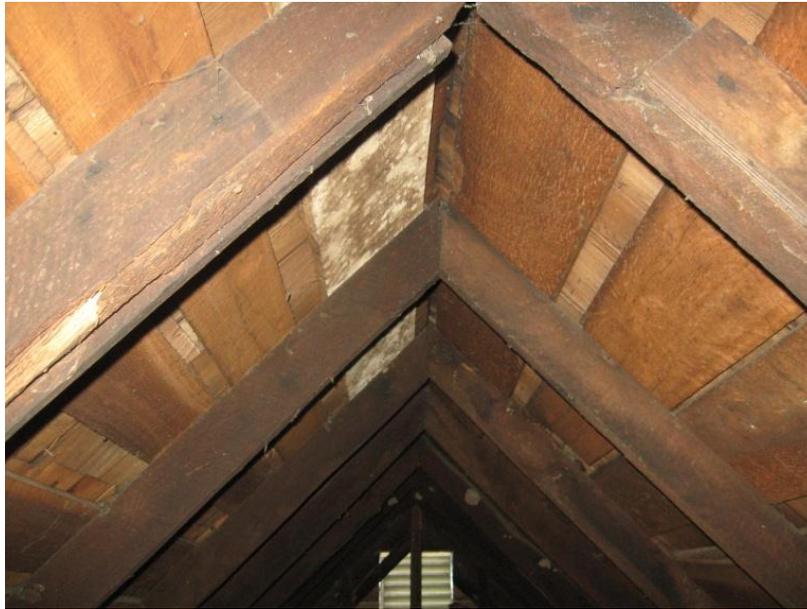
The roof has rafters that are 2"x3.5" spaced at 24" o.c. The wood species has been determined to be red oak from a sample taken at the building site. The rafters span approximately 10.67 feet. At the top they rest on each other without a ridge member (Figure 107). At the bottom they bird mouth over a 2x4 wood plate on top of the wall studs and overhang to create an eave (Re: Drawing 2/S2-S2). The rafters that could be appear to be in good condition. Many have been spliced, though the splices appear to be original to the construction of the house (Figure 108).

Figure 107. Interior roof attic, looking north. (SEA 2011)

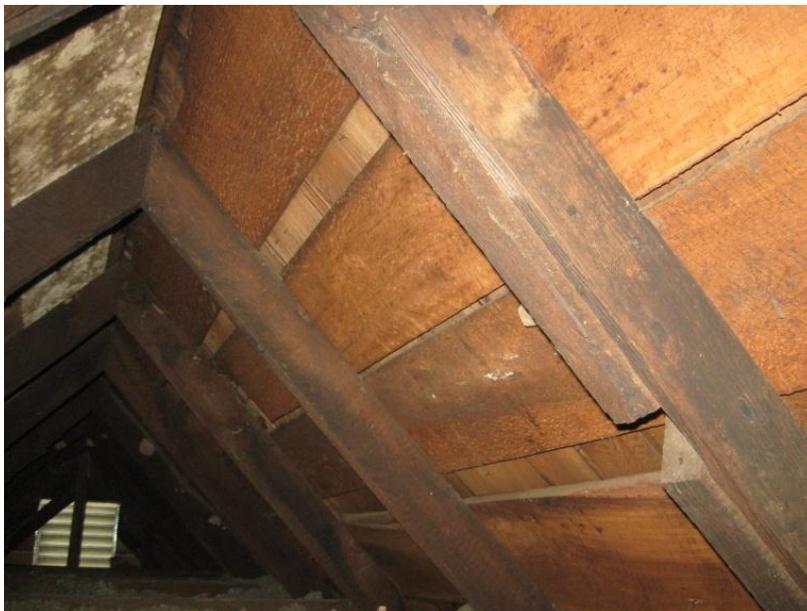
Figure 108. Interior roof attic, looking northeast. (SEA 2011)
