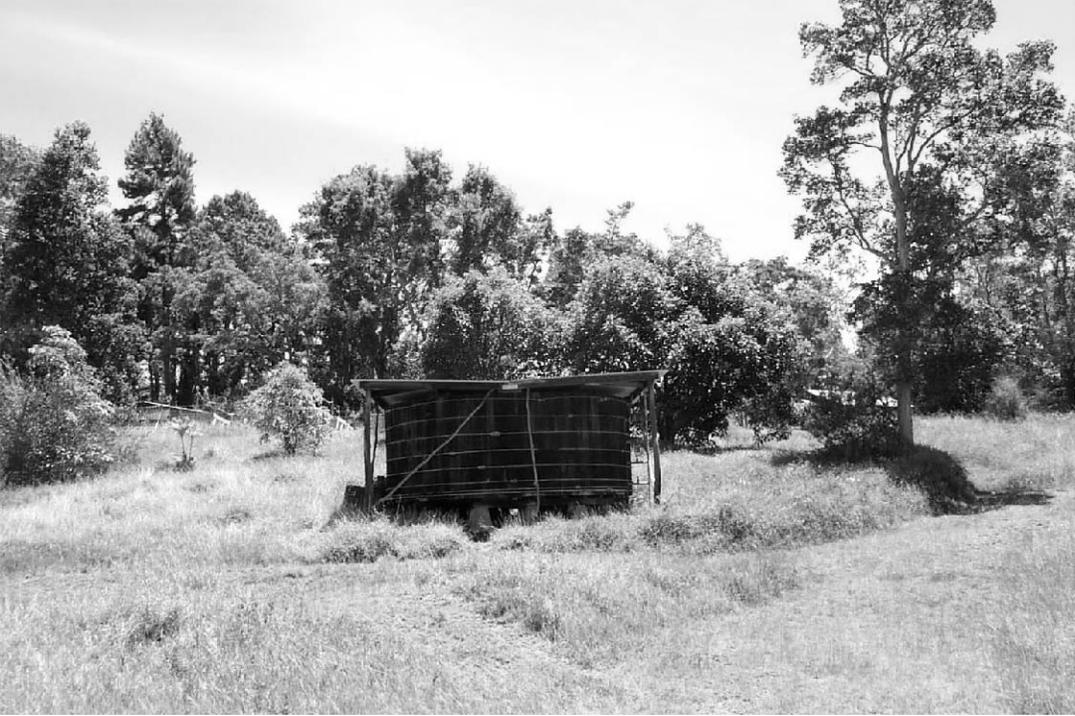
Topography # 1: In Shipman's gravity-powered water system, this water tank a few feet down from the nursery area collected water from the roofs of the hothouses, and serviced the livestock facilities down slope (PWR, HAVO, CLI files, 2003).

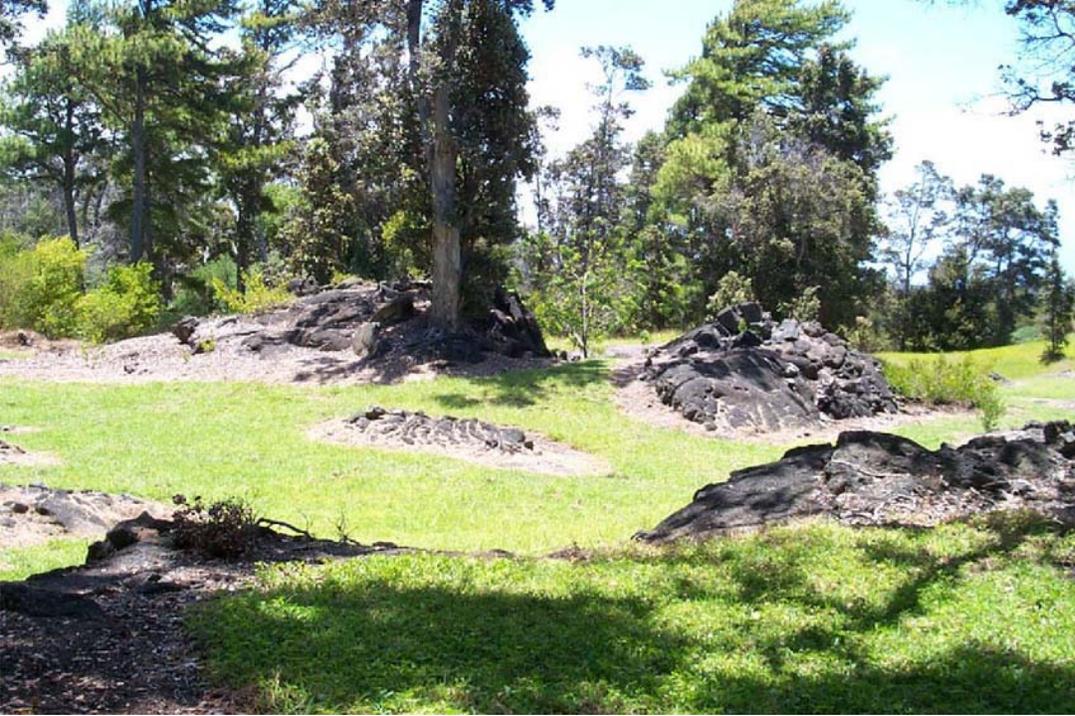
Within the landscape, topography is also integrated into the informal site design. It appears that Shipman sought to integrate or even emphasize natural topography with planted vegetation. For example, the long hedgerow of dracaena follows the contour on the topside of a natural escarpment ranging from four to six feet tall. This hedgerow merges into boxwood and arborvitae as the rocky escarpment fades into a rounded hill. The dwarf date palms that line the driveway loop on the eastern side of the house separate the driveway from a steep drop in the natural terrain. In addition, several irregularly shaped lava outcrops in the southern and western lawn areas still bear plants that remain from the period of significance, both native and introduced. These decorated outcrops are visually defining features in the landscape design (see photo, Topography # 2).

Topography # 2: Lava outcrops are topographic features that contribute to the character of the landscape (PWR, HAVO, CLI files, 2003).

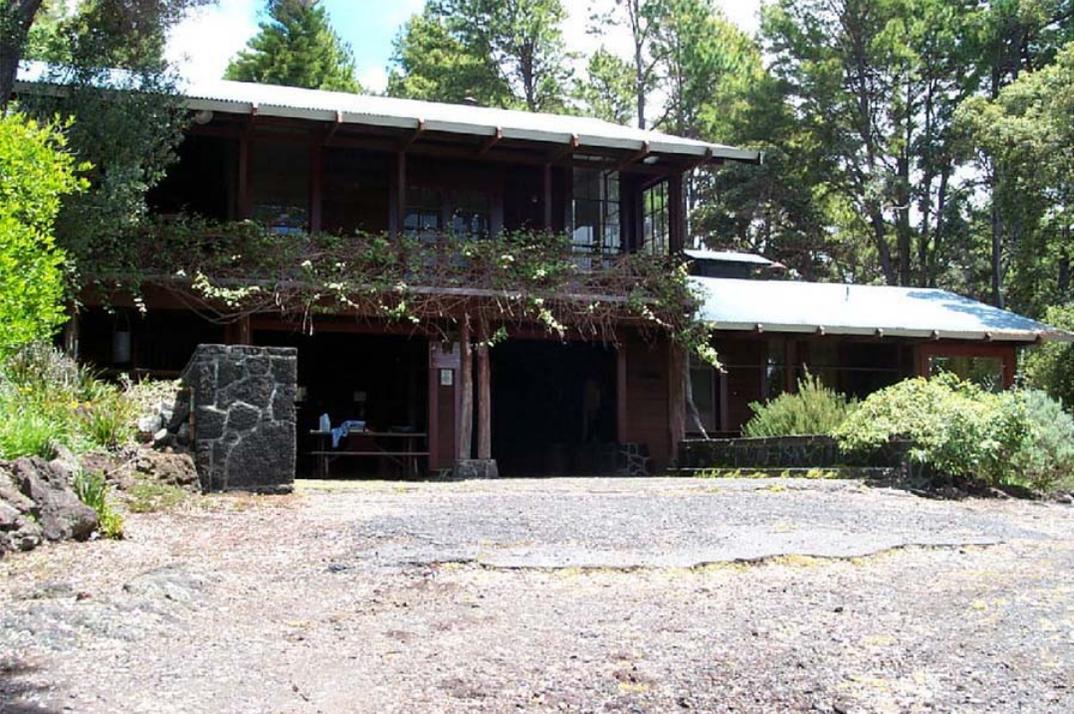
Buildings and Structures # 1: Contemporary photo of the front view of the 'Ainahou Ranch House (PWR, HAVO, CLI files, 2003).

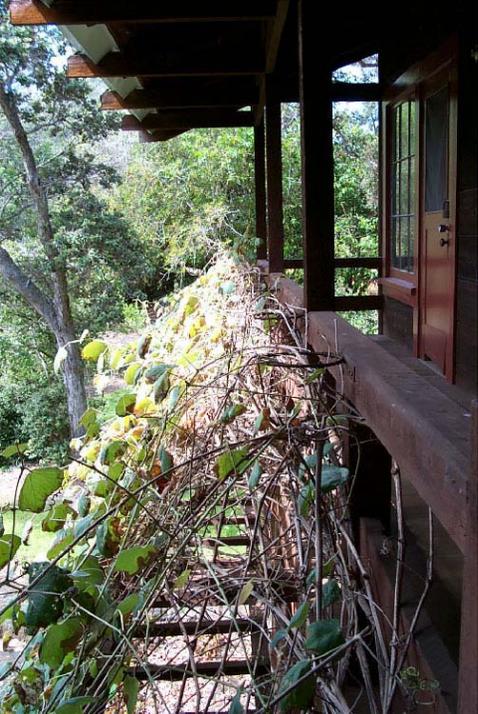
Buildings and Structures # 2: Contemporary photo of the grape trellis located on the south side of the ranch house (PWR, HAVO, CLI files, 2003).

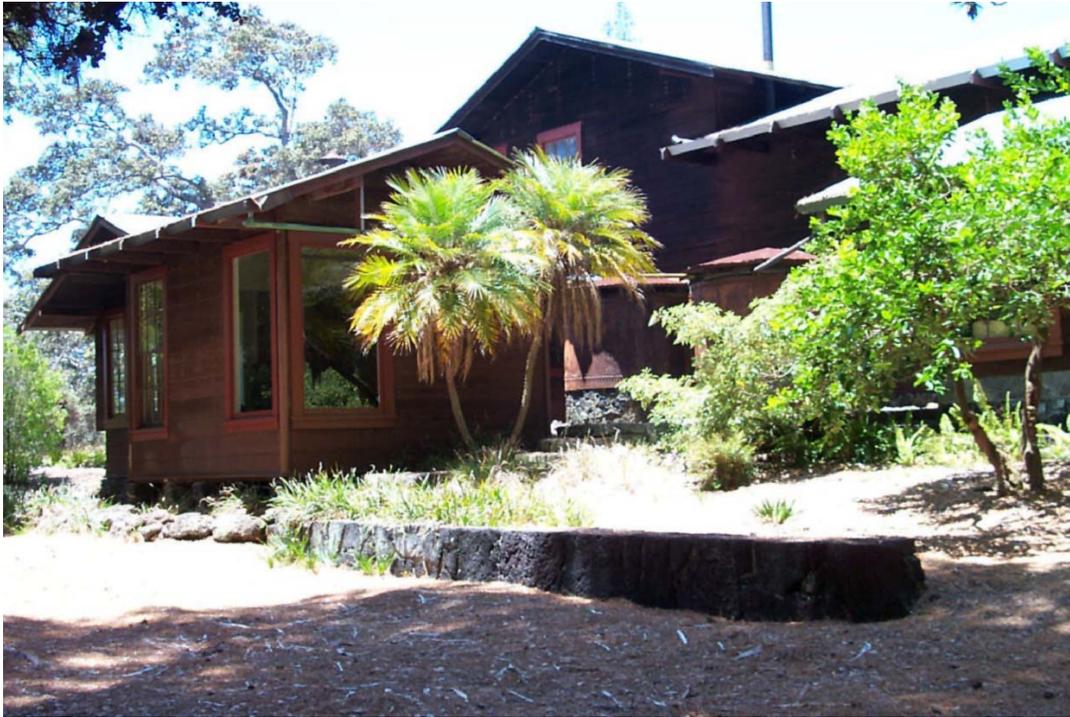
Two small metal water tanks once used for drinking water are nestled in on the east side of the house (see photo, Buildings and Structures # 3). The roof of the ranch house served as the rain shed for these two tanks, which were not issued separate LCS numbers due to their close association with the ranch house. The two large water storage tanks that were contained within the ranch house building are no longer present, but their concrete foundations are still intact. These foundations are also considered part of the ranch house and therefore do not have separate LCS numbers.

Buildings and Structures # 3: Contemporary photo of the east side of the ranch house (looking SW)(PWR, HAVO, CLI files, 2003).

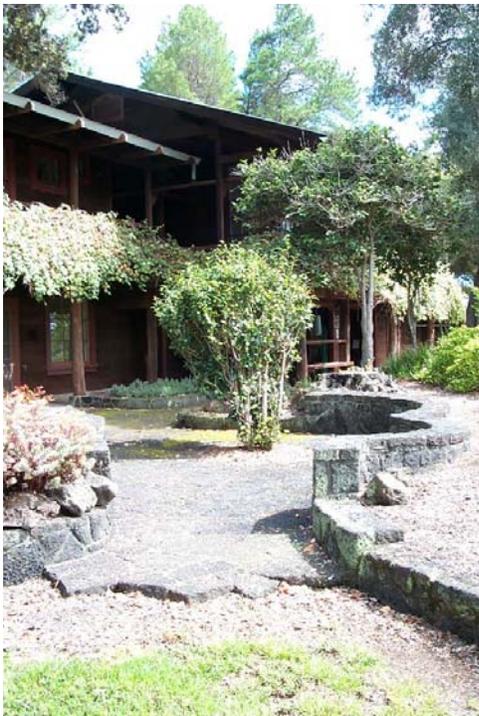
Buildings and Structures # 4: Contemporary photo of the serpentine rock wall framing the outdoor patio area (PWR, HAVO, CLI files, 2003).

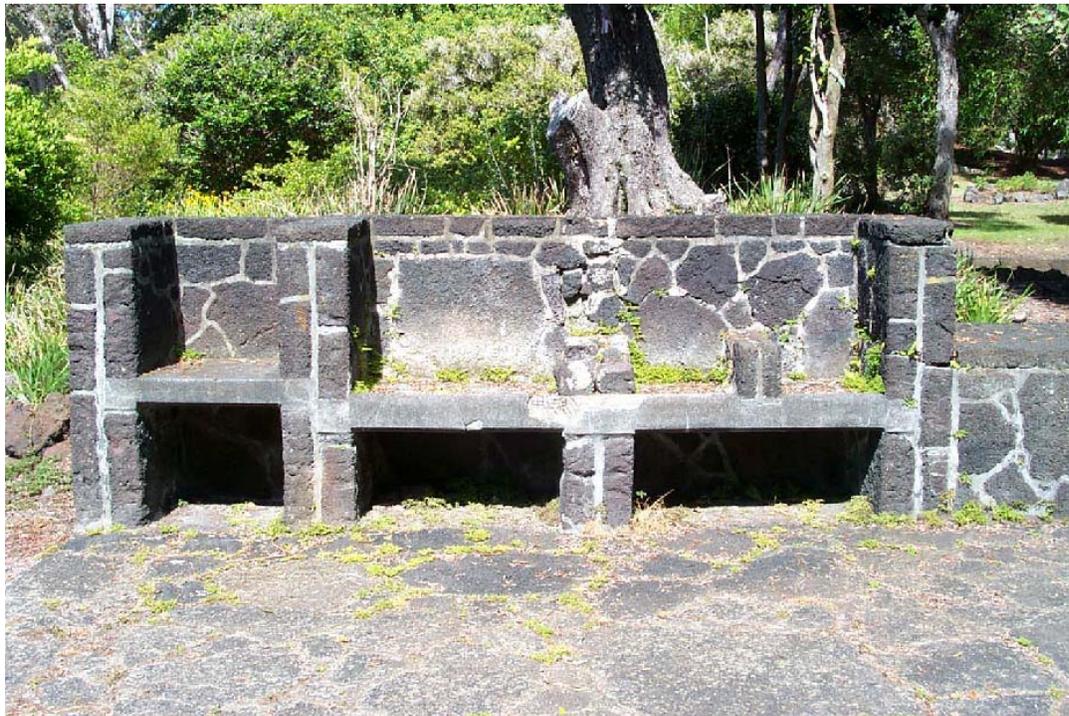
Buildings and Structures # 5: Contemporary photo of the barbecue pits built with lava rocks in a mosaic pattern (PWR, HAVO, CLI files, 2003).

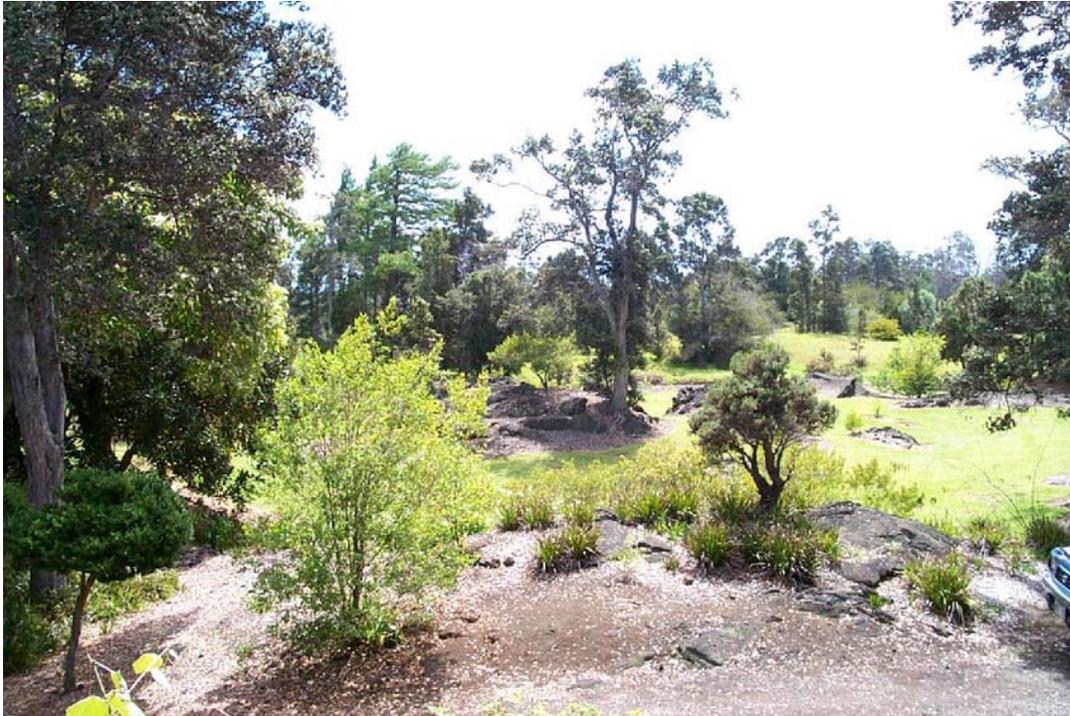
Spatial Organization # 1: From balcony looking south. Note influence of small-scale topography on aesthetics and spatial organization of vegetation (PWR, HAVO, CLI files, 2003).

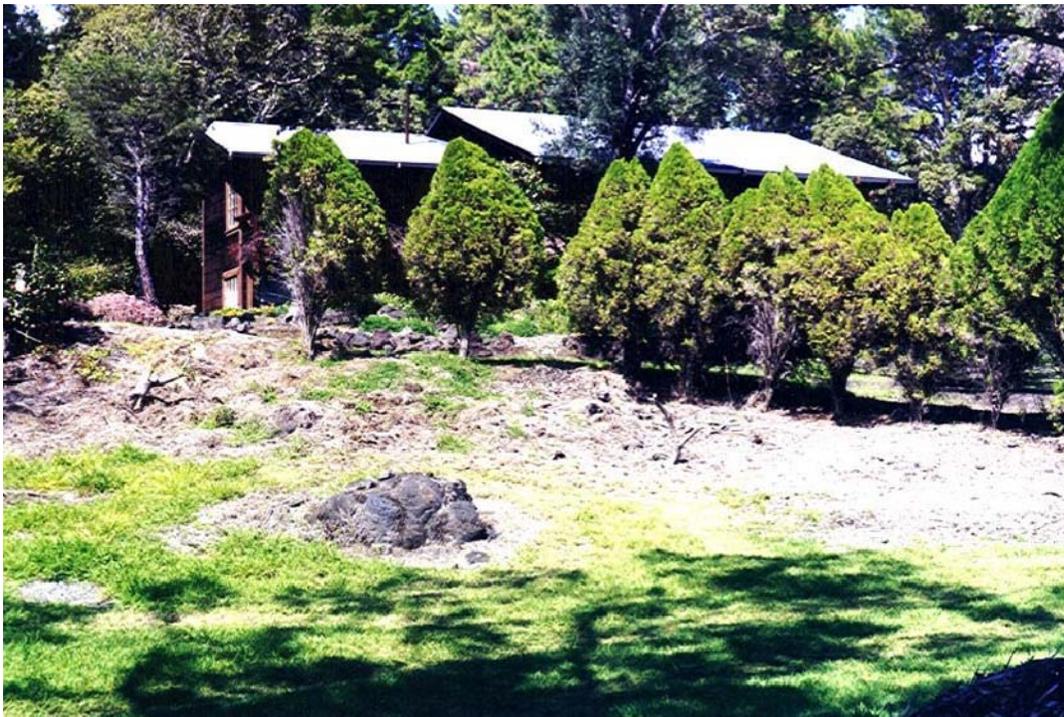
Spatial Organization # 2: Hedge of arborvitae lines the driveway (hidden from view) and the shallow end of a natural escarpment (PWR, HAVO, CLI files, 1999).

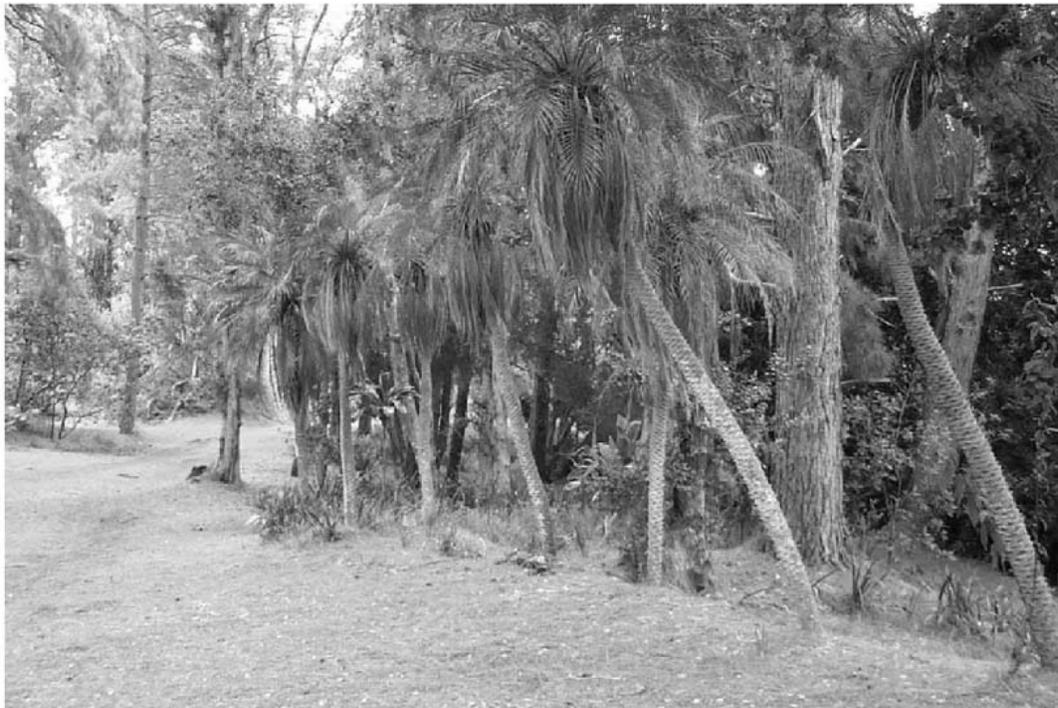
Spatial Organization # 3: Row of dwarf date palms lines the driveway near the east side of the ranch house (PWR, HAVO, CLI, 2003).

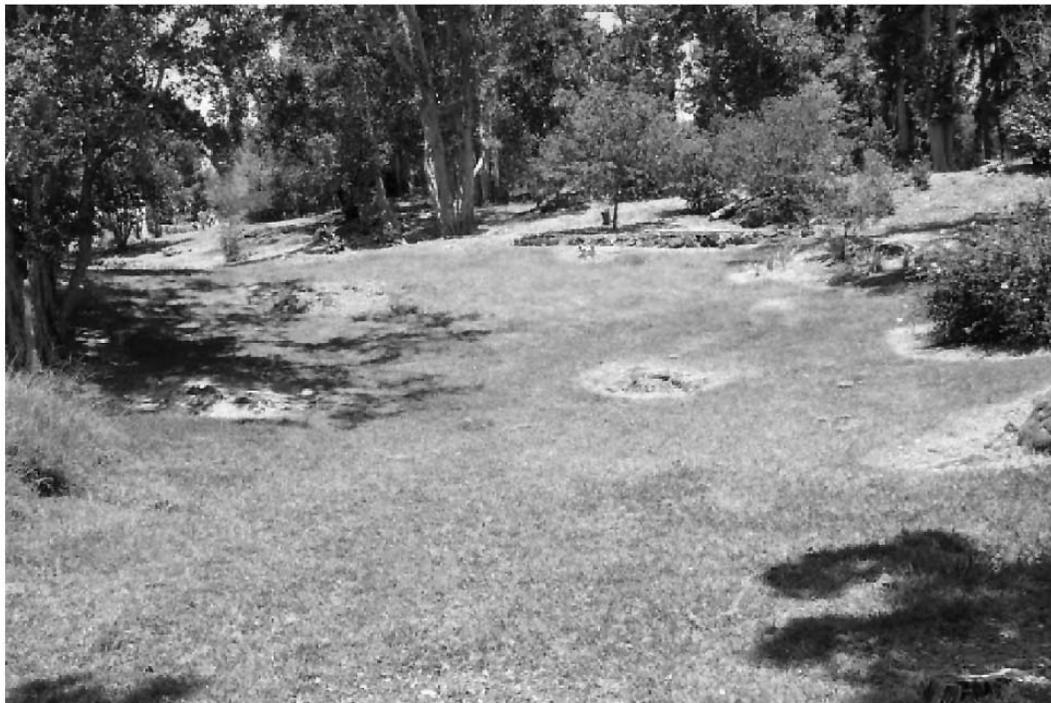
Spatial Organization # 4: An open space creating an informal corridor between the ranch house and the nursery area (PWR, HAVO, CLI files, 2003).

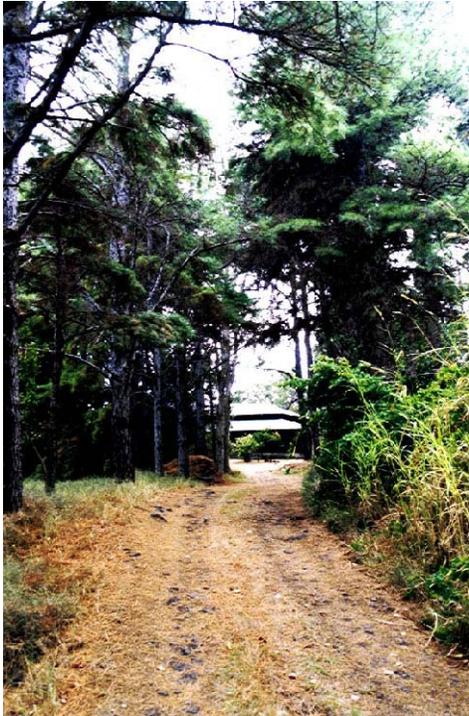
Circulation # 1: Northern portion of the driveway loop, looking southwest towards the ranch house (PWR, HAVO, CLI files, 1999).

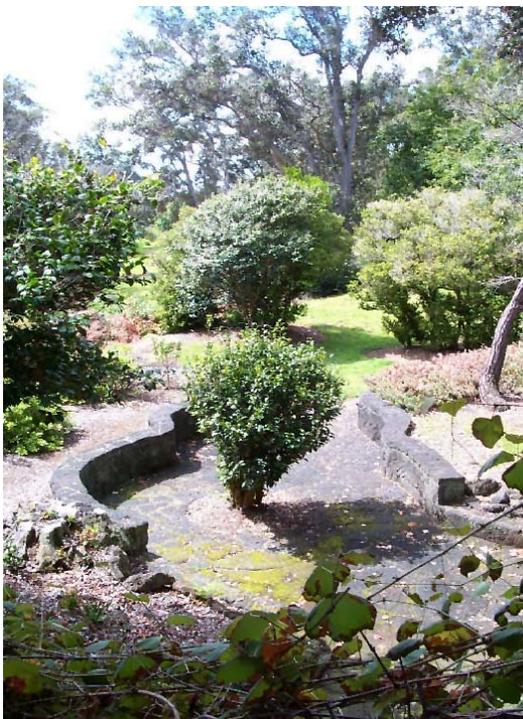
Circulation # 2: Formal walkway / patio on the south side of the ranch house gives way to multiple grass corridors through the gardens in the western lawn area, looking west (PWR, HAVO, CLI files, 2003).

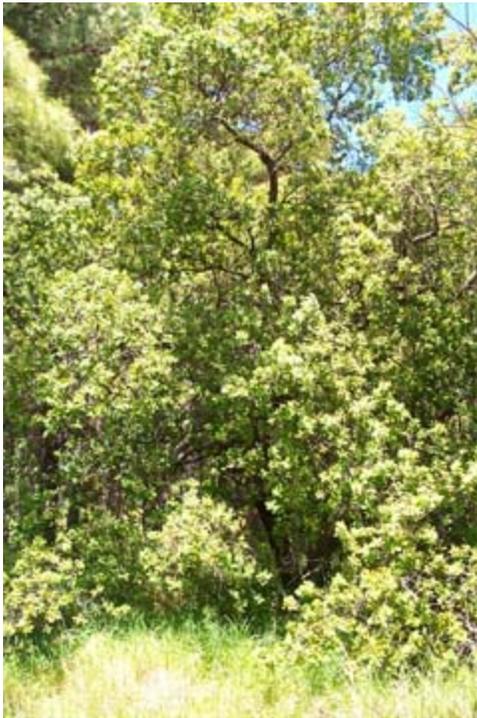
A large native sandalwood tree (*Santalum paniculatum*) (see photo, Vegetation # 1) can be found north of the slash pines bordering the driveway (see Vegetation Map, Enlargement C in Appendix). Two younger sandalwoods also line the driveway, not far from the older one, that may date to the period of significance. Another contributing native feature is the hala pepe tree (*Pleomele* sp.) along the east side of the ranch house (see photo, Vegetation # 2).

Vegetation # 1: Large native sandalwood north of driveway loop (PWR, HAVO, CLI files, 2003).

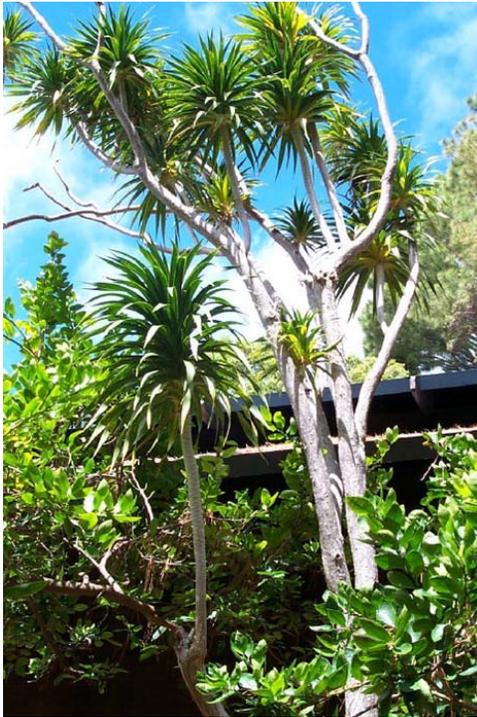
Vegetation # 2: Hala pepe tree fronting the east side of the ranch house (PWR, HAVO, CLI files, 2003).

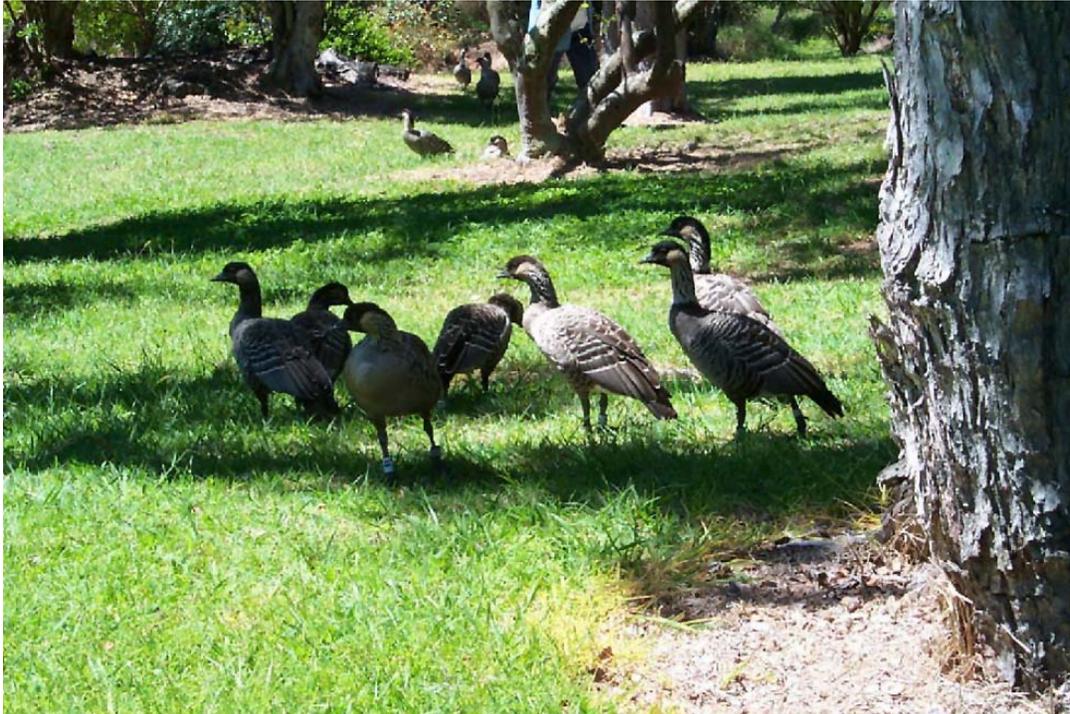
Land Use # 1: Contemporary photo of Nene feeding on grass at the 'Ainahou Ranch House grounds (PWR, HAVO, CLI files, 2003).
