# **Jefferson National Expansion Memorial Old Courthouse**

St. Louis, Missouri

## **Historic Structure Report Special Issues**

July 2013

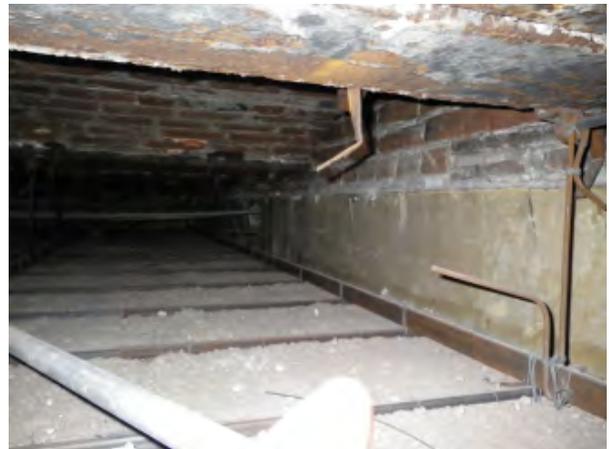
**Ceiling.** The existing ceilings in all three spaces are suspended plaster ceilings installed circa 1955–1959 during the NPS renovation of the building.<sup>52</sup> An access hatch was opened in room 104 to inspect the space above the suspended ceiling. The 1855 structure, consisting of brick vaulting supported by iron beams, is exposed in this area; no evidence of pre-1950s ceiling finishes were apparent (Figure 42). Access was not available for inspection above the suspended ceilings in rooms 102 or 103.

**FIGURE 42.** Above the suspended plaster ceiling in room 104, remnant wall plaster is visible at the corridor; however, no pre-1940s ceiling finishes are present. Photograph by WJE, January 11, 2012.

In room 104, the existing structural west, north, and east walls were present as part of the pre-1855 courtroom. When viewed through the ceiling access hatch in room 104, flat wall plaster with several layers of wallpaper was visible above the 1950s suspended ceiling on the corridor facing wall (refer to Figure 42). In room 102, only the existing structural west and south walls were present as part of the pre-1855 courtroom; the north wall is the corridor, and the east wall is a partition for a bathroom added circa 1950s. No wall finishes which may date to the Dred Scott era were observed above the suspended ceiling from the access hatch.

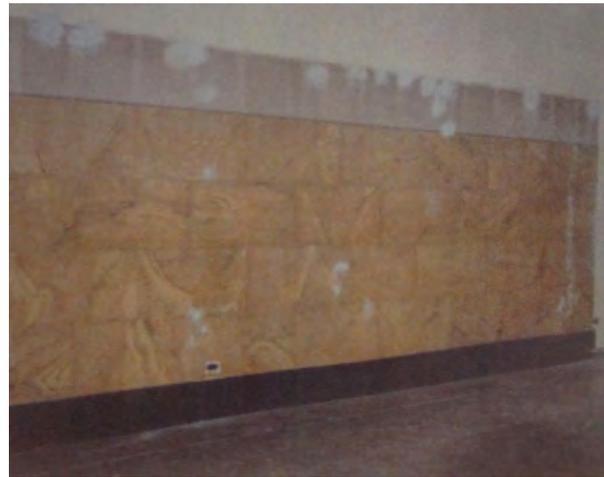
During the 1980 interior renovation of this wing, a decorative marbled paint scheme was revealed on the north wall of room 102 (Figure 43). This scheme may date to the 1860s.<sup>53</sup> The decorative scheme was not restored as part of the 1980 work, and the walls were painted a solid color.

**FIGURE 43.** The north (corridor) wall of room 102 in the west wing. A circa 1860s decorative scheme was exposed during the 1980 interior renovation when a built-in display case was removed. Source: Park Ranger Nancy Hoppe.

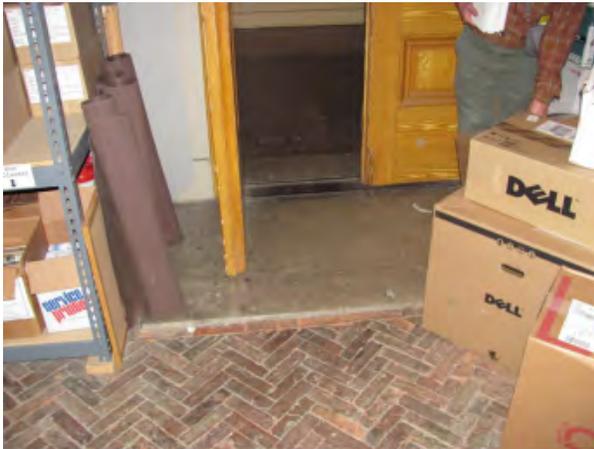
**Flooring.** The *Historic Structure Report: Phase Three* states that the original flooring in the west wing, installed in 1842, was brick paving laid on edge in a herringbone pattern.<sup>54</sup> Similar flooring exists in room 120 on the east side of the south wing (Figure 44). The flooring in the first floor west wing courtroom was covered with carpeting in March 1853.<sup>55</sup>

**FIGURE 44.** In room 120 in the south wing, brick flooring remains intact. This floor was first installed in March 1842. It was heavily restored in 1953, incorporating brick pavers salvaged from the matching room in the north wing. Photograph by WJE, October 19, 2011.

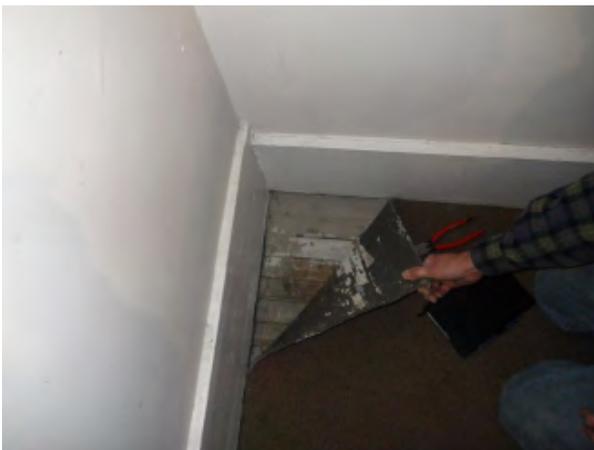
**FIGURE 45.** In room 102, wood strip flooring is present beneath the existing carpeting. Photograph by WJE, January 11, 2012.

Because the wood flooring that exists underneath later floor finishes has an opposing orientation in each of the two courtrooms, and because brick flooring is cited as the original floor material in the west wing, it is likely that the wood flooring in both courtrooms dates to at least 1855 if not later. Since the flooring in the rotunda, west wing corridor, and the two courtrooms is at a continuous level, it seems unlikely that the floor finish of the Dred Scott era courtroom is present below the wood strip flooring. However, when replacement of the existing carpeting in either room is implemented, it may be desirable to selectively dismantle a portion of the wood strip flooring to

see if evidence of the original brick flooring system can be observed.

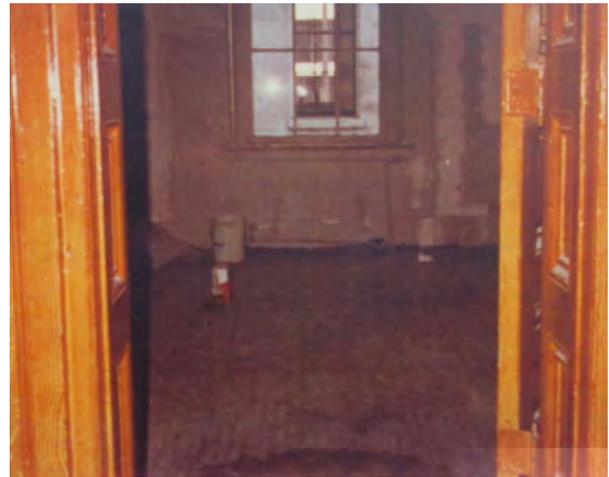
**FIGURE 46.** Room 102 as it appeared in 1980, during renovation of the exhibit space. The wood strip flooring was exposed during the project but was not restored. Source: Park Ranger Nancy Hoppe.

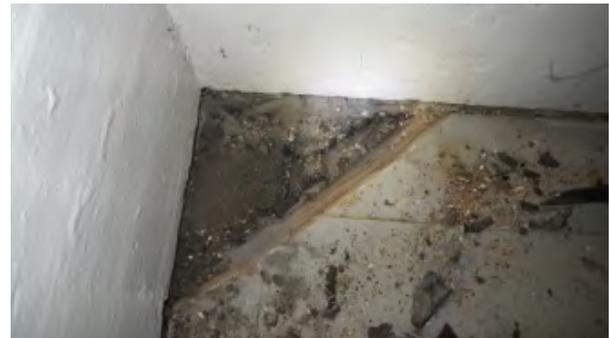
to 3/4 inch thick, and finally a wood strip floor with the boards running east-west (Figure 47).

**FIGURE 47.** In room 104, wood strip flooring is present beneath later flooring finishes, consisting of carpeting; linoleum, 1/4 inch thick plywood underlayment, composition tile, and an underlying fill material up to 3/4 inch thick. Photograph by WJE, January 11, 2012.

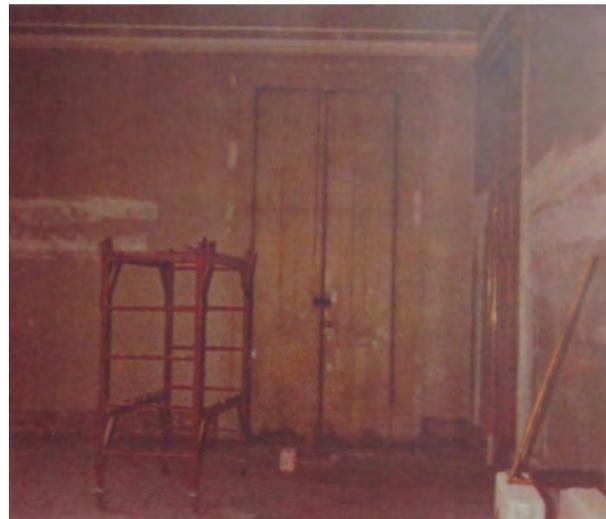
**Window and Door Trim.** As noted, the existing corridor walls were added in 1855; these walls include door openings with wood trim into each courtroom. The trim on the corridor side of each door is similar to the trim on the courtroom side of each door and has a Classical pilaster and cornice design with vertical side pieces. All of these materials date to after 1855 and are painted with a decorative finish imitative of wood graining. The existing finishes and door locksets date to renovation or restoration work performed in the twentieth century. According to the Phase 3 HSR, the existing decorative wood grain finish was first executed circa the mid-1950s, with occasional subsequent touch-up or recoating. The existing decorative wood grain treatment is a restoration of a scheme likely applied when the corridor was built in 1855, or at latest within a few years after its completion.<sup>57</sup> Based on photographs in the collection of the park, it appears that the existing decorative wood graining on the west wall exterior doors was reapplied in 1980 (Figure 48).

**FIGURE 48.** Room 102 during renovation of the exhibits in 1980. Note that the west wall exterior door and trim is painted a solid cream color, likely a primer or undercoat during re-application of the decorative graining, while the corridor door and trim appears to have a decorative wood grain finish. Source: Park Ranger Nancy Hoppe.

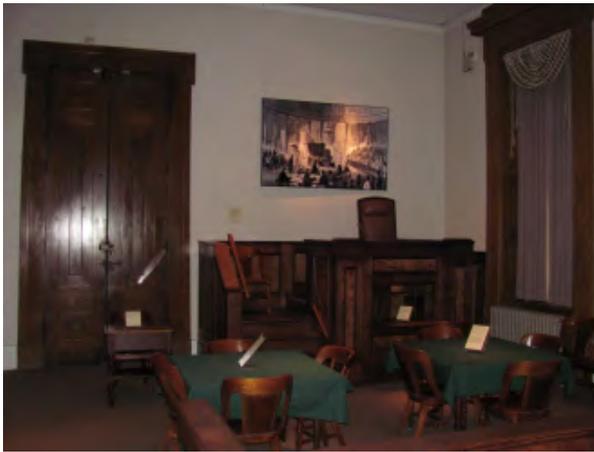
There are also three exterior doors at the west wall, one in each courtroom and one in the corridor. These door openings also have wood trim, but the design matches neither the corridor door openings nor the room 104 window trim (Figure 49). Prior to the 1855 interior changes and the 1859 completion of the west portico, these openings held windows.

**FIGURE 49.** The exterior doors (at left in this view) have a different trim design; these doors and trim likely date to a different time than the window trim at right in this view. Photograph by WJE, October 19, 2011.

elements in the wing (room 104 window trim, corridor door trim, and west wall exterior door trim) could be compared. The analysis could determine if more or earlier layers, perhaps dating to 1842, are present on the window trim and/or exterior door trim, since the corridor door trim definitely cannot be older than 1855. Similarly, stratigraphy from the columns in the second floor courtroom could be analyzed to see if a possible 1842 finish campaign exists on these columns.

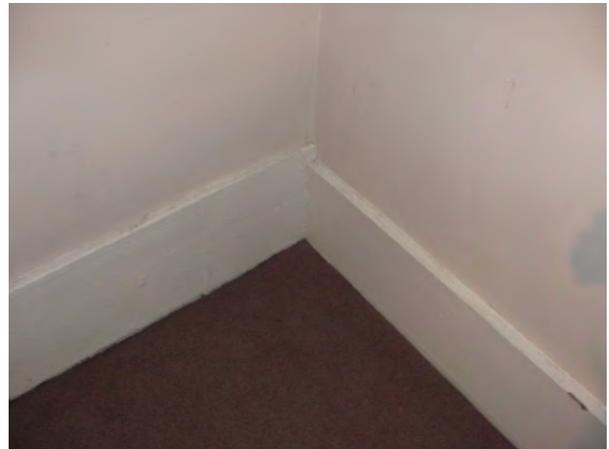
All three spaces have painted rectangular wood trim at the base of the walls. The corridor base is on the 1855 walls and therefore post-dates the Dred Scott courtroom. In rooms 102 and 104, the base is identical on the corridor and non-corridor walls and is therefore assumed to date to after 1855. At the east wall of room 102 (the partition added circa 1950s), the wood base is a different height than the base at the other three walls of the room (Figure 50).

**FIGURE 50.** In room 102, the wood base at the east wall is a different height than the base at the other three walls. Photograph by WJE, October 19, 2011.

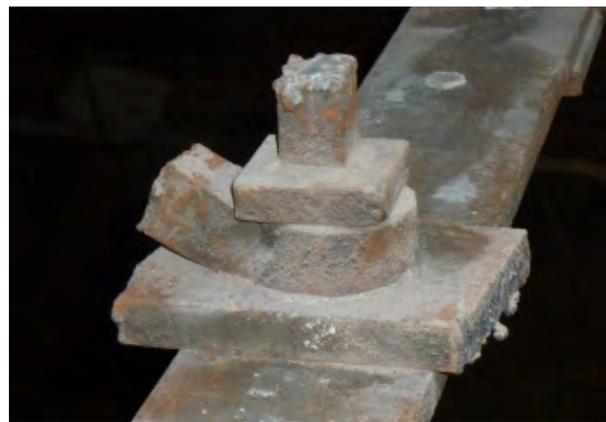
**FIGURE 58.** Remaining connection of a wrought iron truss panel point in the attic above the south wing showing the lower chord and diagonal and vertical members that have all been cut off by torch circa 1941. The bar stock for all elements was rolled and the connections were wrought by hammer (photo by S. Kelley, 2011).

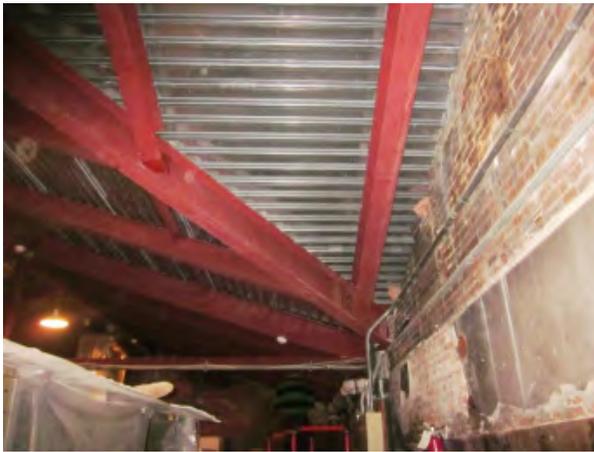
The roof structure, as of the re-roofing in 2011, consists of corrugated metal deck spanning between sloped steel beams. The wide steel flange beams, installed by the NPS in 1941, are approximately 10 inches deep with a flange width of six inches (Figure 72). All ceilings that had been suspended from the previous roof structure were re-suspended from the 1941 roof structure. A flat seam copper roof was installed over this roof structure in 2011 using the existing beams which are still sound. The 1941

**FIGURE 72.** The roof structure consists of corrugated metal deck spanning between sloped steel beams, as viewed in the attic above the north wing (photo by S. Kelley, 2011).

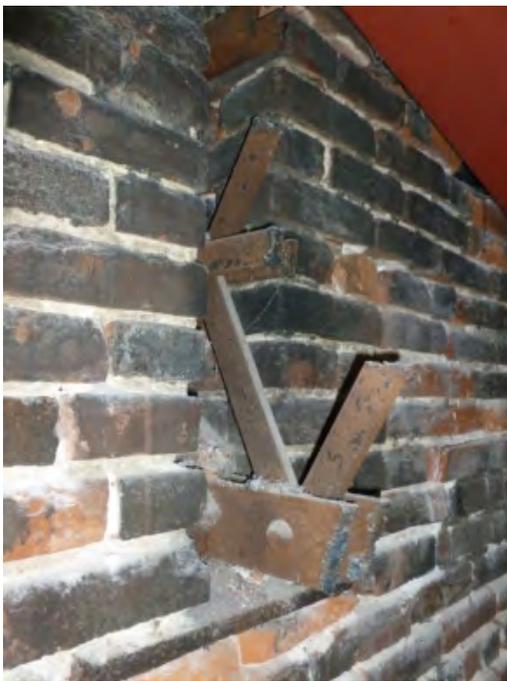
Noticeable deflection has occurred at the remnants of the lattice beams based on the angle of the remaining top and bottom chord elements, which were originally set level. At some locations, the slope of the top and bottom chords was as much as 4 degrees. The slope suggests that these lattice beams had deflected significantly due to the long spans, overloading, lack of adequate lateral bracing to help prevent rotation of the bottom chords, or a combination of these factors.

**FIGURE 73.** A remnant of a lattice beam that was cut almost flush with the bearing wall. Lattice beams were fabricated with a series of 1/2 inch thick by 1-1/2 inch wide plates for the web members sloped at approximately 30 degrees from vertical, with 3 inch deep by 3/4 inch thick plates for the top and bottom chords (photo by S. Kelley, 2011).

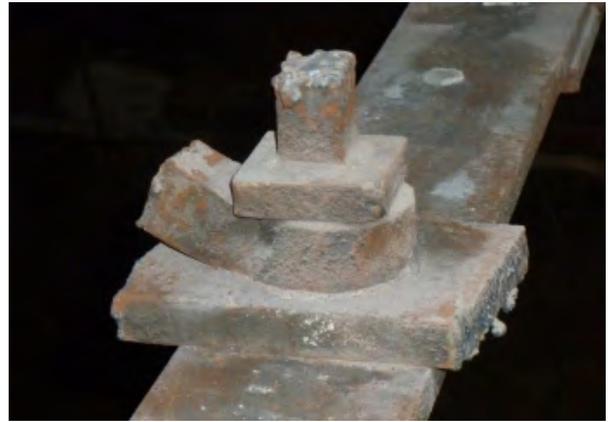
**FIGURE 74.** View of a truss panel point that is still attached to a horizontal transverse bar. The bottom chord and diagonal and vertical members were all torch cut and removed as part of the 1941 NPS re-roofing project (photo by S. Kelley, 2011).

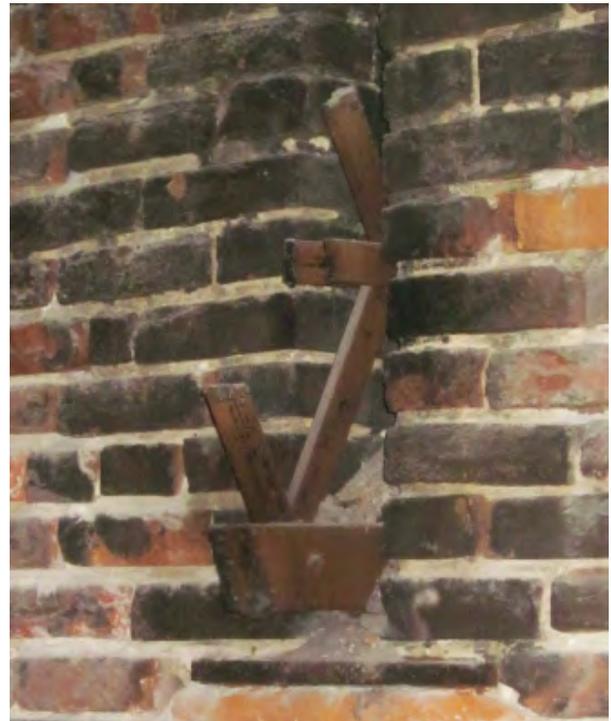
**North and South Wings.** Lattice beams spanning in the north-south direction were observed at the north portion of the attic in the north wing as well as the south portion of the attic in the south wing (Figure 80 and Figure 81). The lattice beams are approximately 40 inches deep and are constructed with 3 inch by 3/4 inch plates for the top and bottom chords, and a series of 1/2-inch by 1-1/2-inch plates sloped at approximately 30 degrees for the web members. Portions of the wrought iron trusses remain in the north section of the south attic above the main corridor (Figure 82 and Figure 83). The brick masonry barrel vault over the south cross hall is exposed and accessible from the attic (Figure 84).

**FIGURE 80.** Remnants of lattice beam at south attic. The member is approximately 40 inches deep and was constructed from a series of rectangular plates (photo by S. Kelley, 2011).

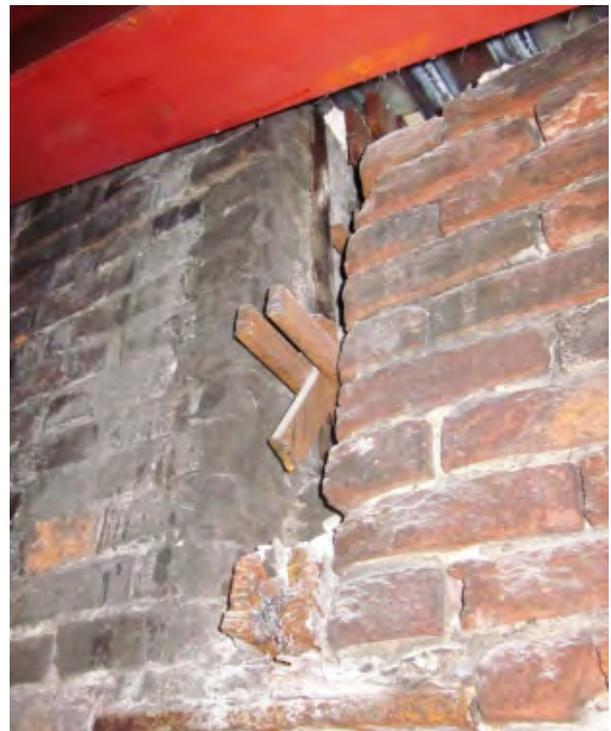
**FIGURE 81.** Remnant of a lattice beam in the attic of the south wing. Note the metal bearing plate beneath the beam that was also set in brick wall. These lattice beams were roughly cut away during the 1941 renovation (photo by S. Kelley, 2011).

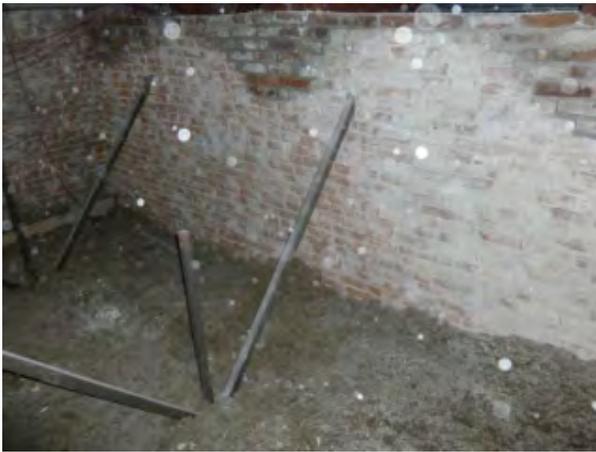
**FIGURE 82.** Wrought iron truss elements in the south wing above the main corridor. Protected by the brick walls on either side, they were left in place during the 1941 renovation but were cut away on the outer side of each wall (photo by S. Kelley, 2011).

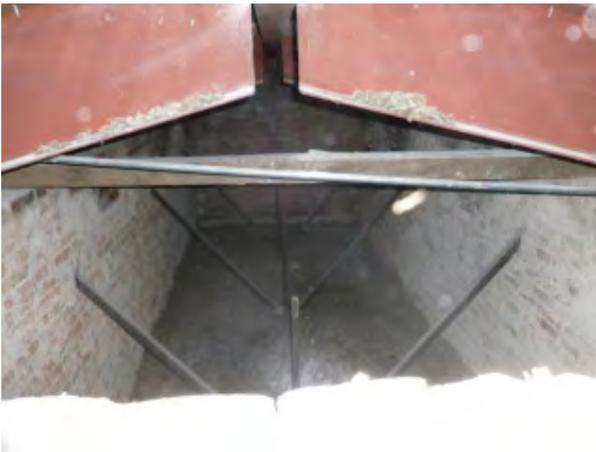
**FIGURE 83.** Another view of wrought iron truss elements above the main corridor in the south wing. The red beams are from the existing roof structure (photo by S. Kelley, 2011).

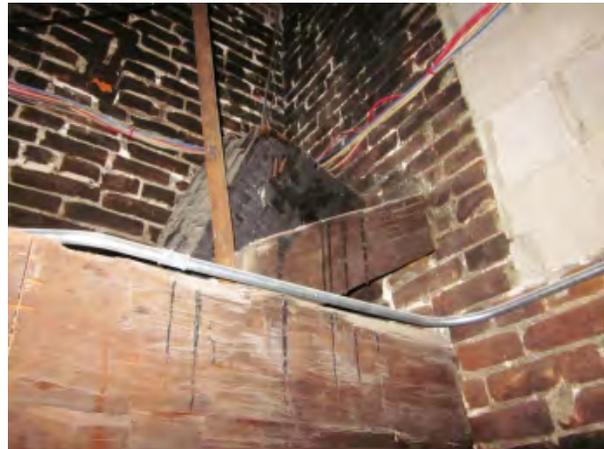
Remnants of heavy timber trusses with iron tie rods spanning in the east-west direction were observed in the north attic. Portions of the furthest north truss remain in situ and evidence of the other timber trusses is limited to the bearing pocket locations. Timber trusses in rooms S305 and S315 were probably in service up until 1941 when they were partially cut away to install the new steel beam roof system. There is no evidence of wrought iron trusses poking out of the walls in these rooms, and sections of the remaining timbers are charred from the 1936 fire (see Figures 85 through 87).

**FIGURE 85.** Remnants of heavy timber trusses with iron tie rods spanning in the east-west direction in the north attic. Note that one of the diagonal members is charred, indicating a fire in this area in the past (photo by S. Kelley, 2011).

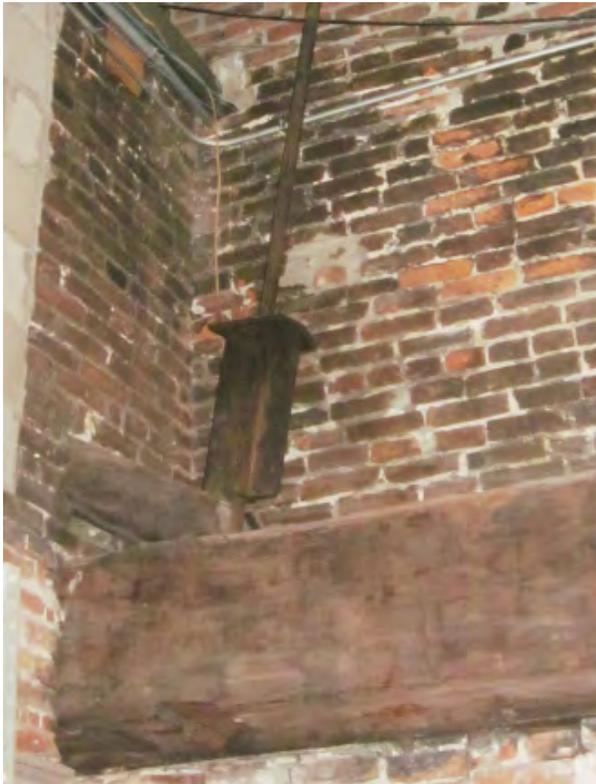
**FIGURE 86.** Remnants of the heavy timber truss in the north attic. In this image the wrought iron rod can be seen, as well as the cast iron fitting for the upper chord members that have been removed (photo by S. Kelley, 2011).

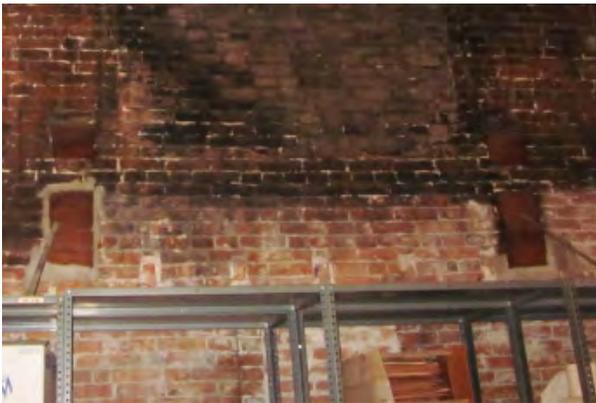
**FIGURE 87.** Evidence of heavy timber trusses in the north attic that were cut flush with the brick masonry wall (photo by S. Kelley, 2011).

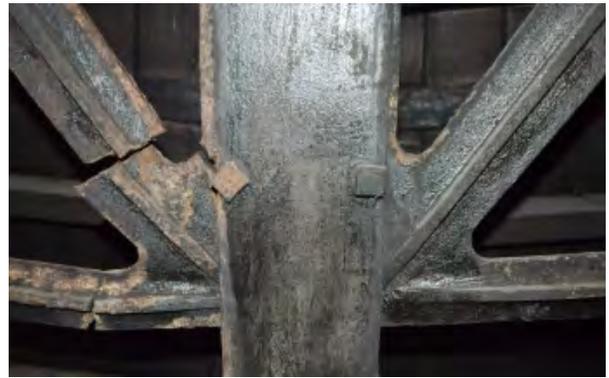
The 2x6 wood purlins are fastened to the outer T-sections with metal joist hangers to provide a nailable surface for the wood plank sheathing below the sheet metal copper roofing. Cast iron x-bracing was installed between ribs near the top of the dome (Figure 94). One of these x-braces was observed to be broken (Figure 95); the break appears to be old and not causing any structural destabilization. Iron castings also form a level surface for a platform below and at the

**FIGURE 95.** Damage observed at one of the cast iron X-braces between the ribs. This location was selected for cast iron sample removal for metallurgical testing (photo by S. Kelley, 2011).

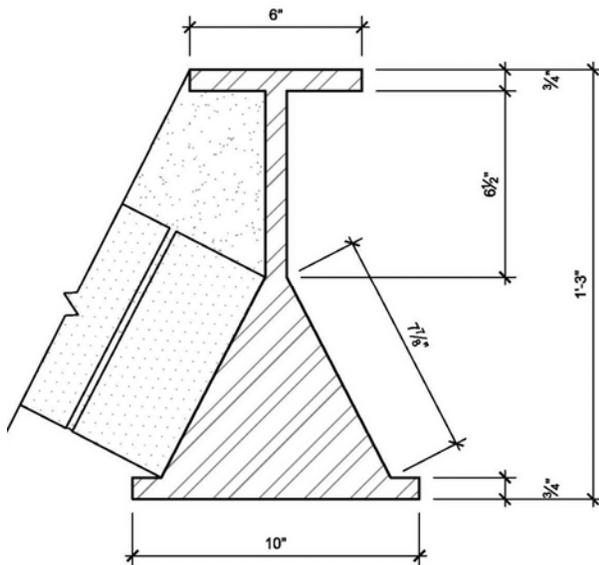
**FIGURE 100.** Close up view of cast iron beam section at inspection opening no. 1 (north wing - first floor). As shown here, a triangular shaped sample (sample no. 10) was removed at this location for metallurgical testing (photo by S. Kelley, 2011).

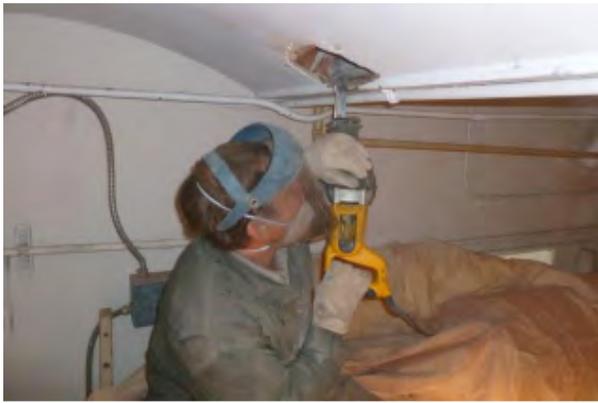
Inspection opening no. 2 was made in the basement ceiling in the east wing room S36 to assess the first floor framing structure above. It consisted of an opening in the existing plaster and masonry vault alongside an iron beam that spans in the north-south direction. In addition, numerous drill probes were made along the length of beam to determine the orientation of the top flange from its underside. These iron beams were likely cast and installed by J. T. Dowdall. This is the oldest cast iron beam seen at the Old Courthouse and is shaped like a railroad rail. See Figure 104 and Figure 105 for conditions observed at this inspection opening.

**FIGURE 104.** Creation of inspection opening no. 2 (east wing - first floor beams) at the face of a cast iron beam (photo by S. Kelley, 2011).

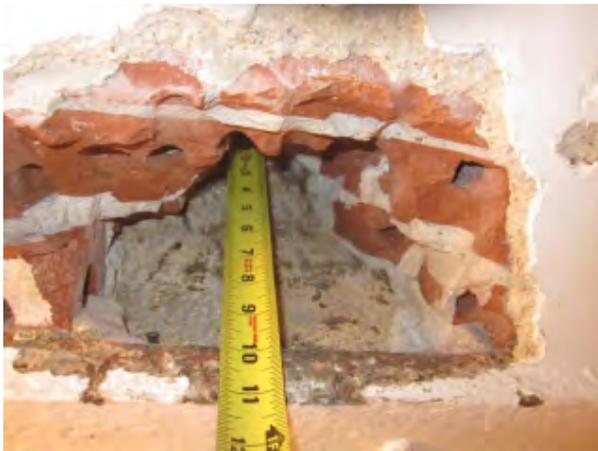
The profile of this beam is shown in Figure 106. Levelness measurements and drill probes taken below the top flange indicated that the top flange is not level. Also noted was the bulge in the web. Based on findings at inspection opening no. 6, the top flange may curve with the high point at the middle of the beam. A sketch of the beam in elevation is shown in Figure 107.

**FIGURE 105.** Close up view of inspection opening no. 2 (east wing - first floor beams) (photo by S. Kelley, 2011).

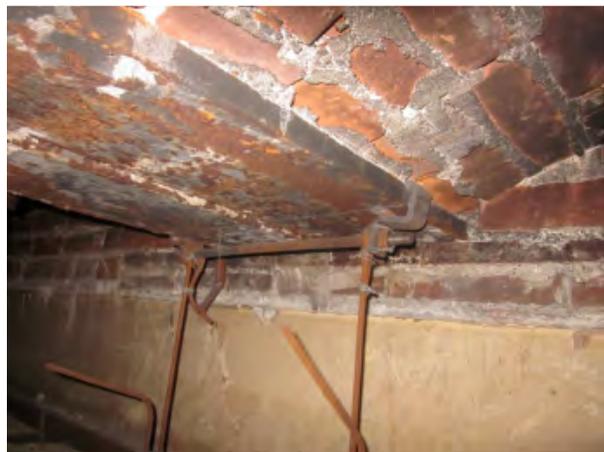
**FIGURE 115.** View of cast iron double beams where they bear on the interior bearing walls in the west wing. The bearing walls were added in 1855 and the beams likely date from this period as well (photo by S. Kelley, 2011).

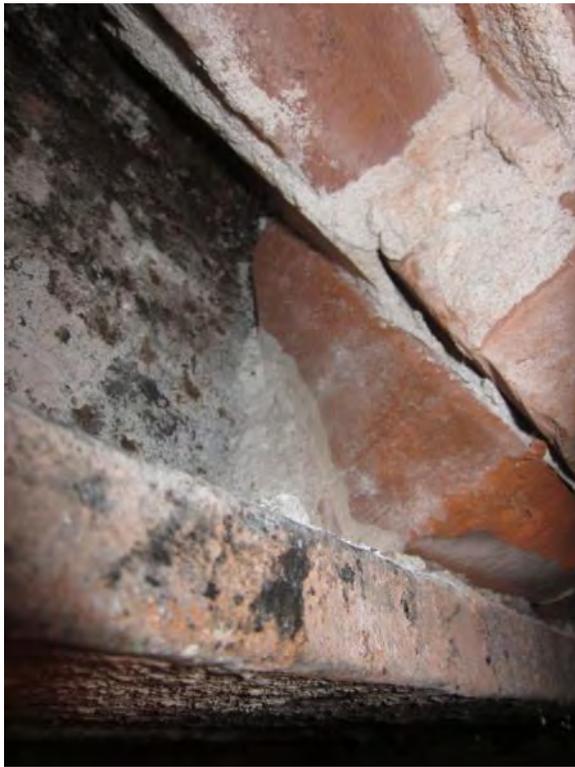
**FIGURE 116.** Close-up view of the web and bottom flange of the cast iron beam at inspection opening no. 4 (west wing - second floor). Note that a specially fabricated brick was utilized to form a spring point for the brick vault (photo by S. Kelley, 2011).

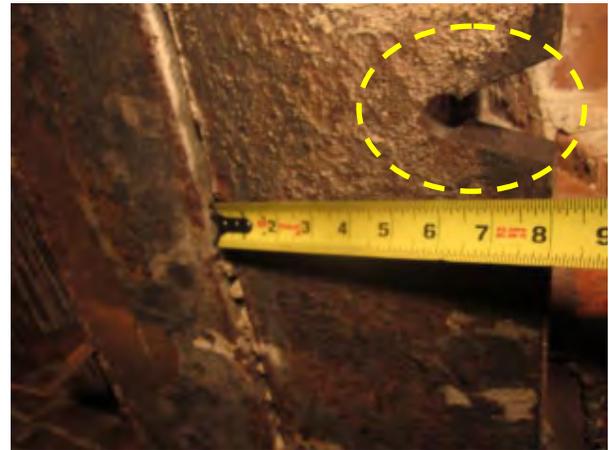
**FIGURE 118.** Close up view of the web and bottom flange of the cast iron beam at inspection opening no. 4 (west wing - second floor). A triangular shaped sample (no. 8), indicated by the dashed oval, was removed for metallurgical testing (photo by S. Kelley, 2011).

- **Sample 8.** West wing, underside of second floor at inspection opening no. 4. The sample was prism shaped with the governing dimensions of approximately 1 inch. The beam was most likely fabricated circa 1855. The laboratory compositional and microstructure analyses indicate that this beam is fabricated from gray cast iron.

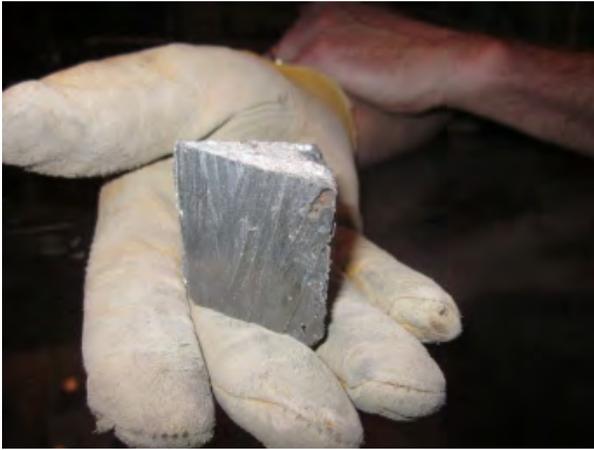
**FIGURE 124.** Cast iron sample (sample no. 1) removed for metallurgical testing at inspection opening no. 5 (south wing - second floor) (photo by S. Kelley, 2011).

- **Sample 1.** South wing, second floor beam at inspection opening no. 5. The beam was likely fabricated by John T. Dowdall circa 1853. The sample was prism shaped with the governing dimensions of approximately 1 inch. The laboratory compositional and microstructure analyses indicate that the beam is fabricated from grey cast iron. Excessive porosity was observed in this sample (Figure 131).
- **Sample 2.** North wing, attic truss remnant embedded in masonry wall. The sample was four inches by 1-1/2 inch by 1/2 inch thick.

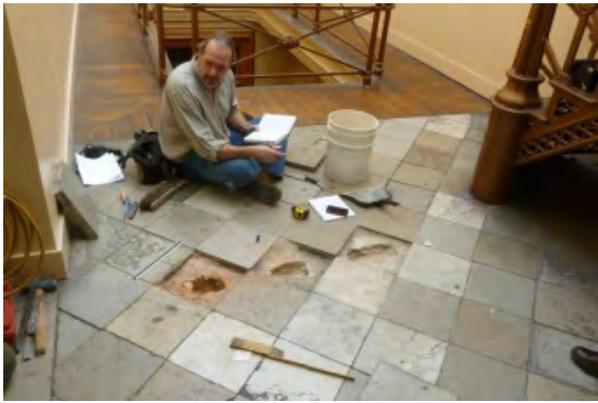
Measurements indicated that the top of the beam is curved, with the greatest beam depth at the midpoint of the span. The width of the top flange is two inches. See Figure 130 for a sketch of the elevation of this beam.

**FIGURE 128.** The top of the cast iron beam was exposed in three locations at inspection opening no. 6 (east wing - third floor) so that the camber of the top flange could be determined (photo by S. Kelley, 2011).

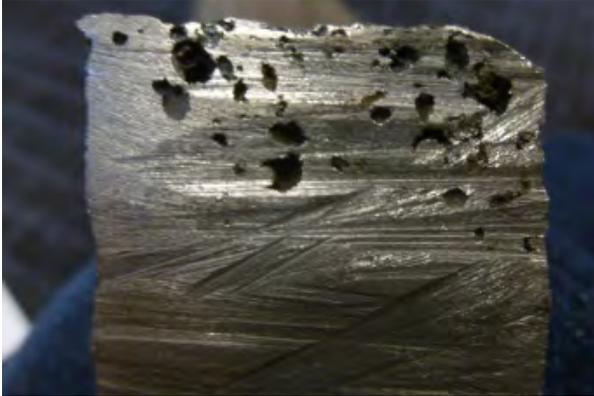
**FIGURE 131.** Excessive porosity observed in sample 1 was caused by either air captured in the mold during casting or gas in the molten material that became less soluble during solidification of the iron.

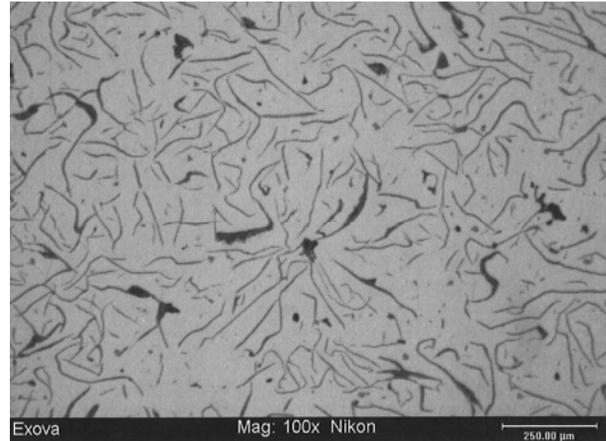
- **Sample 7B.** Dome, bracing element, metal strap bracing between iron ribs and radial bands. The sample was cross shaped and is approximately 2-1/2 inches by 2-1/2 inches by 1/2 inch thick. The bracing was likely fabricated by either Phoenix Iron Company or McPheeter & Pauley circa 1860. The laboratory compositional and microstructure analyses indicate that this dome bracing element is fabricated from gray cast iron.

**FIGURE 132.** A microsection of cast iron as seen at 100x magnification. This is sample 7B taken from the dome S-bracing element. The dark tendrils are slag inclusions. Source: Exova report, refer to Appendix B.

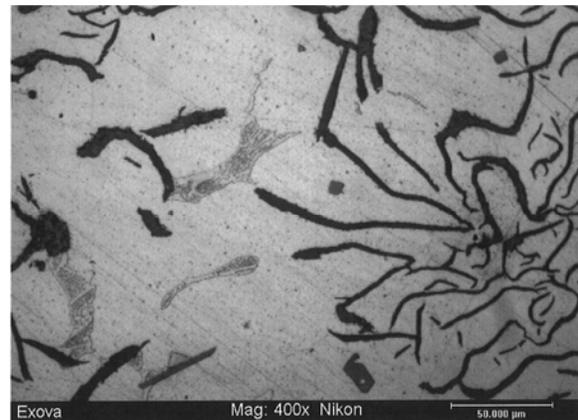
**FIGURE 133.** A microsection of cast iron as seen at 400x magnification. This is sample 1 taken from a south wing floor beam. The dark tendrils are slag inclusions. Source: Exova report, refer to Appendix B.

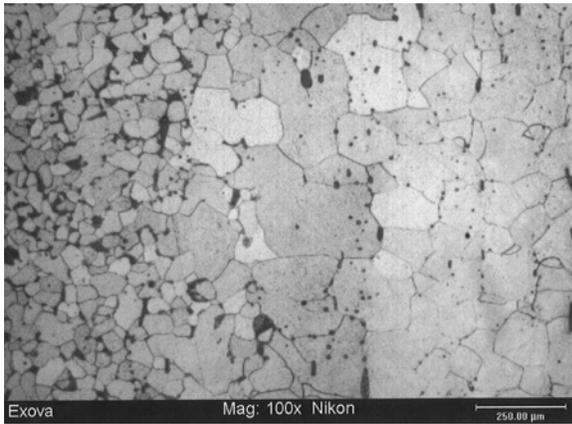
- **Sample 7A.** Dome, radial band of metal strap spanning between iron ribs. The sample was 2-1/2 inches by 1 inch by 1/4 inch thick. The band was likely fabricated by either Phoenix Iron Company or McPheeter & Pauley circa 1860. The laboratory compositional and microstructure analyses indicate that this radial band element is fabricated from wrought iron.

**FIGURE 134.** A microsection of wrought iron as seen at 100x magnification. This is sample 7A taken from a radial band in the dome. The dark webbing and spots are slag inclusions. Source: Exova report, refer to Appendix B.

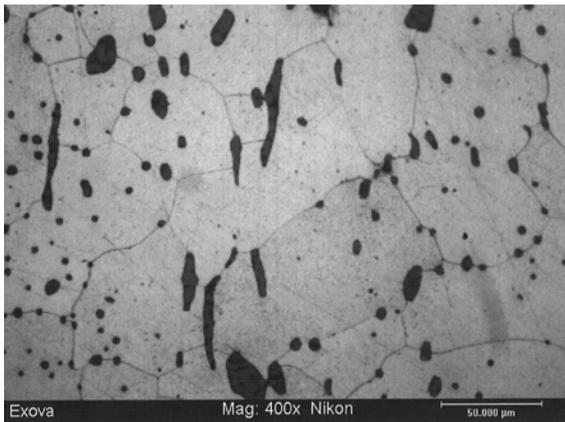
- **Sample 4.** East wing, east portico roof framing member cross bracing between portico roof purlins. The sample was 18 inches by 1-1/2 inch by 3/4 inch thick. This remnant was no longer connected to the original structure, so was easily removed during the structural investigation in October 2011. The beam was likely fabricated by McMurray & Pauley circa 1853. The laboratory compositional and microstructure analyses indicate that this roof framing element is fabricated from wrought iron.

**FIGURE 135.** A microsection of wrought iron as seen at 400x magnification. This is sample 4 taken from a member in the east wing portico roof. The dark webbing and spots are slag inclusions. Source: Exova report, refer to Appendix B.

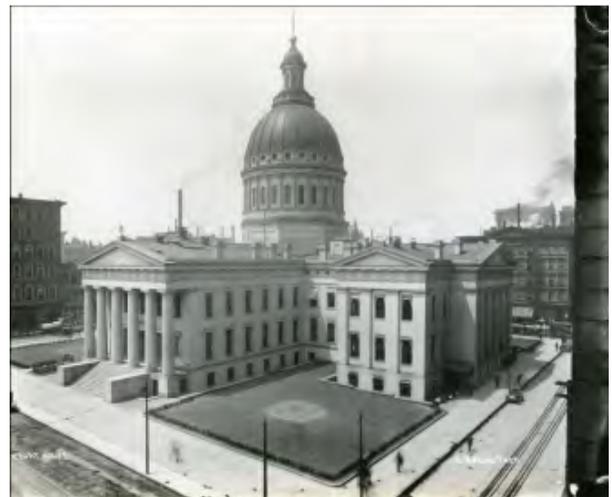
According to the 1906 photograph (Figure 136), these columns appeared to be of the Corinthian order. At some time between 1906 and 1916 the leaf appliques were removed from the column capitals, as evidenced by their disappearance in the photograph of 1916 (Figure 137). A 1936 report states that “the Corinthian leaves of cast iron that formerly were in place on the capitals of the columns encircling the exterior of the dome’s base have all rusted off.”<sup>103</sup> It is

speculated that the bolt connections that held the appliques to the column as well as the leaf appliques had become compromised due to corrosion, leading to the decision to remove all of the appliques.

**FIGURE 136.** The Old Courthouse circa 1906, with the Corinthian column capitals visible. Source: Photograph by Emil Boehl. Missouri History Museum collection, reference n11207.

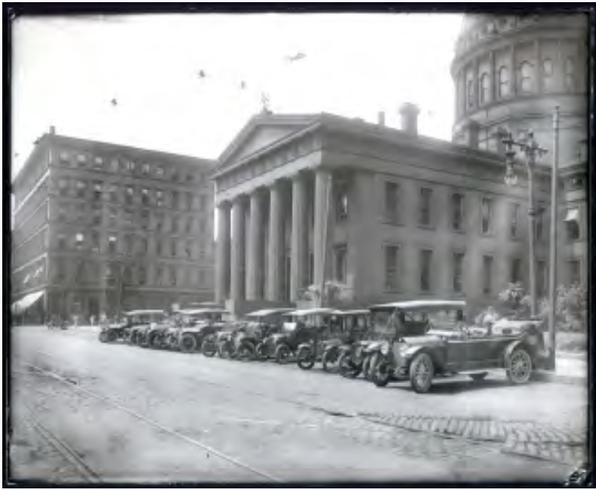
**FIGURE 137.** The Old Courthouse circa 1916; the Corinthian column capitals of the rotunda were no longer present by this time. Source: Missouri History Museum collection, reference n02711. Photographer unknown.

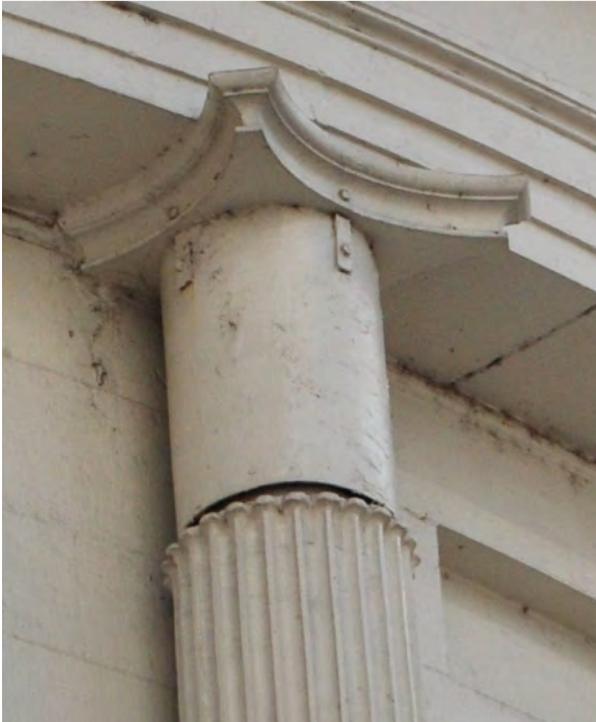
- All of the capitals have been removed except for the abacus at the top of these capitals, which have remained in place.
- Each abacus remains bolted to a tube below (Figure 142). The clips and bolts are likely original. The missing capital leaves were

- At rotunda column 23, the tube has a space at the bottom indicating that the tube was slipped over the structural column beneath. As the abacus may have been part of the support mechanism for the stone above, it would have been extremely difficult to remove the abacus along with the capital.

**FIGURE 142.** At rotunda column 23, the abacus at the top of the capital is still in place and bolted to a tube. The tube is separate from the structural columns, as evidenced by the void space seen at the top of the column flutes. Photograph by S. Kelley, 2011.

- Columns 11, 16, 17 and 23 provide opportunities for further close-up study because they have cavities that can be accessed. These features could be inspected close-up using industrial rope access.
- The column capitals should be inspected in general to verify that they are water tight. Water collecting within the hollow columns would contribute to corrosion and could become a major concern over a period of time.
- Replacing the column capitals should be relatively straightforward, as the original elements were ornamental appliqués and new appliqués could be fabricated. Close up inspection would reveal how the originals were attached, but replacement would not necessarily need to follow the original connection scheme. It will be important to field measure prior to design and fabrication. One difficulty is that only photos remain to document how the capitals

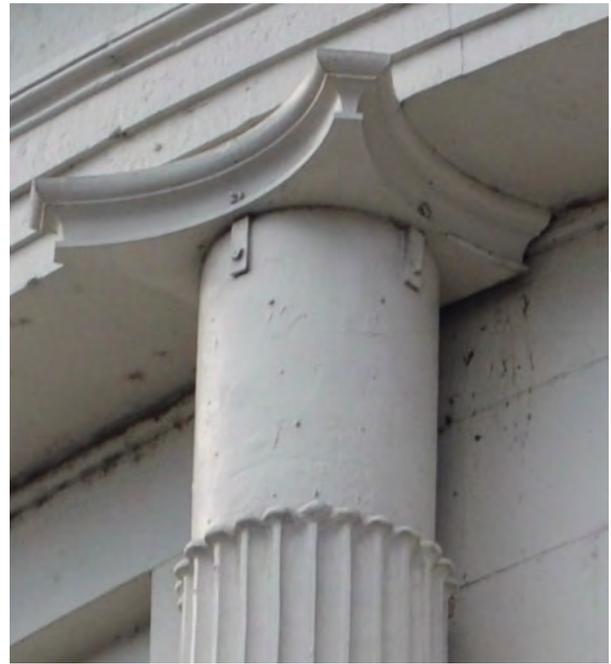
- At rotunda column 1 on the north elevation, there is a reveal between the abacus and stone wall behind (Figure 143). At column 18 on the west elevation, the stone has been cut to fit around the abacus (Figure 144). This indicates that the ironwork was erected prior to laying the stonework.

**FIGURE 143.** Rotunda column 01, showing the space between the abacus and stonework. Photograph by S. Kelley, 2011.

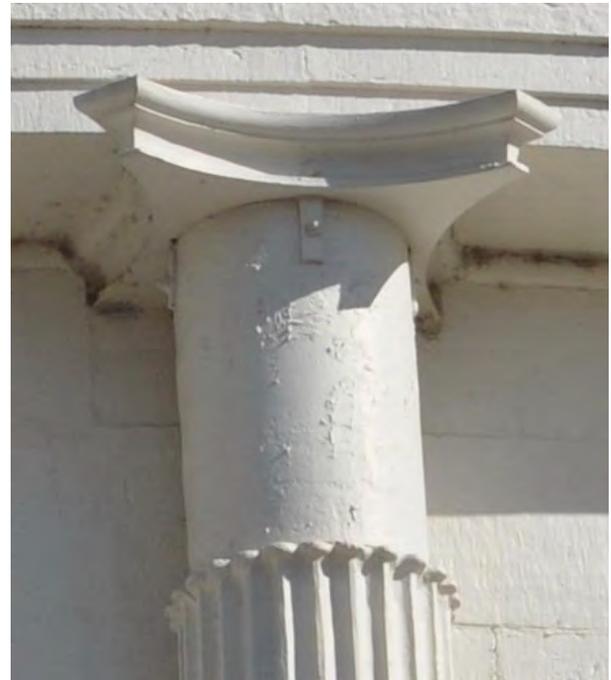
**FIGURE 144.** Rotunda column 18, showing that the stone work was cut to fit around the capital abacus that was already in place. Photograph by S. Kelley, 2011.

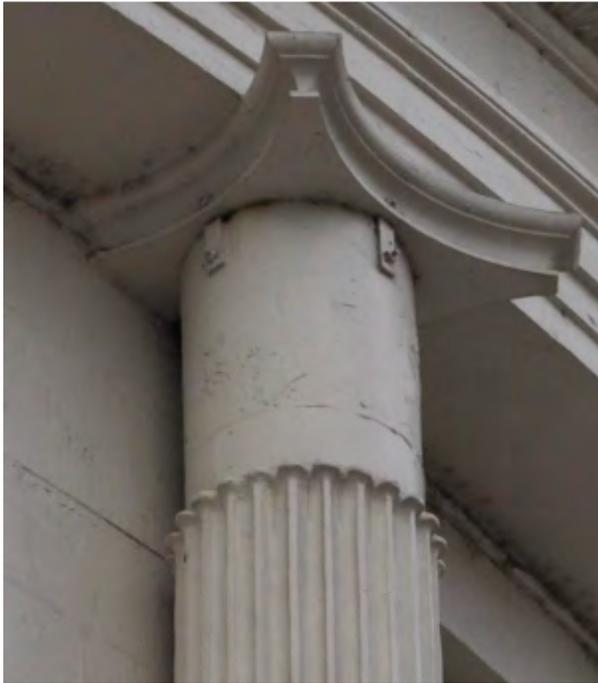
- At several rotunda columns, the tube to which the abacus is attached has been repaired in the past with sheet metal that has been mechanically fastened to the tube, with its joints waterproofed with sealant in some

cases. This can be seen at rotunda columns 4, 7, 11, 12, 16, and 17 (Figure 145 through Figure 150). These patches have been obscured by paint to make them blend in with the column. All of the patches are similar except for that on rotunda column 16, which is much larger and appears to have an open cavity at the back. In addition, rotunda column 11 is missing part of the underside of the abacus.

**FIGURE 145.** Rotunda column 04. Sheet metal has been installed on the lower portion of the capital area directly above the column flutes. Photograph by S. Kelley, 2011.

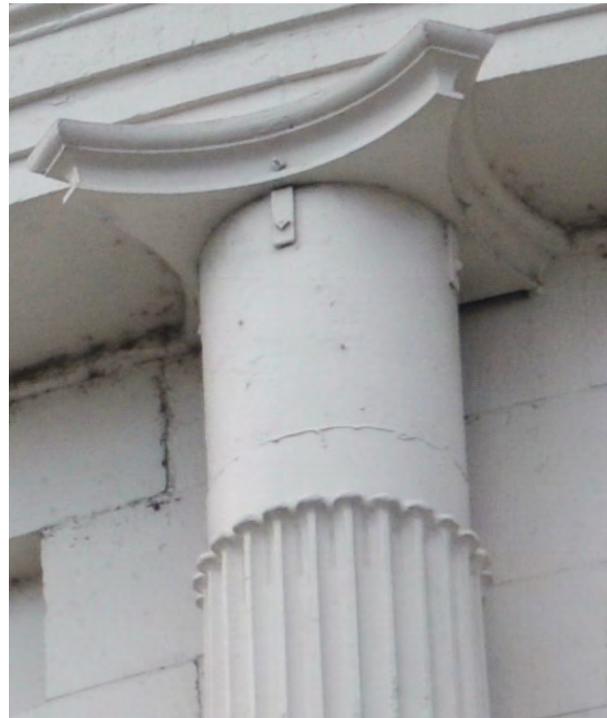
**FIGURE 146.** Rotunda column 07. Sheet metal has been installed on the lower portion of the capital area directly above the column flutes. Photograph by S. Kelley, 2011.

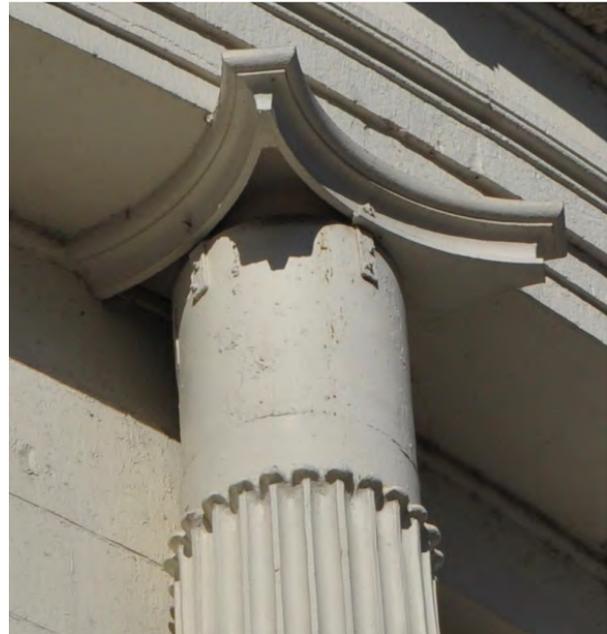
**FIGURE 147.** Rotunda column 11. Sheet metal has been installed on the lower portion of the capital area directly above the column flutes. Note that the underside of the abacus is missing at this location. Photograph by S. Kelley, 2011.

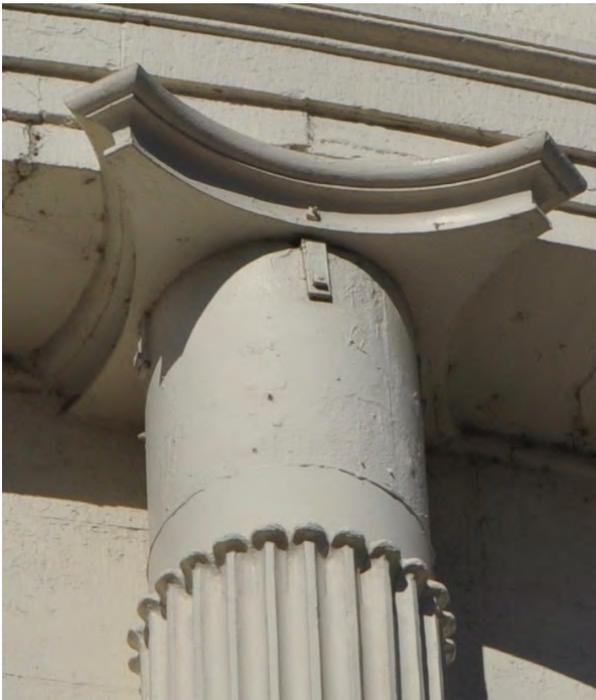
**FIGURE 148.** Rotunda column 12. Sheet metal has been installed on the lower portion of the capital area directly above the column flutes. Photograph by S. Kelley, 2011.

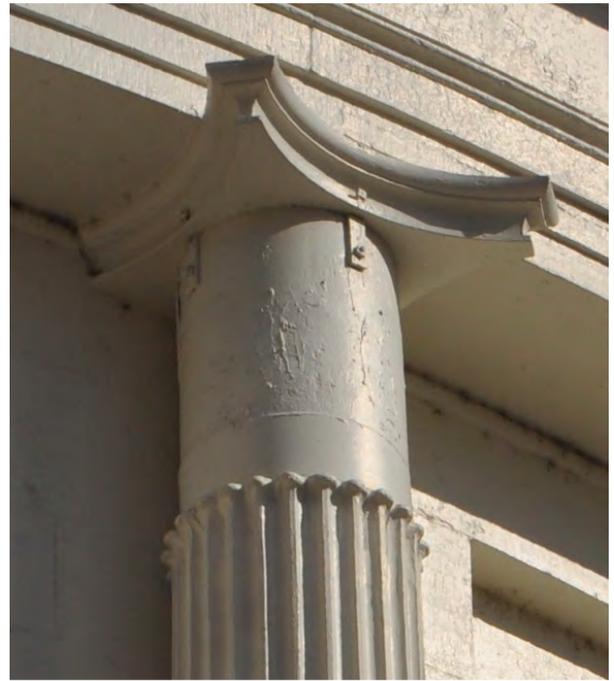
**FIGURE 150.** Rotunda column 17. Sheet metal has been installed on the lower portion of the capital area directly above the column flutes. Photograph by S. Kelley, 2011.

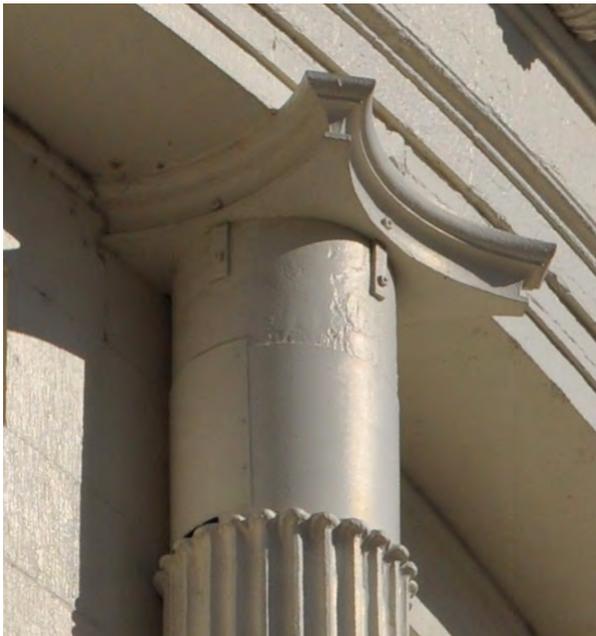
**FIGURE 149.** Rotunda column 16. Sheet metal has been installed on the lower two-thirds of the capital area directly above the column flutes. In this image the vertical overlap joint is clearly seen. Photograph by S. Kelley, 2011.

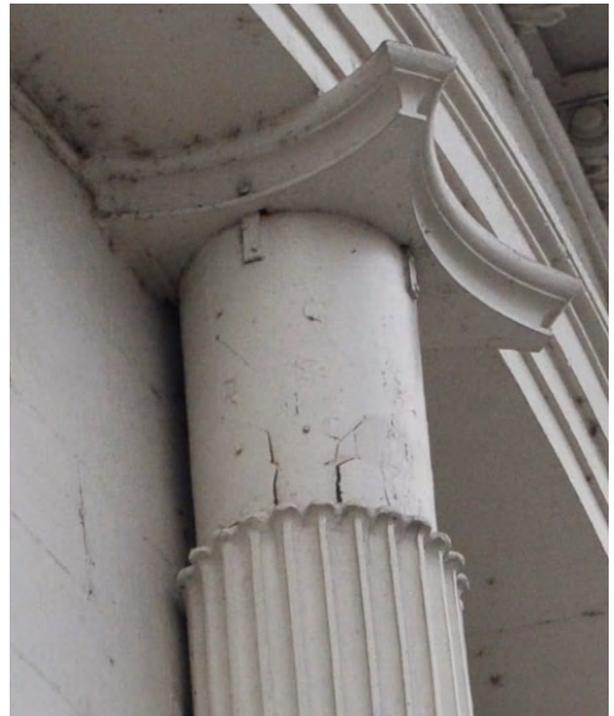
- Rotunda column 3 has some cracking evident at the base of the tube (Figure 151). The cracking appears to have occurred not in the cast iron but in a patching material that is starting to fail.

**FIGURE 151.** Rotunda column 03. The evident cracking appears to be within a patching material that has begun to fail. Photograph by S. Kelley, 2011.

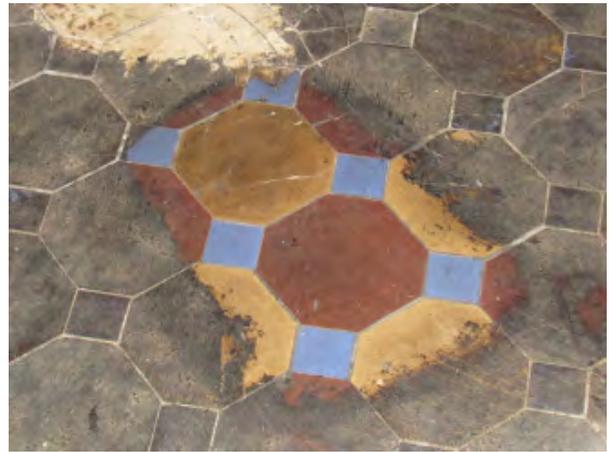
**FIGURE 155.** View of a portion of the encaustic tile floor cleaned in October 2004, showing original colors and pattern. Photograph by WJE, October 19, 2011.

In October 2004, a trial procedure to remove the existing mastic was performed by others using Prosoco SureKlean Asphalt and Tar Remover, a methylene chloride, xylene, and ethyl benzene based gel paint stripper. This trial was successful in partially removing the mastic from the encaustic tile (refer to Figure 155). Either chemical or water based systems may be considered for removing the mastic from the encaustic tiles. For any residue removal project,

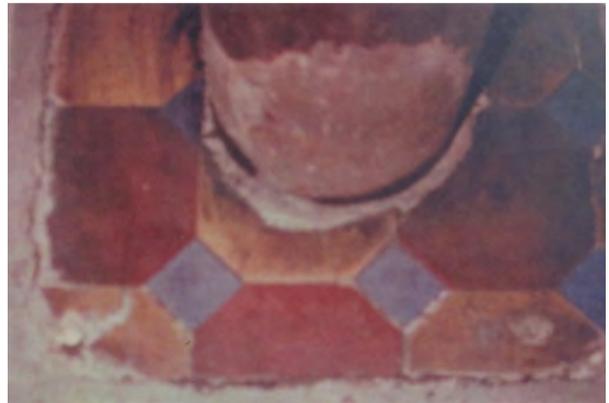
**FIGURE 156.** A portion of the encaustic tile floor near one of the cast iron columns was cleaned as part of the 1980 interior renovation of the space. Source: Park Ranger Nancy Hoppe.
