# **Jefferson National Expansion Memorial Old Courthouse**

St. Louis, Missouri

## **Historic Structure Report Special Issues**

July 2013

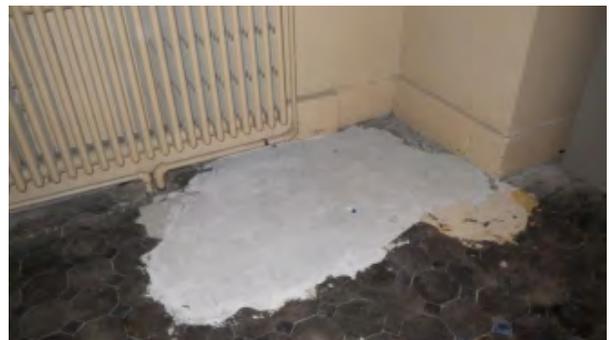
**FIGURE 157.** Portions of the floor are filled with a white leveling compound. Photograph by WJE, October 19, 2011.

Sample 1 represents the fill material at locations where the encaustic tile floor is missing. The fill material is hard and contains spherical pores, which indicates that the material is likely air entrained. Air entraining agents were commonly used as admixtures in cementitious materials starting in the 1950s. The setting bed beneath in-place encaustic tile represented in Sample 2 is much softer and predominantly contains irregular shaped air voids. The differences between the two samples confirm that the fill material likely does not date to the same era as the installation of the encaustic tile, and that the fill was likely added as a repair material after 1950. Based on the material characteristics and the architectural configuration of the room, it is very likely that the encaustic tile installation was originally one consistent pattern across the entire room, matching the three-color design still existing in portions of the room. A large area of missing tiles was filled in with a cementitious leveling compound as a repair sometime after 1950 to create a level substrate for new floor finish materials.

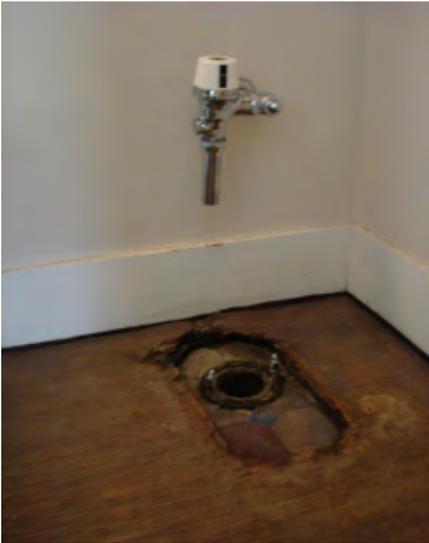
**FIGURE 158.** Encaustic floor tiles were observed below later floor finishes in room S233A during replacement of a toilet. Source: Park Historian Bob Moore, JNEM.

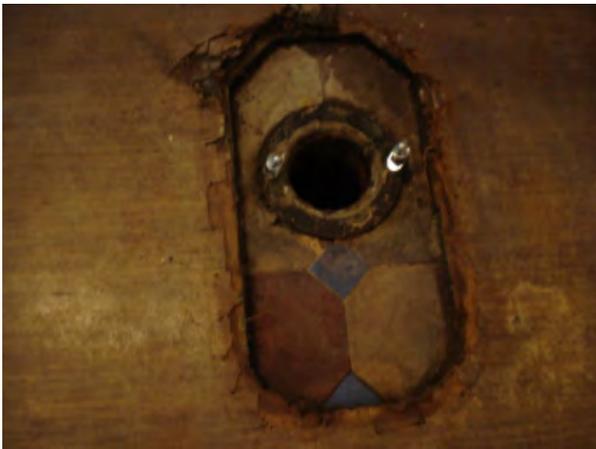
**FIGURE 159.** The color and pattern of the tile flooring in room S233A is identical to the encaustic tile floor in room S124. Source: Park Historian Bob Moore, JNEM.

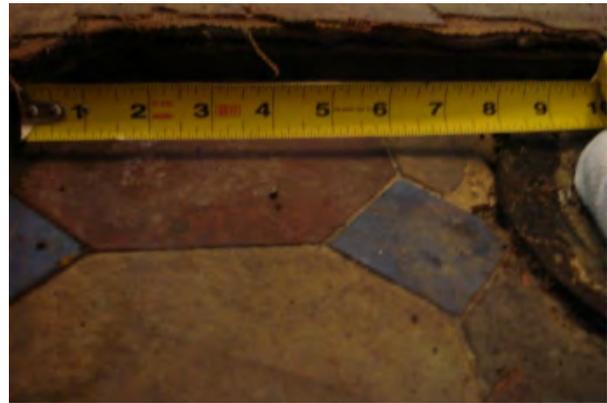
**FIGURE 160.** The tiles in room S233A match the color and size of the tiles in room S124. Source: Park Historian Bob Moore, JNEM.

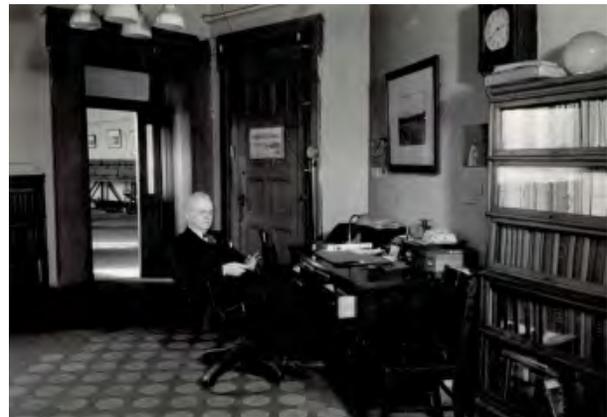
**FIGURE 161.** Old Courthouse, room 125, April 1938, view looking northwest. (Photo dated by calendar on the wall.) Note tile flooring, likely the same three-color pattern as the existing floor in room S124 and the floor tiles observed in room S233A. Source: JEFF Visual Image Reference Collection, Box 19, Folder Old Courthouse Offices (2), photo ID VPRI-004109.

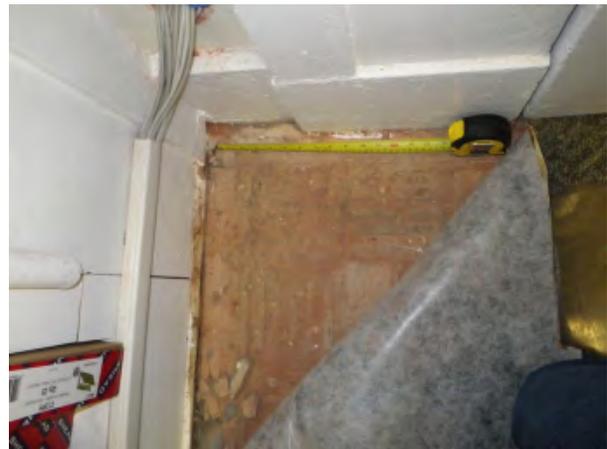
Room S125 on the first floor of the south wing also previously contained an encaustic tile floor of a similar design (Figure 161). The tiles in this room have been removed (Figure 162).

**FIGURE 162.** View of the floor in room S125. Below existing carpeting, a cementitious tile setting bed remains in place, but no encaustic tiles were observed. Photograph by WJE, January 11, 2012.

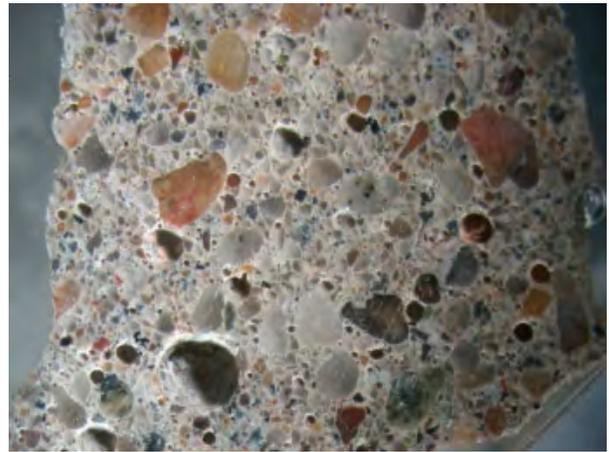
Sample 1 was removed from the mortar fill at locations where the encaustic tile is missing from room S124. The sample was removed using a 1/2 inch barrel diamond core drill to a depth of approximately 3/4 inch. There was a thin dark resinous material on the exposed surface of the sample. The mortar material was firm and well compacted and could not be crushed using hand pressure. The mortar had a light gray matrix that could not be scratched using a copper probe. When viewed microscopically, the aggregate was observed to consist primarily of silicates, including crushed pink granite with particles up to 4mm in diameter. There were small and microscopic spherical voids within the matrix, indicative of an air entraining admixture.

**FIGURE 163.** Overall view of polished section of Sample 1. Note spherical air voids. Laboratory photograph by WJE.

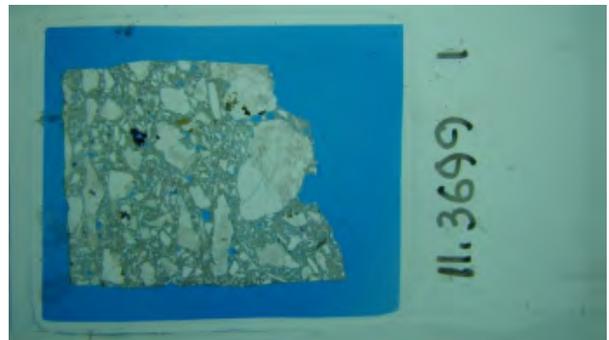
**FIGURE 164.** Overall view of thin section of Sample 1. Blue areas represent air voids filled with blue dyed epoxy as part of sample preparation. Laboratory photograph by WJE.

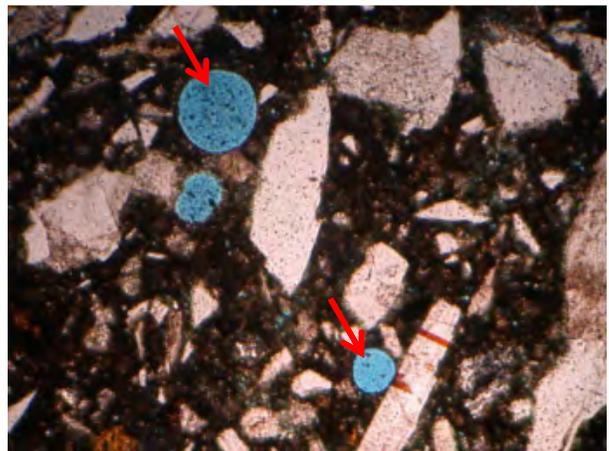
**FIGURE 165.** Thin section of Sample 1 as viewed using plane polarized transmitted light. Note angular aggregate and spherical air voids (red arrows). Laboratory photograph by WJE.

4. Implement removal of mastic residue and leveling compound from tiles based upon trial results.
5. Remove non-historic fill materials at locations of missing individual tiles and larger areas of tile, taking care not to damage intact adjacent tiles.

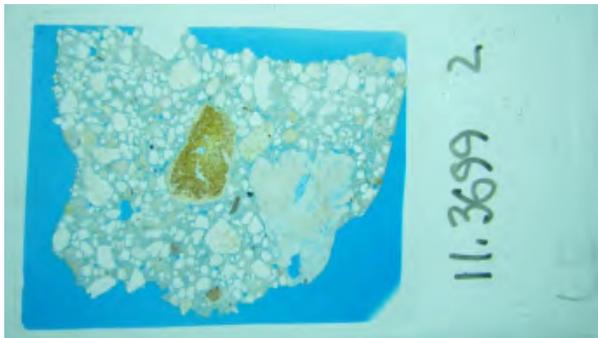
Sample 2 was the setting bed from below the encaustic tile in room S124. The sample was removed from the setting bed that remained attached to a tile which had been removed previously by maintenance staff at the Old Courthouse. The matrix was firm and well compacted and could not be crushed using hand pressure. The matrix was light buff in color. The matrix could be scratched with a copper probe. When viewed microscopically, small white lumps, presumed to be hydrated lime (now carbonated), were observed. The aggregate consisted predominantly of subrounded to rounded quartz aggregate with some aggregate up to 0.5 cm in diameter. There were irregular as well as spherical voids indicative of entrapped air.

**FIGURE 166.** Overall view of thin section of Sample 2. Blue areas represent air voids currently filled with blue dyed epoxy. Note irregularly shaped air voids, in contrast to Sample 1. Laboratory photograph by WJE.

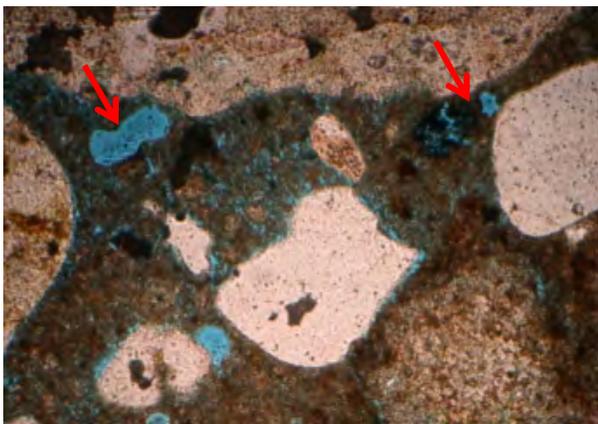
**FIGURE 167.** Thin section of Sample 2 as viewed using plane polarized transmitted light. Note sub-rounded aggregate. Irregularly shaped air voids (red arrows), and porous nature of matrix, in contrast to Sample 1. Laboratory photograph by WJE.

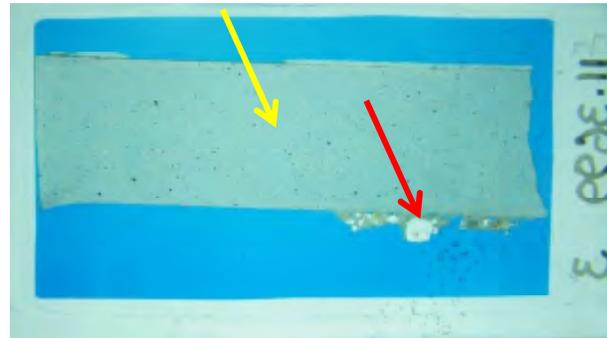
Sample 3 was a portion of one encaustic tile from room 124. The encaustic tile was sound and intact, with relatively low porosity. There was a thin dark black layer of mastic on the exposed surface, as well as a thin white leveling compound that measured approximately 0.25 mm thick. The white leveling compound was relatively porous and could be removed from the surface mechanically.

**FIGURE 168.** Overall view of thin section of Sample 3. Yellow arrow indicates ceramic body. Red arrow indicates adhered mortar, which matches Sample 2. Laboratory photograph by WJE.

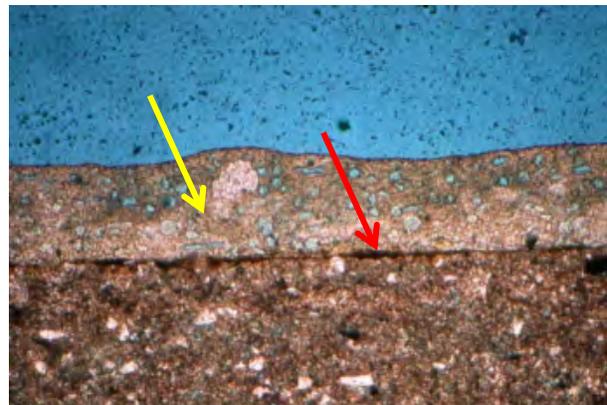
**FIGURE 169.** Thin section of encaustic tile. Yellow arrow indicates white leveling compound. Red arrow indicates black mastic layer. Laboratory photograph by WJE.

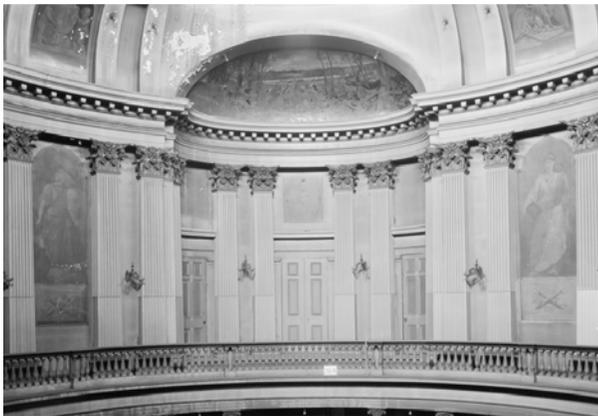
**FIGURE 175.** View of the fourth level, 1934 HABS photograph. Note the monochromatic treatment of the architectural detail, failing paint, and lunette painting and portraits remaining from the Wimar and Miragoli decorative schemes. Library of Congress, HABS No. MO-96-SALU-8-6. Alexander Piaget, photographer.

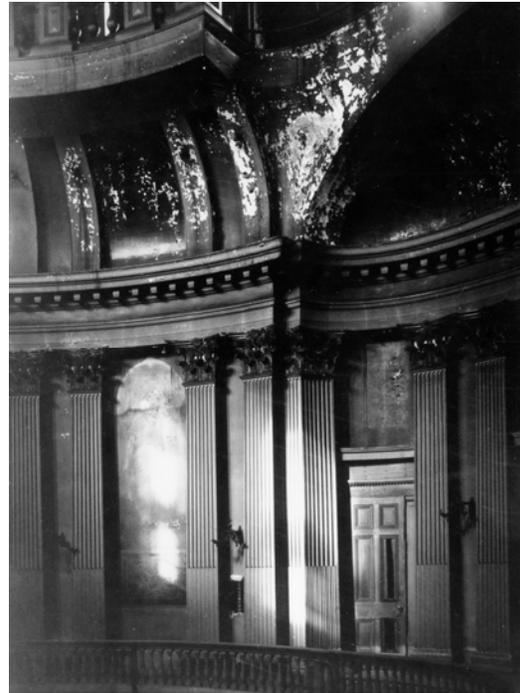
A fire in May 1936 affected the lunette at the west side. More serious damage occurred from water infiltration that resulted when the fire-damaged roof at this area was not repaired promptly.<sup>123</sup>

**FIGURE 176.** View of the fourth level, undated photograph. Given the darkening of the plaster surfaces in this view as compared to the HABS photography, it was likely taken after the 1936 fire. The damage to paint finishes appears more extensive than in the pre-fire HABS photography, and damage has spread to the decorative paintings. Source: JNEM Archive, reference V106-000307.

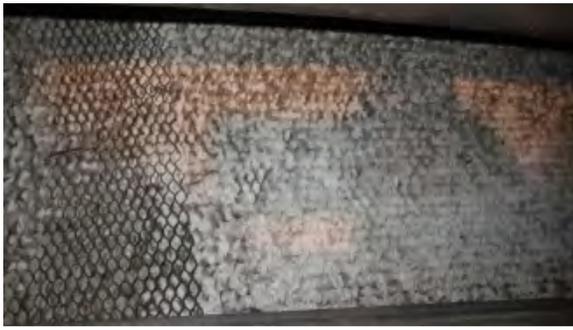
Typically, all plaster was well adhered to either wood or expanded metal lath. The metal lath exhibited light surface corrosion at the upper dome but no significant corrosion was observed in the main dome lath. At the wood lath areas there were relatively few broken keys. (Figure 191 through Figure 193)

**FIGURE 191.** View above the dome showing non-original area of plaster on metal lath. Photograph by WJE, October 19, 2011.

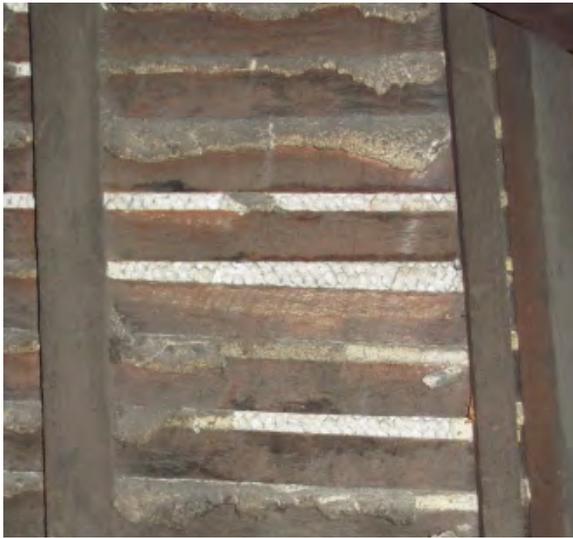
**FIGURE 192.** View above the dome showing non-original plaster on metal applied to a location where original wood lath and plaster keys were abandoned in place. Photograph by WJE, October 19, 2011.

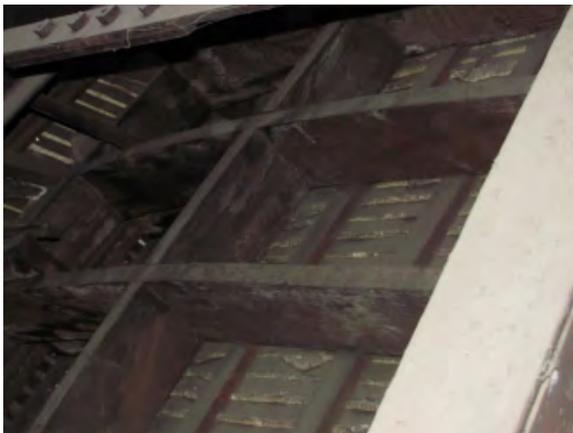
**FIGURE 193.** View above the dome showing area of original plaster on wood lath. Photograph by WJE, October 19, 2011.

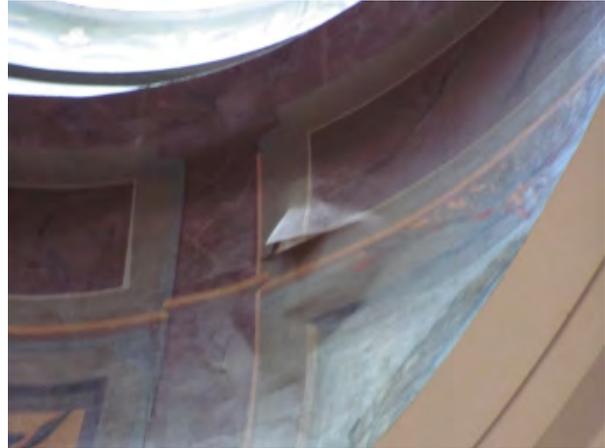
There was no significant cracking observed of the plaster when viewed from the fifth level gallery. There were a few isolated areas of flaking paint, peeling canvas, and water damage, likely as a result of water leakage from the lantern or dome roofing (Figure 194 through Figure 196).

**FIGURE 194.** Peeling canvas at the upper dome. Photograph by WJE, October 20, 2011.

At this time, there are no observed conditions from the limited survey that suggest repairs to the plaster are urgently required. The lantern and exterior balcony should be repaired to improve the water tightness of the assembly. As part of a long term restoration, repainting the plaster surfaces in a historic decorative painting scheme can be considered. Detailed documentation of historic decorative treatment of plaster surfaces is available from reports, drawings, and photographs prepared during the 1985 restoration. This documentation would be particularly important for re-creation of the decorative painting of the dome ribs, which were entirely replaced with new plaster in 1985.

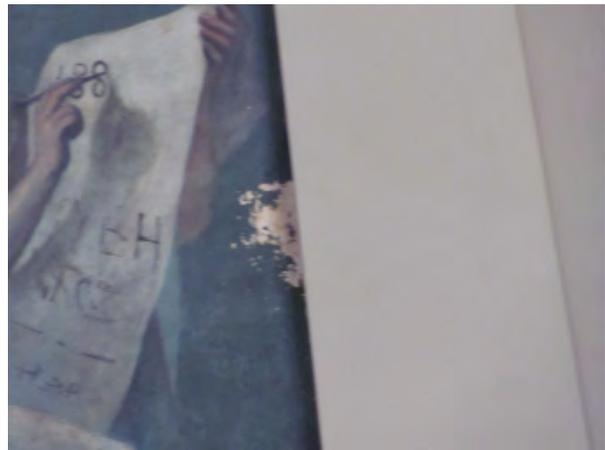
**FIGURE 195.** Loss of paint at one of the Miragoli figures in the dome. Photograph by WJE, October 20, 2011.

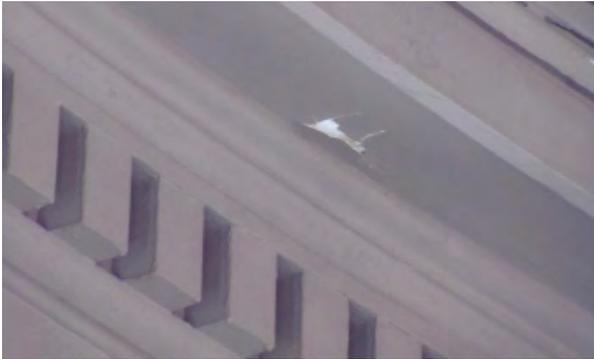
**FIGURE 196.** Flaking paint in the rotunda. Photograph by WJE, October 20, 2011.

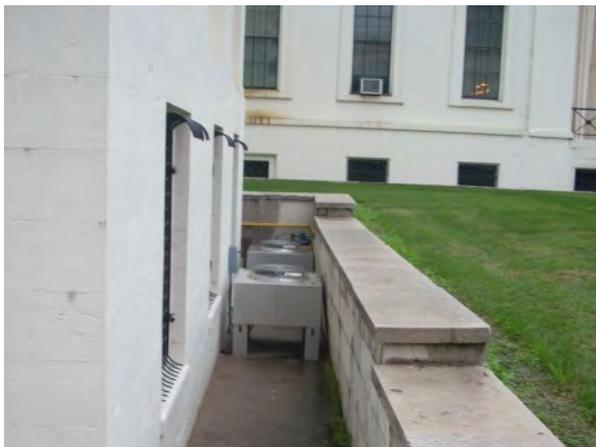
**Cooling Systems.** The first floor conference room –S107, north of the rotunda has a split air conditioning system installed in 2009. The indoor fan coil section is located high on the west wall. The outdoor air cooled condensing unit is in an area well outside, just west of the conference room (Figure 198). This air conditioning system is in good condition.

**FIGURE 198.** Outdoor part of typical split cooling system. Source: Alvine and Associates, 2011

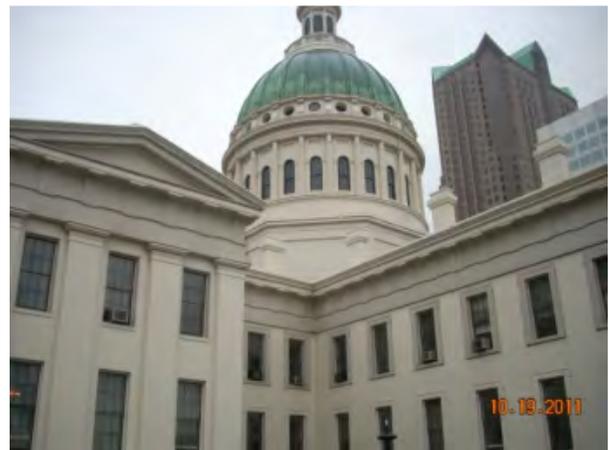
The most common form of cooling in the Old Courthouse is individual window air conditioning units. There are approximately forty-one window air conditioners in the Old Courthouse; thirty of these are located on the second floor, eight on the first floor, and three in the basement. There are eleven two ton window units. The remaining units are all 1-1/2-ton capacity. The window air conditioning units are of a various ages and are typically in fair to poor condition (Figure 199 and Figure 200).

**FIGURE 199.** Exterior view showing various window air conditioning units. Source: Alvine and Associates, 2011

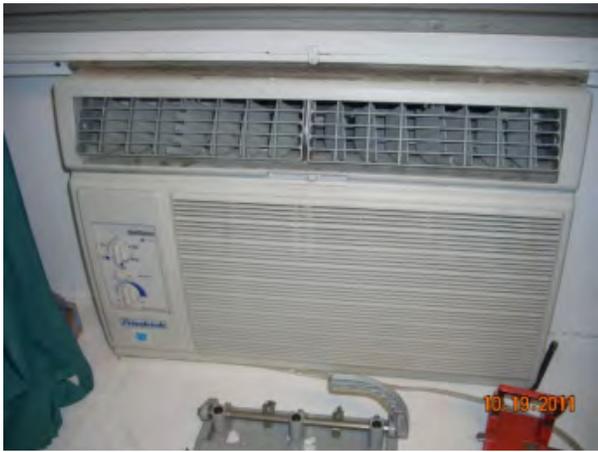
**FIGURE 200.** Typical window air conditioning unit.  
Source: Alvine and Associates, 2011

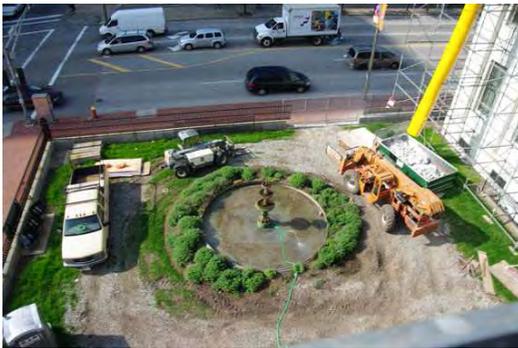
- 2010–2012 Repairs to the Old Courthouse and installation of a new roof to replace the roof installed in 1941 by the National Park Service with approximately 20,000 square feet of lead-coated, standing seam copper. The roofing project required removal of sections of the perimeter fence and wall, use of the courtyards for storage, the placement of gravel over top of existing turf, and access by heavy equipment. The roof repairs were followed by a cornice repair and replacement project involving approximately one-third of the Old Courthouse cornice stones. These two projects required access to the building exterior through the courtyards. In the process of conducting the repairs, heavy equipment, materials storage, and other construction-related activities resulted in extensive damage to the turf lawn and other features of the courtyards. (National Park Service, personal communication, Bob Moore, February 2013) (Figure 208)

**FIGURE 208.** View southeast courtyard showing extensive damage to the turf lawn during the 2010–2012 cornice repair project. Source: Bob Moore, 2013.

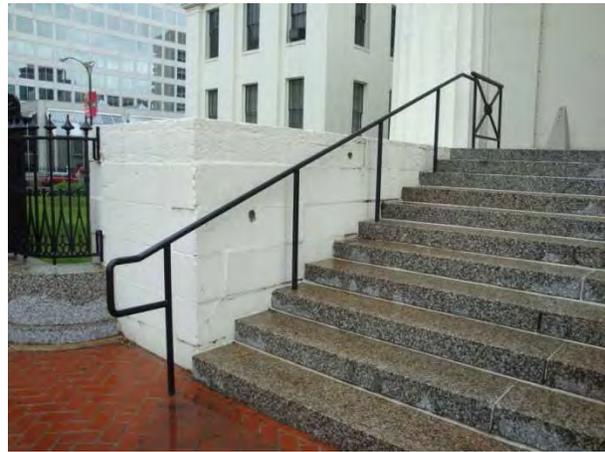
**Porticos.** The east and west porticos of the courthouse are reached via broad flights of granite steps edged by limestone block cheekwalls. Condition issues noted in association with the stairs and portico landing include heavy wear of some of the stair treads and thick applications of sealant in many stair joints. Some of the stones used in the construction of the cheekwalls are cracked or broken, and there are cored holes in the cheekwall of the west portico indicating the former placement of handrails. Some of the stones are stained from the corrosion of the metal handrails, while others exhibit biological growth (Figure 217).

**FIGURE 217.** The stone cheekwalls of the western portico exhibit cracks, biological growth, and cored holes from previous handrail attachments. Photograph by JMA, 2011.

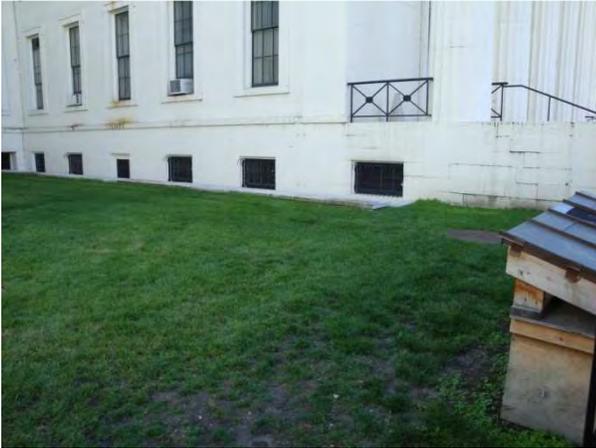
**Courtyards.** The four courtyards that edge the courthouse to its northwest, northeast, southeast, and southwest are frequently used as staging areas for construction and maintenance projects associated with the building exterior that requires heavy equipment and stockpiled materials. Aerial lifts used to wash the windows are also brought into the courtyards on a regular basis. The double-gate entrances are sometimes too narrow to allow passage of the necessary machinery and equipment, leading the National Park Service on occasion to dismantle fence sections to create a larger opening. The heavy equipment has the potential to compact the soil and damage the turf and other features, such as the gates, perimeter wall and fence, planting beds and other features that serve as focal points, and ornamental plantings. Evidence of soil compaction is present where ponding occurs, particularly near the base of the building. Erosion and gouging of the turf is present around most of the gates. In general the

turf is patchy and there are bare spots that may be the result of building maintenance efforts. The disturbance associated with these activities limits the nature of possible future changes to the courtyards. In addition, air conditioning units housed in the courtyards are visually incompatible with the historic character of the courtyards (Figure 220).

**FIGURE 220.** Evidence of compaction and damaged turf within the northwest courtyard. Photograph by JMA, 2011.

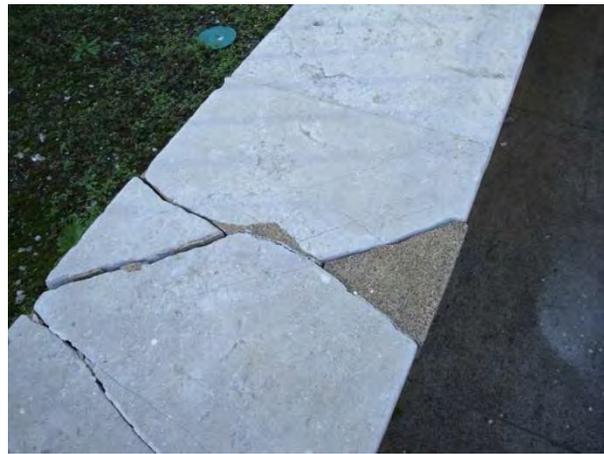
**Areaways.** Each of the courtyards contains retaining walls that parallel the Old Courthouse exterior to establish walkways and lightwells relating to the basement level of the building. The limestone block walls are one of the few nineteenth-century features to survive on the Old Courthouse grounds. These walls exhibit several condition issues and concerns. Many sections of the wall are leaning due to hydrostatic pressure that has built up behind the structures. Some of the blocks are cracked or displaced. Many of the repairs made to these walls and the coping stones have been made using incompatible materials such as brick and concrete. Other condition issues include biological and weedy growth along the base of the wall, cracked and broken marble and concrete stairs, cracked and spalling concrete walks, and the clogging of drains with vegetation (Figure 221).

**FIGURE 221.** An example of a broken coping stone and incompatible repair associated with one of the areaway walls. Photograph by JMA, 2011.

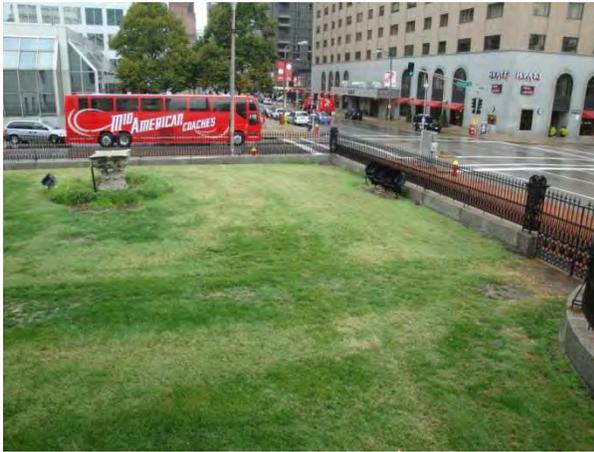
**Turf.** The turf that serves as a groundcover treatment over the majority of the courtyards is composed of the tall fescue variety *Festuca* “Winning Colors.” This variety works well in the courtyards for several reasons. It is well suited to the climate and will grow within a wide range of sun and partial sun conditions. ‘Winning Colors’ fescue can also be overseeded to rejuvenate thin patches as needed. It is able to be maintained through mowing at a height of 3 inches, which is consistent with the park’s maintenance schedule and also works with the undulating surface of the courtyards, while a lower mowing height might lead to an uneven cut. The park considers the soil present within the courtyards to be relatively fertile, although a soil test has never been conducted. Except for a few specific locations, the soil is not currently considered to be too compacted. As noted above, the turf is gouged near the gates and patchy with bare spots elsewhere. Weeds, including Bermuda grass, are present, but have not displaced the fescue to any great degree (Figure 222). A cornice repair project conducted during 2011 and 2012, after fieldwork for this project had been completed, heavily damaged the turf in all of the courtyards.

**FIGURE 222.** View of the turf within the northeast courtyard. Note the patchiness, bare spots, and gouging and erosion at the gate. Photograph by JMA, 2011.

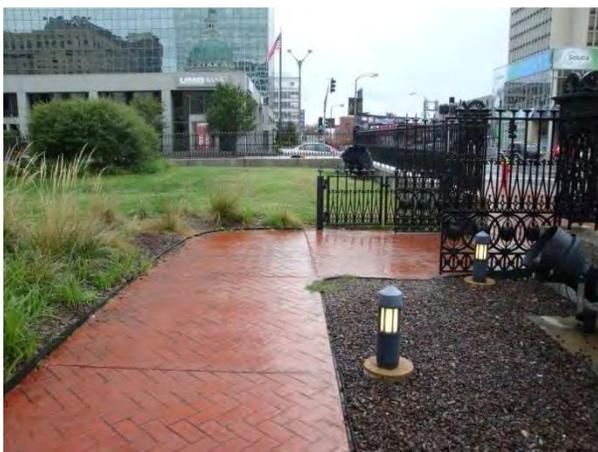
**Universal accessibility.** The mechanical lift that provides universal access to the west portico is accessed via a stamped and colorized concrete sidewalk edged by a berm. The sidewalk is visually incompatible with the historic character of the courtyards (Figure 225).

**FIGURE 225.** View of the access walk and berm. Photograph by JMA, 2011.

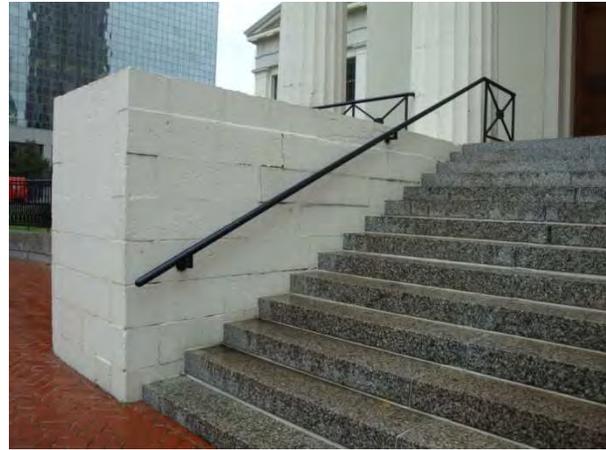
**FIGURE 231.** View southwest of the east portico steps, cheekwall, and handrail. Photograph by JMA, 2011.

Several condition issues and problems were observed in association with the porticos during field investigations conducted for this project in October 2011, including:

- Stair treads. Some of the stair treads are heavily worn. Rainwater collects in these low points and contributes to ponding, which can create slip hazards for pedestrians using the stairs.
- Sealant. Sealant used at the base of each riser is in some areas heavily applied, becoming visually intrusive.

- Cheekwalls. Past repairs have left incongruous seams and evidence of former handrail placement. Staining and biological growth are also evident in association with the cheekwalls in several locations.

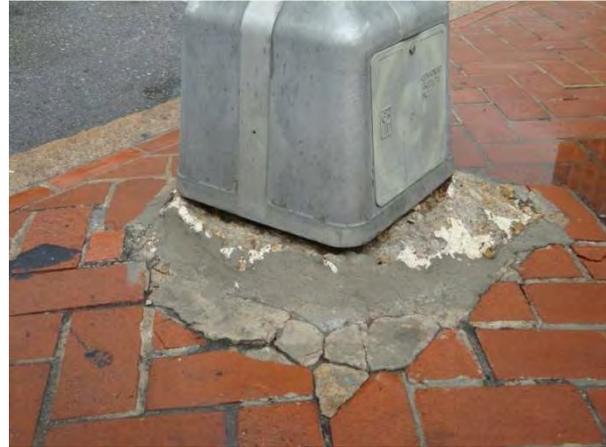
The paving was assessed in fair condition in 2011 by the National Park Service. Condition issues and problems observed in association with the sidewalk in October 2011 include (Figure 235):

- Low spots. Locations where the pavers have subsided or been dislodged to form low spots tend to hold water and exhibit problems with ponding. One of these is located along Chestnut Street near the corner with Broadway.
- Broken and uneven pavement. The paving has been damaged in several locations. Where features such as light poles and fire hydrants have been installed, there is often a

great deal of broken brick. These broken pavers may constitute trip hazards. The edge courses are also frequently broken and uneven.

- Evidence of previous repairs. Where attempts have been made to repair the pavement, incompatible mortar and brick have sometimes been used.

**FIGURE 235.** View of condition issues associated with the brick sidewalk. Photograph by JMA, 2011.

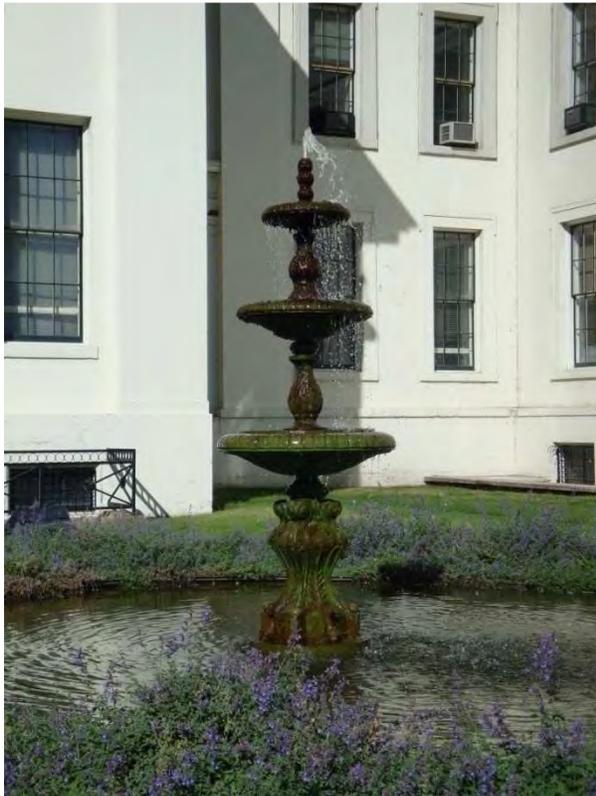
from a mechanical system housed in the basement of the south wing to a spout above the top tier. The water cascades down into each succeeding bowl and returns to the pump from the circular basin at the bottom. The fountain has a green patina (Figure 242). It was assessed in fair condition in 2011 due to staining and biological growth.

**FIGURE 242.** View west of the replica fountain, the focal point of the southeast courtyard. Photograph by JMA, 2011.

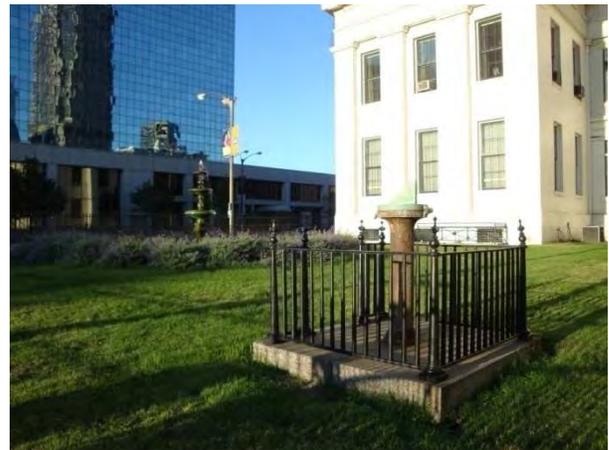
**FIGURE 243.** View southwest of the sundial located within the southeast courtyard. Photograph by JMA, 2011.

The sundial was assessed in good condition in 2011. Condition problems observed in association with the sundial in 2011 included:

- Several of the post finials are loose and could be removed.
- The iron base is rusted.

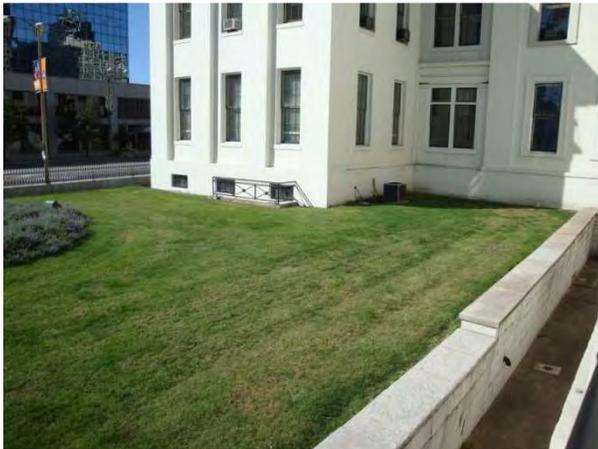
**FIGURE 244.** View southwest of the southeast courtyard, with the areaway (right) and concrete stair (middle left). Photograph by JMA, 2011.

Condition problems observed in association with the areaway in 2011 include:

- **Structural problems.** The limestone block wall is leaning in several locations, likely due to hydrostatic pressure.

- **Vegetative growth.** Vegetative growth is present along the base of the wall between the wall and the concrete walk.
- **Repairs.** A large section of the coping and other sections of the wall have been inappropriately replaced with non-original materials including concrete and brick.
- **Concrete.** The concrete exhibits problems with cracking and spalling.
- **Marble.** The marble threshold is worn, cracked, and broken in places.

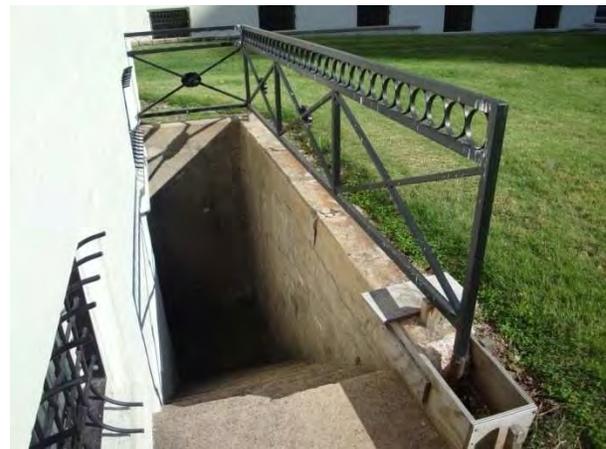
Condition problems observed in association with the concrete stairs in October 2011 include:

- **Concrete.** The concrete retaining wall is spalling and cracking, and a portion of the wall requires replacement.

**FIGURE 245.** View north of the concrete stair edging the south wing of the Old Courthouse. Photograph by JMA, 2011.

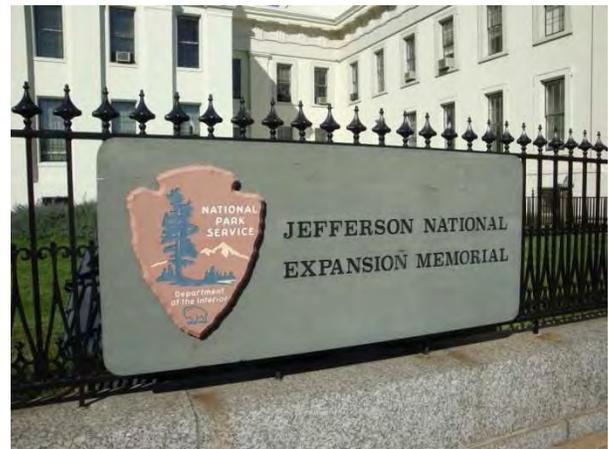
Condition issues associated with these features observed in October 2011 include:

- Damage. Some of the wood of the sign has been gouged.

**FIGURE 246.** View northwest of the identity sign mounted on the Fourth Street fence that frames the southeast courtyard. Photograph by JMA, 2011.

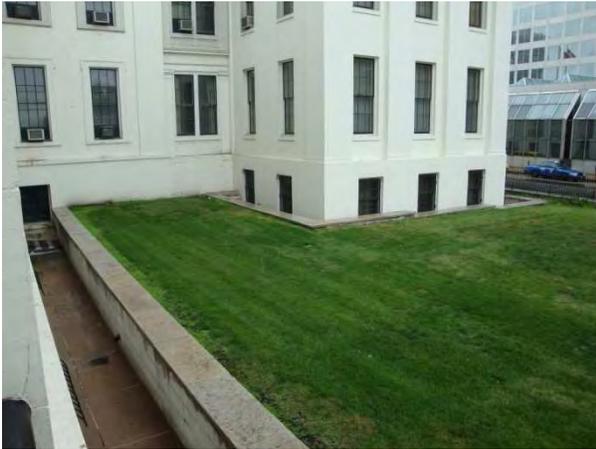
**FIGURE 249.** View west of the areaway that edges the east wing within the northeast courtyard. Photograph by JMA, 2011.

Condition issues and problems identified with the areaways and retaining walls during fieldwork conducted in October 2011 include:

- Structural problems. The limestone block wall is leaning in several locations, likely due to hydrostatic pressure.
- Vegetative growth. Vegetative growth is present along the base of the wall between the wall and the concrete walk.
- Repairs. Some of the limestone blocks in the wall are cracked, or displaced. Others have been replaced with non-original materials, such as brick and concrete.
- Concrete. The concrete exhibits problems with cracking, breakage, and spalling.
- Marble. The marble steps are cracked, broken, and exhibit biological growth.

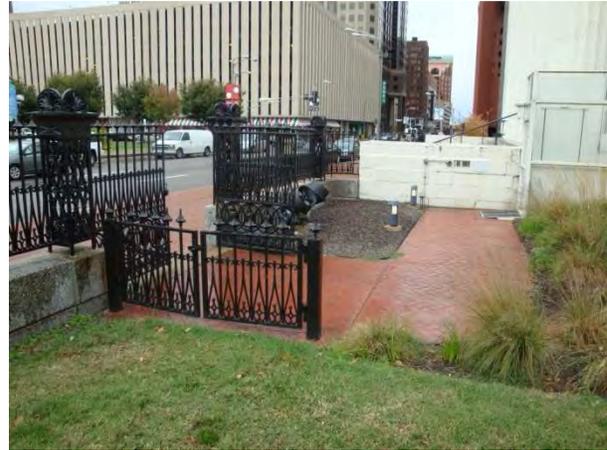
limit visitor access to the courtyard. Portions of the perimeter wall and gate appear to have been damaged as part of the modifications. The original double leaf gate is anchored into an open position with metal poles. The second gate is a low, wrought iron structure similar in appearance to the older gate, but with a portion of the top missing, that is supported by posts set to either side (Figure 253).

**FIGURE 253.** View northwest of the two gates and the berm that limits access to portions of the southwest courtyard. Photograph by JMA, 2011.

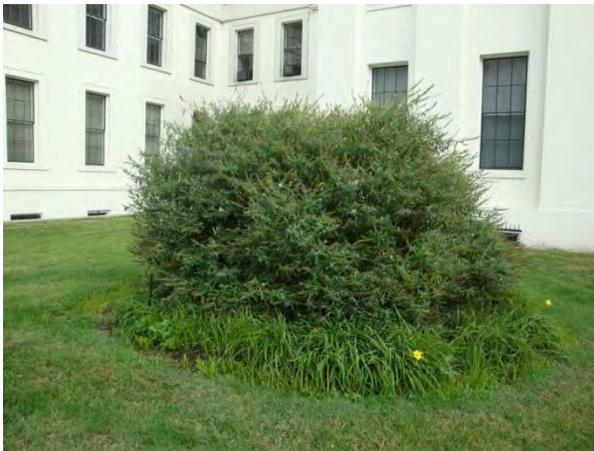
Condition issues and problems identified with the planting beds during fieldwork conducted in October 2011 include:

- Metal edging. The metal edging that contains the central planting bed is not a heavy enough grade for the size of mowers used to maintain the courtyard turf. It has been damaged in several places by the mowers.
- Weeds. The planting bed is filled with weeds.

**FIGURE 254.** View northeast of the butterfly bush and daylily planting that forms a focal point within the southwest courtyard. A rain gauge and uplight are positioned behind the shrub. Photograph by JMA, 2011.

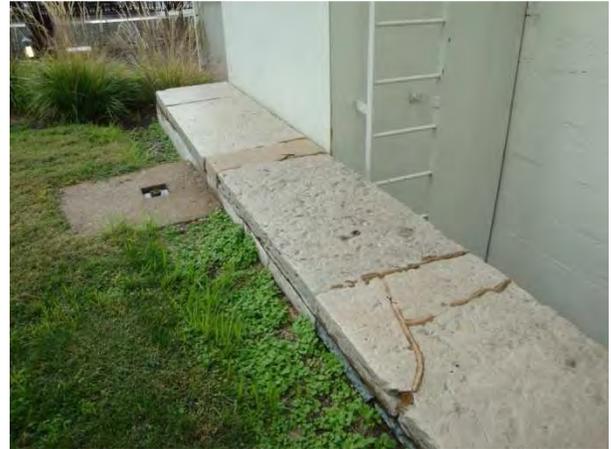
Condition issues and problems identified with the turf and irrigation system during fieldwork conducted in October 2011 include:

- Turf damage. The turf is gouged in places.

- Weeds. There are several areas of weedy growth.
- Irrigation system. Several irrigation heads appear to have been damaged by mowers.

**FIGURE 255.** View west of one of the concrete slabs used to protect irrigation heads within the southwest courtyard. The irrigation head sits adjacent to the areaway retaining wall. The back of the mechanical lift is visible behind. Photograph by JMA, 2011.

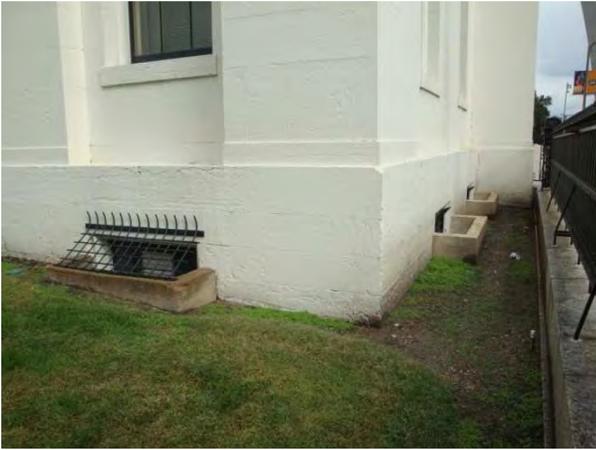
Condition issues and problems identified with the widow wells during fieldwork conducted in October 2011 include:

- Damage. The marble surround is cracked and damaged in several places.

**FIGURE 256.** View east of three of the concrete-edged window wells along the south wing of the Old Courthouse within the southwest courtyard. Photograph by JMA, 2011.

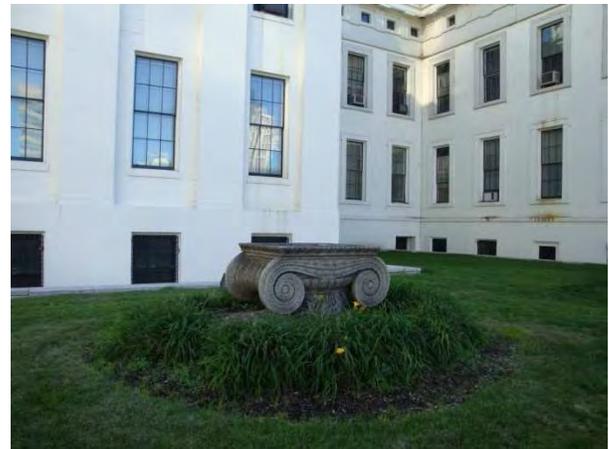
Condition issues and problems observed in association with this courtyard in October 2011 include:

- Ponding. The top of the Ionic capital is relatively level and water tends to pond on

the top, which may lead to freeze-thaw and water penetration problems.

**FIGURE 258.** View southeast of the Ionic capital in the northwest courtyard. Also visible are the daylily plantings associated with the column. Photograph by JMA, 2011.

Condition issues and problems observed in association with the plantings in October 2011 include:

- **Metal edging.** The metal edging that contains the central planting bed is not a heavy enough grade for the size of mowers used to maintain the courtyard turf. It has been damaged in several places by the mowers.
- **Weeds.** The planting bed is filled with weeds.

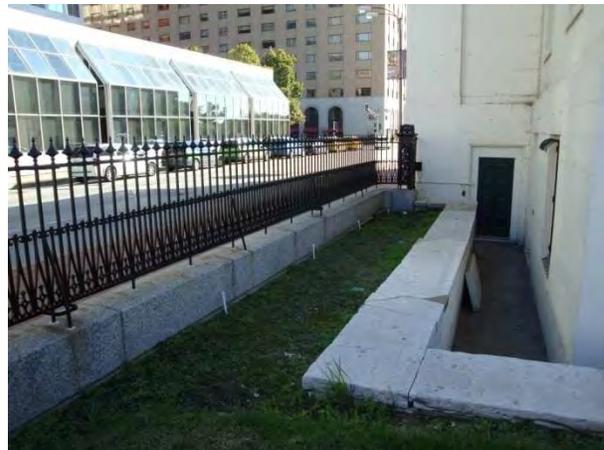
**FIGURE 259.** View east along the areaway that parallels the north wing of the Old Courthouse in the northwest courtyard. Photograph by JMA, 2011.

Condition issues and problems observed in association with the areaways in October 2011 include:

- **Structural problems.** The limestone block wall is leaning in several locations, likely due to hydrostatic pressure.
- **Vegetative growth.** Vegetative growth is present along the base of the wall between the wall and the concrete walk. Biological growth is evident around the window openings.

- Repairs. Some of the limestone blocks in the wall are cracked, or displaced. Others have been replaced with other materials, such as brick and concrete.
- Concrete. The concrete exhibits problems with cracking, breakage, and spalling. The stairs that lead down to the concrete basement-level walkway are spalled and cracked.
- Marble. The marble steps that lead down into the basement-level concrete walkway from Chestnut Street are worn and cracked.

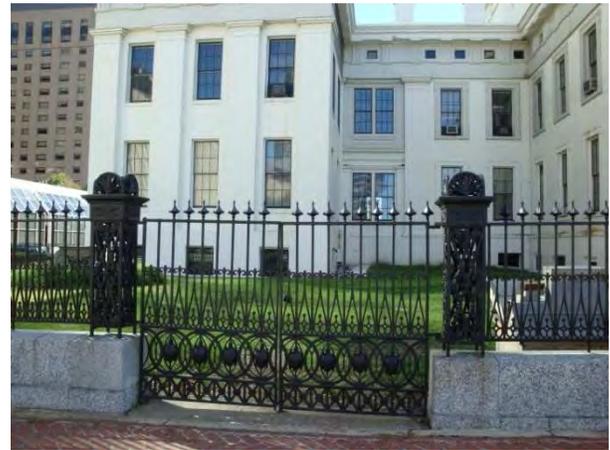
**FIGURE 260.** View of the double-leaf gate along Broadway associated with the northwest courtyard. Photograph by JMA, 2011.

Condition issues and problems observed in association with the gates in October 2011 include:

- Evidence of repair. The concrete curbing that edges the granite base of the fence has been obviously repaired near the corner at Broadway and Chestnut streets, but remains damaged.

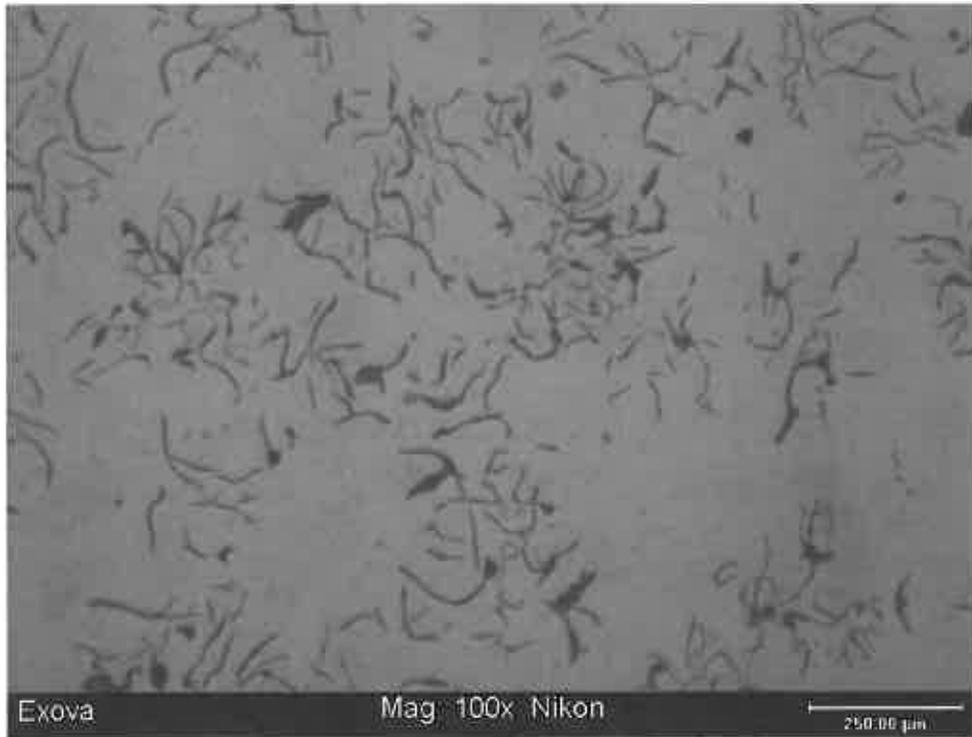
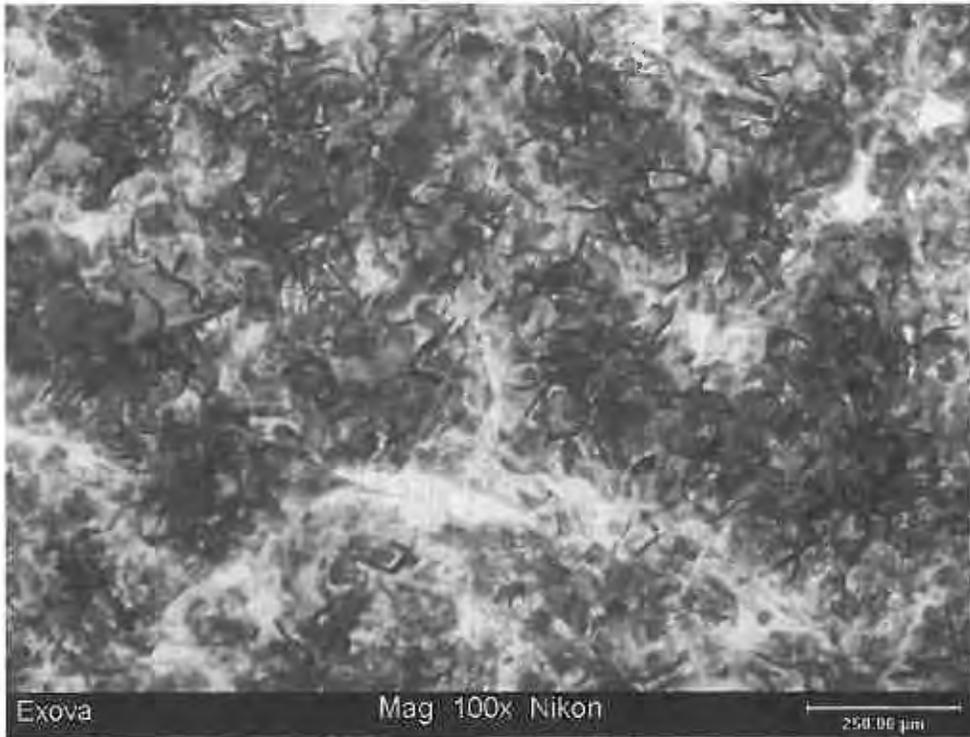
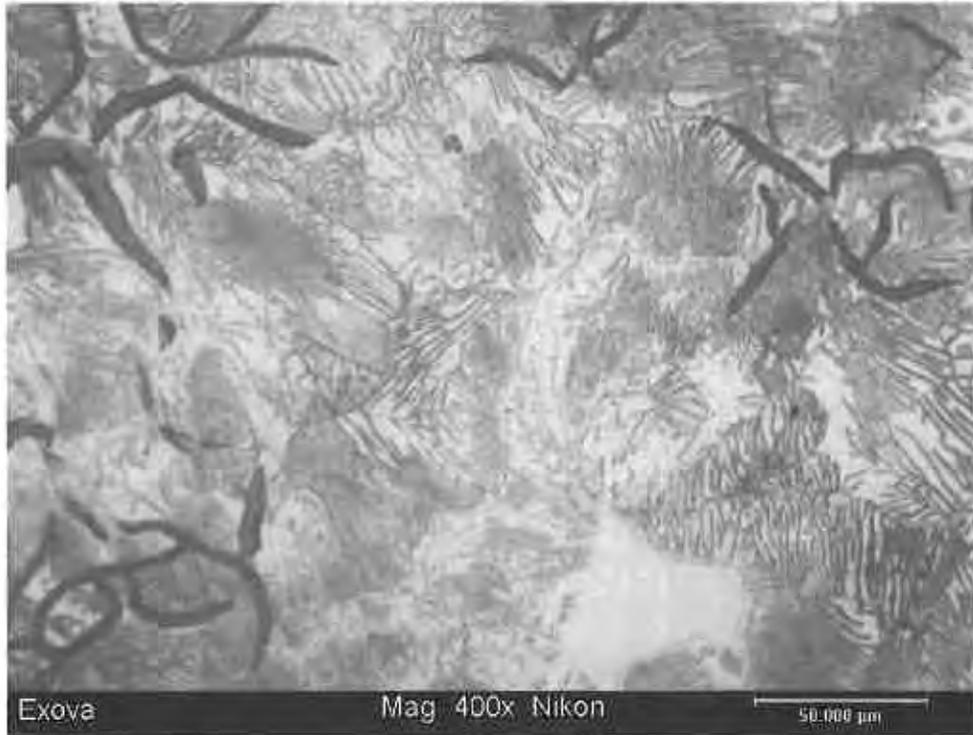
Item - CHEMISTRY AND MICROSTRUCTURE FROM OLD COURTHOUSE IN ST. LOUIS, SAMPLE 9-EAST WING, FIRST FLOOR BEAM, REMOVED 1/12/12

Micro Examination - ASTM E3 -11			
	Position	Details	Comments
002:Microstructural Exam	Random Area	General Structure	See Below
Item 02: Gray iron microstructure observed: flake graphite in an essentially pearlitic matrix with ferrite and steadite

The composition and microstructure of the section are indicative of gray cast iron.
