# **Jefferson National Expansion Memorial Old Courthouse**

St. Louis, Missouri

## **Historic Structure Report Special Issues**

July 2013

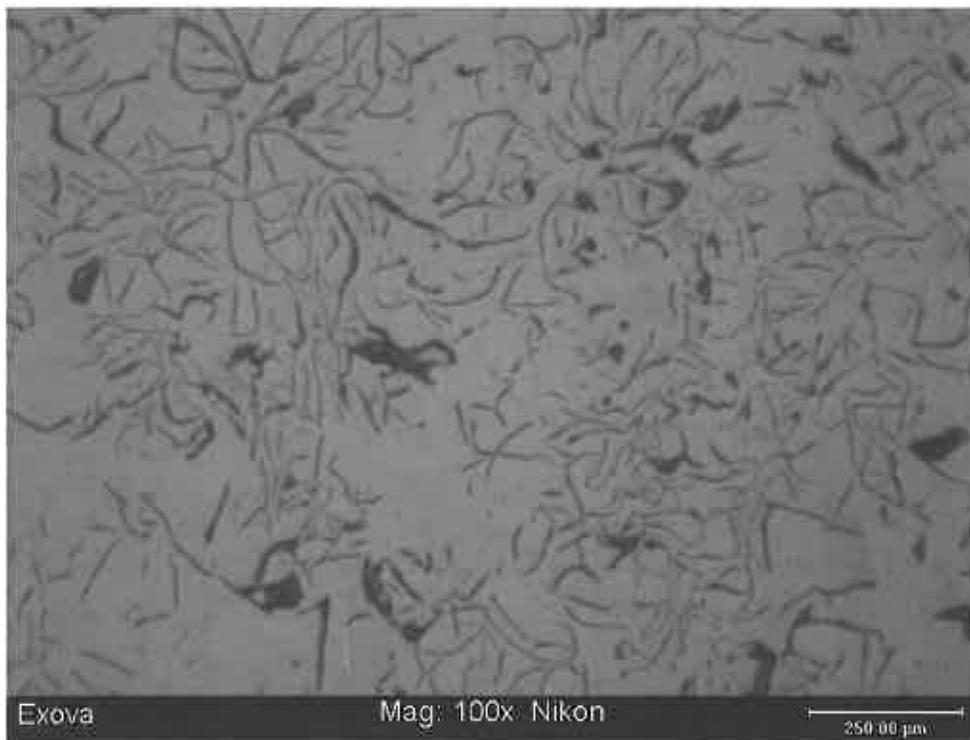
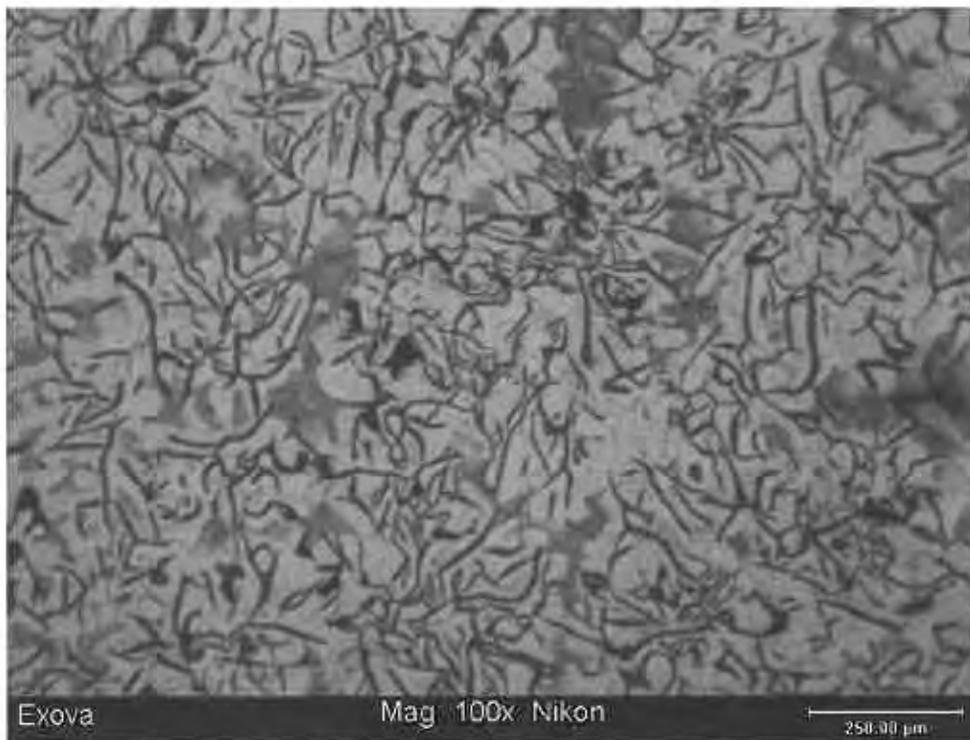
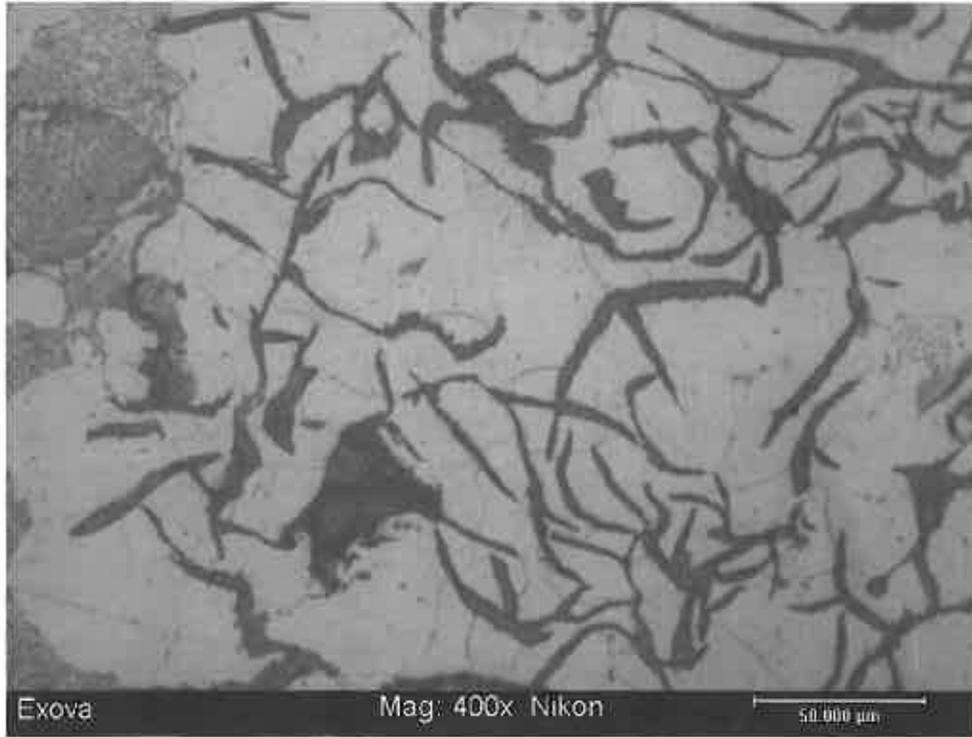
Item - CHEMISTRY AND MICROSTRUCTURE FROM OLD COURTHOUSE IN ST. LOUIS, SAMPLE 10-NORTH WING, FIRST FLOOR BEAM, REMOVED 1/11/12

Item 02: Gray iron microstructure observed; flake graphite in an essentially ferritic matrix with pearlite

The composition and microstructure of the section are indicative of gray cast iron.

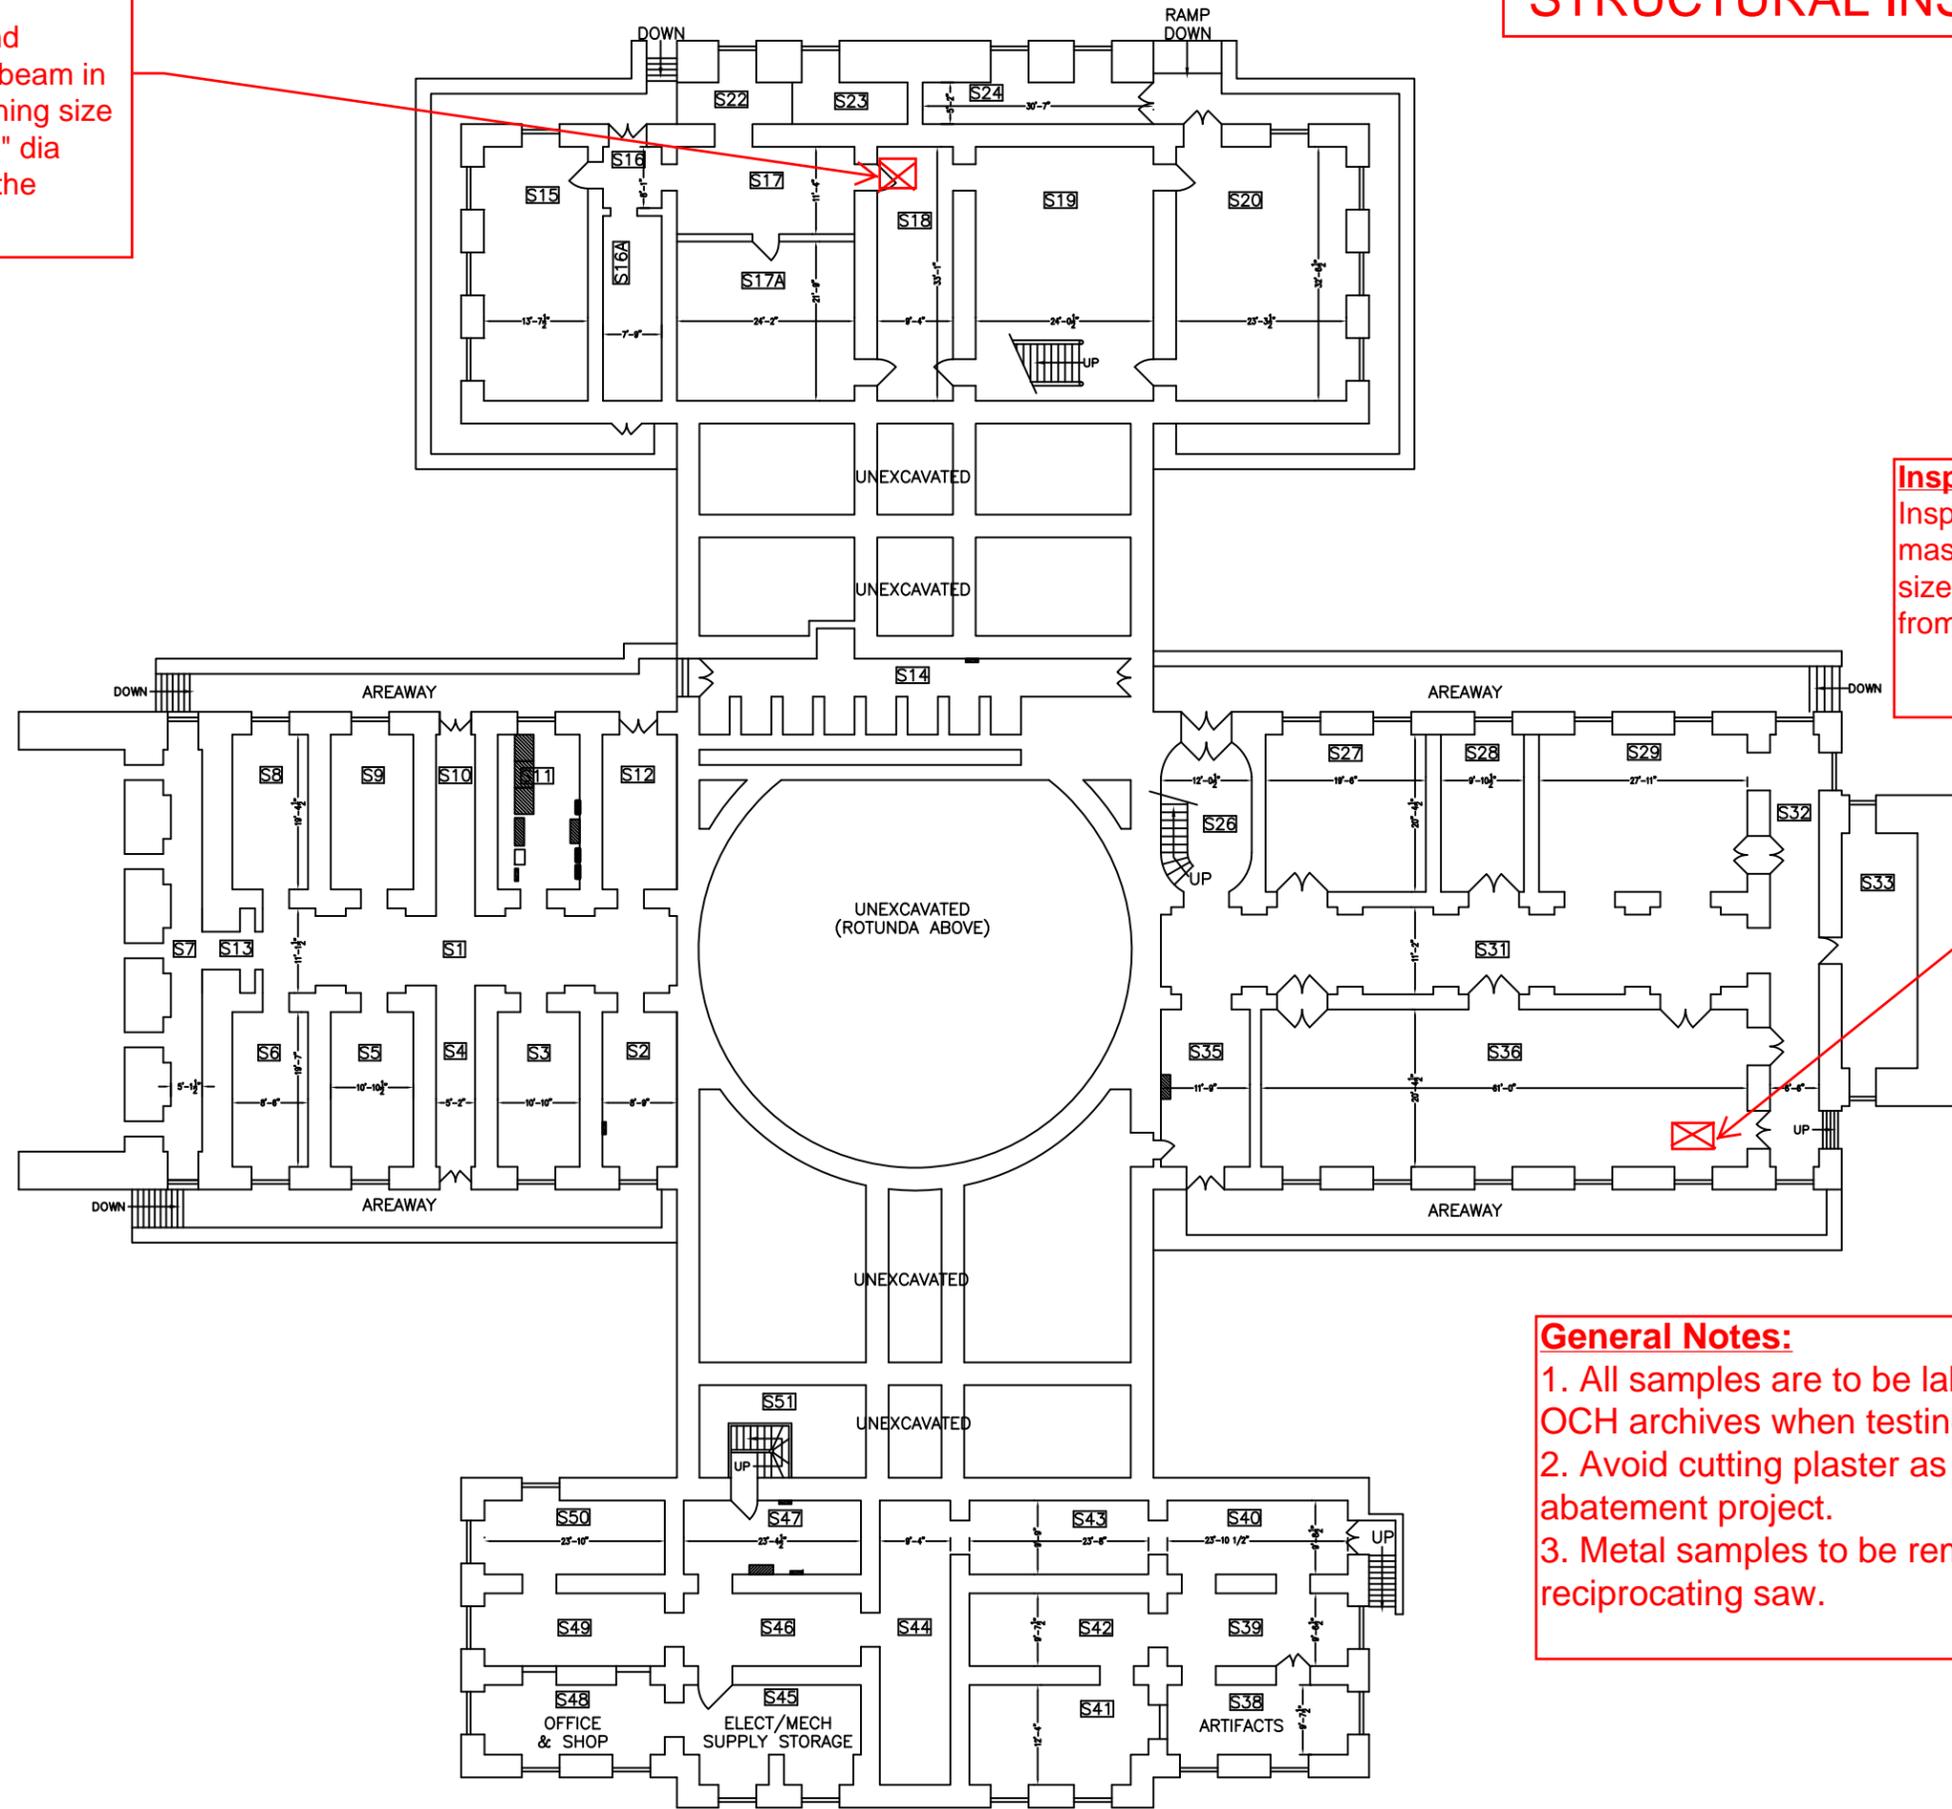
**STRUCTURAL INSPECTION OPENINGS**

**Inspection Opening #1 & Sample Location #10**  
 Inspection Opening in plaster and masonry arch alongside double beam in ceiling of conference room (opening size approx. 8"x12"). Remove (2) 3/4" dia plugs from the bottom flange of the beam.

**Inspection Opening #2 & Sample Location #9**  
 Inspection Opening alongside iron beam in masonry arch in ceiling of workshop. (Opening size approx. 12"x12"). Remove (2) 3/4" plugs from bottom flange of beam.

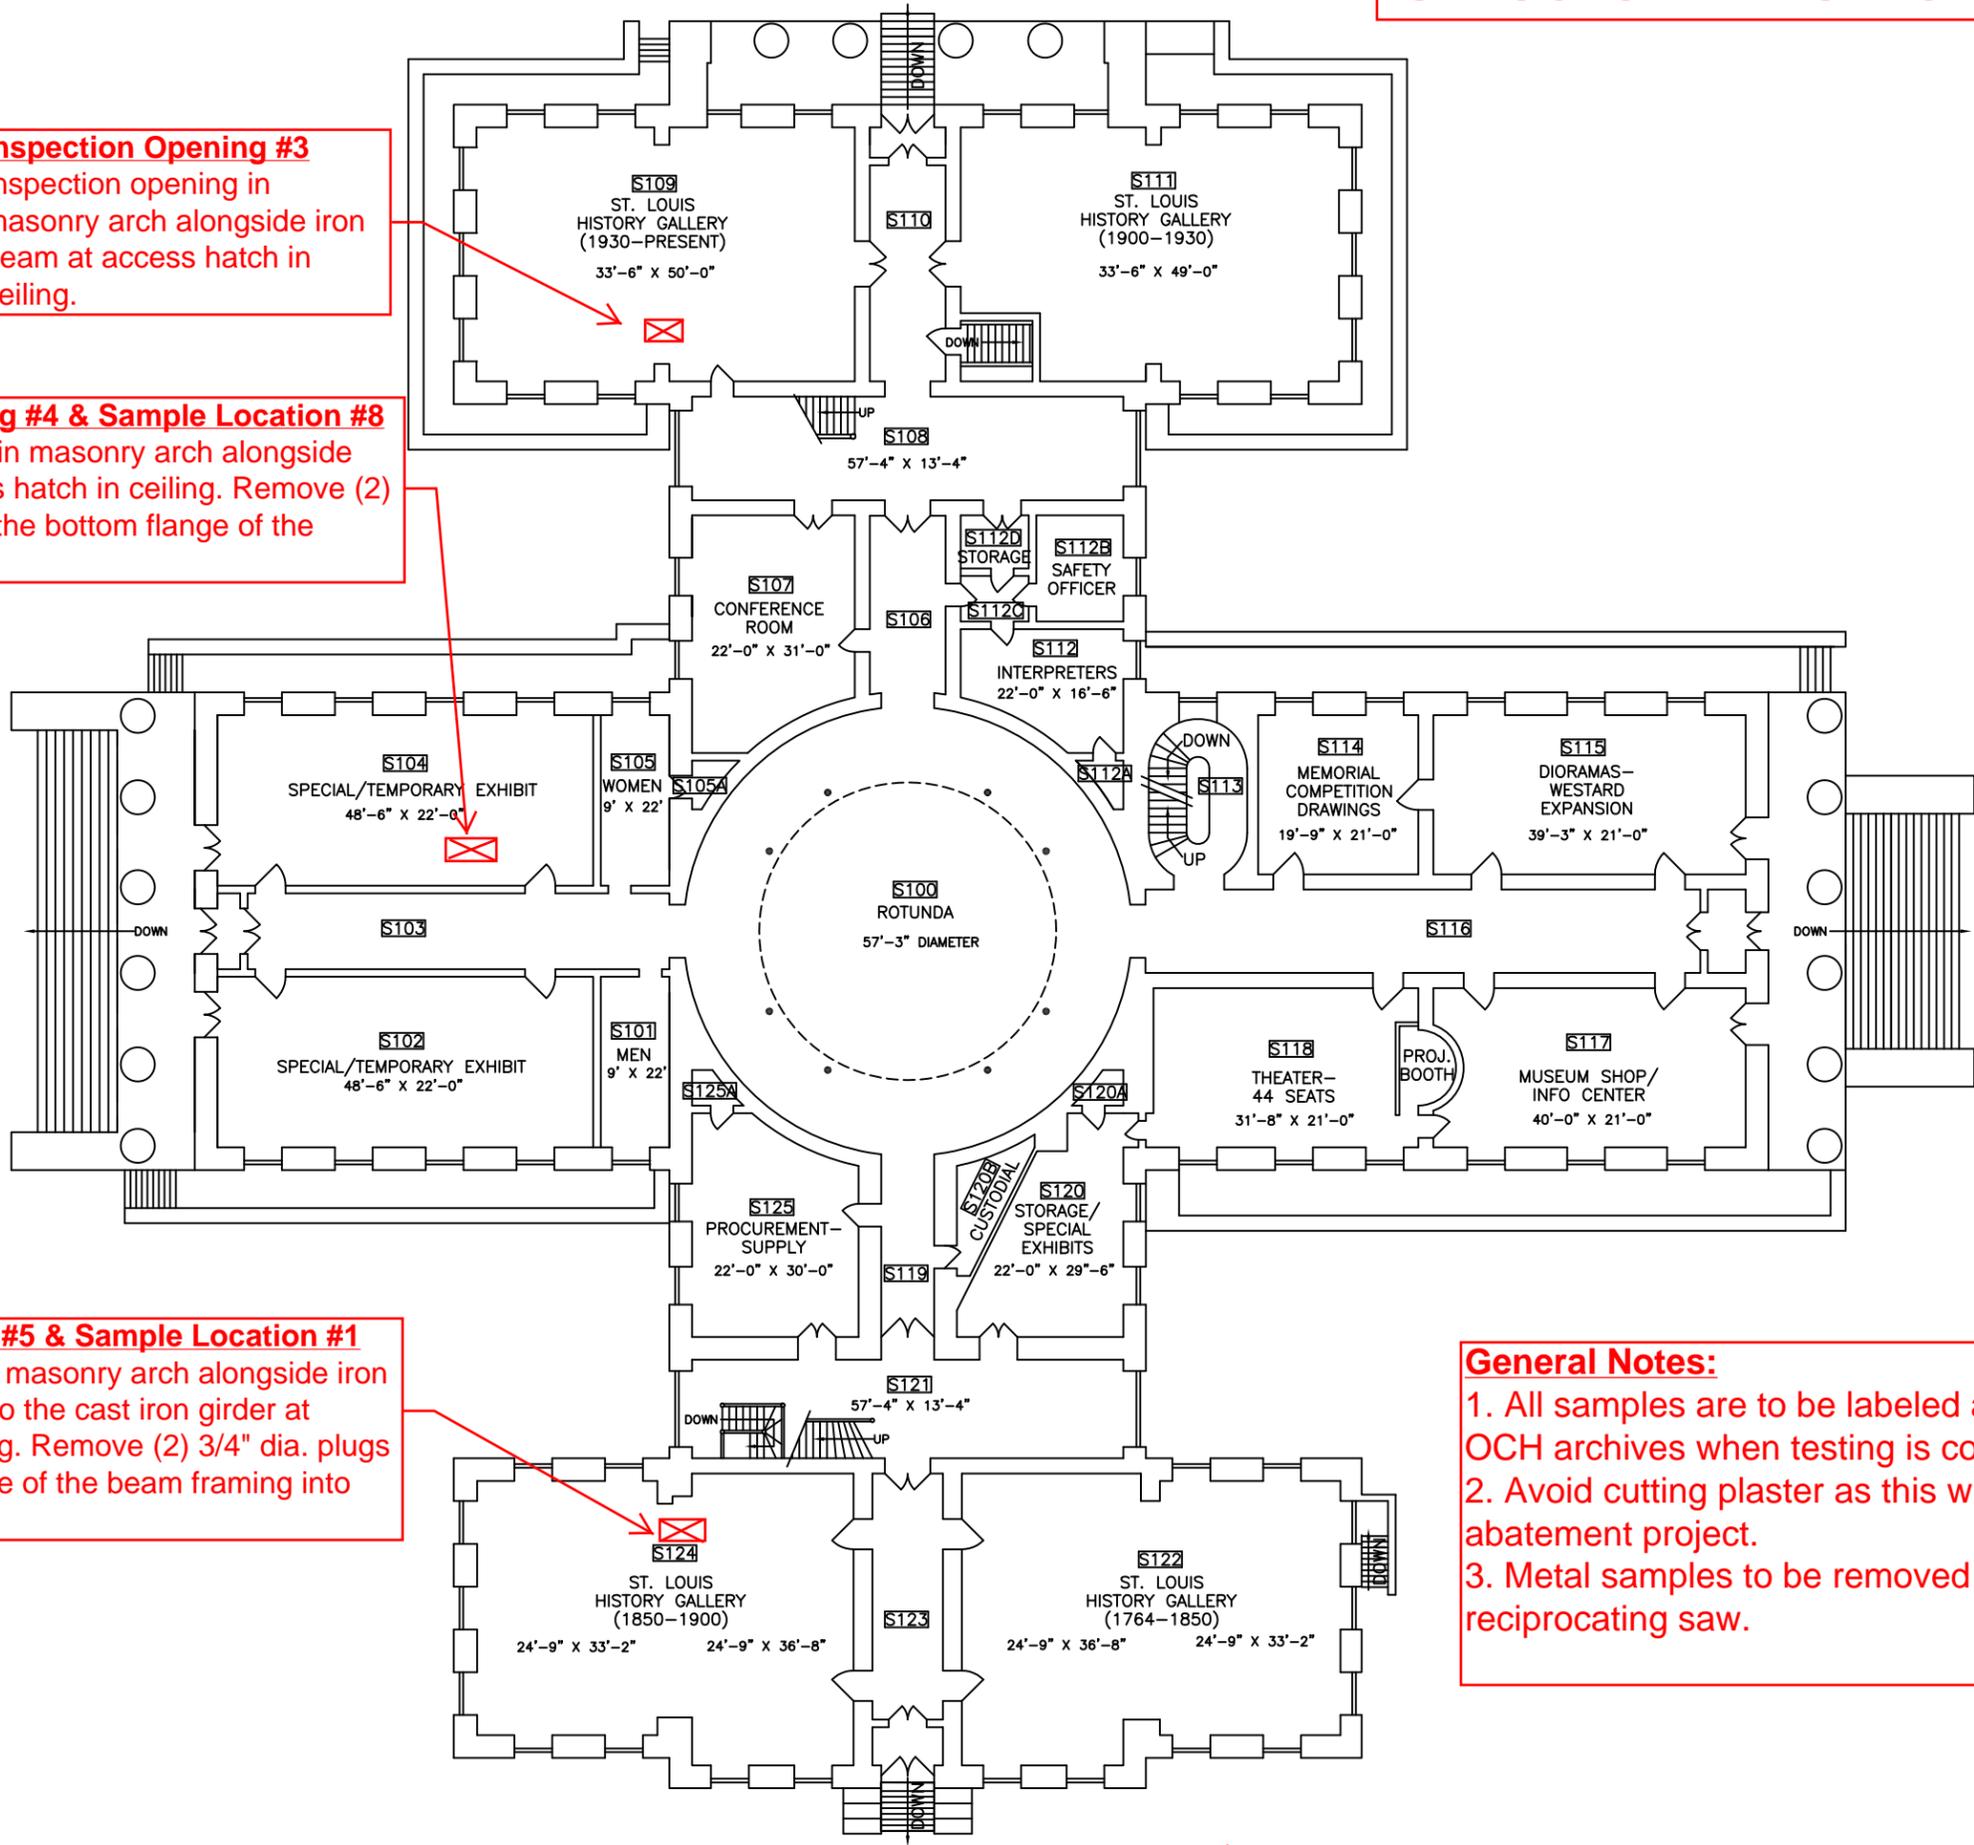
**Inspection Opening #4 & Sample Location #8**  
 Inspection opening in masonry arch alongside iron beam at access hatch in ceiling. Remove (2) 3/4" dia plugs from the bottom flange of the beam.

**Inspection Opening #5 & Sample Location #1**  
 Inspection opening in masonry arch alongside iron beam which frame into the cast iron girder at access hatch in ceiling. Remove (2) 3/4" dia. plugs from the bottom flange of the beam framing into the girder.

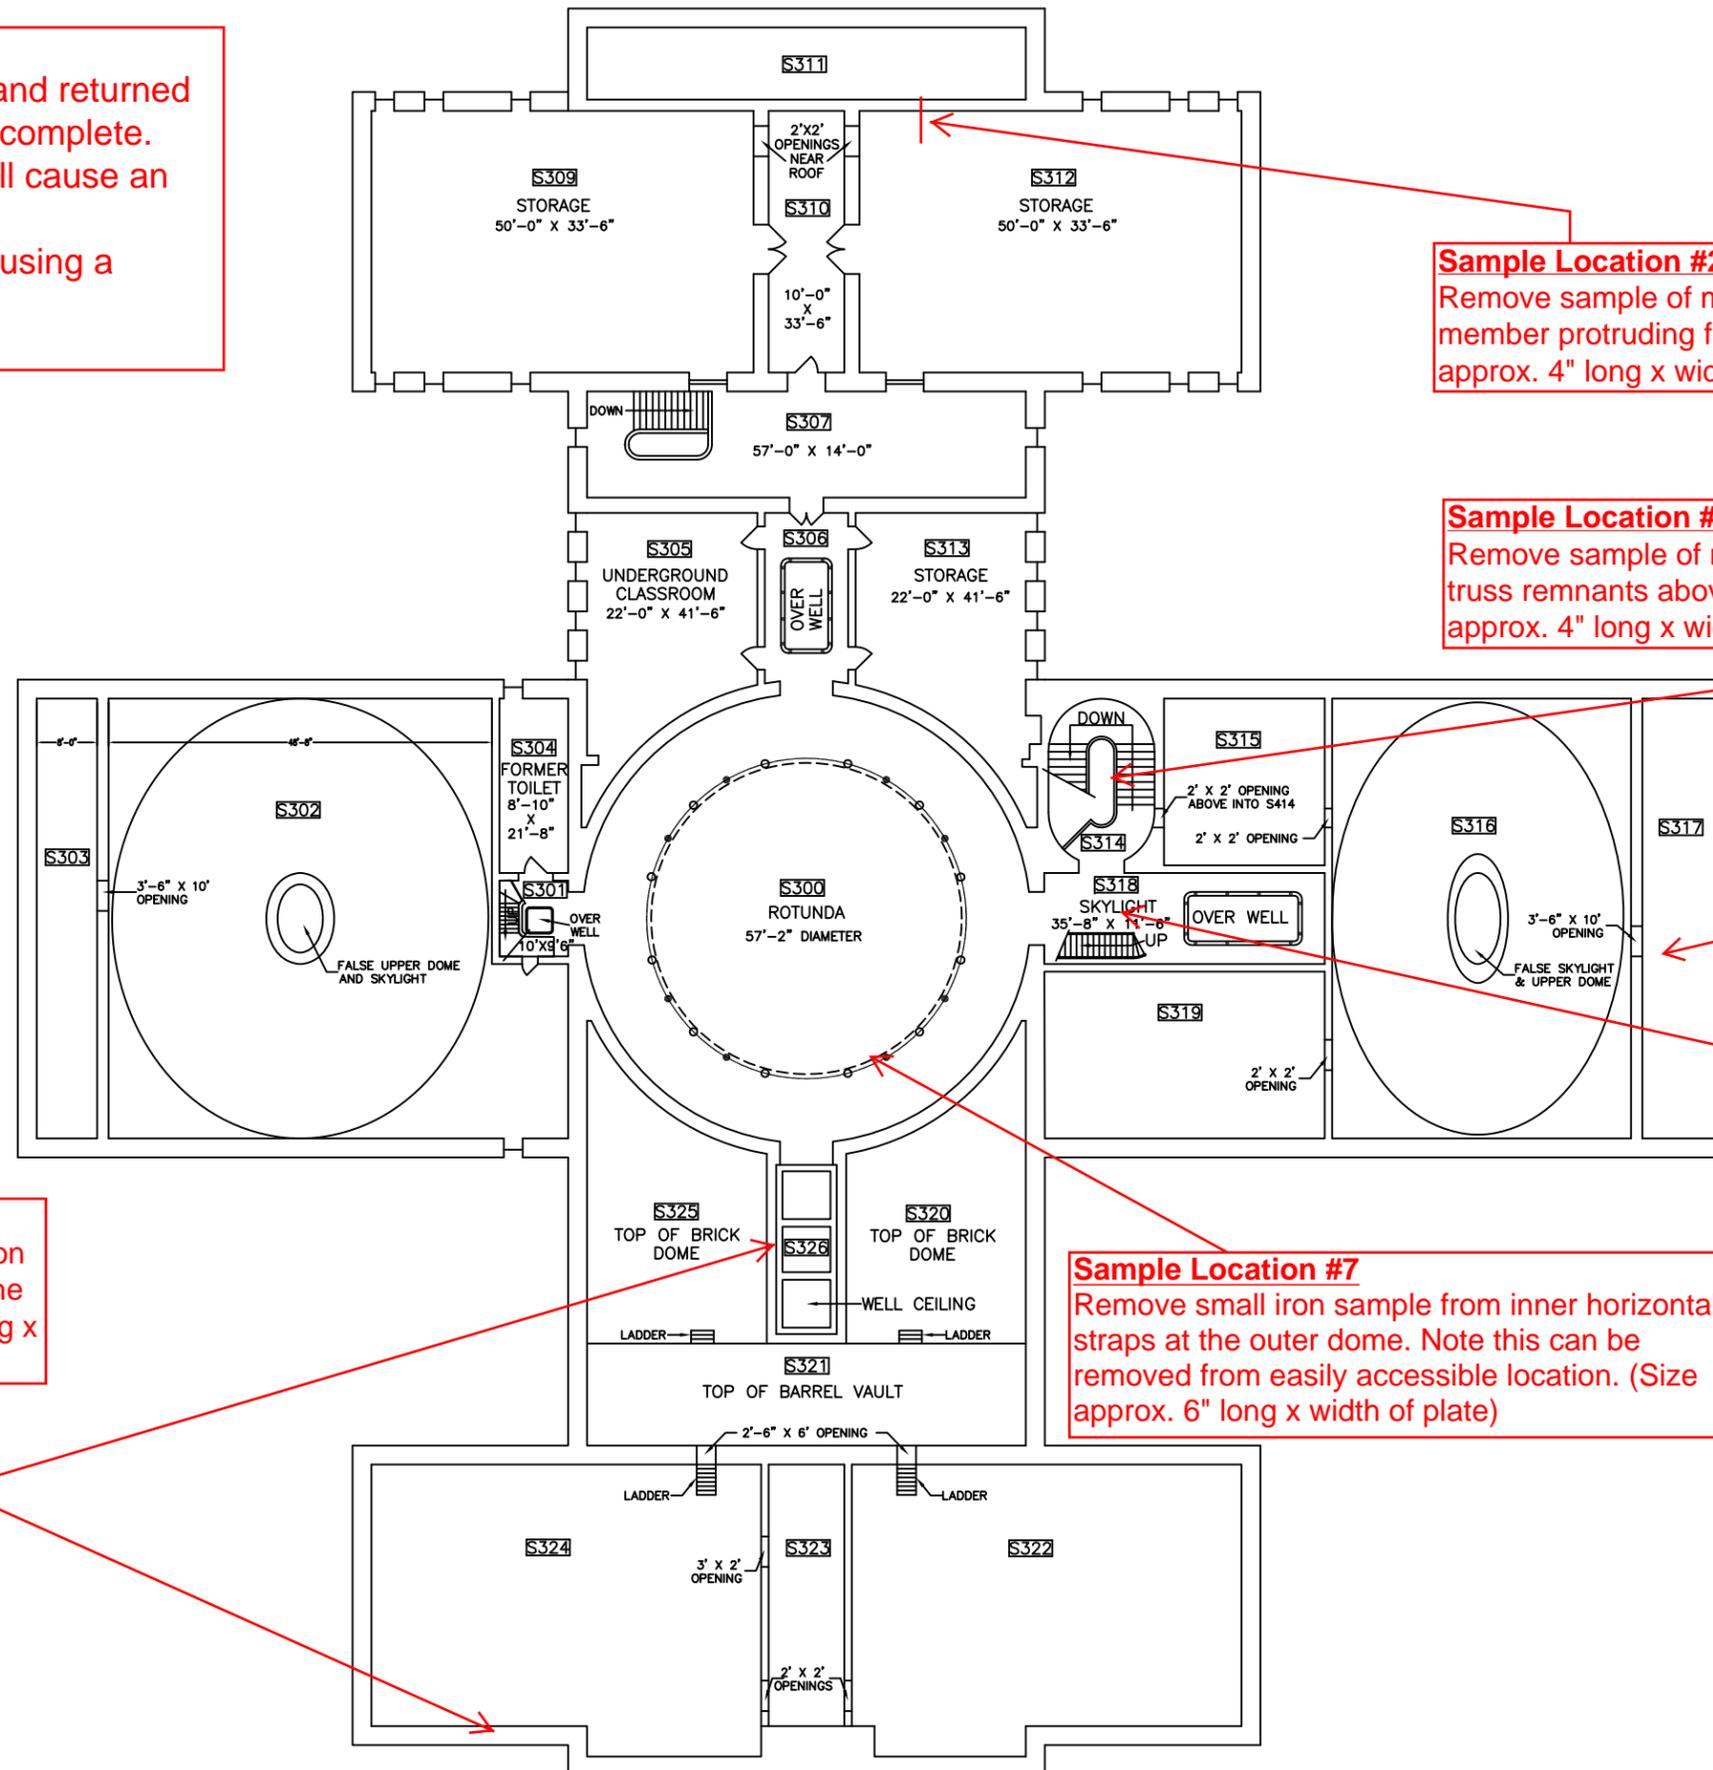
### Sample Location #2

Remove sample of metal of portion of truss member protruding from the masonry wall. (Size approx. 4" long x width of plates)

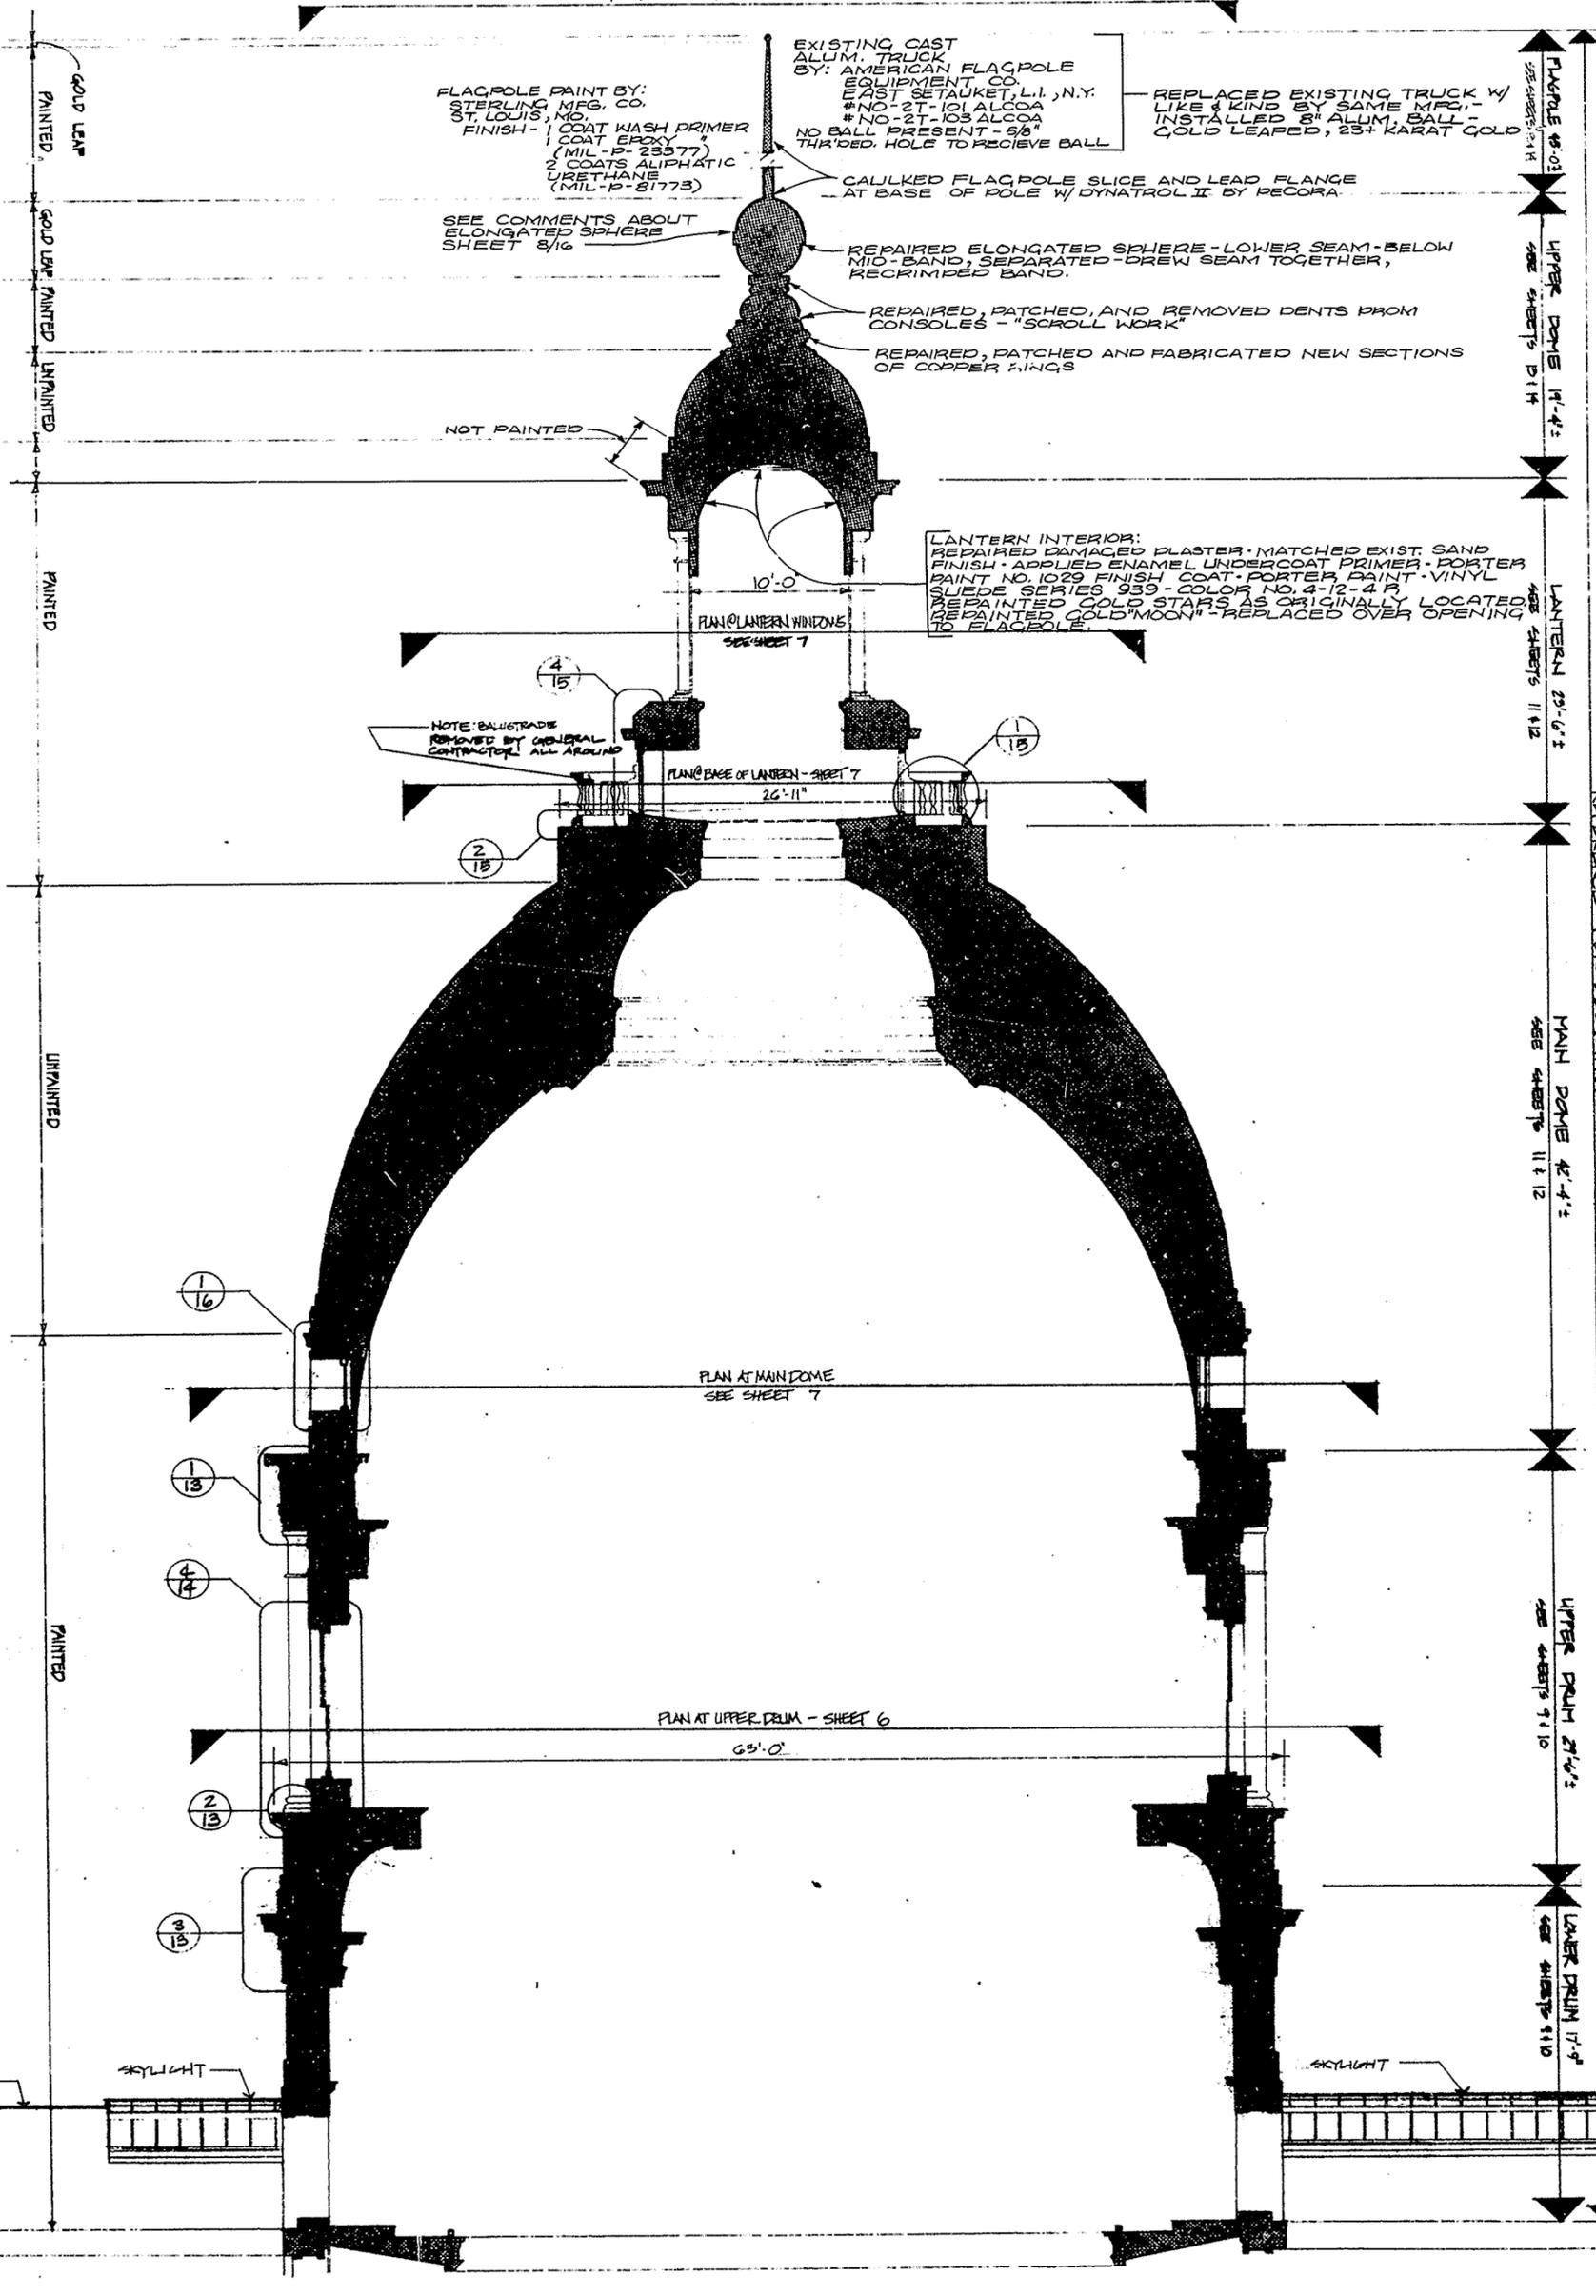
SECTION THROUGH LANTERN, DOME & DRUM  
SCALE IN FEET  
DRAWN @ 3/16" = 1'-0"

REPAIRED ELONGATED SPHERE - LOWER SEAM - BELOW  
MID-BAND, SEPARATED - DREW SEAM TOGETHER,  
RECRIMPED BAND.

REPAIRED, PATCHED, AND REMOVED DENTS FROM  
CONSOLES - "SCROLL WORK"

REPAIRED, PATCHED AND FABRICATED NEW SECTIONS  
OF COPPER FINIS

LANTERN INTERIOR:  
REPAIRED DAMAGED PLASTER - MATCHED EXIST SAND  
FINISH - APPLIED ENAMEL UNDERCOAT PRIMER - PORTER  
PAINT NO. 1029 - FINISH COAT - PORTER PAINT - VINYL  
SLIIDE SERIES 939 - COLOR NO. 4-12-4 R  
REPAINTED GOLD STARS AS ORIGINALLY LOCATED  
REPAINTED GOLD "MOON" - REPLACED OVER OPENING  
TO FLAGPOLE.

REPLACED EXISTING TRUCK W/  
LIKE & KIND BY SAME MFG.  
INSTALLED 8" ALUM. BALL -  
GOLD LEAFED, 23+ KARAT GOLD
